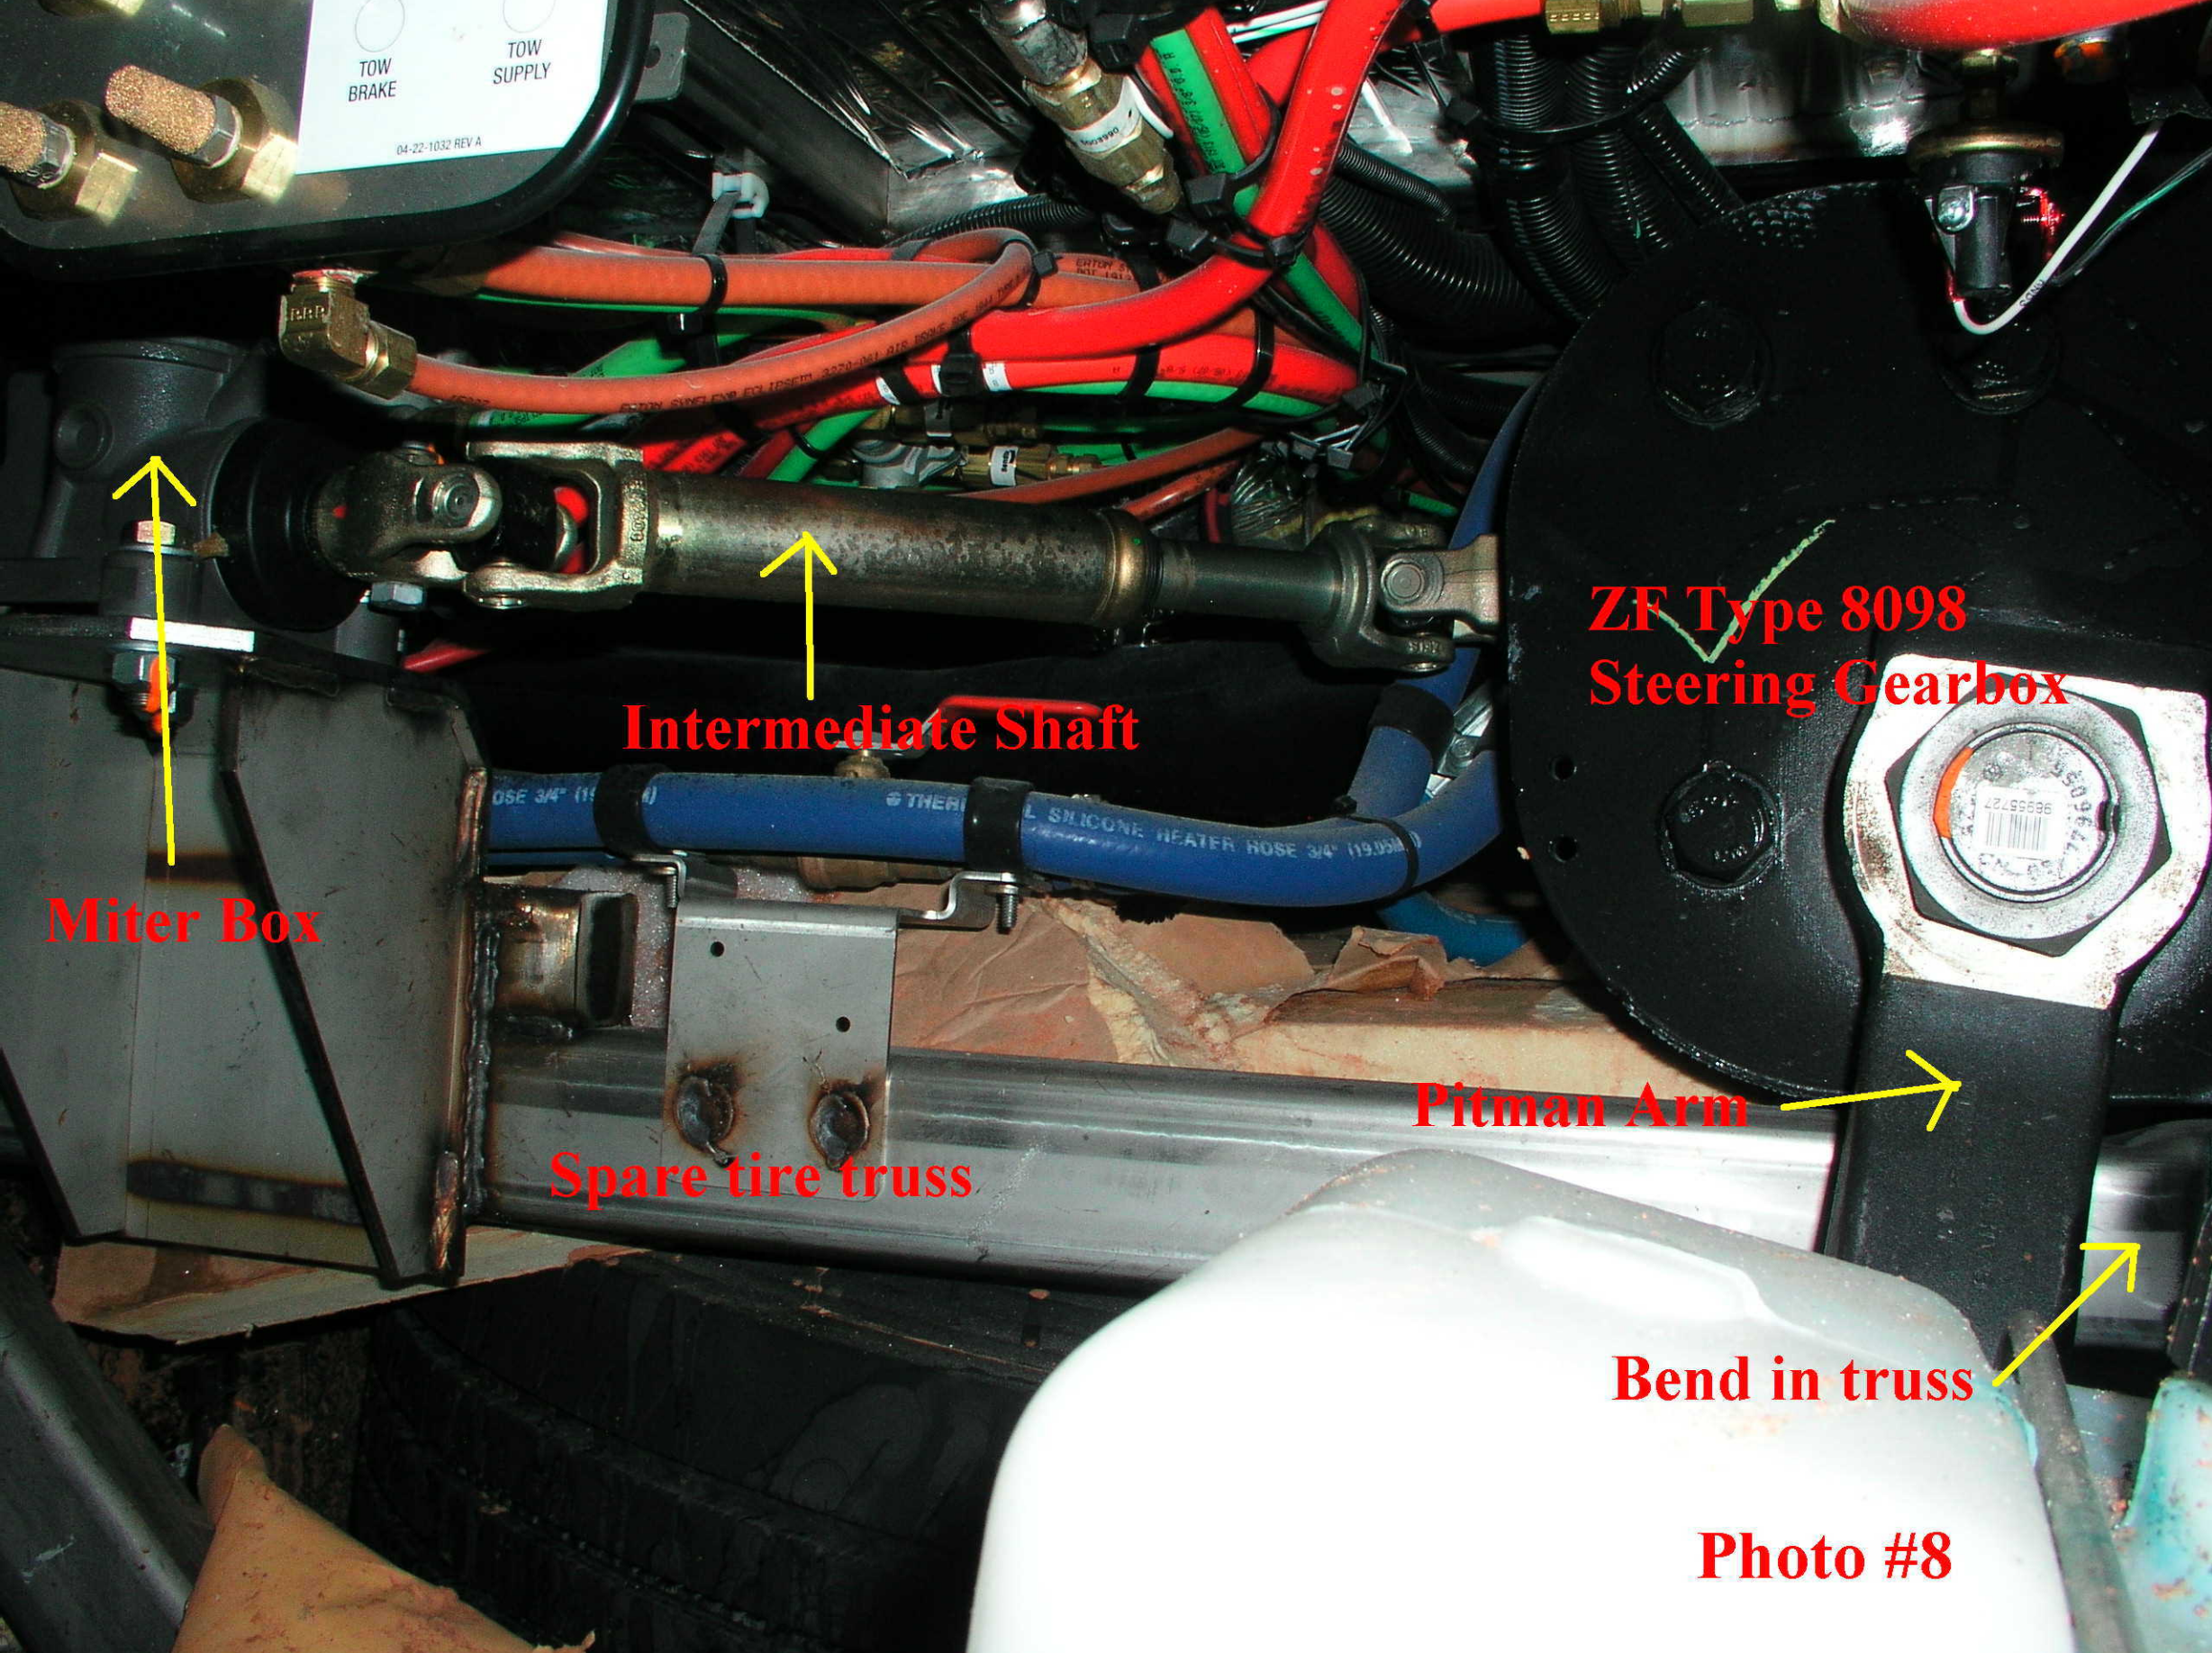
Photo #8

Veh. Photo #08 - Photo with miter box on the left with intermediate shaft attached. The spare tire truss, upon which the miter box is mounted is bowed up, as evidenced by the crease in the truss that can be seen at the very right edge of the photo,
