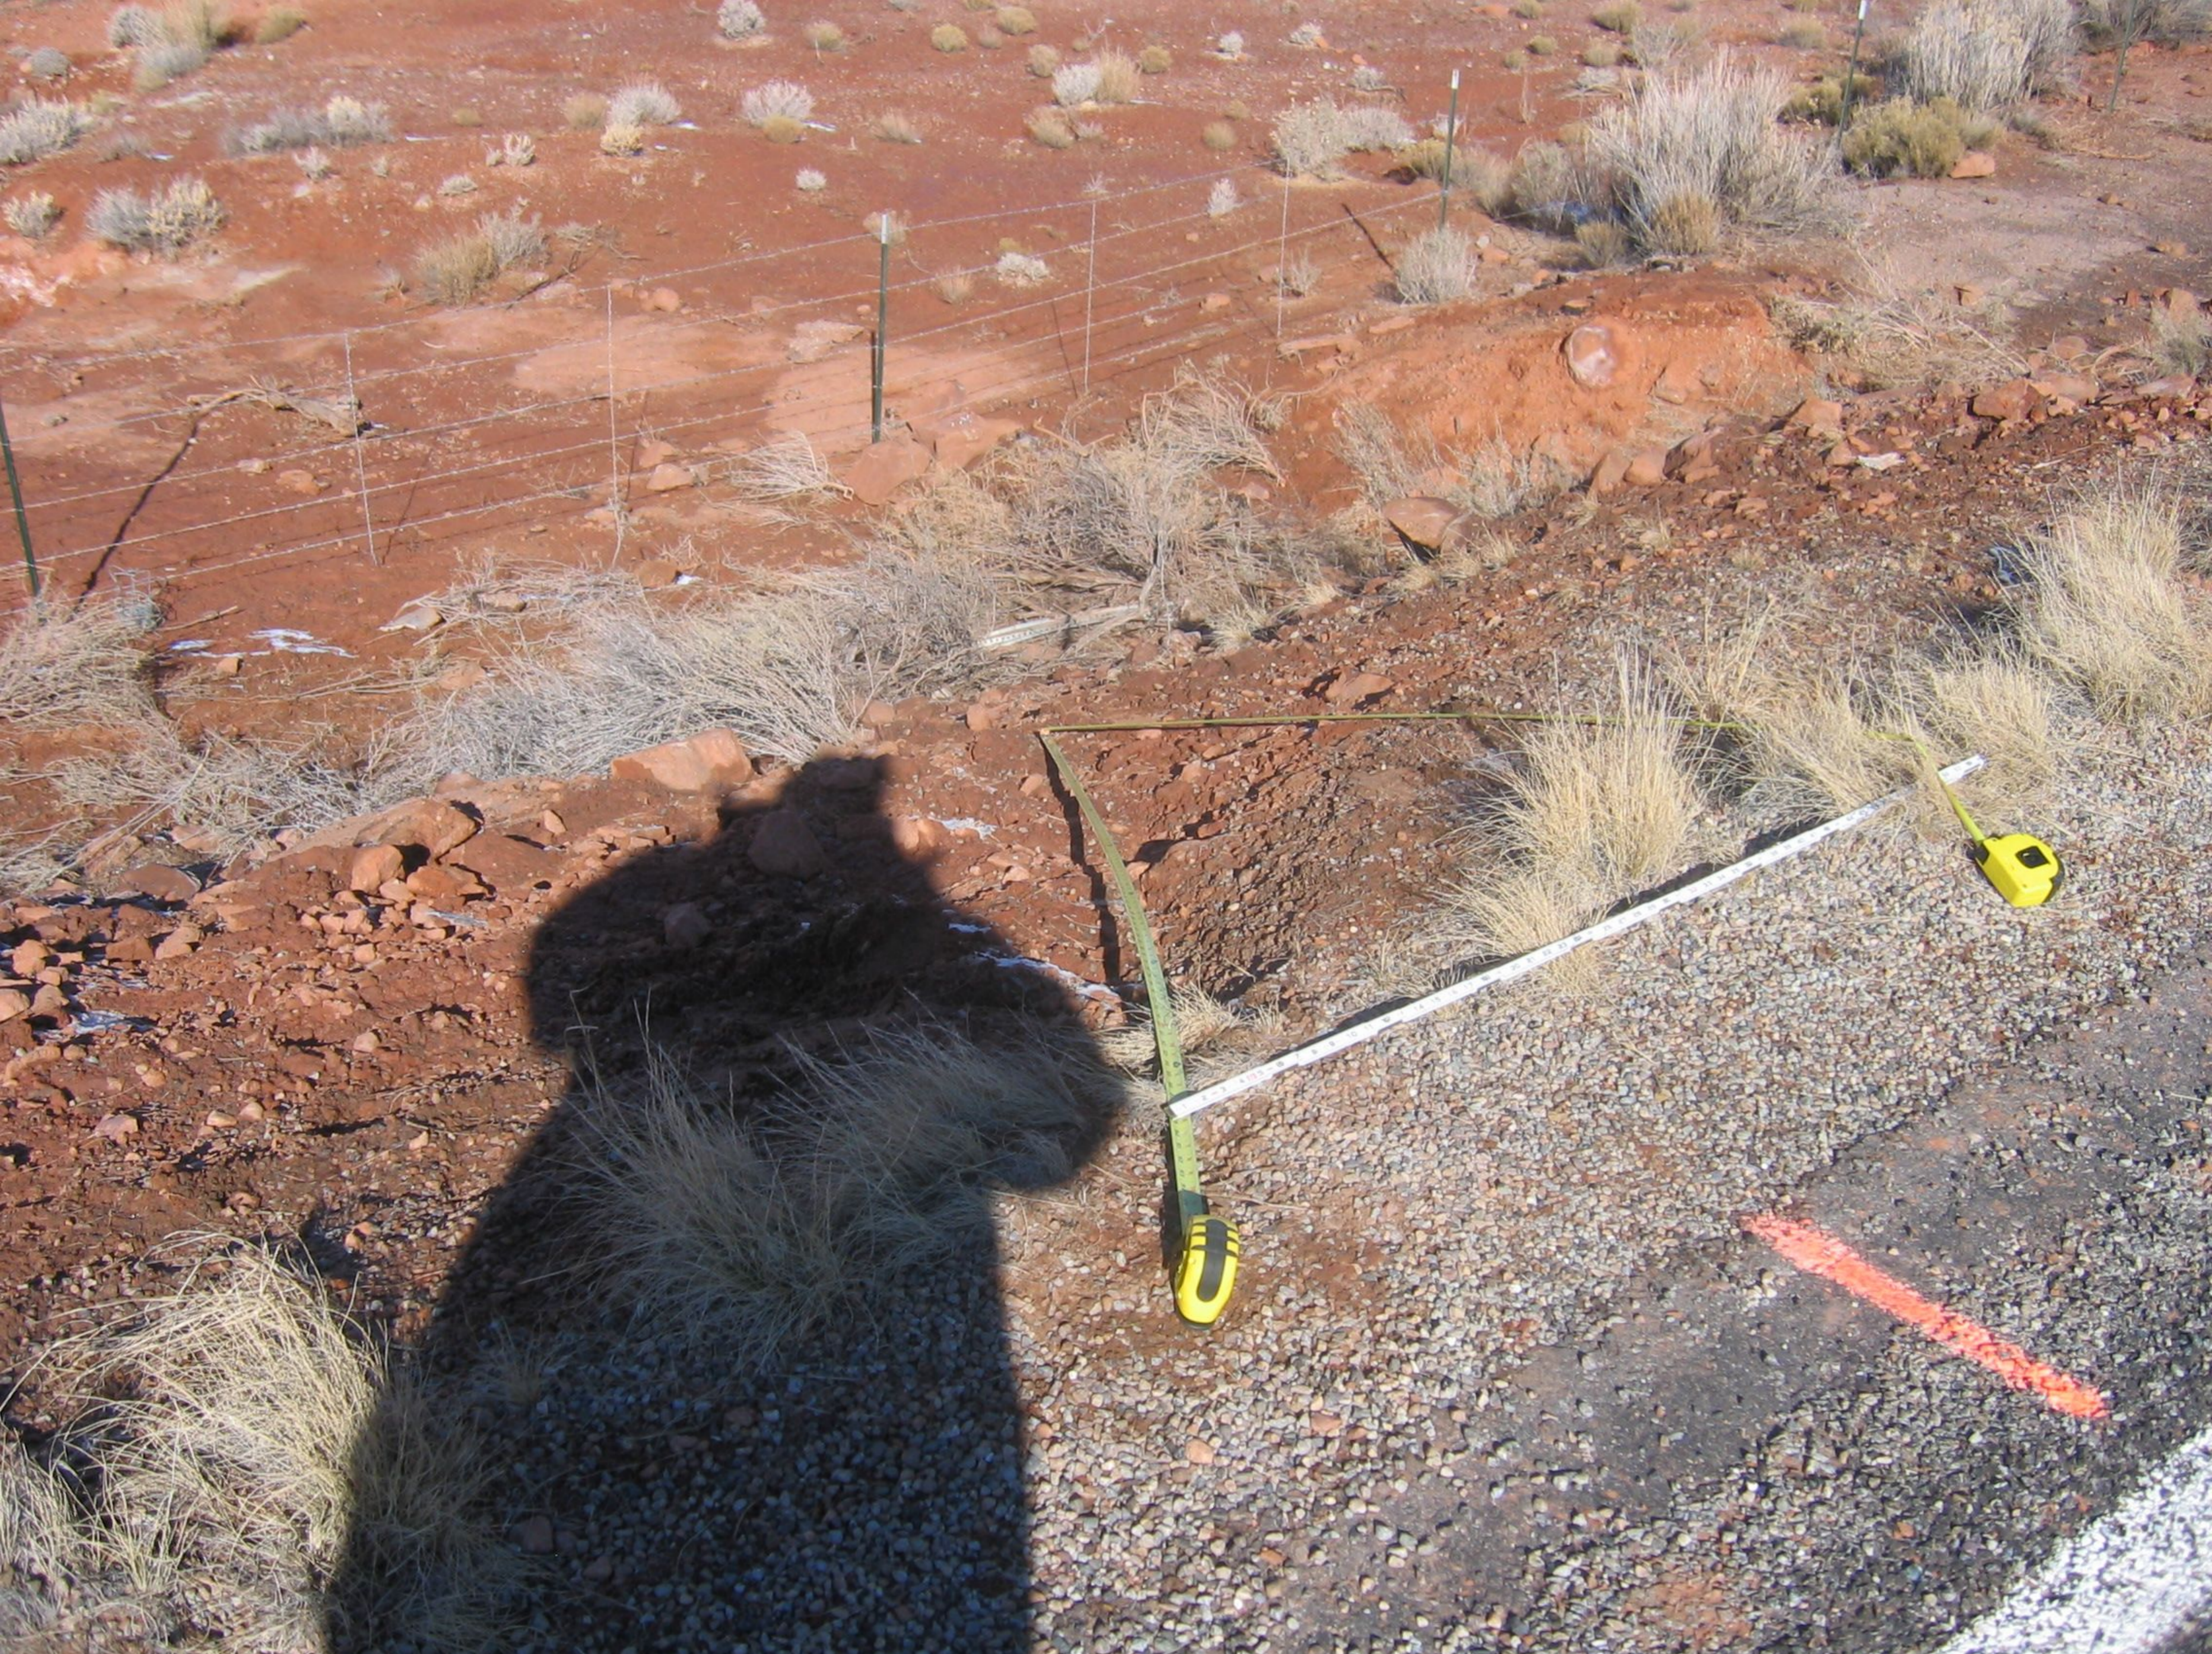
Hwy. Photo #26 - View of ground scar indicating the bus was oriented at approximately 37 degrees to the roadway
