The Navy & Marine Corps Aviation Maintenance Safety Magazine

Fall 2008

In This Issue:
Support Equipment

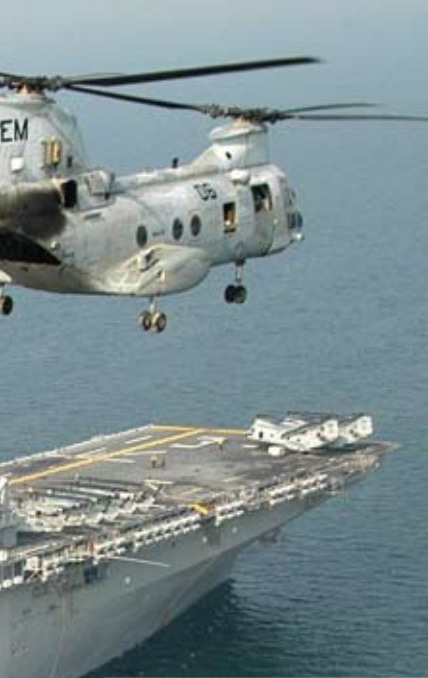
They determined that the cause was right there in the engine compartment. The hydraulically propelled unit has a cable running from the foot-control pedal to an inching valve, which couples a servo to the swash plate and varies the displacement of the pump. The harder you press the foot control, the greater the flow of fluid from the pump to the drive axle. The foot-control cable had hung up in the full-open position.

cover and a scupper drain line. Fortunately, the safety observers were far enough away, so they didn't get run over. After the MEPP stopped, I reached down and manually lifted the foot-control pedal, placed the gear selector in neutral, and turned off the engine. I tried to figure out why this unit had taken off like it was possessed.

After I caught my breath, I surveyed the damage to the island. The MEPP also had been dented and scratched, and the cable-storage compartment had been pushed out of alignment. I humbly walked to my division and told my chief what just had happened. The safety department and quality-assurance division immediately investigated the mishap.

Even though I had done a complete pre-op, according to the correct checklist, I didn't catch this discrepancy. Checking for proper pedal movement and free operation is not one of the static checks. I learned that pre-op checklists are not always all-inclusive. Prior to operation, I now check all controls during my static inspection of self-propelled equipment. USS *Keasarge*

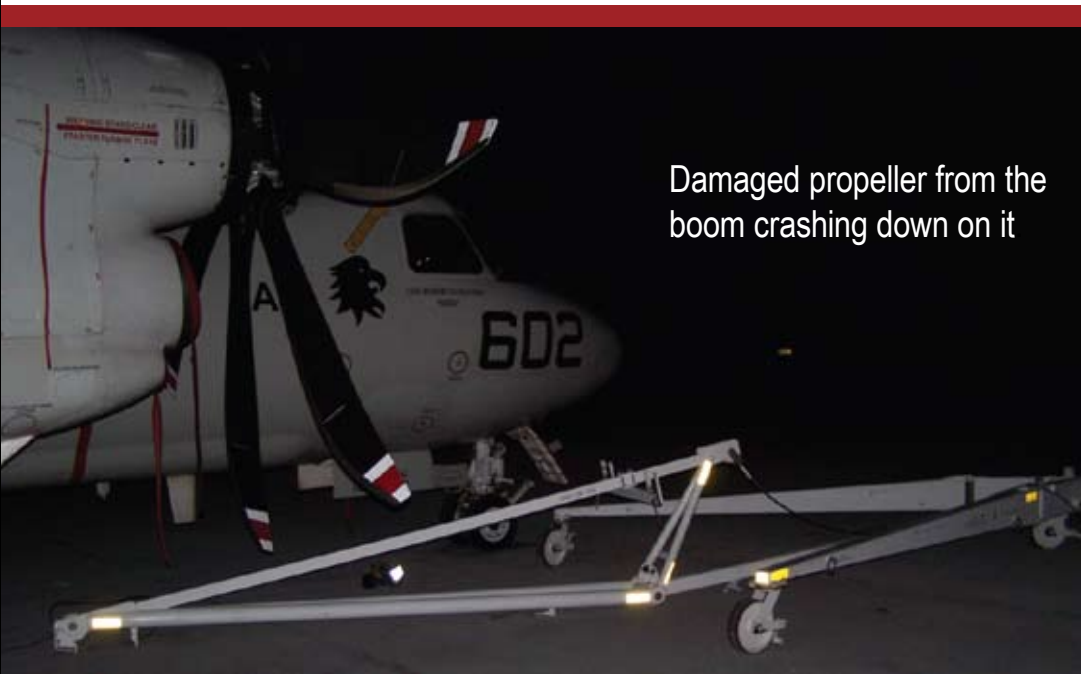
Despite our experience with the equipment and our knowledge of the warning, we failed to follow the correct procedures; we removed the main-mast pin first. This left the weight of the boom completely supported by the mast cables, which quickly parted. The boom crashed down onto the starboard propeller, gouging a blade and cracking the hub. Two safety cables and the main hoist cable on the crane also were destroyed.

Damaged propeller from the boom crashing down on it

We came out of this experience with some costly aircraft damage, and some valuable lessons learned. The damage to the aircraft could have been completely avoided had we backed the crane clear of the aircraft. If we had reviewed our procedures for stowing the crane before doing the maintenance, we would have been reminded of the warning about the main-mast pin. We also learned that nothing is routine when operating in dark and unfamiliar places. A few moments of ORM, thinking about what could go wrong in a different environment, might have saved us from this costly mistake.

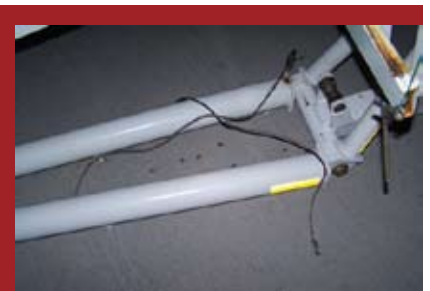
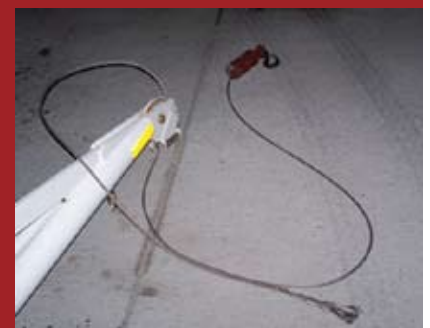
Cables were also destroyed.

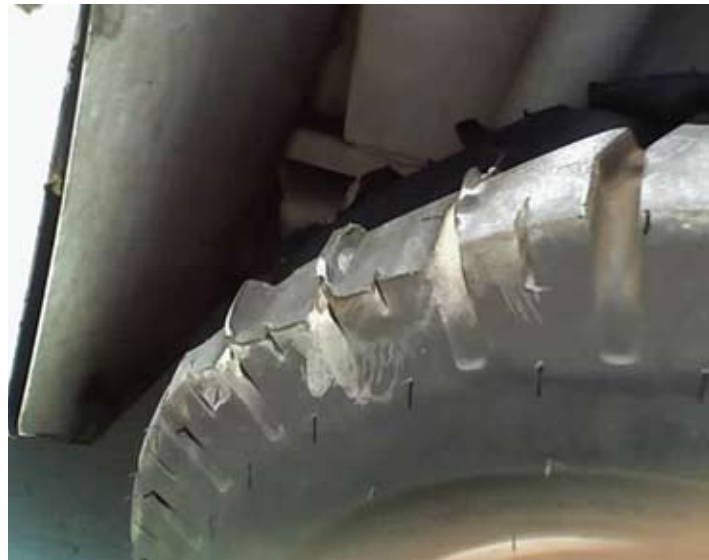
This is the damaged tire, which was the property of the squadron next door.

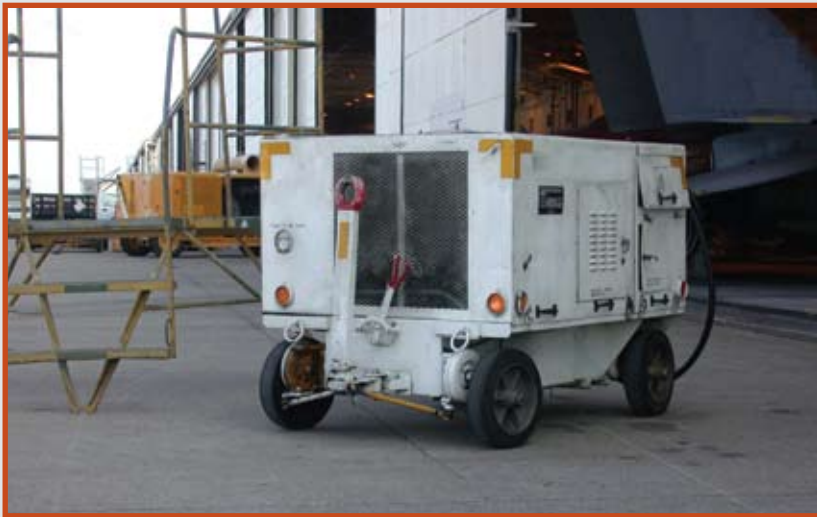
Someone forgot to use chocks on this unattended Jenny.

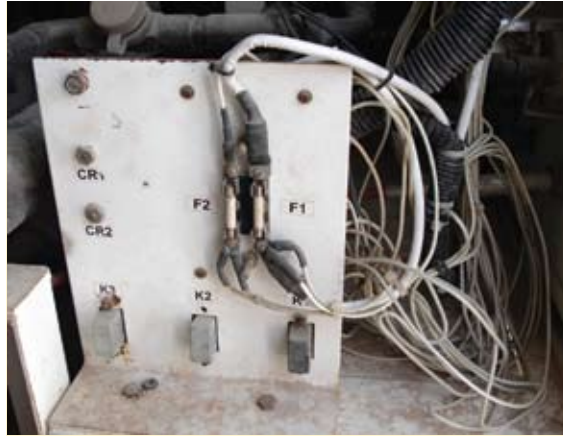
Proper fuse layout

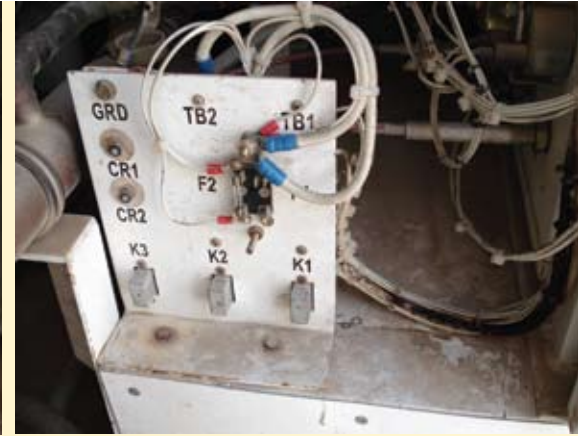
VP-8 bypassed fuse panel

panel, which normally holds two fuses wired in parallel, wasn't only missing a fuse; it had been re-routed to bypass the second fuse assembly altogether. Without a fuse to protect the electrical components from power surges, unrestricted voltage had coursed through the wiring and started an electrical fire.

Analyst comment: The fuse was bypassed? Where was QA? Was special authorization given to jump this fuse? Was there a MAF for the repair? These parts are not hard to replace, and I question the thought process here regarding the maintenance on the SE.

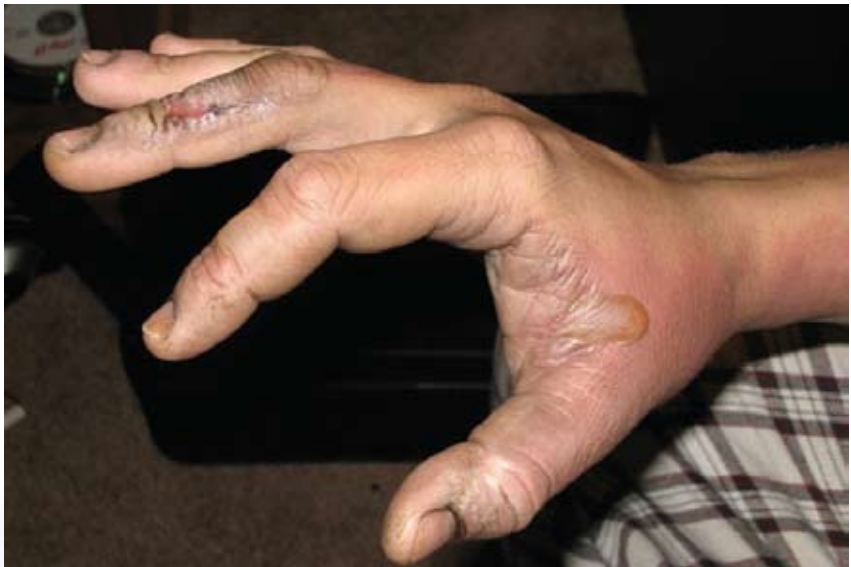
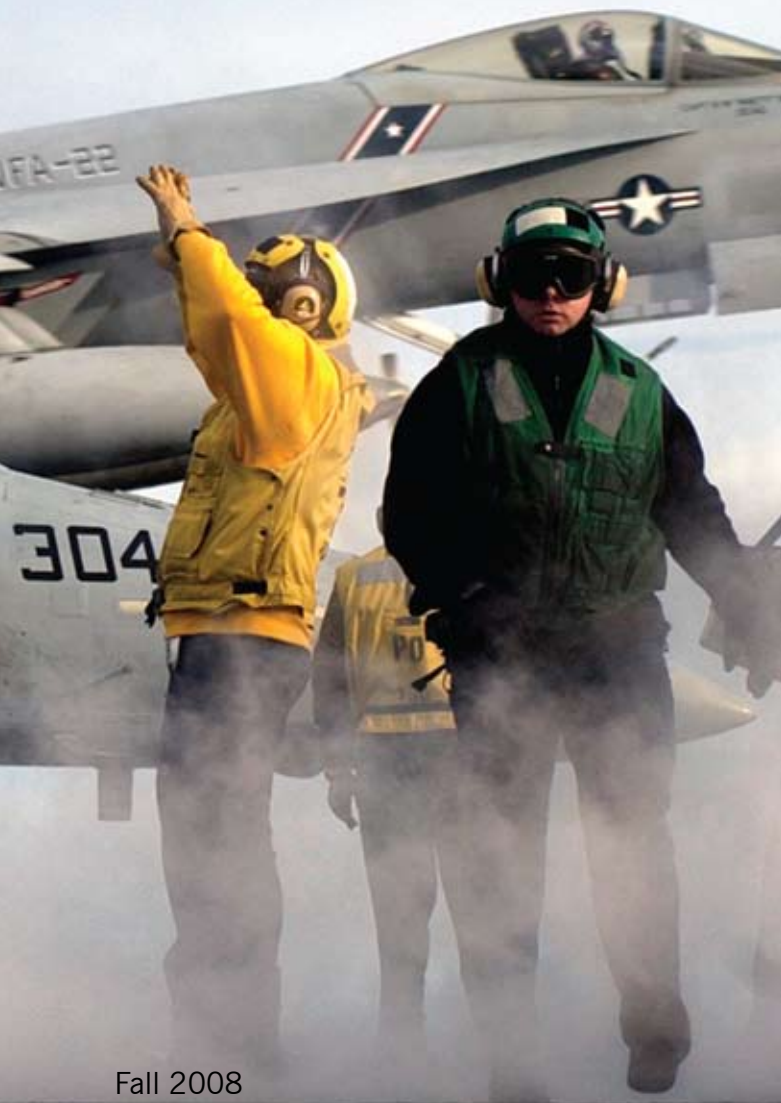
Receptacle (above) and power cord (below)

main reason for this was a partly-seated power cord in the receptacle. When I walked up to the power head and pushed it in a little more, an extremely large, hot flash of fire arced from the receptacle. My hands and face were severely burned.

The investigation revealed an obstruction between the power cord and the receptacle. Unknown to me at that time was the possibility that the door’s bonding wire could have worked its way in front of the receptacle’s conduit. When I tried to further seat the power cord, I actually had caused the simultaneous contact of the power cord, metal bonding wire, and the external-power receptacle.

The investigation also revealed some major discrepancies in how long the door's bonding-wire strap should be. As the straps get worn, slightly longer and more dangerous straps are replacing them. Furthermore, the

strap connect points seem to be different on each aircraft on the line. Some are mounted inside the receptacle's wall, while others are connected on the hinge. This situation can mean that even though the strap is the right size, it is "effectively" too long because it is mounted an inch or so away from where the manufacturer intended.

We submitted a TPDR addressing the inconsistencies in the length of bonding straps. I suspect other squadrons may have similarly configured aircraft. A simple walk down the line might reveal a number of such hazards.

- Don't take ground-power cord operations lightly. Respect hazards associated with electrical power.
- Follow all steps and procedures to the letter. They are written for a reason, and we are not at liberty to deviate.
- Be sure to secure the source of the electrical power before you do anything to the power cable itself.
- Be sure you have a clear path between the power cable and receptacle. If the cable will not seat properly, there probably is a good reason for it. ⚡
