# Mech

# THE NAVY & MARINE CORPS AVIATION MAINTENANCE SAFETY MAGAZINE

Vol. 47, No. 3 Summer 2008

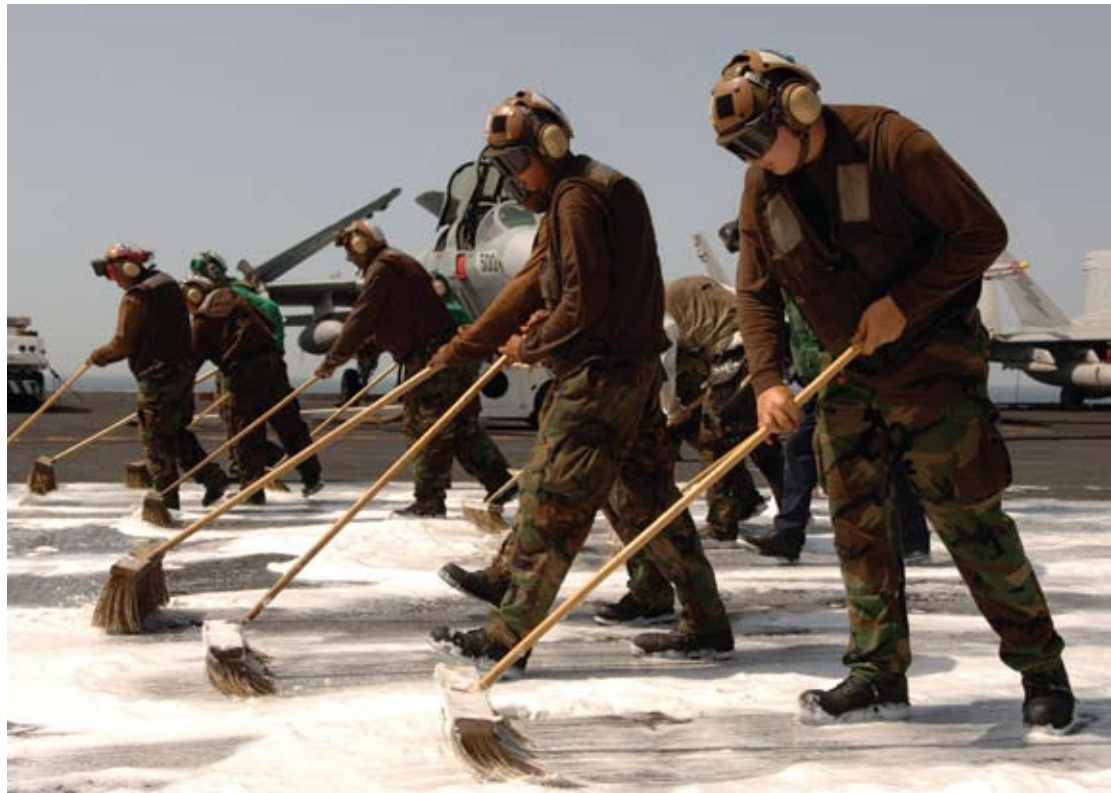
The incident occurred when an airman was scrubbing the flight deck near a catapult. She was wearing gloves but had the sleeves of her flight-deck jersey rolled up to her elbows. What the airman did not consider was that the catapult tracks get very hot after early morning “no loads” and the raging heat of the Arabian Gulf sun. She slipped and fell on the tracks, incurring second-degree burns to her forearm.

In this case, if the airman had had her sleeves rolled down, it likely would have lessened the severity of the burns. Outside of flight quarters, rolling sleeves down while scrubbing the flight deck might not be defined as

a requirement anywhere. However, it certainly stands to reason that catapult tracks can get extremely hot, and you should be prepared when working near them.

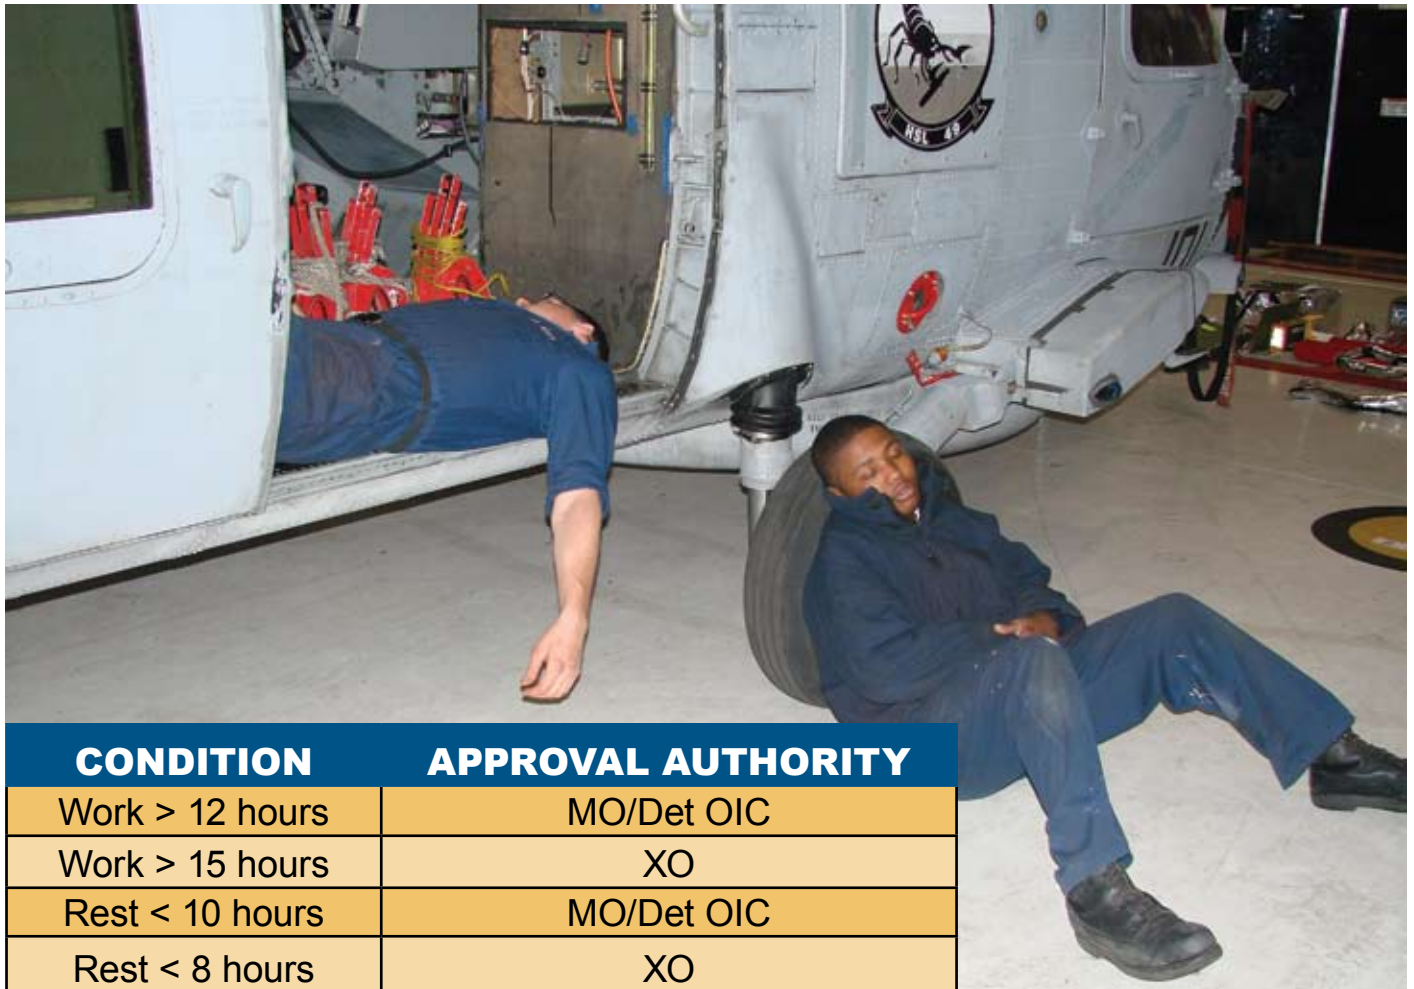
CONDITION	APPROVAL AUTHORITY
Work > 12 hours	MO/Det OIC
Work > 15 hours	XO
Rest < 10 hours	MO/Det OIC
Rest < 8 hours	XO

safety of its personnel by standardizing risk management approval for personnel who work extended hours. The rules are simple and easy to follow—personnel working more than 12 hours require department-head approval. Individuals working more than 15 hours require executive officer's approval and should only be requested "on very rare occasions." Not only are we concerned about working hours, but rest in between shifts is just as important. For personnel with less than 10 hours off, the department head must be notified, and permission for personnel to be granted less than eight hours off must be requested from the executive officer.

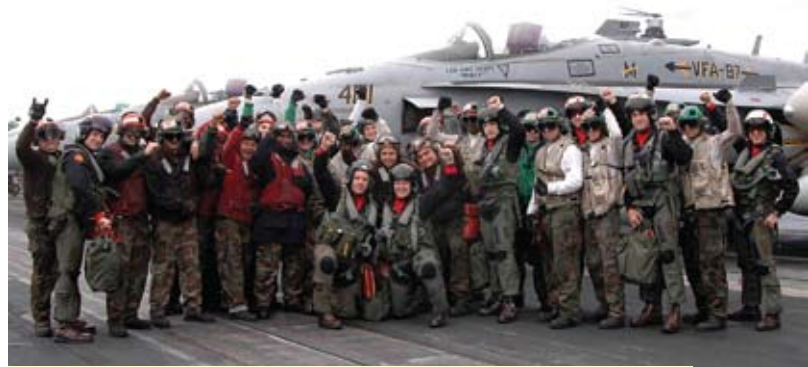
USS Theodore Roosevelt (CVN-71), VFA-87, 2006

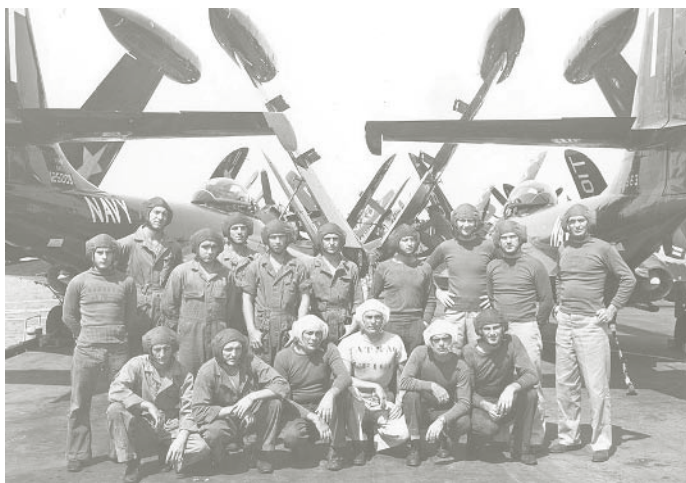
USS Franklin D. Roosevelt (CVN-42), 1953  
 Photo compliments of Daniel M. Christy, son of Capt. Ralph L. Christy, Jr., deceased Navy Flight Surgeon who helped David M. Clark design the original sound protector.

Company, used “Mickey Mouse” earmuffs in the original cranial-helmet system. This “state of the art” head and hearing protection was worn to protect against the F2H-2 Banshee’s twin Westinghouse J34 turbojet engines, capable of producing 3,140 pounds of thrust each.

‘Good enough’ often becomes the basis for ‘the way things always have been done.’ In the case of the current flight-deck cranial, what was good enough for maintainer head and hearing protection in the 1950s no longer is good enough to keep maintainers safe in 2008.

The HGU24/P and HGU-25(V)2/P are commonly and collectively known as the cranial. While this design has withstood the test of time, it fails to meet nearly all modern-safety standards for hearing protection, impact protection, and electrical shock prevention, and it fails to support several key 21st century mission scenarios.

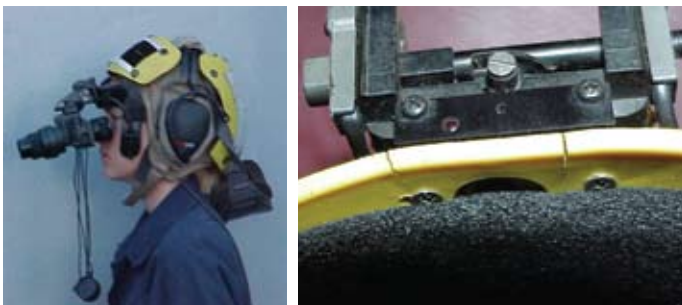
Left: One of several fleet "fixes" to NVD mounting (note poor eye alignment, snag hazards). Right: Crack in cranial impact shield from NVD mount.

CPG3 Command Master Chief, ABHCM(AW/SW) Wynn Young, was among the first to report hazardous shortcomings of the cranial. He developed a point-paper, which highlighted the cranial's failure to support NAVAIR 00-80T-106, requiring the use of night vision devices (NVDs) on amphibious flight decks, as well as the 'can do' spirit of the fleet maintainer. The paper noted that fleet solutions, however noble and well-intentioned, often result in non-standard, unsafe practices. NVD attachment to the cranial often results in poor NVD eye alignment, vision and face hazards, and cracked cranial-impact shields.

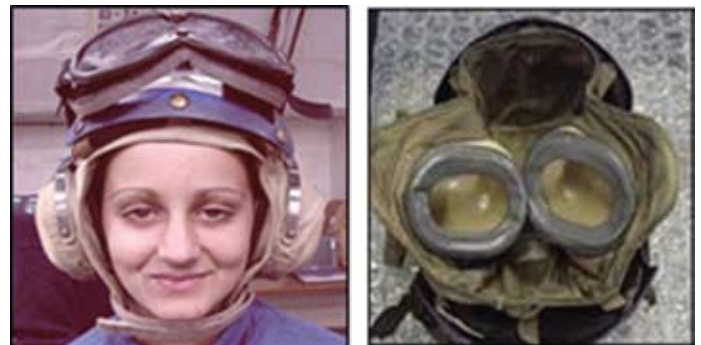
Largest cranial does not fit all (cranial is hard to clean and standard earcup seals harden, crease, and leak noise).

Further, NAVAIR AIR 4.6, Human Systems Department, conducted surveys of more than 1,000 flight-deck personnel on board CVNs, LHAs, LHDs, and across fleet squadrons. The survey included a detailed assessment of cranial-helmet fit and maintenance condition (e.g., earmuff headband tension, earcup foam and cushion integrity), earplug use and insertion depth, and head-size measurements. Worn without earplugs, the cranial provides approximately 21 dB of noise attenuation when correctly fit, worn, and maintained. All survey subjects reported wearing a cranial helmet with earmuffs, but 75 percent of subjects were issued a questionable size (most wore the largest of four sizes available), and 41 percent of earcup cushions and foam inserts were deteriorated, hard, creased, or missing. Many maintainers, who were issued even the largest of the four cranial sizes, reported being in severe pain after wearing them 5 minutes.

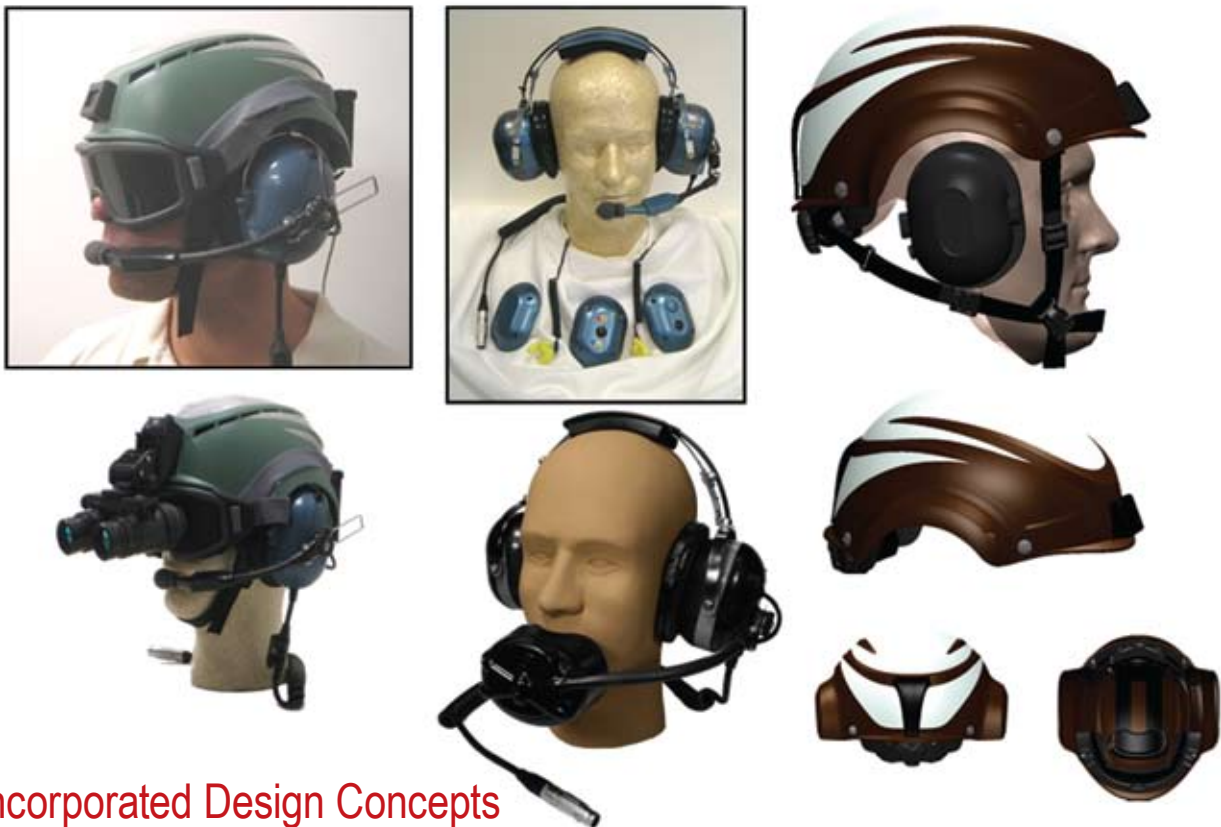
ATI Incorporated Design Concepts
