NTSB National Transportation Safety Board

Office of Highway Safety

Tire Testing and Simulations

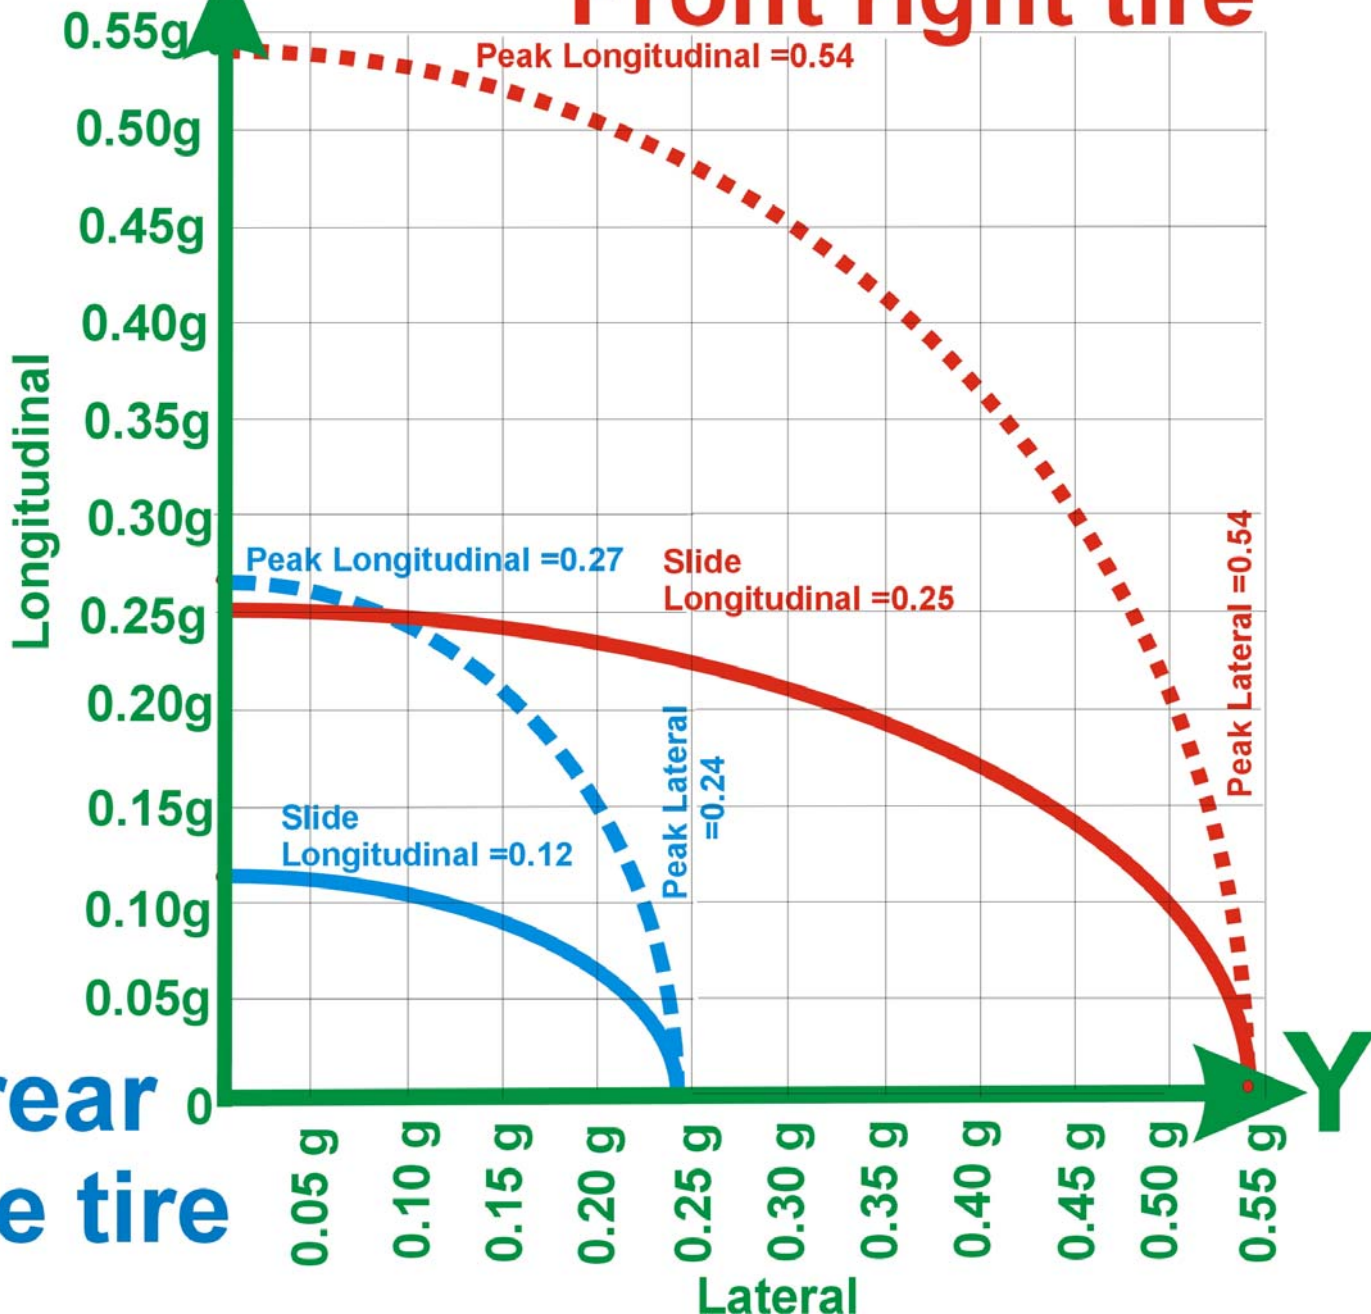
Front right tire

Left rear
inside tire

- Average peak lateral friction less than half steer axle tire
- Lower lateral friction
- Frictional braking capability about half steer axle tire
- Slide friction value equivalent to ice

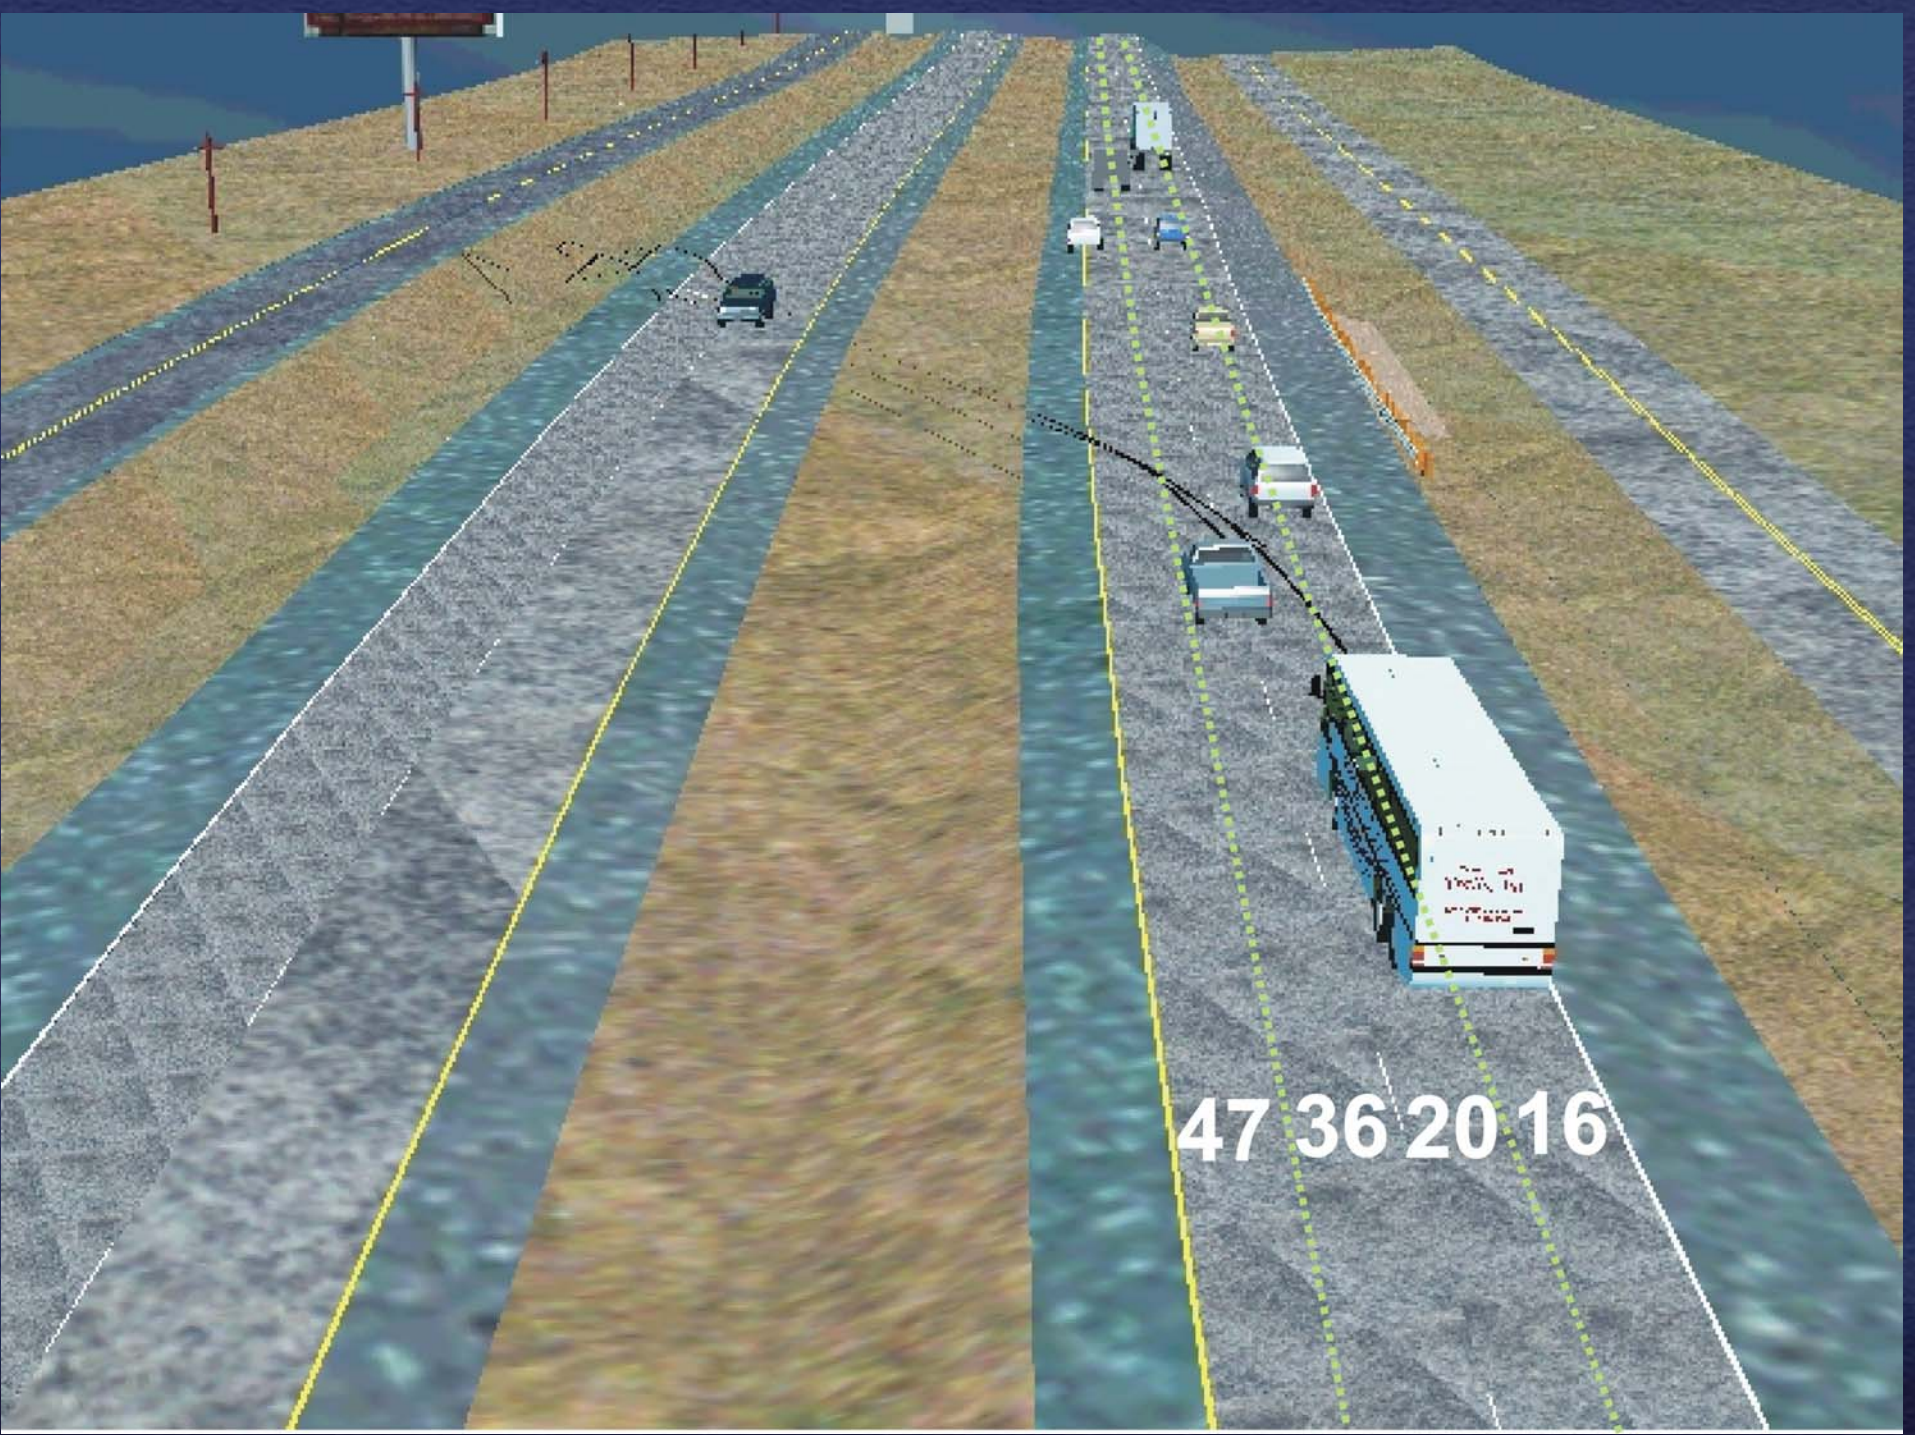
47 36 20 16

Simulation Purpose

- Evaluate motorcoach driver's statements
- Motorcoach's braking and cornering capability
- Contribution of roadway and tires
- Speeds at impact
- Dynamics of vehicles postcollision
