***Volume V – Performance
Floodwall and Levee
Performance Analysis***

***Interagency Performance Evaluation
Task Force (IPET)***

NRC Meeting

May 15, 2006

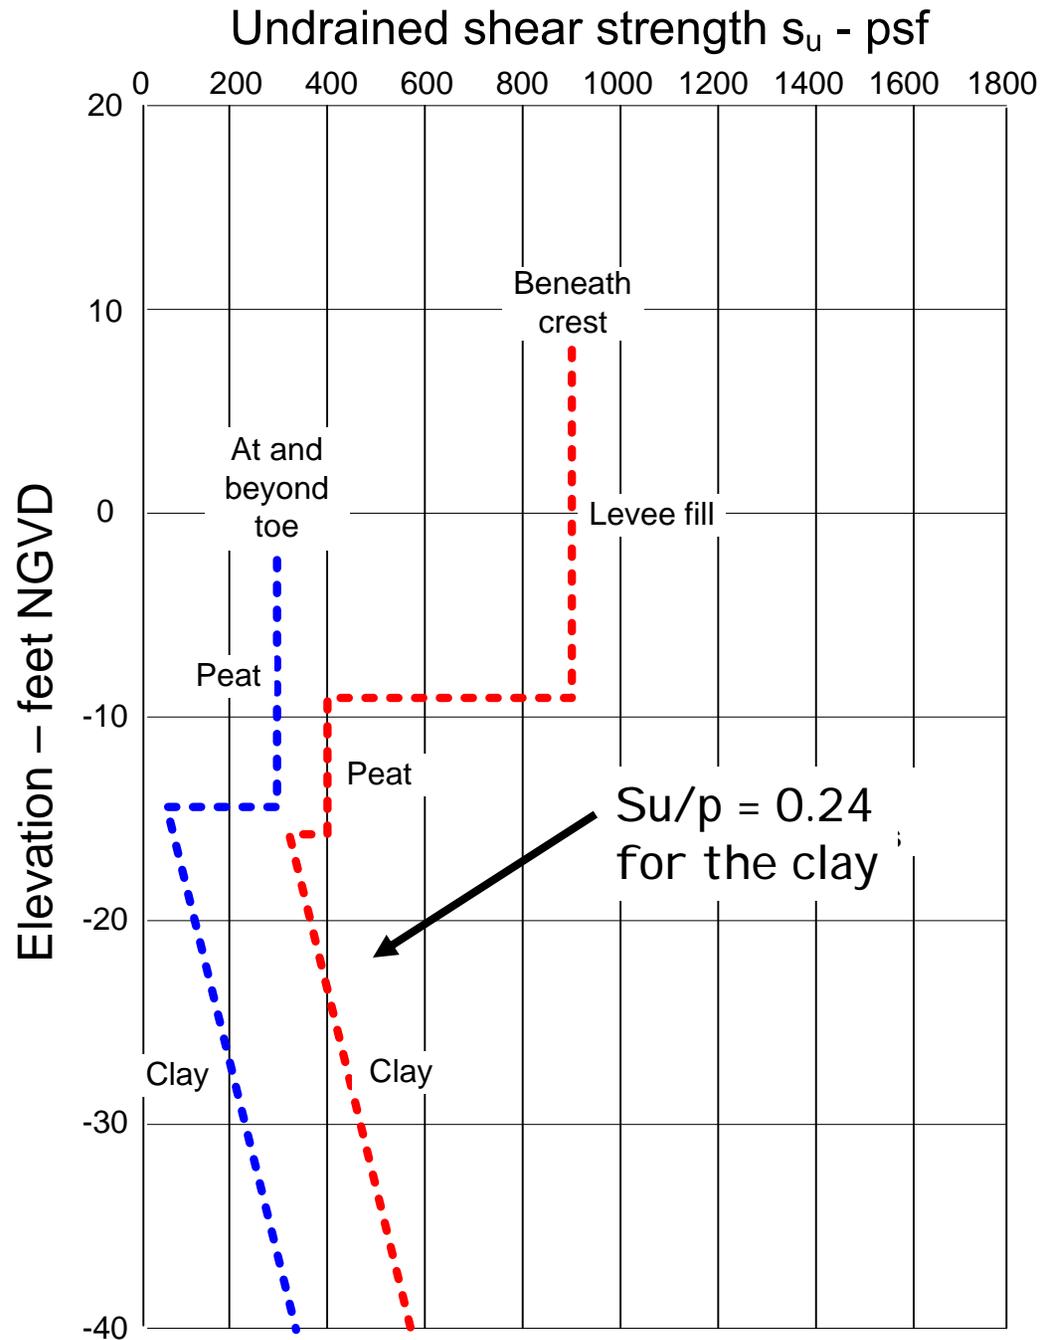
IPET strengths

Clay strength

$$\Delta s_u / \Delta z = 11 \text{ psf / ft}$$

Four tests, consistent rate of increase in s_u with depth

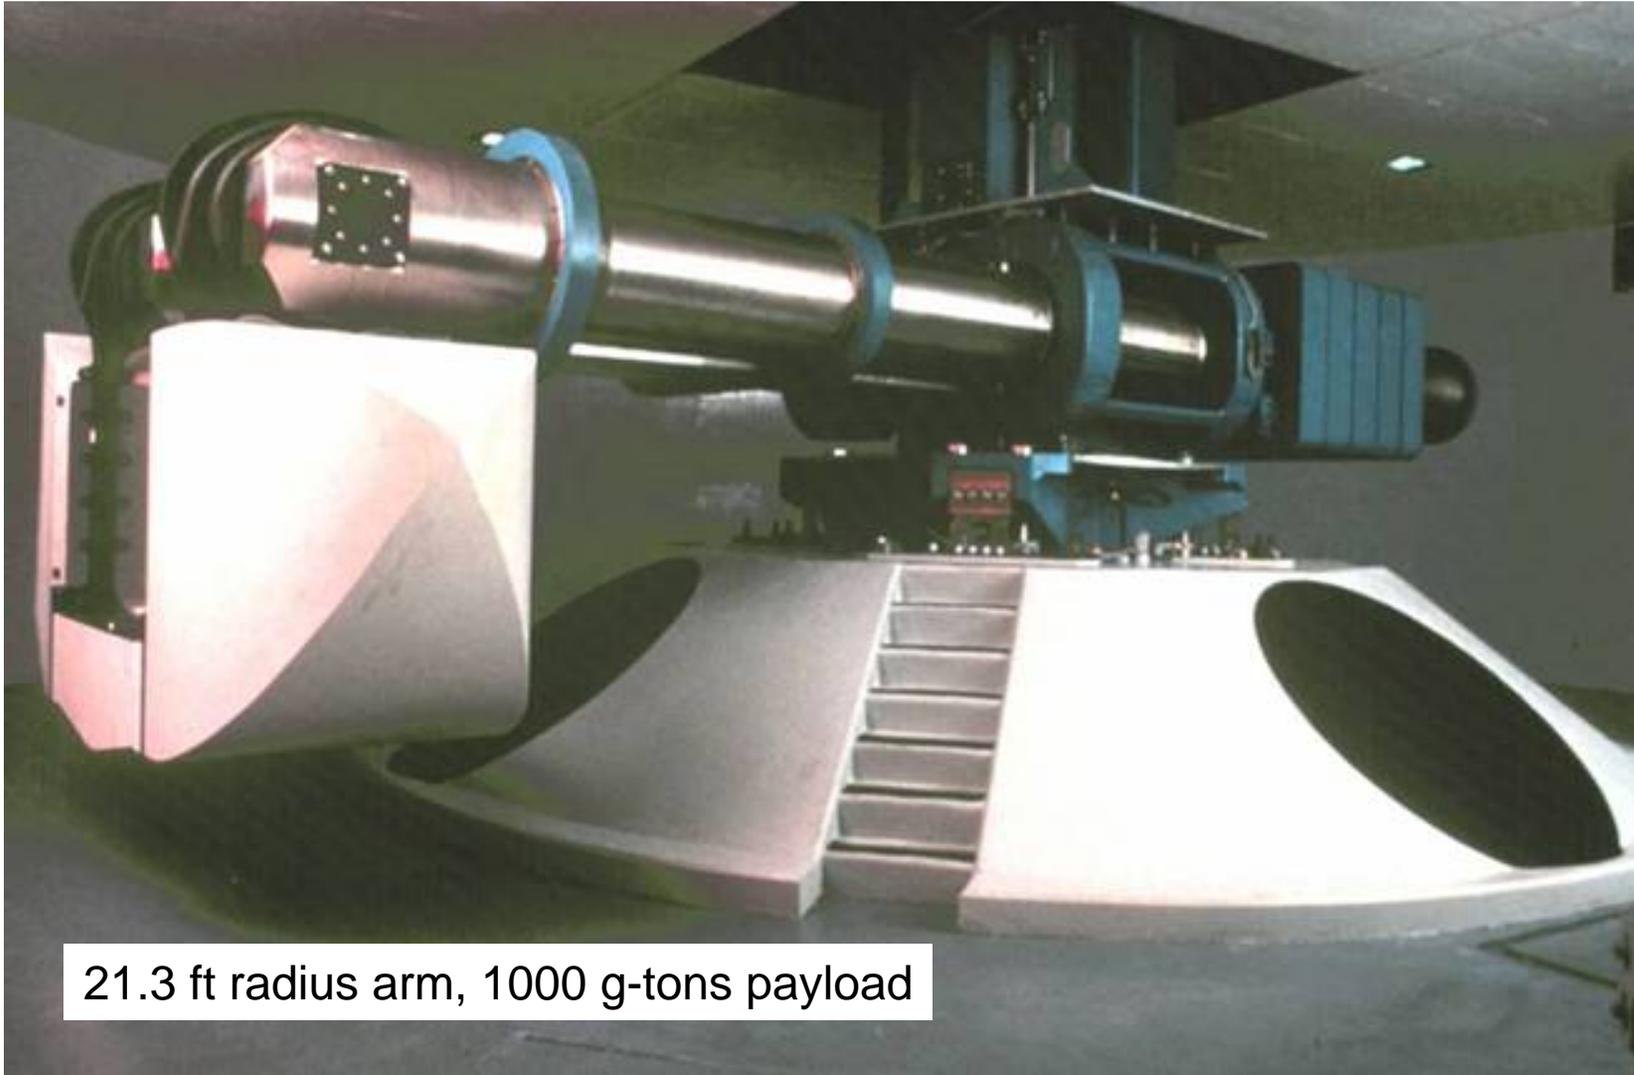
Centrifuge tests to study failure mechanism

21.3 ft radius arm, 1000 g-tons payload

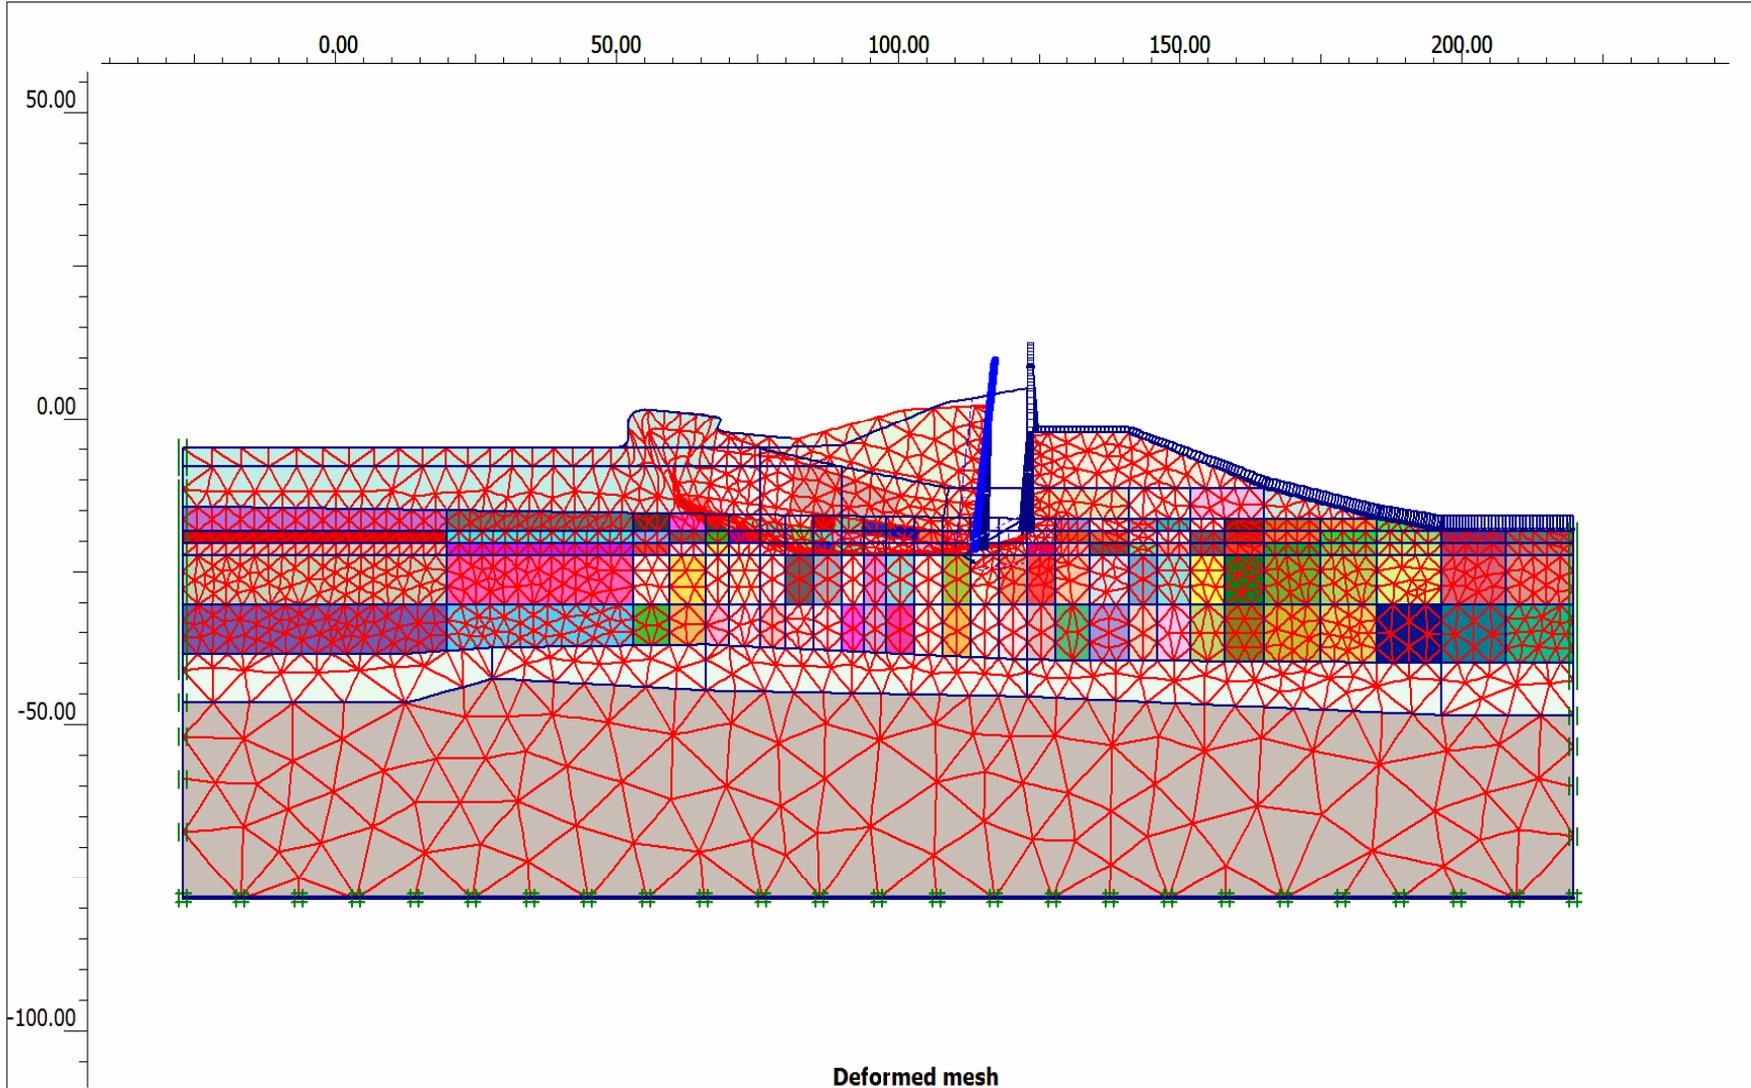
Deformed mesh

Extreme total displacement 53.74×10^3 ft
(displacements scaled up 200.00×10^{-6} times)

<i>Project description</i>				
17th_10+00, Canal Elevation +8.5, Crack, Phi-C Reduction				
<i>Project name</i>	<i>Step</i>	<i>Date</i>	<i>User name</i>	
17th_10+00-7_reed8_levee	526	05/03/06	U.S. Army Corps of Engineers

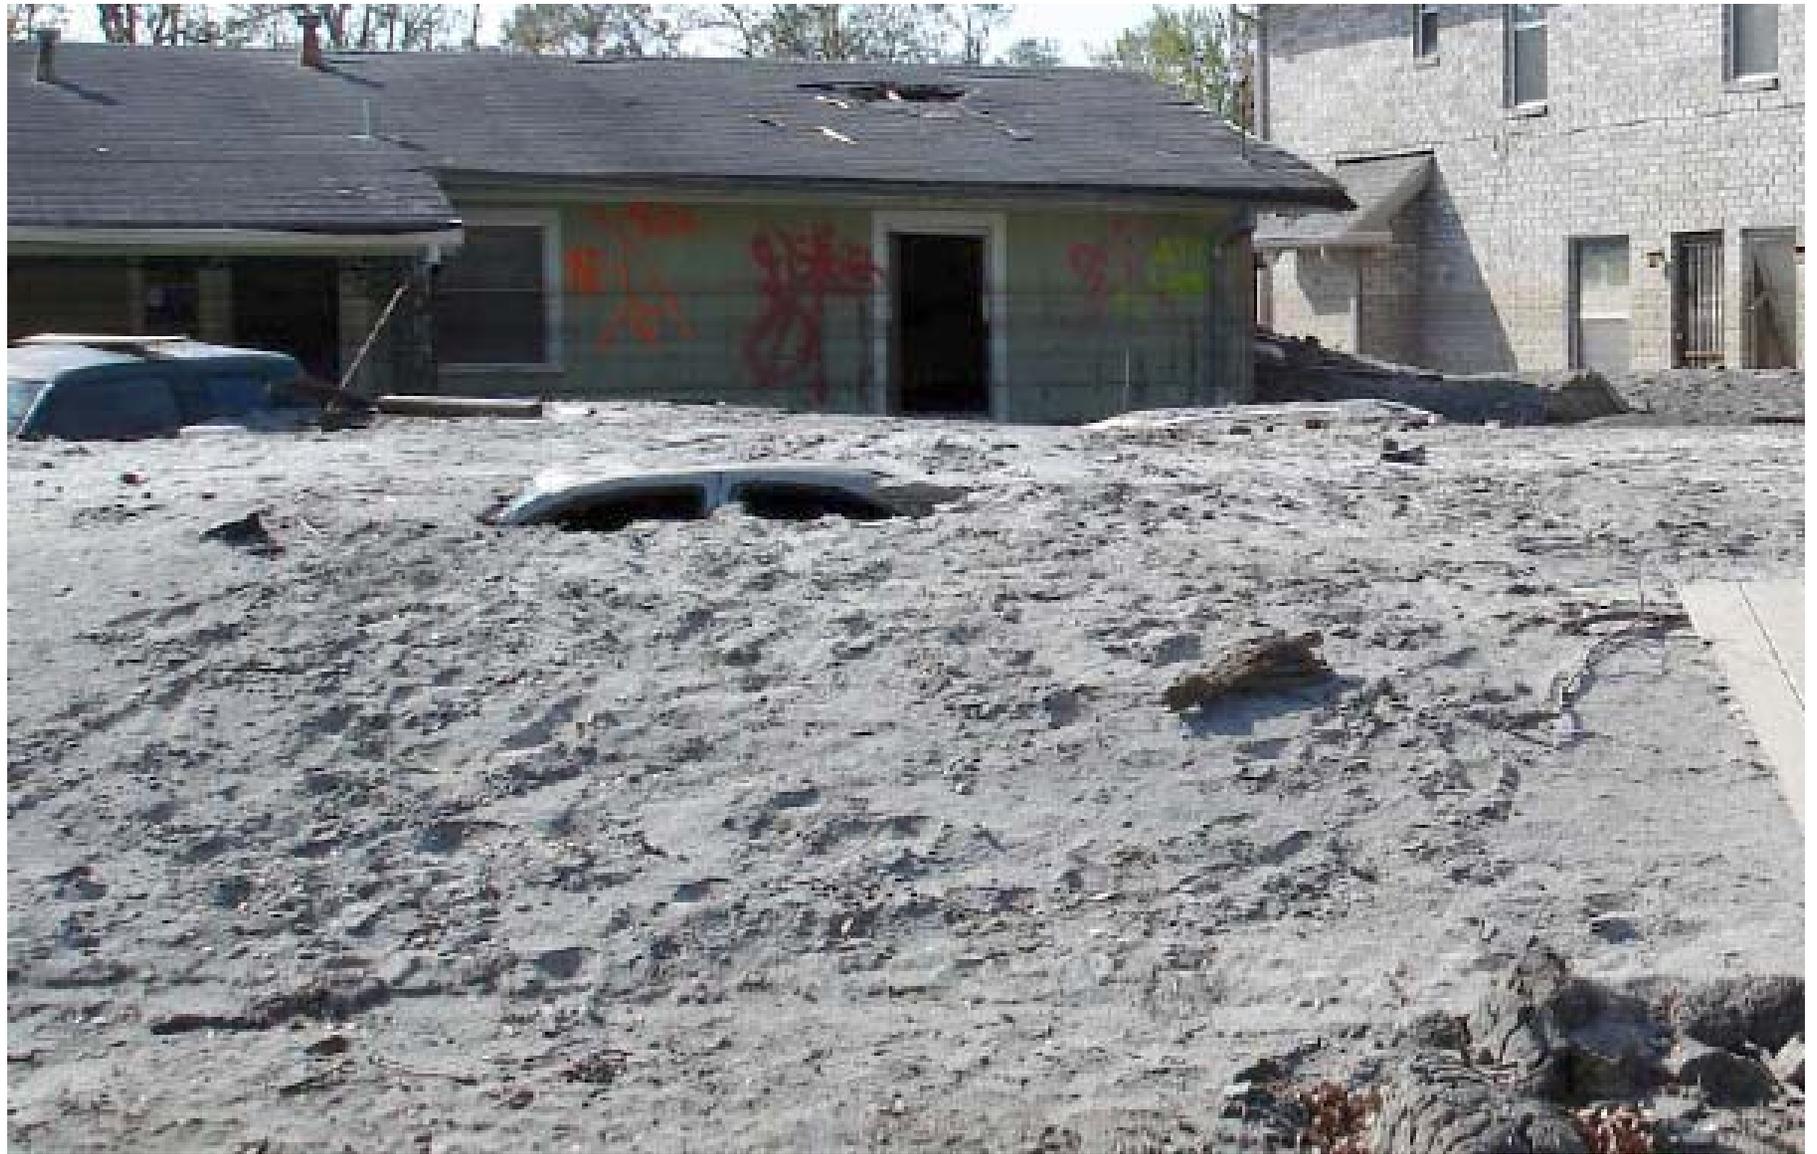
London Avenue south breach – about 60 ft wide – much sand washed through the breach into the neighborhood

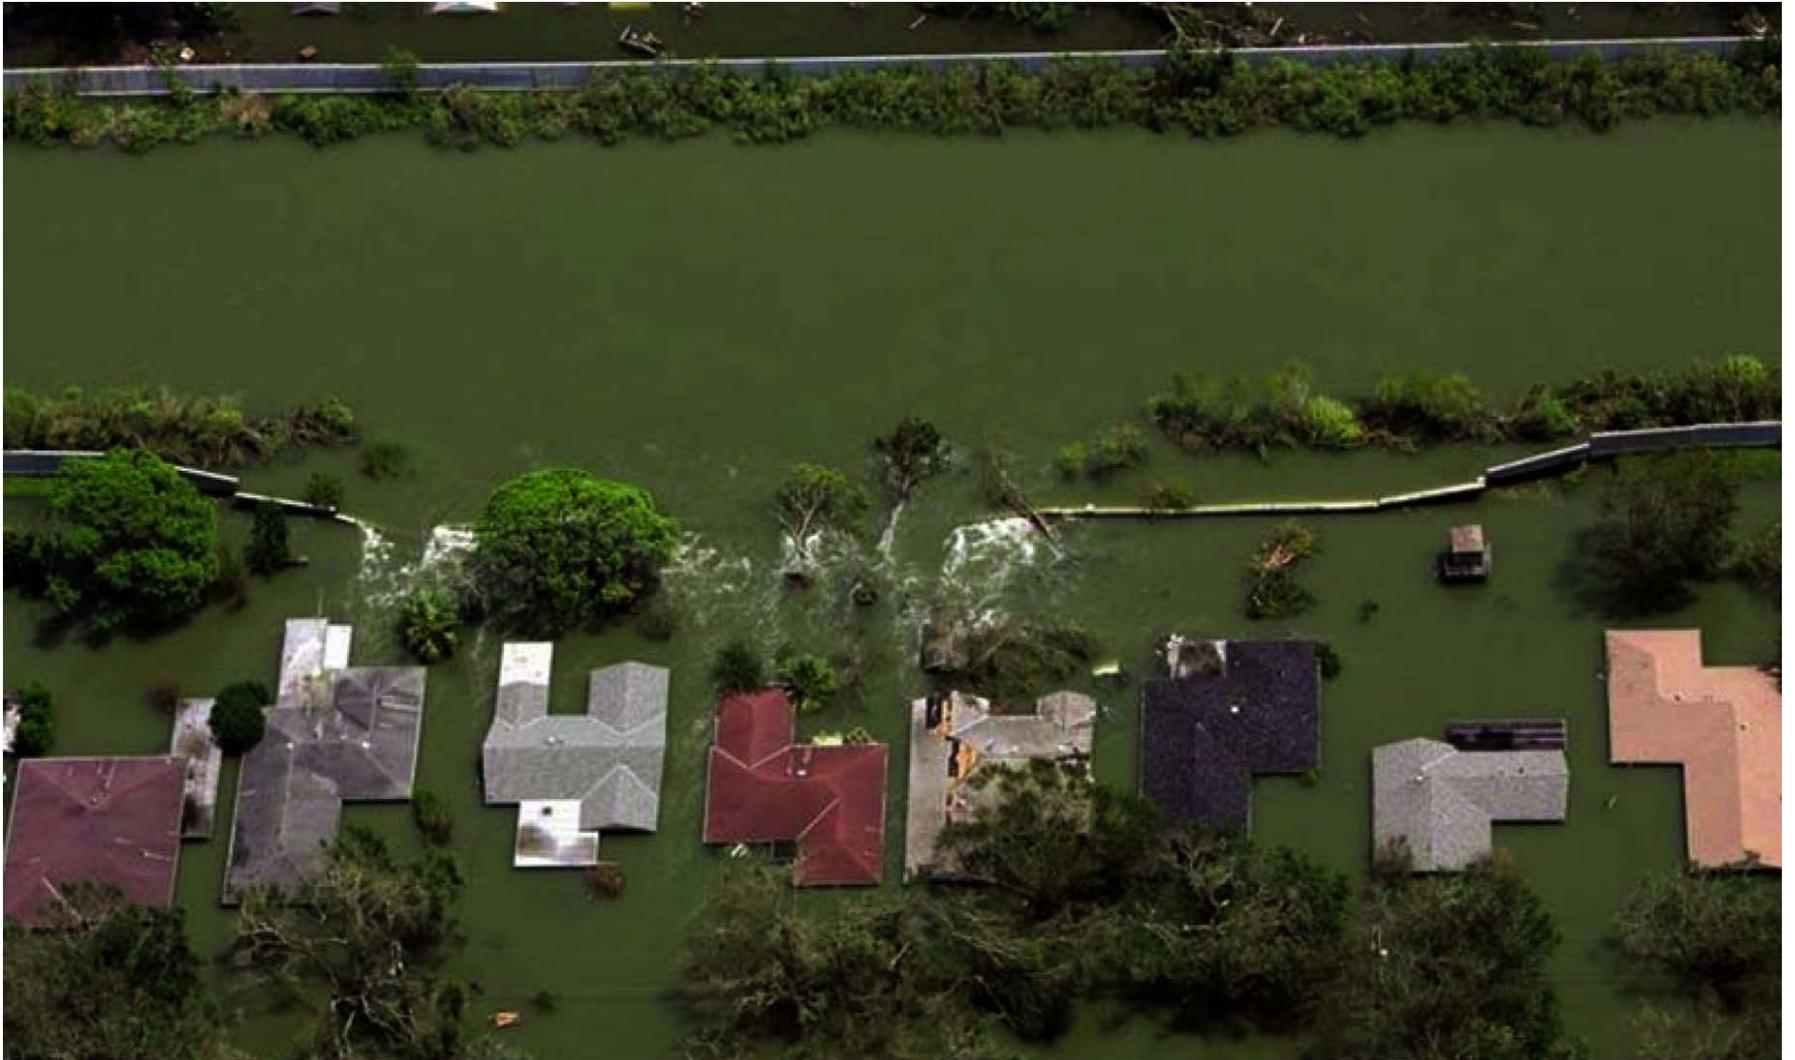
London Avenue north breach – about 410 ft wide – similar to 17th Street canal I-wall failure

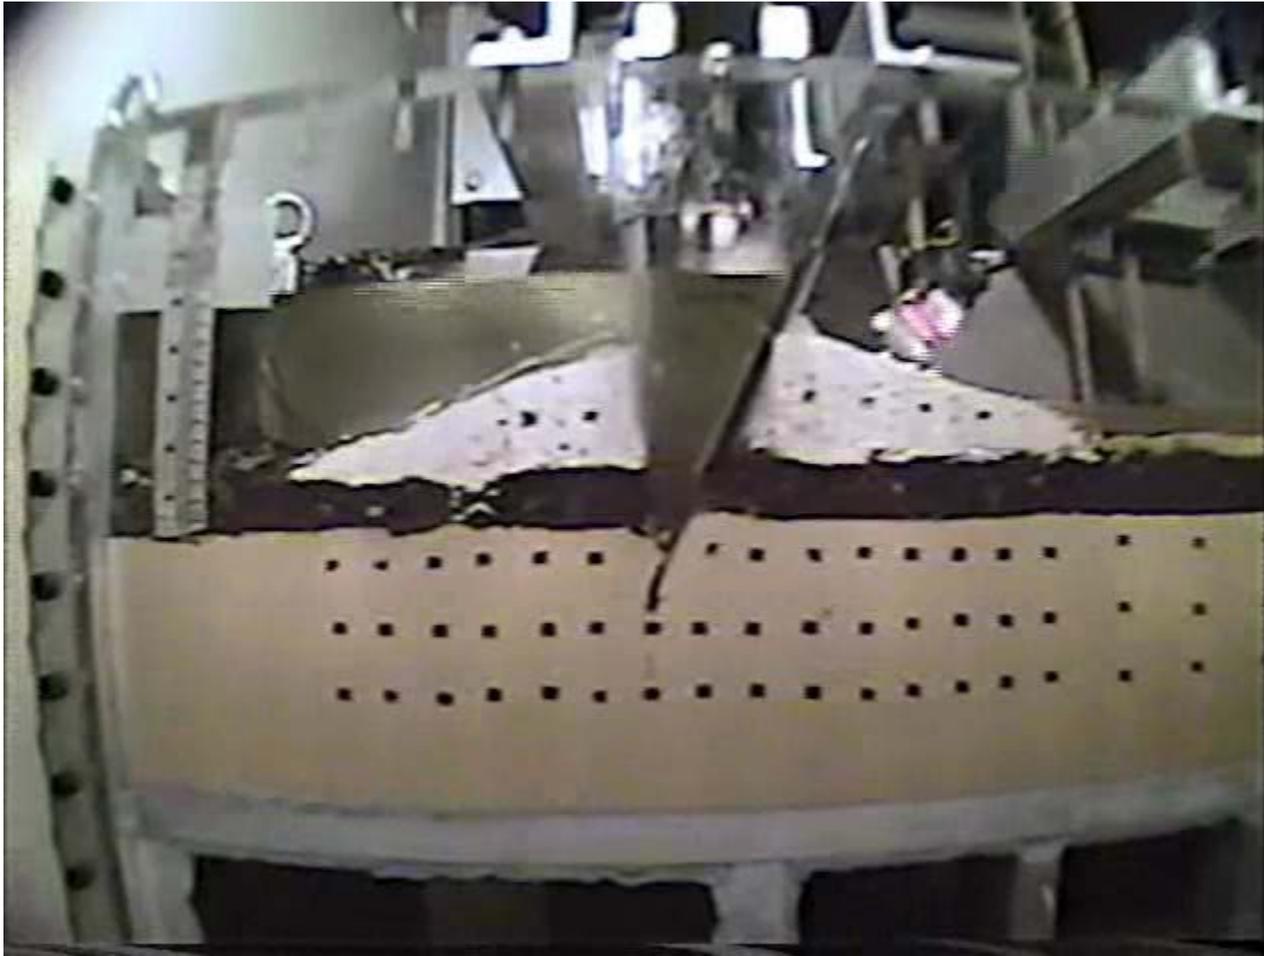
Piezometric levels under the landward levee berm rise as water rises in the canal, (ERDC London South)

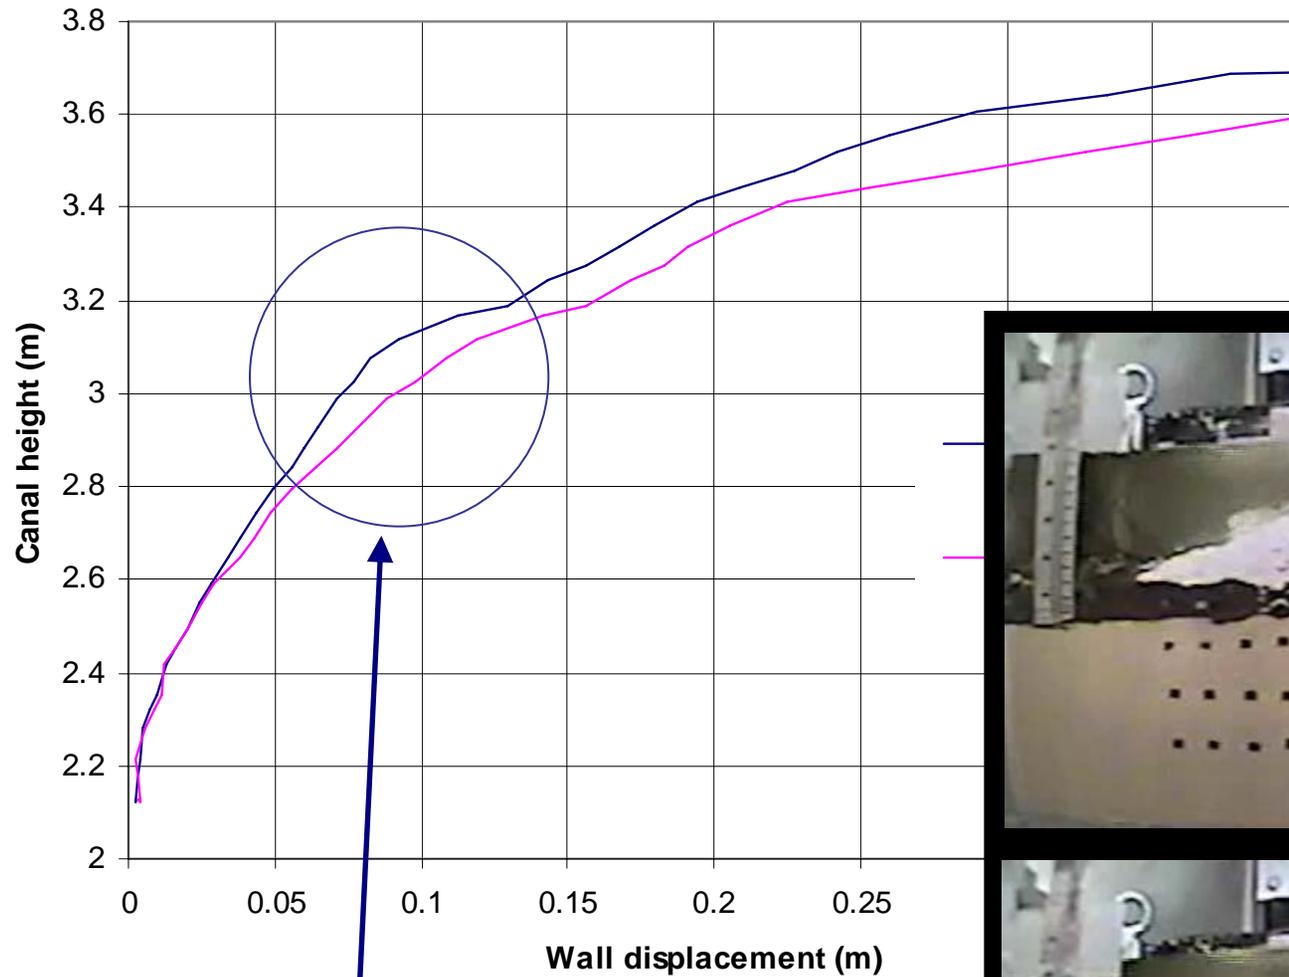
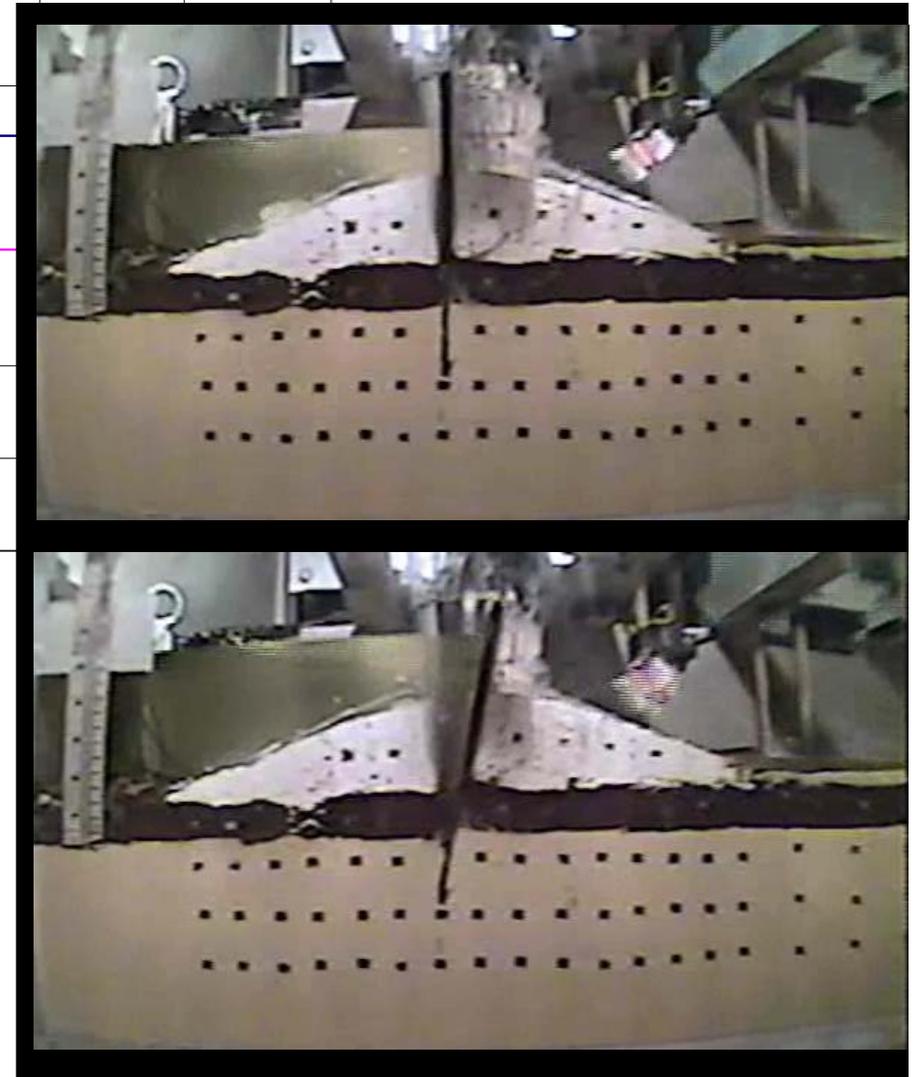
Crack opening phase, marked by start of wall rotation and pore pressure rise around the toe of the sheet pile (ERDC London South)

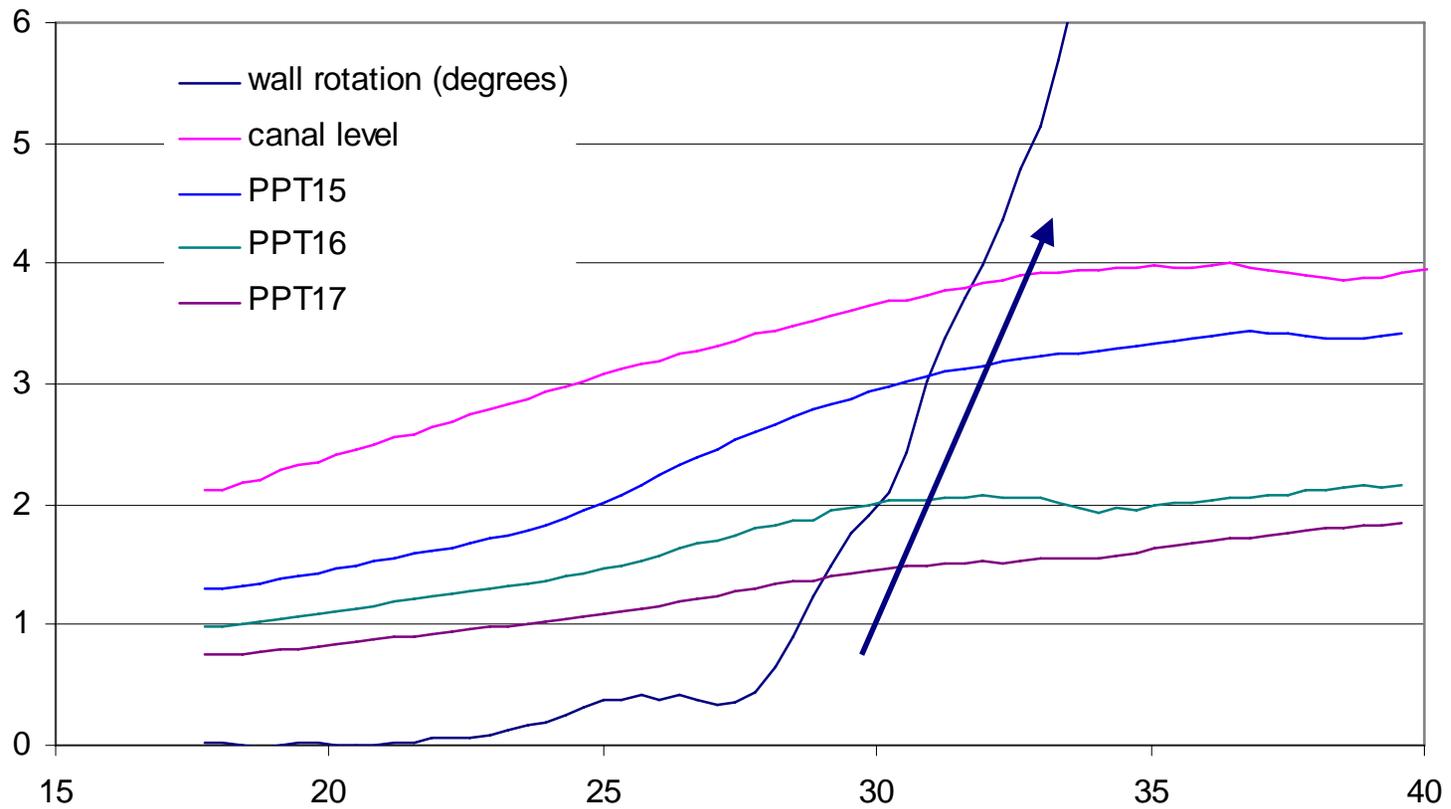
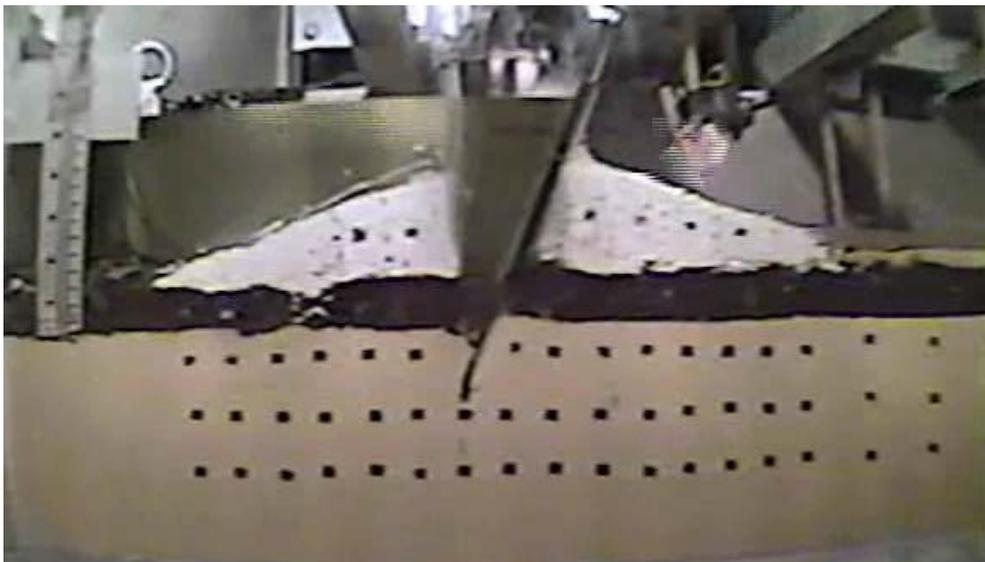
Crack opening phase, marked by start of wall rotation and followed by large scale failure (ERDC London South)

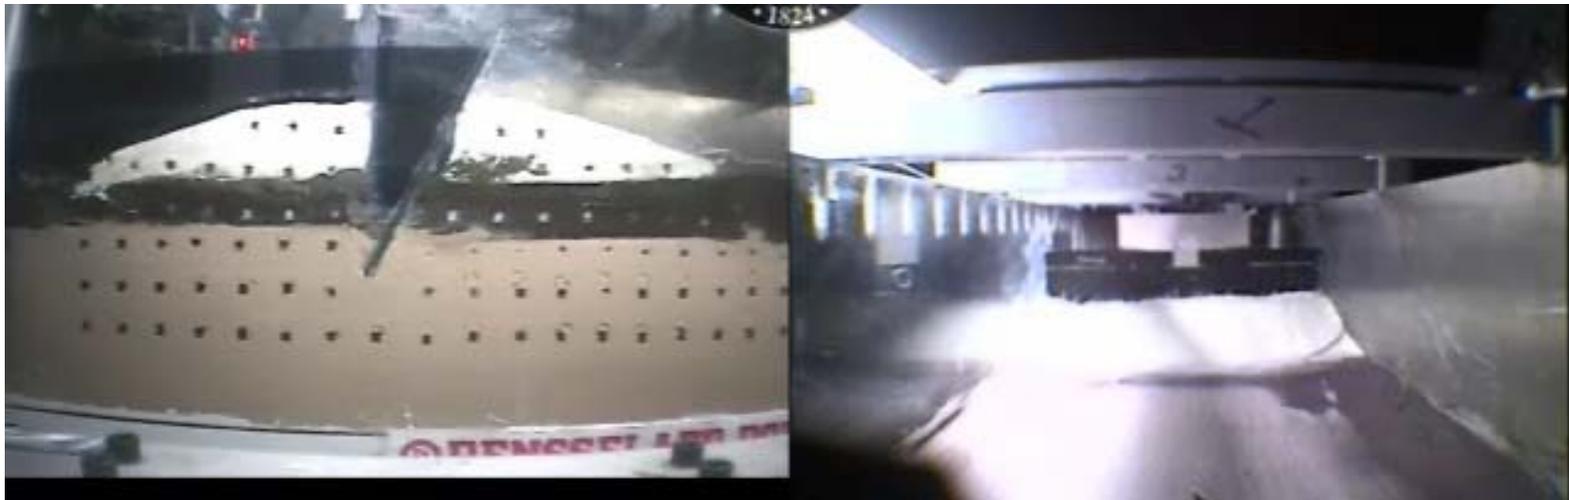
Main failure phase, beyond the levee on the landward side there is a small increase in piezometric level and water emerges from the toe of the levee (RPI London South)

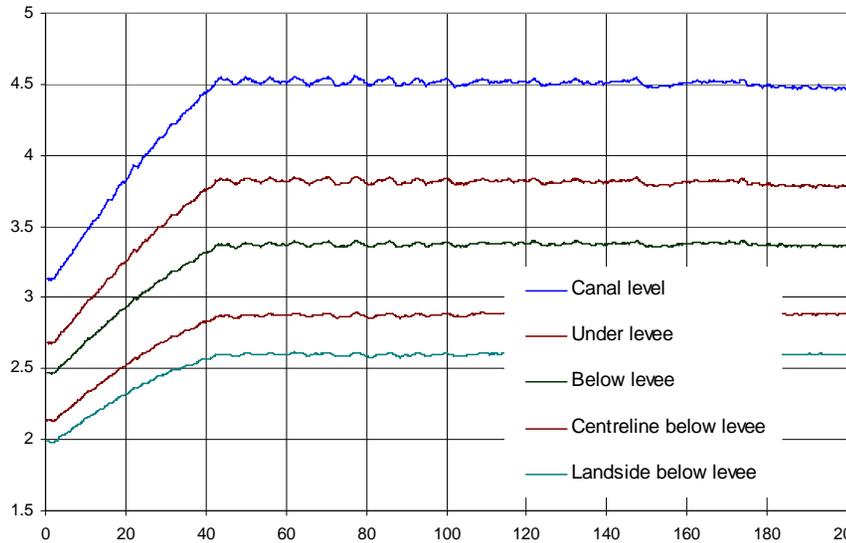
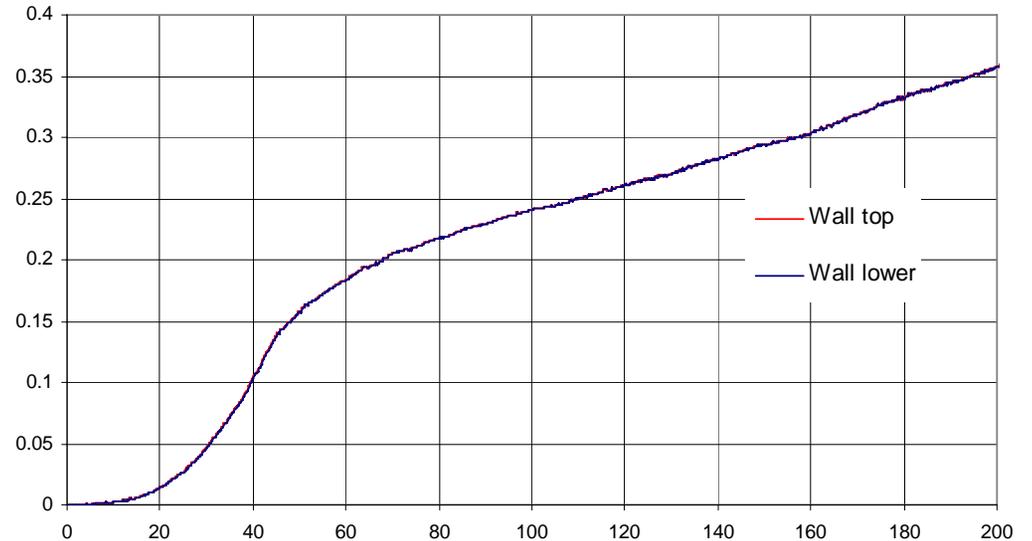
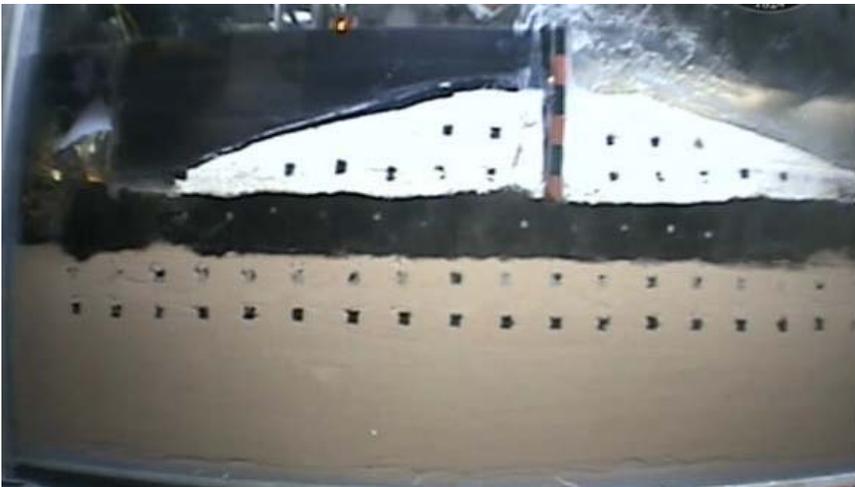
Orleans Canal – end of Stage 2

Piezometric levels under the canal side levee berm rise again as water rises to the top of the wall in the canal, (RPI Orleans Canal). Movement of the wall ten times greater small.

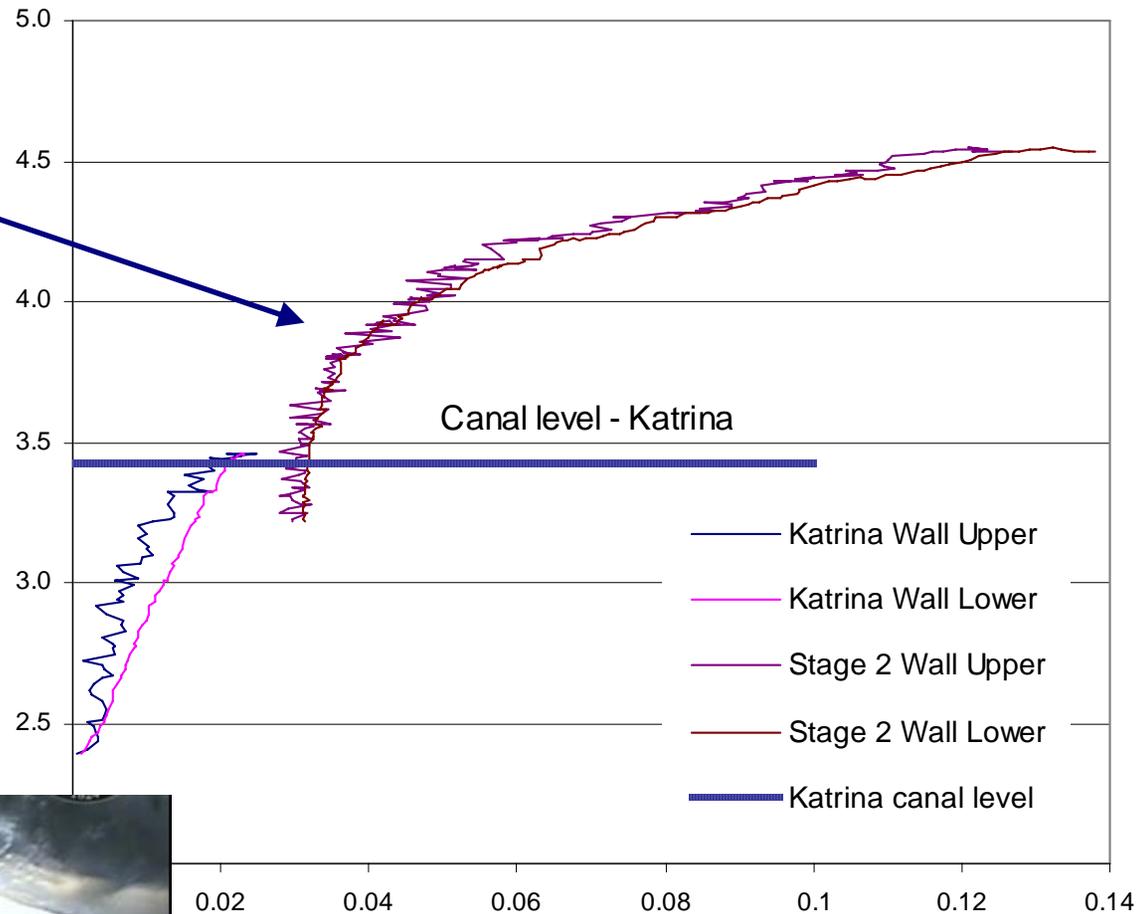
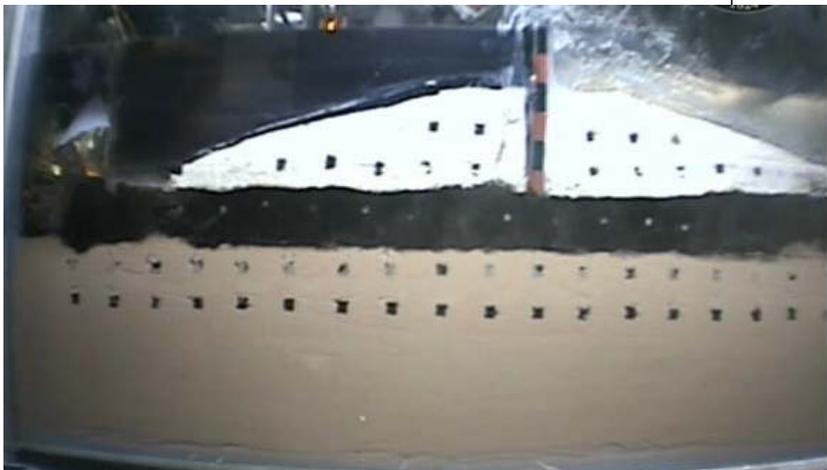
Orleans Canal – crack formation

Reduction of stiffness indicative of crack formation with canal 0.5m above Katrina level

Loading of wall leads to crack formation in translation at canal levels above Katrina levels, wall remains stable at maximum water level

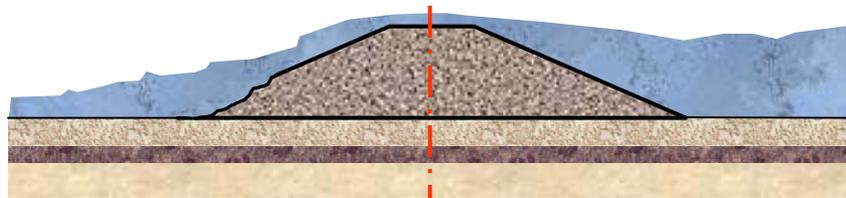
- Overtopping by surge and waves
- Hydraulically filled levees
 - High silt and sand content in the levee
- Water flowing over the levee causes scour and erosion of levee

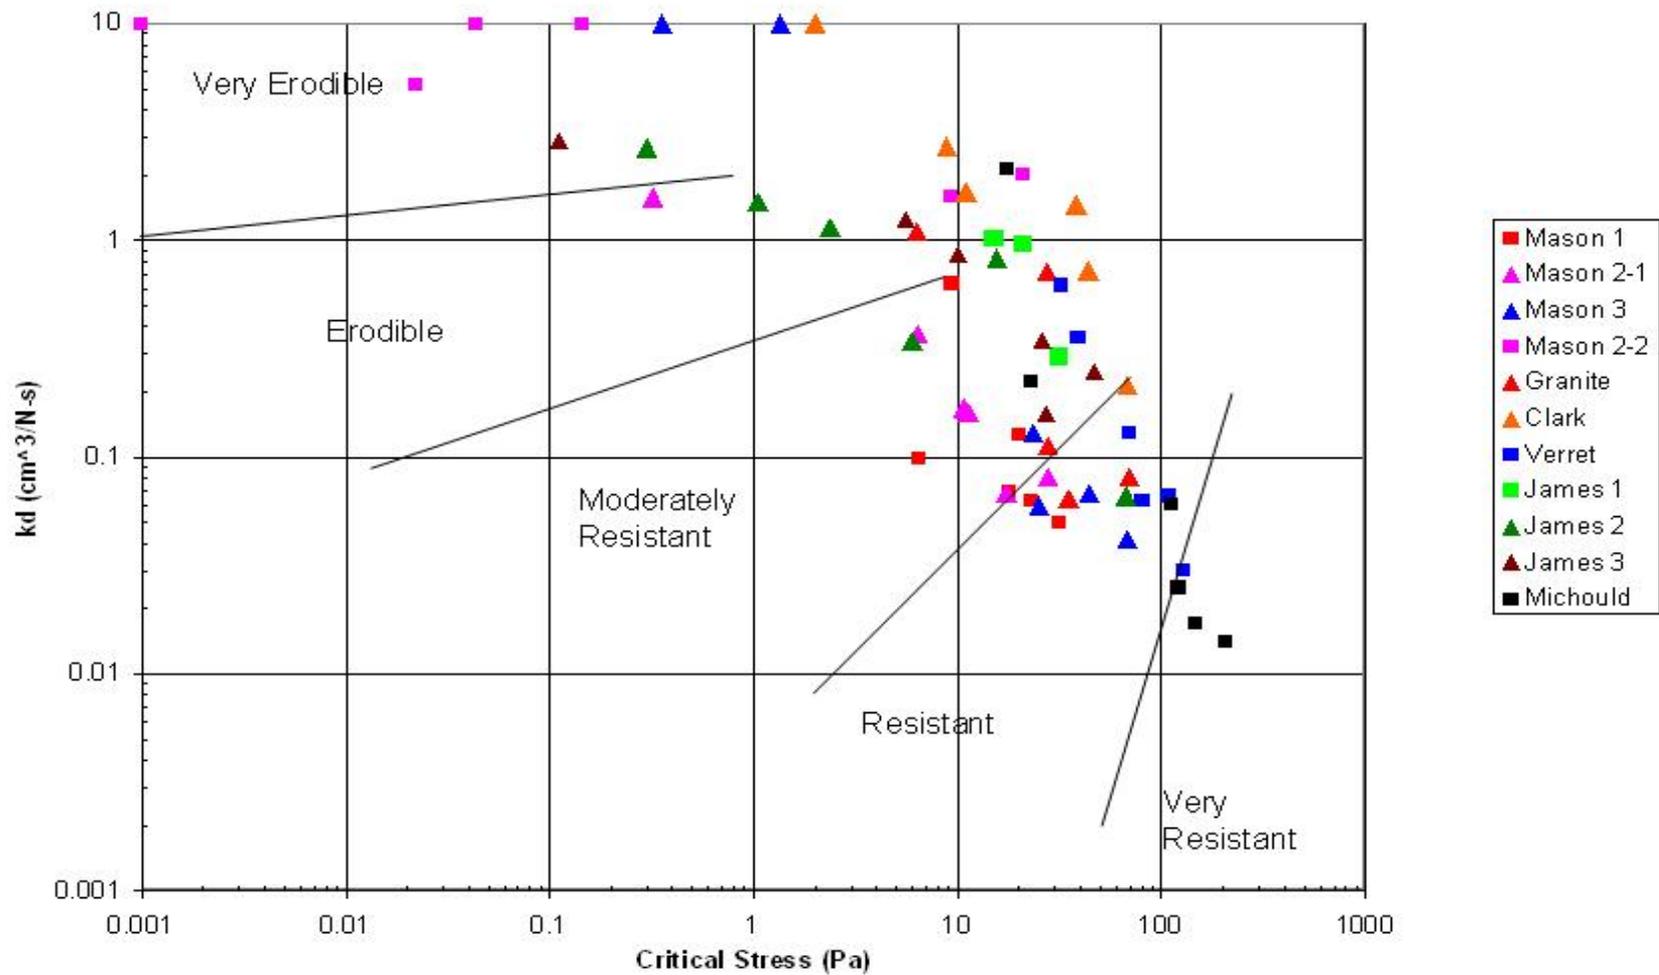
Critical Stress vs Erodibility St. Bernard Parish and New Orleans East Levee Repair

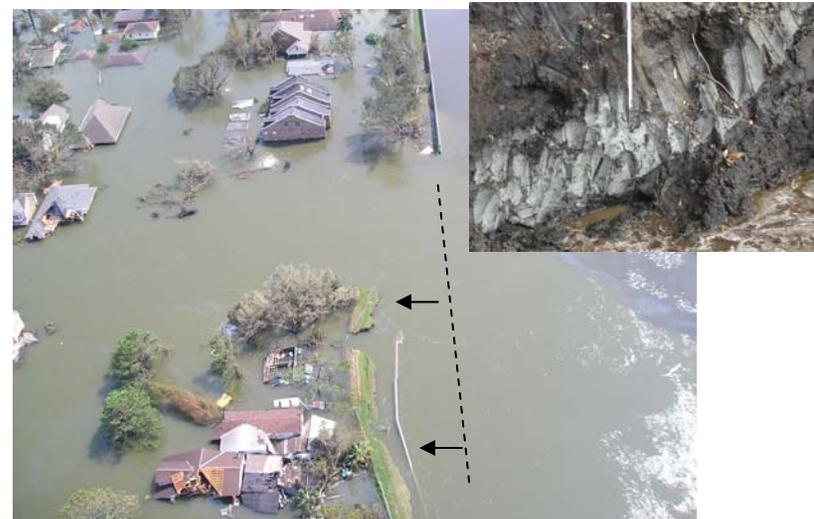
- Deflection of I-wall by surge/waves
- Full hydrostatic pressure along wall splits levee into two blocks
- Weaker clay at levee toe causes failure in subsurface clay layer
- Soil block from wall back displaced

Displacement of wall and part of levee

- **Failure Mechanisms:**
 - Gap formation between the wall and levee soil adjacent to canal side of the wall
 - Variation in shear strength from the levee crest to the toe and beyond
- **Lessons Learned:**
 - Consider the vertical and horizontal variation in shear strength throughout the critical cross sections
 - Assume that the gap will occur and design the walls and levees to ensure that they are stable
 - Increase the levee toe footprint
 - Add stability berms

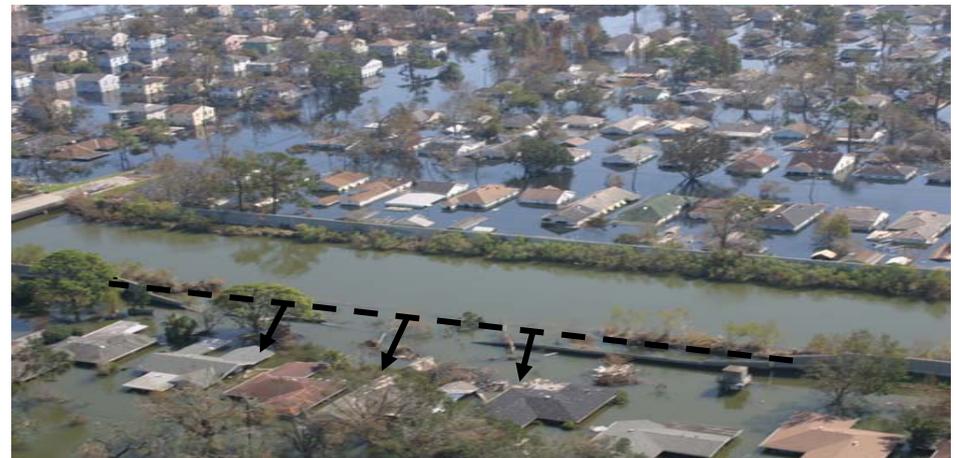
- Deflection of I-wall by surge/waves
- Full hydrostatic pressure along wall splits levee into two blocks and increases pore pressures in underlying sand layer
- High pore pressures cause loss of shear strength in underlying sand layer, leading to sliding instability
- Levee and I-wall displaces laterally

Displacement of wall levee

- **Failure Mechanisms:**
 - Gap formation between the wall and levee soil adjacent to canal side
 - Uplift pressures on the base of the levee and the marsh layer led to instability of the I-walls and levees
- **Lessons Learned:**
 - Assume that the gap will occur and design the walls and levees to ensure that they are stable
 - Increase the levee toe footprint
 - Add stability berms
 - Control the underseepage
 - Relief wells
 - Seepage cutoff walls
 - Seepage berms

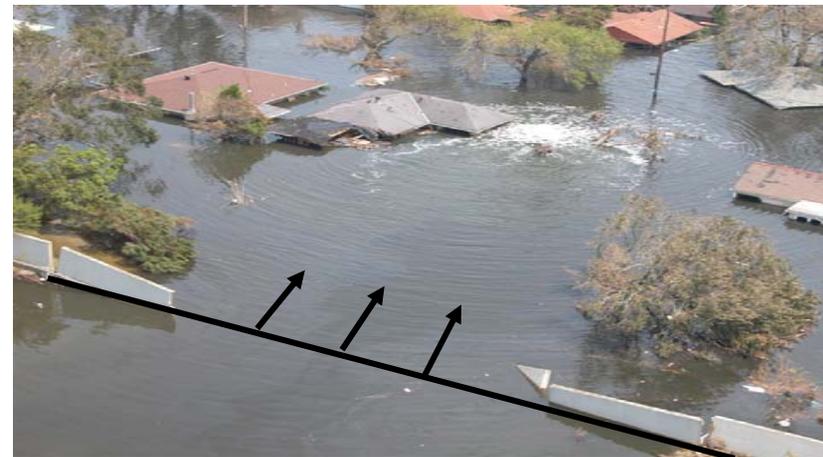
- Deflection of I-wall by surge/waves
- Full hydrostatic pressure along wall splits levee into two blocks and increases pore pressures in underlying sand layer
- High pore pressures cause piping and erosion at the toe, leading to loss of shear resistance
- Levee and I-wall displaces laterally

Displacement of wall levee

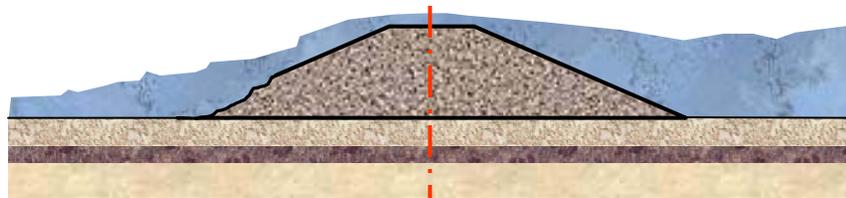
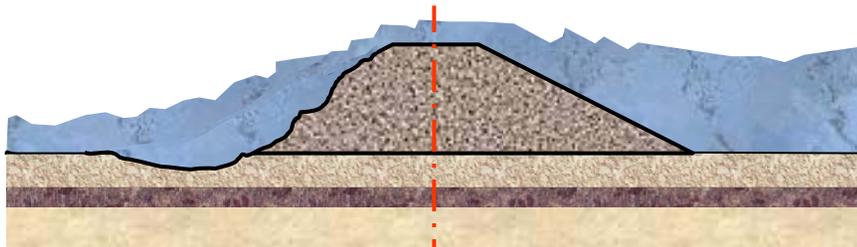
- Overtopping by surge and waves
- High silt and sand content in the levee
- Water flowing over the levee causes scour and erosion of levee

- **Failure Mechanisms:**
 - Overtopping from surge and waves
 - Hydraulically filled levees
 - High content of silts and sands
- **Lessons Learned:**
 - Need to assess the erodibility of the emplace levee materials
 - Avoid silts and sands and hydraulic fills for levee construction
 - Increase the compaction effort for levee materials

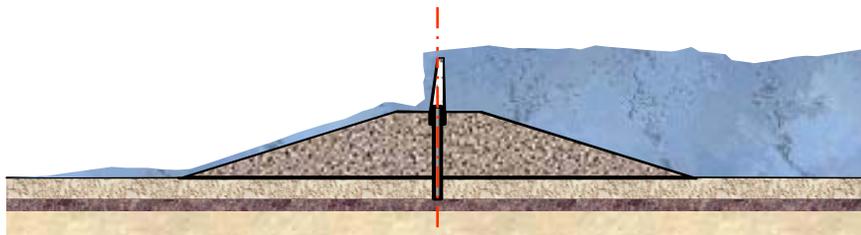
- Overtopping by surge and waves
- Water flowing over the wall causes scour and erosion of levee

- **Failure Mechanisms:**
 - Overtopping from surge and waves
 - Erosion of the protective side levee embankment adjacent to the wall
- **Lessons Learned:**
 - Provide an erosion-resistant surface on the levee adjacent to the wall on the protected side
