# **Appendix 16**

## **Concrete I-Wall and Sheet Piling Material Recovery, Sampling and Testing: IHNC**

# Appendix 17

## Finite Element Seepage Study – Seepage Analysis for Foundation Breaches

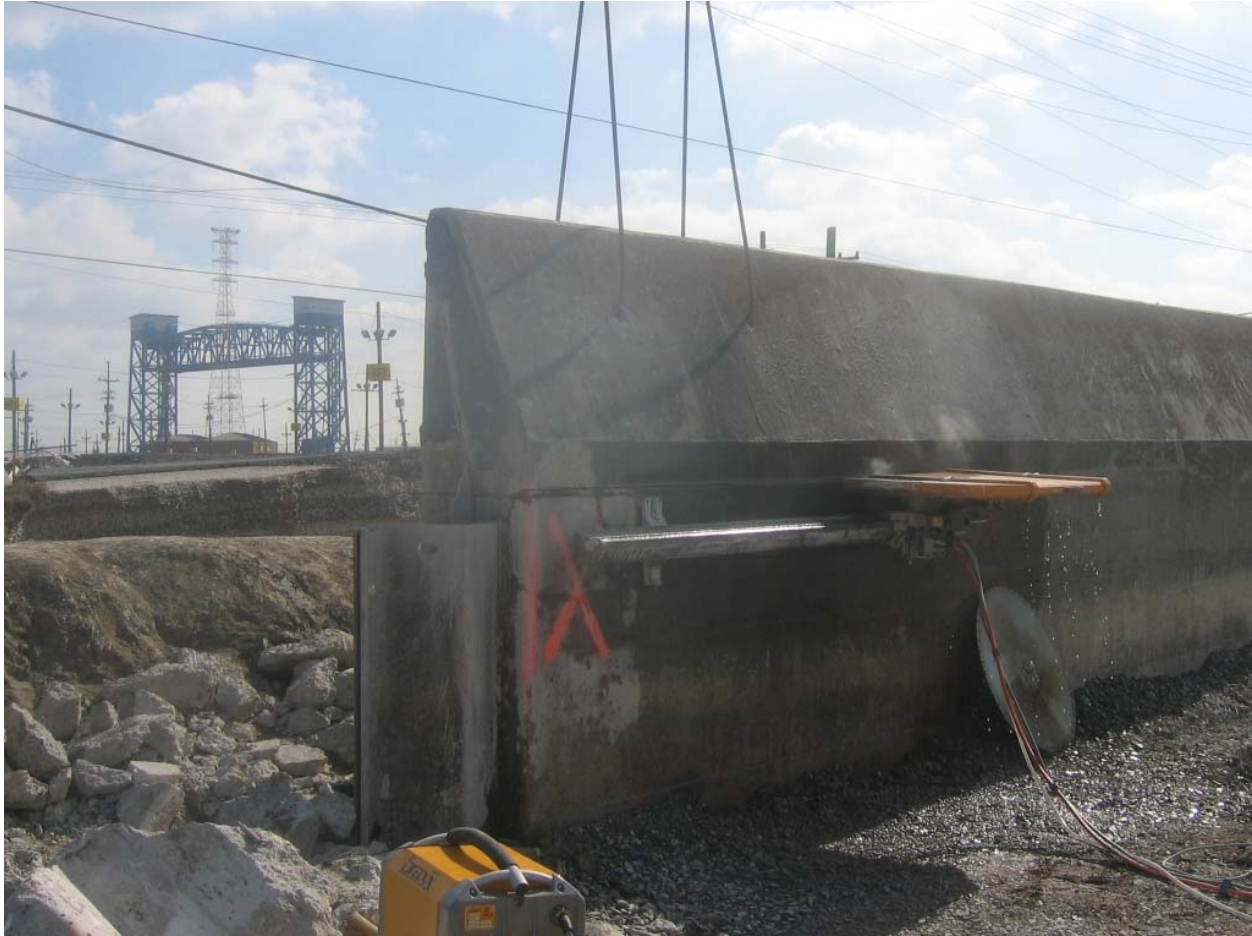
Figure 16-1. Sawcutting Concrete Wall Sample

An approximately eight foot long by 44 inch high section was sawcut from the top of the concrete I-wall as shown in Figure 16-1. The sample was taken from a location at approximately Station 0+44 and was labeled IPET-WE-EW 0+44.

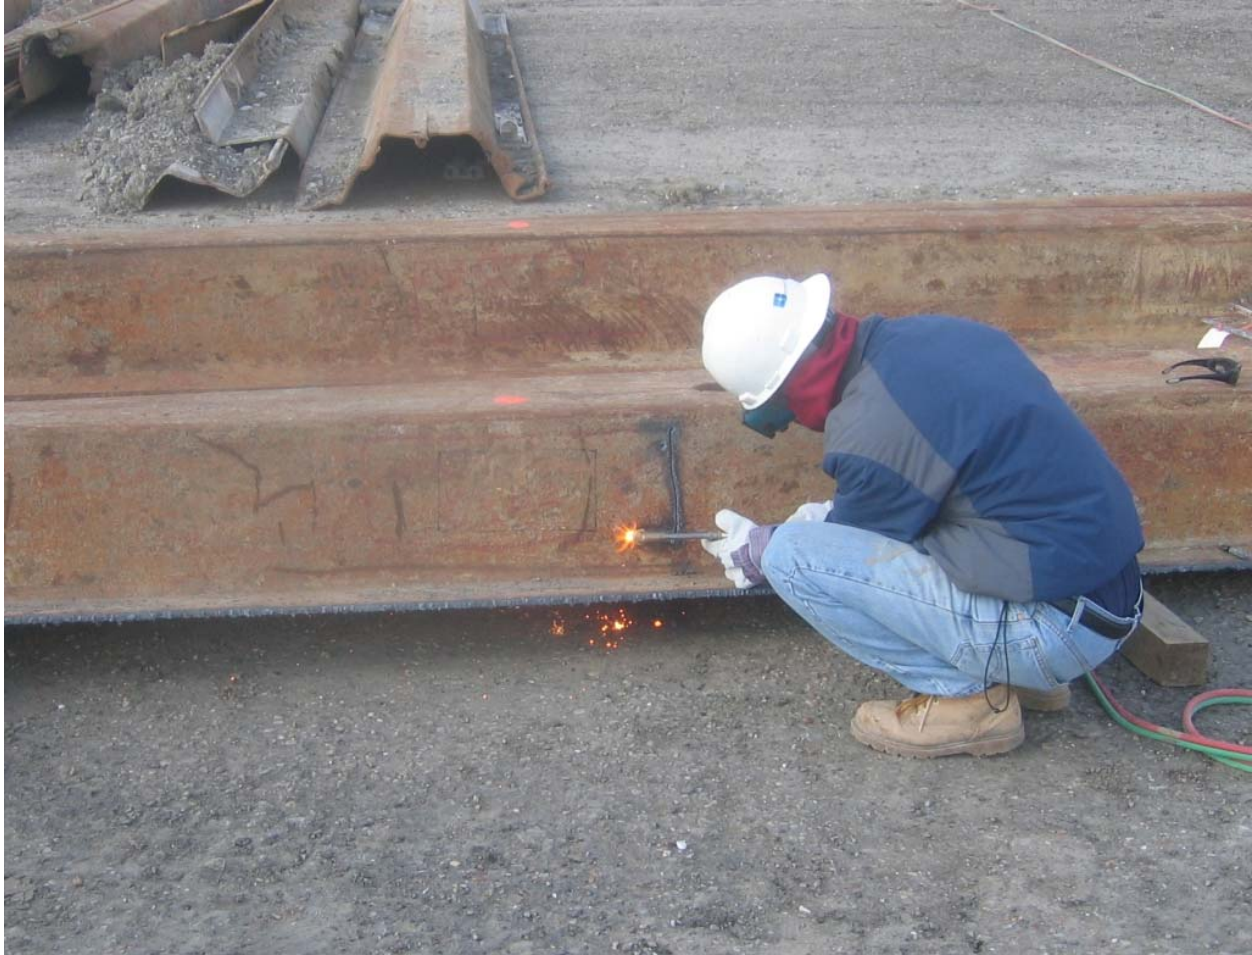
Figure 16-2. Flame Cutting of Material Samples from Piling IHNC-SP-WS-B2

An 8 by 24 inch sample was taken from the web each of two sheet piling at the site. (See Figures 16-2 and 16-3.) The pilings were labeled IHNC-SP-WS-B1 and IHNC-SP-WS-B2 and the corresponding samples were labeled IHNC-WS-B1A and IHNC-WS-B2A. The samples were provided to Beta Testing & Inspection for testing. The sheet piling was transported to the warehouse at the New Orleans District office.

A welder provided by Pittman Construction cut one 8"x 24" specimen from each of the two-sheet pile using an acetylene cutting torch. Mandina's Inspection a subcontractor of BTI then prepared and tested each specimen in tension to failure in accordance with ASTM A-370. For test results see table SP-1 and graph SP-1

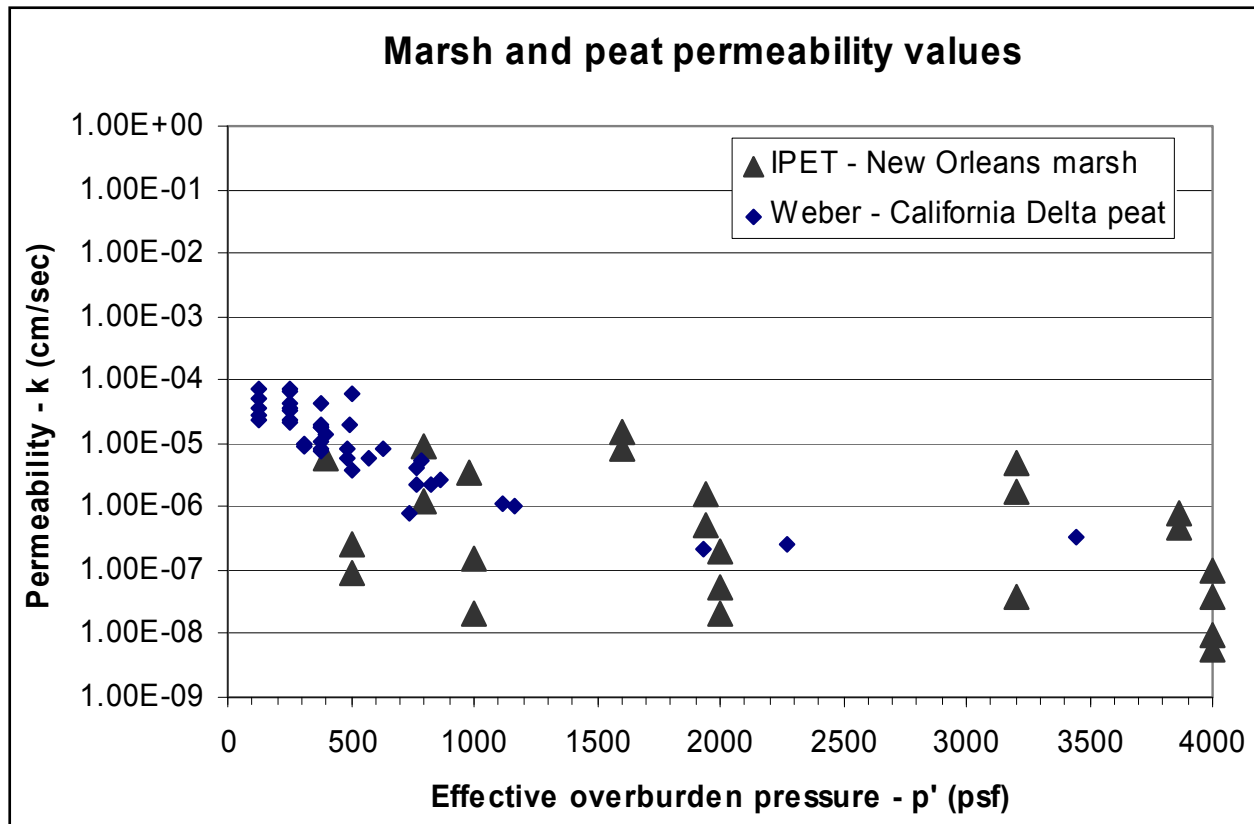
Figure V-17-15. Values of marsh permeability measured by IPET in consolidation tests on New Orleans marsh material, and by Weber (1969) in field piezometer tests on California Delta peat.

Weber (1969) found a similar variation of permeability with effective overburden pressure using field permeability (piezometer) tests on peat in the California Delta, as shown in Figure V-17-15. Weber’s peat coefficient of permeability values are roughly the same as the values determined from the IPET consolidation tests on marsh material from New Orleans, but the scatter of the values from consolidation tests is greater. The difference may be due to the fact that the consolidation tests represent point values, whereas the field tests represent average values for a larger volume of soil. There may also be some inherent differences between the materials.

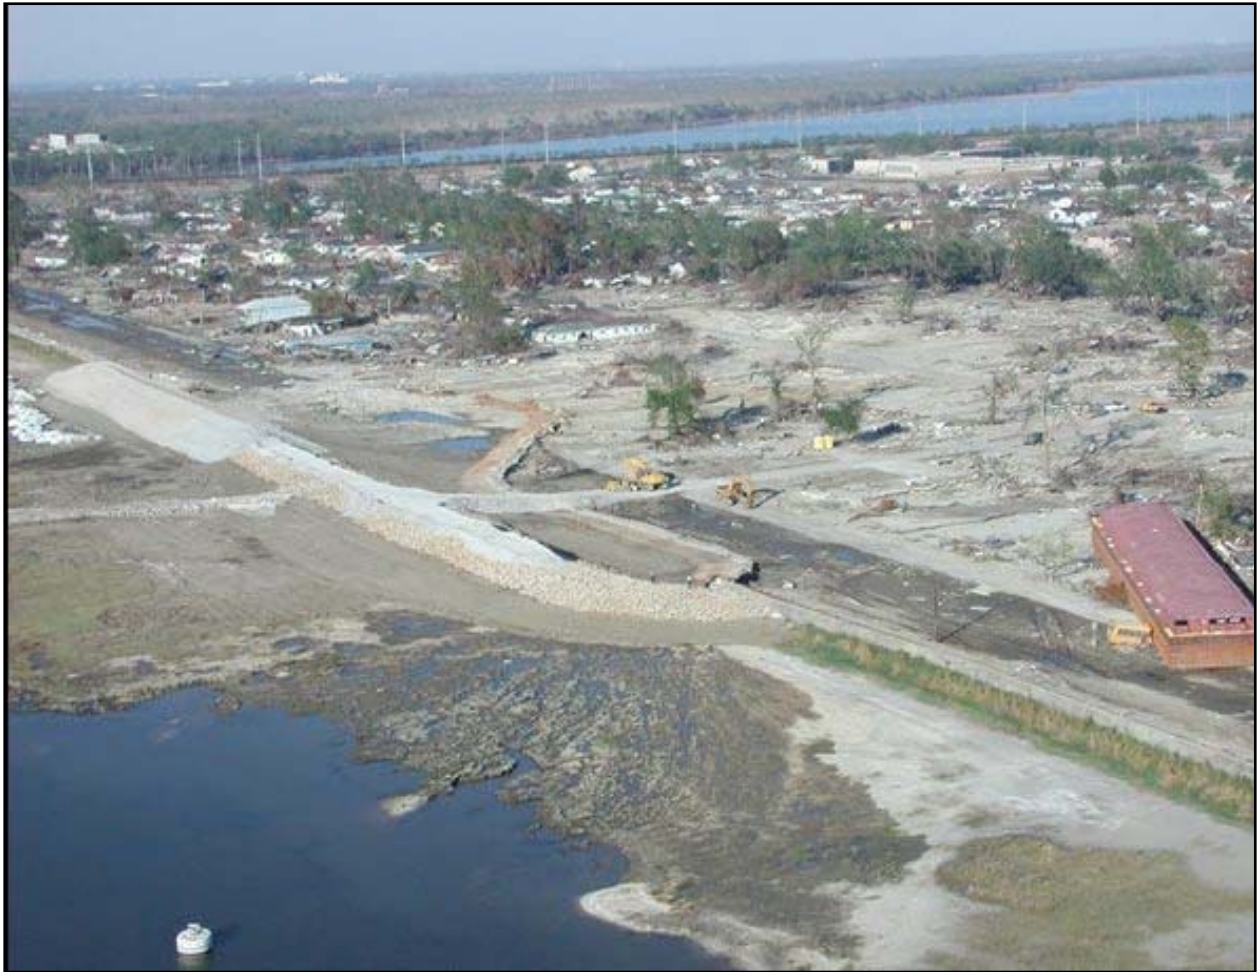
Figure V-17-35. Aerial view of the south breach at east bank of the IHNC (at the west end of the Lower Ninth Ward), showing in crevasse splay generated by reverse drainage flow. (Figure 6.45, NSF-Berkeley report (ILIT Final Report, July 31, 2006)

This calls into question the rest of the NSF-Berkeley investigation of the breaches along the IHNC east bank Lower Ninth Ward. They stated that the failure of south breach was due to underseepage. The NSF-Berkeley group states the crevasse splay shown in the foreground of Figure V-17-35 (Figure 6.45, NSF-Berkeley report ILIT Final Report, July 31, 2006) was due to reverse underseepage. The NSF-Berkeley report states, “*Finally, clear and uncompromising evidence of the high lateral permeability of these deposits at this site is presented in Figure 6.45, which shows a well-developed classic crevasse splay that resulted from reverse underseepage through these same highly pervious marsh deposits as the ponded floodwaters drained out from the Lower Ninth Ward after the hurricane passed.*”

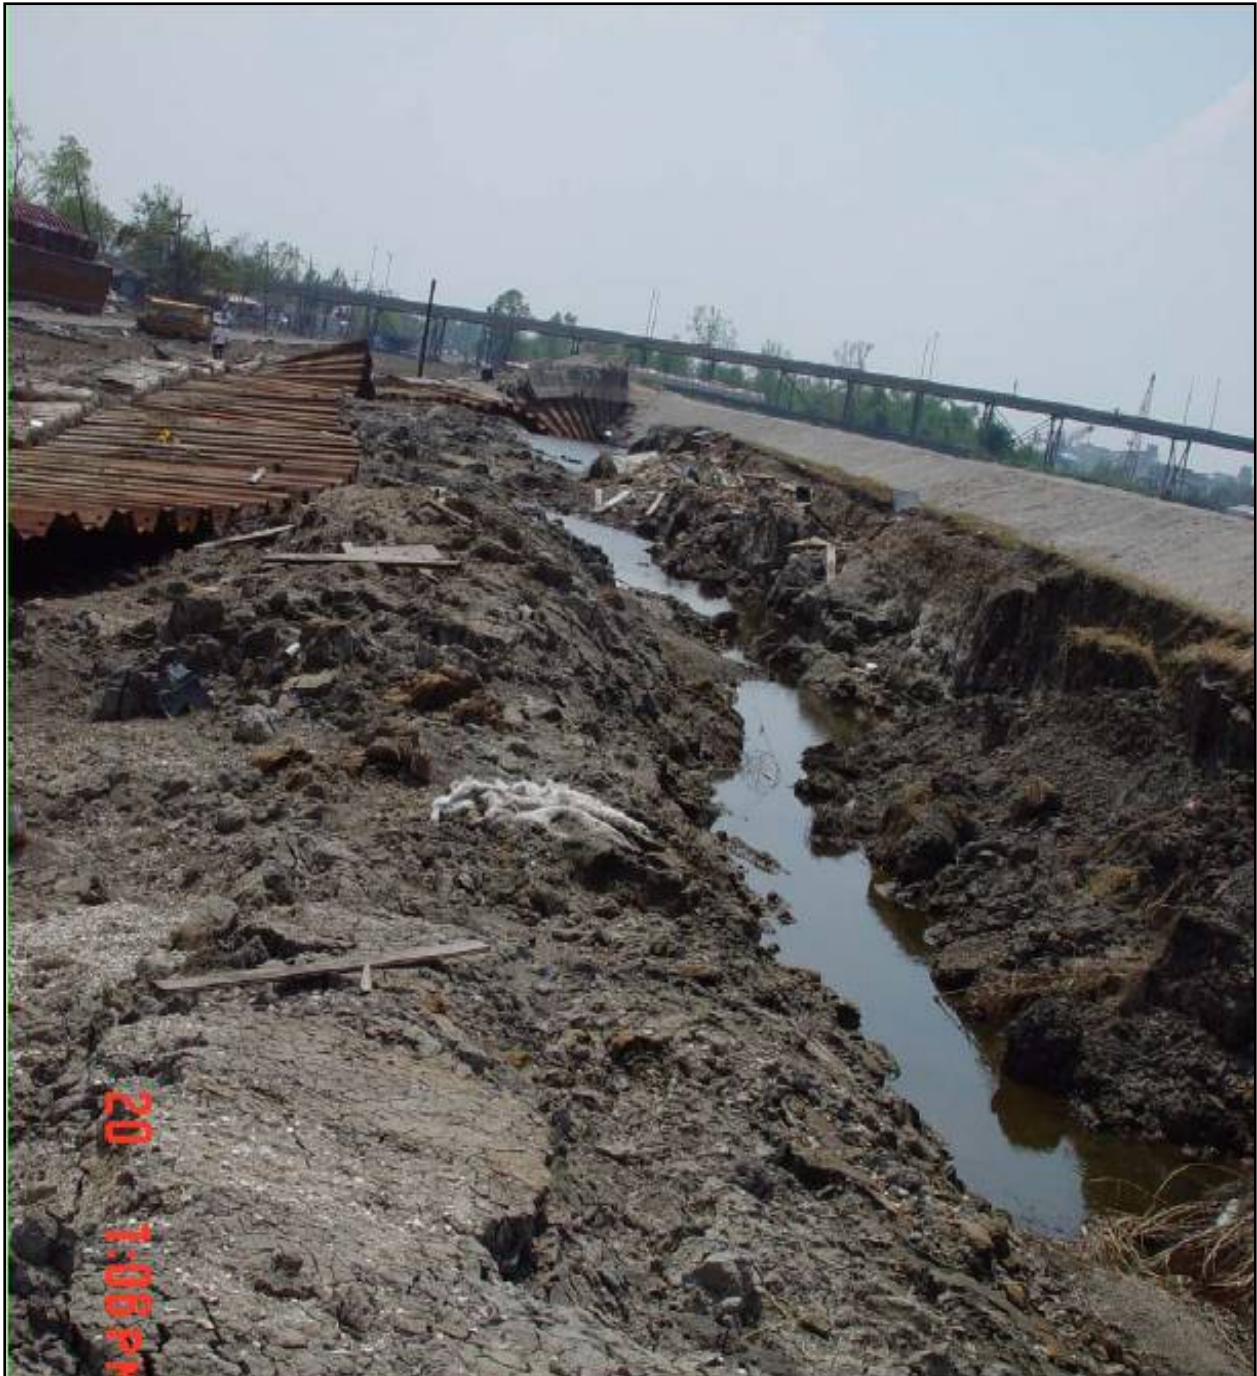
Figure V-17-37. Scour and Erosion Leading to the Failure of the I-Wall on the IHNC adjacent to the South Breach (Lower Ninth Ward)

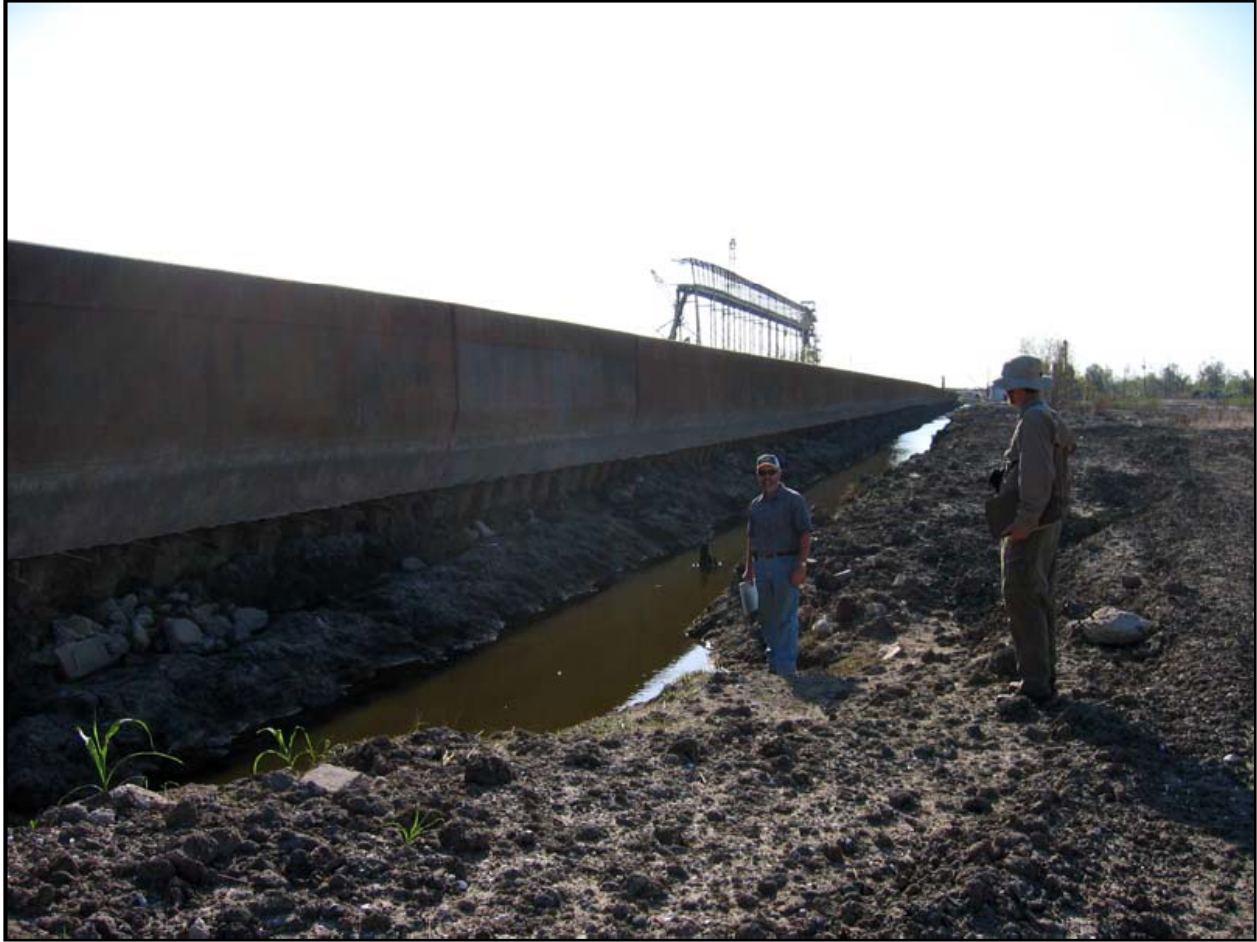
Figure V-17-38. Scour trench on the protected side of Citrus Back Levee I-wall. (Figure 7.14, NSF-Berkeley report (ILIT Final Report, July 31, 2006)

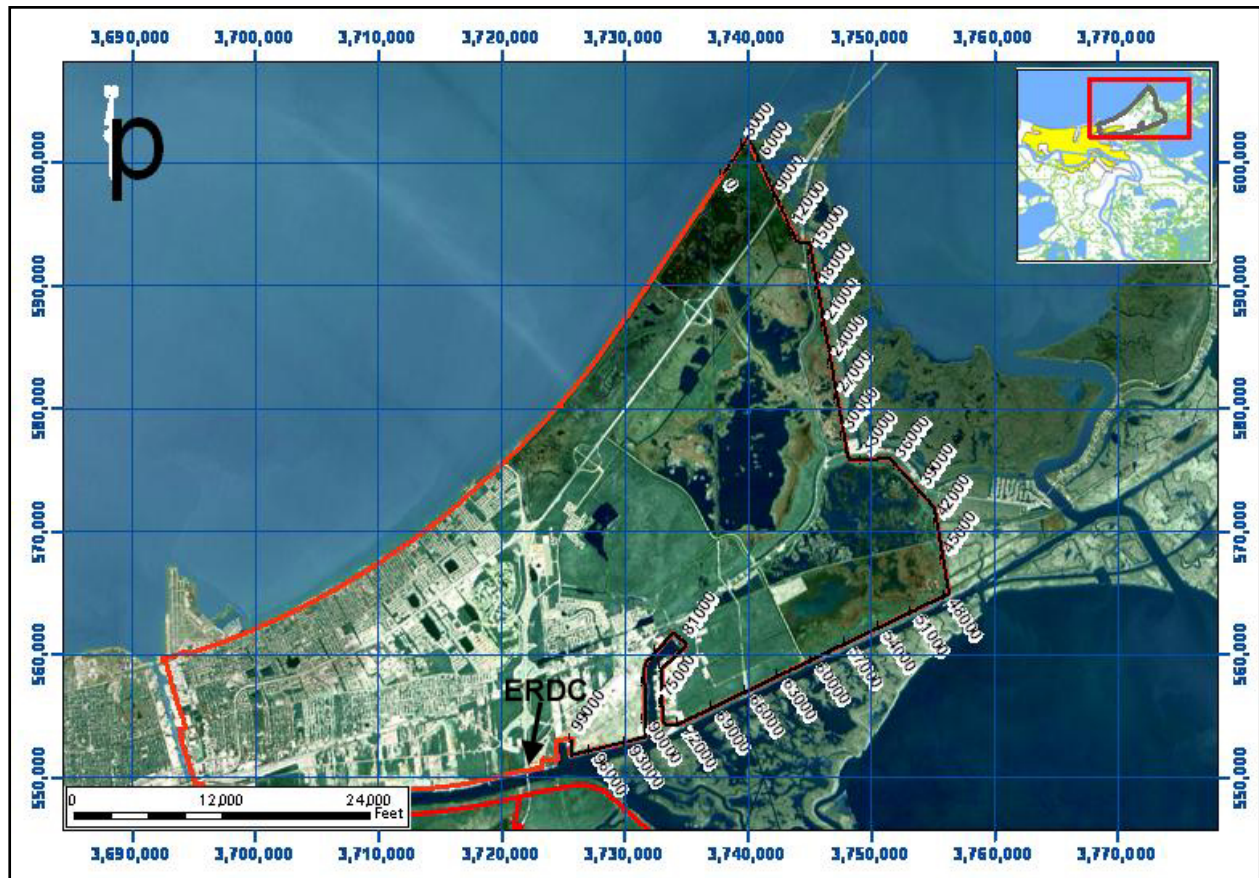
Figure 8. LIDAR stationing used in this report, starting at Lakefront levee and ending at the Michoud Slip along the GIWW. ERDC erosion test location under the I-510 Bridge is shown.

The LIDAR data along the levee crown can also be expressed as an elevation profile. Figure 8 is a plan view of the LIDAR stationing used in this investigation. Figures 9 through 12 show selected post storm LIDAR survey data along the NOE BL. These data allow comparison of scour depths to construction methods and associated soil types, in addition to wave height and surge elevation.

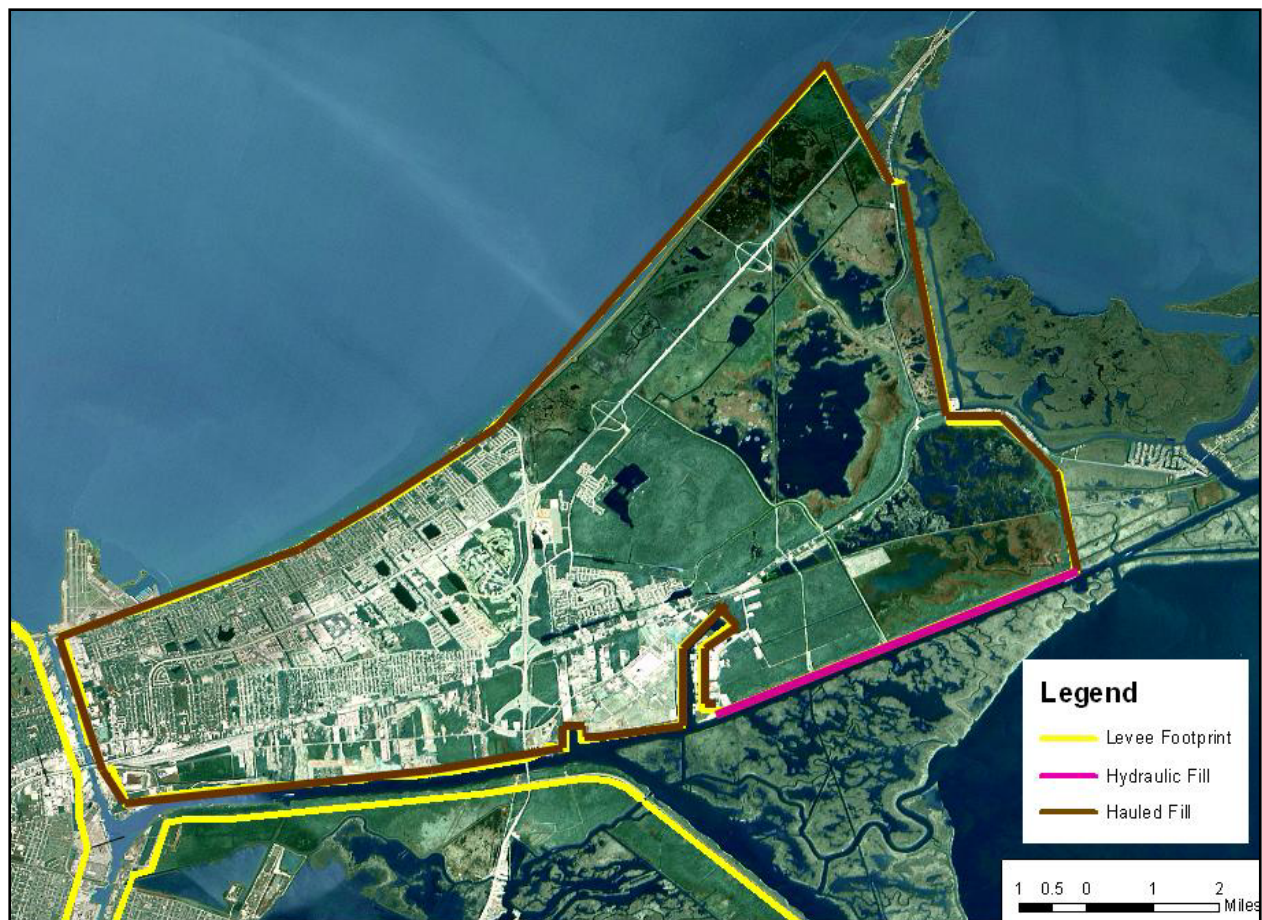
Figure 13. NOE Levee construction materials (from USACE DM NOE Back Levee, Citrus Back Levee, South Point to GIWW levee, Lakefront Levees, IHNC levees after 1969)

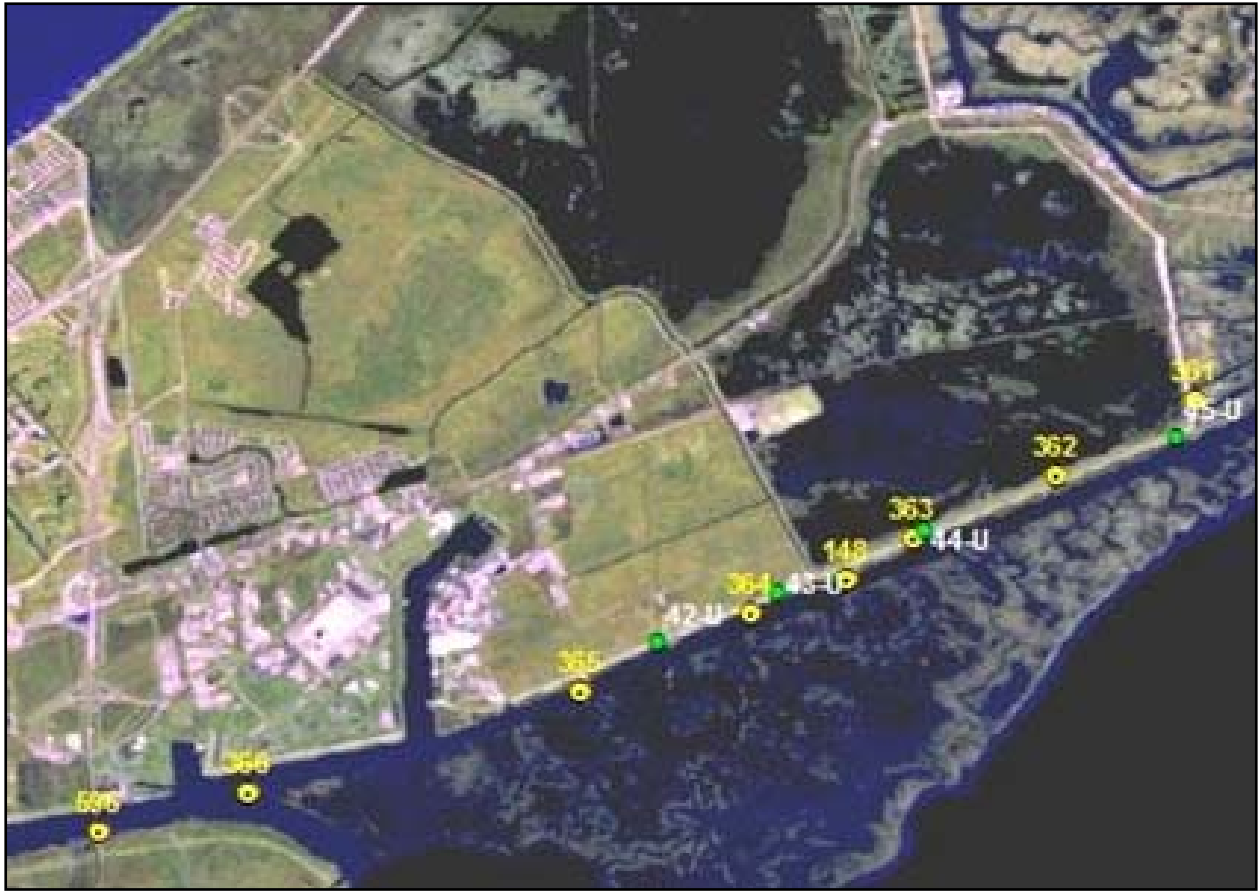
Figure 14. Location of undisturbed borings ( 42-U, 43-U, 44-U, 45-U) drilled in 2001 along the NOE Back Levee

Four soil borings located on Figure 14 (42-U, 43-U, 44-U, 45-U - 2001) were drilled in 2001 after the final lift was constructed to approximate elevation 19 ft above msl. The borings show that the levee materials at the crown surface (the final soil construction lift) were silts, sands and lean clays. Borings 42-U and 43-U (Figure 15) were west of the pump station 15 (previous figures 9 and 10), and borings 44-U and 45-U (Figure 16) were east of the pump station 15 (previous figures 11 and 12). Figure 17 shows descriptions of the soil types. Borings 44-U and 45-U had more fat clay layers in the top 10 ft than the other two borings (42-U and 43-U), but the presence of fat clay layers was not necessarily indicative of higher erosion resistance since the levees east of pump station 15 typically had higher erosion, scour, and breaching frequency than the west side.

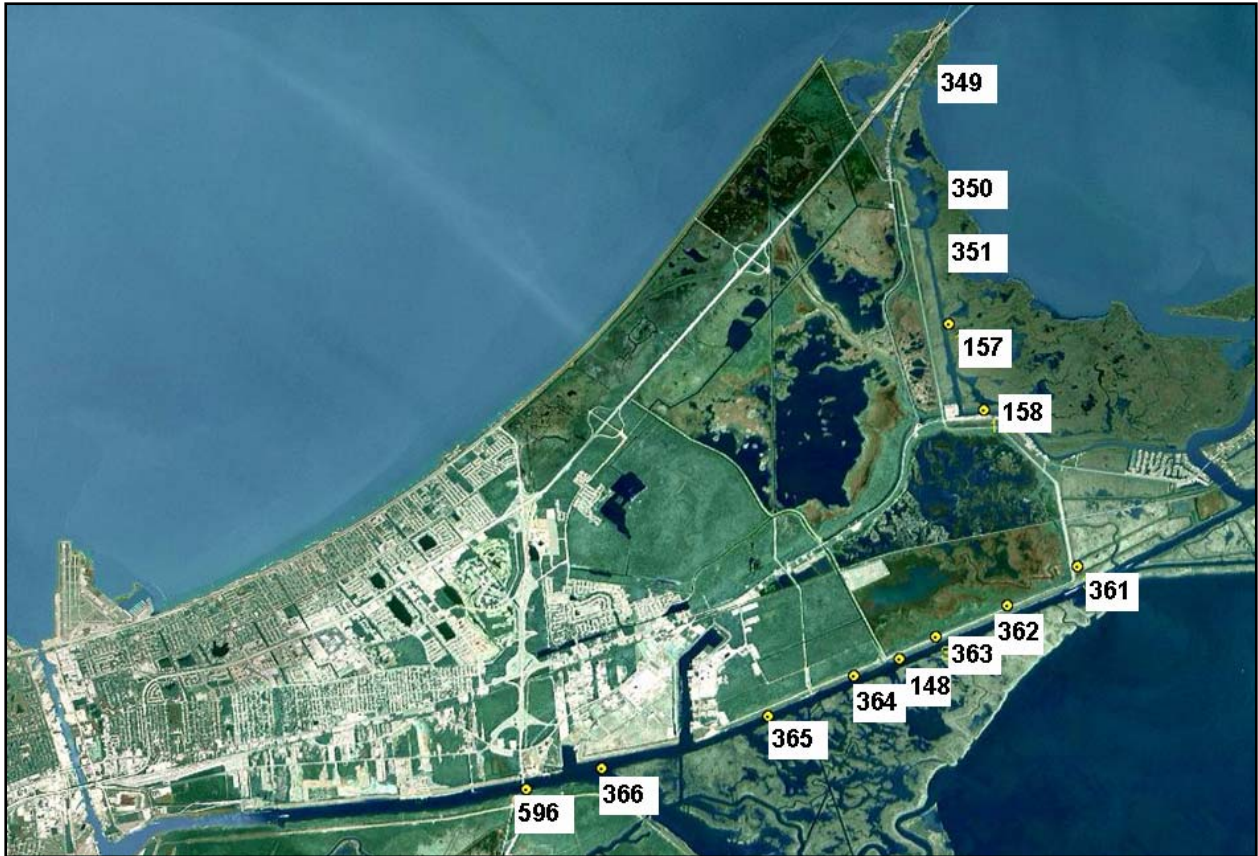
Figure 19. Selected hydraulic data points for surge analysis (350, 351 and 349 are shown on Figure 18)

Table 3 shows the model-calculated surge maximum elevation and the wave heights associated with the maximum surge, in addition to the measured high-water marks surveyed near these points, and the surveyed levee elevations. The high water mark data points were sparse and are described in another IPET report. The calculated maximum surge, “interpreted” surge after consideration of the high water mark survey, the interpreted surge plus the wave height, and levee elevations are plotted in two figures (Figure 20 and 21). Figure 20 is a plot of the data along the north bank of the GIWW between Paris road and the intersection of the GIWW and the South Point levee. Figure 21 is a similar plot expressing data along the South Point levee, (i.e., the eastern boundary of the NOE basin). Note that the interpreted surge data mimic the trend of the calculated surge data.

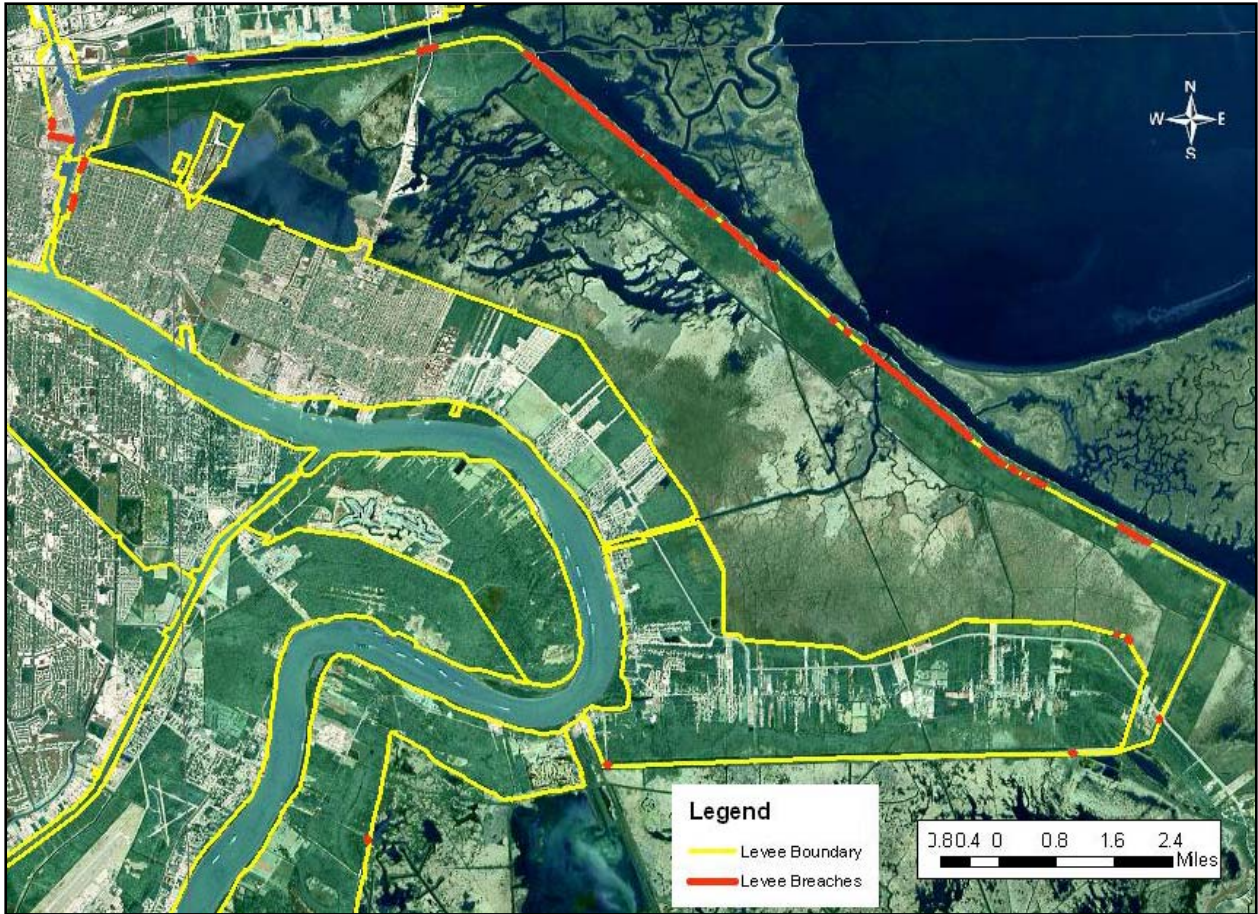
Figure 26. St. Bernard Parish breach locations.

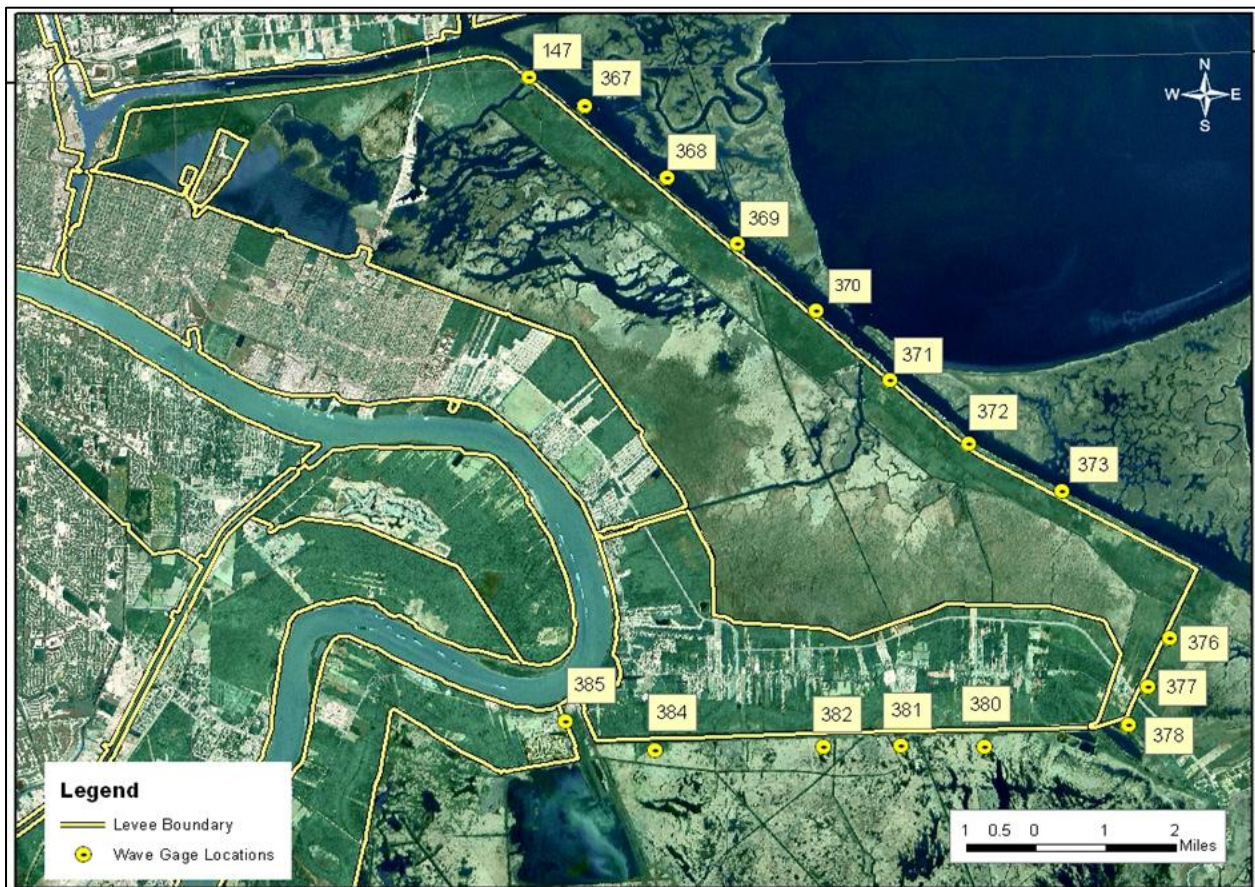
Figure 47. St. Bernard ADCIRC model points for hindcasting

Figure 47 shows selected numerical data points extracted from the IPET Storm Team hydraulic analyses. Numerical models ADCIRC and STWAVE were used to estimate the surge

and wave hydrographs, respectively, associated with hurricane Katrina. Table 6 shows the model calculated storm surge maximum elevation and wave heights associated with the maximum surge, in addition to measured high-water marks surveyed near these points and surveyed levee elevations. The high water mark data points were sparse and are described in another IPET report. The maximum surge, interpreted surge after consideration of the high water mark survey, the interpreted surge plus the wave height, and levee elevations are plotted in three figures (Figures 48, 49 and 50). The figures separate the data into straight line reaches of levee (with some overlap) for ease of illustration. For example, Figure 48 shows the data along the MRGO. The data shows the calculated maximum surge is approximately 2.5 ft lower than the interpreted surge when the high water mark survey is considered. Note that the interpreted surge also expresses the trend calculated by the numerical model. Figure 48 also dramatizes the height of water flow over this reach of levee by comparing levee elevation to the interpreted maximum storm water level (i.e., interpreted surge elevation plus calculated wave height).

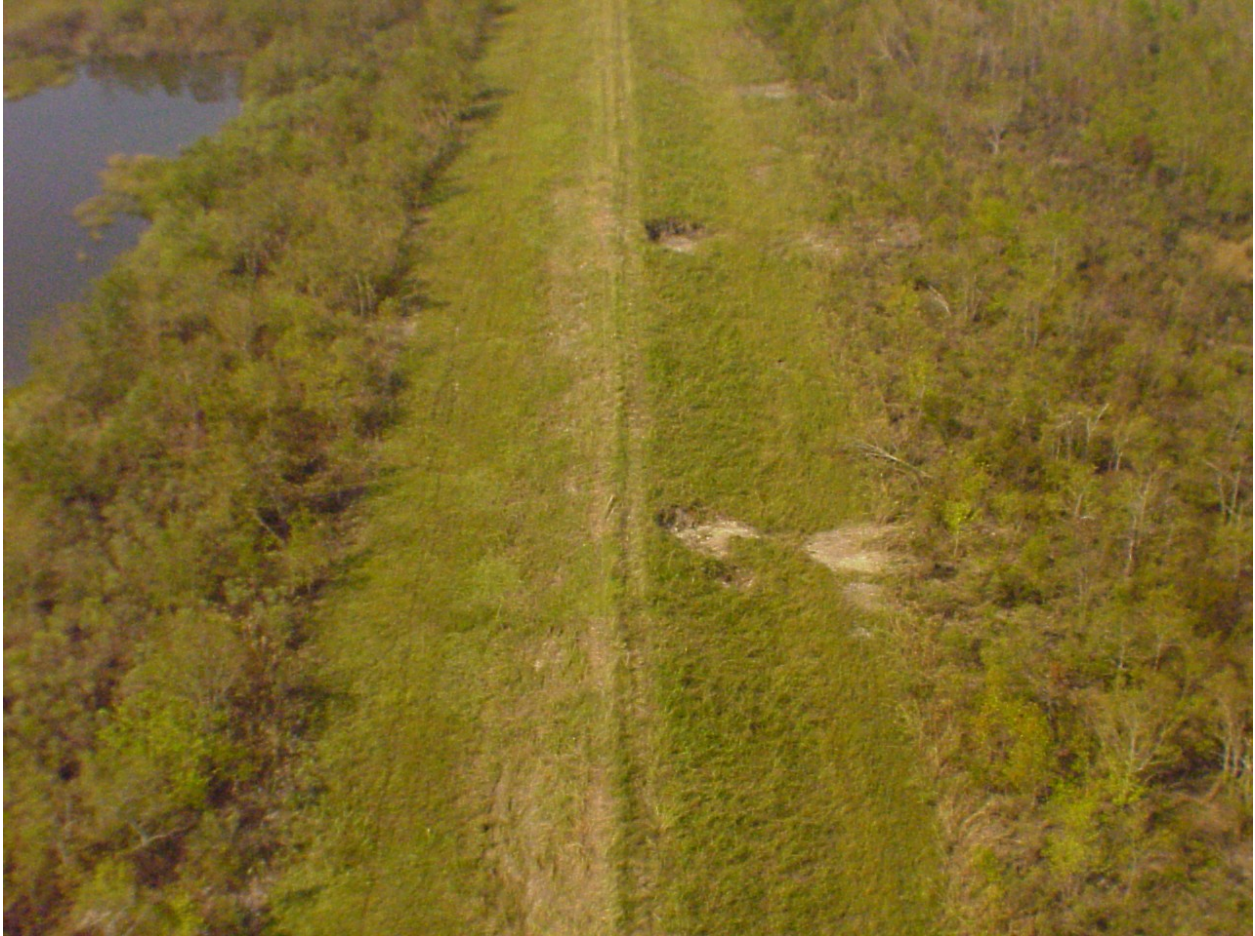
Figure 5. Stage A erosion on the Citrus Back Levee

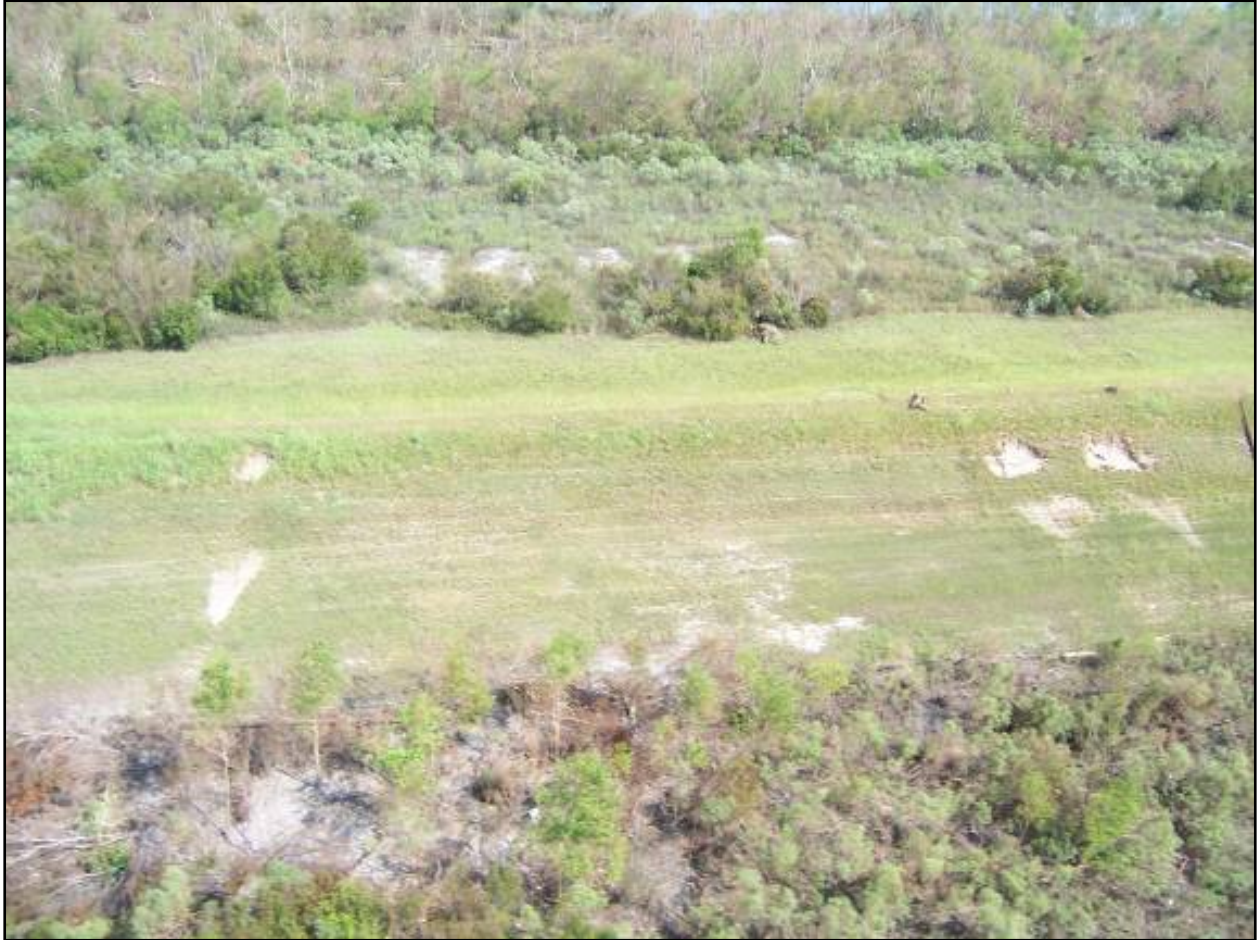
Figure 9. Stage A erosion on south bank GIWW levee, St. Bernard Parish

Figure 9 shows backside slope erosion and minor erosion on the stabilizing berm slope along the south bank GIWW levee between Sta. 65+008 and STA. 277+20 in St. Bernard Parish. The General Design section for the south bank GIWW indicated that the levee was built to approximate elevation 14 ft. circa 1970, and an additional lift up to elevation 19 was added circa 1985. Post-Katrina LIDAR along the south bank GIWW showed the uneroded levee crown was up to approximate elevation 16 ft. Storm surge along the GIWW was approximately 15 to 17 ft, causing an estimated overtopping depth of approximately 1 to 2 ft. Drawing 9 of 19, New Orleans District file H-8-45533, shows several layers of stiff lean clay (CL) at centerline top of levee (boring elevation 16.8 ft) from the 5/11/2000 soil boring 5A-CAU, B/L Sta 135+50.

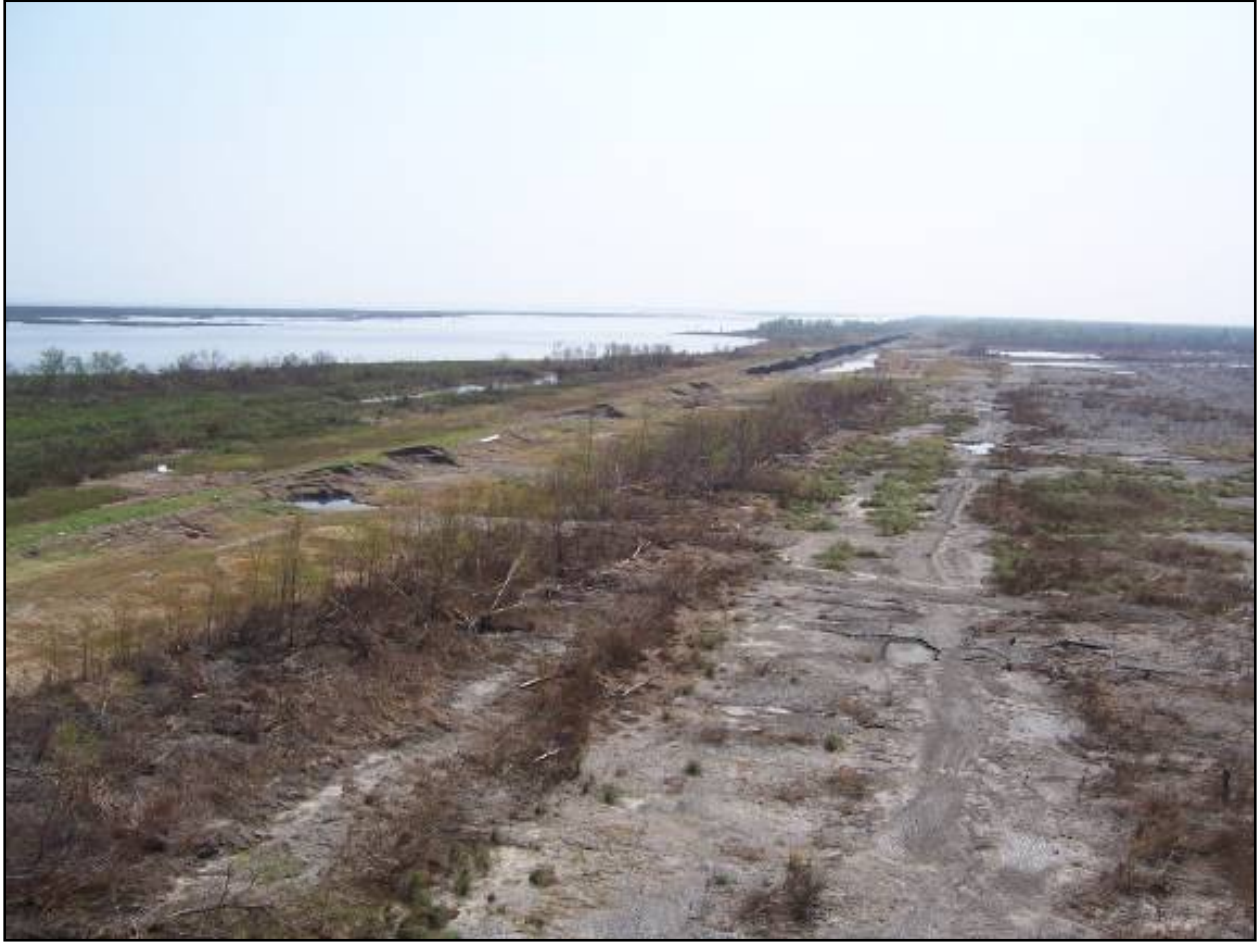
Figure 15. Stage B crown erosion on remaining levee southeast of Bienvenue Control Structure

Figure 15 shows a small section of the levee between Bayous Bienvenue and Dupre, viewed to the south from approximate B/L Sta 570+00. The MRGO is to the left of photo. Approximately 6.2 miles of levee along the MRGO were overtopped and breached at numerous locations. Storm surge along the MRGO was approximately up to 21 ft, so the approximate overtopping depth was about 5 ft along this reach. Soil boring 12BU-CHBD (01-16834) from 2001 at Sta 570+00 (Figure 16) shows the top 1.4 ft of levee (at crown elevation 16) was composed of lean clay (CL), with fat clay (CH) layers underneath. At a depth of 8.5 ft below the crown, a shear Q test indicated cohesion value 270 psf at 51% water content and 68 pcf dry density in a CH layer. At a depth of 16.8 ft, cohesion was slightly higher (396 psf) at 62% water content and 62 pcf dry density, also in a CH layer. This low strength profile indicates that the levee's ability to withstand hydrodynamic pressure loading would be seriously impaired if the levee footprint was reduced. There were numerous locations along this reach where the footprint was significantly reduced due to soil loss on the backside, which most likely accelerated breaching progression.

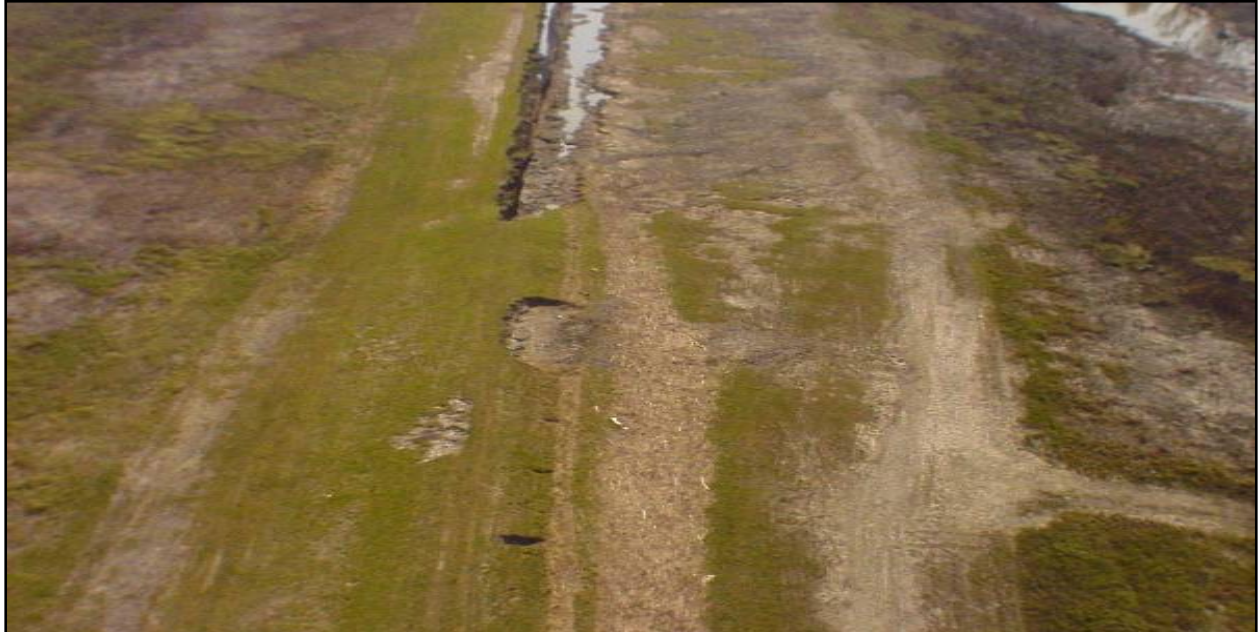
Figure 18. Stage C breach development on short reach of levee between Verret and Caernarvon

approximately 15 ft, but dropped to about 12 ft for about a mile in this eroded section. Storm surge and wave heights were up to 3 ft higher than the levee along this reach, and this was the only significant breach between Verret and Caernarvon. The levee along this reach was constructed of Mississippi River hydraulic sand fill, capped with local borrow material fat clay interbedded with silt and/or sand lenses, and shaped to grade with Mississippi River batture soil (truck-hauled fill). Similar to other levees' construction materials and history, this section contains heterogeneous soil layering probably compacted to different densities over a half-century or so timeframe. Figure 19 shows a pre-Katrina boring at Sta 1225+61 with a thin surface layer of very stiff lean clay underlain by very stiff fat clay and the hydraulic fill sand.

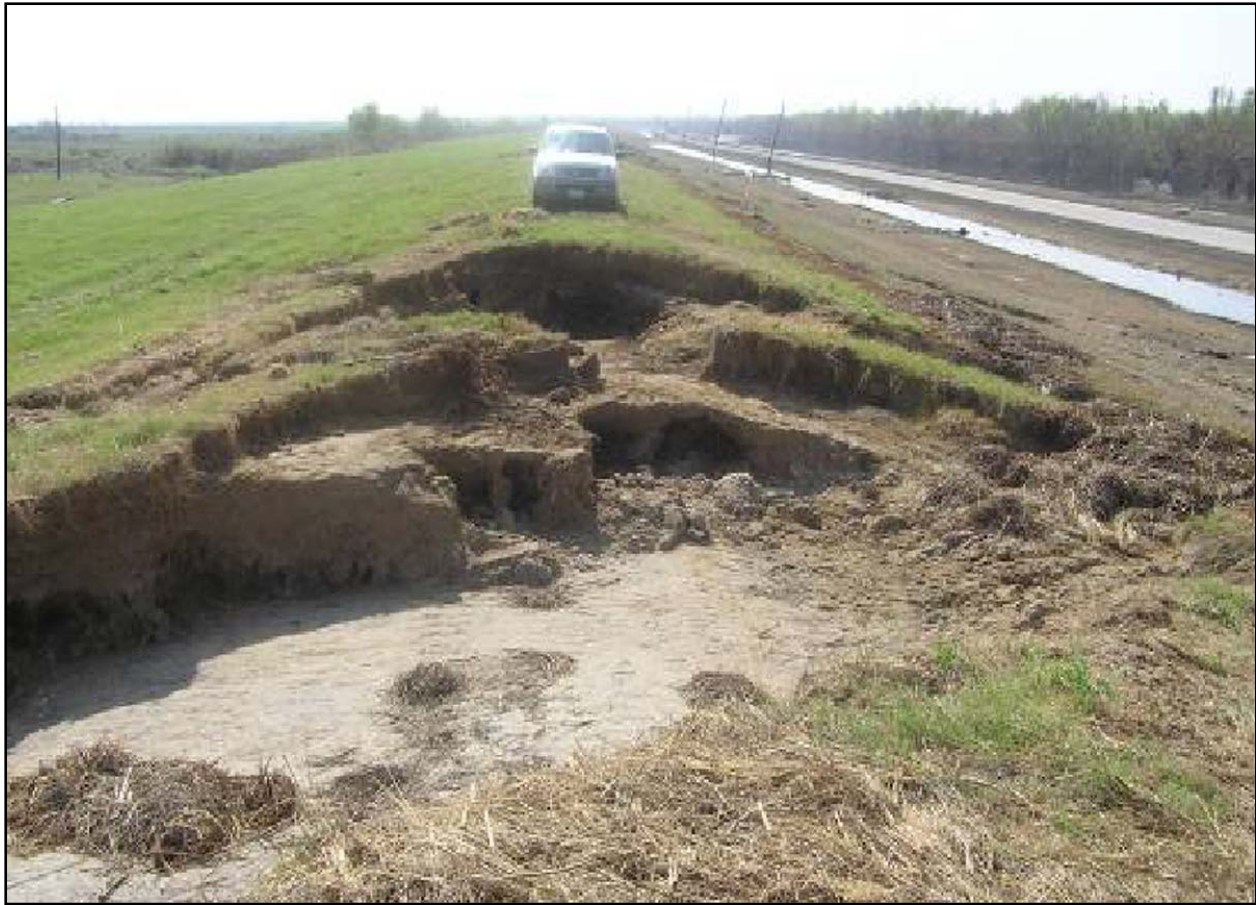
Figure 20. Stage C breach along Plaquemines Parish levee
