# **Appendix 16**

## **Concrete I-Wall and Sheet Piling Material Recovery, Sampling and Testing: IHNC**

# Appendix 17

## Finite Element Seepage Study – Seepage Analysis for Foundation Breaches

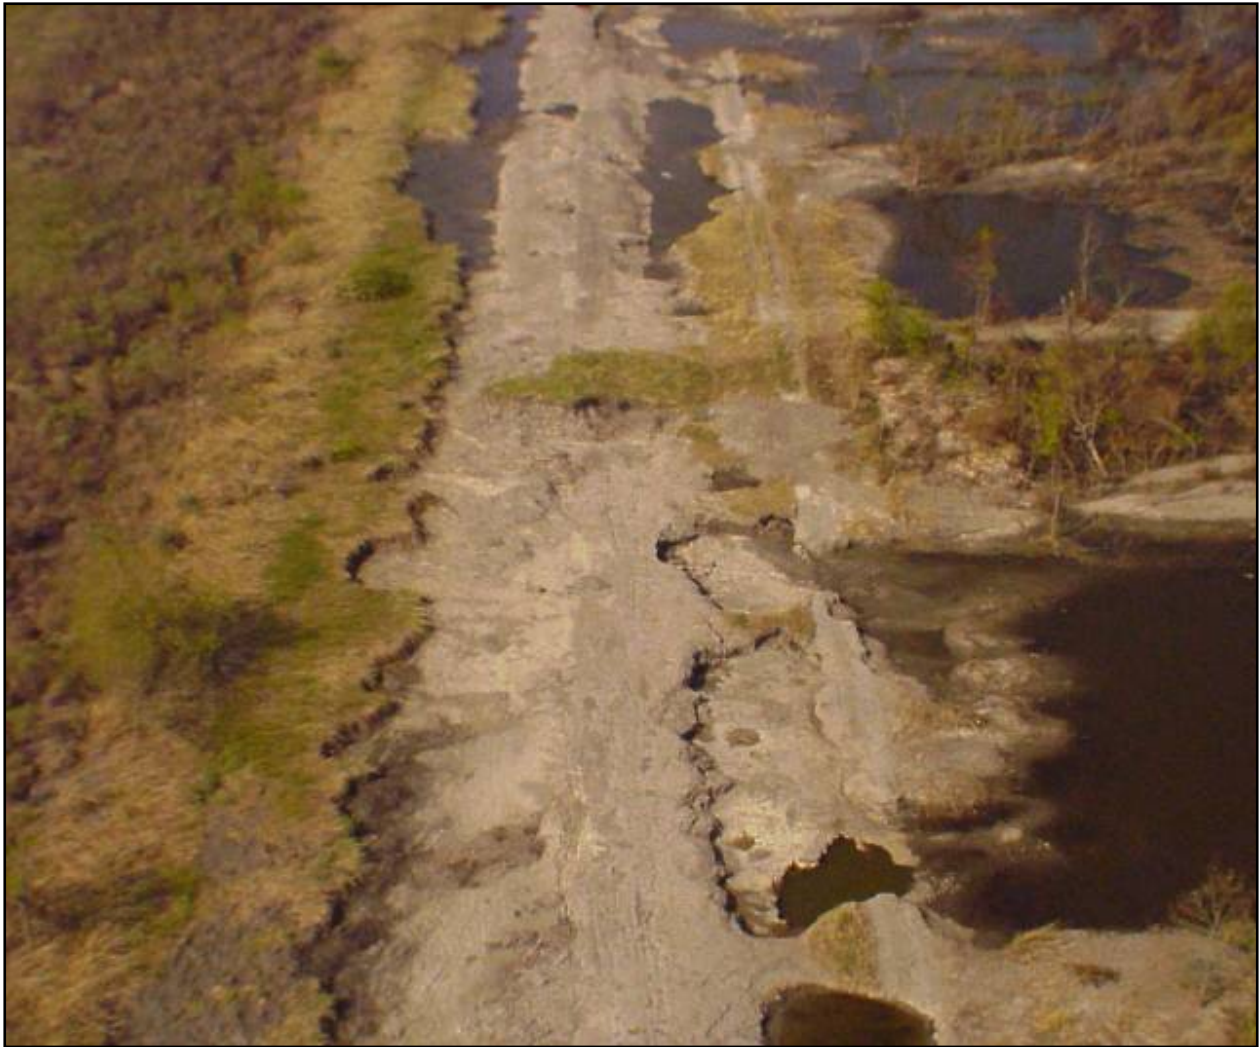
Figure 21. Stage D erosion east of pump station 15, N.O. East Back levee

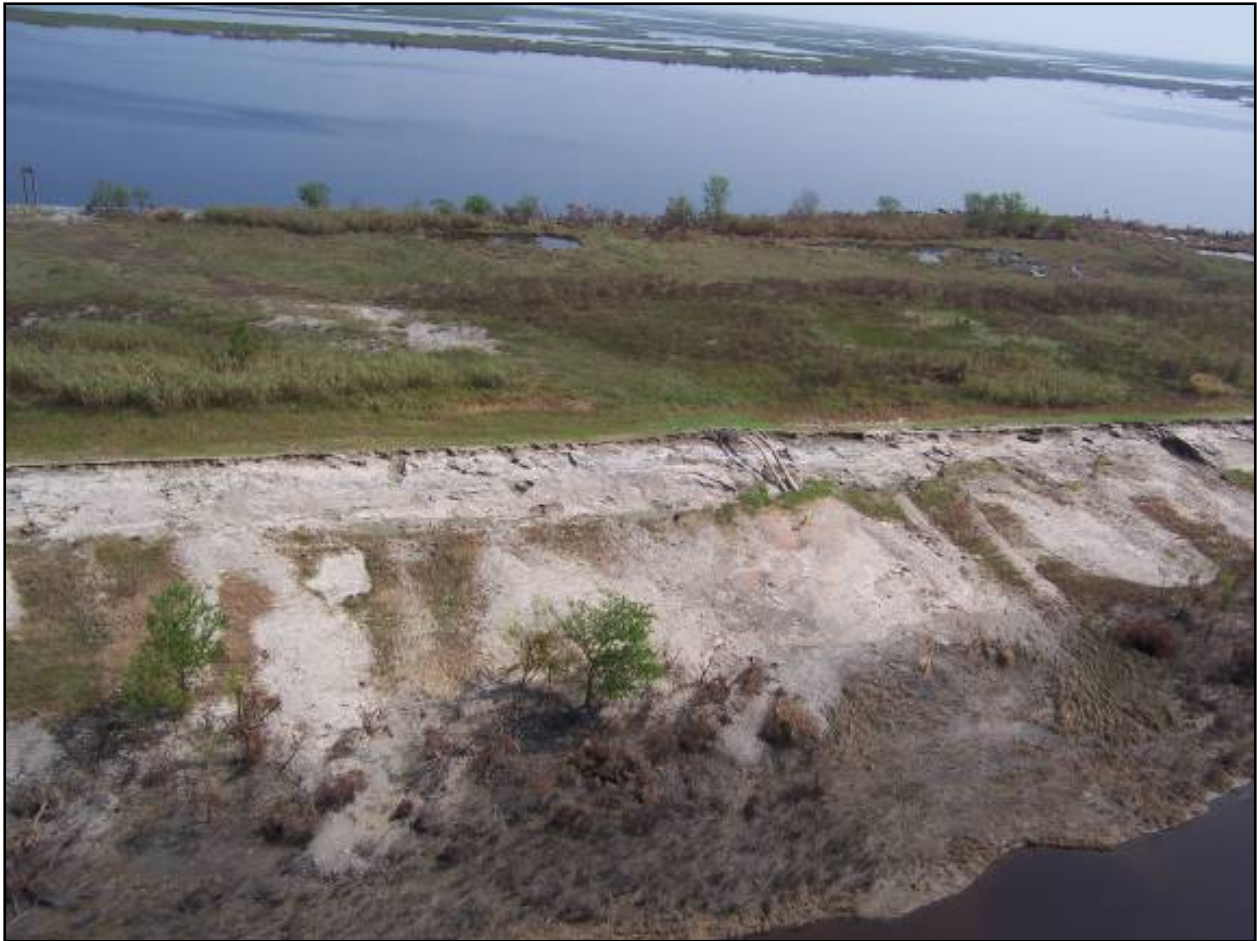
Figure 25. Stage D erosion between Bienvenue and Dupre structures, St. Bernard Parish

Figures 25 and 26 are photos of a 19,000 ft. levee reach between Bayou Bienvenue (Sta 383+00) and Bayou Dupre (Sta 704+00) that lost approximately 12' of levee height from its original (design) height 17.5 ft, and a 2300 ft levee reach that only lost about 8 ft height. Storm surge and wave overtopping between Bienvenue and Dupre ranged from approximately 3 ft to 7 ft, with the highest overtopping occurring closer to Bayou Dupre (IPET 2006).

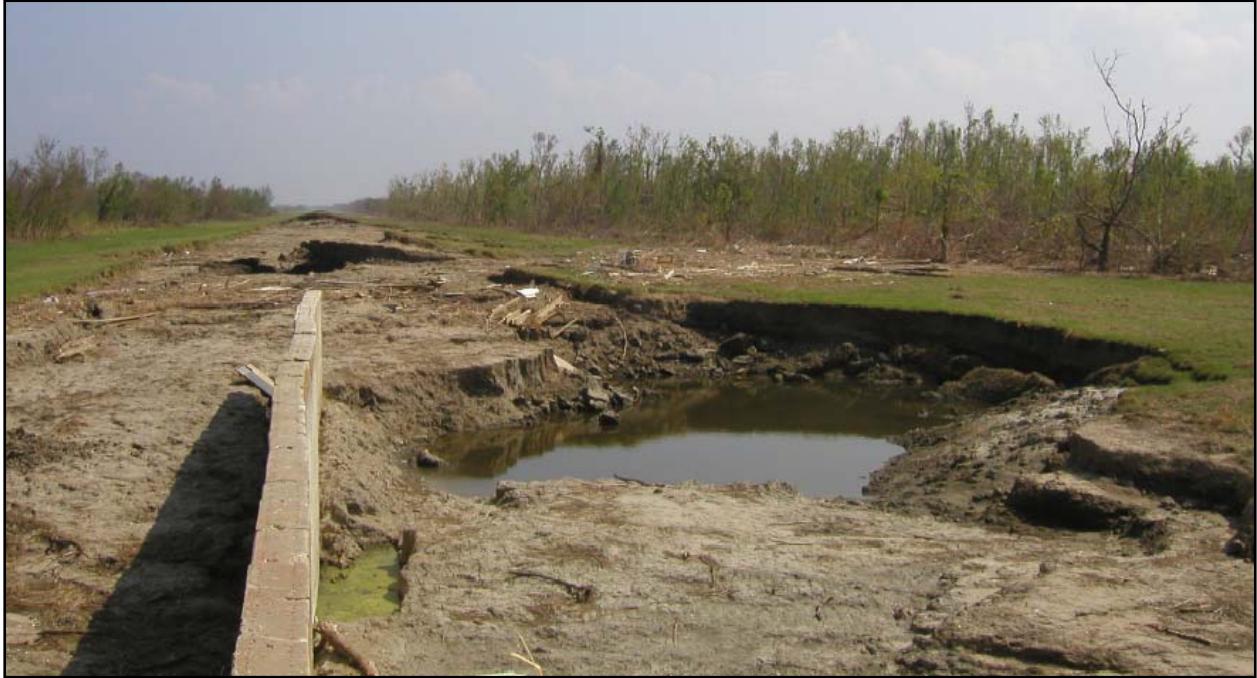
Figure 35. Stage D scour at the floodwall / levee at the southeast side of Bayou Dupre control structure

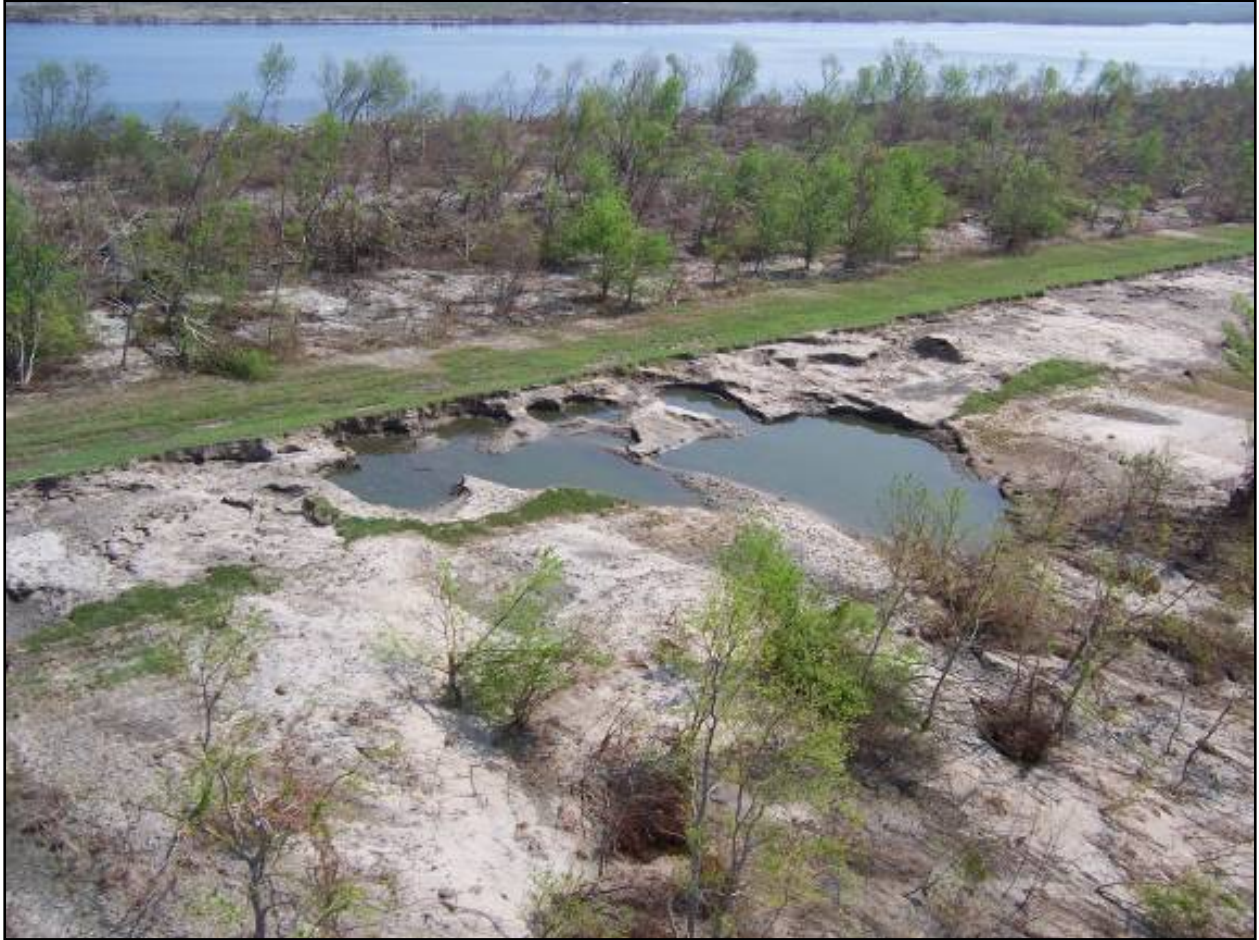
Figure 36. Stage D erosion southeast of Dupre Control Structure

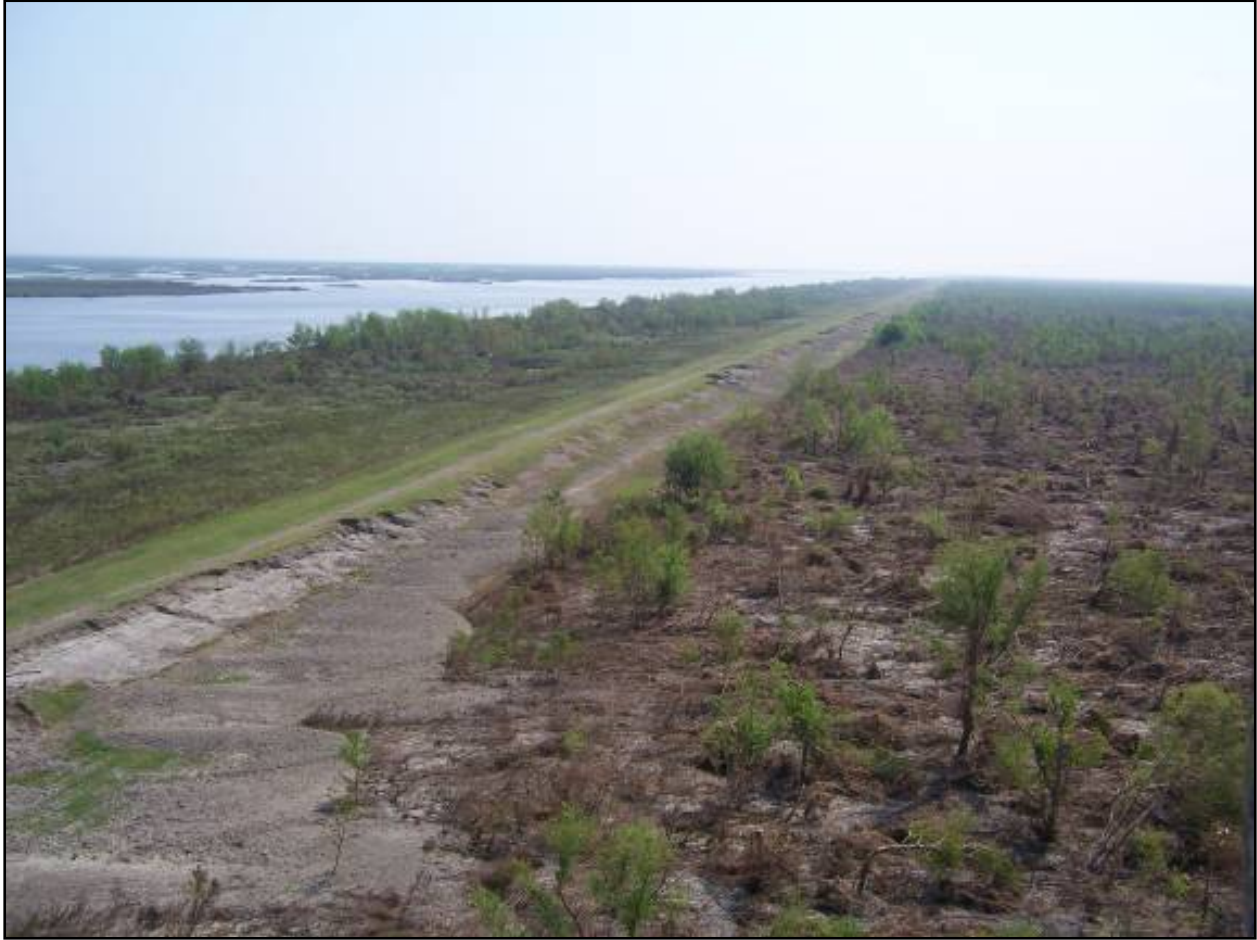
Figure 37. 2,500 ft. of levee from Dupre Control Structure to Sta 1007+91 that lost approximately 8' of elevation.

Figure 36 shows a portion of the 8,000 ft. section of the levee immediately southeast of Bayou Dupre (St. Bernard Parish) that was severely damaged and not only lost approximately 12 feet of original levee height but also part of the original levee foundation. The storm surge and waves overtopping this section of levee were approximately 7 ft. above the crown height. Figure 37 shows another portion of the levee southeast of Dupre.

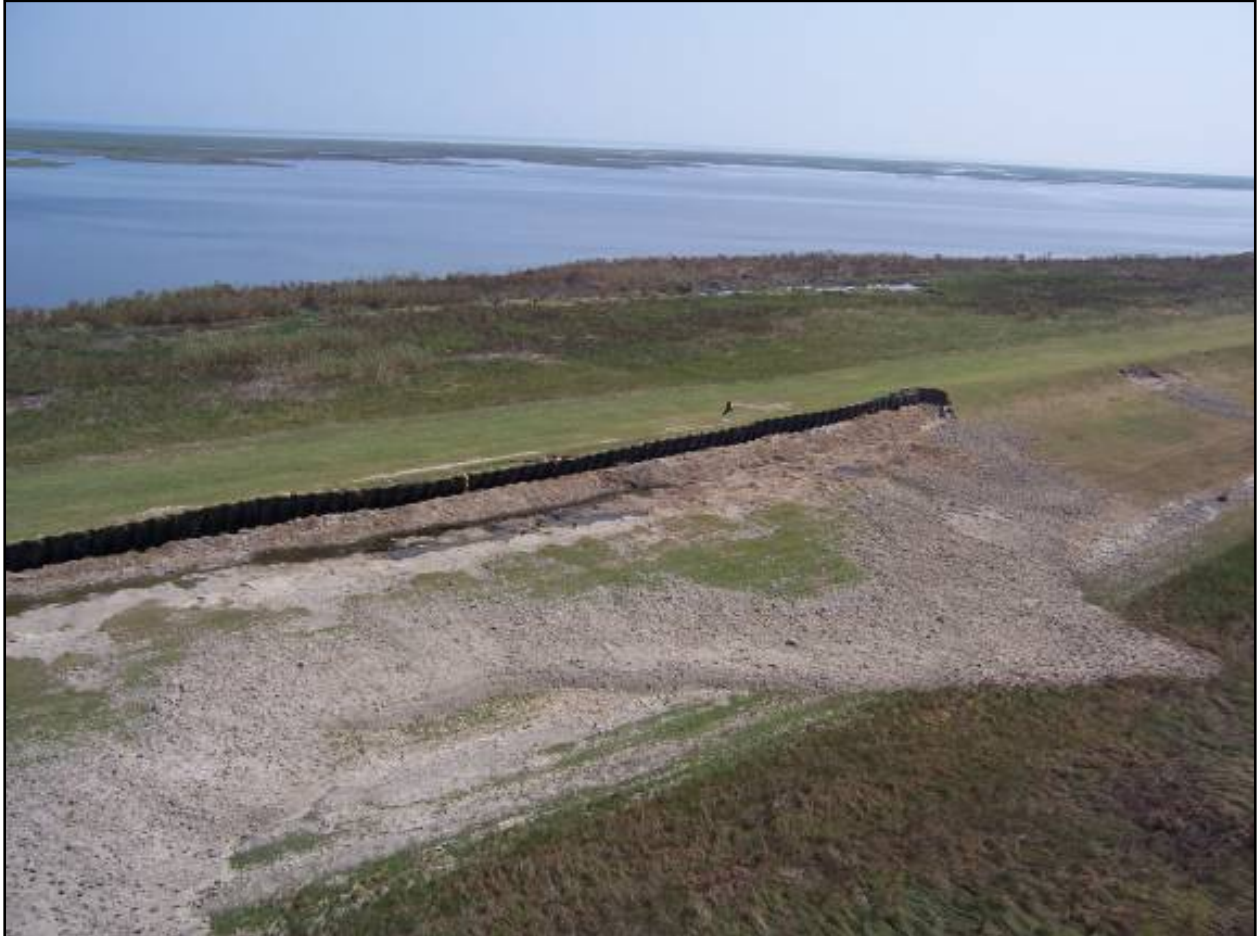
Figure 40. Sheetpile-to-levee transition showing significant scour behind the sheetpile and minimal erosion on the levee southeast of Dupre.

Figure 40 shows a sheetpile / levee transition along the MRGO southeast of Dupre at B/L Sta 980+58. Note that scour occurred behind the sheetpile wall and minimally beyond the levee transition. Approximate sheetpile elevation was 17 ft and levee crown elevation was 13 ft. Beyond the transition, the levee crown elevation was approximately 17 ft. The approximate surge and wave overtopping drop was 7 ft above the soil at the sheetpile base and 4 ft over the transition levee, thus the overtopping water velocities were different. Nearest soil boring 10-CUHA (Figure 41) from 1991 at Sta 976+00 in the sheetpile reach shows the top 4 ft of levee (elevation 13) was composed of lean silt and clay (ML and CL) with CH layers underneath.

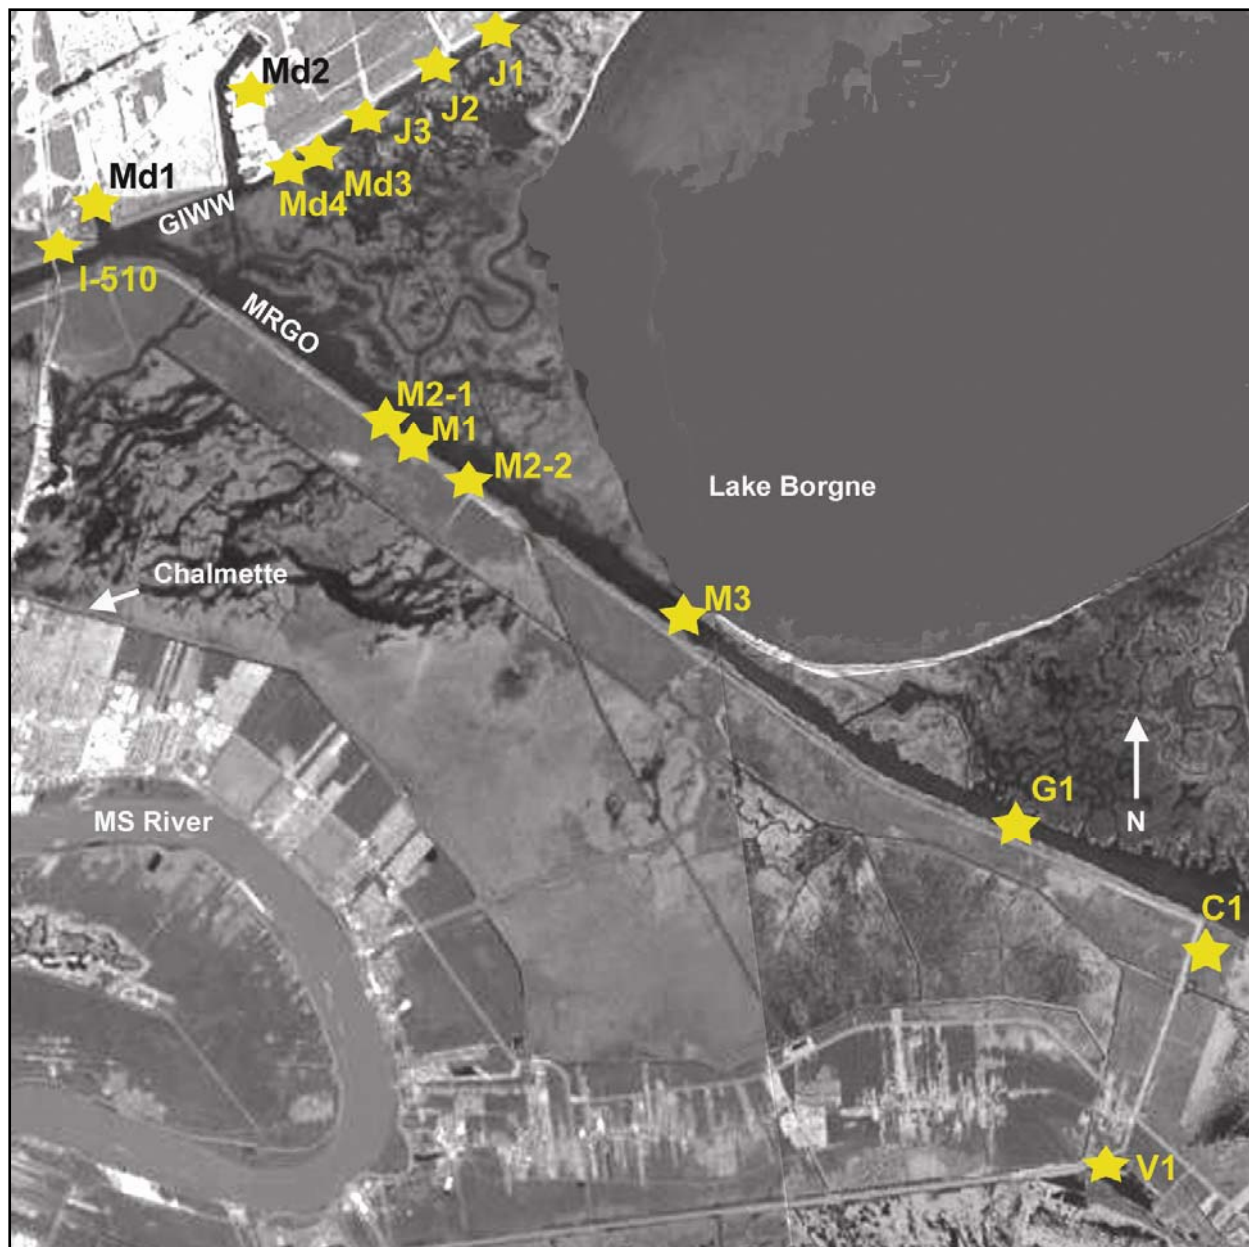
Figure 47. Overview of Jet Index testing sites (15 total) located on New Orleans East and St. Bernard levees.

Two identical Jet Index test devices were assembled and deployed to New Orleans. Fifteen sites were selected in New Orleans East and St. Bernard, shown in Figure 47. At each site, two concurrent Jet Index tests were conducted on the levee floodside at three separate locations, generally beginning at the levee toe and progressing up the slope. At each of the 15 sites, 6 Jet Index tests were thus conducted, for an overall total of 90 tests. The floodside location was selected due to the water intake requirement for the pump system, and minimized pumping distance, pressure fluctuations, and ongoing construction traffic impacts. It was assumed that the soil materials and construction compaction efforts were the same on both the floodside and the backside, enabling floodside test result conclusions to also be applicable to the levee backside.

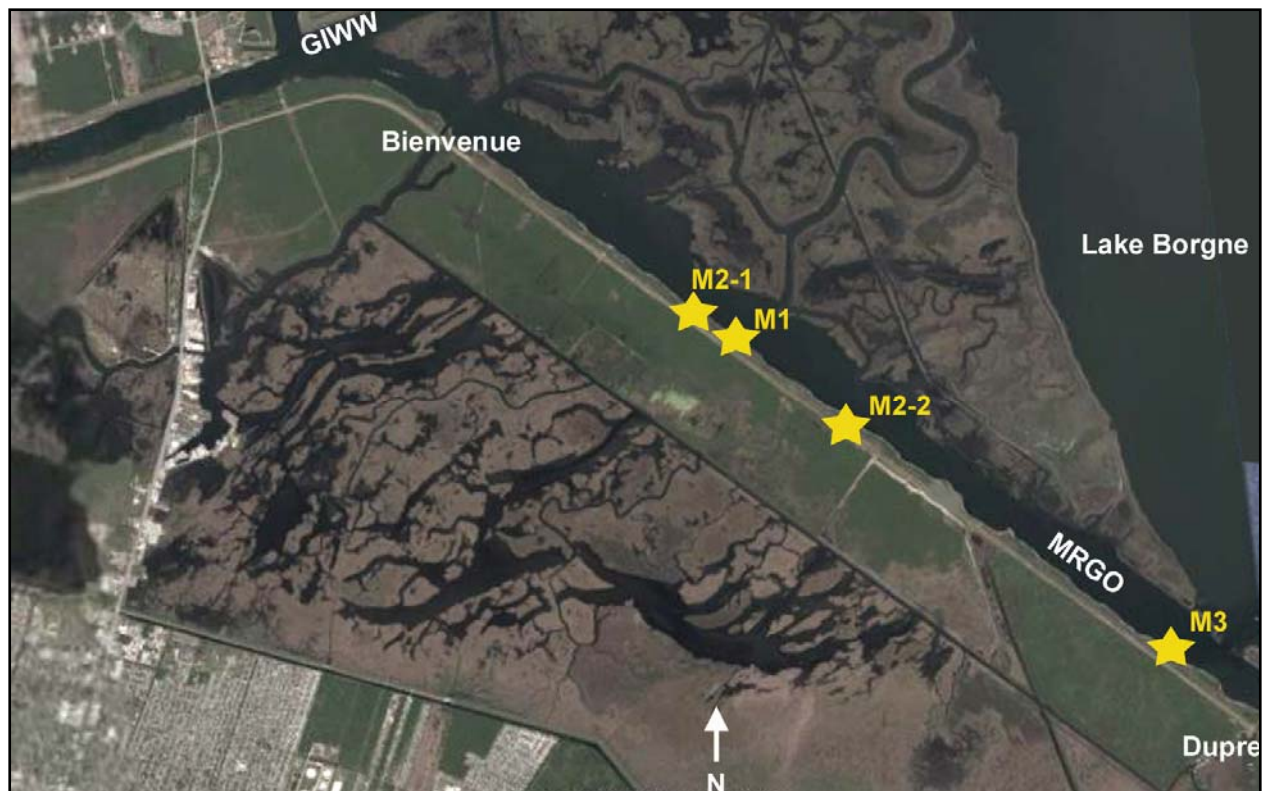
Figure 48. Levee test locations between Bienvenue and Dupre Control Structures

The initial Jet Index tests were conducted along the St. Bernard Parish levees (Chalmette Area and Chalmette Extension Hurricane Protection Plan levees). Test locations are shown in Figures 48 and 49, and levee site and soil conditions are summarized in Tables 1 through 9.

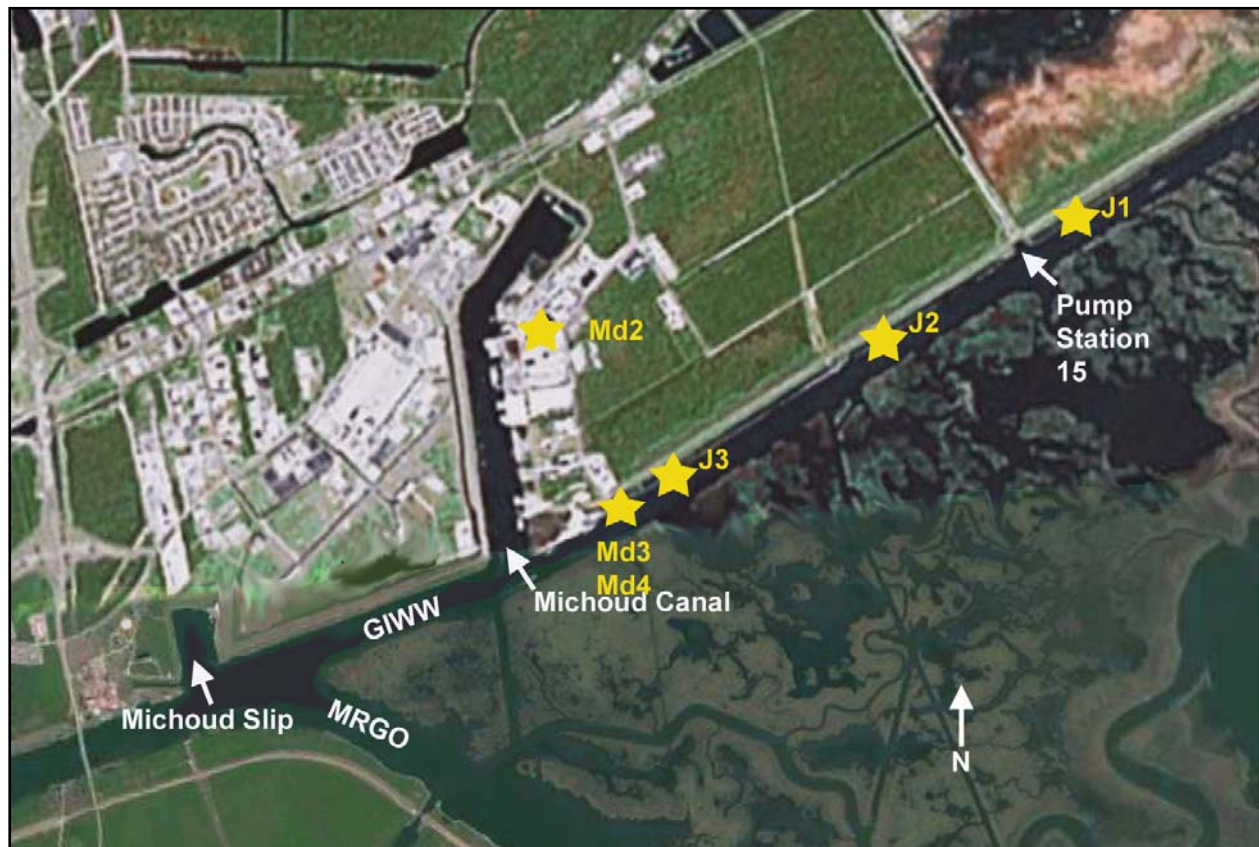
Figure 50. East Back and Michoud Canal levee test locations

Jet Index tests were conducted along the Orleans East levees (East Back, Michoud, and Citrus Back). Test locations are shown in Figures 50 and 51, and in-situ levee conditions are summarized in the following tables.

These sites were located on levees being reconstructed (backfilled, compacted, graded) by the Corps of Engineers contractors James, Inc. (sites J1, J2, and J3) and Boh Bros, Inc. (Md sites). Site Md2 was an I-wall levee that had overtopped with minor scour damage.

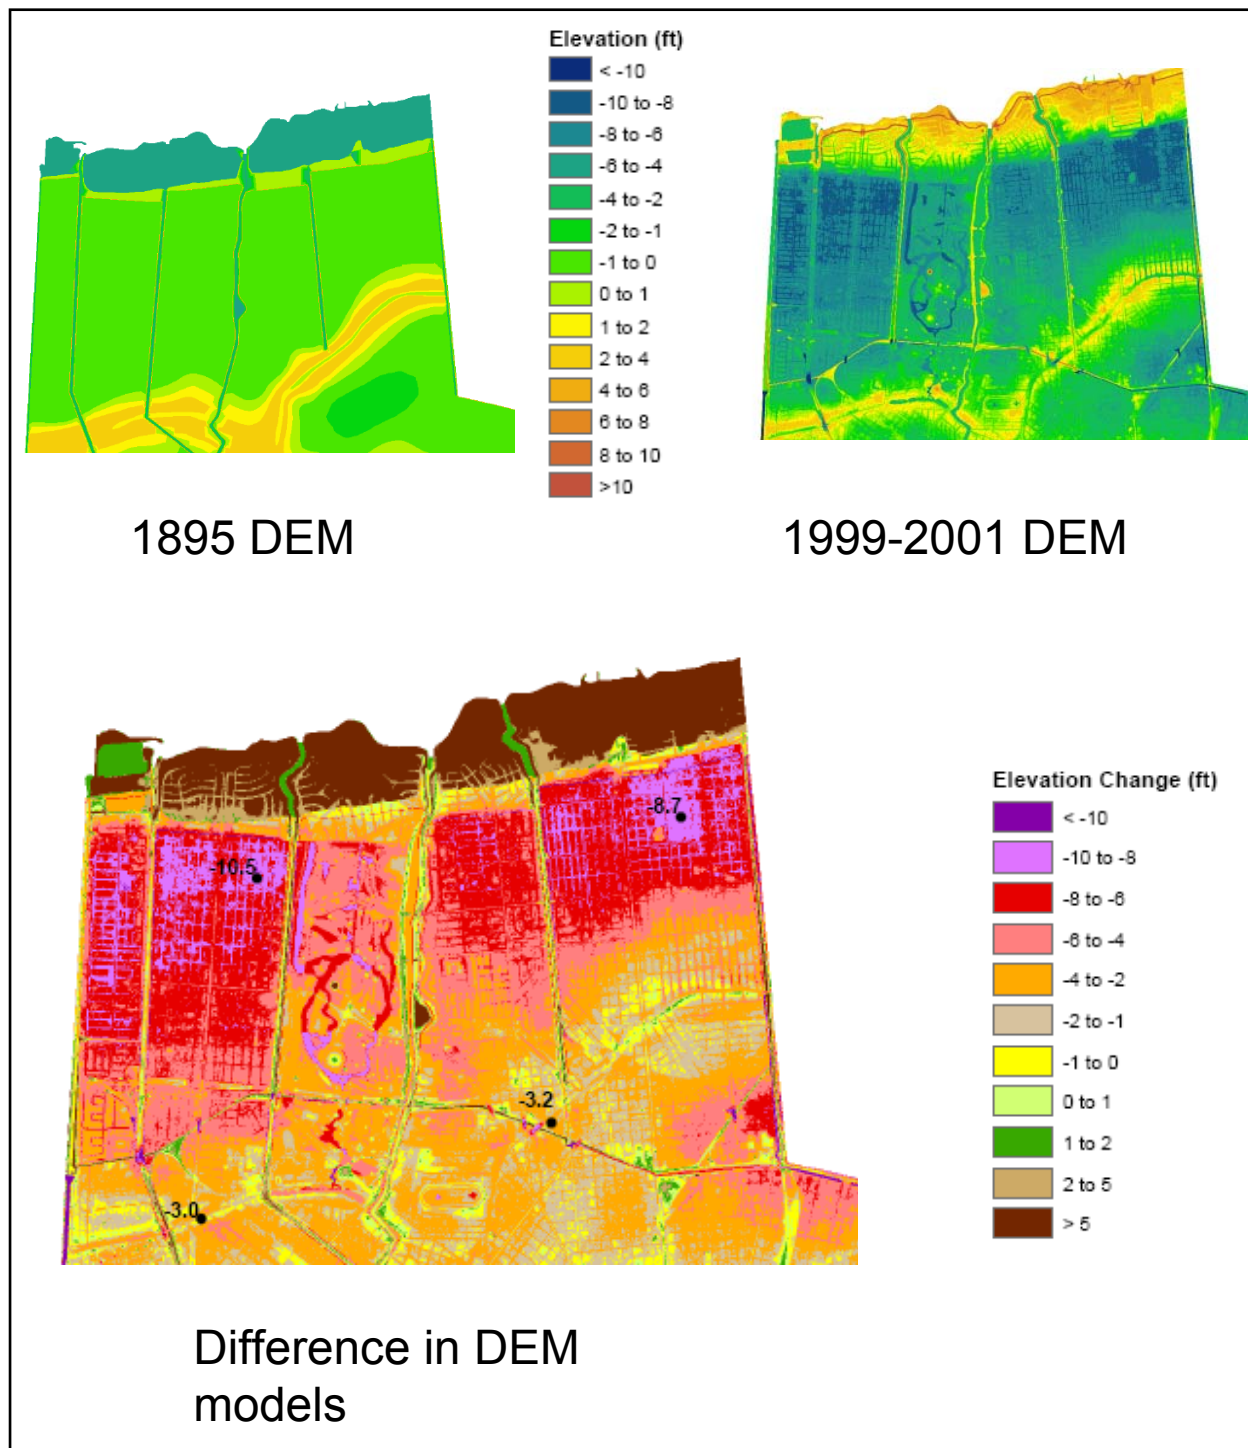
Figure 8. Changes in ground surface elevation between 1895 and 2001 (URS, 2006). Comparison is based on 1895 historic topographic map and 1999-2001 digital elevation models (DEMs). Locations of failures are identified by open circles, from left to right are 17th Street Canal, London Canal North breach (top), and London

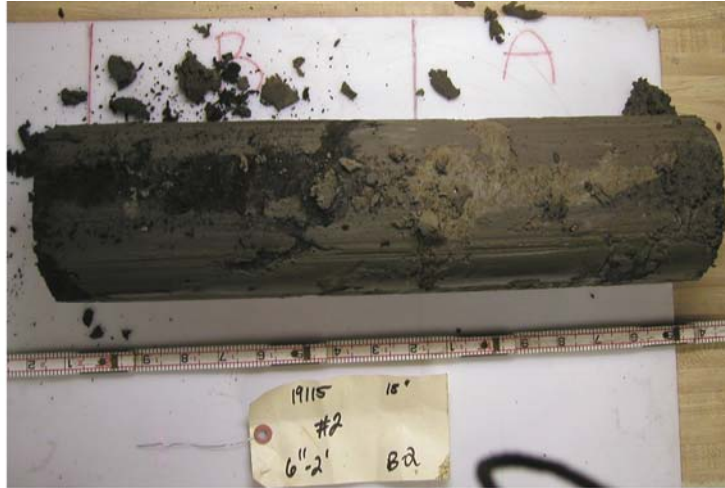
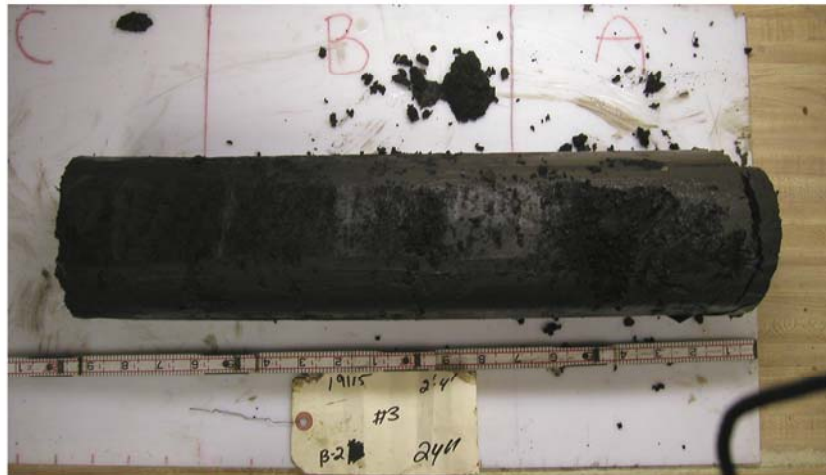
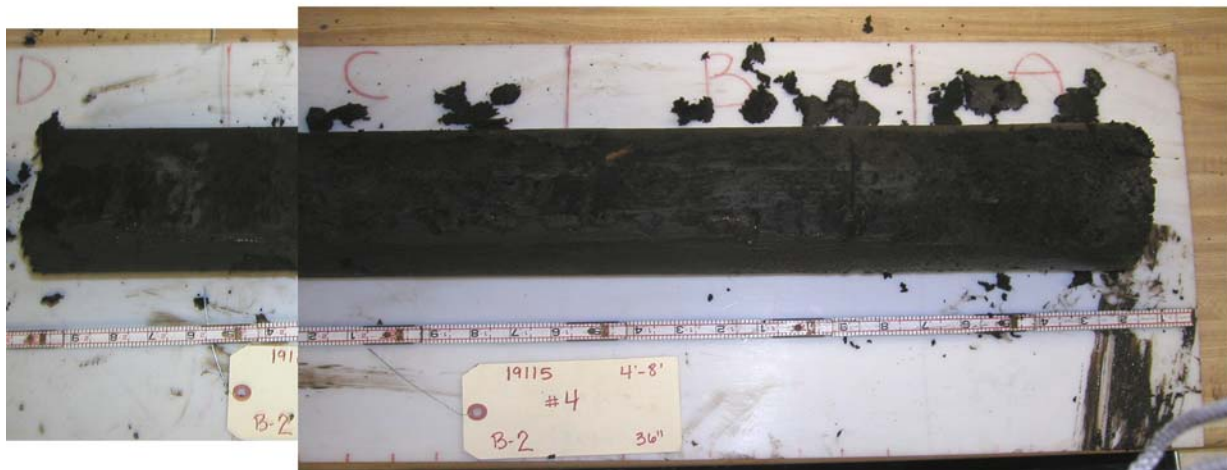
Figure 7c. Boring B-14, samples 2 (top), 3 (center), and 4 (bottom), 0.5 to 2 ft, 2 to 4 ft, and 4 to 8 ft, respectively. Top of samples are at right and bottom at left. Sample 2 from levee fill, and samples 3 and 4 are in the swamp/marsh environment--note the high water and the high organic content as indicated by the CHOA to CHOC designation (see Figures 1 and 7b). Presence of wood pieces and roots are common in samples. Samples from west edge of displaced levee section and are disturbed.

Properties most often used to classify deltaic soils into depositional environments are texture, water content, organic content, and presence of shells (sif). Note photographs of soil samples are presented in Figures 7c through 7f. Boundaries between depositional environments marked by red lines, 1 = fill, 2 = swamp/marsh, 3 = lacustrine; 4= relict beach, 5 =bay sound-estaurine. Based on soil texture, color, water content, consistency, absence or presence of shells, laminations, and/or other soils structure properties.

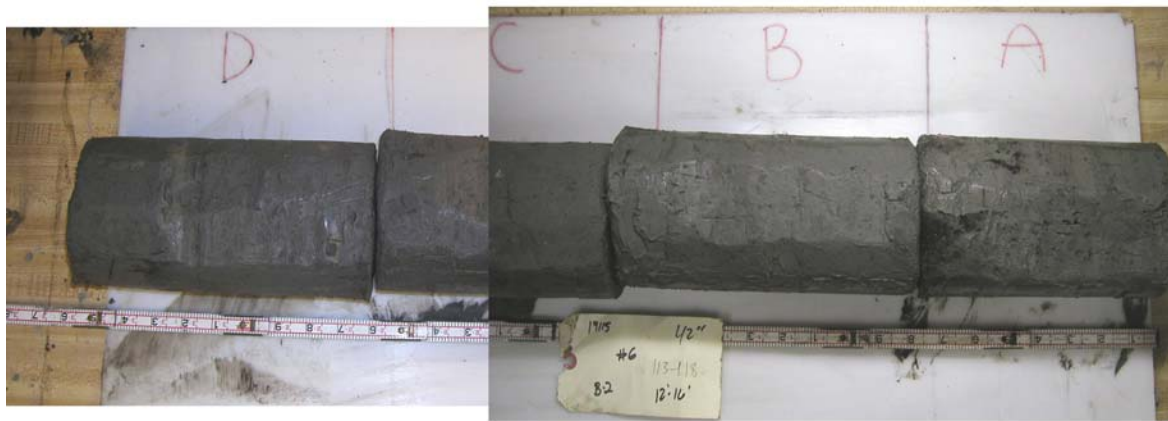
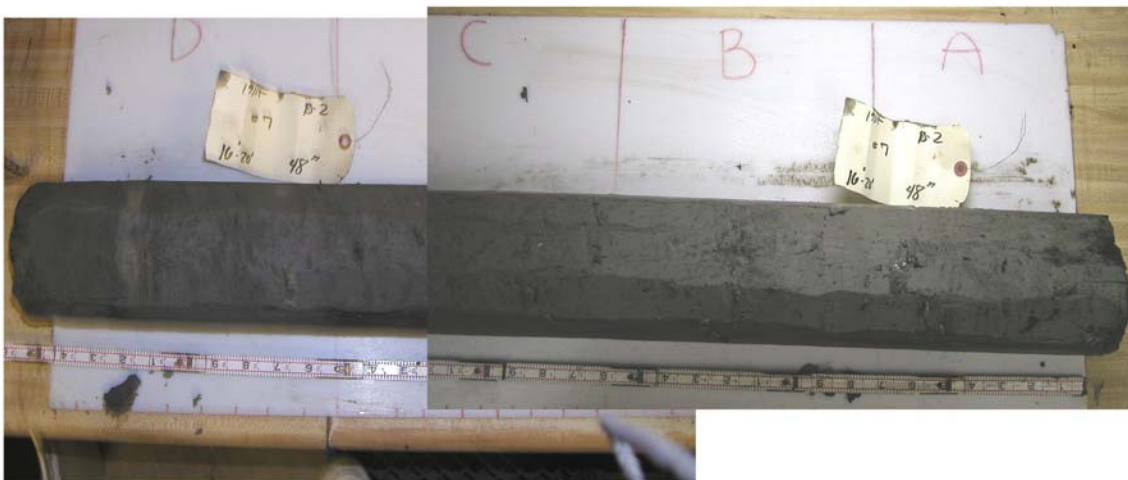
Figure 7d. Boring B-14, samples 5 (top), 6 (center), and 7 (bottom), 8-12 ft, 12-16 ft, and 16-20 ft; respectively; sample 5 is from swamp/marsh environment, and samples 6 and 7 are from the lacustrine environment. Note the darker color, higher water and organic contents for sample 5 (Figure 7b, CHOA to CHOC). Lighter grey color, lower water and organic contents, shell fragments (white specs), and laminations and lenses of silt and/or fine sand are diagnostic of lacustrine (lake) sediments

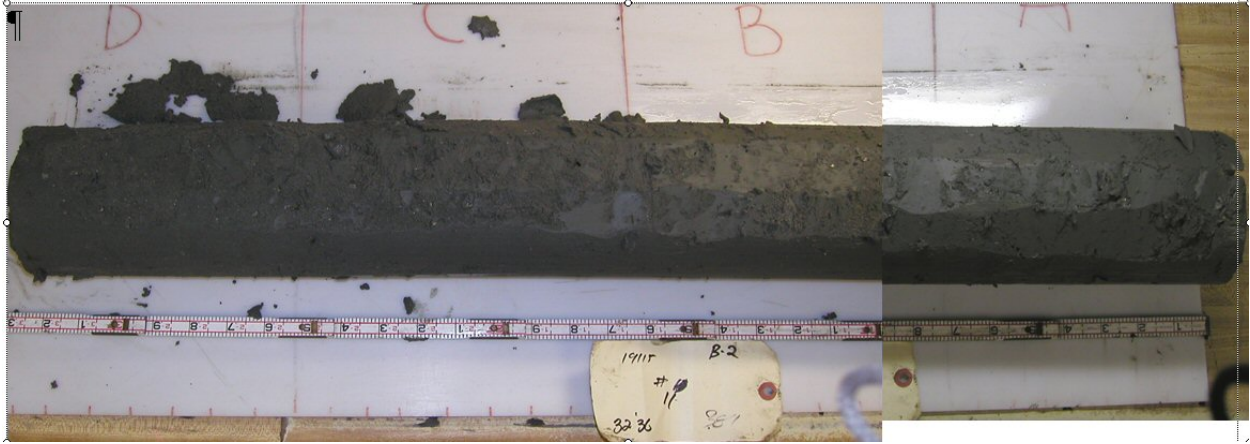
Figure 7f. Boring B-14, sample 11; depth from 32 to 36 ft, view of lacustrine grey clay, note the shell fragments near base of sample (left side), overlying and merging with the relic beach sand at 35 to 40 ft (Figure 3). See Figure 7b for lab summary descriptions.

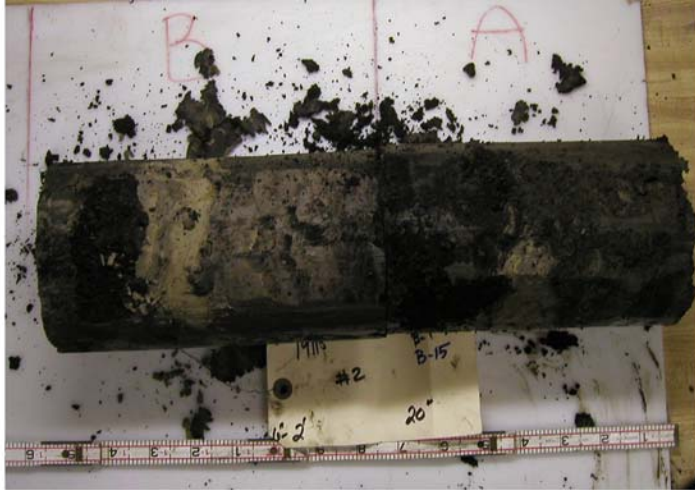
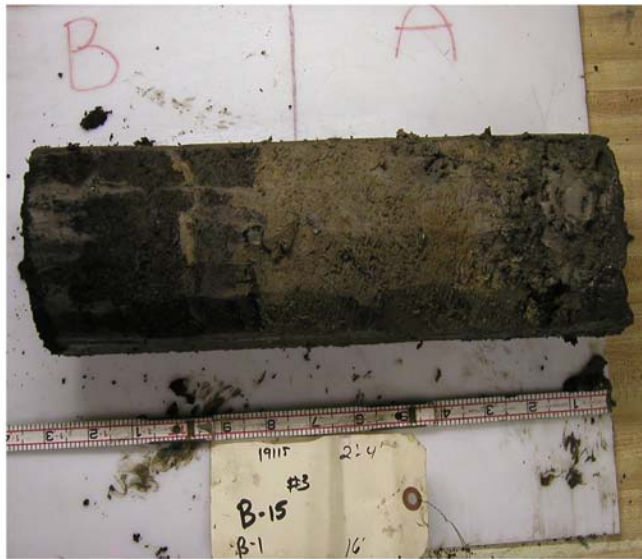
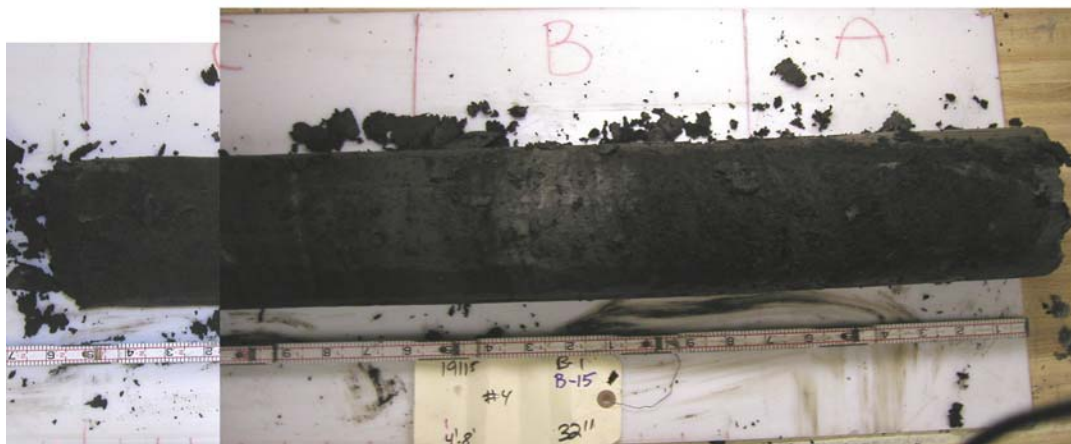
Figure 8c. Photographs of soil samples from B-15, samples 2 through 4, 0.5 to 8 ft depth; samples 2 and 3 from the levee fill, sample 4 from the swamp/marsh environment--note the high water content identified in Figures 8a and 8b, and the high organic content as indicated by the CHOA to CHOC designation for sample 3 (see Figure 1). Presence of wood pieces and roots are common in samples.

Figure 8b. Lab test results for B-15 (see modified USCS in Figure 1 for soil texture classification). Photographs of soil samples described above are presented in Figures 8c through 8f. Boundaries between environments are identified in red; 1 = fill, 2 = swamp/marsh, 3 = lacustrine; 4= relict beach, 5 =bay sound-estuarine. Based on soil texture, color, water content, consistency, absence or presence of shells, laminations, or other soils structure.

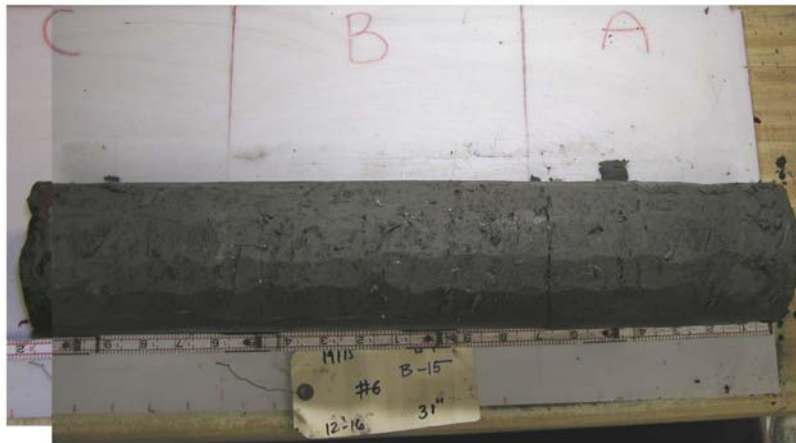
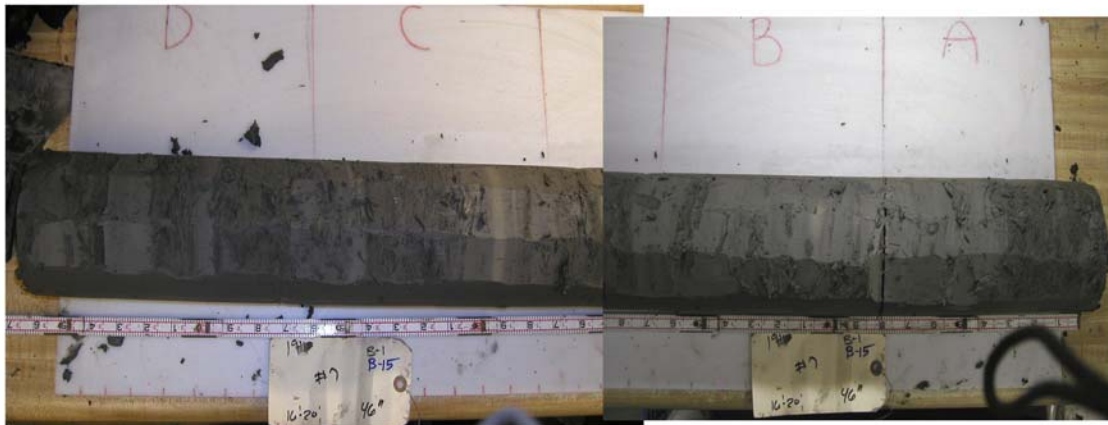
Figure 8d. Boring B-15, samples 5 (top), 6 (center), and 7 (lower); depths from 8 to 12 ft, 12 to 16 ft, 16 to 20 ft, respectively. See boring and lab logs in Figures 8a and 8b for descriptions. Sample 5 at top (right) contains the slip surface which is grey clay with distorted inclusions of peat in parts A and upper half of B. Shear zone is underlain by nearly 1 ft of peat (marsh deposits). Marsh deposits above and below grey clay layer have age date of 2,900 years. Lacustrine deposits begin in 5C at 10.6 ft. Note the sharp contact with the lacustrine deposits, and the distinct change to soft grey clay with trace organics and most importantly shell fragments (white specs) and silt and fine sand laminations. Note the change in water content between marsh and lacustrine in boring and lab logs. Bioturbation occurs in upper part of the lacustrine stratigraphic unit.

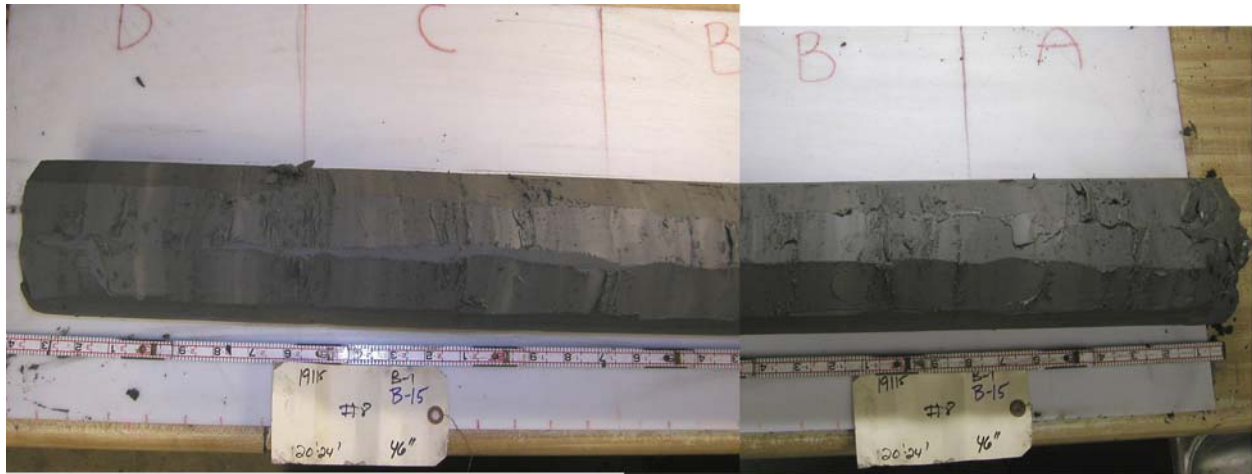
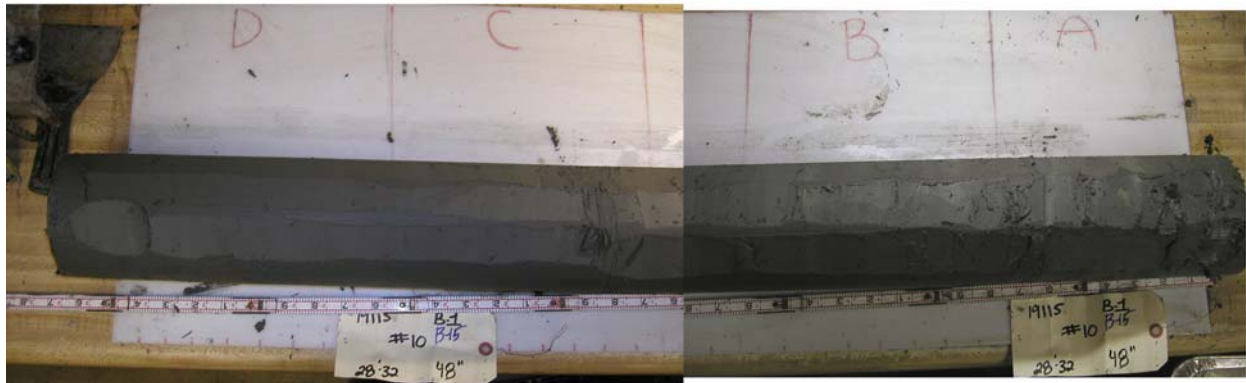
Figure 8e. Boring B-15, samples 8 (top), 9 (center), and 10 (lower); depths from 20 to 24 ft, 24 to 28 ft, 28 to 32 ft, respectively. See boring and lab logs in Figures 8a and 8b for descriptions. All three samples are from the lacustrine stratigraphic unit. This unit characterized by grey clay, note the presence of light colored silt and fine sand lenses, laminations, and thin beds. Also, note the water content in boring and lab logs ranges between 37 and 89 percent. Samples are merged in photographs above by bedding features between adjacent photos, and may not align with the sample board in background.
