# **Appendix 16**

## **Concrete I-Wall and Sheet Piling Material Recovery, Sampling and Testing: IHNC**

# Appendix 17

## Finite Element Seepage Study – Seepage Analysis for Foundation Breaches

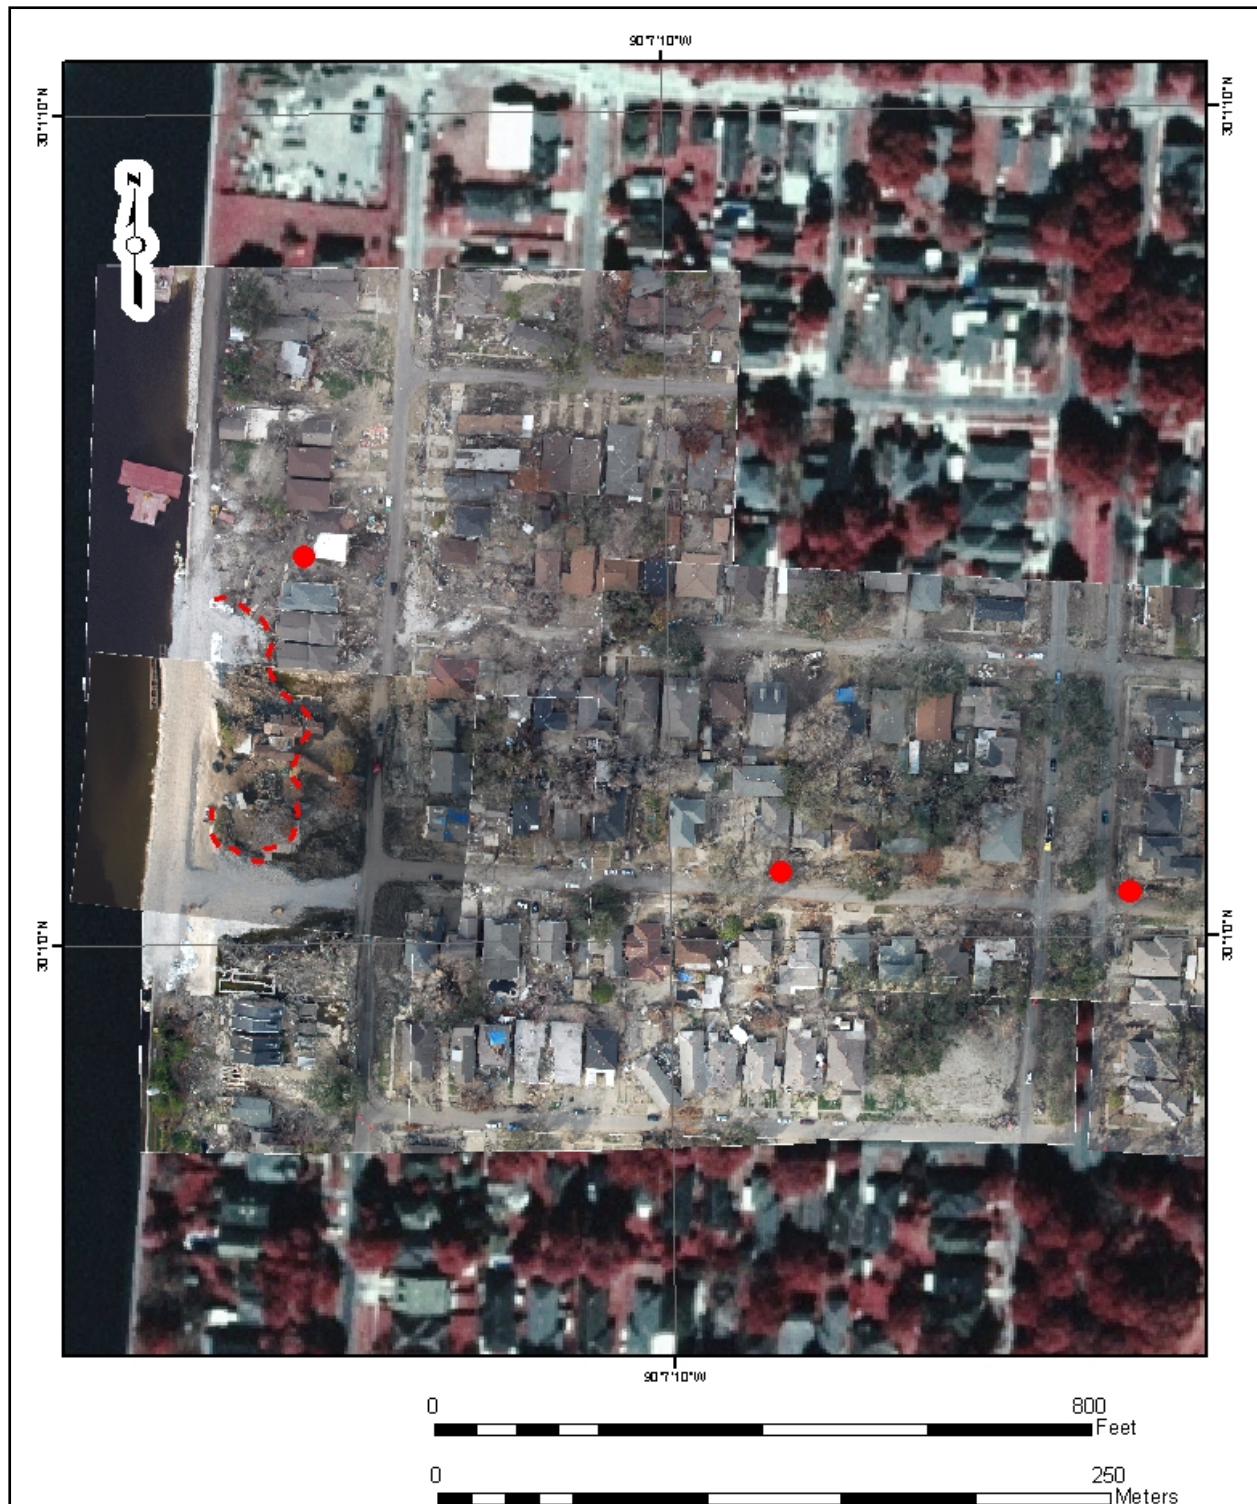
Figure 23a. November 2005 photograph showing locations where the grey lake clay and overlying marsh contact was observed. The accompanying photographs show close-up views of the swamp/marsh/lacustrine stratigraphy. The presentation of sites in the accompanying photographs is in a west to east direction in the above photograph. Sites are designated as west (Figures 23b and 23c), center (Figure 23d), and east (Figures 23e and 23f).

One of the most significant occurrences was located near boring 64 at 6942 Bellairie Drive (see Figure 22a and 23a, western location). This 6 ft block of soil was transported only a short distance from the breach. The soil block was located approximately 150 ft north and east of its original position, and was only a short distance from boring 64 (Figure 23b). The soil block was orientated in a semi-horizontal position in the probable direction of current flow, and was behind the remains of a garage that was transported due east of its original location. The stratigraphy of this soil block consisted of approximately 3 ft of marsh and 3 ft section of lacustrine soils. Clearly visible in the photographs in Figures 23b and 23c are whole shells that are embedded in the lower lacustrine grey clay matrix. Dark grey to black organic marsh soils are directly above the lake clays. The contact between these two different depositional settings was firmly attached to each other, was very distinct, and was relatively sharp, as opposed to being a gradual transition. Also present nearby were logs that were 2 to 3 ft in diameter and were embedded in the upper swamp section of the organic sequence.

The third soil block that is noteworthy was located at 6901 Fluer de Lis. This block of soil was at the intersection of Spencer Avenue and the north lane of Fluer de Lis (eastern location in Figure 23a). This soil block was located about 1,180 ft east of the failed levee. The organic soil block at this location was less than 5 ft long, and contained the underlying lake clay, which was firmly attached to the base of the organic sequence (Figures 23e and 23f). The characteristics of the lake clay at the base of this soil block indicate it is from the lacustrine horizon, instead of being part of the shear zone

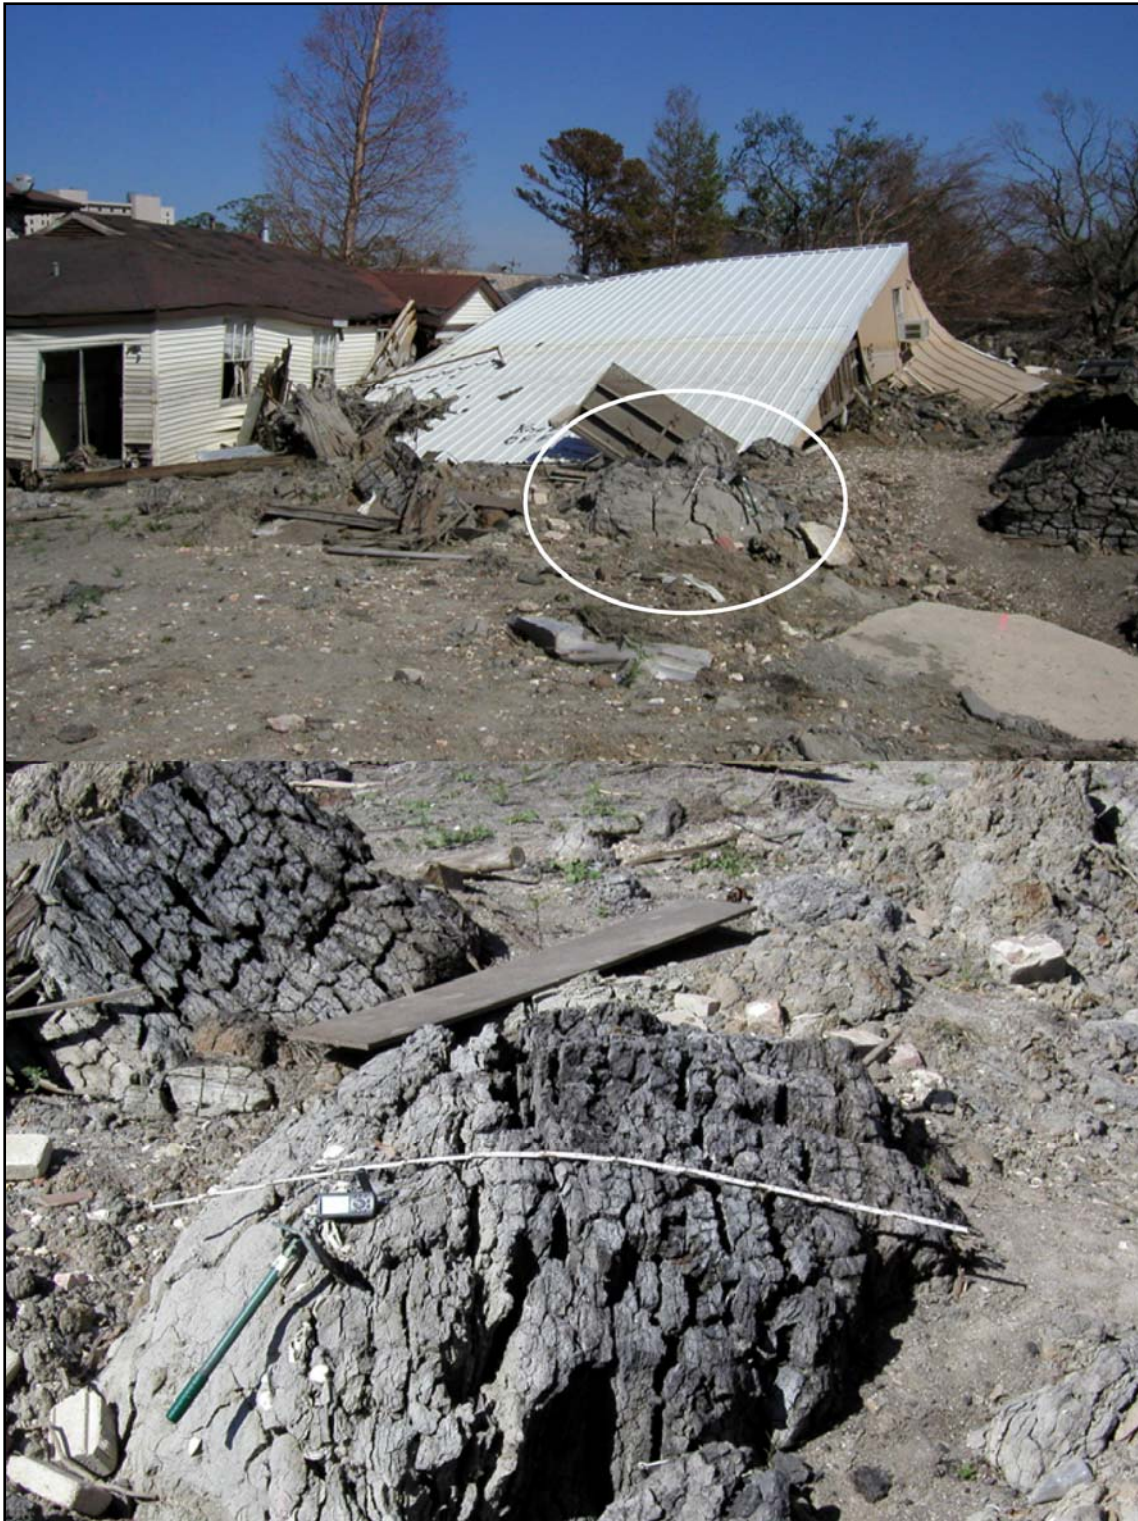
Figure 23b. Block of soil from levee foundation near boring 64, showing the intact marsh and lacustrine contact. A six foot folding rule is stretched across the soil mass. Upper photo shows the general setting (see Figures 22 and 23a for location). Lower photo shows block with about 3 ft of marsh and 3 ft of grey lacustrine clay. Whole shells are embedded within the grey lacustrine soils near the base of the soil block, where the shovel tip is located. Close-up view is shown in Figure 23c.

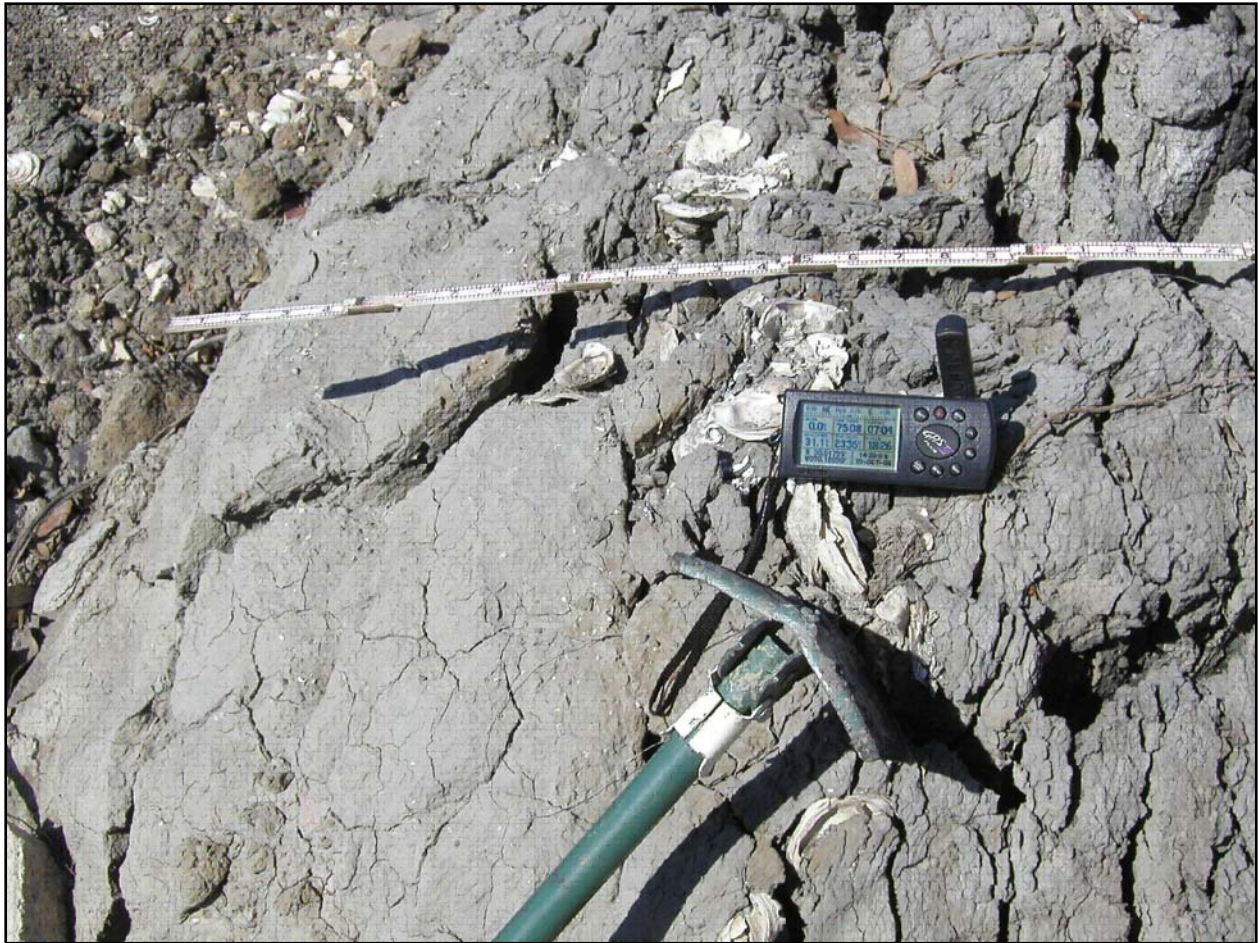
Figure 23c. Close-up view of the grey lacustrine clay that formed the levee foundation in the vicinity of boring 64. The soil block shows whole shell and fragments embedded throughout the grey clay. Note the shell below the shovel with clay embedded into the interior of the shell. This grey lacustrine clay was firmly attached to the overlying marsh soils as shown by Figure 23b.

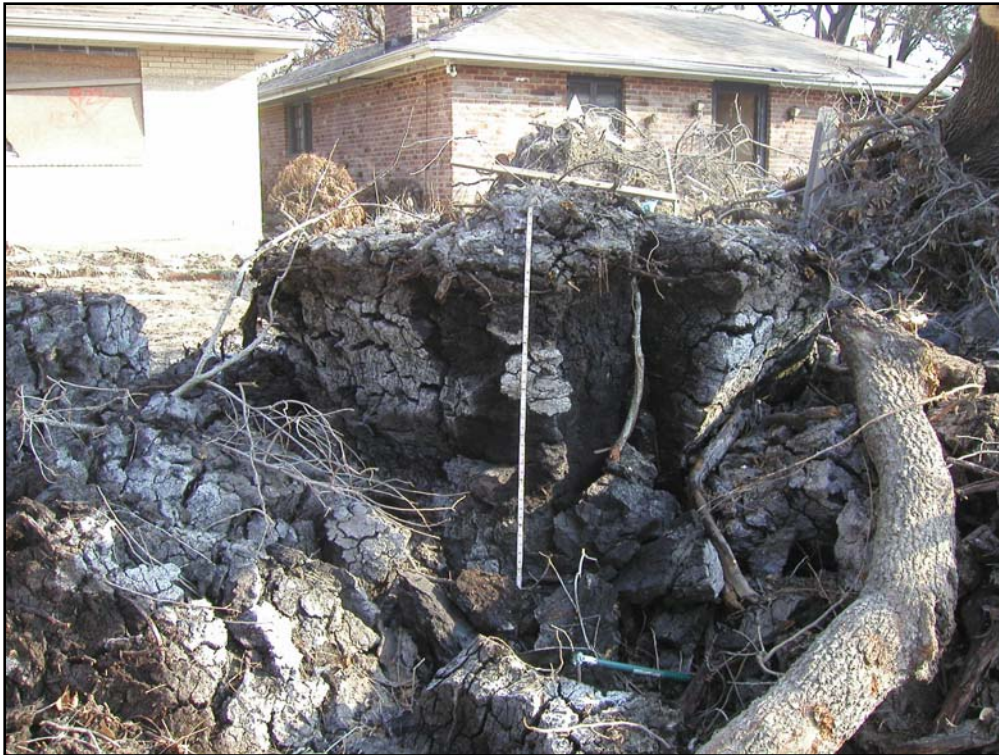
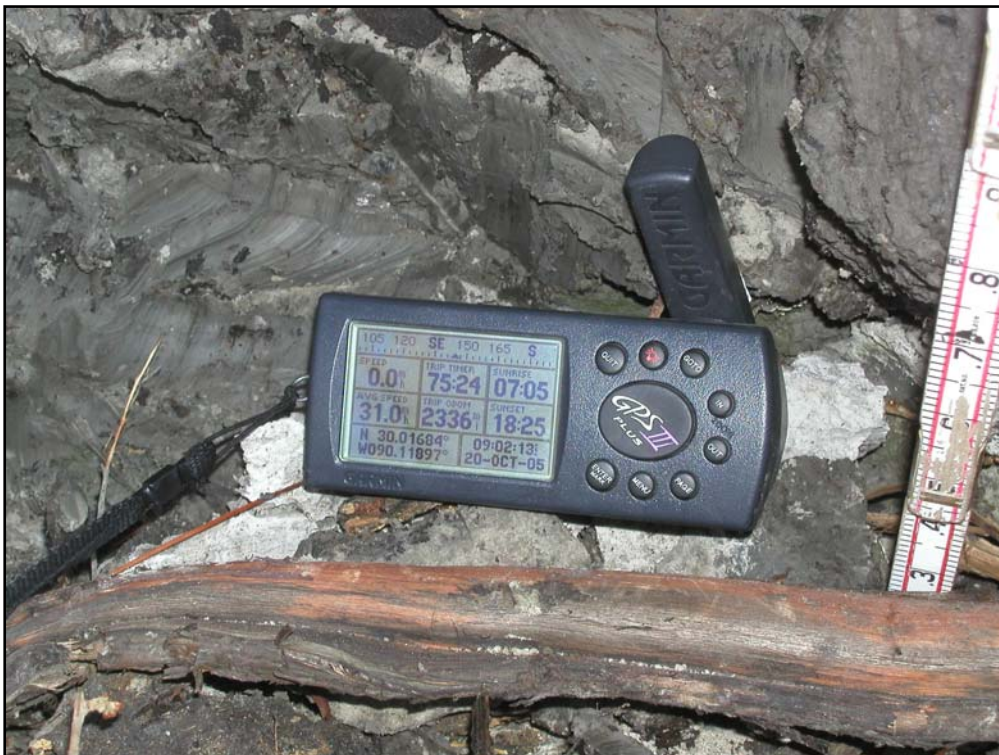
Figure 23d. Grey lacustrine clay at base of organic soil block (bottom photo). Swamp soils at top of soil mass where the wood and roots are present. Generally, most of the soil blocks were orientated with wood part upward and/or laying in direction of water current.

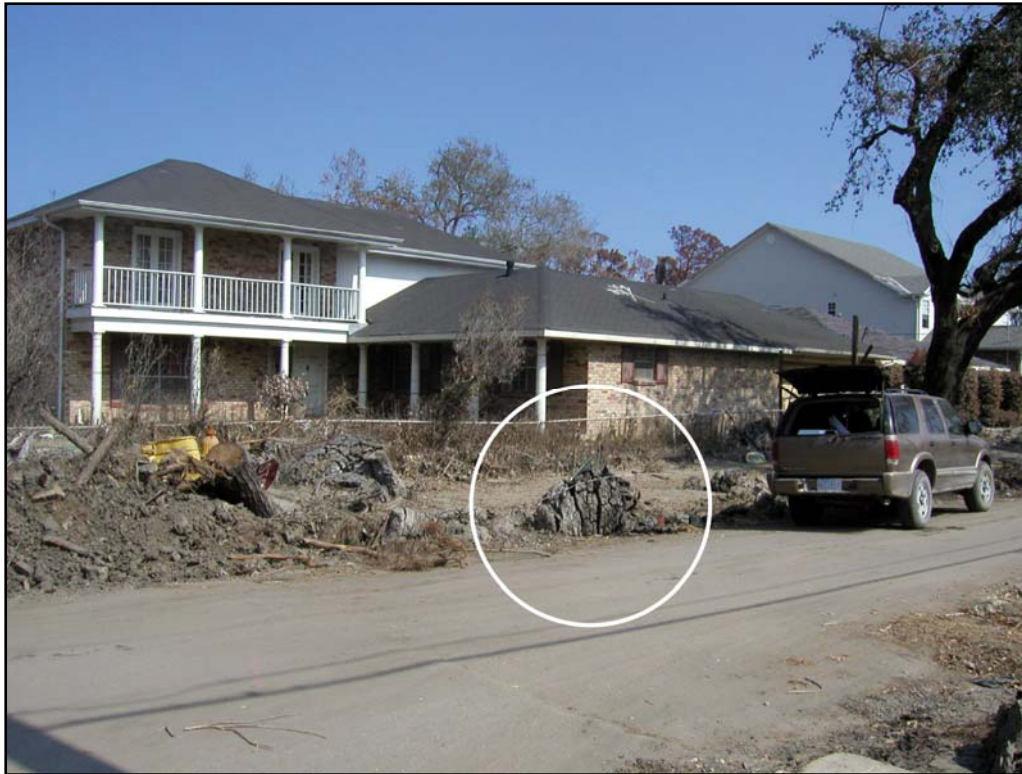
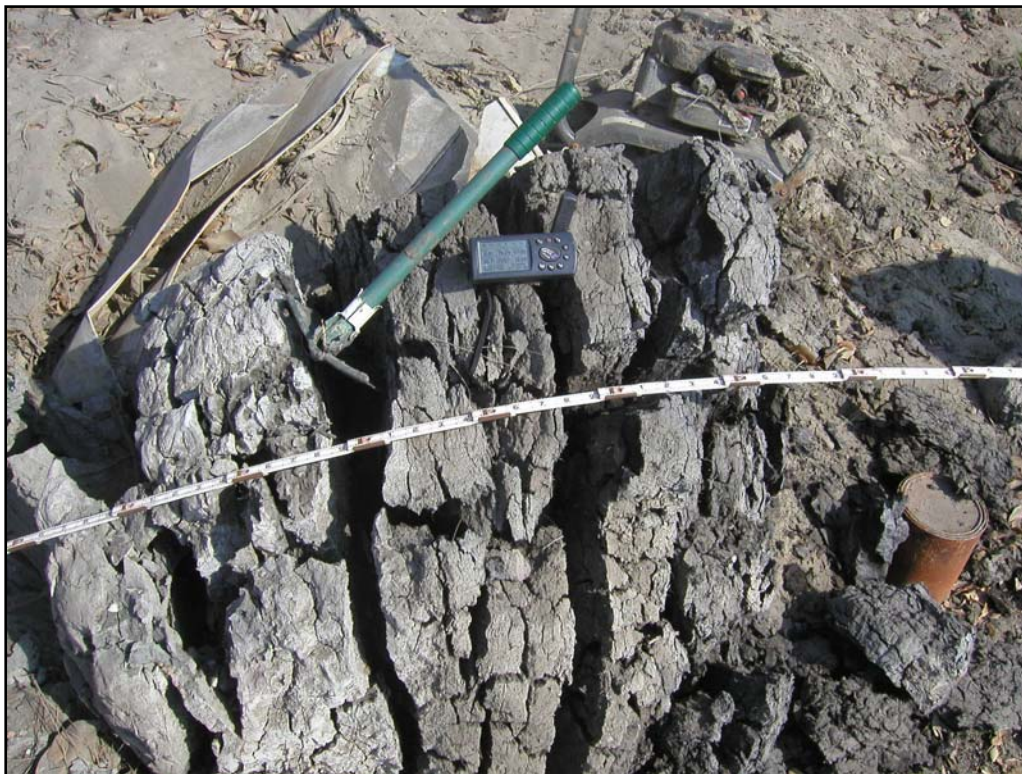
Figure 23e. Grey lacustrine clay at base of organic soil block (bottom photo). Close-up view of the lake clay in Figure 23f. Location is identified in Figure 23a and corresponds to the eastern site.

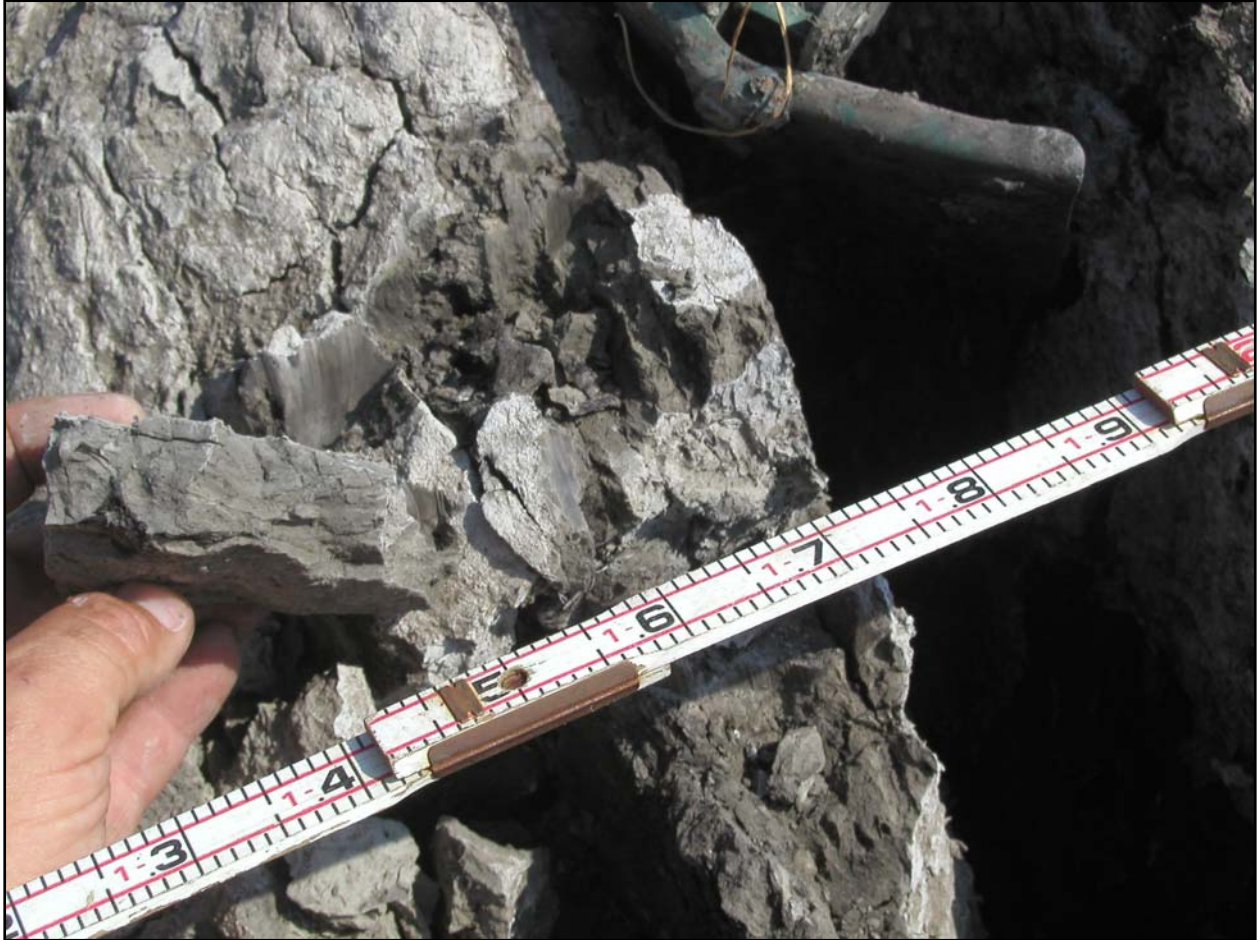
Figure 23f. Close-up view of the grey lake clay from the soil block at the intersection of Spencer Avenue and north bound lane of Fluer de Lis.

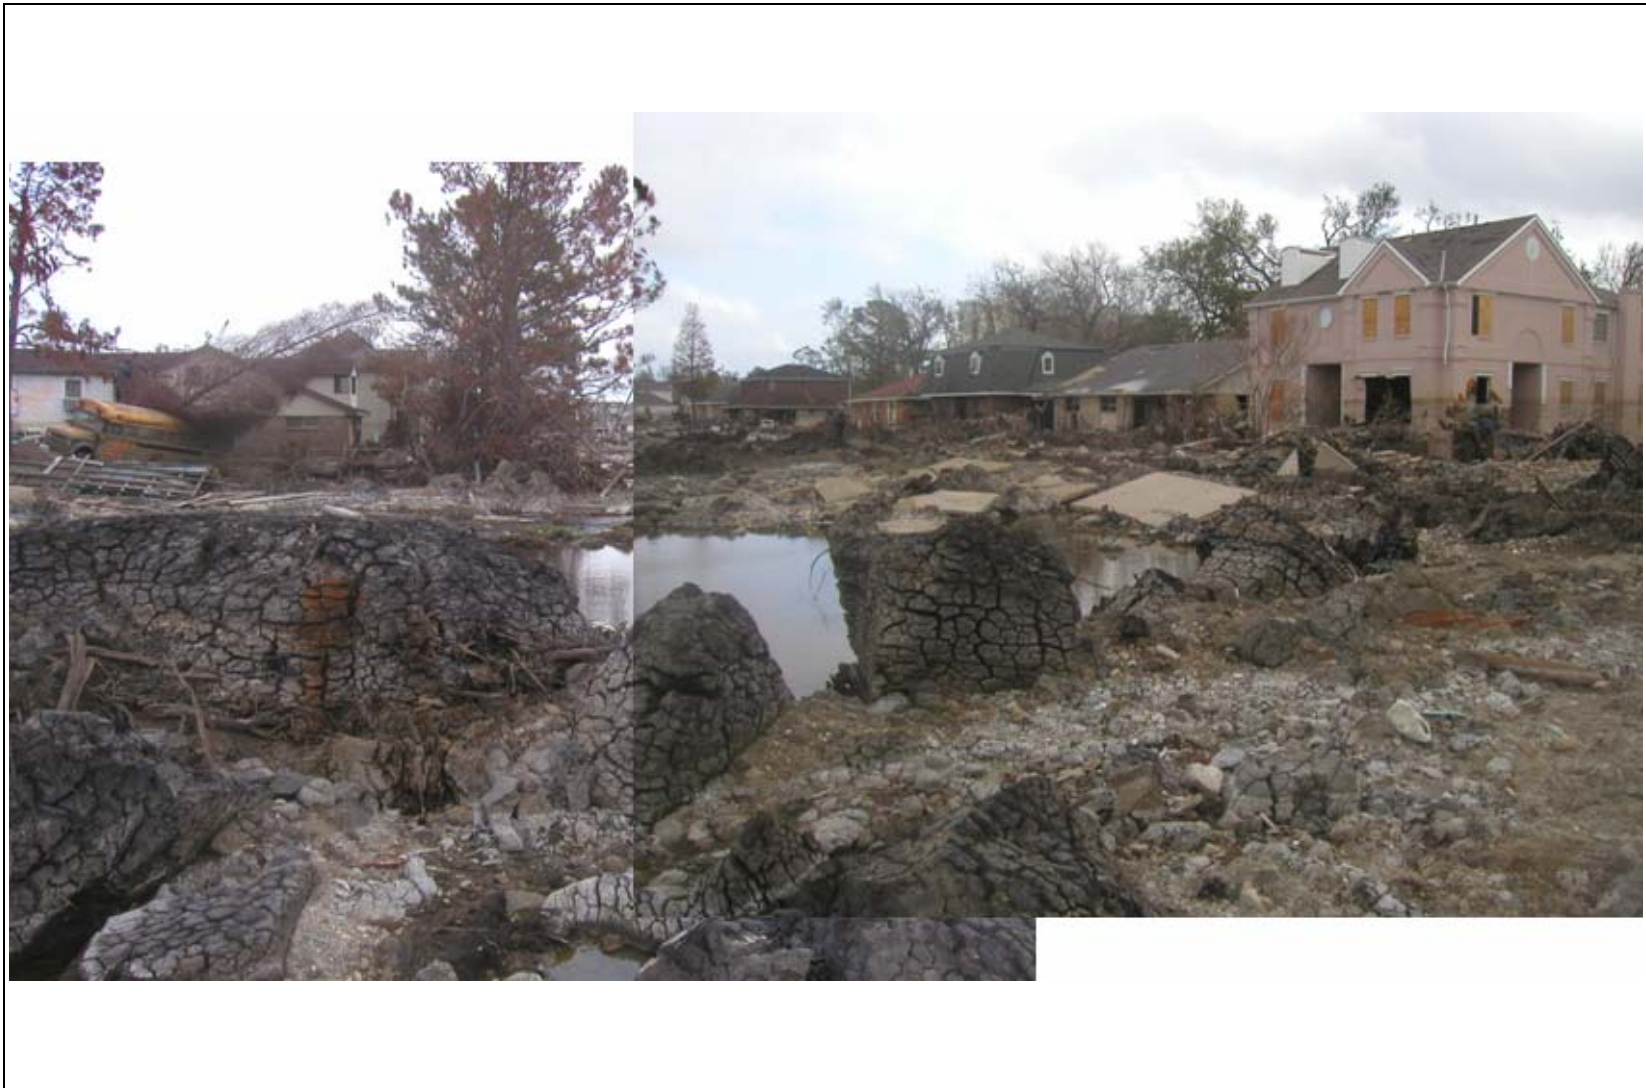
Figure 24. View of Bellaire Drive on 3 October 2005 looking northeast from near intersection of Bellairie Drive and Spencer Avenue. Soil blocks were transported by force of moving water into the neighborhood, especially along Spencer Avenue, Stafford Avenue and 40th Street. A general observation from the survey of soil blocks in the neighborhood was the stratigraphic position of the swamp, which was observed to be at the top of the organic horizon.

upward from a marsh to a swamp setting. The presence of wood, logs, and stumps are interpreted to occur in the middle to upper part of the organic sequence (Figure 24). The IPET position differs sharply from the NSF position, which indicates stumps occur near the base of the organic sequence and also at the top of the sequence (NSF, 2006, Chapter 3, Figures 3-18 and 3-19, p. 3-39 and 3-40).

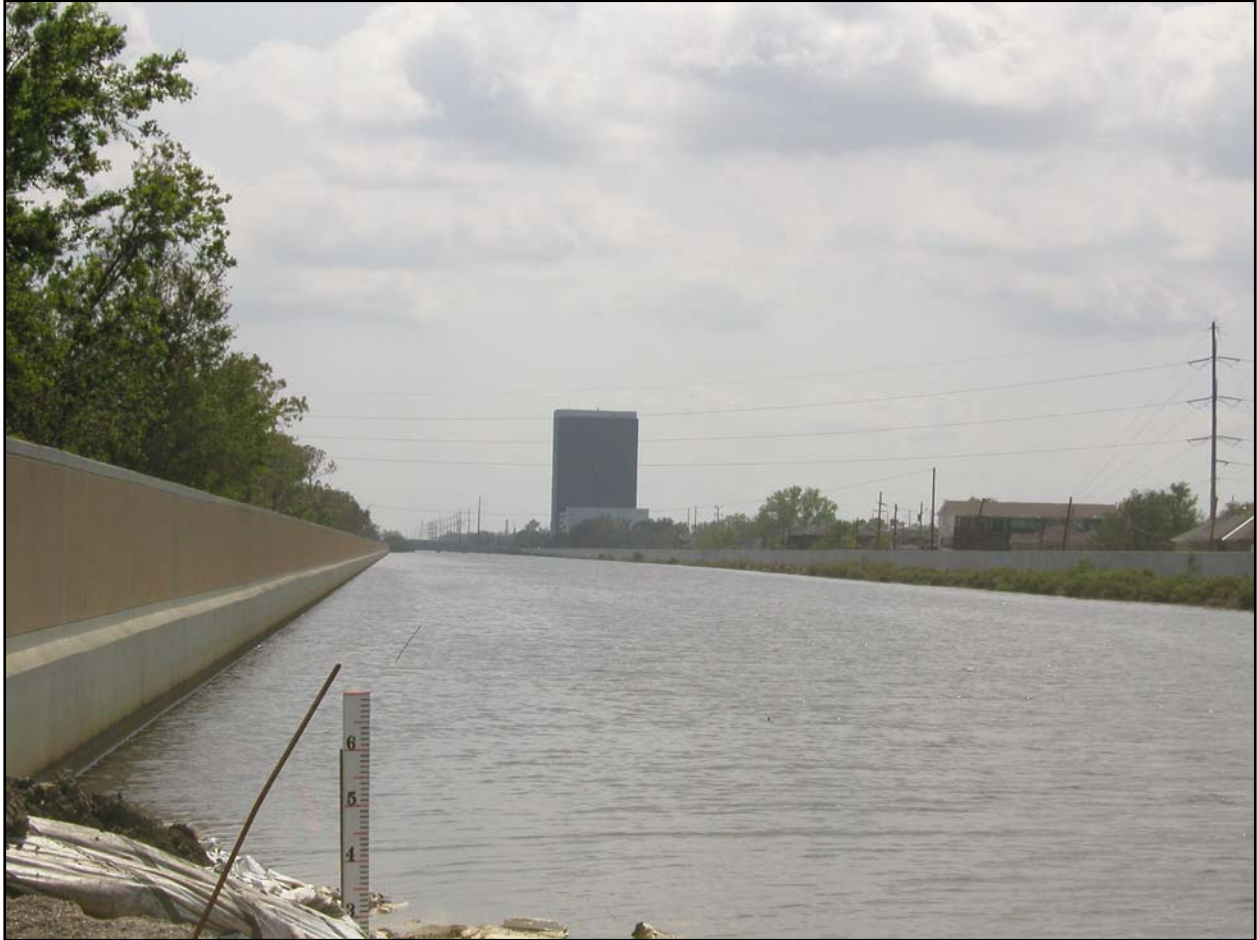
Figure 26. View of the 17th Street Canal looking south toward Veterans Avenue. Note the Orleans Parish side (left) of the canal has no embankment section above the water level, while the Jefferson Parish side (right) has an exposed embankment section. Approximately 20 measurements were made from top of wall in a southerly direction from the breach on the Orleans Parish side with a weighted tape measure to determine the water depth to the top of the embankment. These measurements indicate the water level was approximately 1 ft deep on the canal side adjacent to the I-wall.

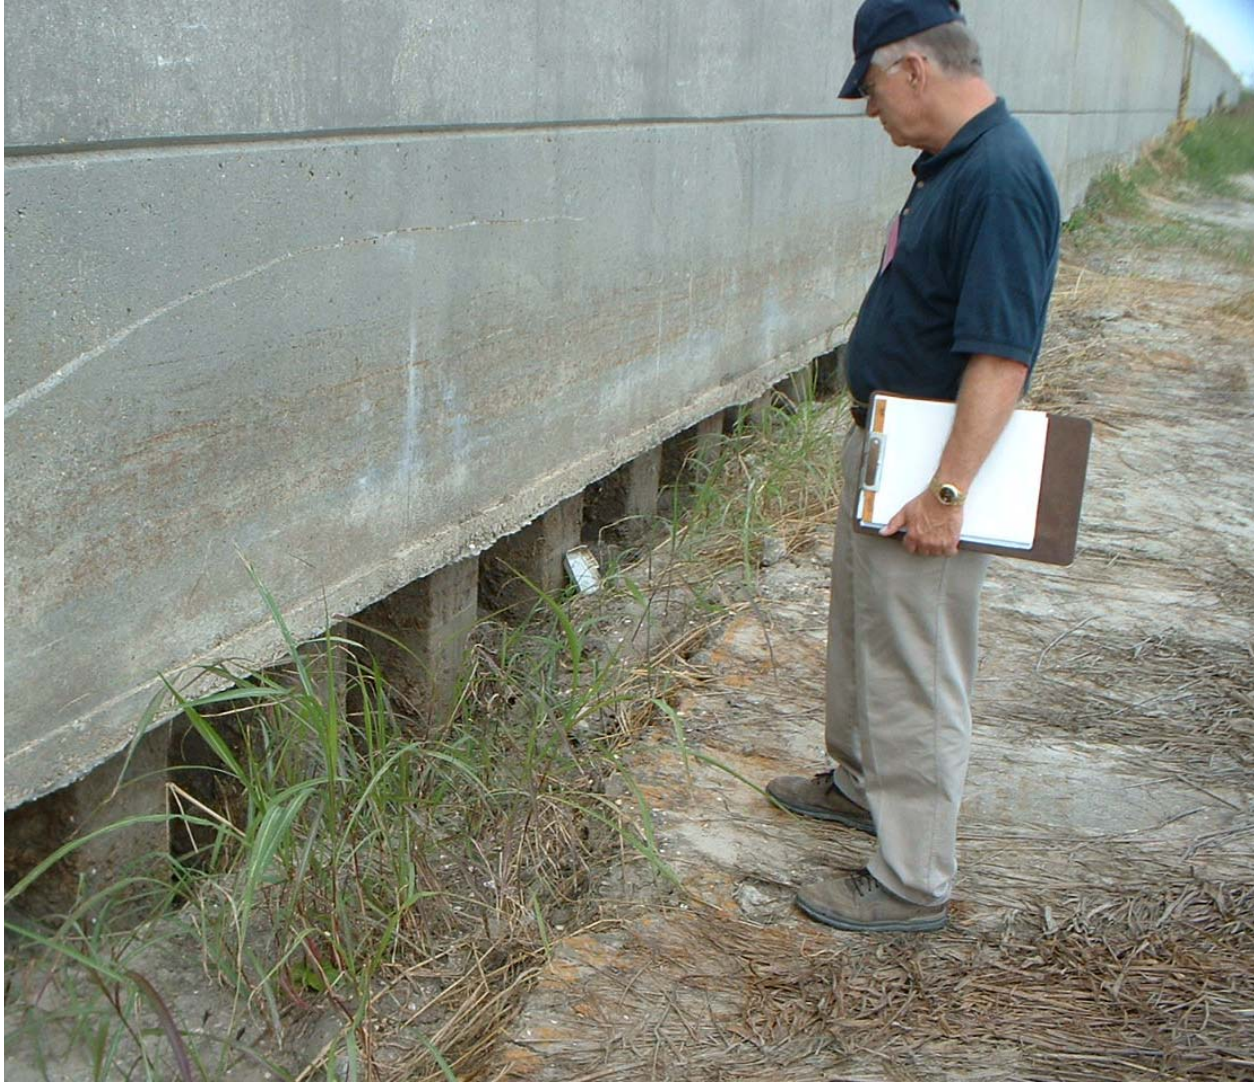
Figure 2a. Post-Katrina photographs of Michoud Canal I-Wall at pump station.

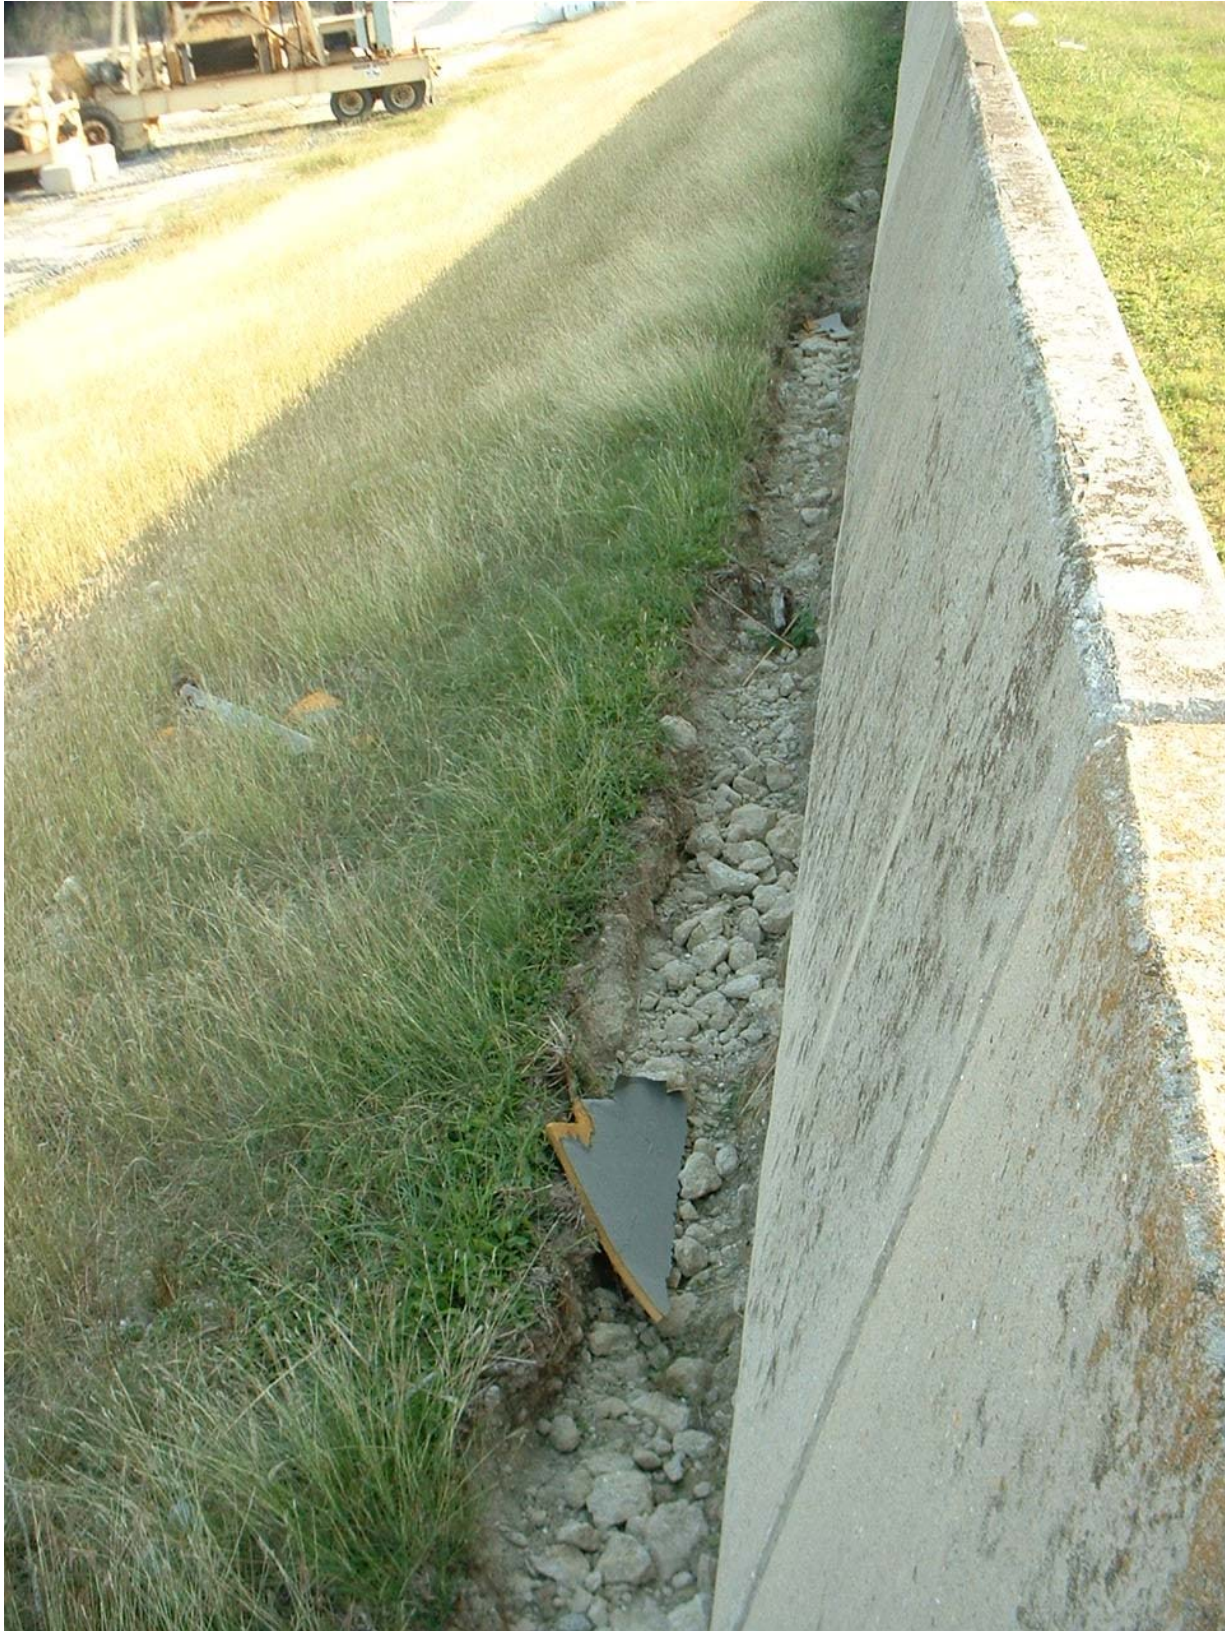
Figure 2b. Post-Katrina Photographs of Michoud Canal I-Wall showing erosion from overtopping waves.
