**Project Report To
Texas Water Development Board**

**Single Beam Bathymetric Survey of Rio Grande
River from the Brownsville El Jardin Weir to the
Gulf of Mexico.**

Hydrographic Consultants, Inc.

March 5th, 2008

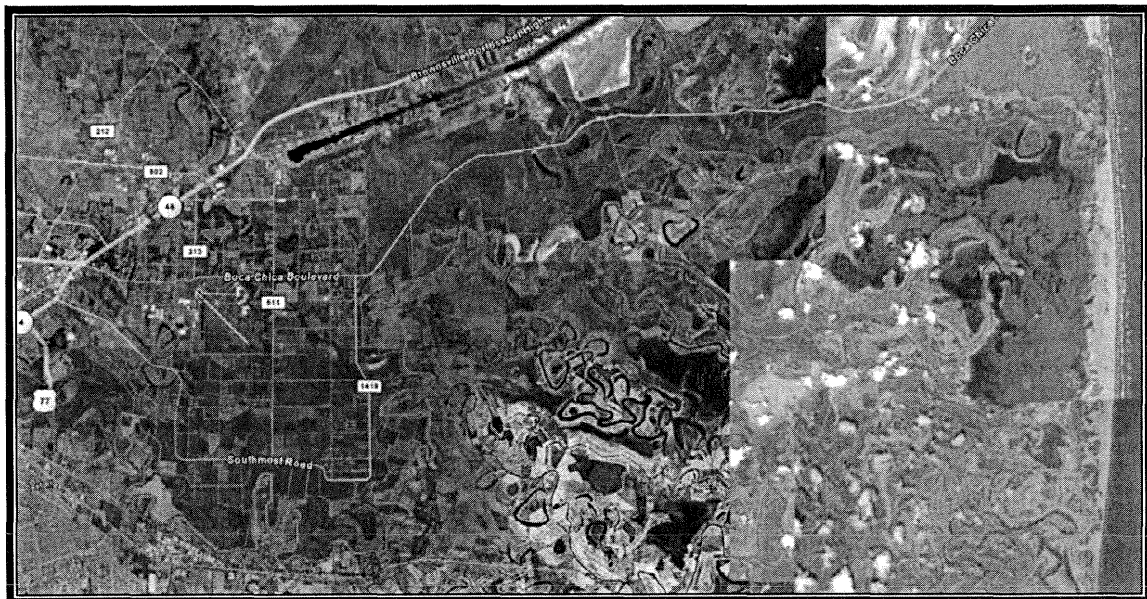
Figure 1. Survey Area.

The survey coverage was to consist of 49 miles of river below the El Jardin weir in Brownsville to the Gulf of Mexico (figure 1). The survey area was divided into 9 separate reaches, each reach was completed before proceeding to the next

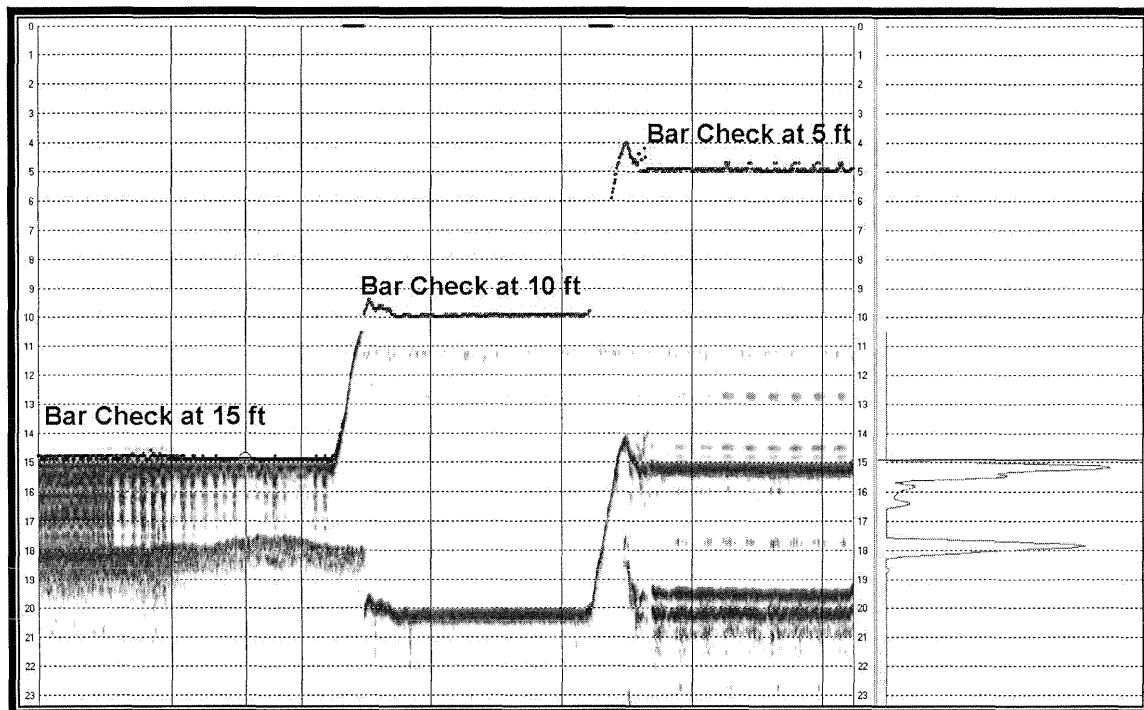
Figure 3. Electronic Echogram of a typical Bar Check used to calibrate the Echo Sounder at 5, 10 and 15 ft.

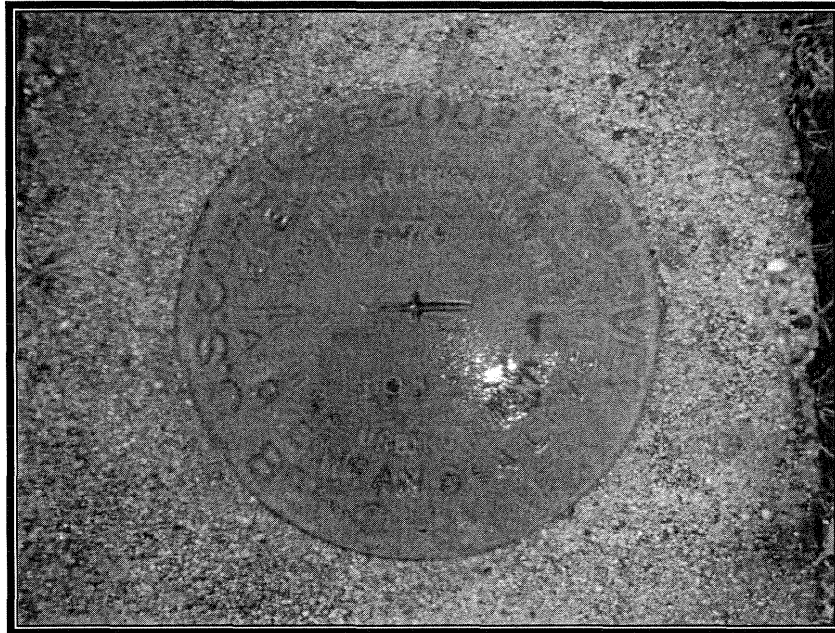
Figure 5. NGS Monument AB0058 used as check in point.

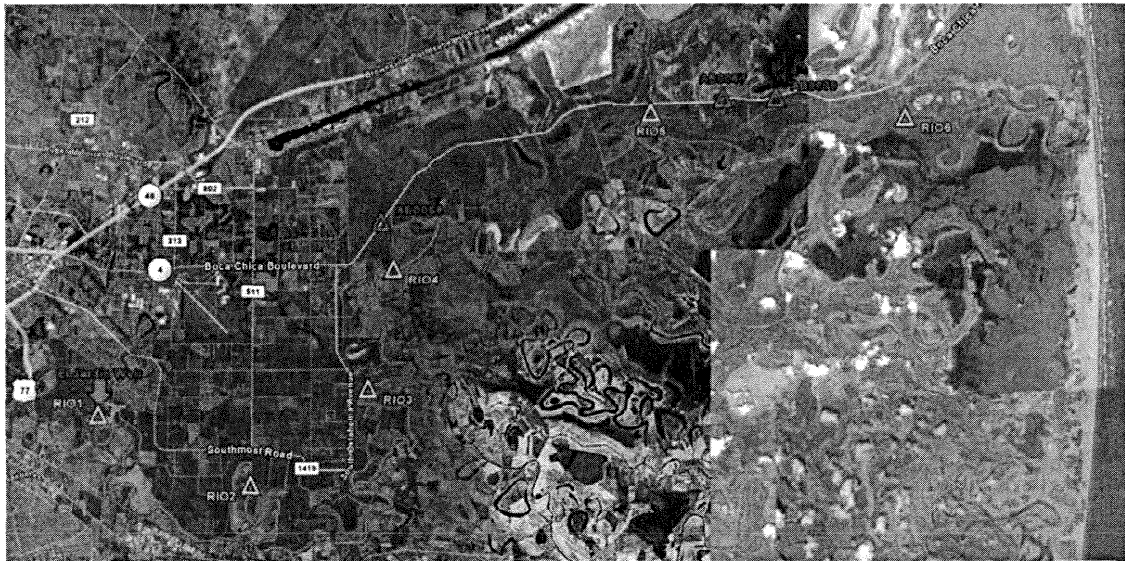
Figure 7. Showing NGS control points and relative position of the six water level logger stations located along the Lower Rio Grande Valley.

The Hobo Water Level Logger is a compact device that measures and internally logs pressure, temperature and time. The data logger is enclosed in a weighted, plastic tube that is suspended in the water column by a wire rope. Because the data logger is recording pressure and time only, a conversion must be performed to convert pounds per square inch into feet of water. Further, the scale must be shifted so that the water depth reported by the data logger is the same as the tide at any given instance. Figure 7 shows the position of each tidal station along the river.

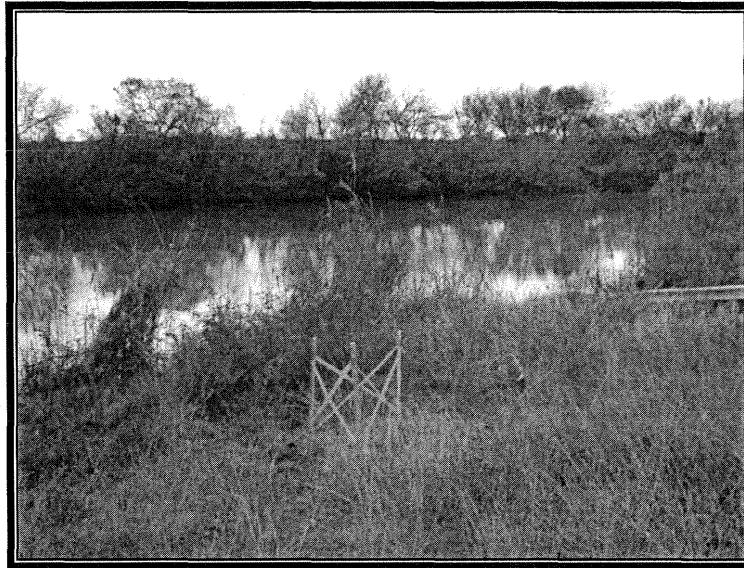
Figure 10. Showing location of Hobo water level logger and RIO3.

RIO3 was located about 12.3 river miles downstream from RIO2 on the property owned by Loop Farms (figure 10). The water level was measured when the logger was launched before surveying Section 1 and when the logger was retrieved after Sections 3-5 were completed.

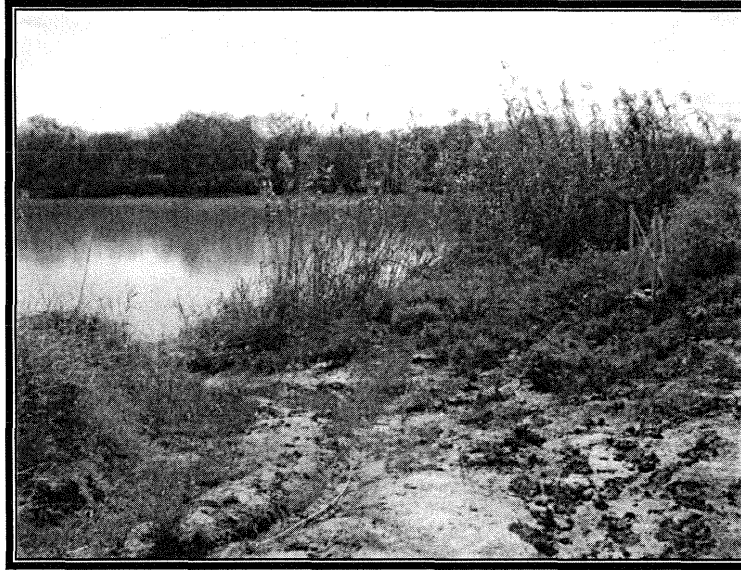
Figure 12. Showing location of Hobo water level logger and RIO5.

RIO5 was located about 12.1 river miles downstream from RIO4 on the property owned by Texas Parks and Wildlife (figure 12). The water level was measured when the logger was launched before surveying Section 5 and when the logger was retrieved after Sections 5-9 were completed.

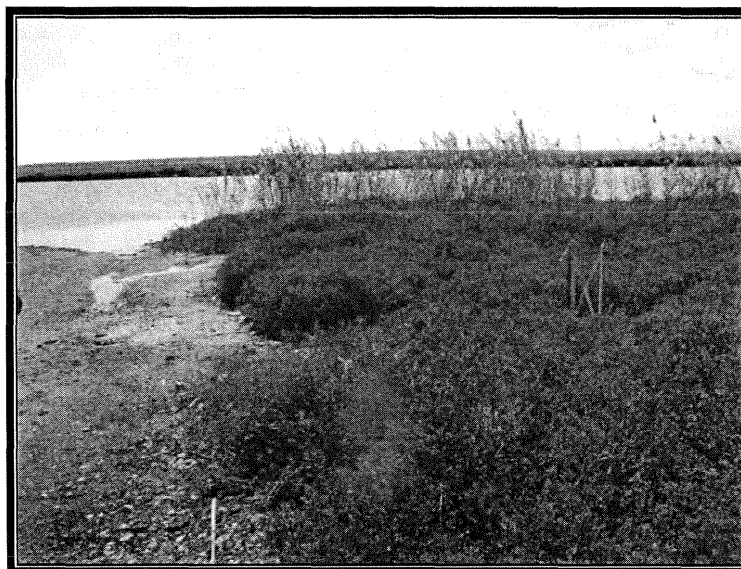
Figure 13. Showing location of Hobo water level logger and RIO6.

RIO6 was located about 6.2 river miles downstream from RIO5 on the property owned by Texas Parks and Wildlife (figure 7). The water level was measured when the logger was launched before surveying Section 8 and when the logger was retrieved after Sections 8-9 were completed.

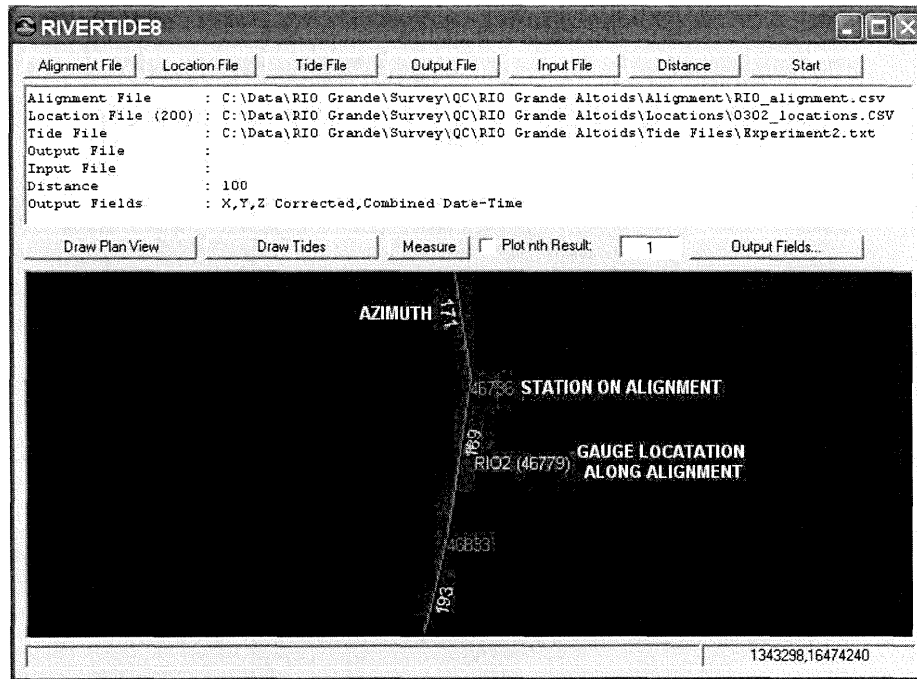
Fig 15 Zoomed in screen capture of above showing distance and azimuth vectors

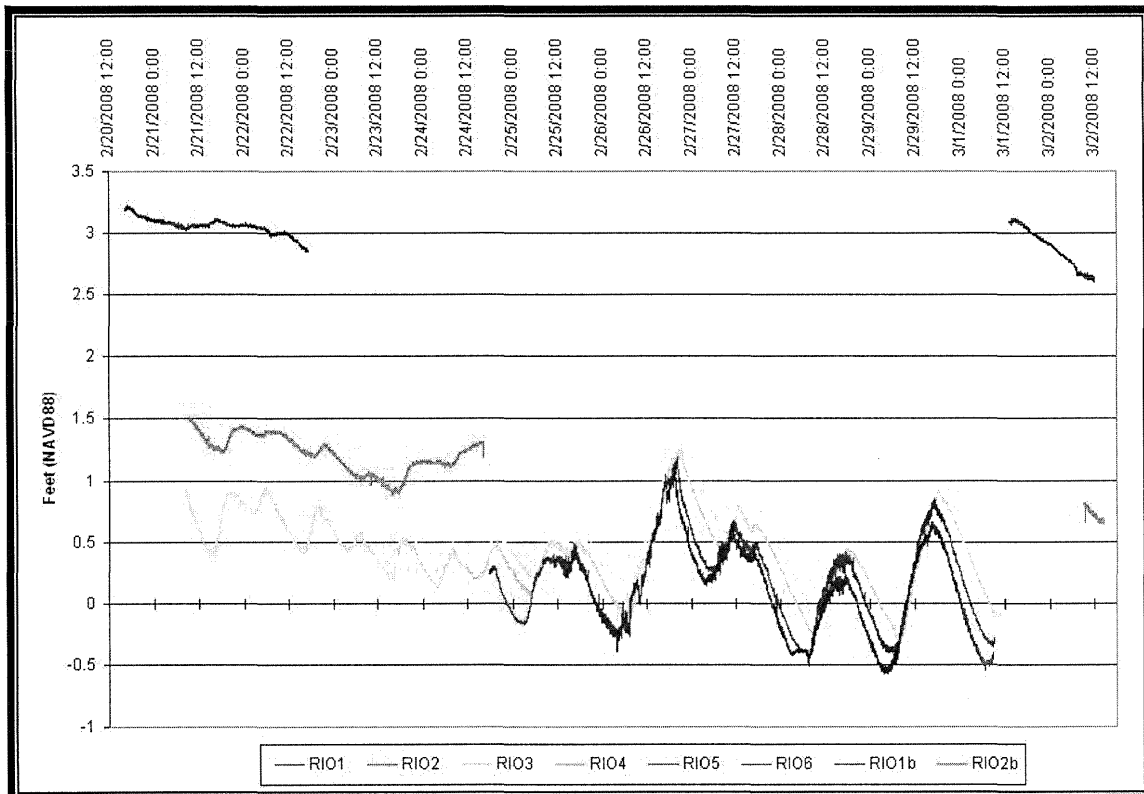
Figure 17. Tidal graph referenced to NAVD88, showing relationship of the water levels throughout the survey period.

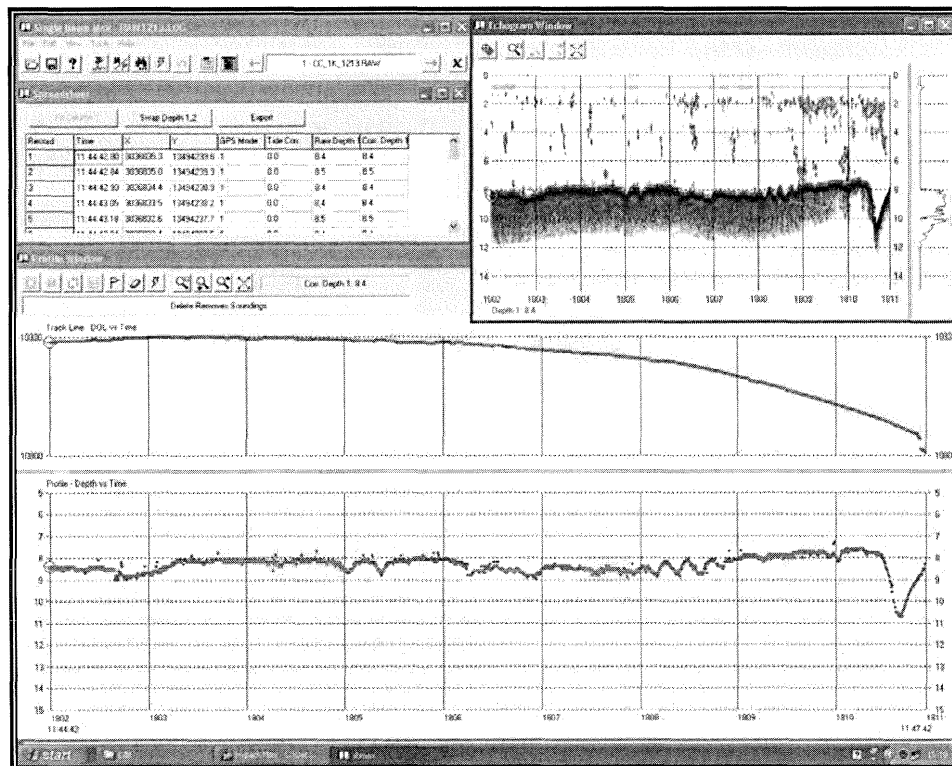
Figure 18. Typical Screen from Hypack Single Beam Editor showing Echogram (top right) Spreadsheet (top left) and plan view (bottom).

The Odom CVM is a paperless echo sounder. It is connected to the Hypack data collection computer by a high speed Ethernet interface. Not only are the digital soundings sent to Hypack but also an electronic version of the actual echogram (see Figure 3). This feature is very useful for data processing in Hypack because the electronic echogram is available as a window in the single beam editor portion of Hypack (see Figure 15). It is very easy to recognize where the echo sounder has digitized on noise in the water column rather than the river bed and it is also easy to correct this during data processing. Without this feature it can be quite time consuming to check through the paper scrolls particularly in very shallow water and noisy conditions. The Hypack single beam editor utility was also used to inspect the navigation data for any jumps due to GPS or differential outages caused by overhanging vegetation (not a major problem on this survey). Once the data had been cleaned the tide file was applied and the corrected file exported as an ASCII X,Y,Z data set. An export of the same file with no tide applied was also exported. All data is available on the DVD that accompanies this report.

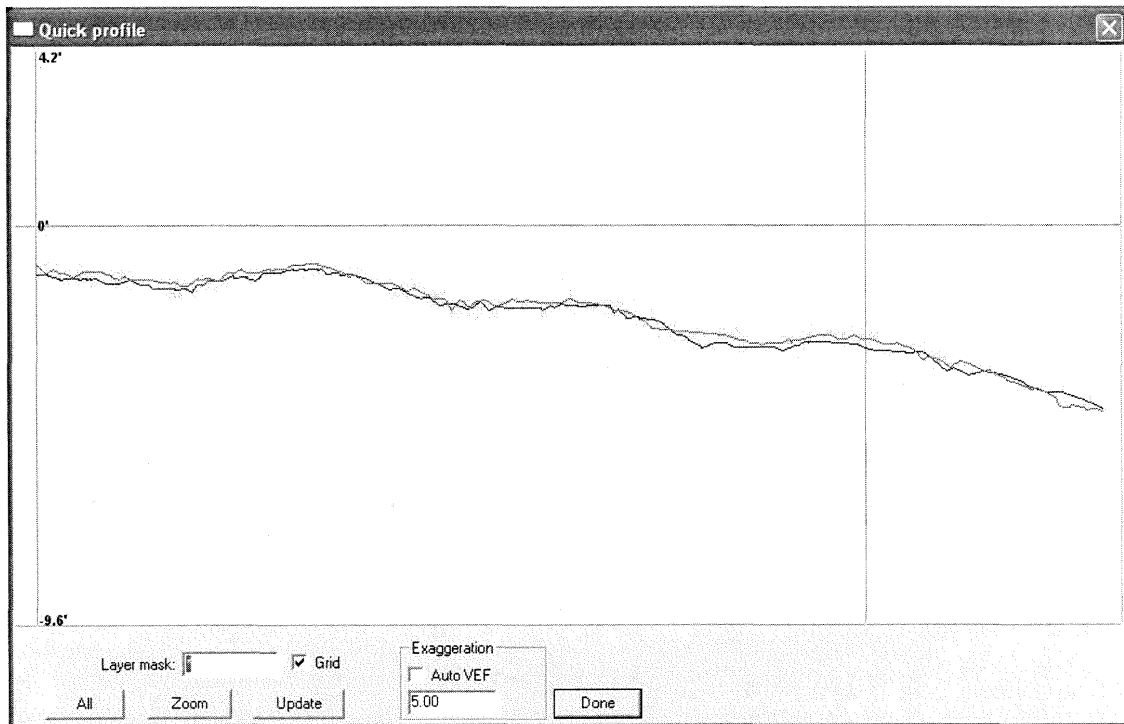
Fig. 19 River Section 1 to River Section 2 Cross Section

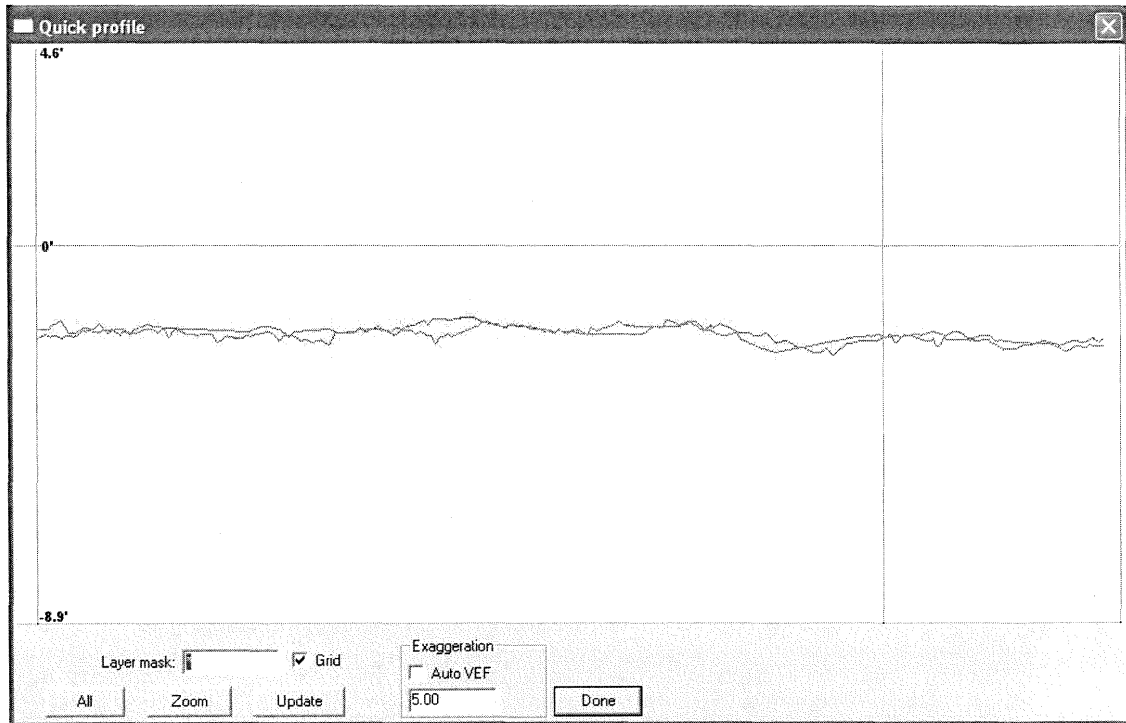
Fig. 20 River Section 2 to River Section 3 Cross Section

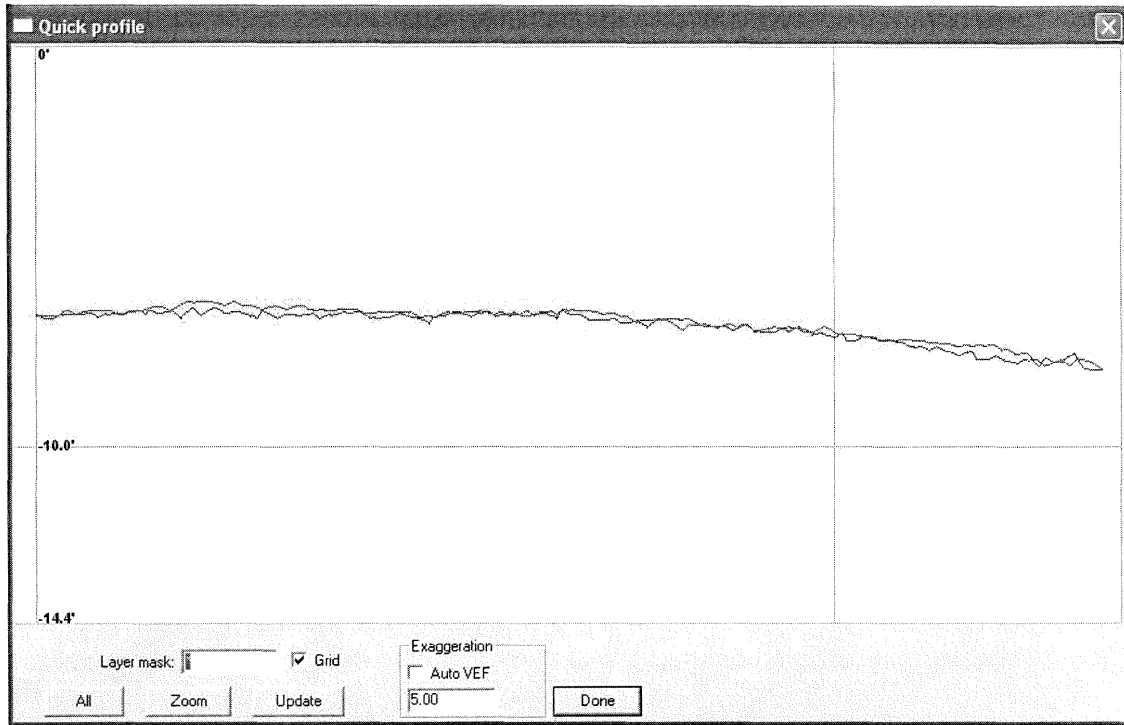
Fig. 22 River Section 4 to River Section 5 Cross Section

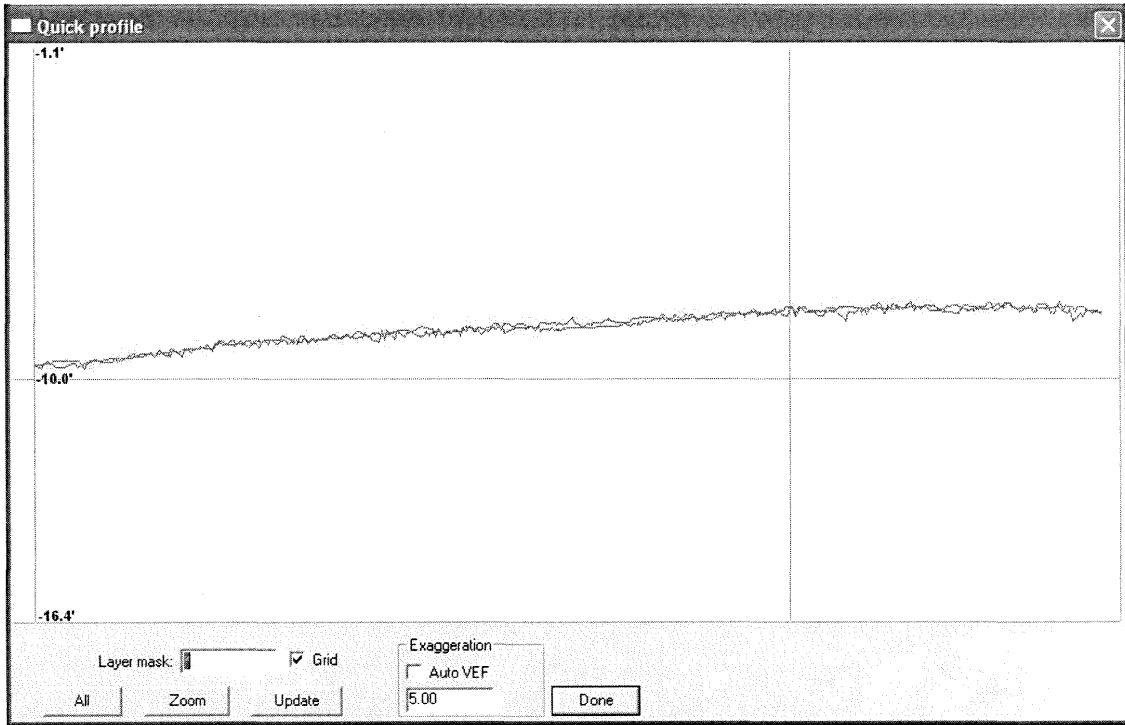
Fig. 24 River Section 6 to River Section 7 Cross Section
