**DECLINE OF SUBMERGED VEGETATION IN THE GALVESTON BAY SYSTEM:  
CHRONOLOGY AND RELATIONSHIPS TO PHYSICAL PROCESSES**

**Warren M. Pulich and William A. White**

**Prepared as part of a Cooperative Agreement  
between the  
Texas Parks and Wildlife Department  
and  
Bureau of Economic Geology**

**Bureau of Economic Geology  
W. L. Fisher, Director  
The University of Texas at Austin  
Austin, Texas 78713**

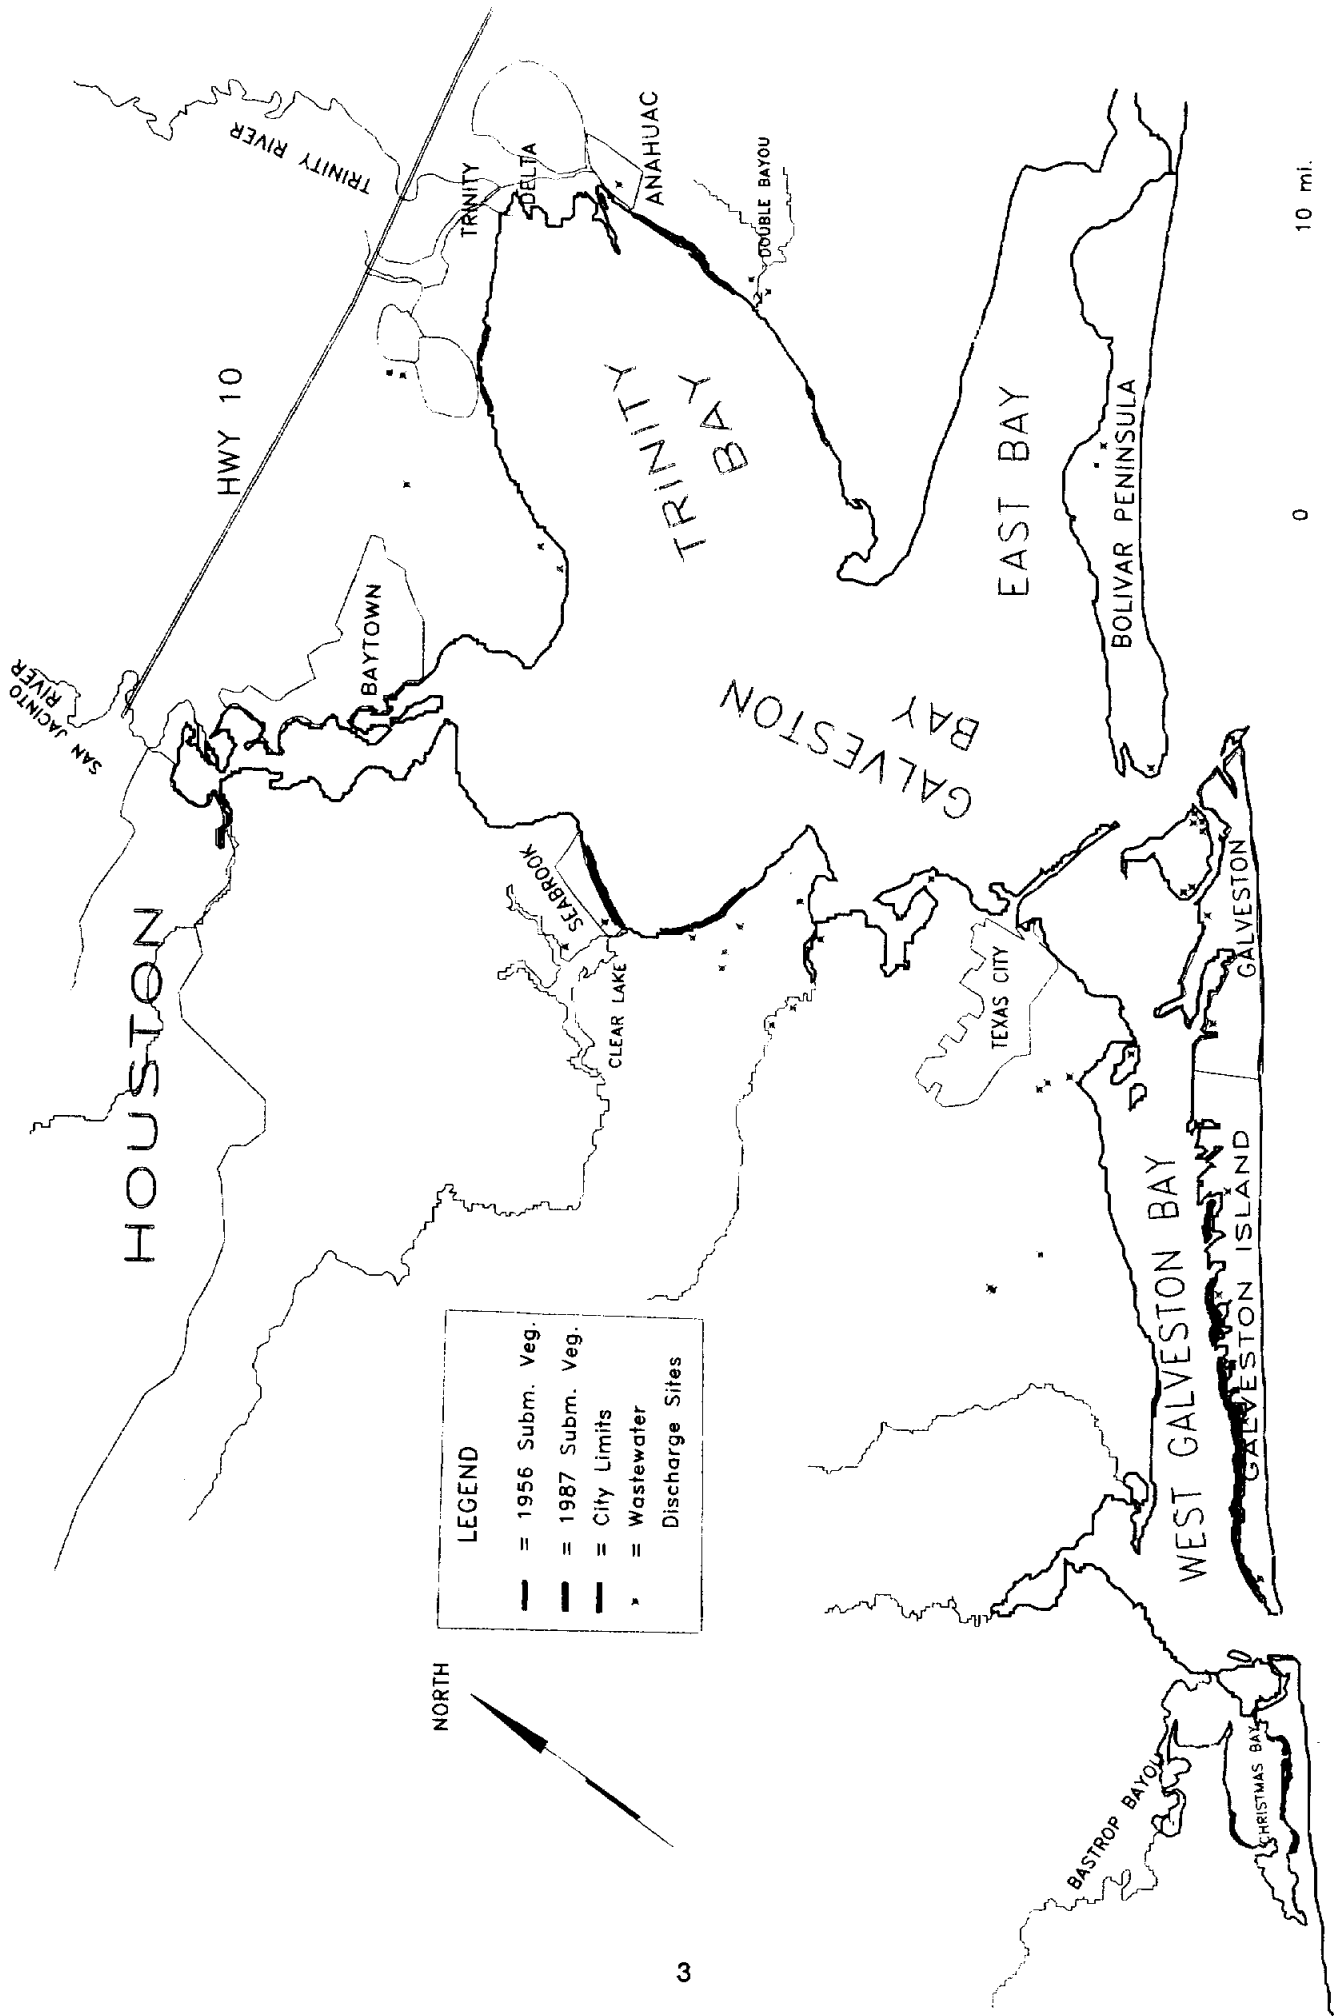
Figure 1. Map of the Galveston Bay system comparing 1956 and 1987 locations of submerged vegetation. Wastewater discharge sites compiled from 1988 records in Texas Water Commission permits section.

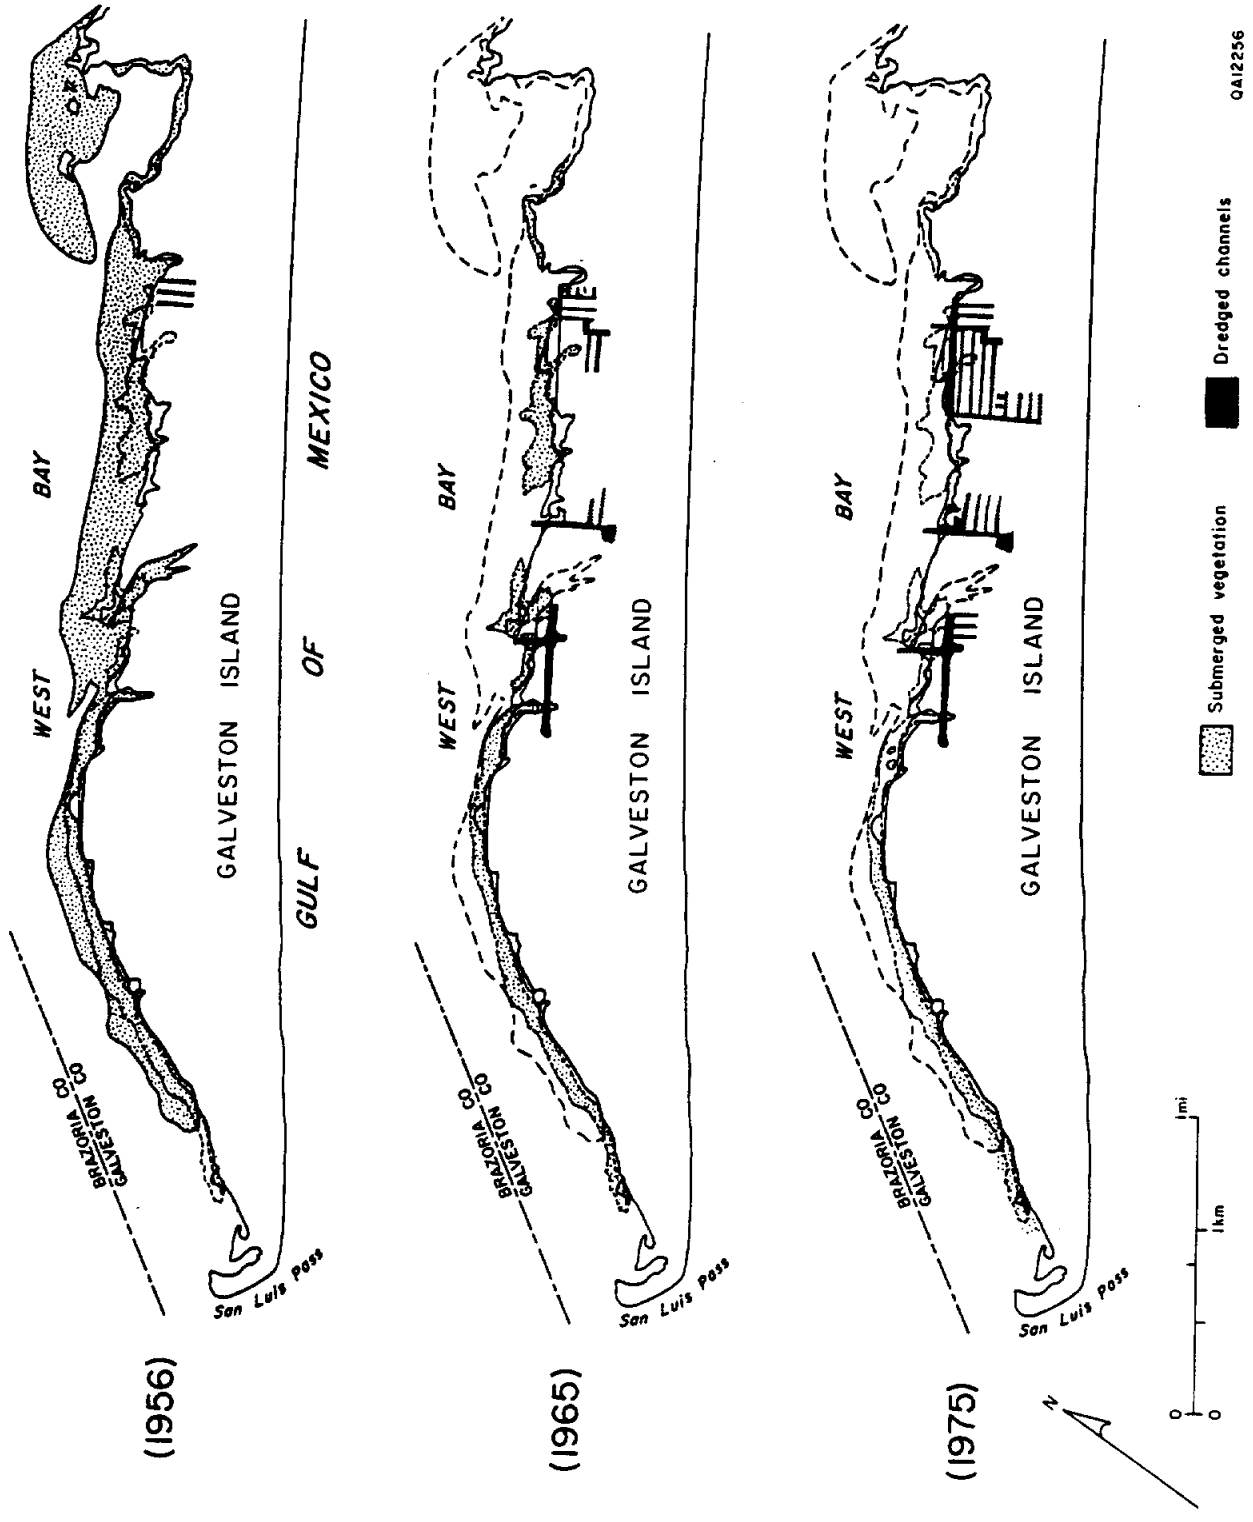
Figure 2. Historical changes in the distribution of seagrass and dredged channels along the western half of Galveston Island, West Bay.

Analysis of aerial photographs from 1956, 1965, 1975, and 1987 substantiates the progression of seagrass loss for Lower West Bay (Fig. 2). Reports by West (1973), Gilmore and Trent (1974) and area scientists (Sammy Ray, Texas A&M University at Galveston; Kirk Strawn, Texas A&M University; Roger Zimmerman, National Marine Fisheries Service, Galveston; personnel

communication) further corroborate the occurrence and decline of Halodule from the West Bay area. After a dramatic decrease in seagrasses from approximately 1,100 to 300 acres between 1956 and 1965, the remainder of the reduction appears to have occurred gradually (Fig. 2).

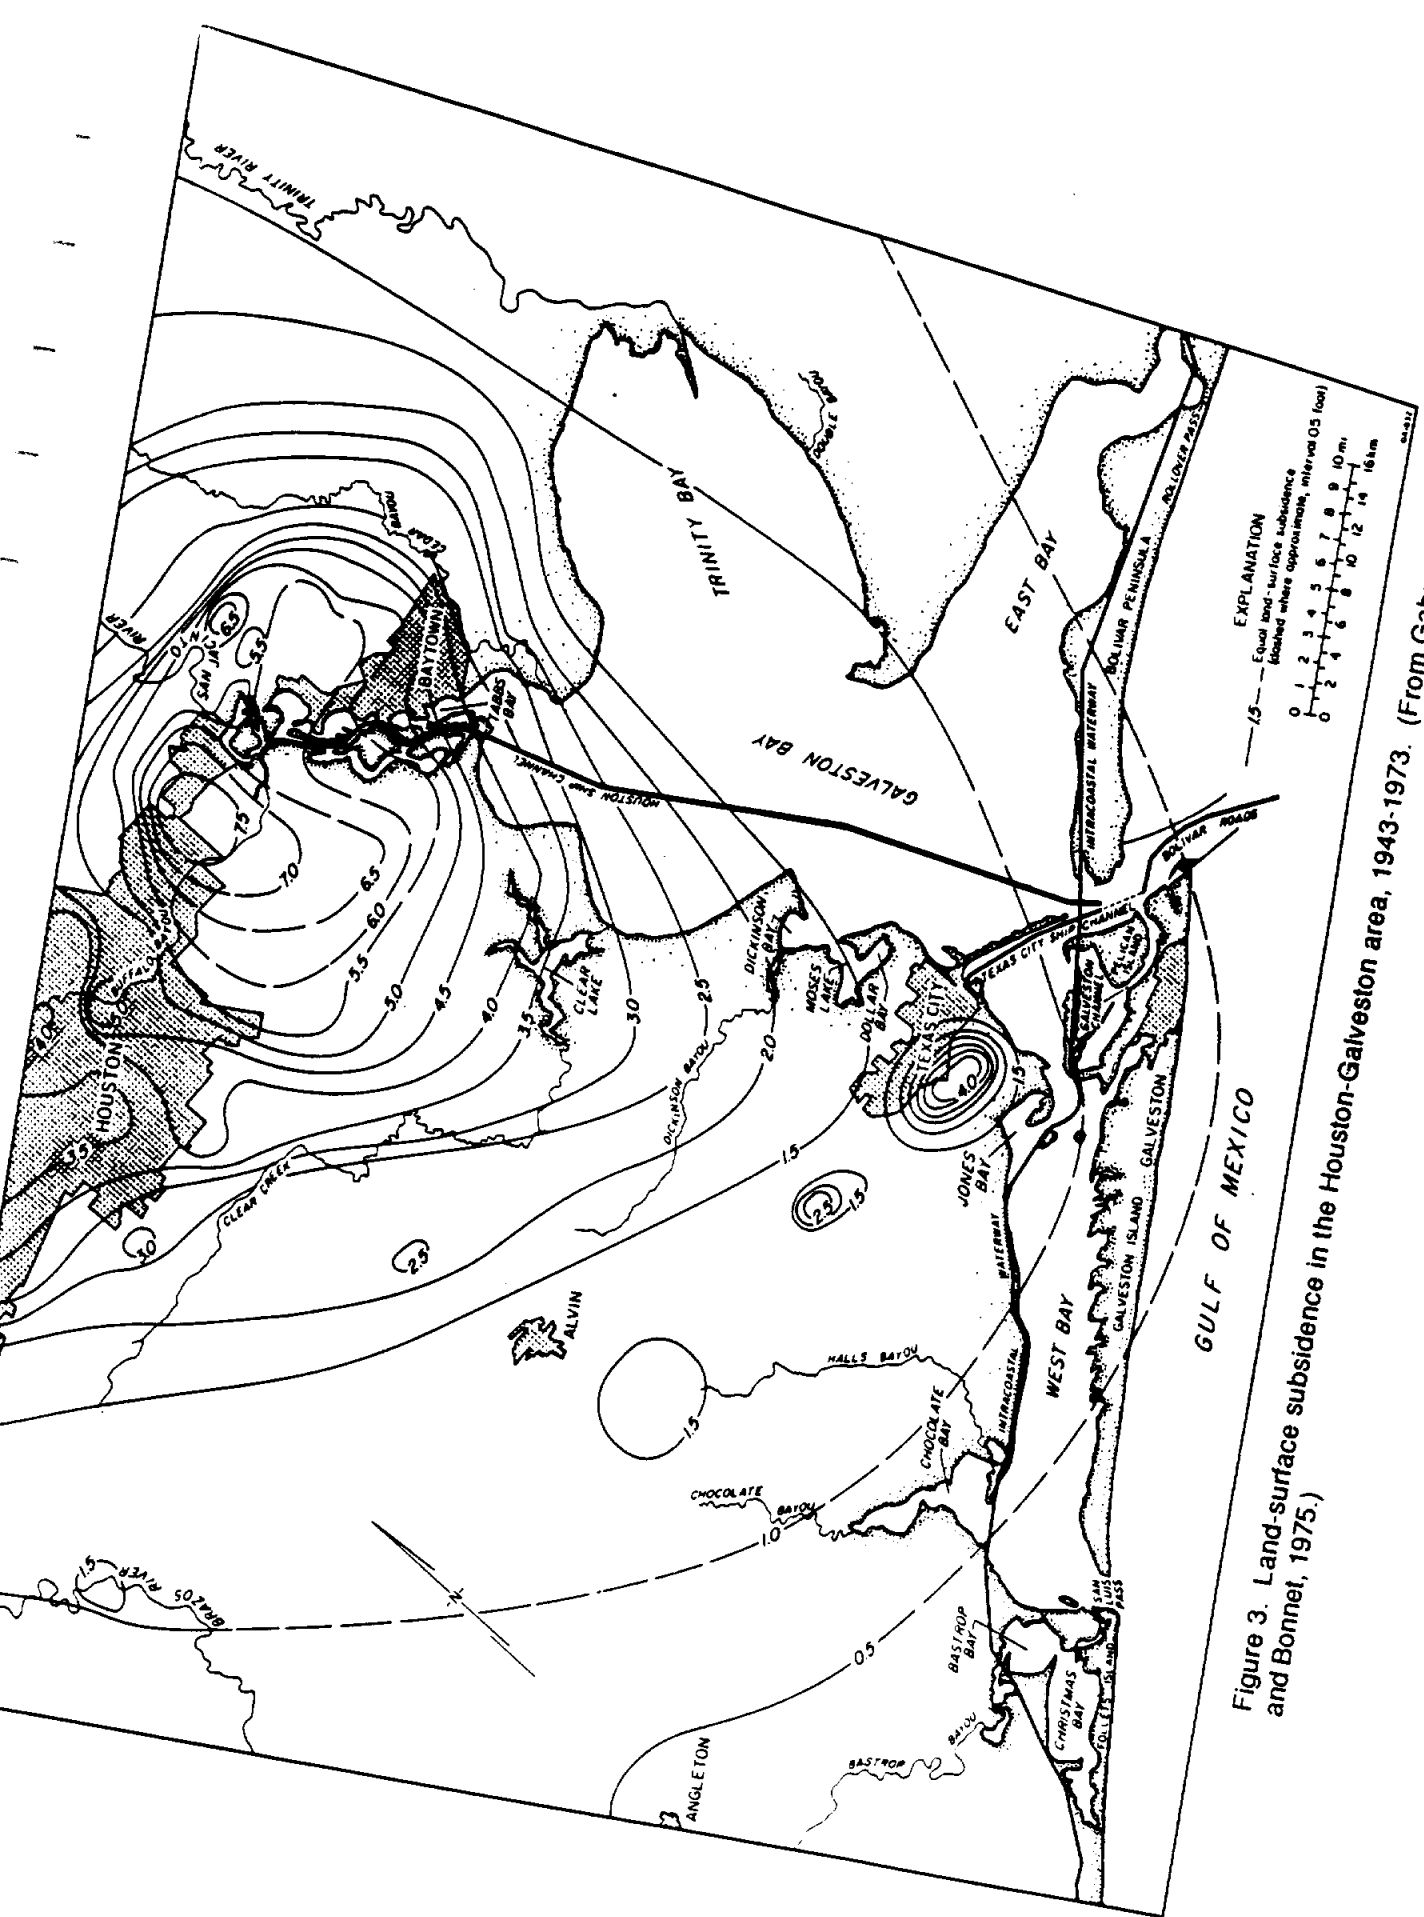
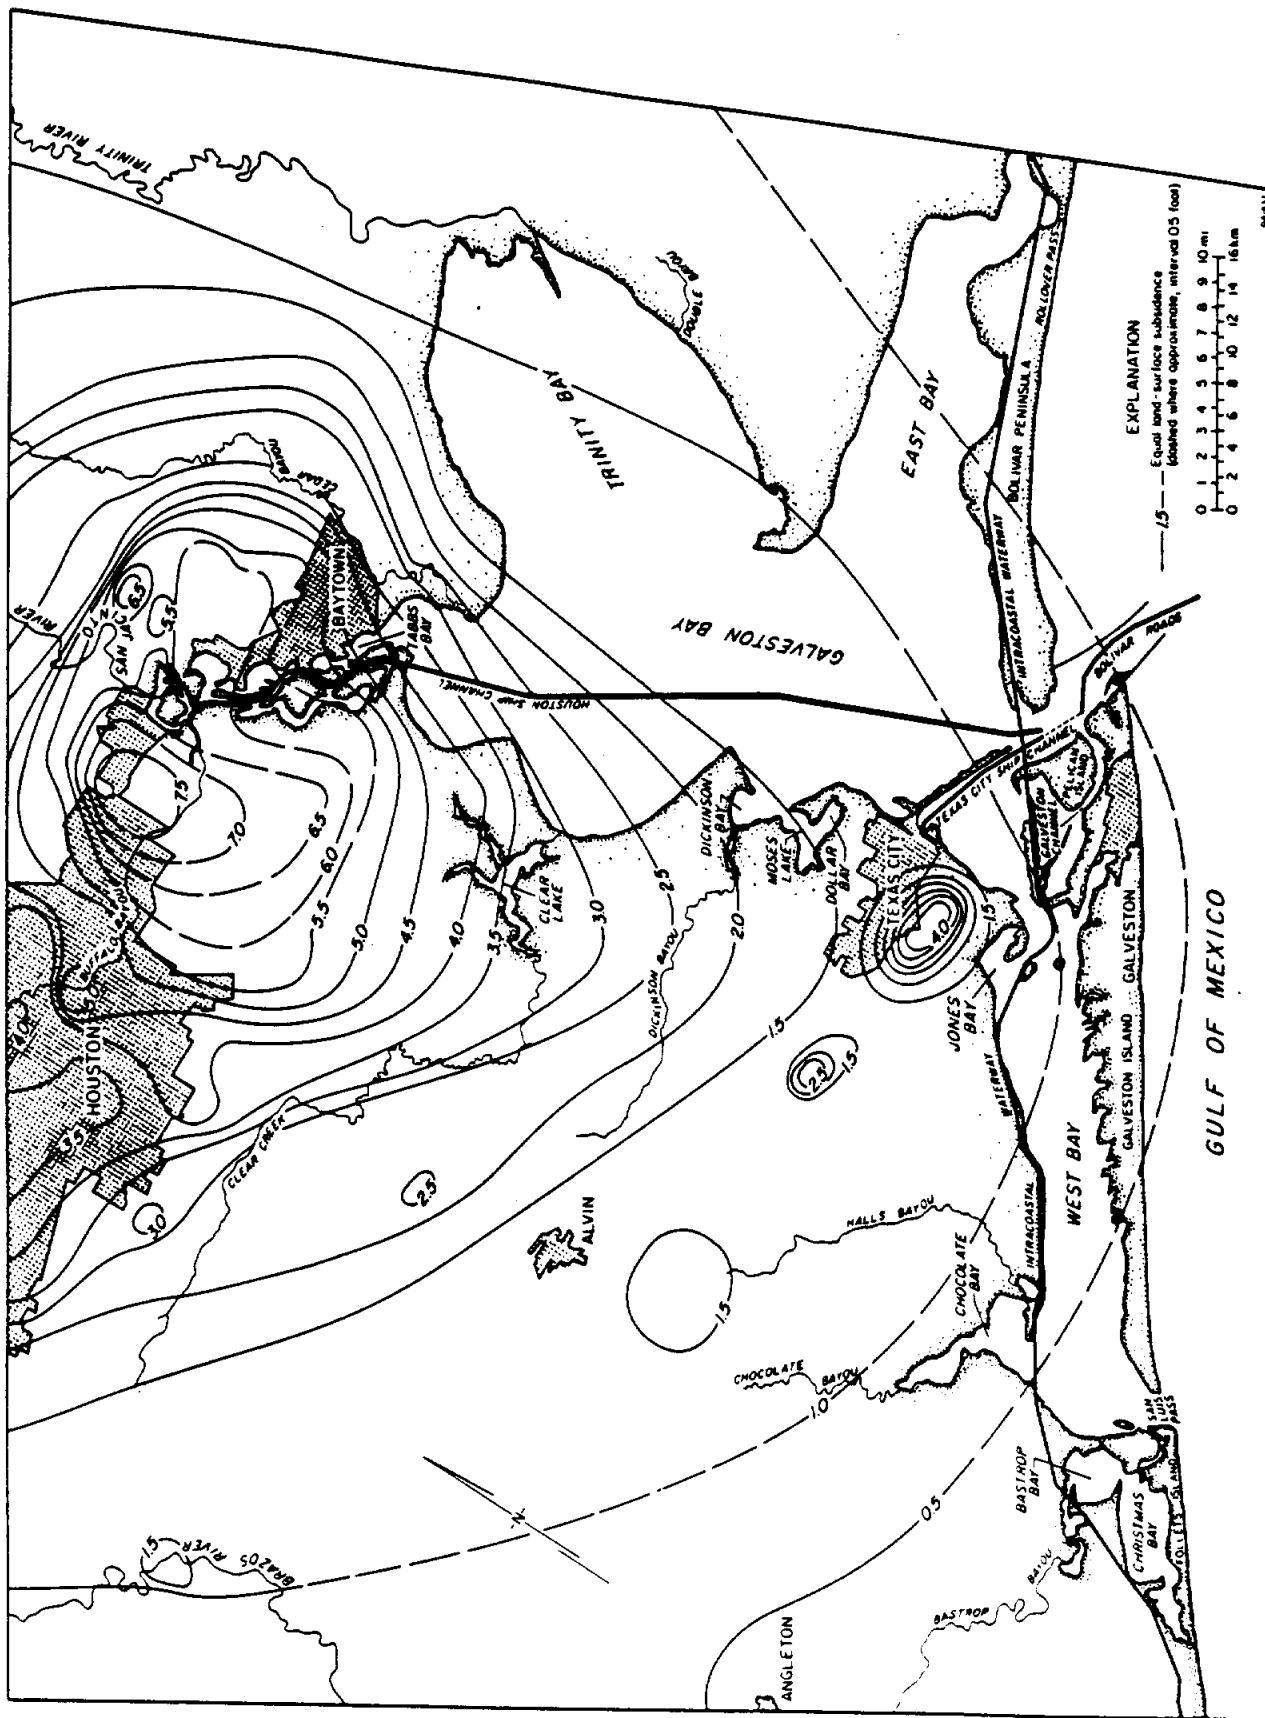
Figure 3. Land-surface subsidence in the Houston-Galveston area, 1943-1973. (From Gabrysch and Bonnet, 1975.)

The SV area affected most by subsidence is on the west side of Galveston Bay near Seabrook (Fig. 3). Historical trends in subsidence in the Seabrook area indicate that rates increased after 1943 and reached a maximum of about 6 cm/yr for the period 1964-1973 (Fig. 4). Subsidence in the Seabrook area between 1943 and 1973 was approximately 0.9 m, and from 1943 to 1978 it exceeded 1.2 m (Gabrysch, 1984). Water depths near shore possibly increased by as much as 30 to 60 cm between 1968 and 1977 (Morton and McGowen, 1980). The amount of subsidence in other SV areas is considerably lower than in the Seabrook area, ranging from less than 0.5 m in upper Trinity Bay to less than 0.4 m in West Bay and 0.2 m in Christmas Bay for the period 1943 to 1973 (Fig. 3). In the eastern part of Trinity Bay and in the southwest part of West Bay, subsidence during the period 1943 to 1978 was less than 0.3 m (Gabrysch, 1984).

The significance of sea-level rise in the 1960's and 1970's due to subsidence was examined by reviewing Figure 3. For the most part, high subsidence rates occurred only along the mainland side of Upper West Bay. However, the north end of Galveston Island showed a moderate decrease in elevation since 1943 (Fig. 3). It appears that subsidence was not a significant factor in the loss of sub-

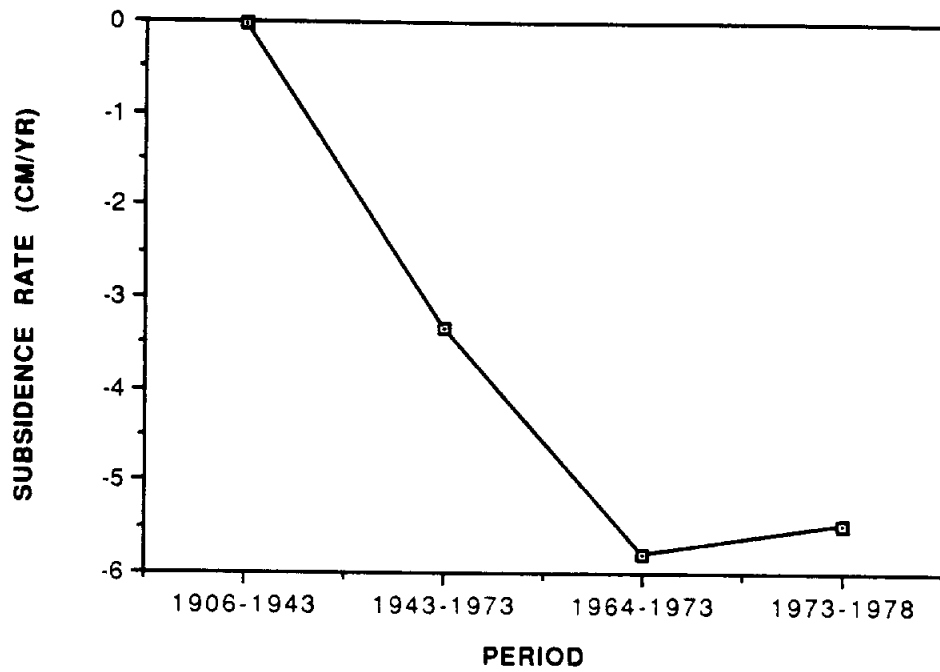
Figure 4. Subsidence rates along the Galveston Bay margin in the Seabrook area. (Based on data from Gabrysch and Bonnet, 1975, and Gabrysch 1984.)

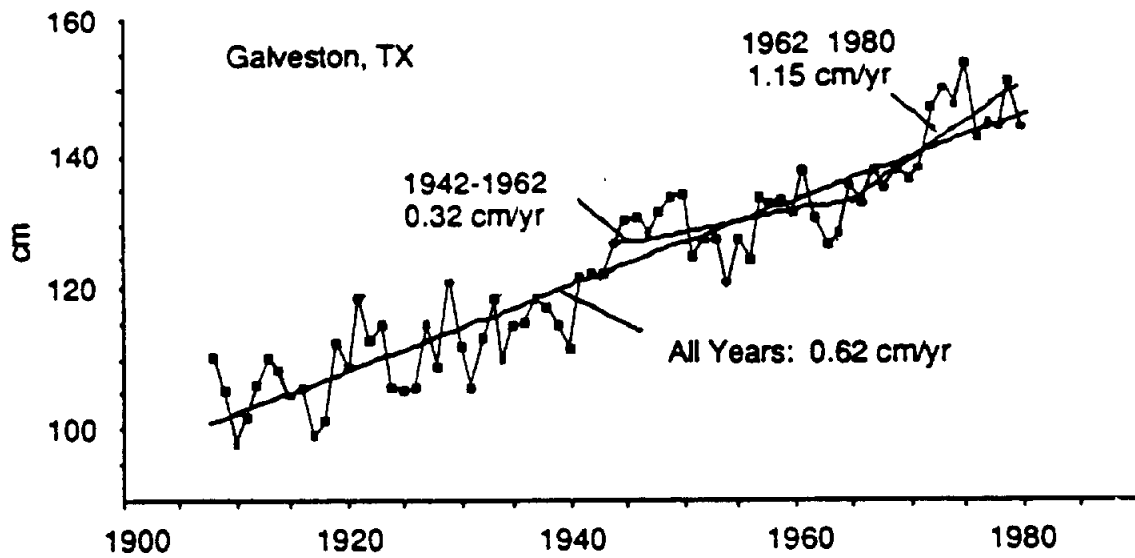
Figure 5. Annual changes in water level based on tide gauge records at Galveston (Pier 21), with variations in rates of rise indicated for different periods. (Modified from Turner, 1987.)

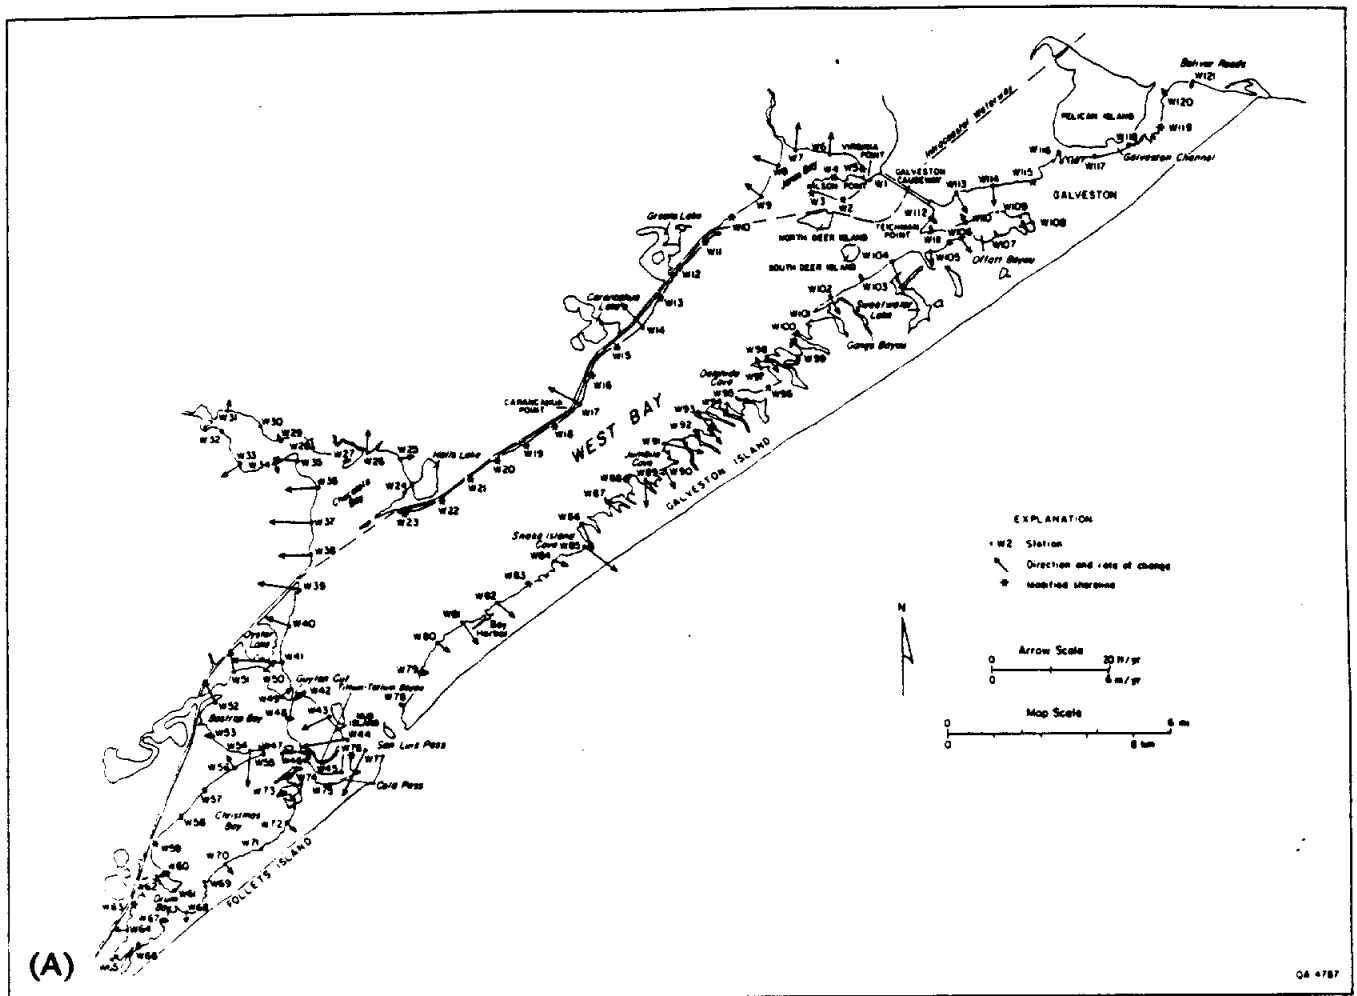
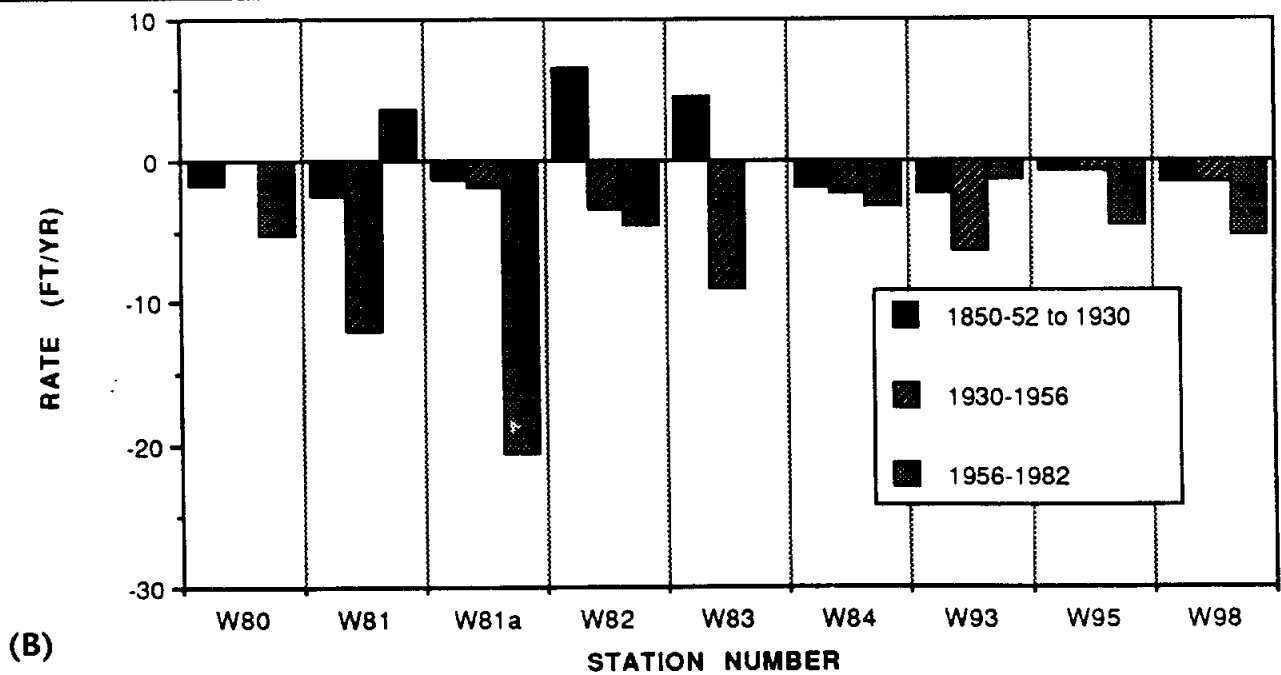
Figure 6. Bay shoreline changes along Galveston Island during specified periods. (A) Station location map and rates of shoreline change along West Bay, 1930 to 1982 (From Paine and Morton, 1986) and (B) rates of shoreline change for specified periods (From unpublished BEG data).

As mentioned previously, the Galveston Island shoreline in West Bay is one of two areas where rates of erosion have increased during more recent periods (Table 2). In fact, the average rate of erosion during the period 1930 to 1982 is about 2.5 times the average rate during 1850-52 to 1930. More specific analysis of shoreline changes over three time periods along Galveston Island indicates that rates of erosion in general were higher during the period from 1956 to 1982 than during earlier periods (Fig. 6). This latter period coincides with the time during which submerged vegetation declined and disappeared. Although loss of grasses may contribute to higher rates of erosion (Orth and Moore 1983), rates can also be accelerated as a result of human activities (Paine and Morton, 1986). Dredging of channels in nearshore areas can increase erosion by producing deeper water in which larger more destructive waves can reach shore. The larger waves may also contribute to increased turbidity through erosion, and through resuspension of silt and clay that has settled in channels.

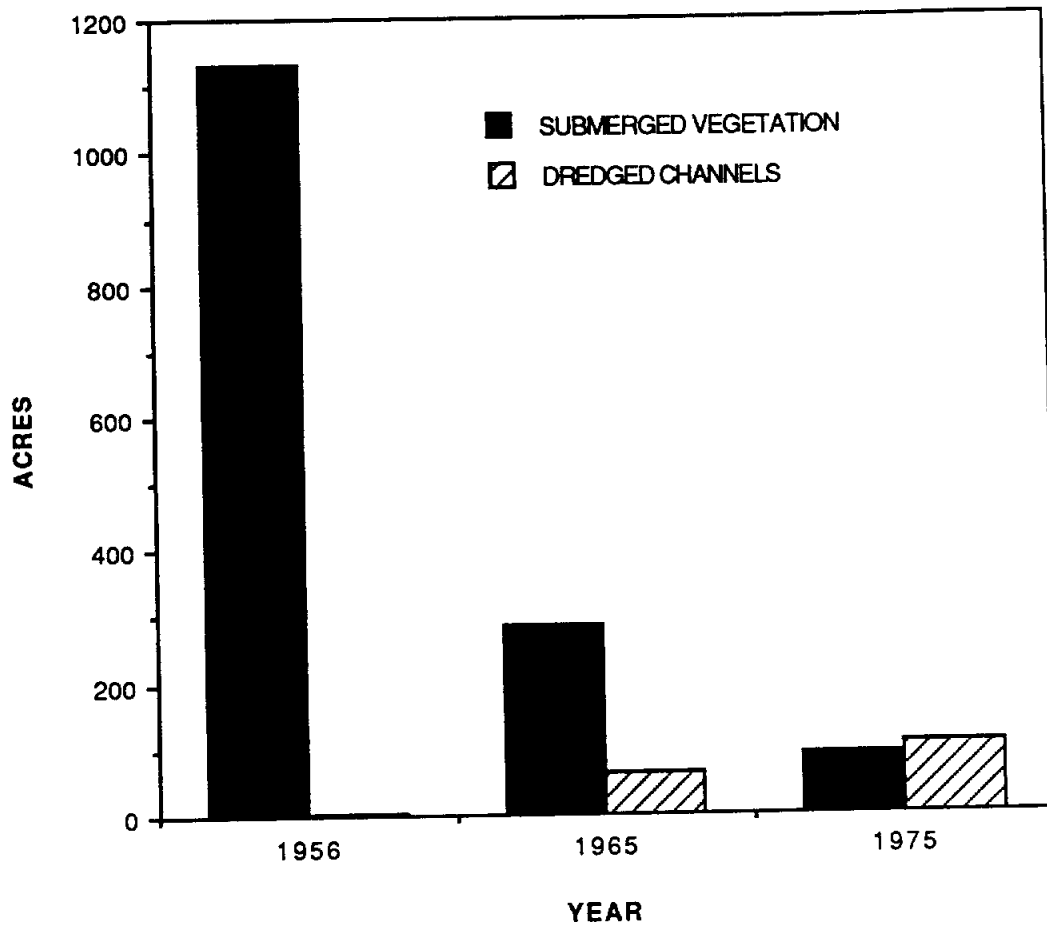
Figure 7. Changes in areas of submerged vegetation and dredged channels along the western half of Galveston Island, West Bay, 1956-1975.

The increase in Galveston Island residential and commercial waterfront developments follows closely the chronological decline of seagrasses in West Bay. Many of these construction projects represent classical examples of "dredging and filling" of wetlands. When the progression of dredged channels, bulkheaded marinas and resort housing is charted from aerial photographs, such areas show substantial increases between 1956-1965 and 1965-1975, as demonstrated by dredged channels in Figure 7. Dredged channels in the Lower West Bay physically displaced many acres of seagrasses over the 20 year period. In addition, spoil material from dredging was often disposed of in open water areas, burying adjacent seagrass beds and producing high levels of turbidity.

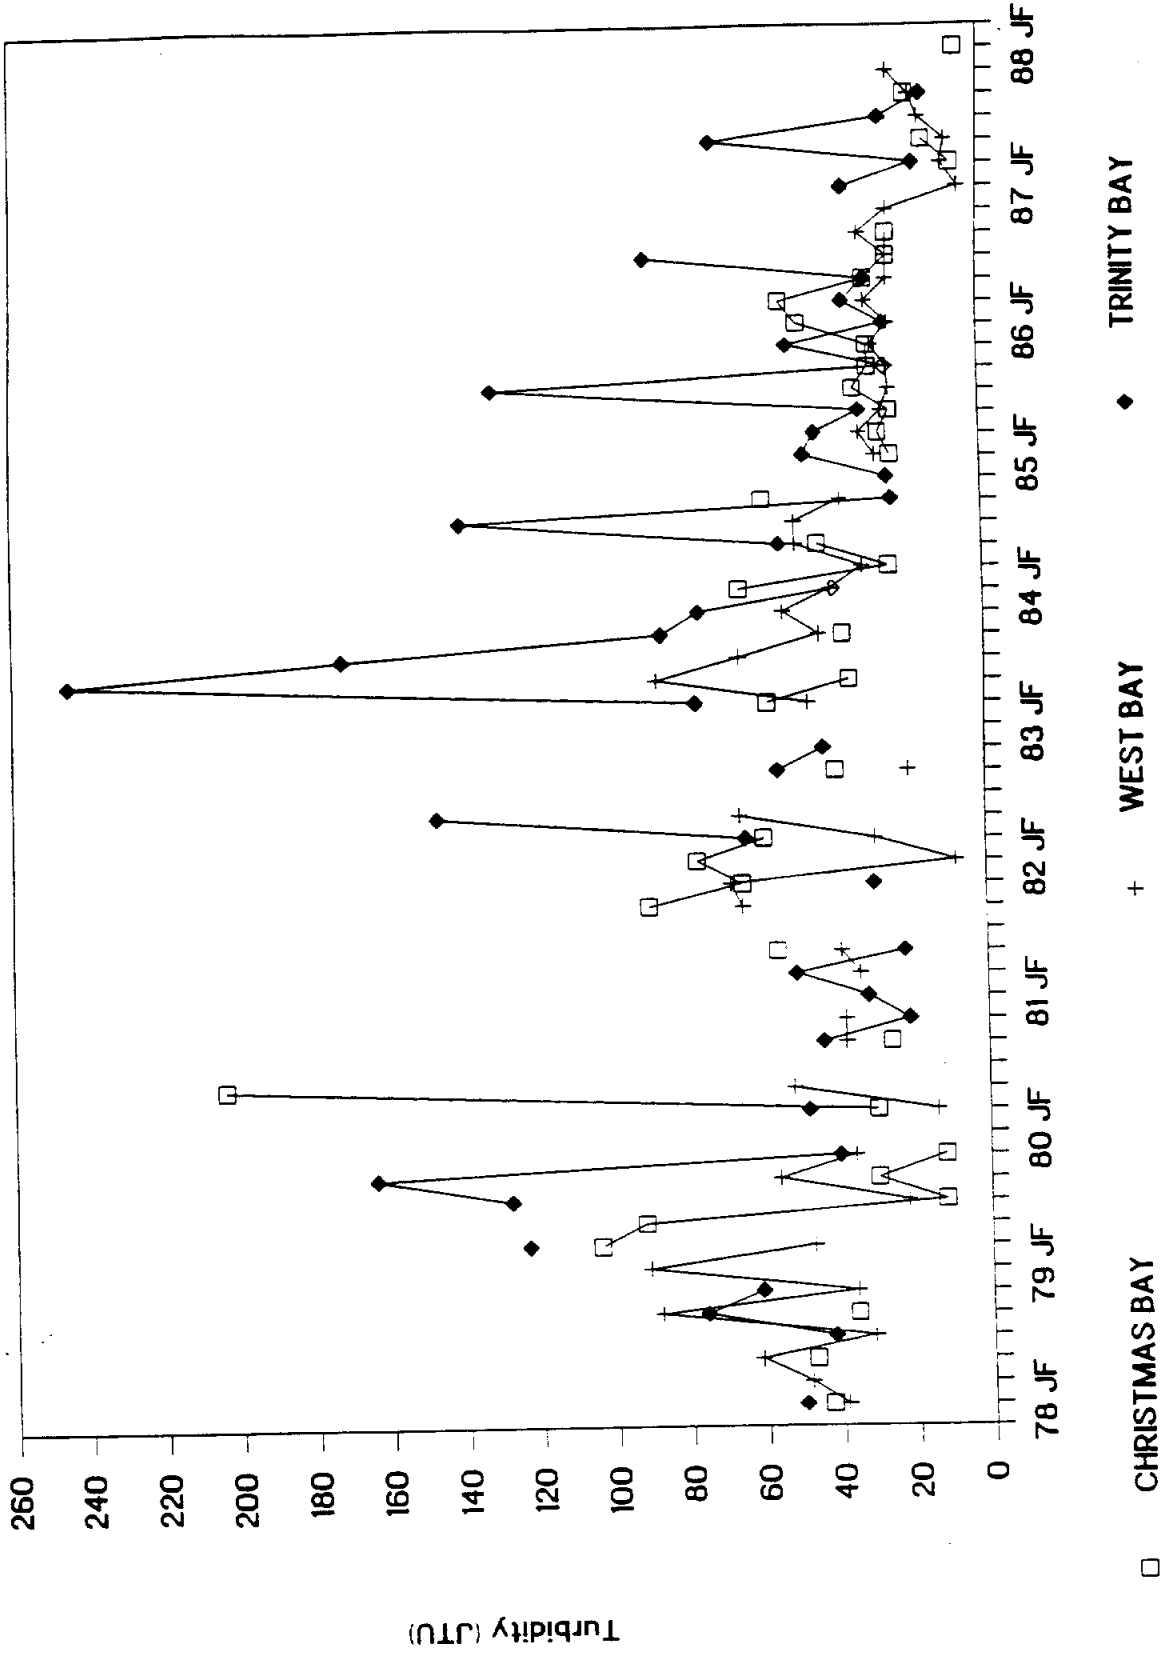
Figure 8. Mean turbidities in areas of submerged vegetation in Christmas, West, and Trinity Bays.

West Bay and Christmas Bay water were not appreciably different at this time. When bimonthly means were compared (Fig. 8), the two areas showed essentially similar turbidity regimes over this ten year period. The current SV sites on the east shore of Trinity Bay also serve as controls for the lower bay turbidity regimes. Although these areas experience higher turbidities than the lower bay areas, due to freshwater inflows from the Trinity River, Ruppia still grows well at this higher turbidity level.

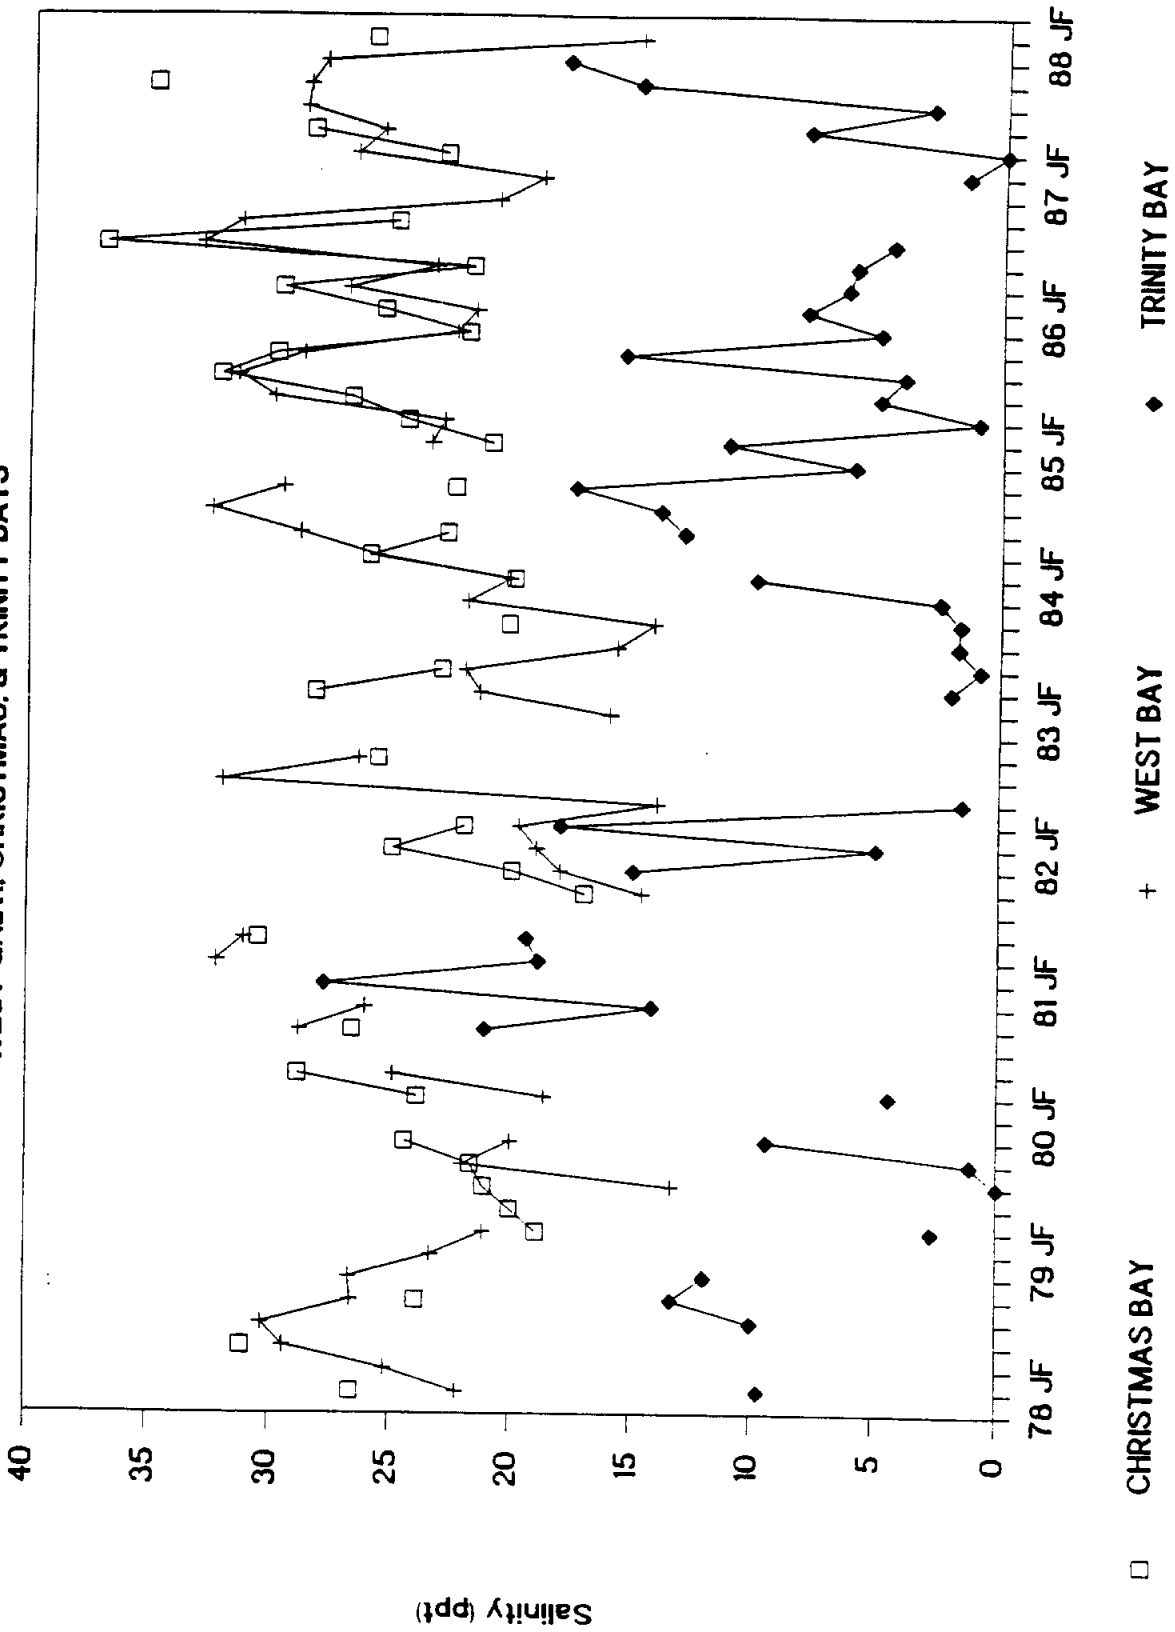
Figure 9. Mean salinities in areas of submerged vegetation in Christmas, West, and Trinity Bays.

Mean salinities in West, Christmas, and Trinity Bays are compared in Figure 9. There is no evidence to suggest that salinity regimes have contributed to a decline in SV areas. Salinities in Christmas Bay, where seagrasses are relatively abundant, are similar to salinities in West Bay where seagrasses have disappeared.
