Self-Guided Tour

Fort Leaton

State Historic Site

WELCOME TO FORT LEATON STATE HISTORIC SITE

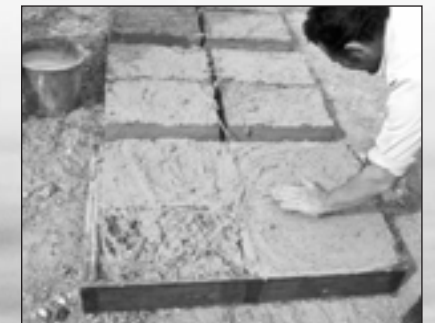
Adobe brick being made during restoration work.

Fort Leaton was constructed of the native materials on hand: earth, rock and wood. Large, sun-dried adobes laid on rubble stone foundations comprise its walls, which range in thickness from a single 18-inch layer to a double width of 44 inches, nearly four feet. The adobe—a mixture of straw, water and clay—were pre-cast in wooden forms. After setting and hardening somewhat, the adobe were removed from the forms and allowed to dry thoroughly in the hot desert sun.

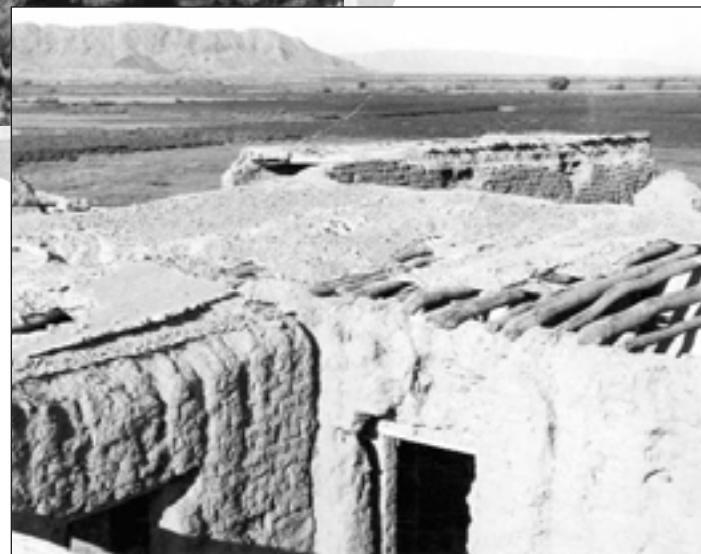
The original cottonwood ceiling joists (vigas) were covered with river cane and then packed with up to 18 inches of adobe mud.

Constituting the major living space, these rooms would have served as Leaton's private quarters—the grandest in the structure. All of the plaster you see was applied during the 1969 restoration. Look above you and note the ceiling construction, with its hefty cottonwood *vigas* (beams) and smaller crosspieces called *latillas*.
