Environmental Assessment

Santa Ynez Unit C1 Cable Repair

Proposed Action: Minerals Management Service Concurrence with ExxonMobil's Proposal to Repair the C1 Power Cable

Operator: ExxonMobil Production Company

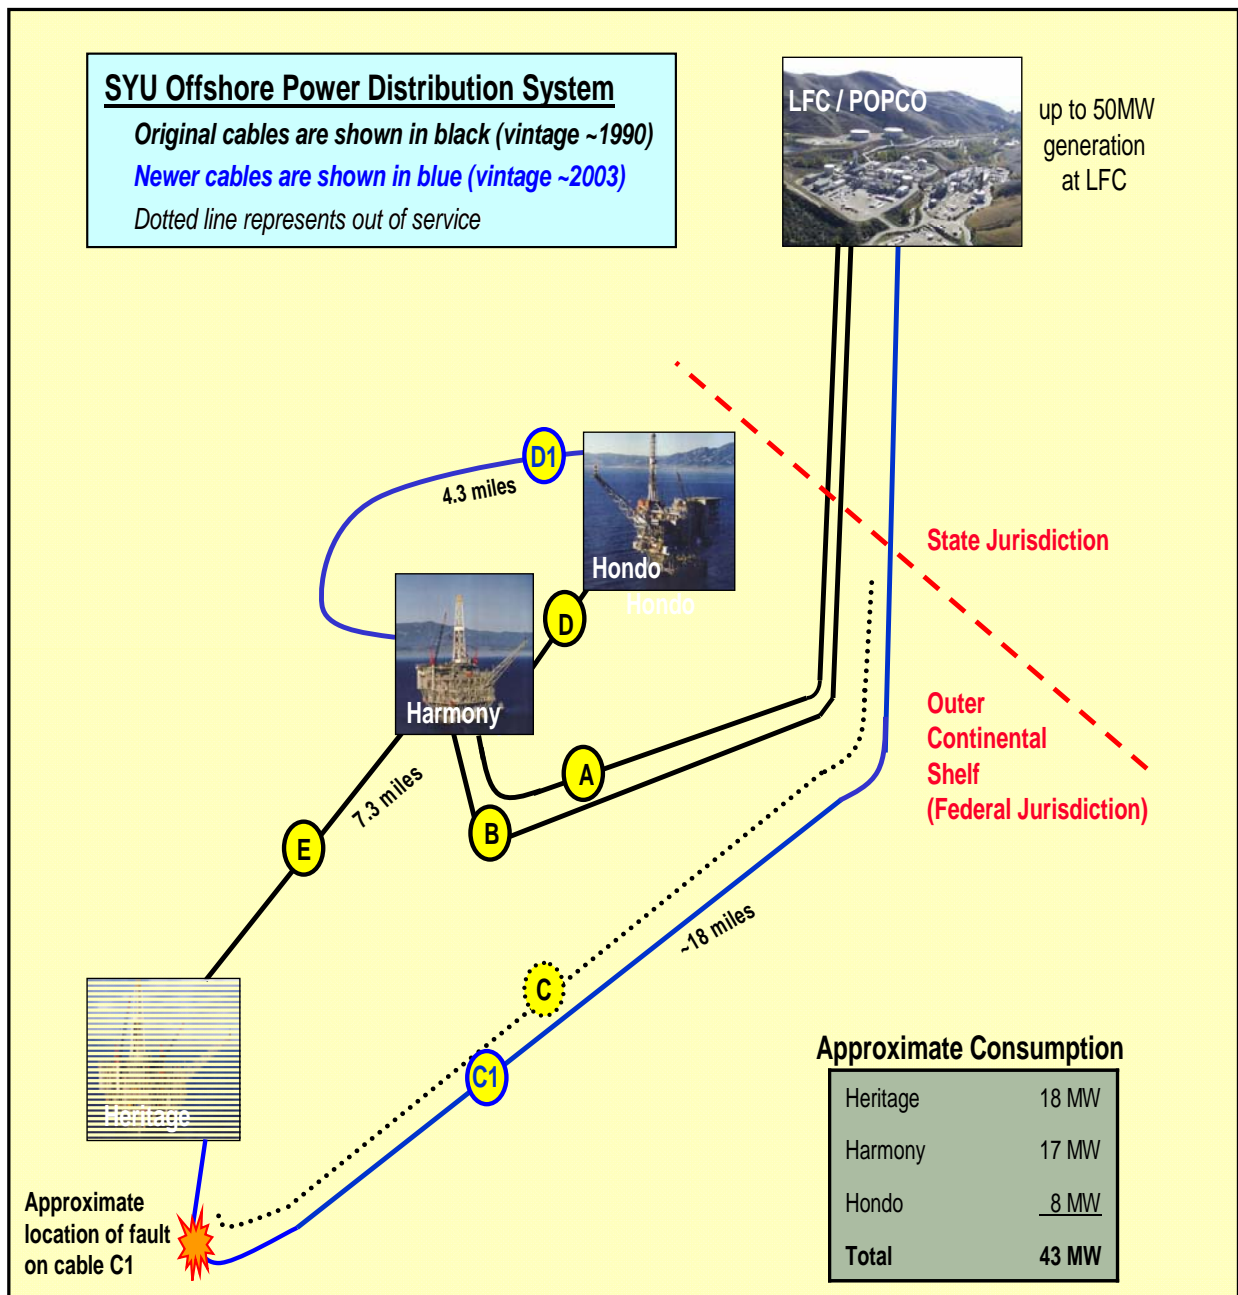
Figure 1-1. Santa Ynez Unit Offshore Power Distribution System showing the location of the offshore facilities, the power cables, and the location of the failed C1 cable.

The proposed project would restore redundancy (with E cable; Figure 1-1) to the offshore electrical power system that supports oil and gas production operations at Platform Heritage. The redundancy was lost on April 20, 2009 when a failure occurred in the C1 cable that connects Platform Heritage and the onshore cogeneration facility in LFC. The proposed repair would be located on Lease OCS-P 0182, approximately 2,800 ft (853 m) southeast of Platform Heritage in approximately 1,125 ft (343 m) of water depth.

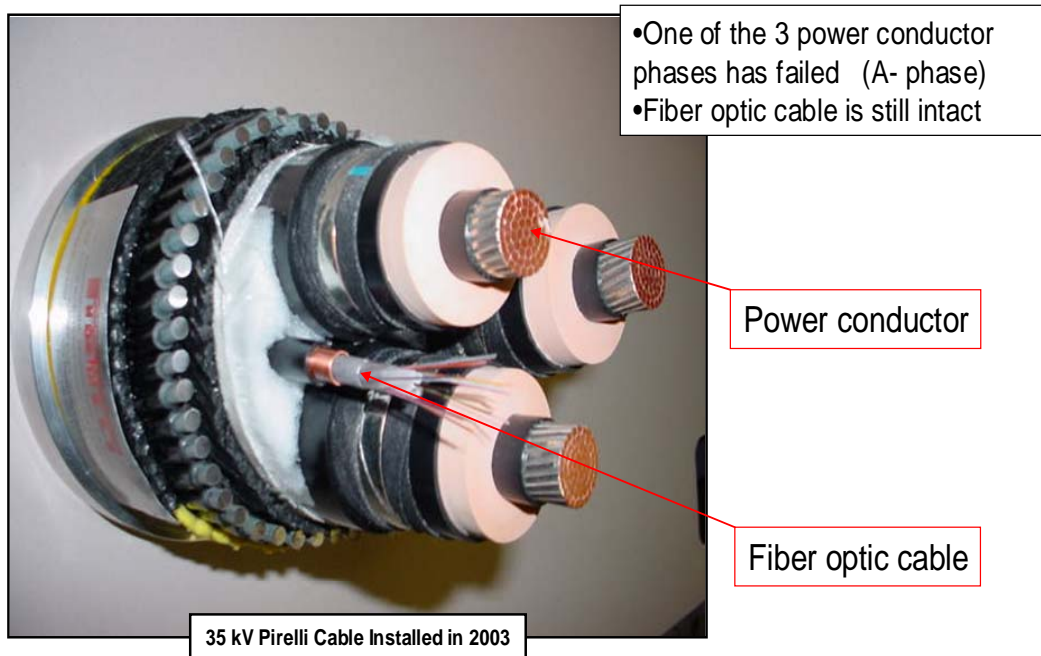
Figure 1-2. Photo of a sample of a cable identical to the failed power cable.

ExxonMobil conducted several tests and a ROV inspection of the C1 cable following the failure. The initial tests indicated a direct ground fault had occurred in the proximity of the shore side splice approximately 5,800 ft (1,768 m) along the cable, or about 2,800 ft (853 m) in a straight line distance southeast of the Platform Heritage power cable J-tube bell mouth, in about 1,125 ft (343 m) of water depth. The tests were conducted using a Murray bridge (resistance measurement) and TDR (time domain reflectometry) techniques. In addition, a ROV inspection survey of the failed cable area was used to conduct low frequency toning technology and visual observation to determine the exact location of the fault. The ROV recorded the location of the fault by taking GPS fixes and measuring the distance from the bight apex and/or the splice locations. The location of the fault is a sufficient distance from the power cable bell mouth to conduct a sea based repair approach to splice a replacement section into the cable to repair the fault. A schematic of the cable cross-section is shown in Figure 1-2.

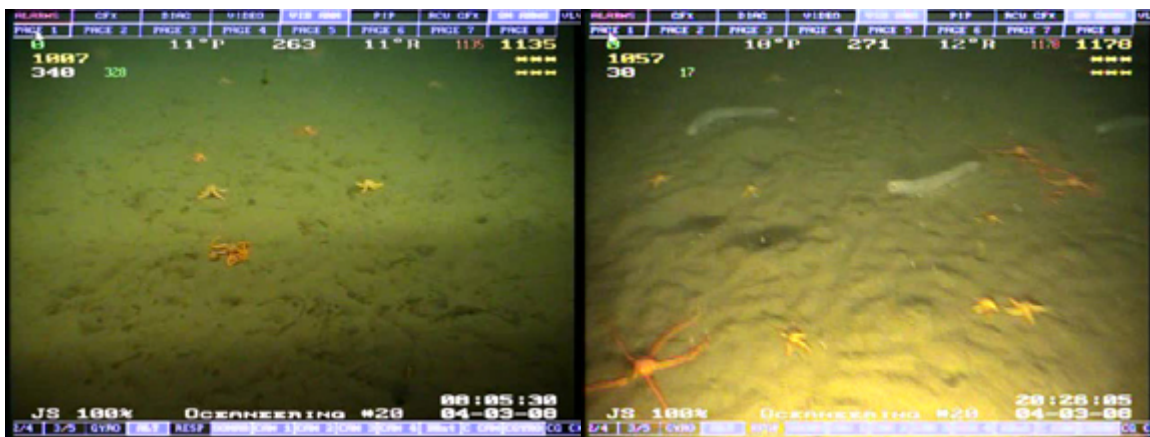
Figure 2-3. Representative snapshots of seafloor near C1 cable from Remotely Operated Vehicle (ROV) survey, April 2008.

The seafloor of the project area has been exposed to human disturbance at multiple points in the past as demonstrated by the original C1 cable lay down in 2003, the first C1 cable repair in November 2008 (Section 1.4), and debris found 600 and 2000 ft (92 and 610 m) from the cable. The ROV surveys showed that power cables in the vicinity of the platforms are partially buried with approximately one-half to one-third of the cable diameter exposed (de Wit, 2001; Exxon 2008b). Typically, the up-current side is partially or completely buried with the down-current side more exposed. The 2008 ROV survey showed that exposed portions were sparsely fouled with anemones and bryozoans. Rockfish, flatfish, and sea cucumbers were often seen resting next to the cable. There was no observable disturbance to the sediment next to or under the cable with the exception of one area where cable movement has caused a trench about 15 ft long, 5 ft

wide, and 4 ft deep (4.6, 1.5, and 1.2 m). It appears that the seafloor here is mud, as opposed to loose sand elsewhere, and that mud enabled the trench to form with cable movement.
