NEBRASKA

Forest Highway Network and Planning Data 2008

Prepared by:
Federal Highway Administration
Central Federal Lands Division

June - 2008

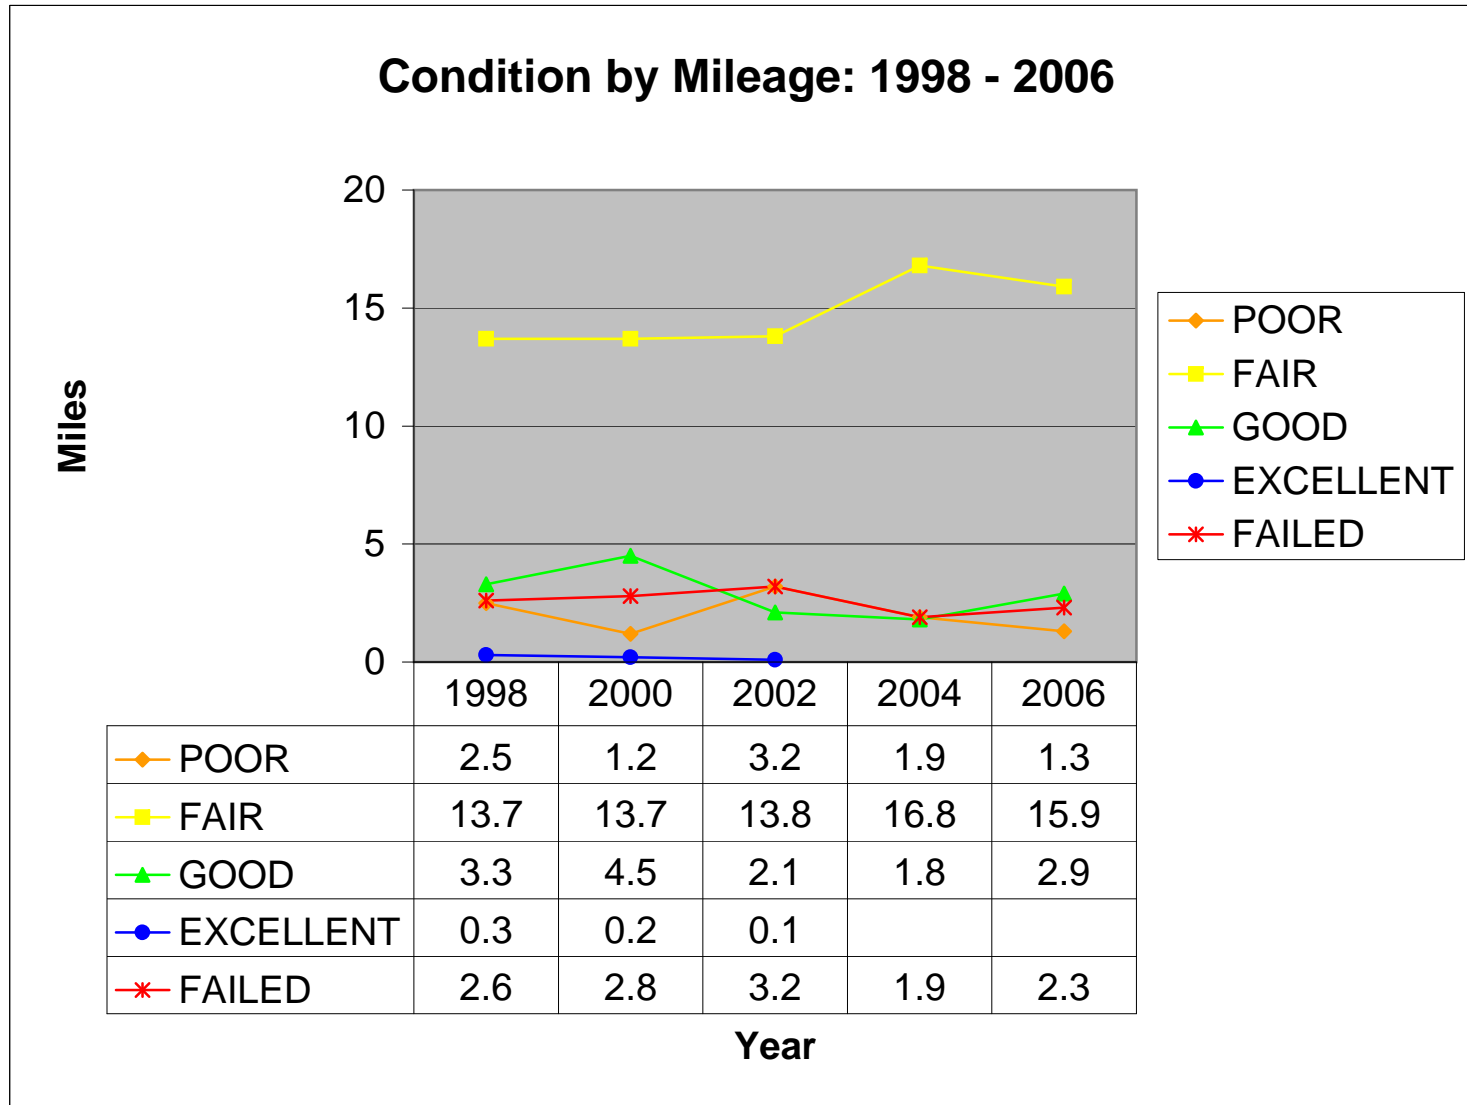
(Figure 1)

Nebraska Forest Highway Network - Condition by Mileage

Note: For comparison, road segments with no rating data for one or more years are not included in the above graph.

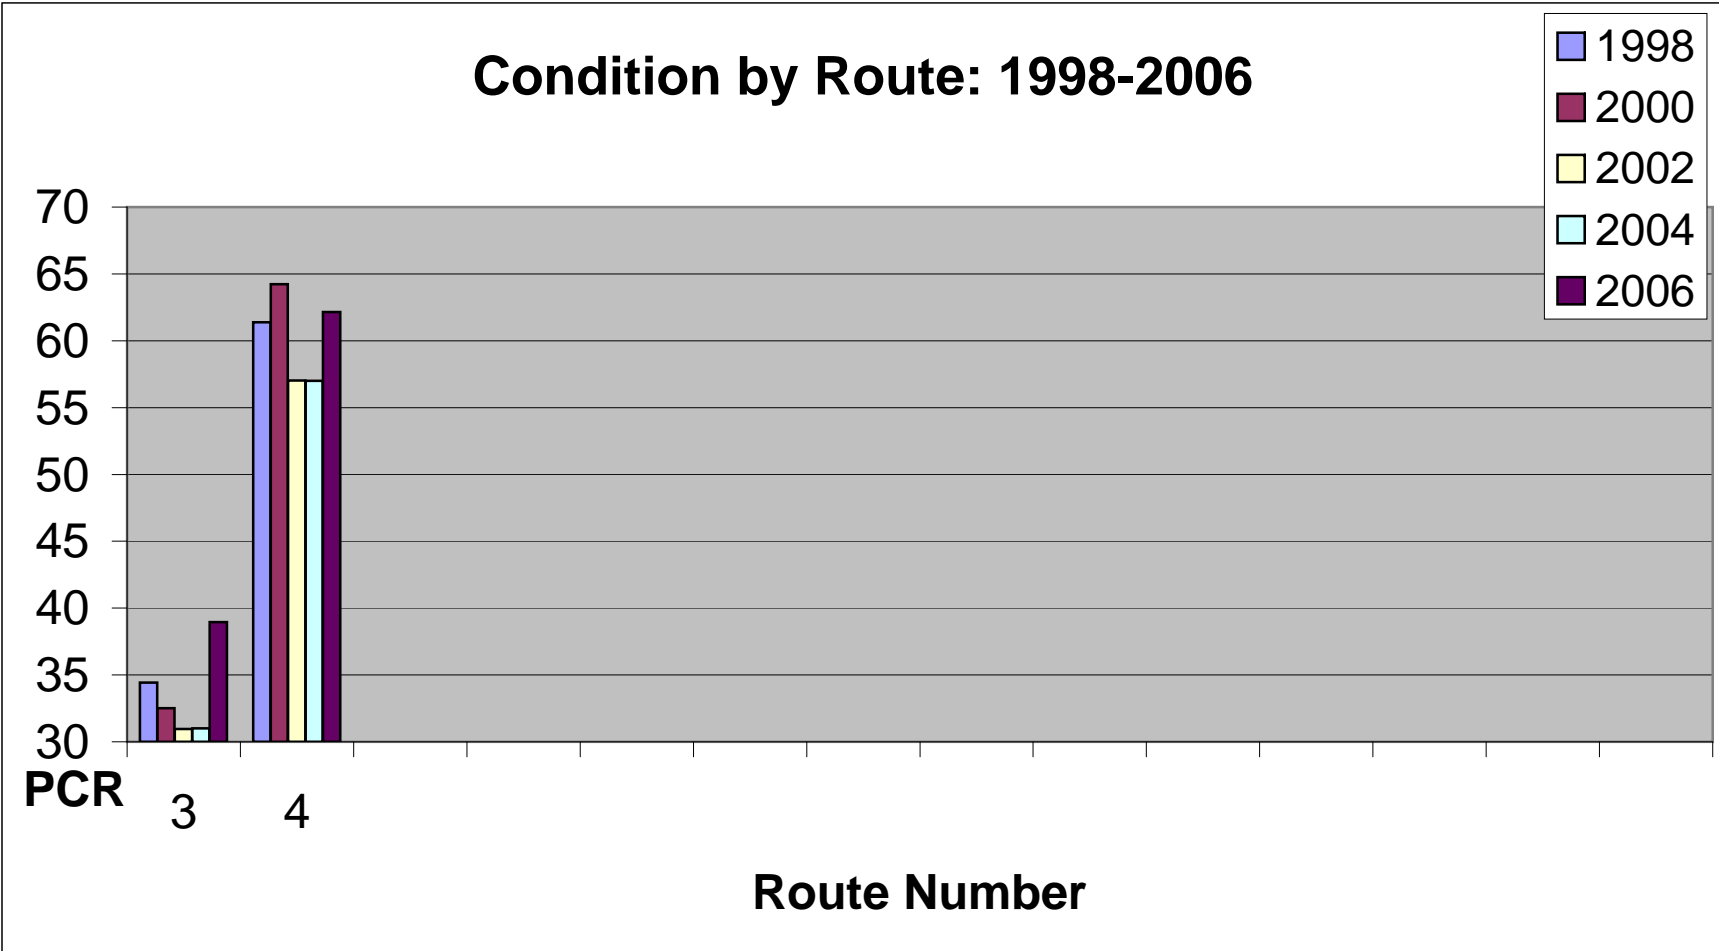
(Figure 2)

Nebraska Forest Highway Network -Condition by Route

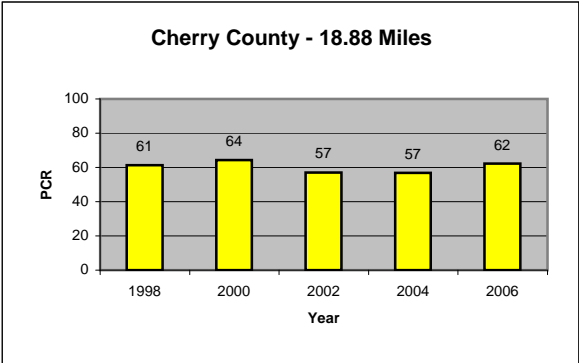
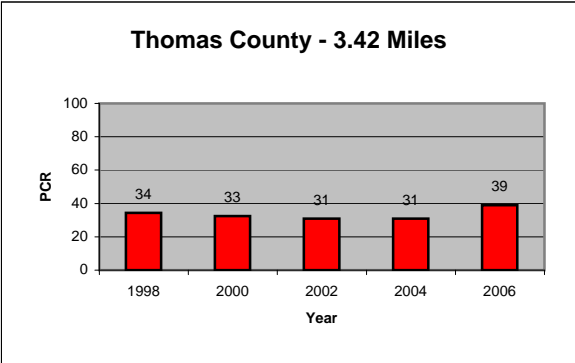
(Figures 3 4)

Nebraska Forest Highway Network - Pavement Condition Ratings by County

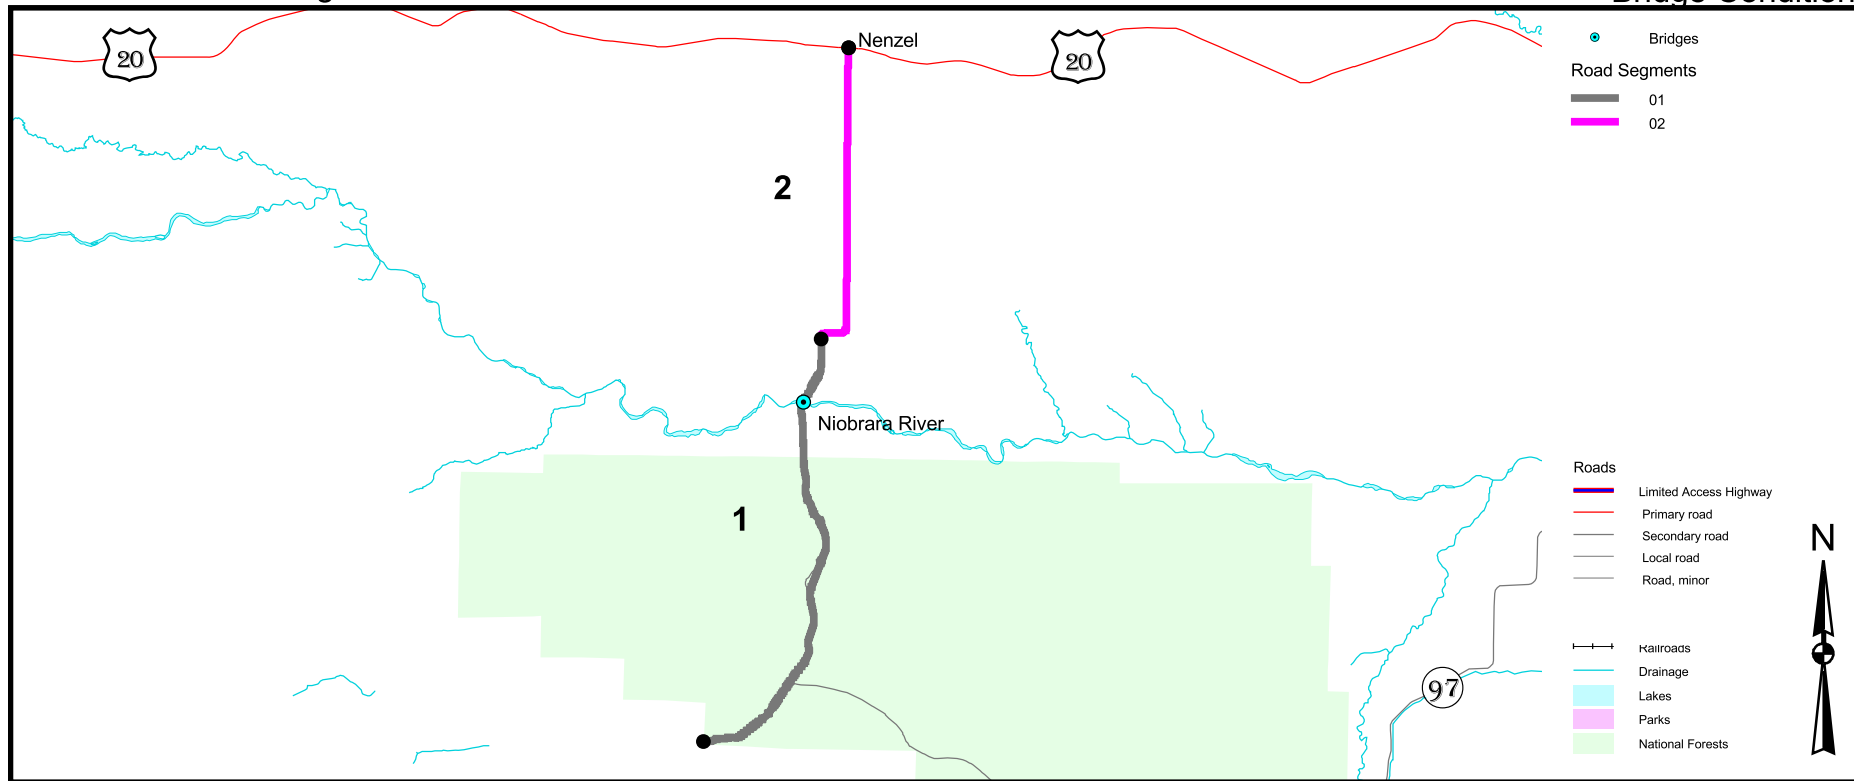
FH 4 Nenzel Ranger Station Road

Bridge Condition

| FH | STATE/LOCAL ROUTE | NBIS NUMBER | MP | FACILITY | OWNER | WIDTH (FEET) | LENGTH (FEET) | STRUCTURALLY DEFICIENT? | FUNCTIONALLY OBSOLETE? | SUFF. RATING |
|---|---|---|---|---|---|---|---|---|---|---|
| 4 | S16F | SS16F00917 | 10.00 | Niobrara River | State | 28.00 | 213.90 | - | - | 91.70 |

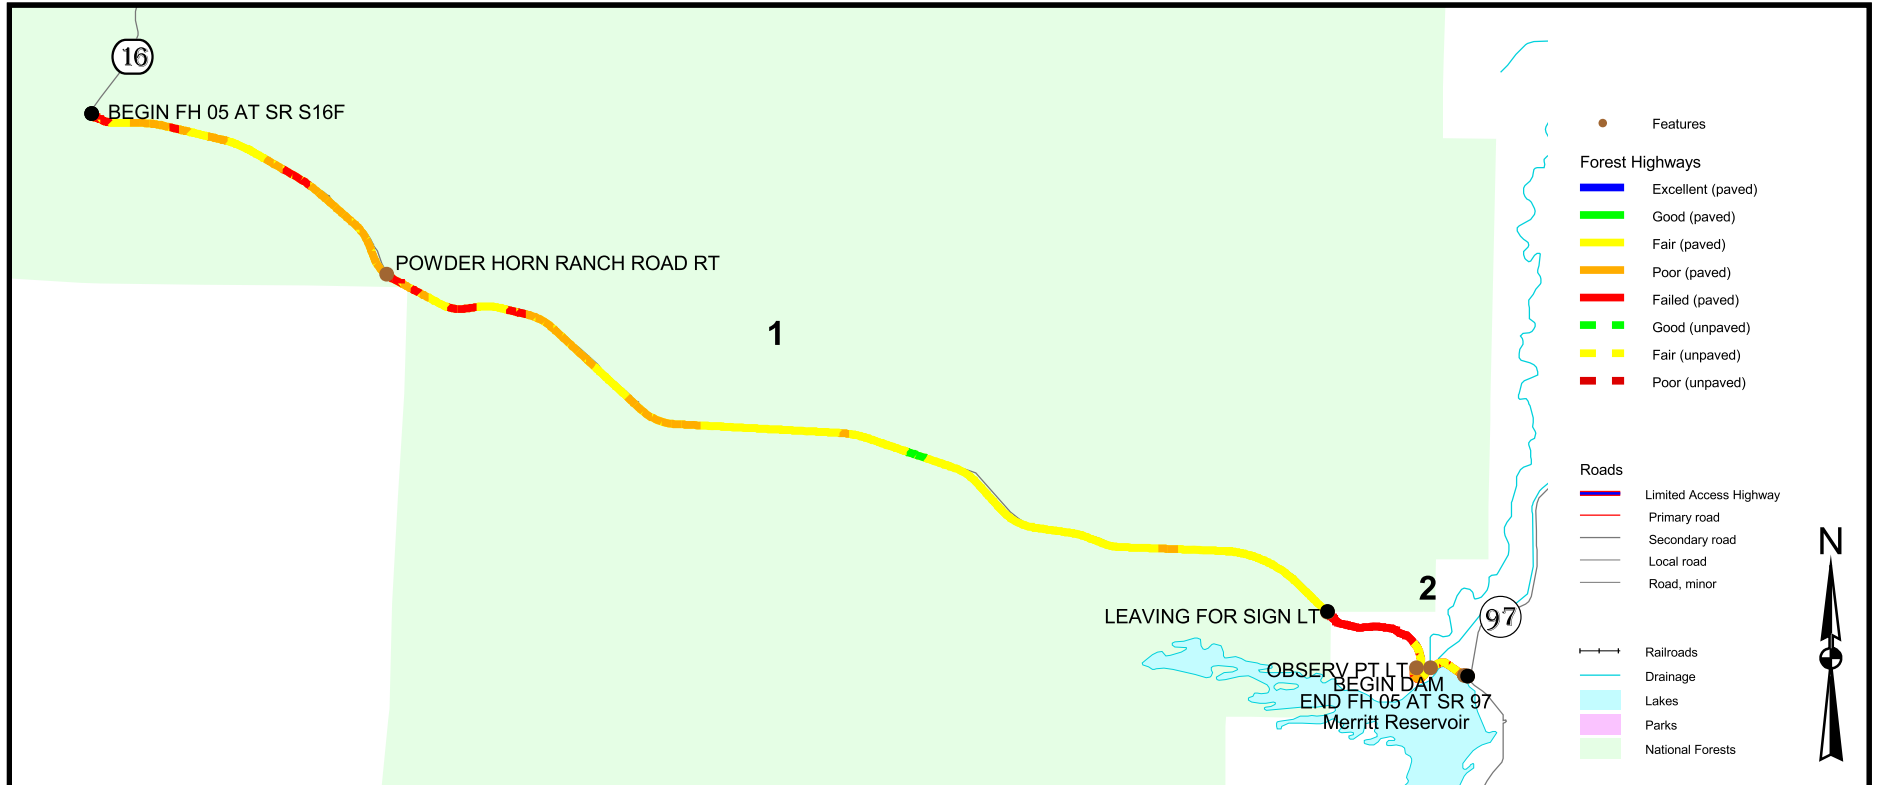
Map above shows the actual condition (paved sections only) which may not correspond to the average condition reported for each segment in the chart below. See Summary page i for more information.

| FH | SEG NUM | STATE/LOCAL ROUTE | START MP | END MP | SEG LENGTH | ADT | WIDTHS | | SURFACE TYPE | IRI | REMAINING SURFACE LIFE (YEARS) | CONDITION RATING | CONDITION |
|---|---|---|---|---|---|---|---|---|---|---|---|---|---|
| 5 | 1 | Niobrara-Merritt Dam R | 0.00 | 13.37 | 13.36 | 70 | 30 | 24 | Flexible | 161 | 7 | 52 | Fair |
| 5 | 2 | Niobrara-Merritt Dam R | 13.37 | 15.25 | 1.91 | 70 | 30 | 24 | Flexible | 272 | 0 | 33 | Failed |

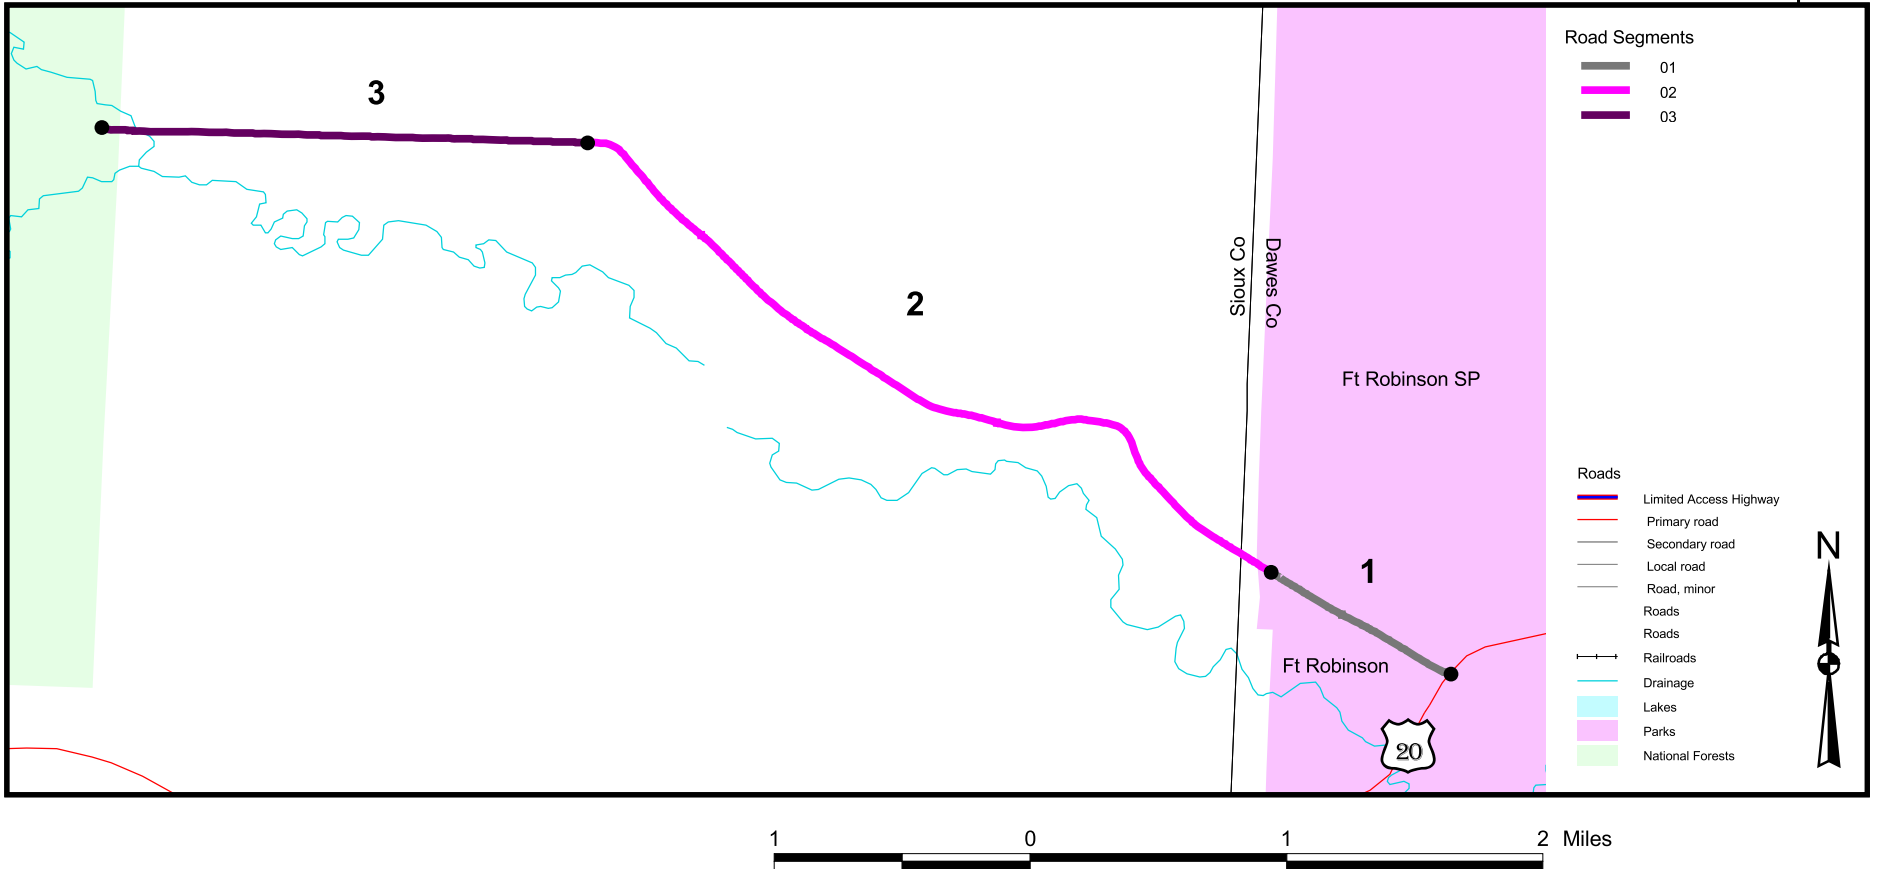
FH-7, Soldiers Creek Road. This route starts at the junction with US-20 at Fort Robinson and proceeds northwesterly 6.05 miles (9.73 km) over a county road to the Forest Boundary.

Evaluation: FH-7 is operated by the Nebraska Game and Parks Commission. It is functionally classified as a local road serving the Nebraska National Forest. According to Forest Service data, 25% of the traffic is Forest related. The principal Forest resources served are recreation and grazing. The route also serves Fort Robinson State Park.
