Career Fire Fighter/EMT Dies in Ambulance Crash - Florida

SUMMARY

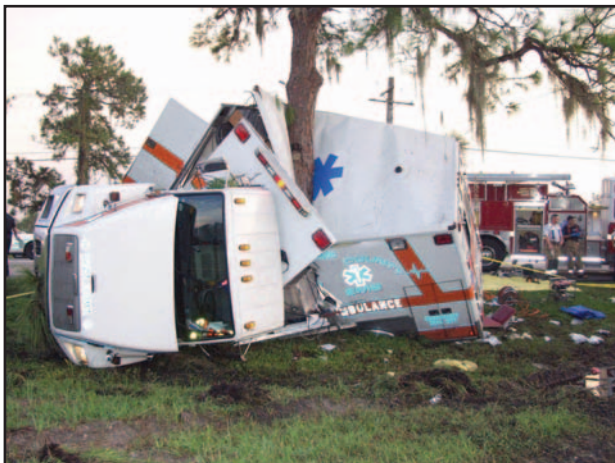
Photo courtesy of the Sheriff's office

The county EMS Division's vehicle was a model year 2000 Type I ([cover photo](#)) ambulance with a gross vehicle weight rating of 20,000 pounds. Overall vehicle length was 298 inches. It was purchased new from the manufacturer. The EMS Division's policy was to perform vehicle maintenance every 2,500 miles using a preventive maintenance checklist.² The most recent maintenance performed on the incident vehicle occurred on July 26 through July 28, 2004. This maintenance did not include tire replacement. The mileage of the vehicle at the time of this maintenance was 184,647. The mileage at the time of the incident was noted to be 193,980. According to the vehicle maintenance personnel interviewed, the state does not require routine vehicle inspection certification.

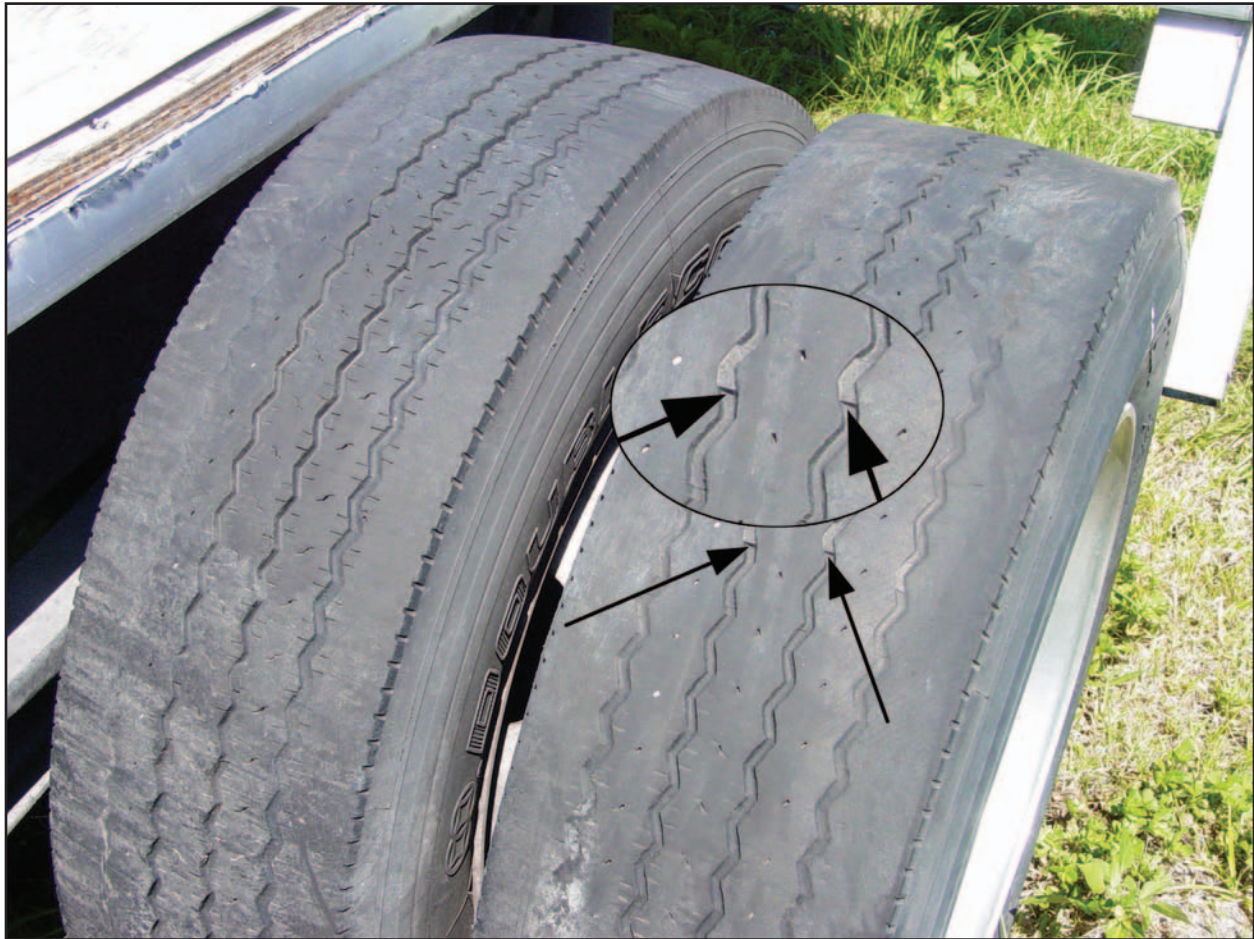
The tires mounted on the vehicle, particularly the rear tires, showed signs of excessive wear and "wear bars," or "tread indicators," were visible

([Photo 1](#)). It is the EMS divisions' policy to change tires as needed at intervals throughout the life of the ambulance. The EMS divisions' maintenance records documented that the rear tires were replaced on February 18, 2004 at 162,542 miles. The Sheriff's report³ documented different make and model tires than were identified on the EMS division's maintenance records.

*Photo 1. Illustrates the significant wear on one set of the rear tires.
Arrows indicate the visible wear bars.*

Recommendation #1: EMS and fire departments should replace worn tires as part of the apparatus maintenance program

According to the National Highway Traffic Safety Administration (NHTSA), “Tires have built-in tread wear indicators that let you know when it is time to replace your tires. These indicators are raised sections spaced intermittently in the bottom of the tread grooves. When they appear even with the outside of the tread, it is time to replace your tires.”⁶ The tires mounted on the vehicle involved in this incident showed evidence of excessive wear and had visible tread wear indicators ([Photo 1](#)). Actual measurements taken of the rear, non-steering tires with a tread-depth indicator during the NIOSH investigation identified the tires as having the following maximum tread depth:
Left (driver’s side) rear outside tire: 4/32 inch
Left (driver’s side) rear inner tire: 2/32 inch

distance. Drivers should also routinely check for worn tires and should maintain tire pressure at recommended levels, avoiding under inflation. The tires on the ambulance showed evidence of excessive tread wear and the wear bars were visible on at least one rear tire ([Photo 1](#)). The driver of the incident vehicle stated that she was driving at approximately 30-35 mph and the roadway was wet. Vehicle speed could not be verified in this investigation.

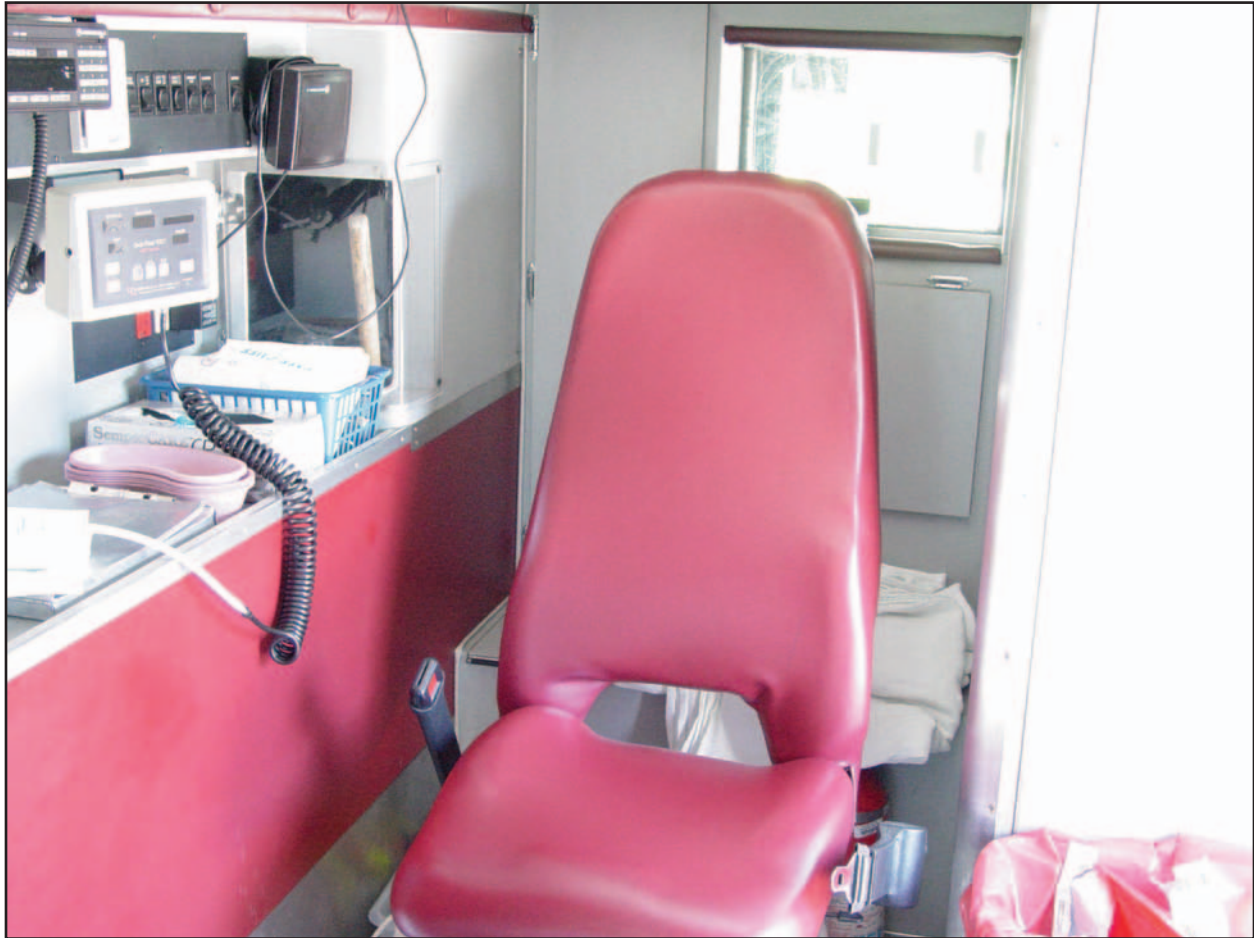
Photo 2. Photo from similar ambulance illustrating the attendant's seat configuration prior to crash. (Photo courtesy of the Fire Department.)

Discussion: The victim had been riding in the attendant's seat, (captain's chair), restrained by a lap belt. [Photo 2] Use of occupant restraint systems such as lap and shoulder belts have proven an effective intervention for protection from vehicle crash-related fatalities. However, as evidenced by the circumstances present during this incident, additional vehicle crash worthiness issues such as vehicle structural integrity may significantly impact occupant survivability. The driver reported that the vehicle was traveling between 30 and 35 mph when vehicle control was lost. Investigators could not estimate the speed of the vehicle, or the collision speed or related forces. However, during the ambulance's side impact with the tree, the forces were sufficient for the roof and street side of the patient compartment structure to collapse, and the curbside wall to separate from the floor. This structural failure allowed the unrestrained paramedic to be ejected and the victim to be crushed by the collapsing structure (Photo 3).

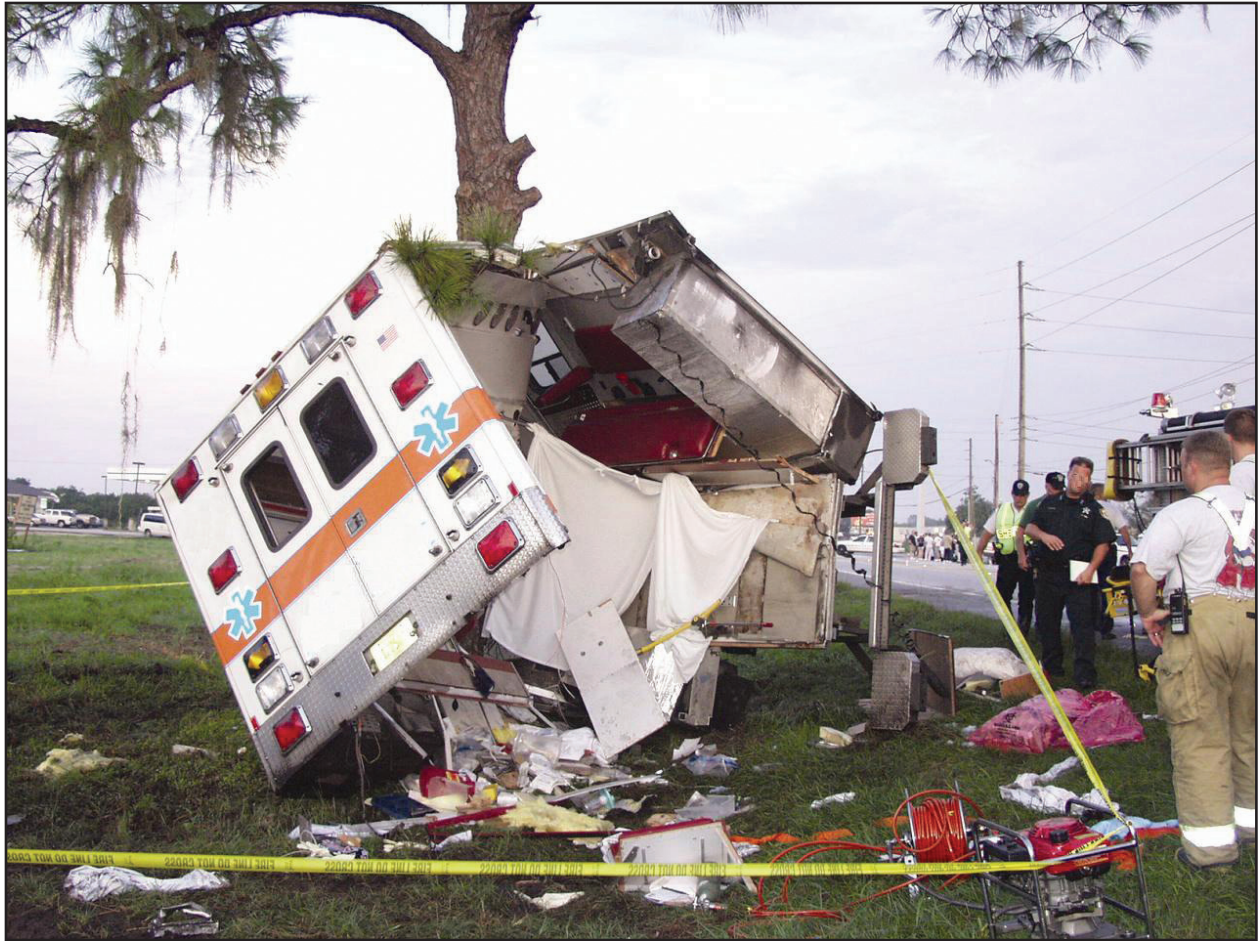
Photo 3. Patient compartment of ambulance after crash, showing the separation of curbside wall and roof. (Photo courtesy of the County Sheriff's office)

Medical Services Systems Ambulances address structural integrity for the patient compartment in general terms but do not specify a level of side impact protection related to dynamic parameters such as acceleration.^{10, 11} Also, ambulances are not required to be dynamically tested as complete vehicles. Increased structural standards and designs could improve patient compartment structural integrity and allow for the implementation of other crash-related injury interventions. These might include improvements to the compartment layout to minimize the movement of patient care providers which would allow better utilization of occupant restraints and the application of energy absorbing padding on bulkhead surfaces to minimize energy transfer to occupants during crashes. Further protection could be provided through the use of improved seating locations and designs, compartmentalization of seating locations and application of air bag technology.
