PROGRAM POLICY LETTER NO. P11-V-16

Suitability, Safety and Performance of Circuit Breakers

RECOMMENDED GUIDELINES on REPAIR or REBUILD and MAINTENANCE of  
CIRCUIT BREAKERS

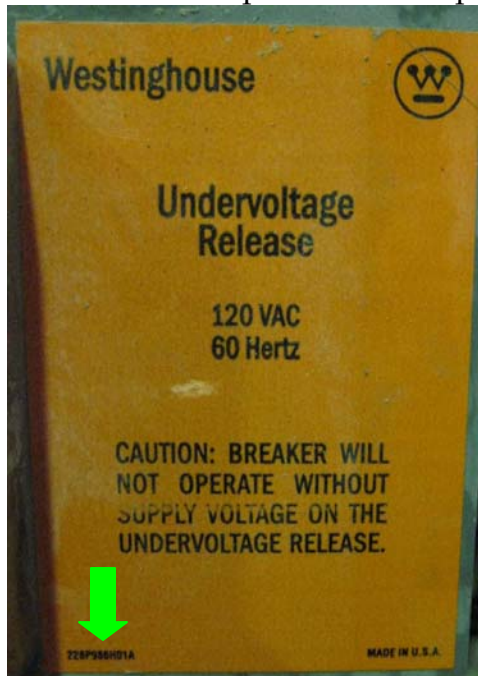
OEM

1. Labeling - if visible
  - a. If the circuit breaker has been rebuilt by a third party facility, it should have the name of that rebuild facility attached.
  - b. A new or OEM rebuilt breaker should have OEM labeling. Most OEM labeling can be identified by a label number. Comparison will show lack of a number; different font sizes; layouts not the same; and possible misspellings. OEM labels that have been reproduced may be an indication of problems. See pictures below.

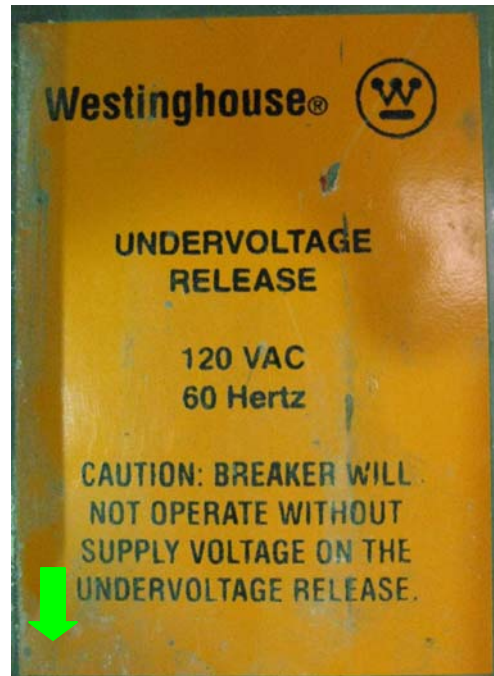
NON-OEM

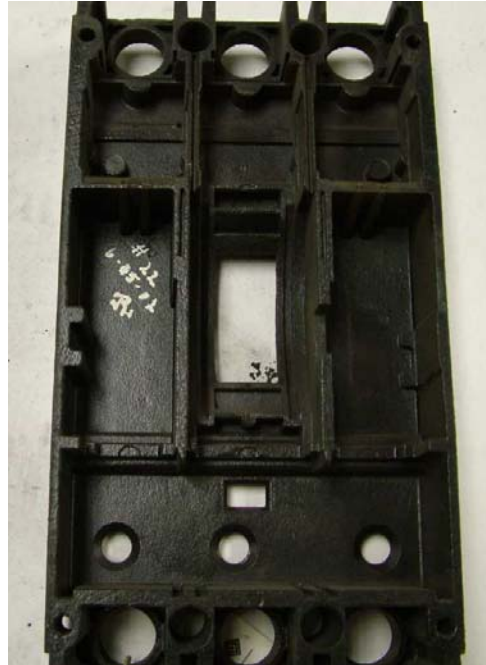
Shot blasting removes resin from the case and may weaken the structure so that it could fail under a catastrophic event inside the breaker, such as an arc blast. This is an indicator for further inspection.

Shot Blasted &amp; Painted

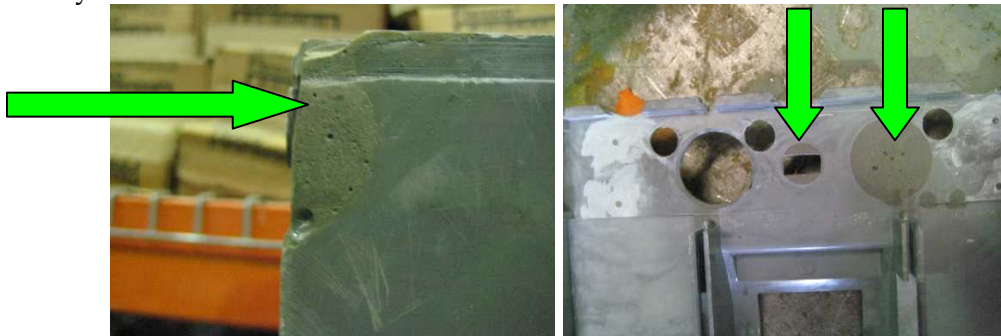
Cases repaired and/or modified using epoxy can be hazardous. A damaged case can be weak enough that an event occurring inside the circuit breaker can cause the case to fail and rupture causing the epoxy to become shrapnel that can injure personnel nearby. The patching material may not be enough to restore the case's strength. Some patching material may be conductive and can cause a shock hazard.

Epoxy Repair to Case Corner

Epoxy Modification to Cover

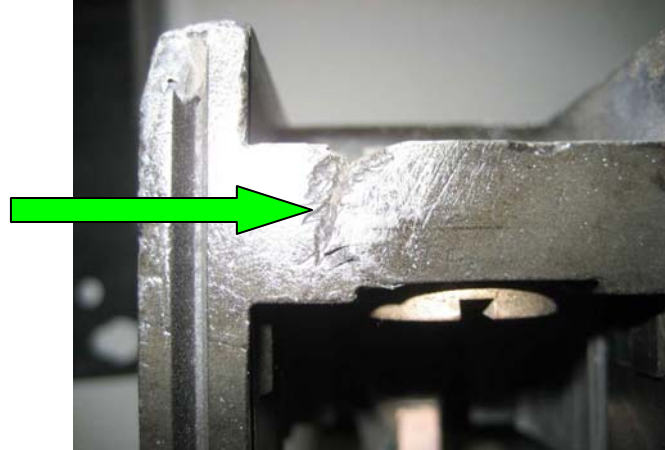
Hairline cracks and broken pieces on the case can present a serious hazard in that they compromise the integrity of the case in the event of a fault. Cracks in the case also compromise the electrical integrity of the circuit breaker and can pose a risk of arcing.

Cracked Case

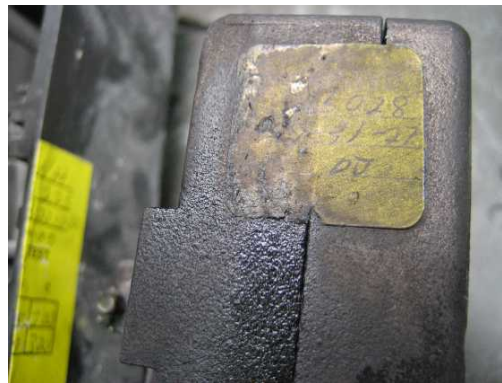
Signs of overheating (such as carbon smears, warped or melted case, and/or burnt areas) are cause for having the mine operator open a circuit breaker for a more in depth inspection or removal from service. These are indicators that the circuit breaker case integrity has been compromised. Signs of overheating are also indicators that the electrical insulation between the phases may have been compromised through carbon tracking.

Bubbled & Charred

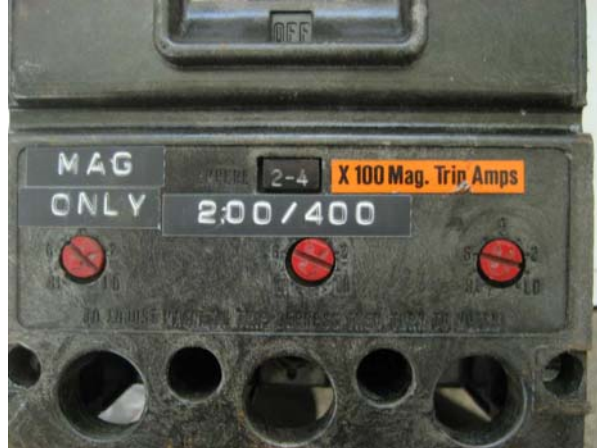
If the circuit breaker trip unit is not properly set, it can cause damage to the cable it is protecting. It also poses the hazards of shock and fire. The trip unit must be visibly identified to ensure it is adjusted correctly.

Settings on High

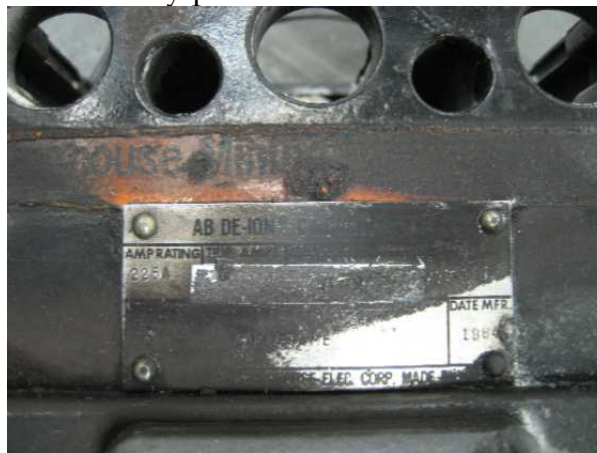
Circuit breakers should not have anything attached to the case, and especially not with metallic fasteners. However, some of the older circuit breakers still in use have metallic ID tags fastened to the outside of the breaker with metal rivets. The metallic plate is an indicator to inspect for insulating material inside the breaker. These rivets must not extend to the inside of the case. If the rivet hole is drilled through, it must be insulated with a suitable dielectric. Failure to follow this requirement could allow a dangerous electric potential to be present on the exterior of the breaker, which could be contacted by personnel.

Metallic Tag (Painted)

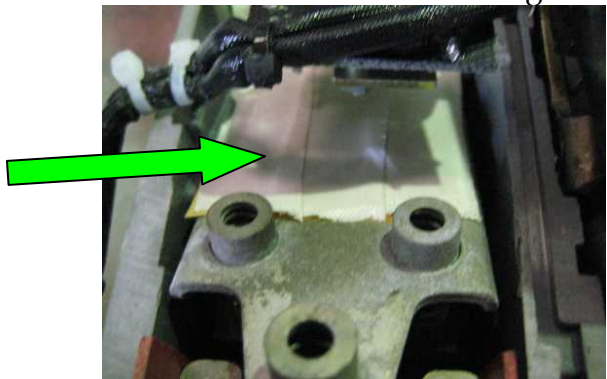
Tape Around Movable Arm

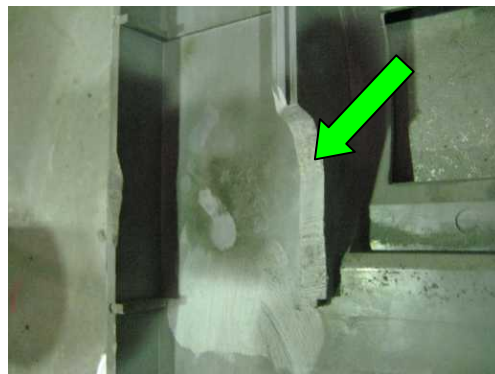
- holes through the outside of the case, except as allowed by the OEM. Example: a hole for wire from an auxiliary switch to pass through from the inside of the case that is no longer used would be allowed
- cut-outs between the phases that compromise the electrical separation
- cut-outs that are not as specified by the OEM for mounting a UVR or other certified component

Case Phase Barrier Cut Away

A modification is anything that changes the structure of the case. The Original Equipment Manufacturer (OEM) provides acceptable modification instructions for permitted accessory installation. Any other modification will be considered criteria for removal from service. Some instances of non-specified or unapproved modifications are:

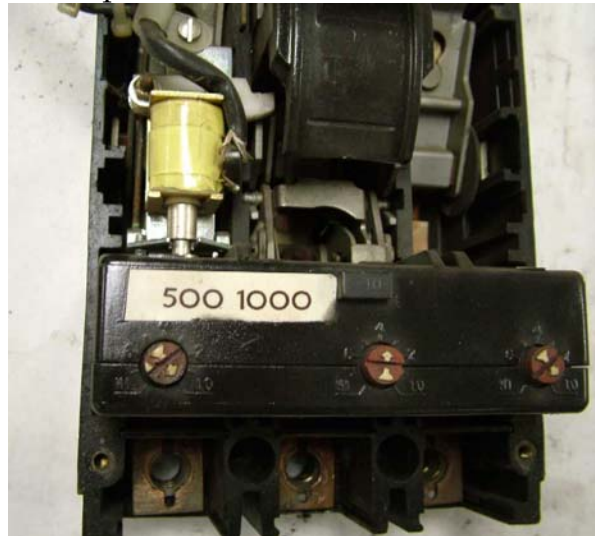
Paint inside the case of a circuit breaker creates at least two hazardous conditions. The first is a change in insulation characteristics of the molded case. Over time, the paint can deteriorate from the heat and ionization that occurs in the circuit breaker. This can lead to carbon tracking between the phases and subsequent phase to phase and/or phase to ground faults. The second hazard is the addition of a potentially flammable component to a plasma ball occurring because of a fault. Be aware, some Westinghouse 1000 volt circuit breakers do have a dielectric coating that resembles paint inside the breaker case and cover.

Painted & Shot Blasted

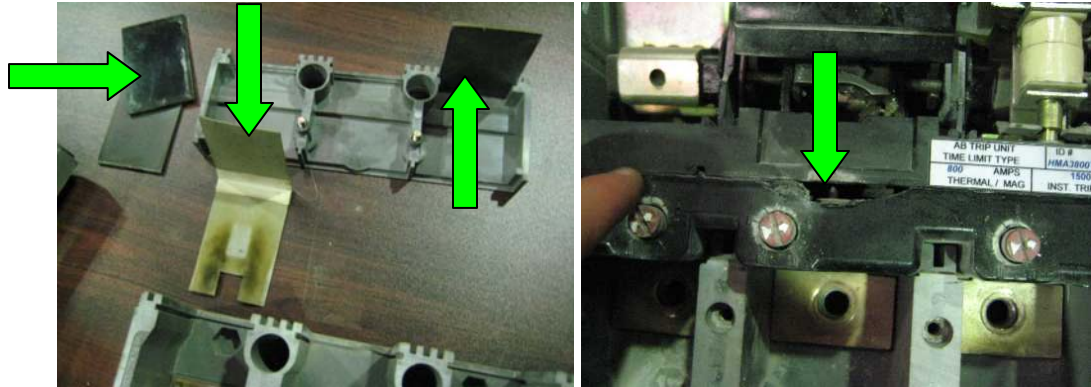
There are removable insulators (fish boards) within the circuit breaker case. If any of the fish boards, (cardboard like tabs around the tips), inserts along side of the reset handle that allow removal of the reset mechanism, or any of the top and/or bottom phase insulators are missing or broken, a short circuit hazard or electrical shock hazard is created. Missing components, such as missing or damaged arc chutes, can pose an arc flash hazard.

Fish Boards

Broken Trip Unit Housing

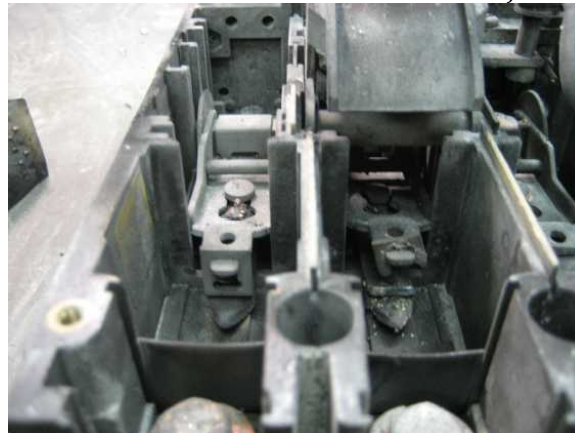
Contact tips used in mining circuit breakers are made of a special alloy that allows the tips to open under load without welding. The use of tips other than those specified by the circuit breaker manufacturer pose a risk of welding under load. The hazard is potentially life threatening and has caused the death of at least one miner and serious injuries to others.

Welded Contact Tips

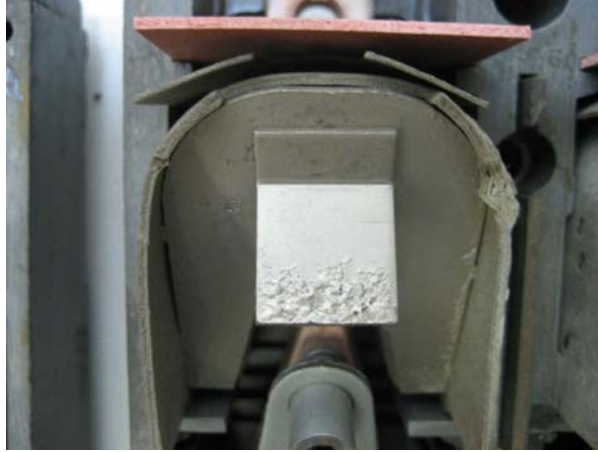
The arc chutes in a circuit breaker are designed to spread and cool the arc that occurs when the tips break. Paint covering the arc chute diminishes or prevents the arc from being extinguished in a controlled manner. In addition, the paint can contribute to the arc's heat and plasma ball. A damaged arc chute can also minimize the effect the arc chute has on extinguishing the arc. An uncontrolled arc can lead to a short circuit event inside the circuit breaker causing an arc explosion.

Painted Arc Chute

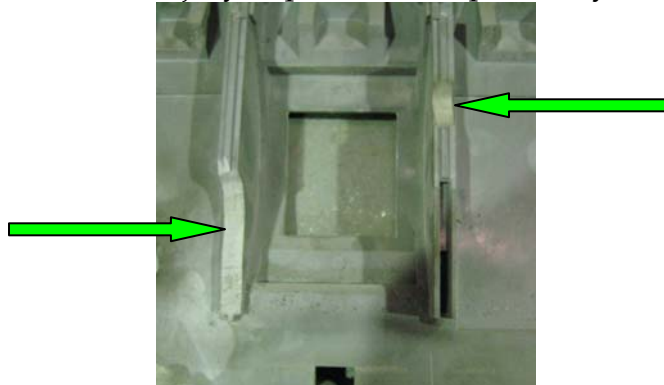
The circuit breaker case is designed to maintain the arc flash, caused by a breaker opening under load, inside the case and to prevent any shorting between the phases. The material of the case between the phases can be compromised through damage, such as cracks or broken pieces, or from modifications not approved by the manufacturer of the circuit breaker. This can cause the case to become weakened enough that it will no longer contain the force it was designed to contain and/or the electrical clearance between the phases could be compromised and allow an arcing short to occur. Either can cause injury to personnel in proximity to the breaker.

Cover Insulation Cut Away

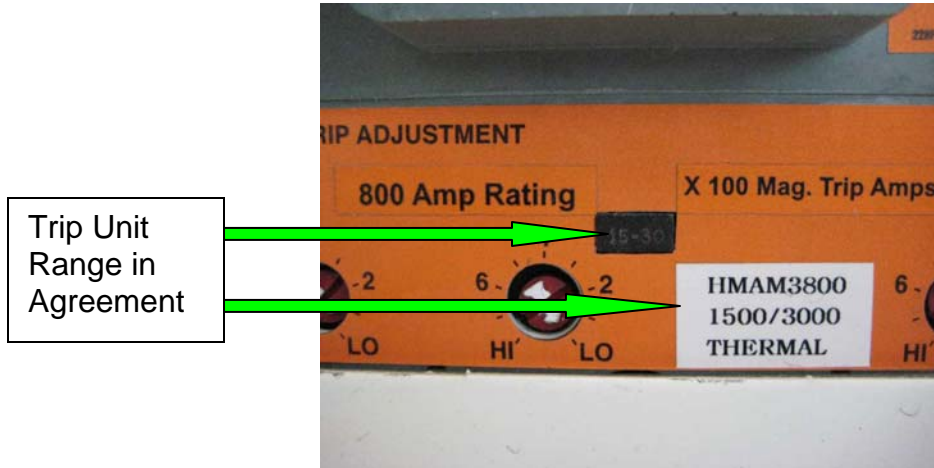
The trip unit must be visibly identified in order to ensure it is adjusted properly to protect the cable attached to the output connector. The identifier must be clearly visible and it must agree with the markings on the trip unit, if it is placed on the outside of breaker case. A trip unit that has had the identification markings removed or the wrong identification attached through human error could allow the cable it is protecting to experience enough current on a fault to generate enough heat to cause a fire.

Trip Unit  
Range in  
Agreement

Trip Unit ID and Settings

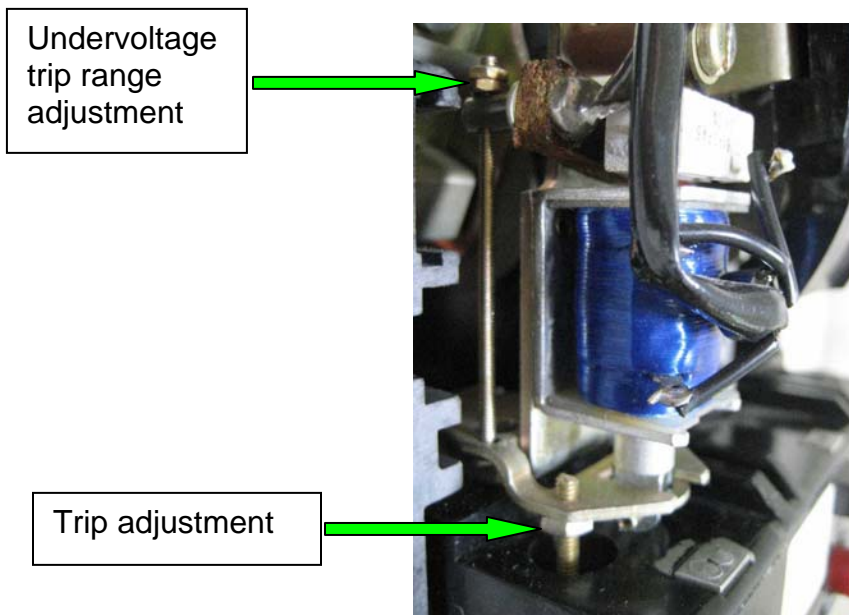
The ground fault, ground wire monitor, and undervoltage protection circuits rely on the undervoltage release relay (UVR). If the relay is damaged or not properly adjusted, these safety circuits cannot operate the breaker. An inoperative UVR poses hazards of injury, fire, and death.

Undervoltage  
trip range  
adjustment

Trip adjustment

UVR Adjustment Points
