*River Corridor Closure Project*

# **Recovery Act Weekly Report**

For the week ending March 4, 2011

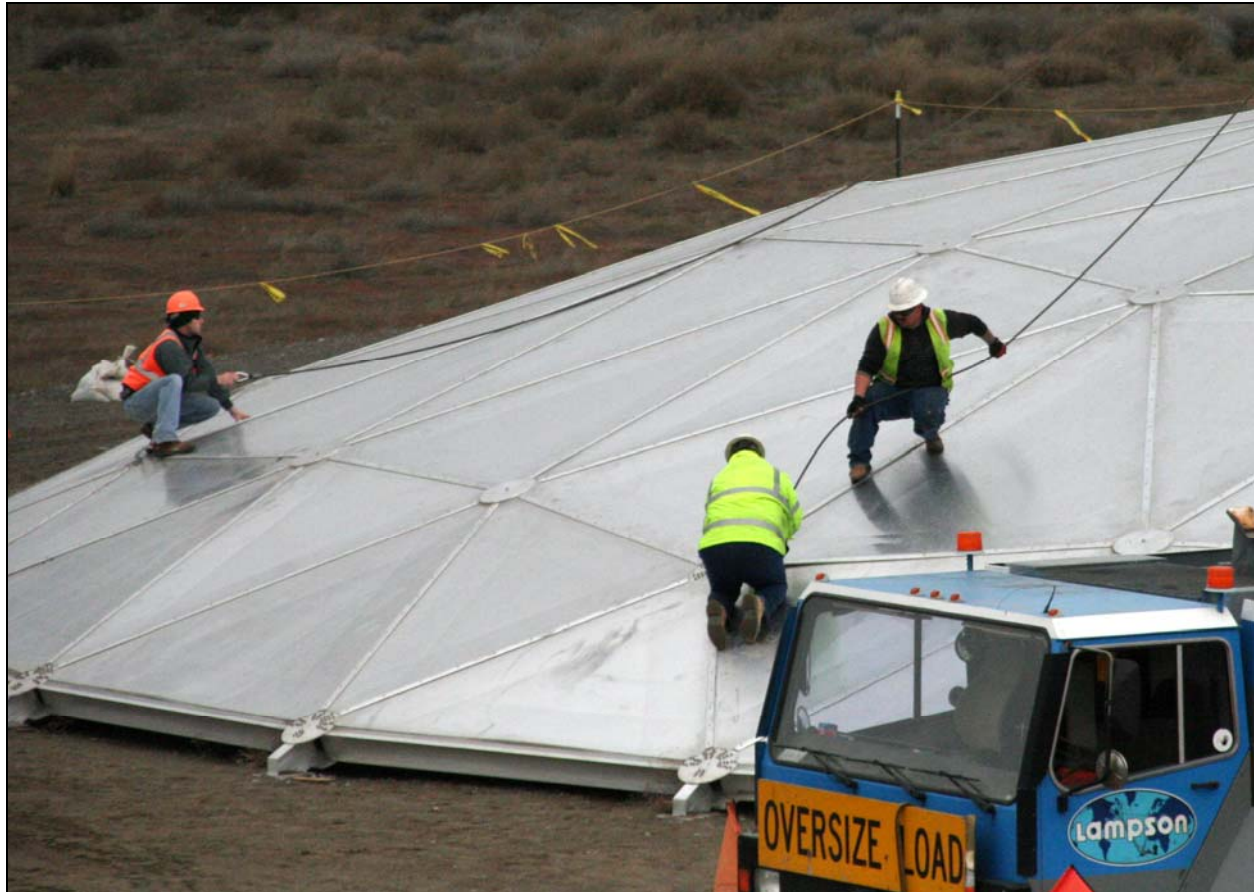
Workers from Lampson International prepare to raise the dome cover for Leachate Storage Tank No. 4 at the Environmental Restoration Disposal Facility. (Photo 1)

WCH completed construction of the dome covers for ERDF's two new leachate storage tanks and set them on the tanks. The tanks and 13-foot-high dome covers were designed by ColumbianTec Tank of Kansas City, Missouri. The dome covers were constructed by Darrell Thompson Tank of Bakersfield, California. They are made of structural steel and aluminum, and weigh about 27,400 pounds. The tanks measure 100 feet in diameter and have a capacity of about 425,000 gallons.

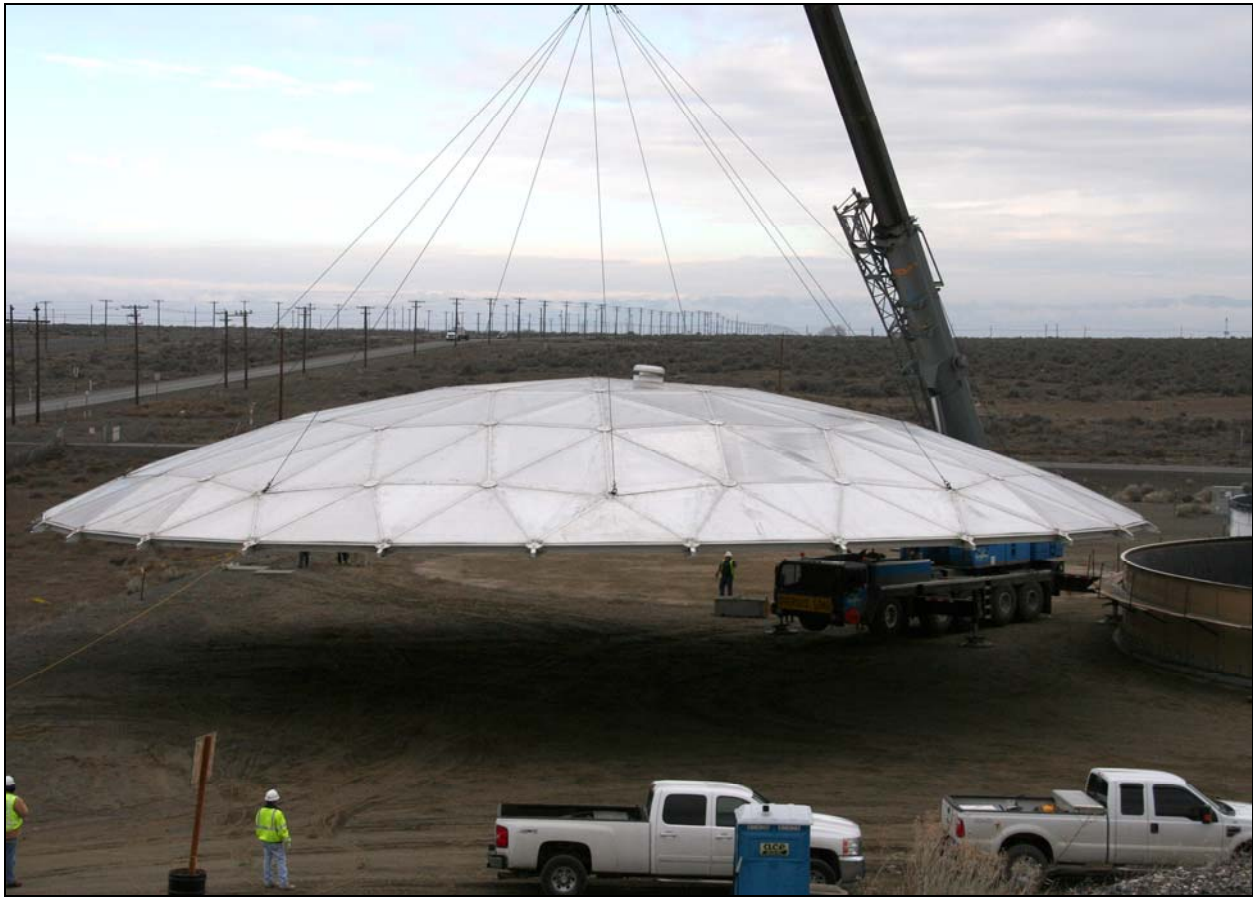
*The dome covers for the new leachate storage tanks were constructed by Darrell Thompson Tanks & Construction of Bakersfield, California. (Photo 2)*

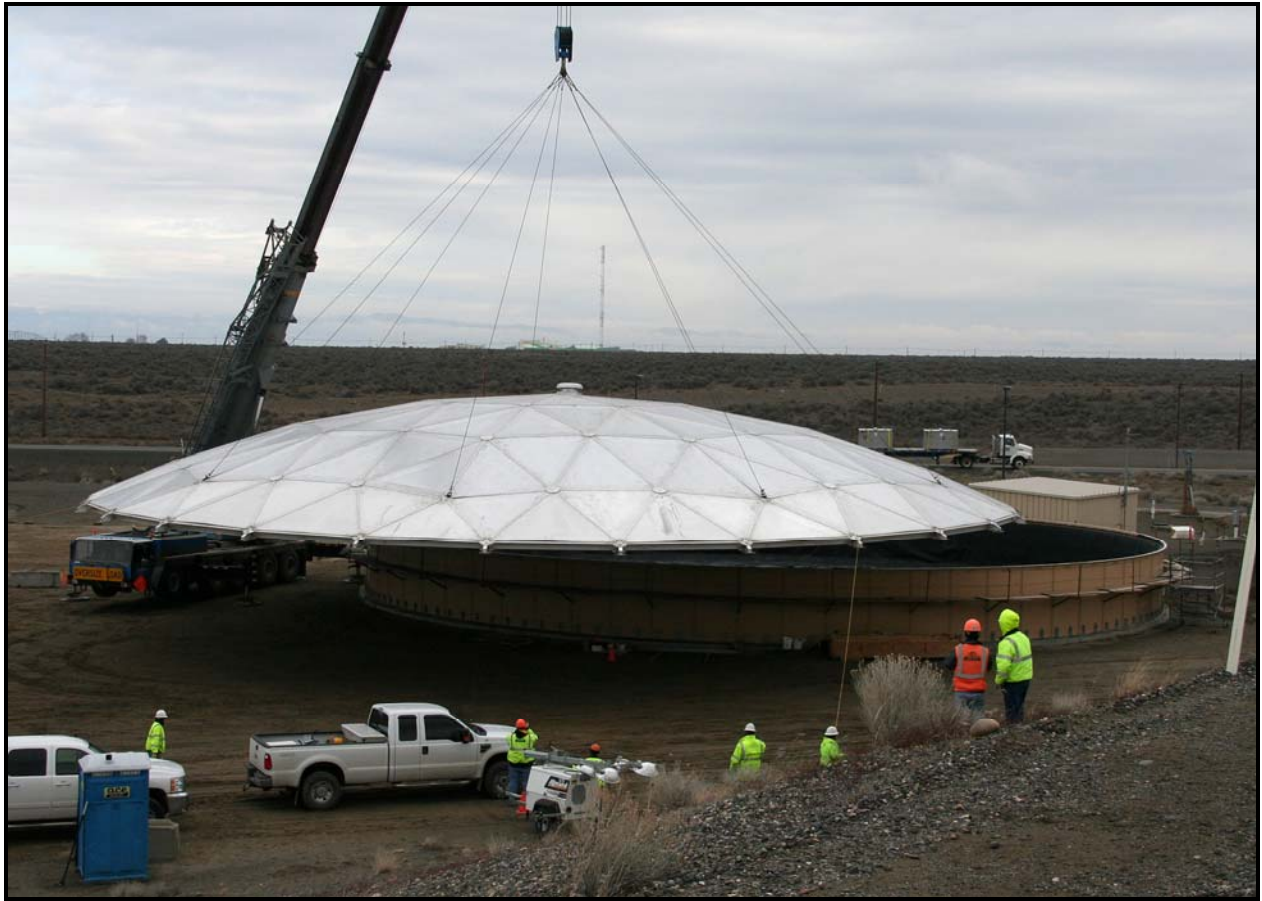
*The 27,400-pound dome cover is placed on Leachate Storage Tank No. 4 at the Environmental Restoration Disposal Facility. (Photo 3)*

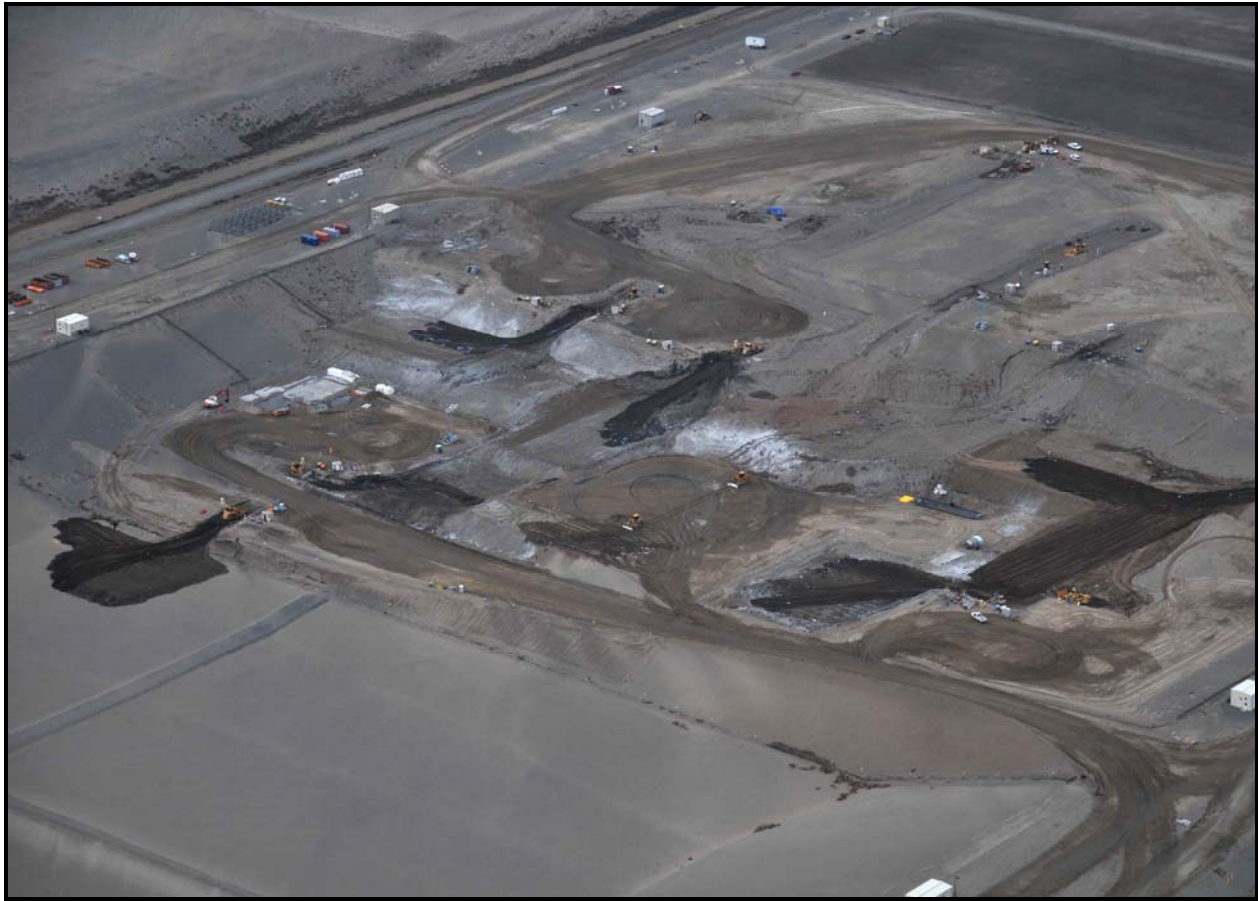
*This aerial photo taken in mid-February shows waste being introduced into super cell 9 (lower left) at the Environmental Restoration Disposal Facility. (Photo 4)*

WCH continued to introduce waste in super cell 9, which was placed into service in mid-February. WCH and subcontractors TradeWind Services and DelHur Industries completed construction of the super cell with “zero” recordable injuries, 10 weeks ahead of schedule, and approximately \$6 million under budget.

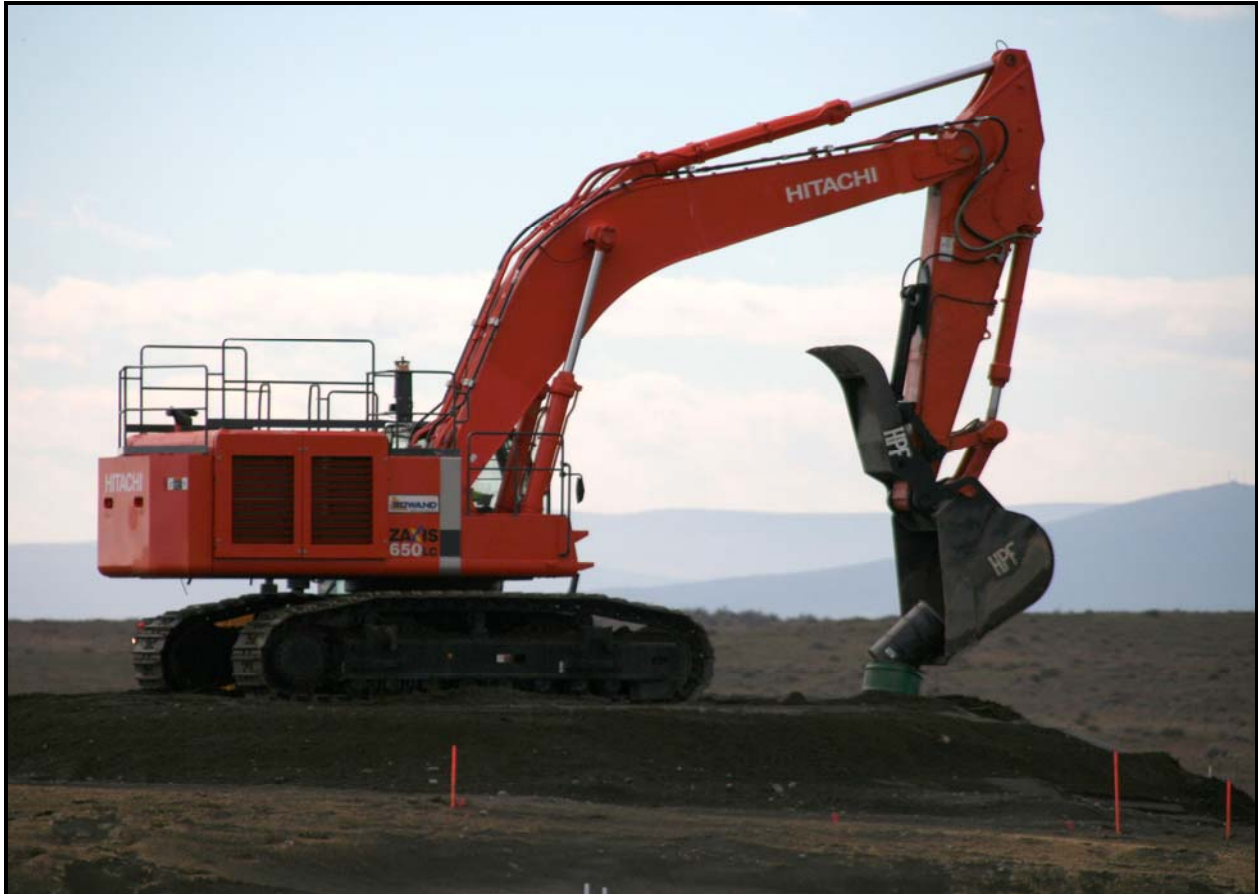
*An excavator carefully places a drum inside a salvage container during mock-up exercises at the 618-10 Burial Ground. (Photo 5)*

WCH continues to prepare for full-scale remediation of the 618-10 Burial Ground trenches, which is scheduled to begin later this month. The project is conducting training and mockup exercises, and setting up water tanks and the drum-punch area.

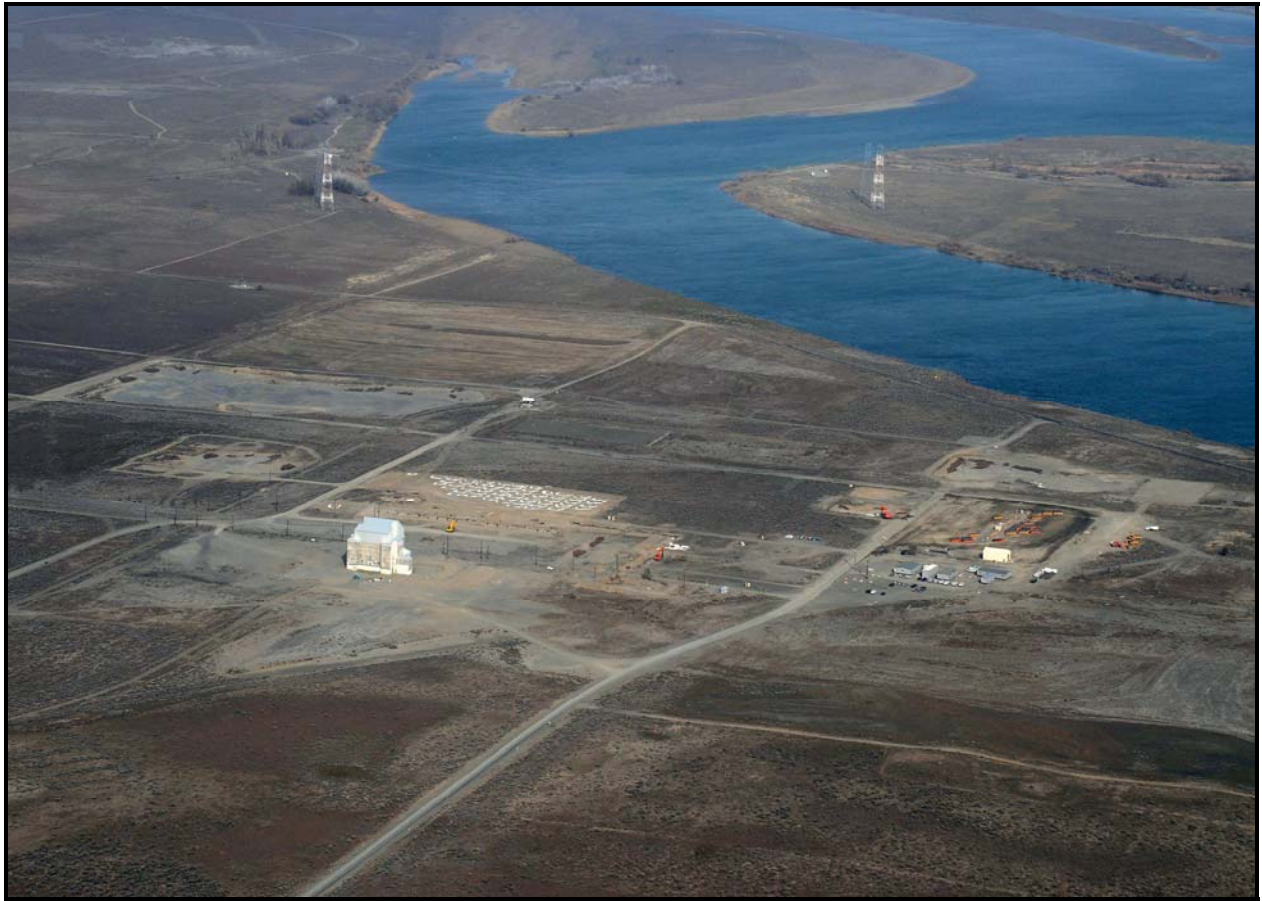
*An aerial view from the southeast shows 100-F Area, where Recovery Act dollars are funding the remediation of 19 waste sites. (Photo 7)*

WCH and subcontractor Ojeda Business Ventures are making significant progress with the remediation of 19 waste sites at 100-F Area. Field work began in September and will conclude this spring. Last week, the project team completed another 90-day safety campaign by conducting work without any first-aid or recordable accidents.

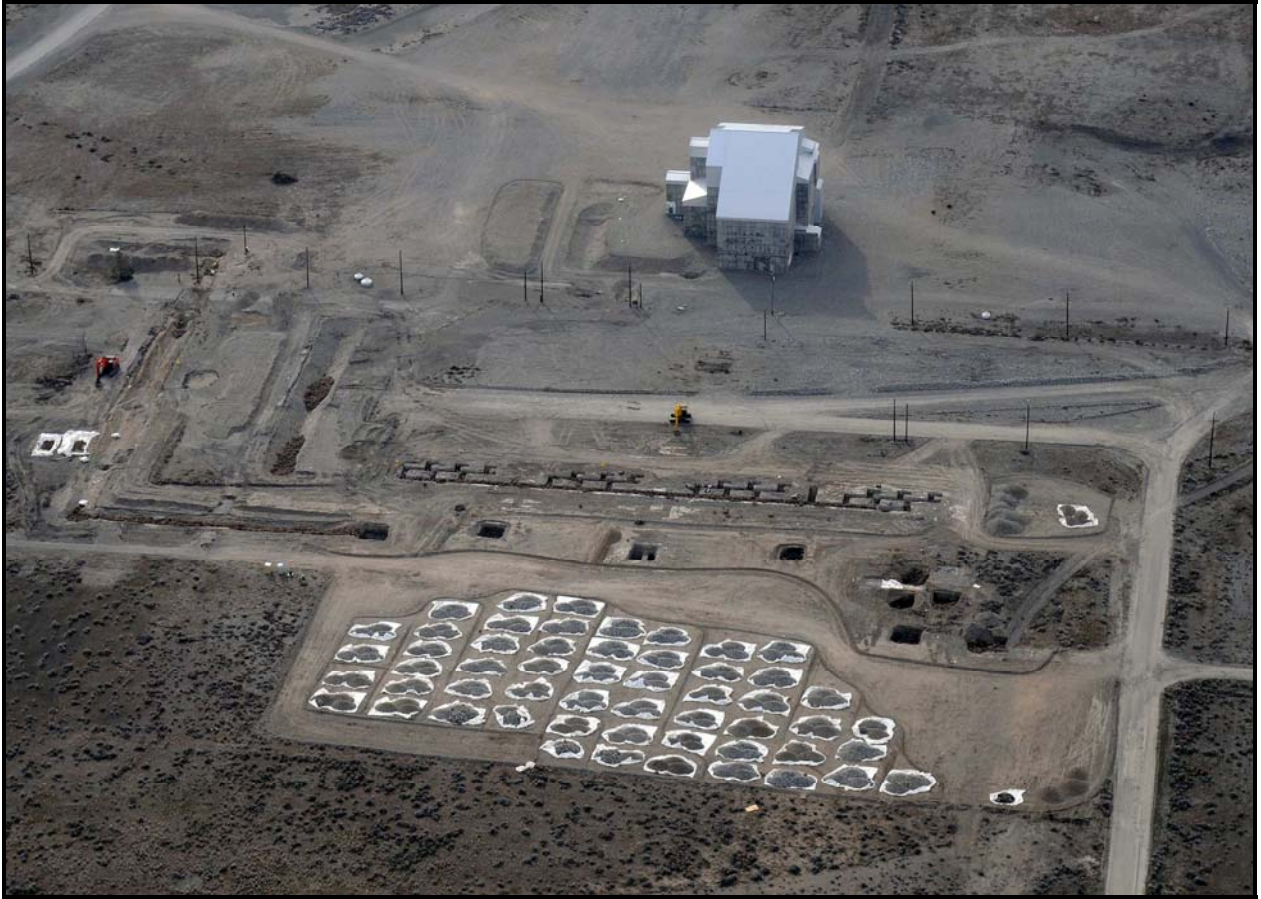
*An aerial view from the east side of F Reactor shows material from the test pit campaign at 100-F-57 that was placed on white plastic. (Photo 8)*

WCH continues to receive laboratory data from a test pit campaign at 100-F-57, where stained concrete and soil were found and the presence of hexavalent chromium was confirmed.
