River Corridor Closure Project

Recovery Act Weekly Report

For the week ending April 22, 2011

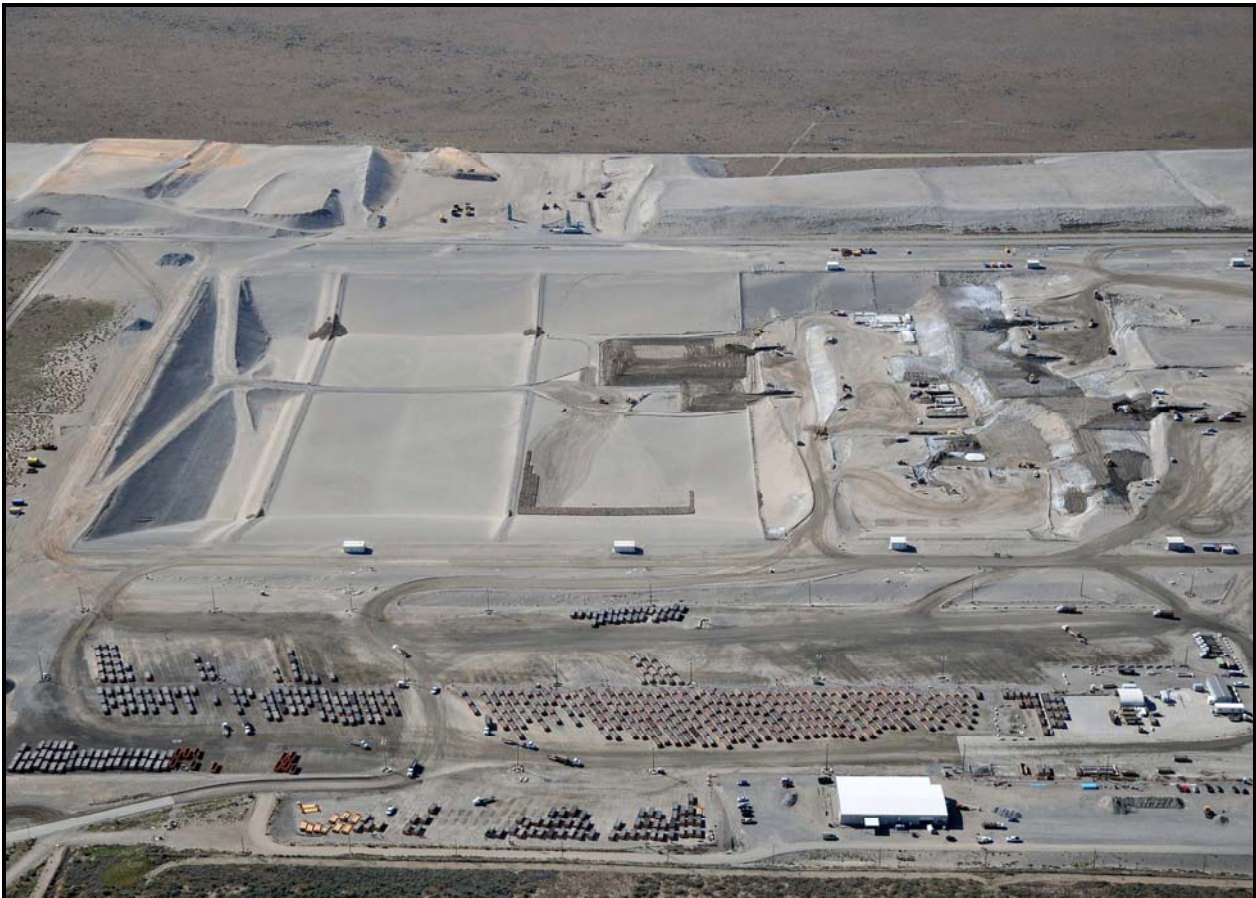
This is an aerial photo from the north side of the Environmental Restoration Disposal Facility taken in April. (Photo 1)

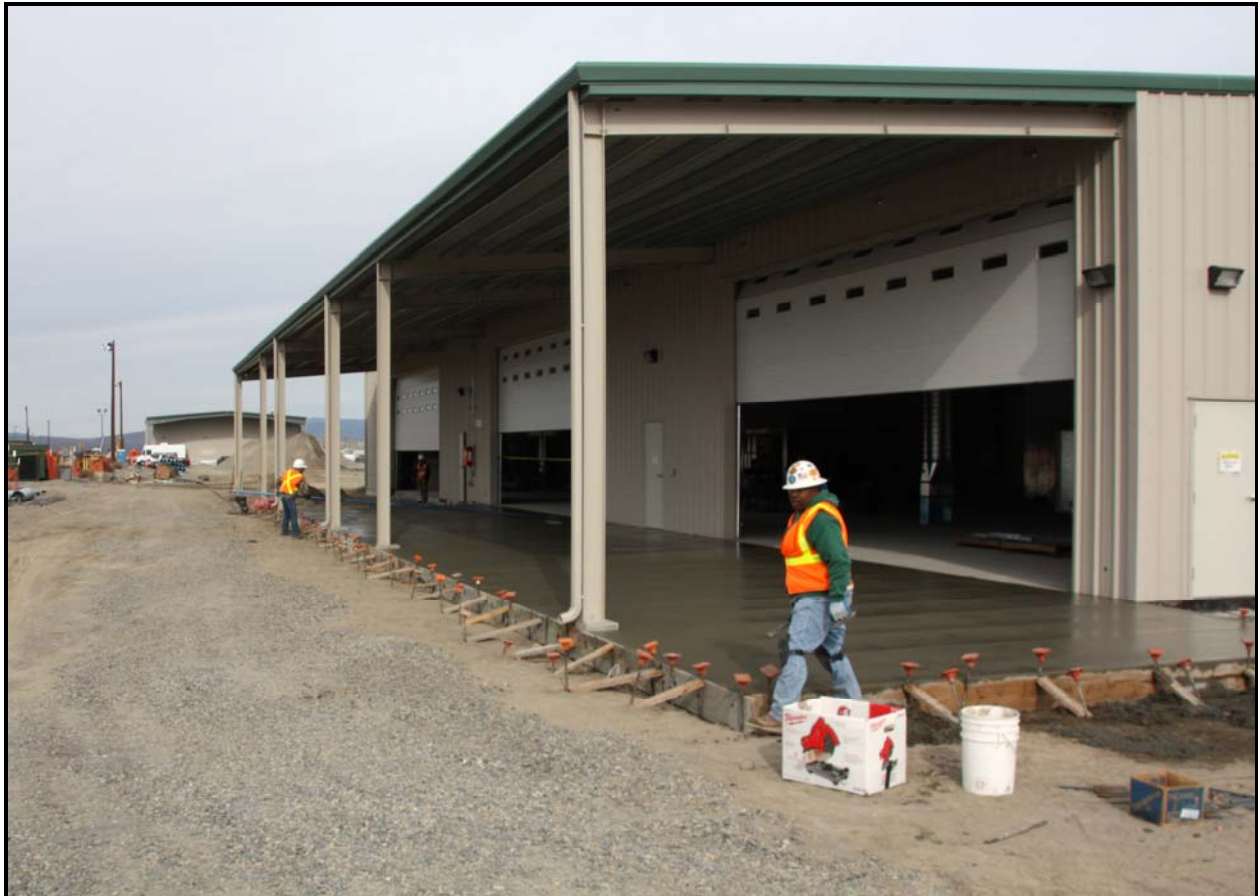
ELRFowler poured the concrete slab outside the front of ERDF's container maintenance facility. (Photo 2)

EMF/operations center, and finish work continues at the container maintenance facility (CMF). The outdoor concrete slab on the south side of the CMF also was poured.

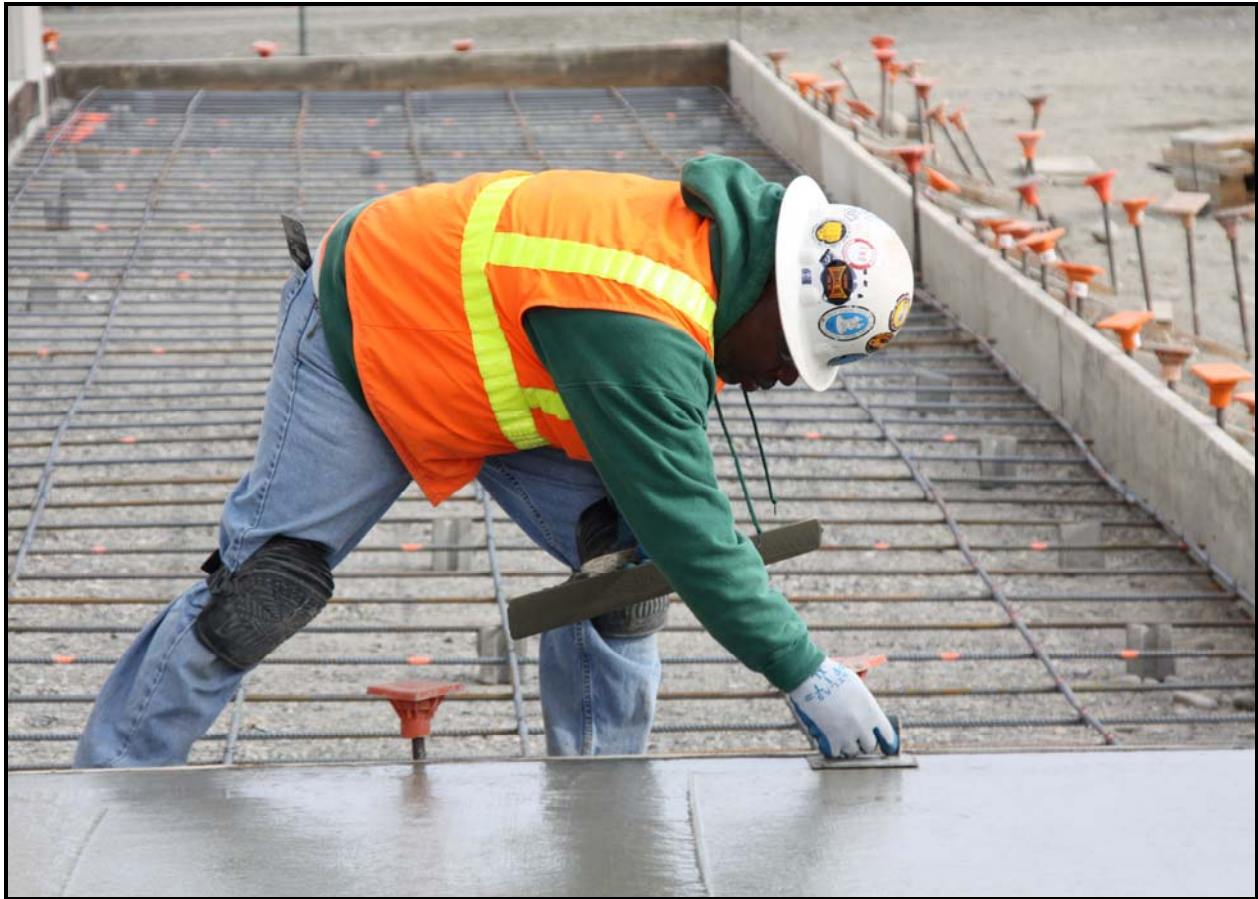
An ELRFowler employee edges the recently poured concrete slab at ERDF's container maintenance facility. (Photo 3)

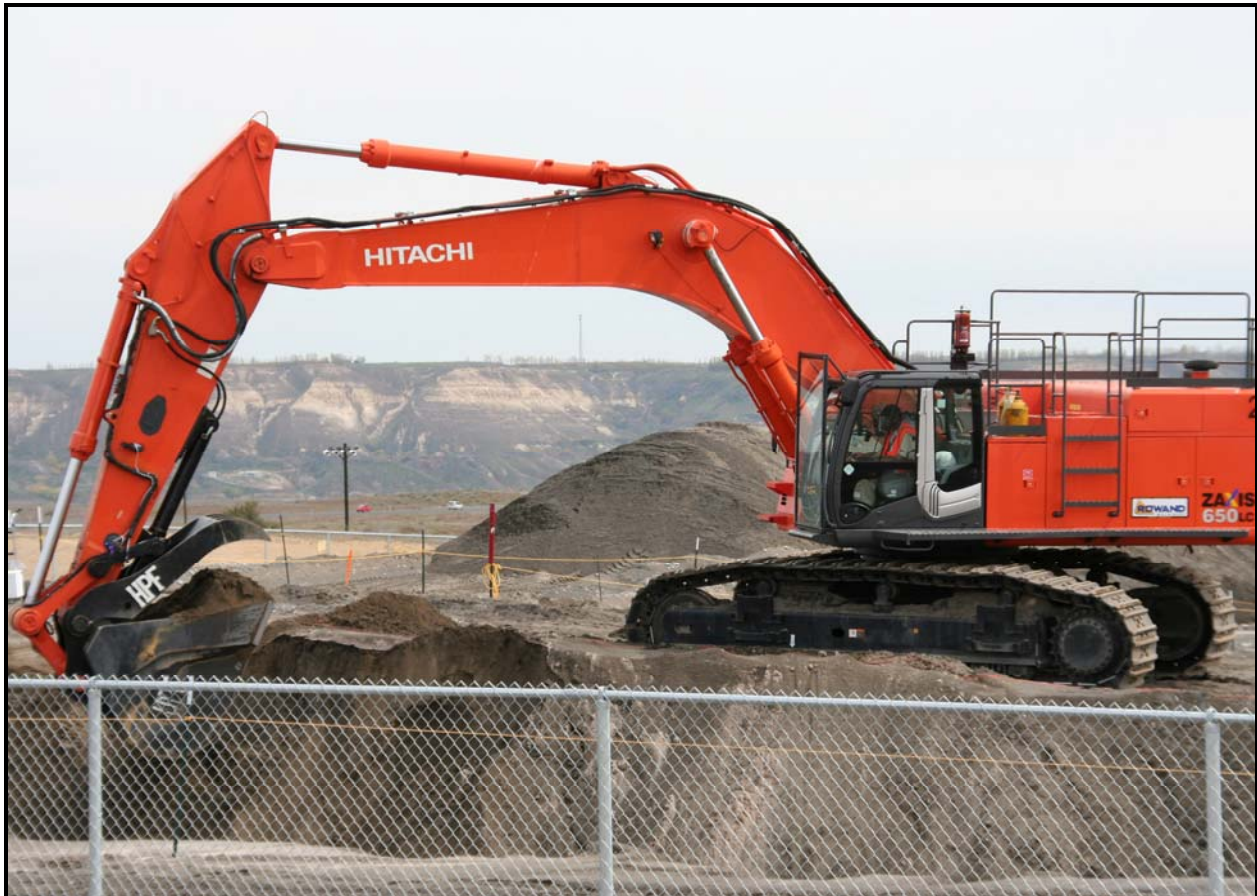
Washington Closure Hanford began trench excavation at the 618-10 Burial Ground. (Photo 4)

WCH began trench excavation on the northeast side of the 618-10 Burial Ground. Before excavation, the north surge trench was completed. Surge trenches are excavated in clean soil adjacent to the burial ground. They provide a below-ground area to hold material excavated during the trench excavation process.

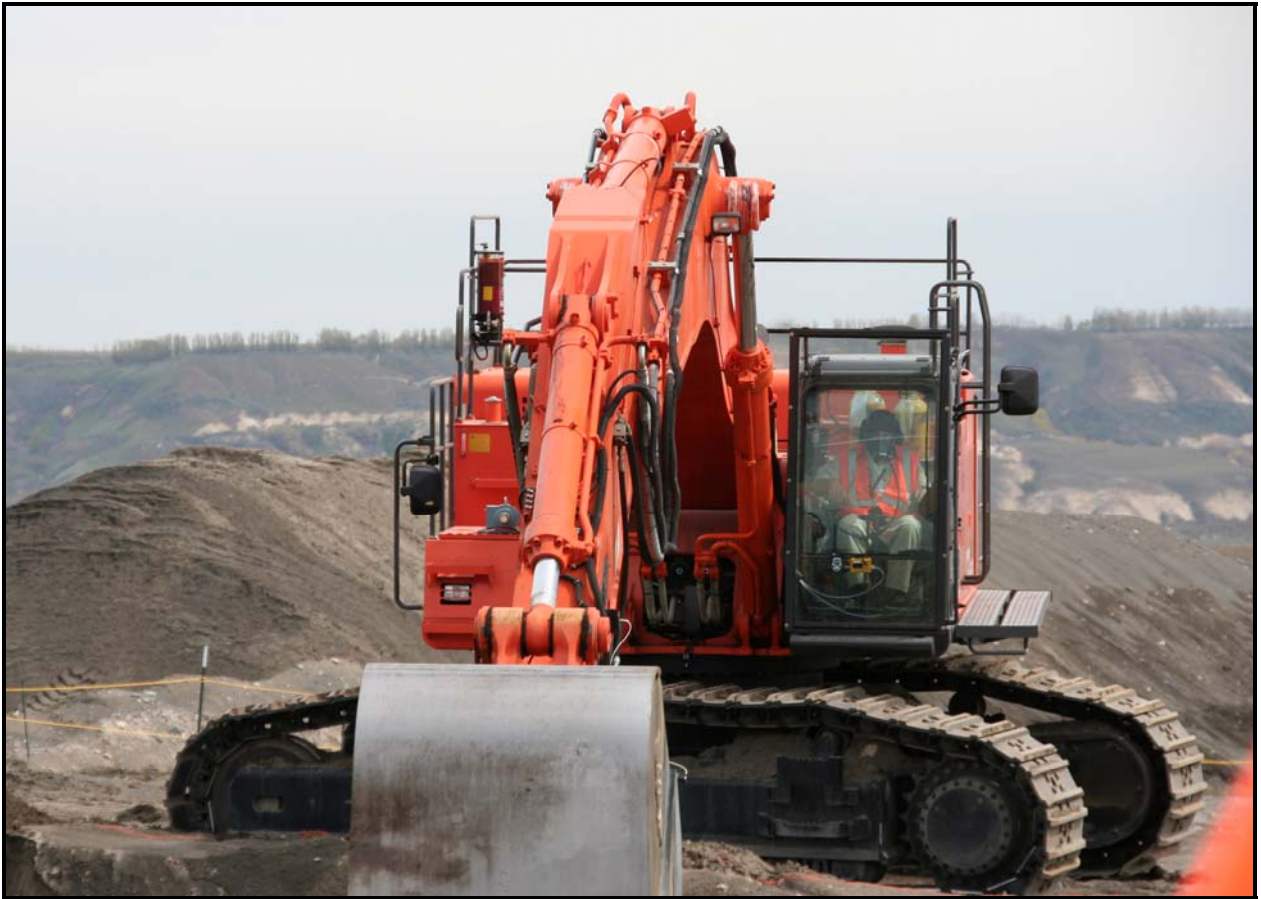
Excavation of the 618-10 Burial Ground is scheduled to be completed in April 2012. (Photo 5)

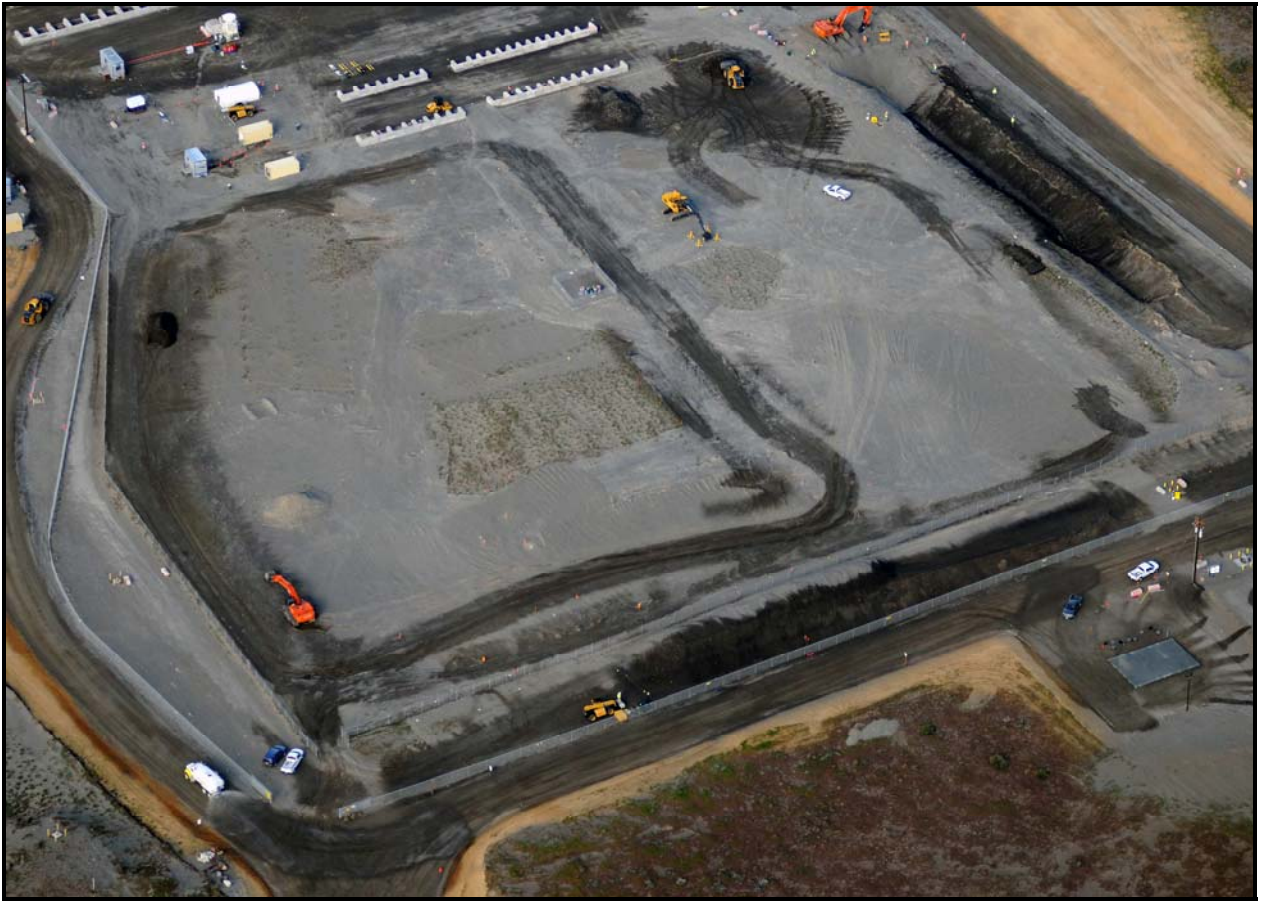
An aerial view shows the 618-10 Burial Ground before the beginning of trench excavation. (Photo 6)

The 618-10 Burial Ground operated from 1954 to 1963, receiving low- and high-level radioactive waste from 300 Area laboratories and fuel development facilities. Low-activity wastes were primarily disposed in 12 trenches, while the moderate- and high-activity wastes were disposed in 94 vertical pipe units (VPUs). The VPUs were constructed by welding five bottomless drums together and buried vertically about 10 feet apart.

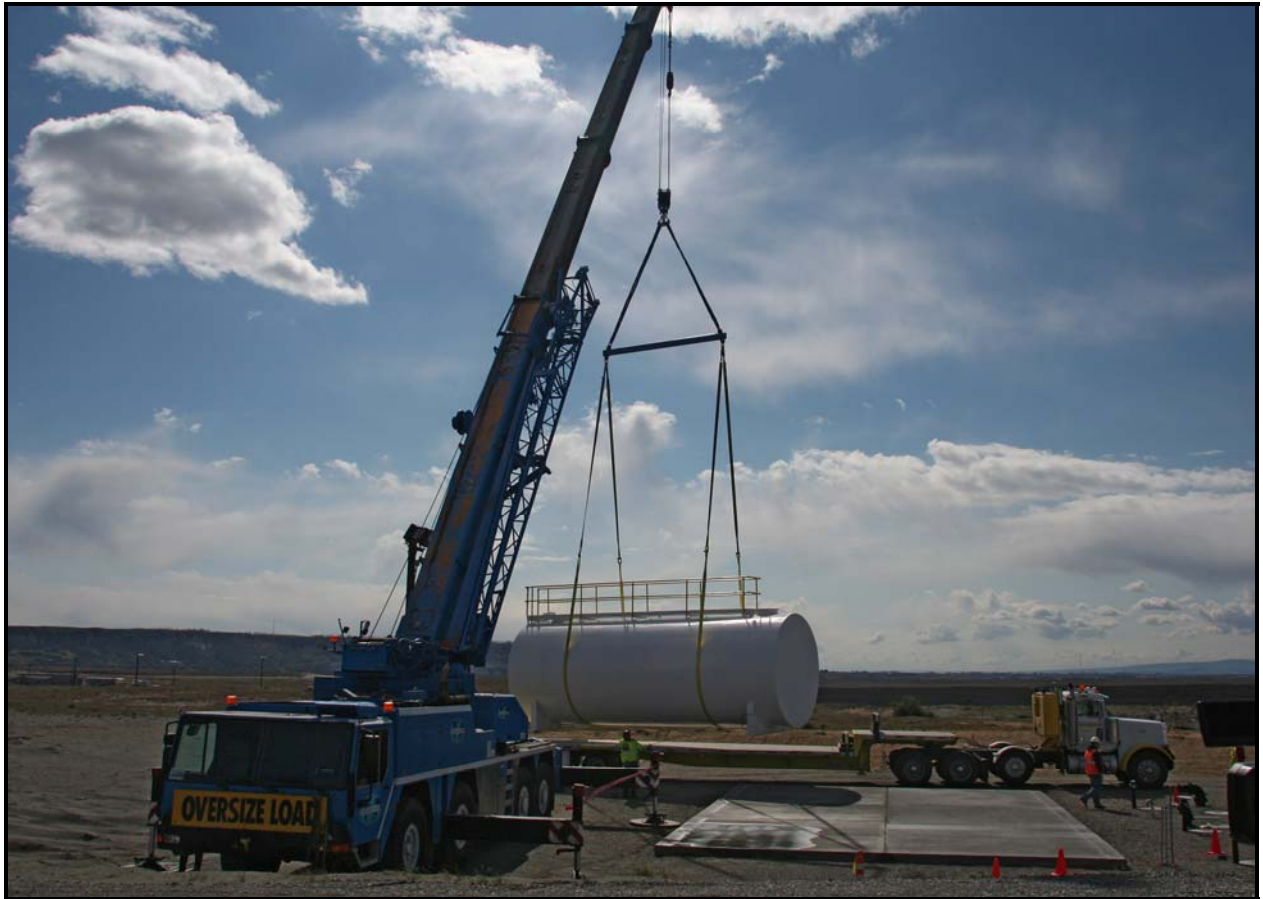
Washington Closure Hanford subcontractor Lampson International moves the first of three water tanks into place at the 618-10 Burial Ground. The tanks are used for dust suppression. (Photo 7)

Before trench excavation began, the project team prepared the site by removing the old perimeter fence fabric and posts and set boundary posts, ropes, and signage. Three 22,000-gallon capacity water tanks for dust suppression also were installed.

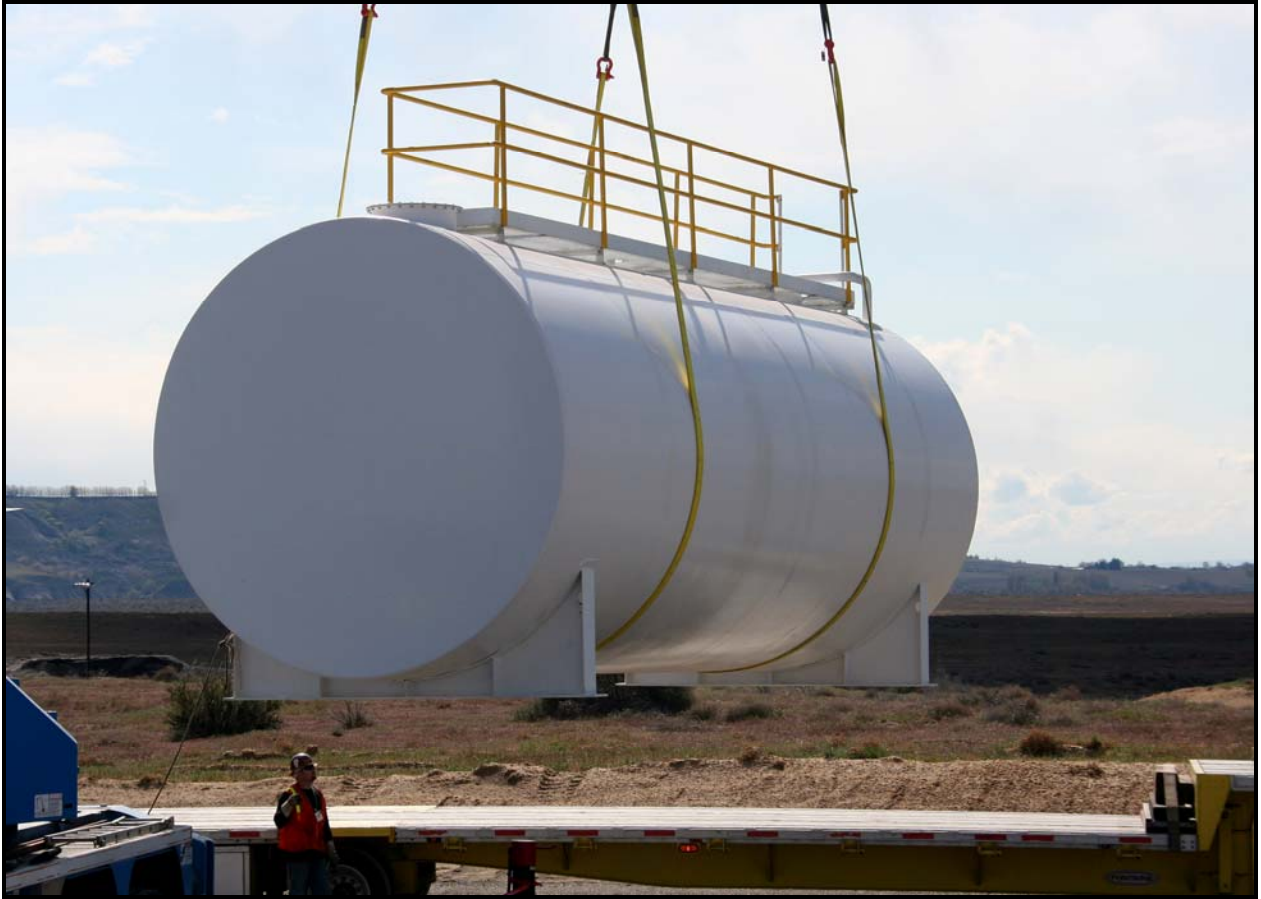
Each of the water tanks used for dust suppression at the 618-10 Burial Ground has a capacity of 22,000 gallons. (Photo 8)

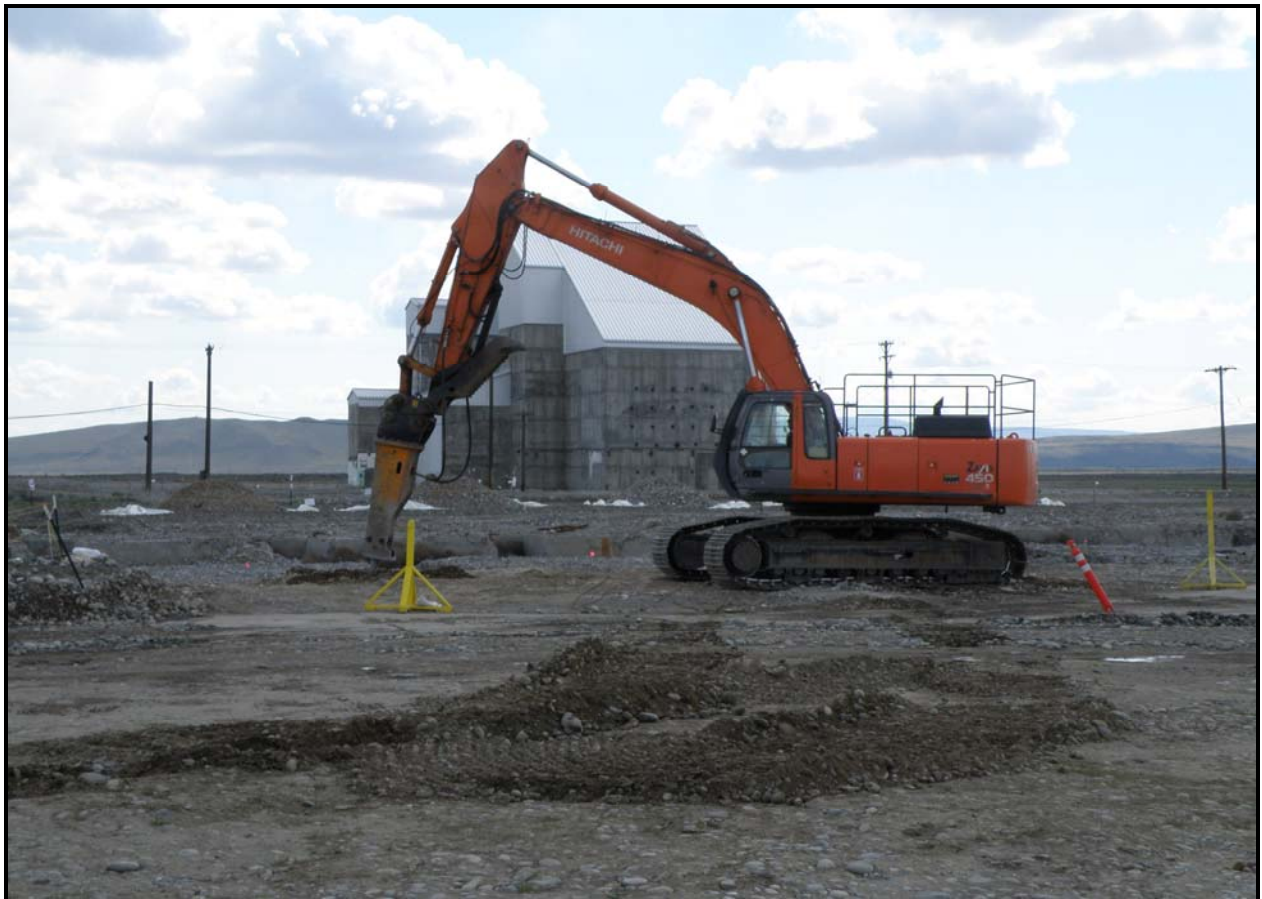
Washington Closure Hanford subcontractor Ojeda Business Ventures continues to break concrete at 100-F-57. The site contains hexavalent chromium. (Photo 9)

The project team is demolishing concrete at 100-F-57 and loading out concrete and underlying soil. The site consists of stained concrete and soil containing hexavalent chromium. Grab samples also were collected from 100-F-57, 100-F-49, and 100-F-26:7.

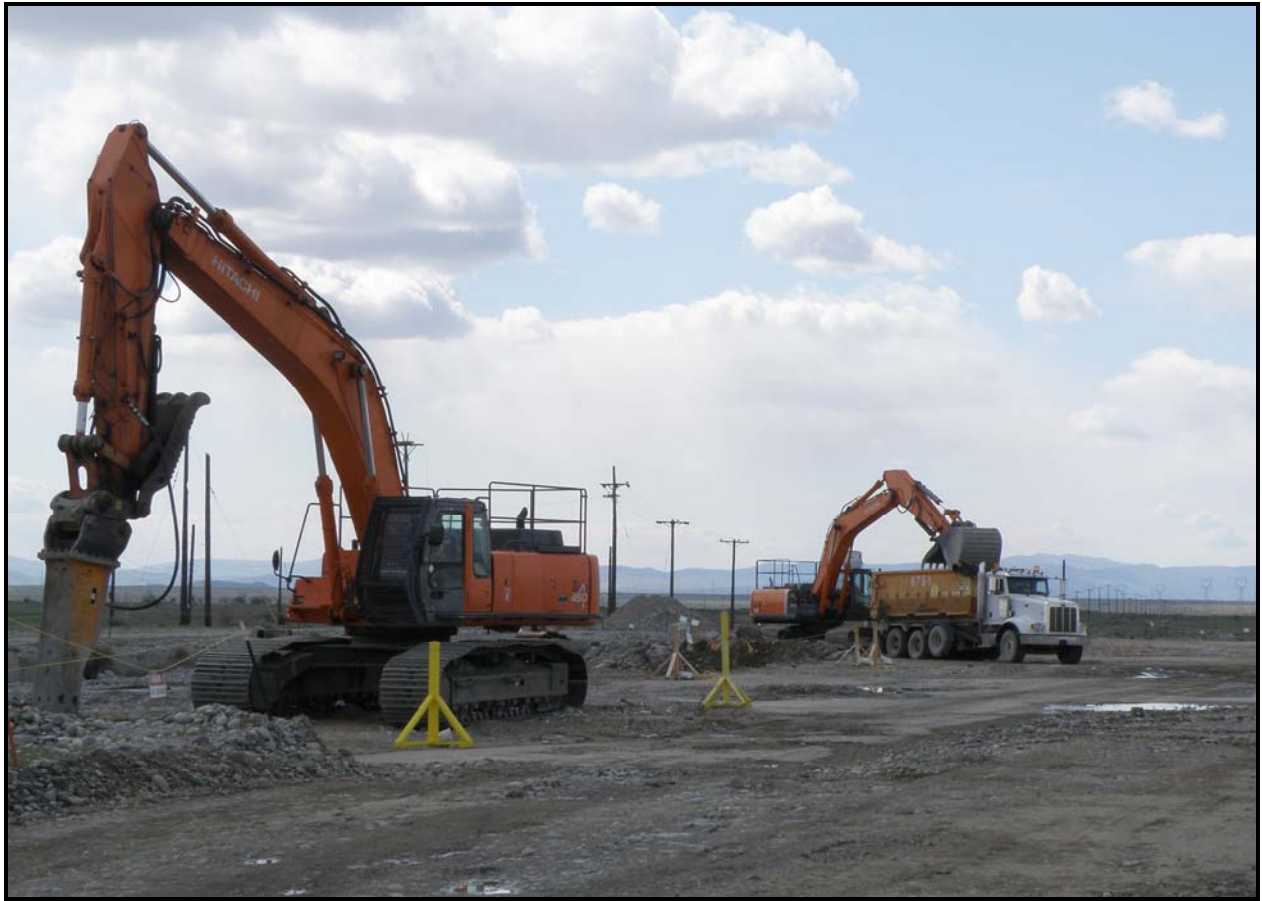
Concrete demolition and loadout of concrete and soil continues at 100-F-57. (Photo 10)
