River Corridor Closure Project

Recovery Act Weekly Report

For the week ending May 8, 2011

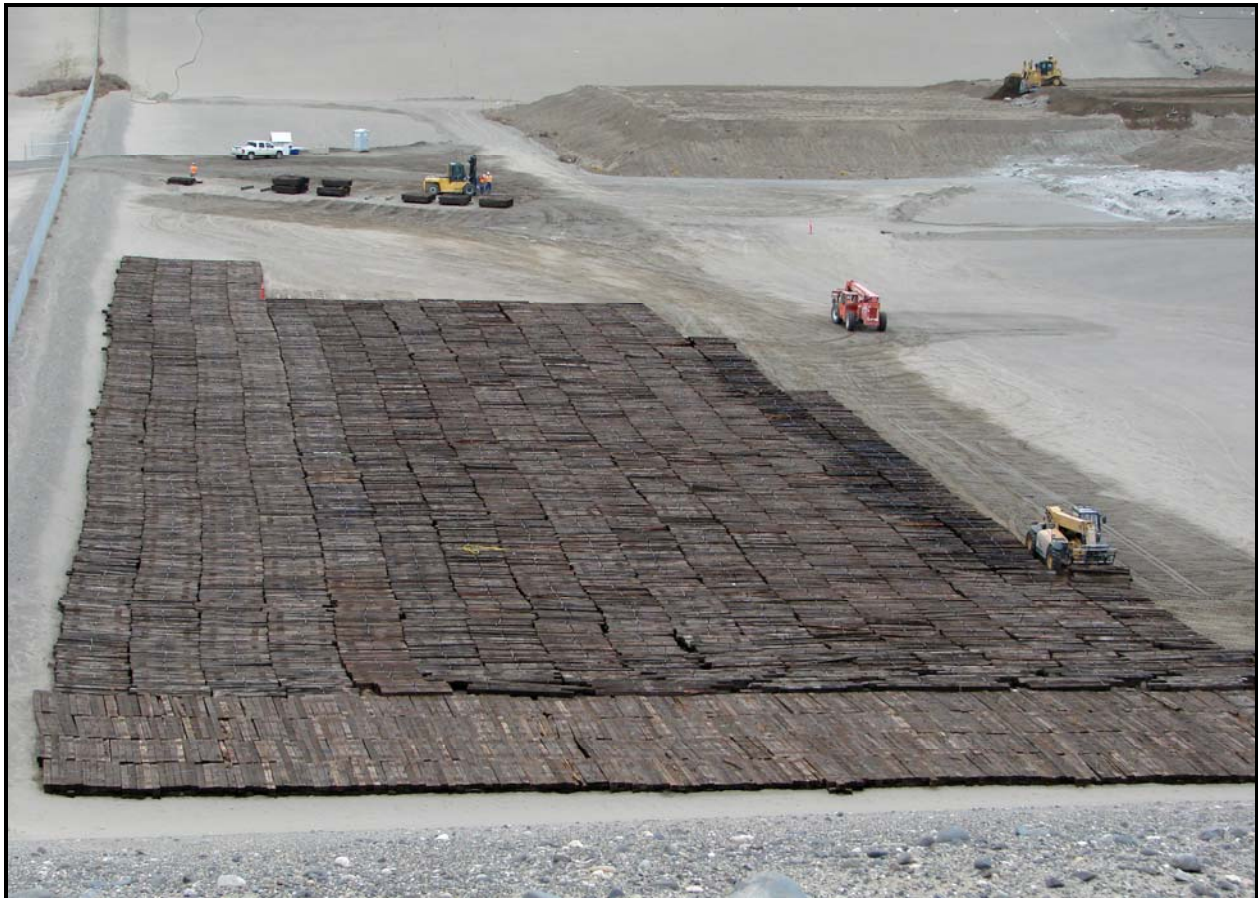
About 65,000 railroad ties from the Hanford Site are being disposed in super cell 9 at the Environmental Restoration Disposal Facility. (Photo 1)

Super cell 9 was placed into service in mid-February. WCH and subcontractors TradeWind Services and DelHur Industries completed construction of both super cells with no recordable injuries, months ahead of schedule, and more than \$16 million under budget.

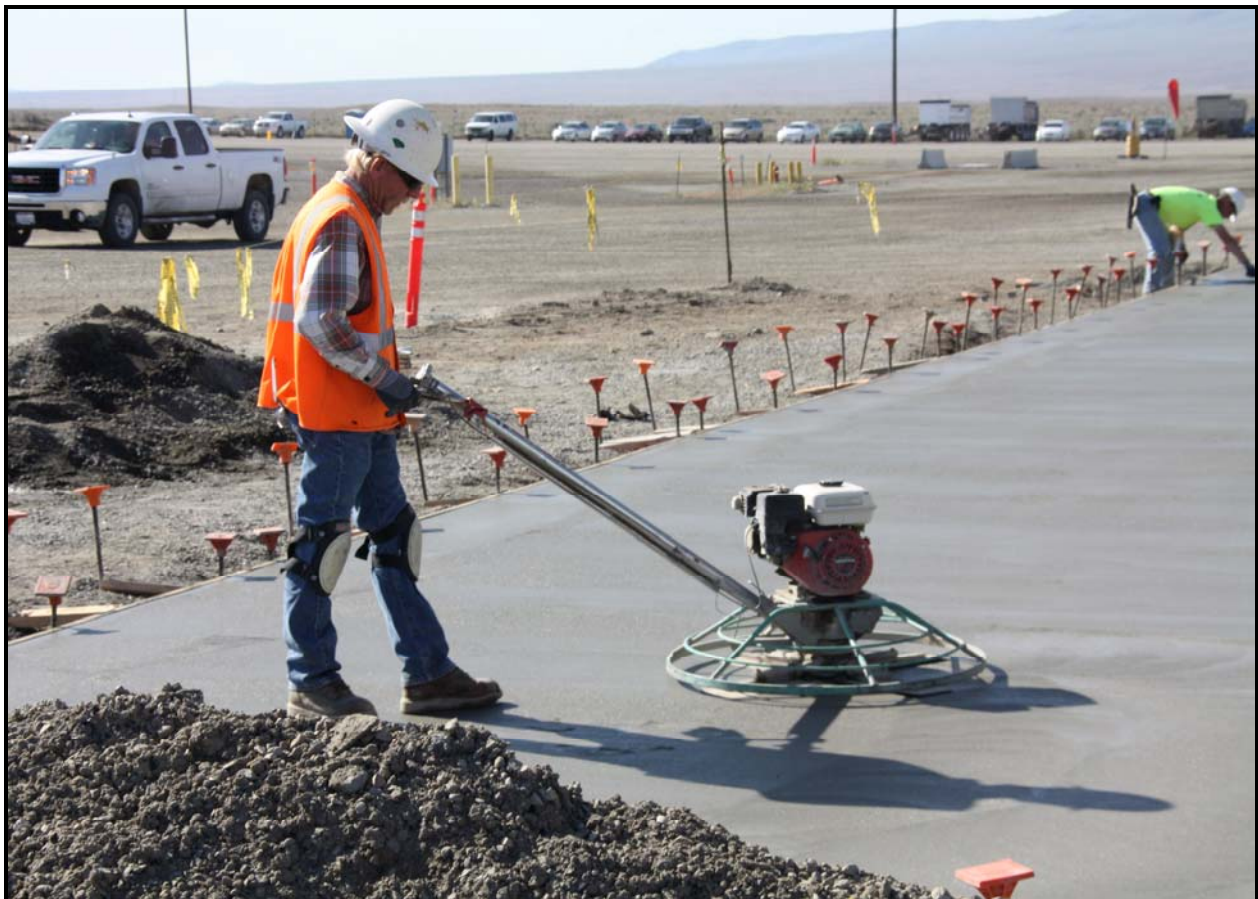
An ELRFowler employee uses a power trowel on recently poured concrete at the east side of ERDF's transportation maintenance facility. (Photo 2)

The expanded transportation maintenance facility will include two additional truck bays, a large concrete pad, an exterior awning that will cover two smaller concrete pads, and a conference room. The project began pouring the concrete footers on the east side of the building.

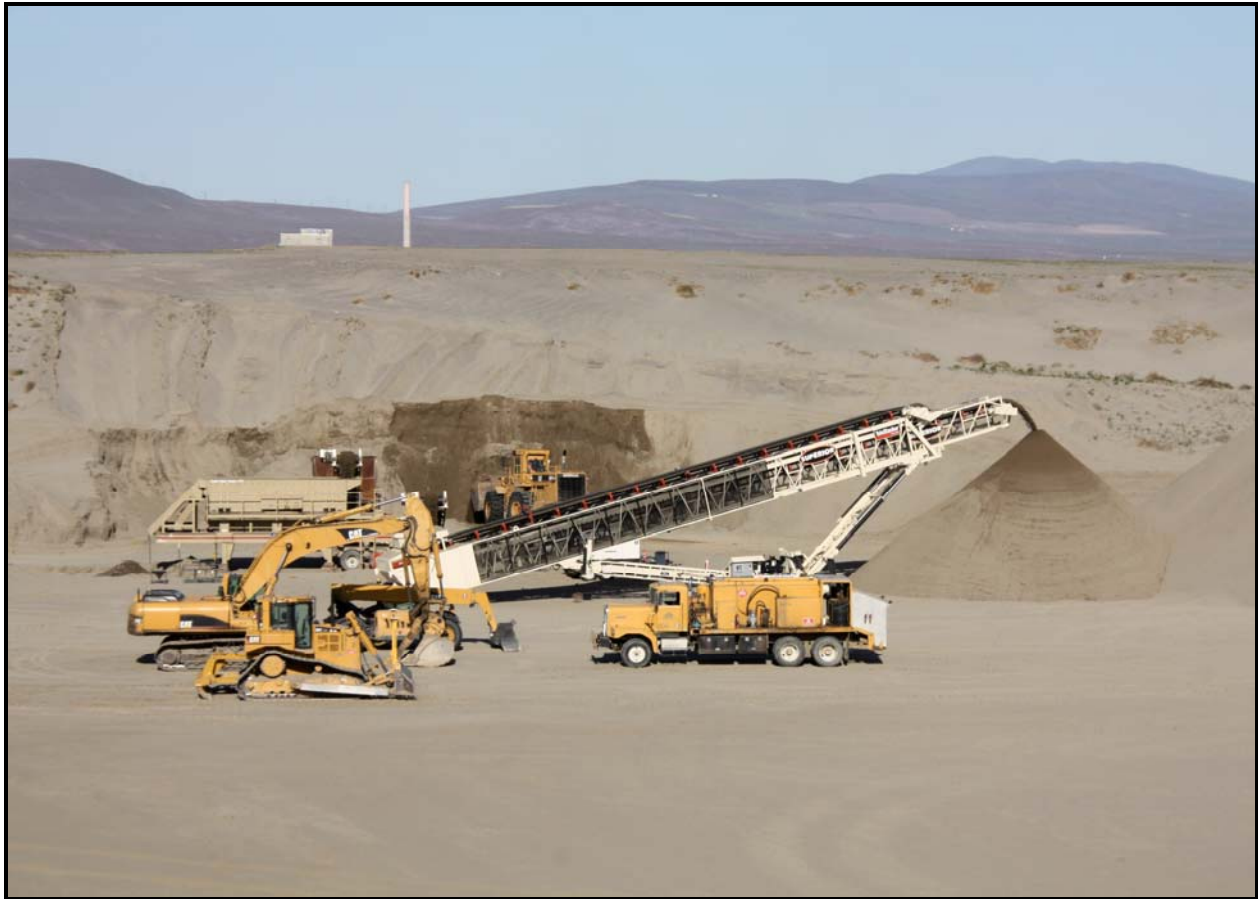
Washington Closure Hanford subcontractor DelHur Industries tests a soil screen plant set up in support of ERDF's new batch plant. (Photo 5)

WCH subcontractor DelHur Industries completed operational testing of the soil-screen plant for ERDF's new batch plant. Safety guards are being installed at the batch plant, and an operations test is scheduled for later this month. The batch plant will produce concrete used to mix with debris, ensuring no void space during disposal operations.

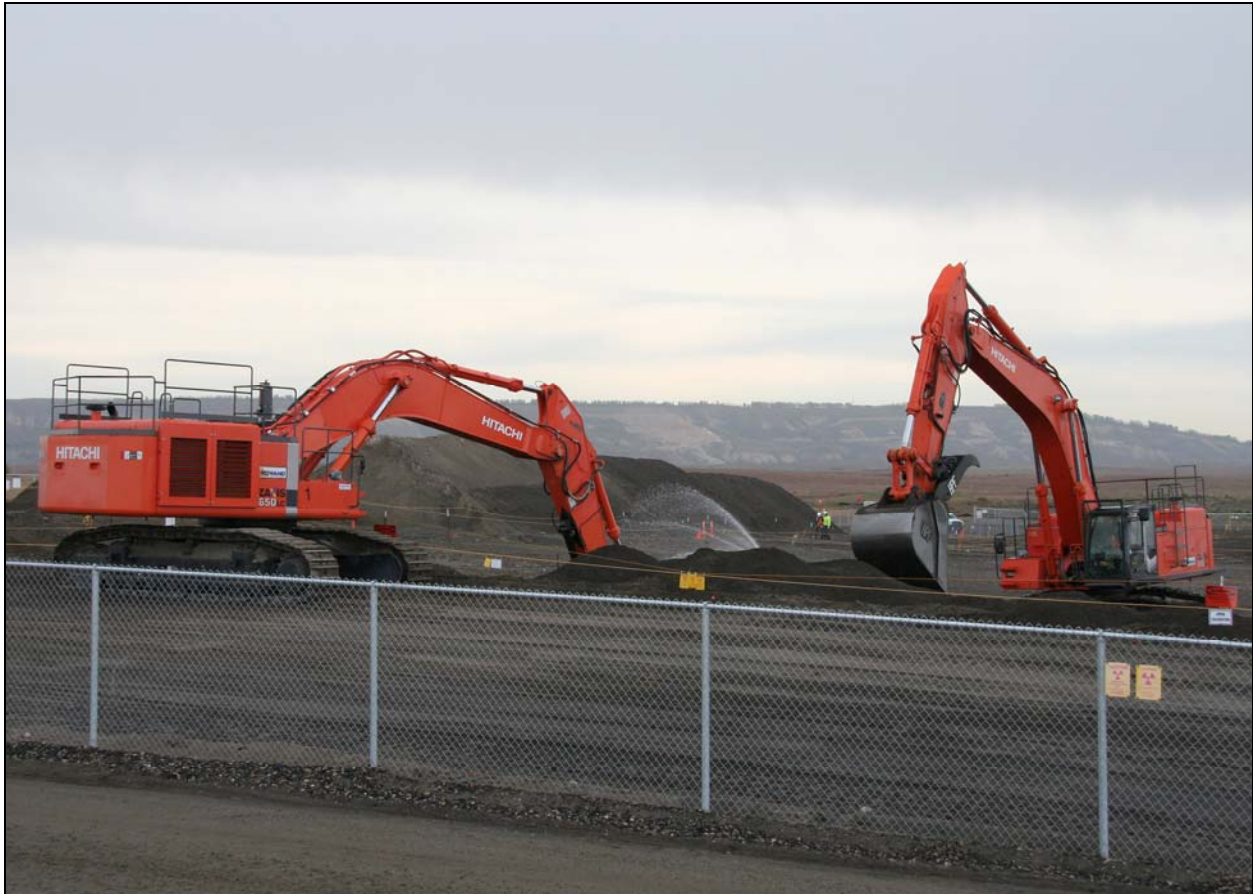
Washington Closure Hanford continues trench excavation on the north side of the burial ground. (Photo 6)

WCH continued trench excavation at 618-10 Burial Ground. The project team is working on the north and south sides of the burial ground and has excavated 13,650 bank cubic meters.

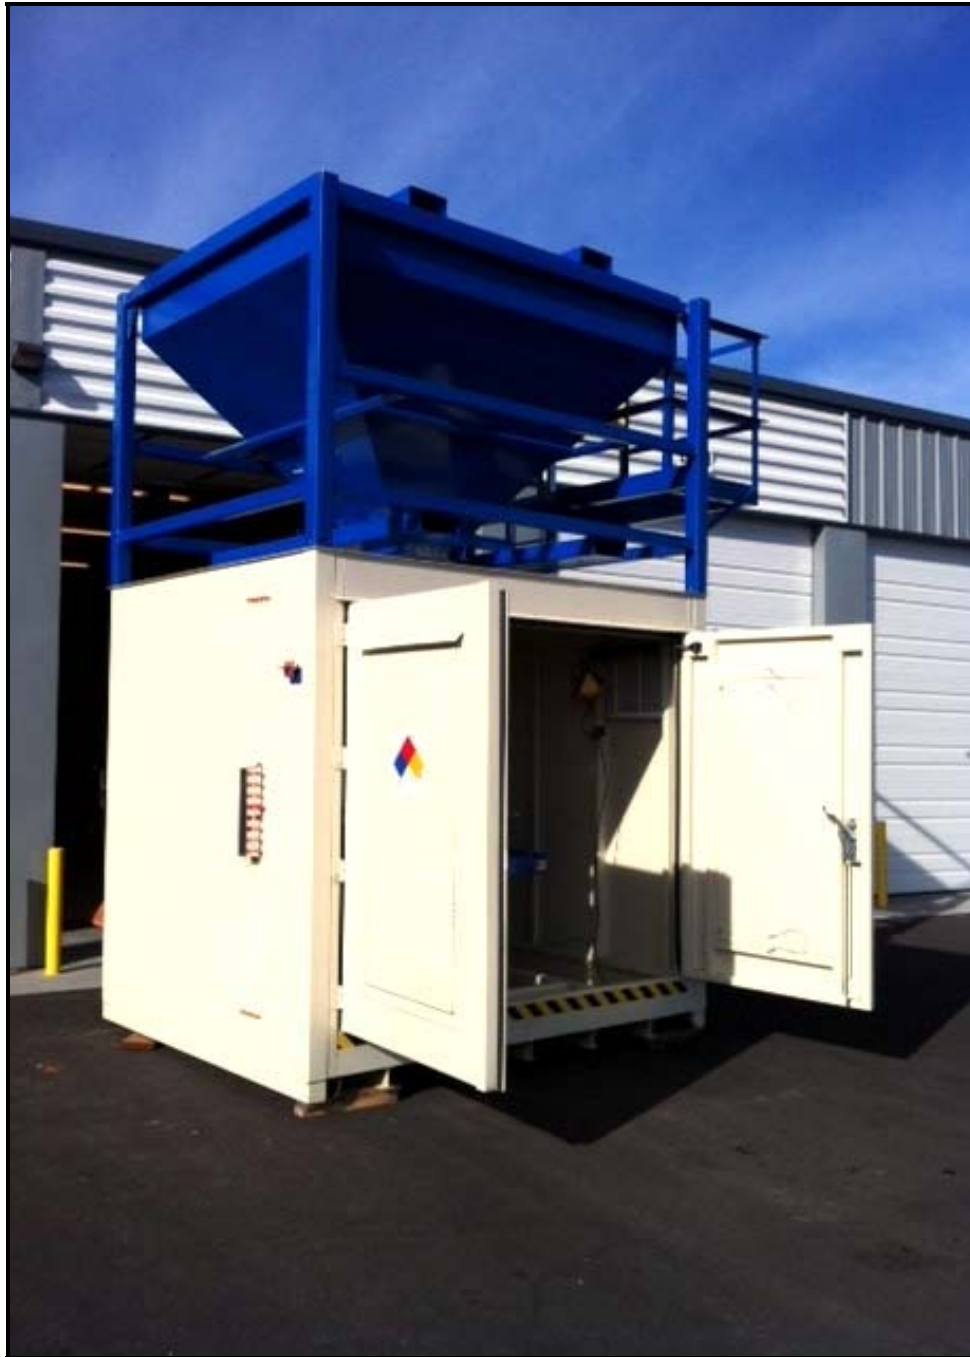
Washington Closure received a second drum penetration facility at the 618-10 Burial Ground. (Photo 7)

The project team set the final water storage tank and connected it to the piping system. A second drum penetration facility also was delivered to the site. The drum penetration facility will be set up next week.

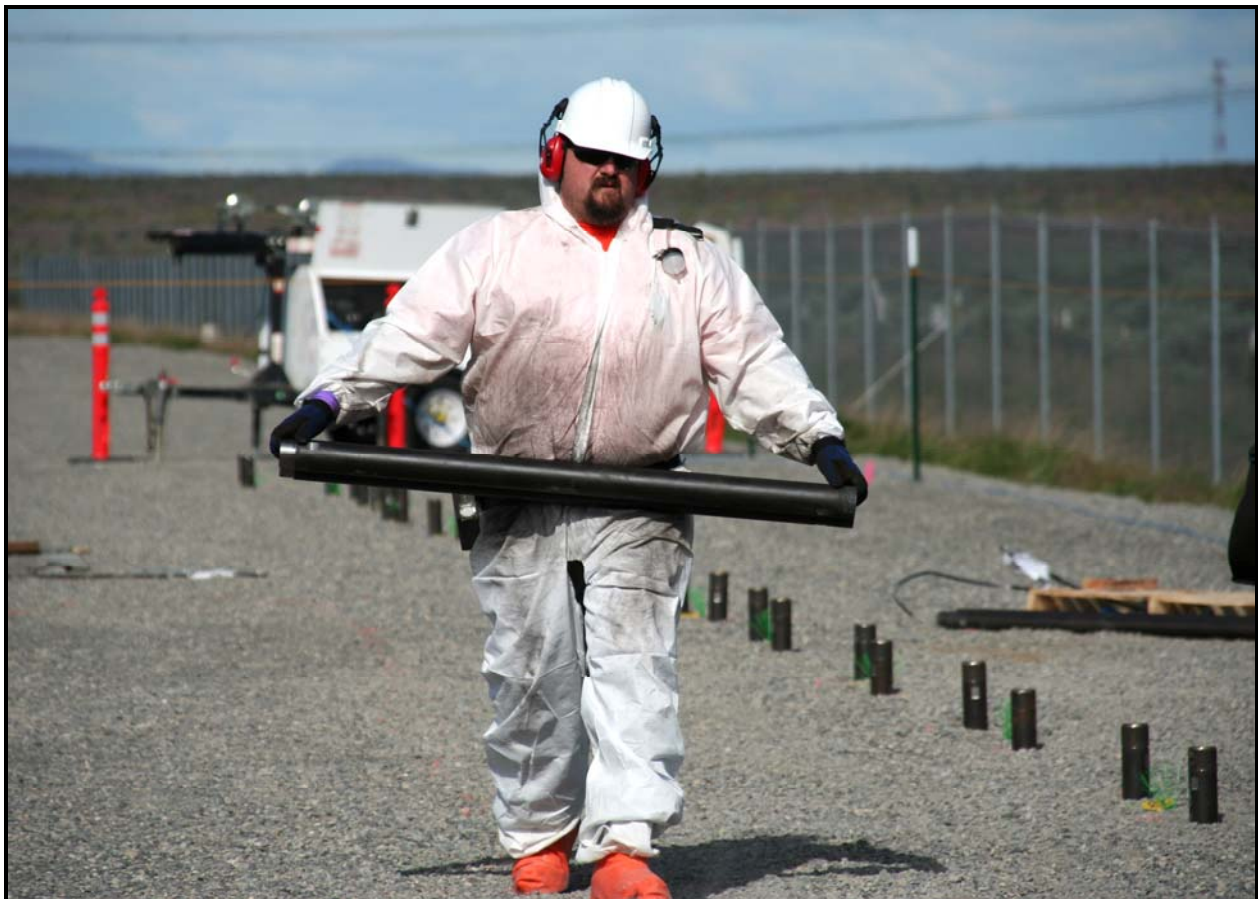
Washington Closure Hanford subcontractor North Wind installing cone penetrometers at the 618-11 Burial Ground. (Photo 8)

North Wind installed two cone penetrometers (narrow steel tubes) about 6 to 8 inches from the exterior of each VPU and to an approximate depth of 6 feet below the VPU. A gamma-logging probe will now be inserted into the cone penetrometers to identify the location of radioactive materials within the VPUs.

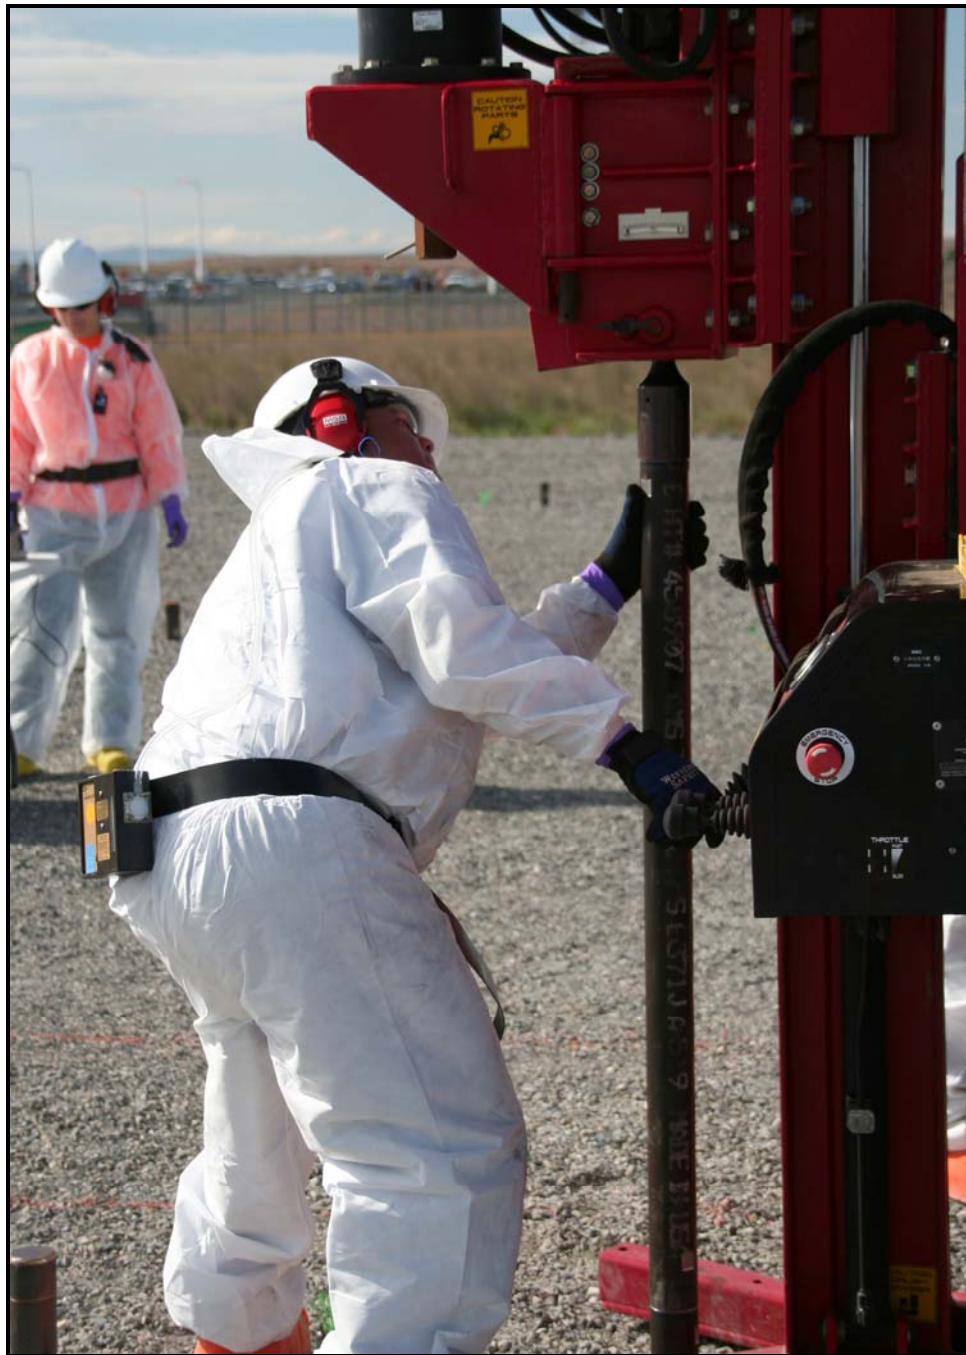
Cone penetrometers are installed to a depth of approximately 24 feet. (Photo 9)

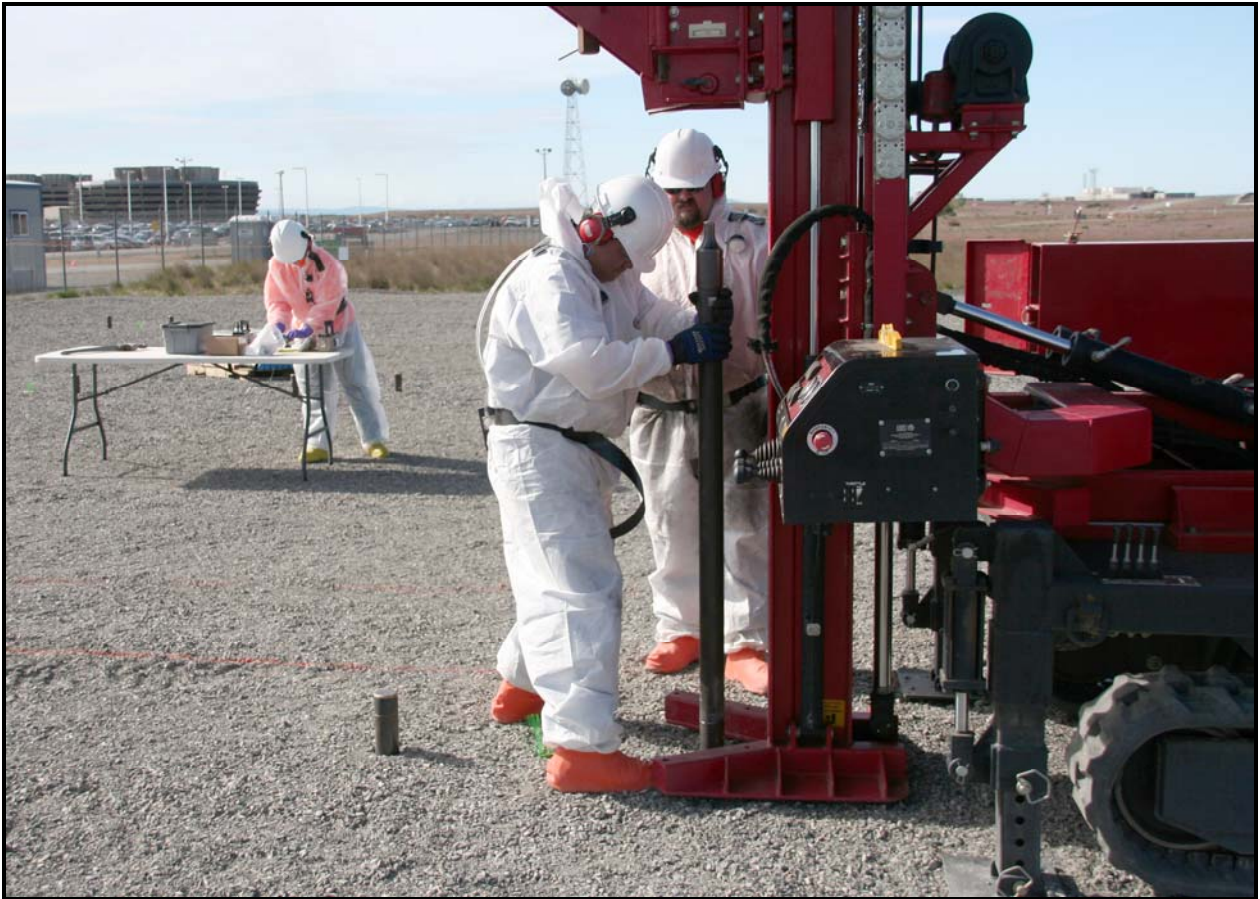
The cone penetrometers are narrow steel tubes that will house instrumentation to identify the location of radioactive materials within the vertical pipe units at the 618-11 Burial Ground. (Photo 10)

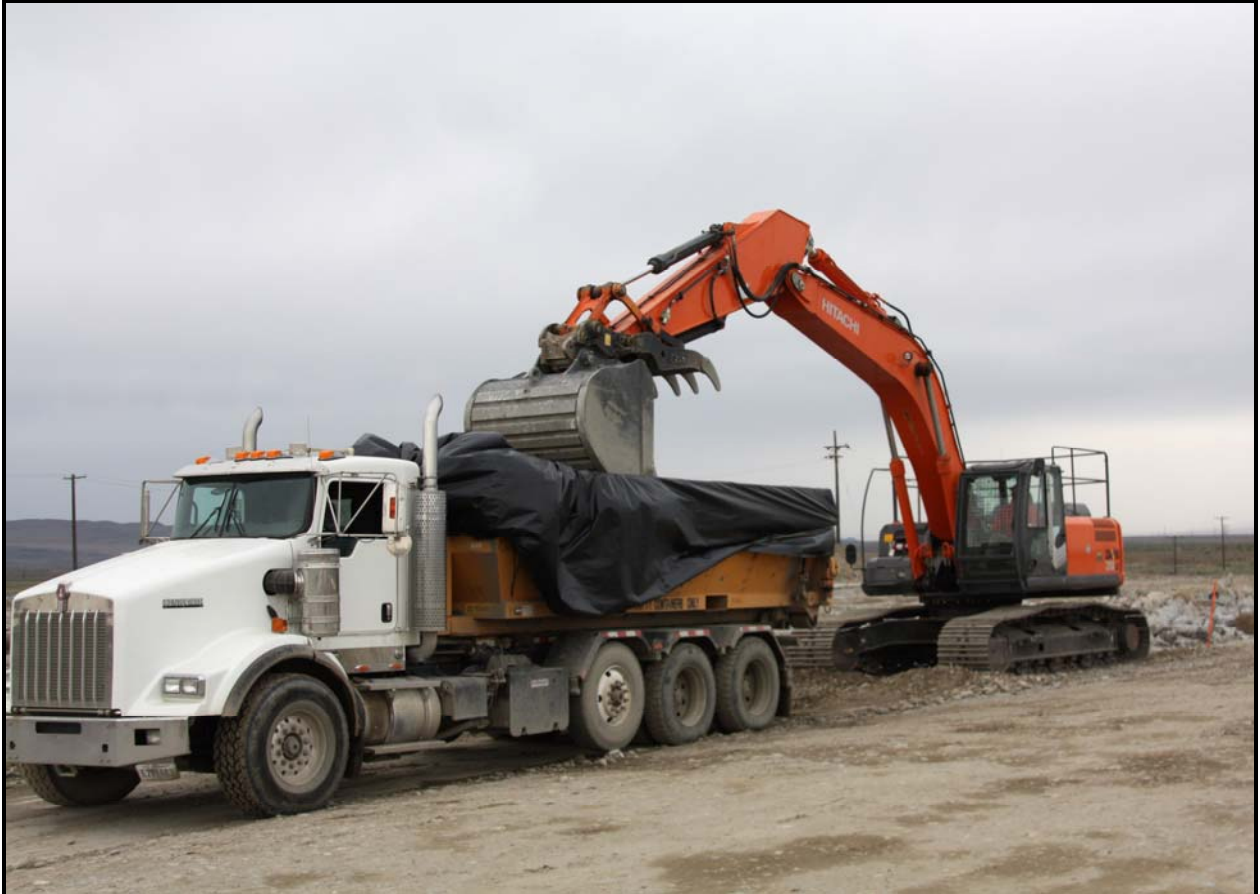
Washington Closure Hanford subcontractor Ojeda Business Ventures loads out rubble from 100-F-57. (Photo 11)

WCH and subcontractor Ojeda Business Ventures continued with the remediation of 19 waste sites at 100-F Area. The project team is demolishing concrete at 100-F-57 and loading out concrete and underlying soil. The site consists of stained concrete and soil containing hexavalent chromium. Closeout samples also were collected from 100-F-44:9 (steel pipeline).
