BABIL RAILWAY STATION
REHABILITATION
HILLA, IRAQ

SIGIR PA-05-019
MARCH 10, 2006

Special Inspector General for Iraq Reconstruction

Babil Railway Station Rehabilitation in Hilla, Iraq

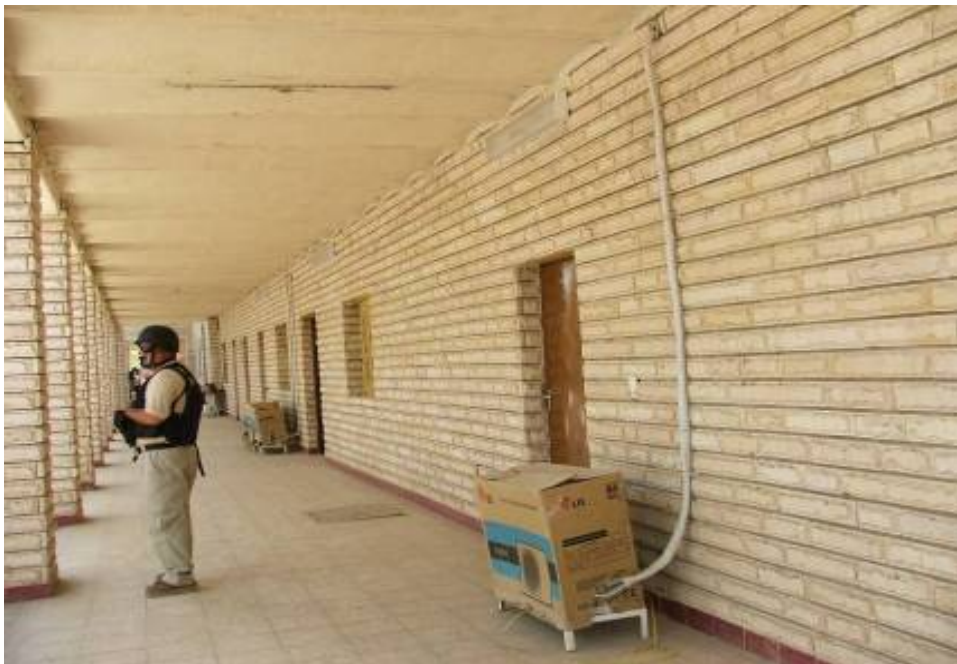
The contract's BOQ required the supply and installation of 100 square meters (m²) of Shafqueem facing brick and 115 m² of brickwork. We observed new facing brick and brickwork on the complete front and rear sections of the Babil Railway Station and around the supporting columns of the front and rear breezeway area. Installation of facing brick appeared to be consistent with the requirements of the contract.

Site Photo 1 shows the facing brick on the rear wall of the Babil Railway Station and the columns.

Site Photo 1. Facing Brick on Rear Wall and Columns

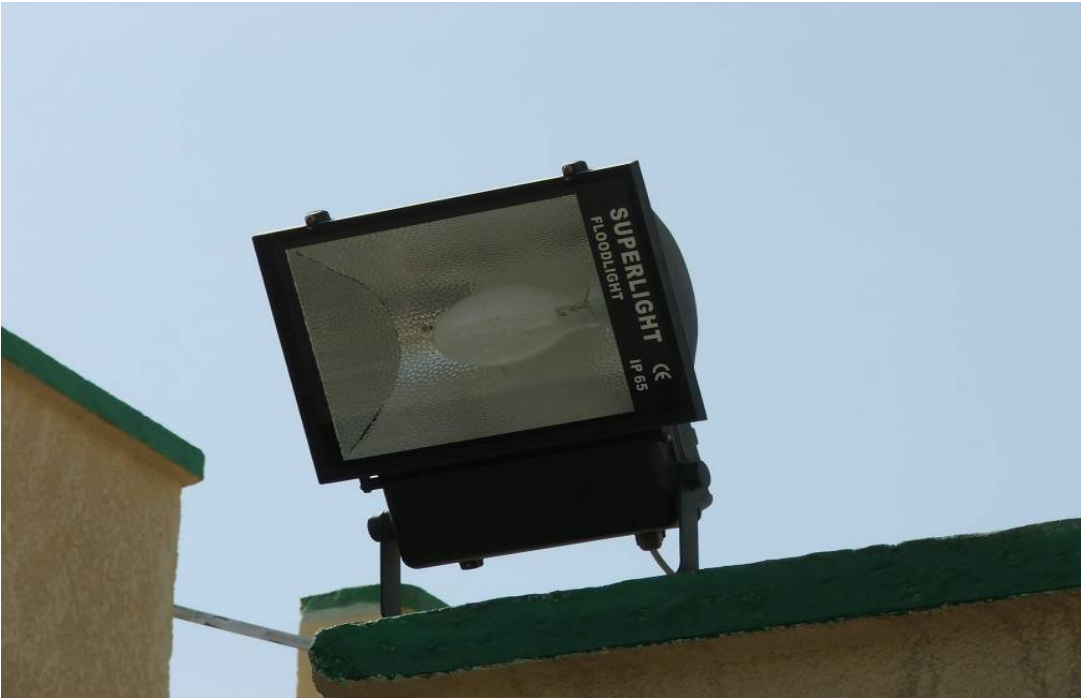
The contract's BOQ required the supply and installation of 124 double 2x40 watt (w) fluorescent luminaire type F-I interior lights and wiring, and the supply and installation of twelve outdoor 250 w type FL12 lighting fixtures. In addition, the BOQ required the electrical wiring of sixteen 24,000 British Thermal Unit (BTU) air conditioning (A/C) split units, two 30,000 BTU A/C split units, and four 36,000 BTU A/C split units. During the site assessment, we observed new exterior lighting fixtures, interior lighting fixtures, and wiring for the A/C split units. We did not note any deficiencies concerning the electrical lighting and electrical upgrades.

Site Photo 2 shows one of the exterior lighting units mounted on the backside of the Babil Railway Station. The recessed fluorescent lighting and false ceiling inside the Babil Railway Station can be seen in Site Photo 3.

Site Photo 2. Mounted Exterior Light Unit

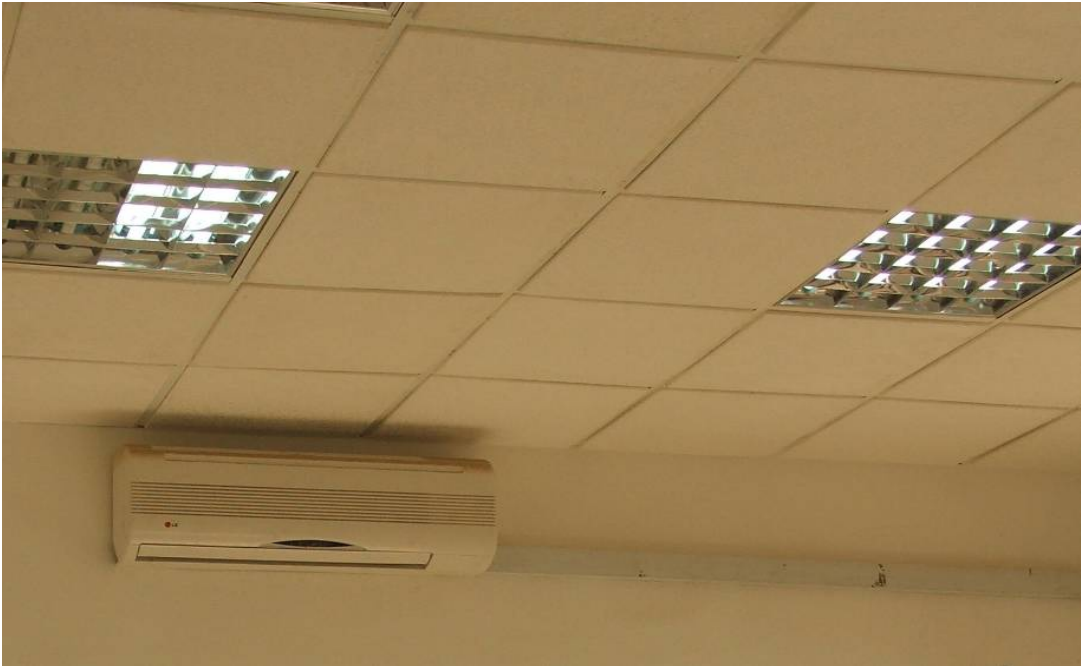
Site Photo 3. Interior Recessed Lighting and False Ceiling

The contract's BOQ required the supply and installation of 714 m² of false ceiling, consisting of Gypsum tiles on metal grid. During the site assessment, we observed installed false ceiling tile in all three of the interior rooms visited. The installation of false ceilings appeared to be consistent with the requirements of the contract. Site Photo 3 shows the false ceiling inside the Babil Railway Station.

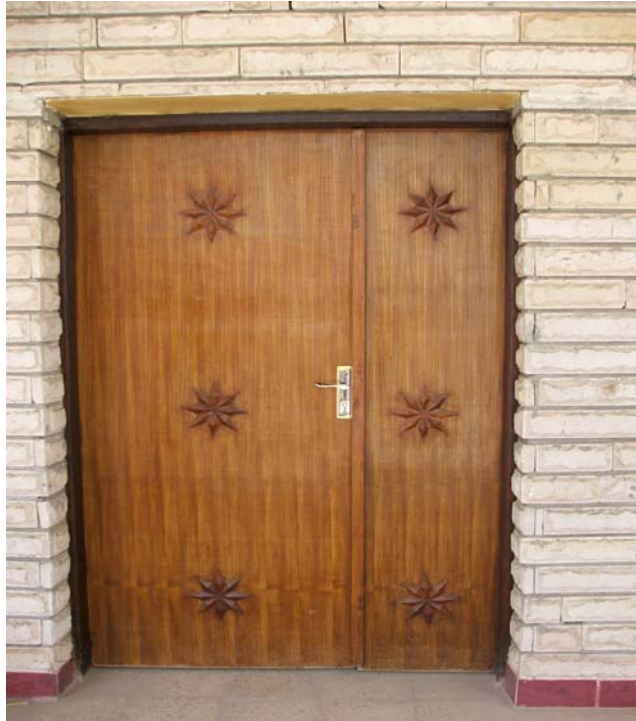
The contract's BOQ required the supply and installation of thirty heavy wood doors and frames, eight new aluminum windows, and the repair of twenty-nine windows. During the site visit we observed installed windows, which appeared new, and new and/or refurbished doors. No deficiencies were noted; however, only a small percentage of the doors and windows were inspected.

The exterior wooden door can be seen in Site Photo 6. Site Photo 7 shows a rear exterior aluminum window.

Site Photo 6. Exterior Wooden Door
