MOSUL AIR TRAFFIC CONTROL
TOWER AND NAVIGATIONAL AIDS
MOSUL, IRAQ

SIGIR PA-06-034
APRIL 25, 2006

SUBJECT: Report on Project Assessment of the Mosul Air Traffic Control Tower and
Navigational Aids, Mosul, Iraq (Report Number SIGIR-PA-06-034)

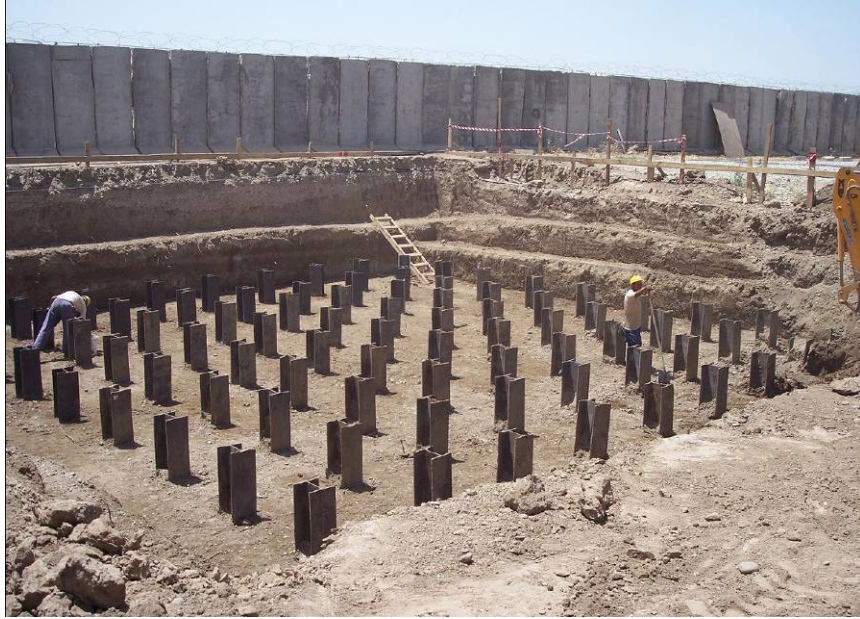
Site Photo 1. Foundation construction with steel piles
- Photo provided by USACE

Site Photo 1 shows the piles in place after completion of the pile driving operations. Site Photo 2 shows steel reinforcement positioned above the piles prior to concrete placement. Although we were not present to observe any of the foundation construction, which took place months earlier, our review of the site photos and daily Quality Control (QC) reports indicate the foundation was constructed properly in accordance with the contractor's design.

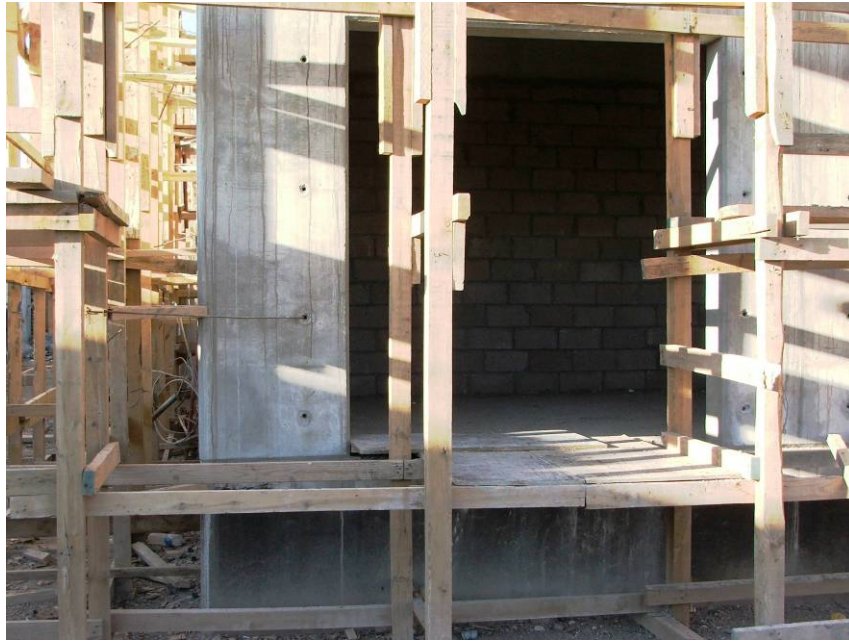
Site Photo 4. Ground floor electrical room in the ATC tower building

For an example of the ground floor construction, refer to Site Photo 4, which shows the door opening into the ground floor electrical room. For an example of the interior construction on one of the upper floors, refer to Site Photo 5, which shows the reinforced concrete walls and ceiling slab typical of what we found in the tower.

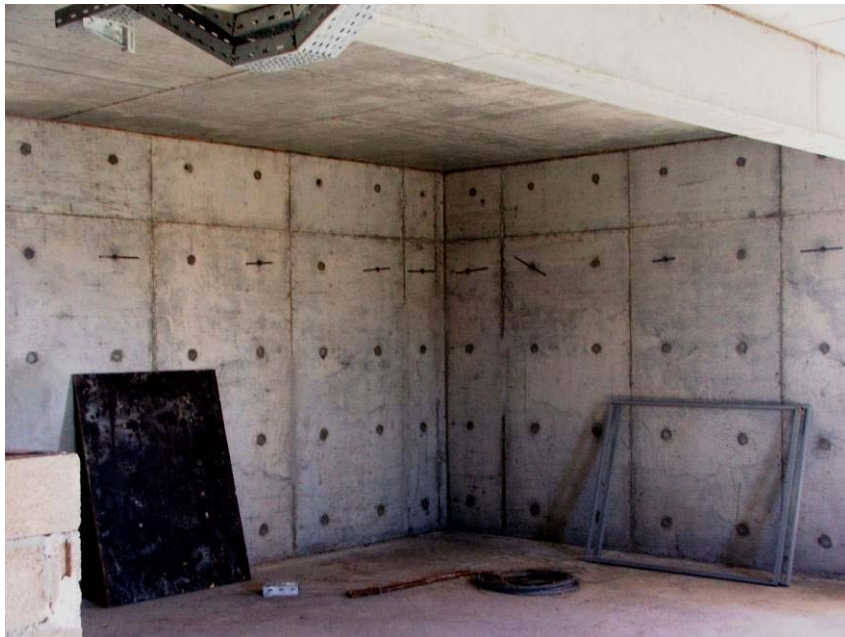
Site Photo 5. Reinforced concrete walls, floor, and ceiling in the ATC tower

Site Photo 5 is representative of the high quality of workmanship of the reinforced concrete work in the ATC tower facility. The finish of the concrete surfaces was smooth and devoid of any noticeable defects such as segregation or honeycombing.

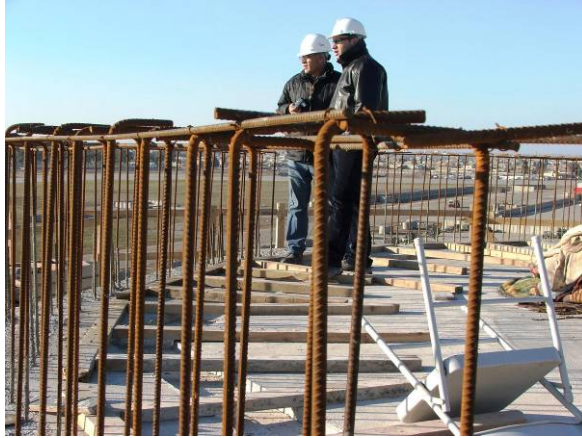
Site Photo 6. ATC tower concrete base

At the time of our site visit, the reinforced concrete base supporting a portion of the tower cab including the walkway was in place, but the cab had not yet been installed. Site Photos 6 and 7 show the concrete base for the tower cab and the walkway that will circle the cab. The reinforcing steel shown in each picture is part of the 1 m high reinforced concrete base that will support another part of the tower cab.

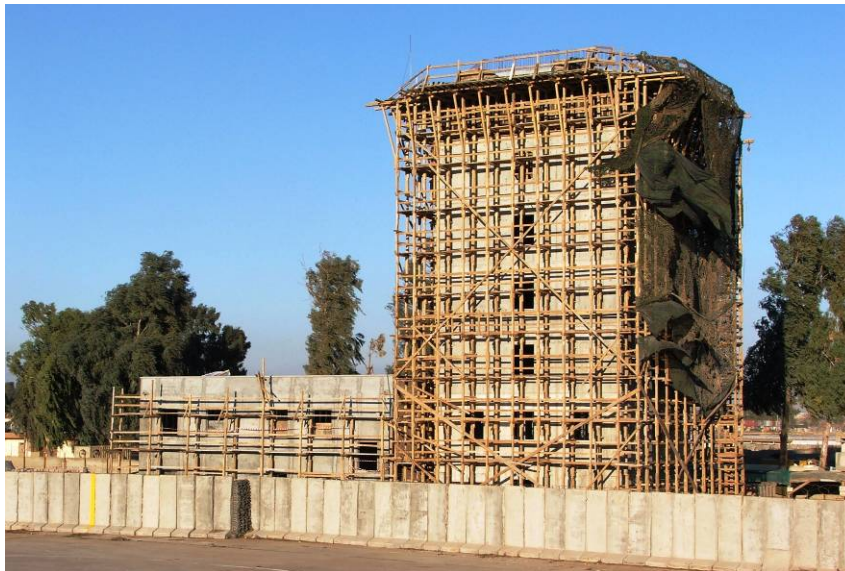
Site Photo 8. The exterior of the ATC tower facility

The administration building consisted of two floors of administrative space within a 16.4 m by 10 m structure to support 30 people. The ground level floor plan included a conference room and work shops, as well as bathrooms. The first floor consisted of office space for the staff supporting air operations. Site Photo 8 shows an exterior view of the ATC tower facility, with the administration building on the left.

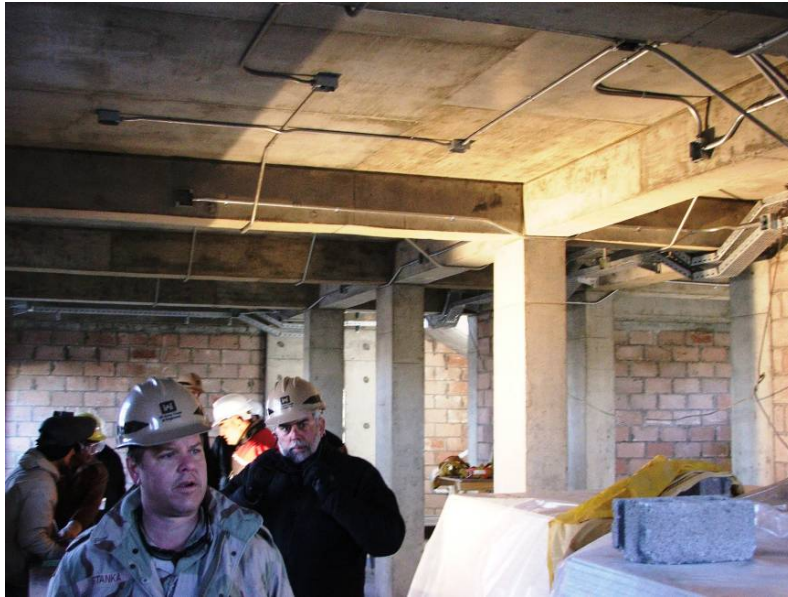
Site Photo 9. Ground floor in the ATC tower administration building

a plaster coating and painted. At the time of our site visit, the structural frame and exterior walls had been constructed and the contractor was working on plastering the exterior. Electrical conduit and cable raceways were being installed in the interior. Site Photo 9 shows the CMU walls, reinforced concrete columns, beams and roof slab in the ground floor area. The photo also shows electrical conduit and cable raceways being installed and anchored to the concrete.

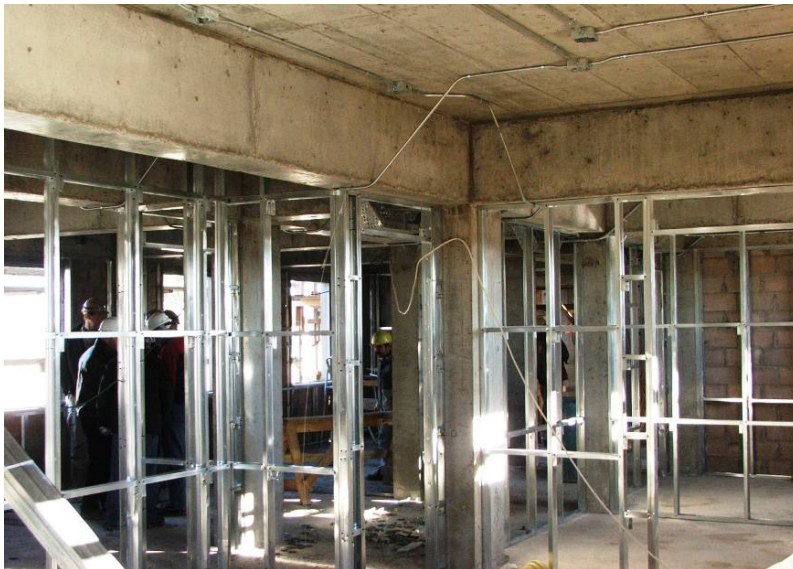
Site Photo 10. Interior wall construction in the ATC tower administration building

We also observed interior wall construction during the site visit. Site Photo 10 shows the metal studs in place for office walls located in the first floor.

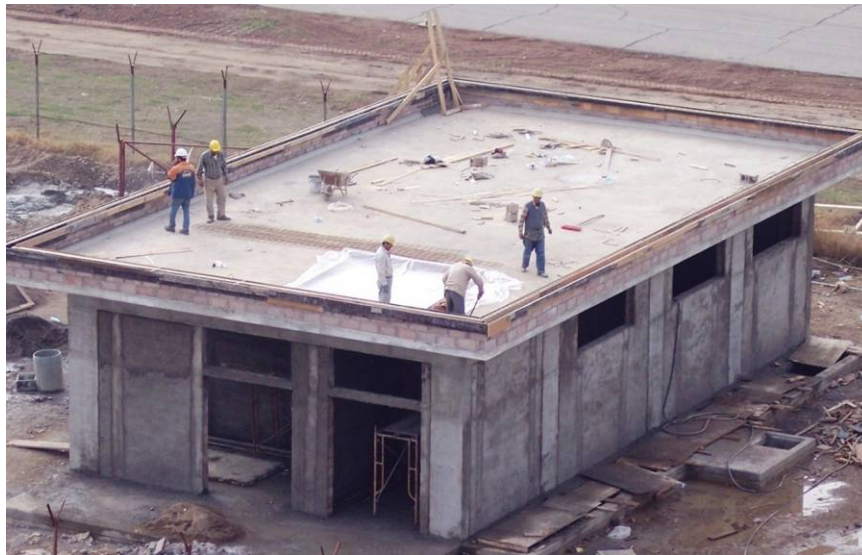
Site Photo 11. Substation 1 during construction –Photo provided by USACE

The same building design was utilized for each substation. The substations were designed as a single level, 8.8 m by 16.5 m rectangular reinforced concrete structure with exterior and interior concrete block walls as shown in Site Photo 11.

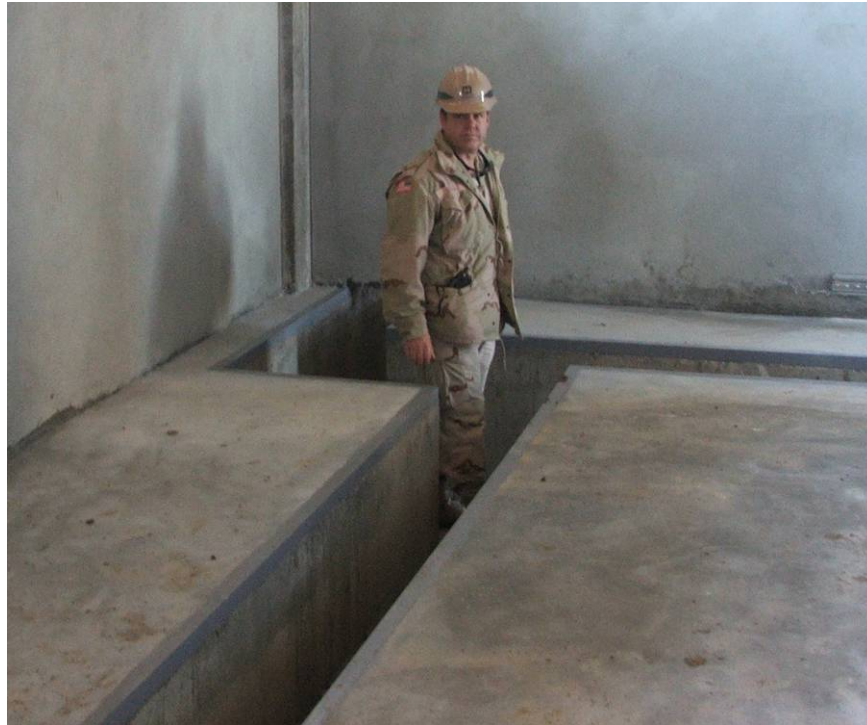
Site Photo 12. Recessed cable raceways in the substation

The floor plan included a room for electrical switchgear, as well as separate rooms for controls, a transformer, and a generator. To accommodate the placement of electrical cables and connection to equipment, recessed raceways were located in the concrete floors. Site Photo 12 shows the raceways.

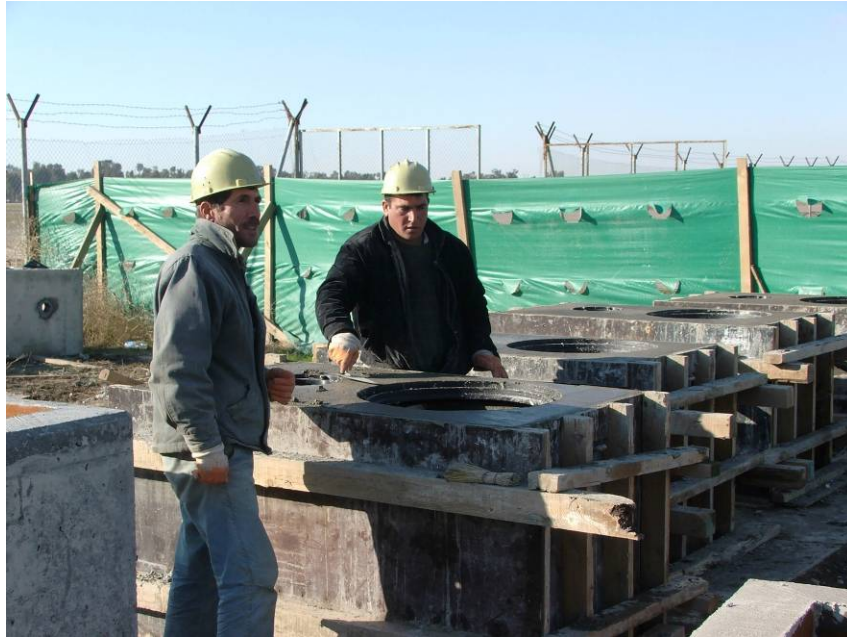
Site Photo 13. Pre-cast concrete hand holes being constructed

The contractor had set up a pre-cast operation at their equipment lay down yard adjacent to the ATC tower. Their operation appeared to be very efficient in producing large numbers of hand holes for the project. According to the USACE Resident Engineer, 312-hand holes were required for the runway and taxiway

lighting systems. Site Photo 13 shows the pre-cast operation for constructing the hand holes and Site Photo 14 shows a hand hole in place along the taxiway and also shows the mounting enclosure for the taxiway luminaries.

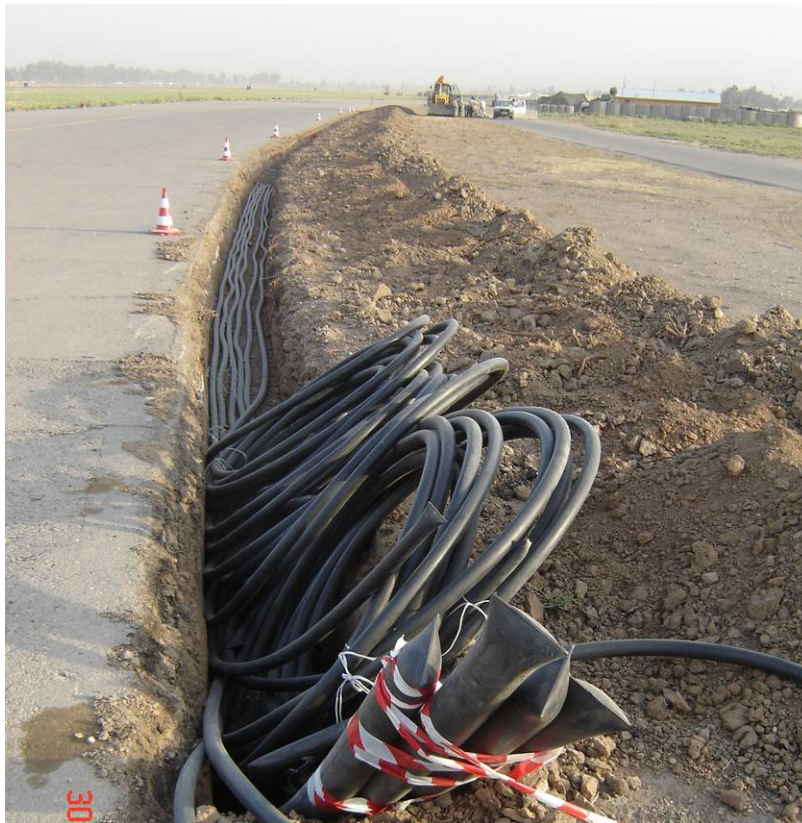
Site Photo 15. Conduit installation for NavAids – Photo provided by USACE

The luminaries for taxiway and runway edge lighting were required to be installed onto breakaway mountings. The design also required the electrical cable connecting the lights and other NavAids to the power source to be encased in PVC conduit. Site Photo 15, provided by the USACE, shows the trenching and PVC conduit installation for various NavAids, including taxiway edge lighting.

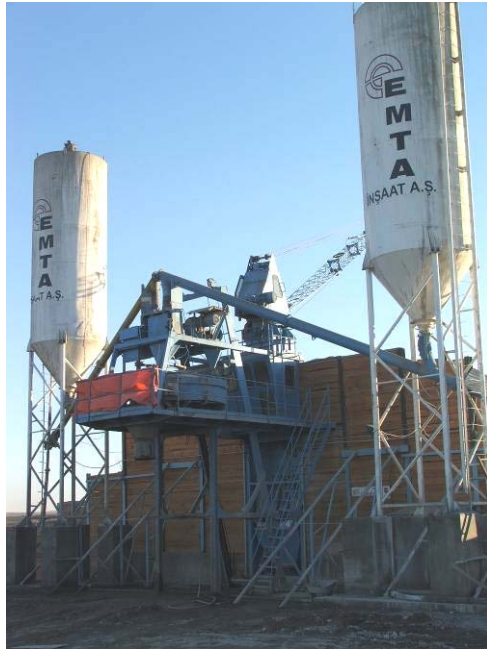
Site Photo 16: Concrete batch plant

A significant component of the ATC tower facility included structural concrete. The amount of concrete needed to construct the facility necessitated the utilization of materials, equipment, and processes that could produce consistent mix proportions when batching concrete. To meet the demand for high quality structural concrete, the contractor erected a concrete batch plant near the construction site on an adjacent FOB. The batch plant, shown in Site Photos 16 and 17, included two cement silos, separate stockpiles for coarse and fine aggregate, a water storage tank, and automated controls for mixing materials.
