NEW 2ND BRIGADE BASE
KIRKUK, IRAQ

SIGIR PA-06-041
APRIL 20, 2006

SUBJECT: Report on Project Assessment of the New 2nd Brigade Base, Kirkuk, Iraq
(Report Number SIGIR-PA-06-041)

New 2nd Brigade Base, Kirkuk, Iraq

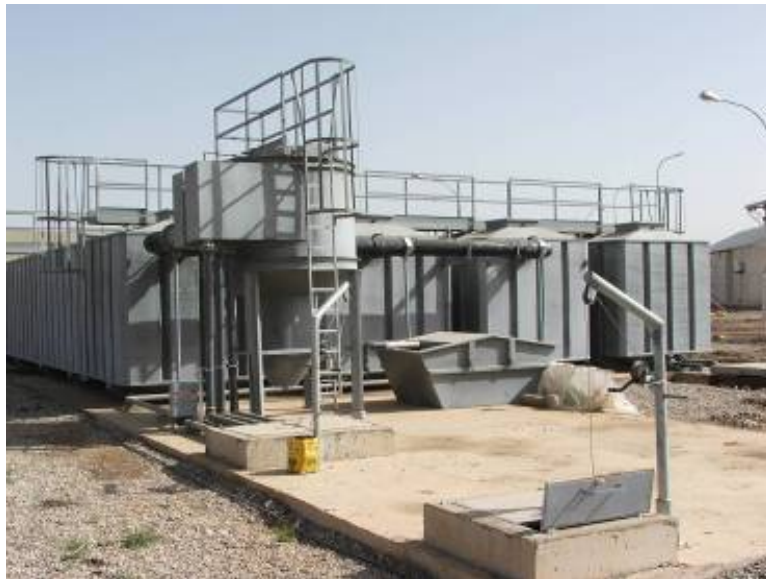
At the time of the assessment, the selection and fabrication of the wastewater treatment system was complete and the system was in-use (Site Photo 2). The treatment system used physical, biological, and chemical processes to purify the water before discharge. Site Photos 3 and 4 show the flow diagram and a filter press for the wastewater treatment plant, respectively. The wastewater treatment plant appeared to meet the contract requirements.

Site Photo 2. Waste water treatment plant

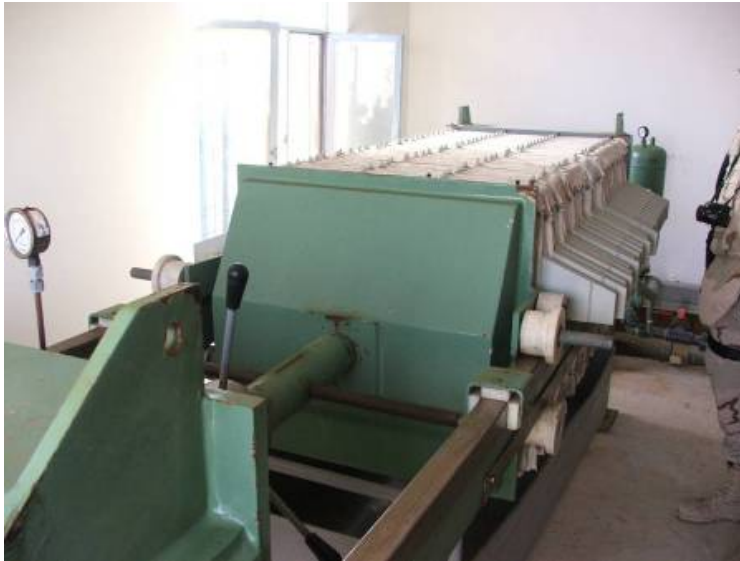
Site Photo 4. Filter press for waste water treatment plant

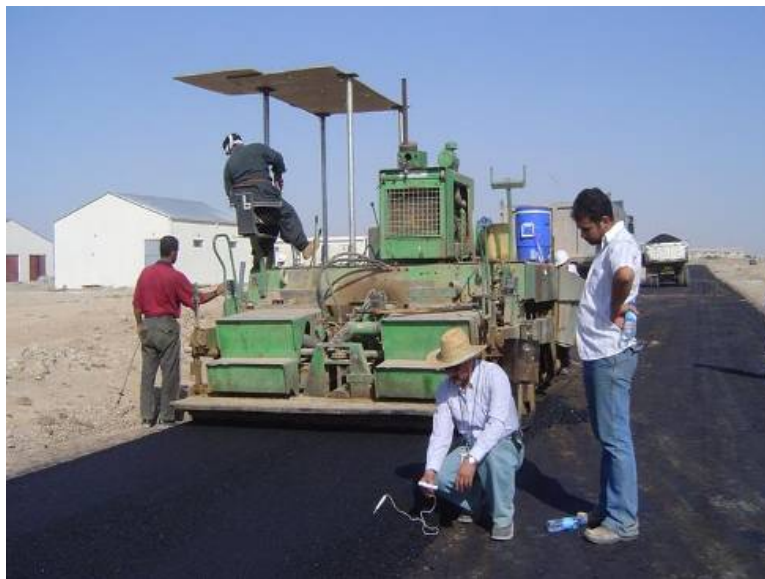
The asphalt roads, concrete sidewalks, parking areas, gravel pads, parade grounds, and soccer fields appeared to meet the contract requirements and were in-use.

Site Photo 5. Asphalt road under construction (Photo courtesy of ECC)

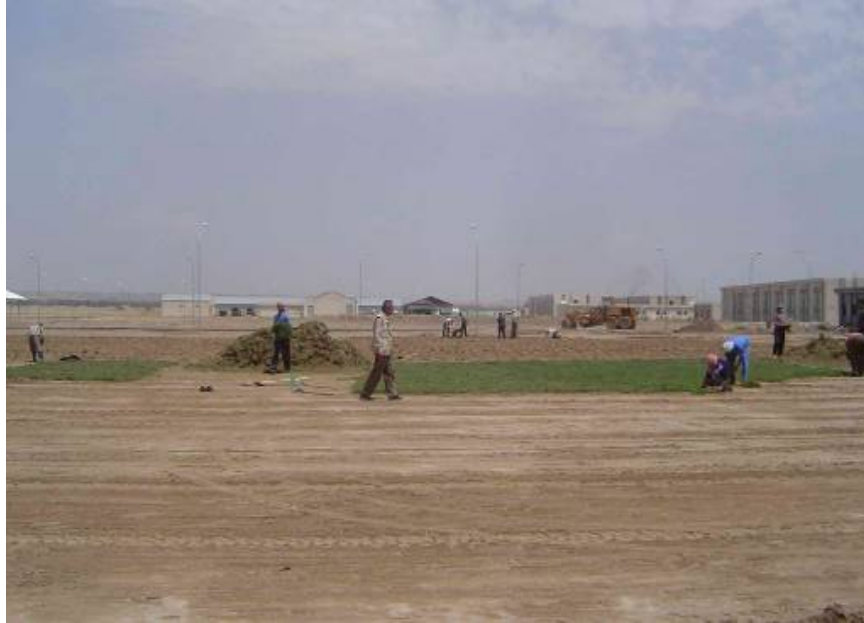
During the site visit, we observed a completed parade ground with reviewing stand and four soccer fields. Site Photo 6 shows the soccer field during construction, while Site Photo 7 shows a soccer field in use by Iraqi soldiers at the time of our assessment.

**Site Photo 6. Soccer field under construction
(Photo courtesy of ECC)**

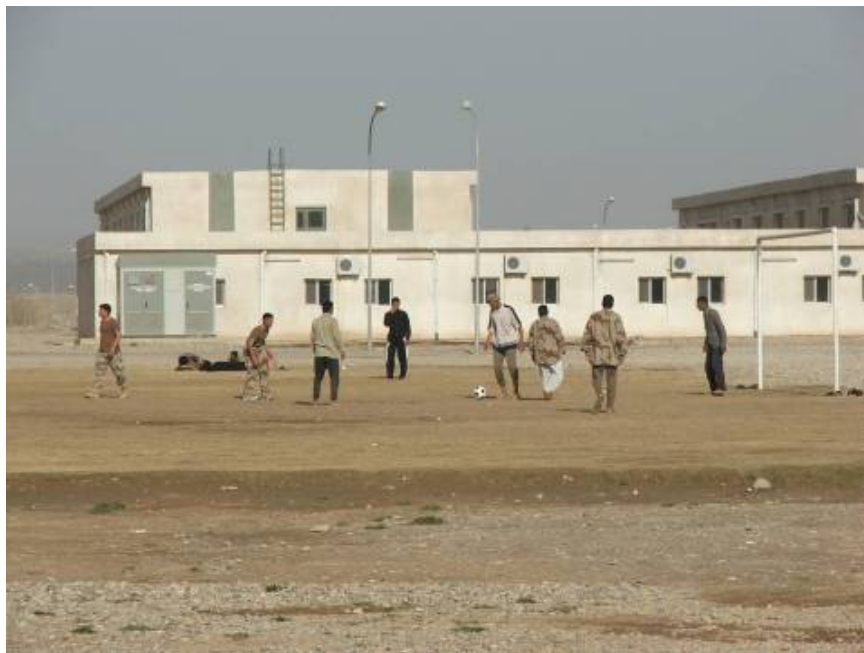
Site Photo 7. Iraqi soldiers using soccer field

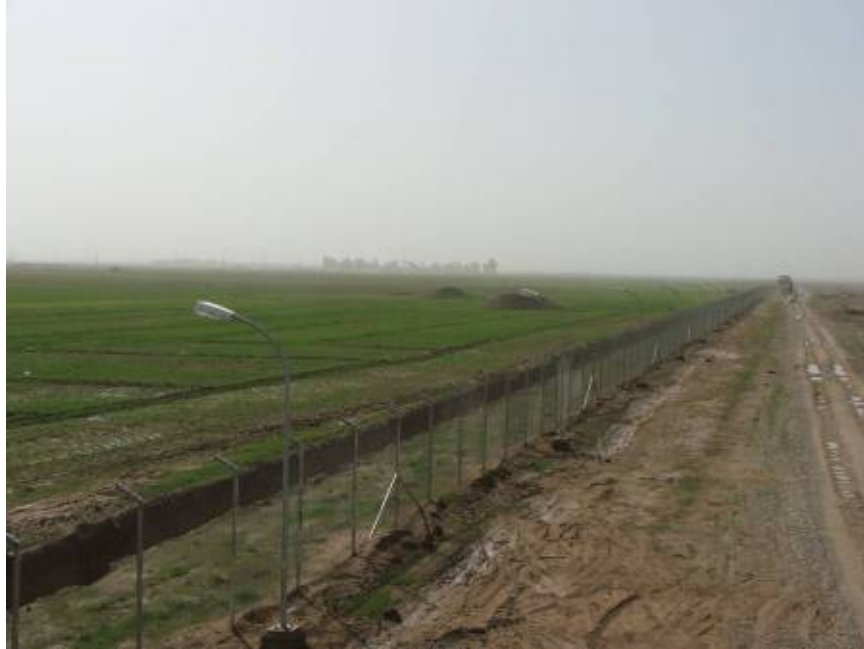
The contract required the construction of a perimeter security fence. The design specifications required a lighted fence around the perimeter of the base with a concrete wall, berms or a trench, and observation posts. We observed a perimeter fence, trench, and observation posts manned with armed guards, as shown in Site Photos 8 and 9, respectively. Concrete walls, berms, and trenches were installed to prevent vehicles from easily driving through the fence. The fence, vehicle obstacles, and manned guard observation post observed during the assessment appeared to meet the design specifications and be practical and functional.

Site Photo 8. View of fence and trench from observation post

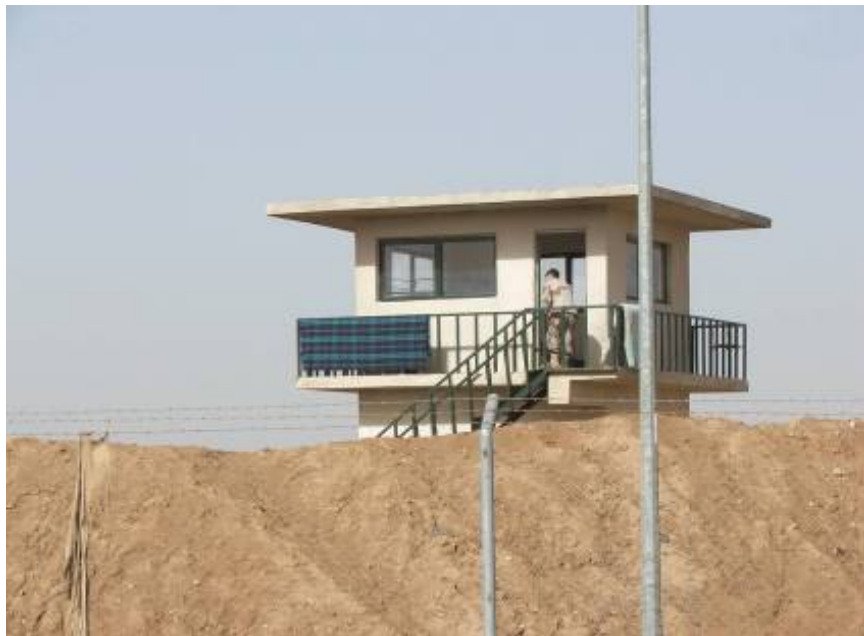
Site Photo 9. Observation Post

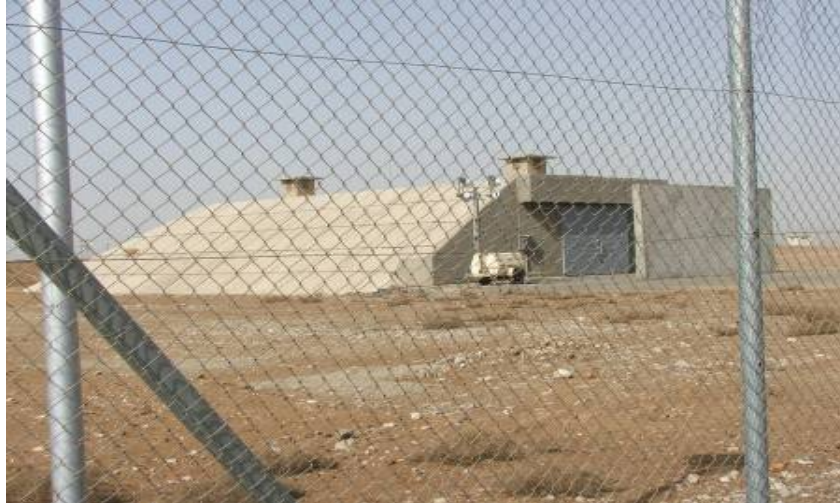
At the time of the assessment, the design and renovation work for the ammunition supply point (ASP) was complete (Site Photo 10). The SORS originally required the new construction of an ASP facility, with the size of the facility 40 meters by 60 meters and 4 meters tall. A subsequent contract modification cancelled the construction of a new ASP facility and required the renovation of an existing building to meet ammunition storage requirements. We were told that the ASP was in use for the intended purpose.

Site Photo 10. Ammunition supply point

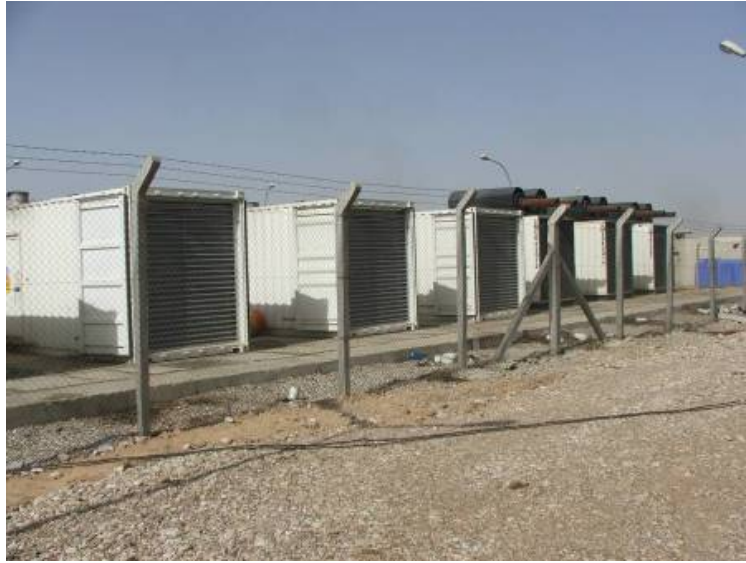
power. A group of eight self-contained 1 MW diesel generators were installed and in-use for their intended purpose of providing electrical power to the base (Site Photo 12).

Site Photo 12. Eight 1MW electrical generators

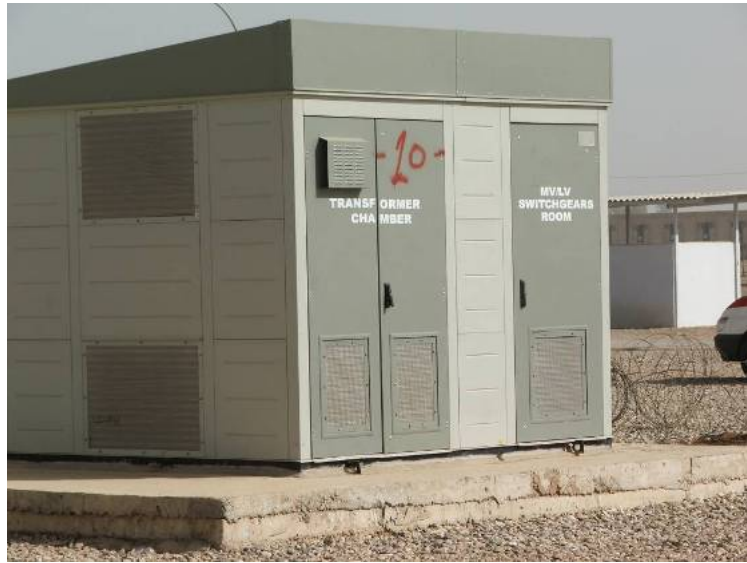
The power distribution system consisted of power transmission lines, including high and low voltage cable, switchgear, transformers (Site Photo 13), concrete pads, security fencing, covered central fueling station with a containment system (Site Photo 14), cooling system, generator building, and generator office. The central fuel supply requirements were to provide double walled tanks with two supply fittings, a concrete pad with a spill retention wall, grounding, and shading. The 24-hour fuel supply appeared to meet the requirements of the contract and was in-use at the time of the assessment.

Photo 13. Electrical transformers and switchgears

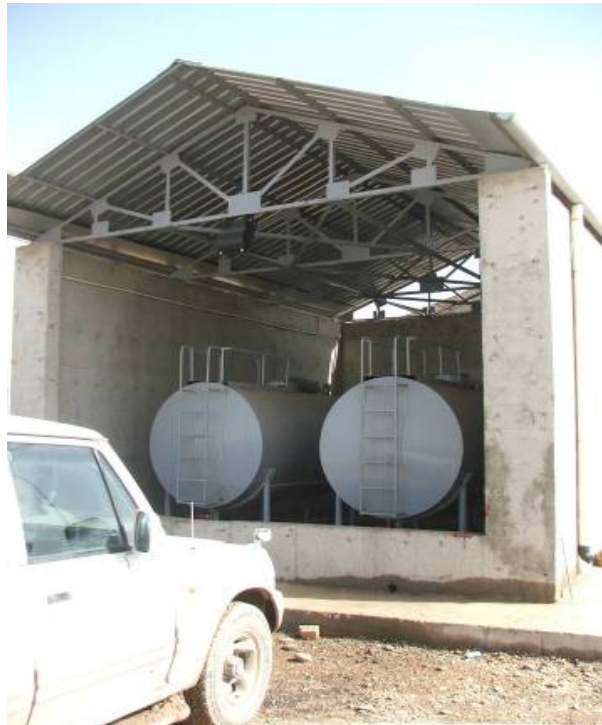
Photo 14. Central fuel supply

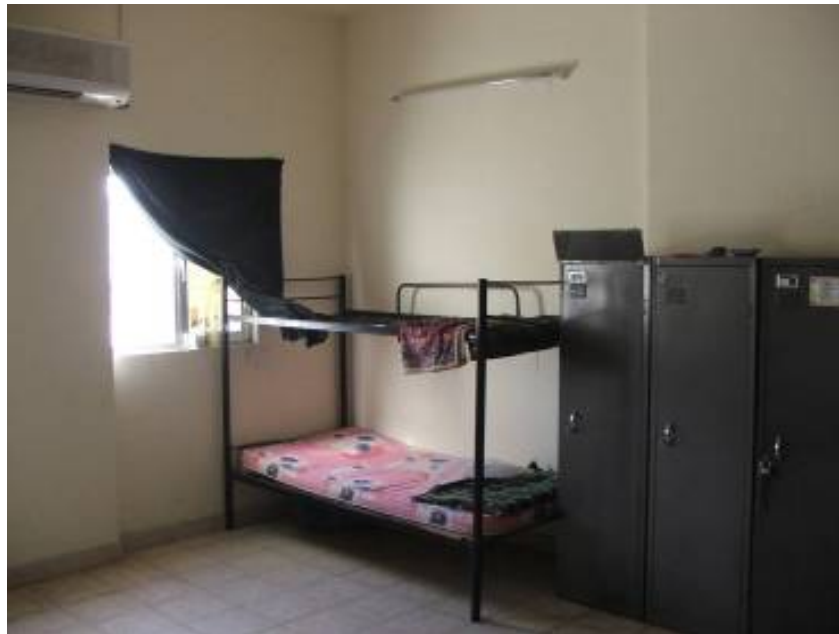
The barracks appeared to meet the requirements of the contract. We observed lighting, fans, electrical outlets, laminated glass windows, fire alarm and air conditioning systems, which appeared to be functional and meet contract requirements. Site Photos 17 and 18 show the outside of the barracks and a bunkroom in the enlisted barracks.

Site Photo 18. Sleeping quarters of enlisted barracks

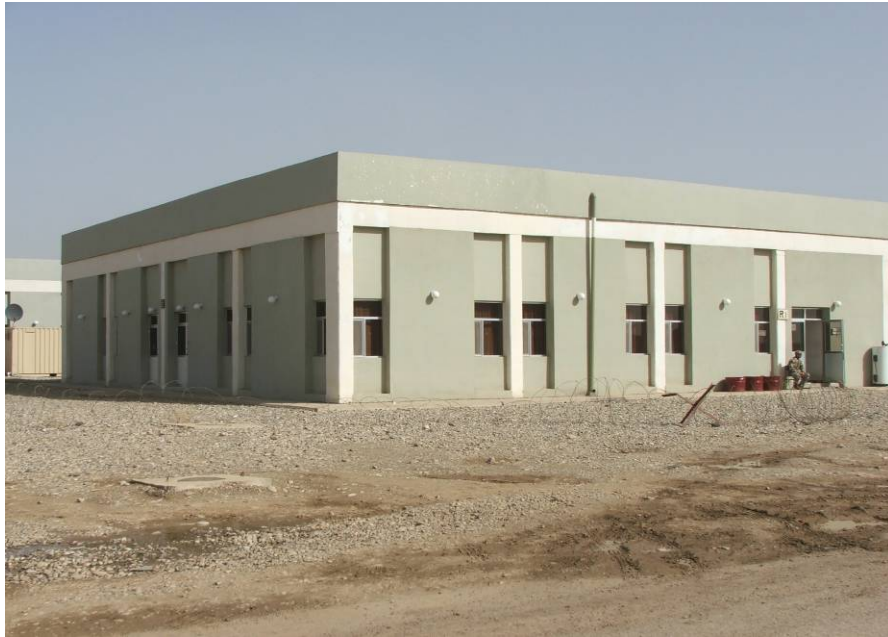
The SORS required the construction of three dining facilities, each in the approximate size of 24 meters x 30 meters and capable of seating 256 soldiers at a time. At the time of the assessment, the design and construction of the dining facilities were complete (Site Photo 19). Site Photos 20 and 21 show the dining facility in-use for lunch and during cleanup, respectively. From the brief site visit and from viewing the photos taken during construction, the dining facilities appear to have met the contract specifications. Due to the customs and preference of the Iraqi cooks, the contractor provided gas burners for the

Site Photo 19. Outside of dining facility building

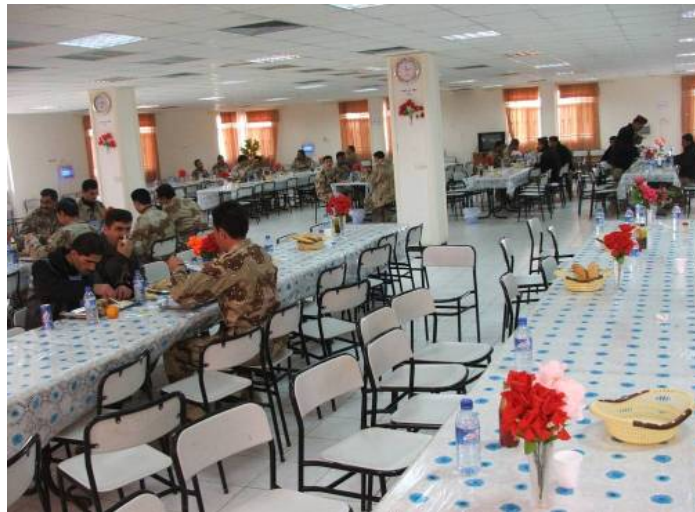
Site Photo 20. Dining facility in use

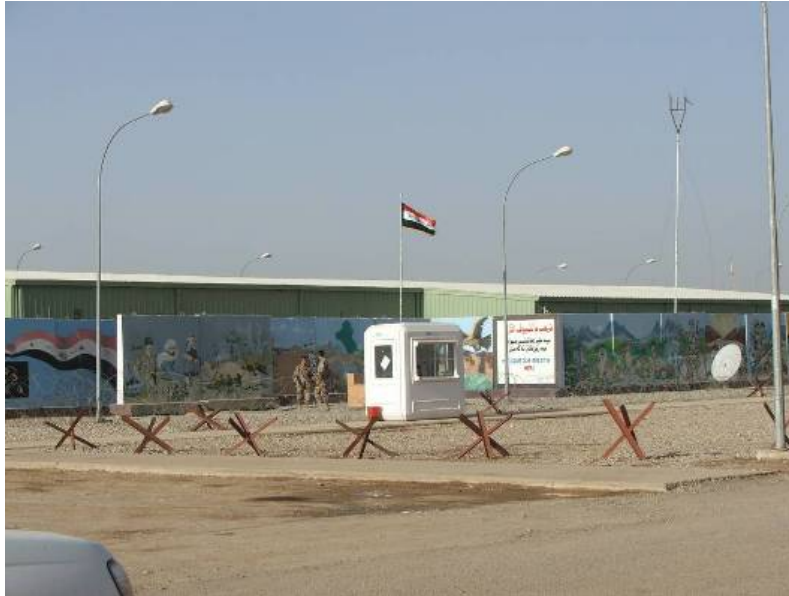
At the time of the assessment, the headquarters building design and construction were complete. The single story headquarters building was behind the concrete walls, as shown in Site Photo 23. Due to the time limitation on site, we did not assess the headquarters building during this visit.

Photo 23. Headquarters building

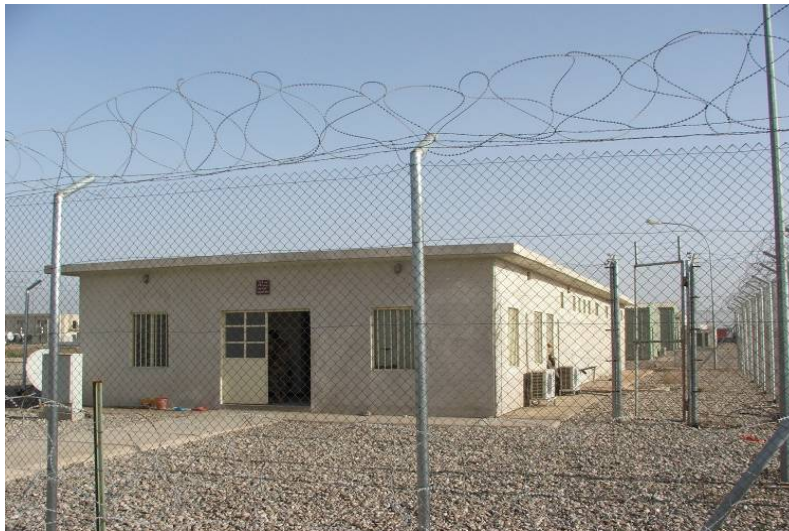
During the assessment, we visually observed the outside of the jail facility (Site Photo 24). The design and the construction of the jail were complete. The jail was in-use at the time of the assessment and therefore the assessment team did not have the opportunity to examine the inside or outside of the facility close-up. Instead, the assessment team reviewed the contractor's during and after construction photographs to determine whether the jail met the intent of the contract's requirements. It appears the jail did meet the specifications of the design.

Site Photo 24. Jail facility

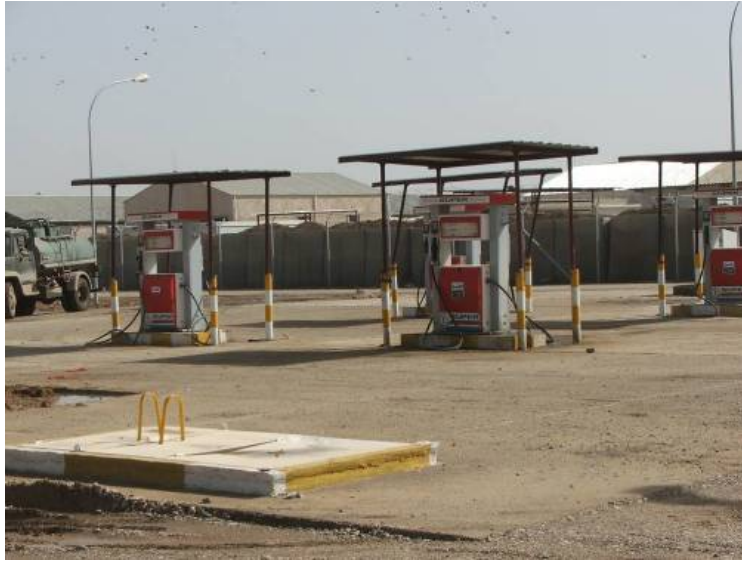
At the time of the assessment, the design and construction of the gasoline station were complete (Site Photo 25). The design was changed to consolidate all gasoline stations into this one station for better management and control. The station appeared to be level with good drainage of the concrete pad. The facility had a small office, four covered

gasoline pumps, and two underground tanks. The gasoline station appeared to meet the specifications of the design and to be well constructed.

Site Photo 25. Gasoline station

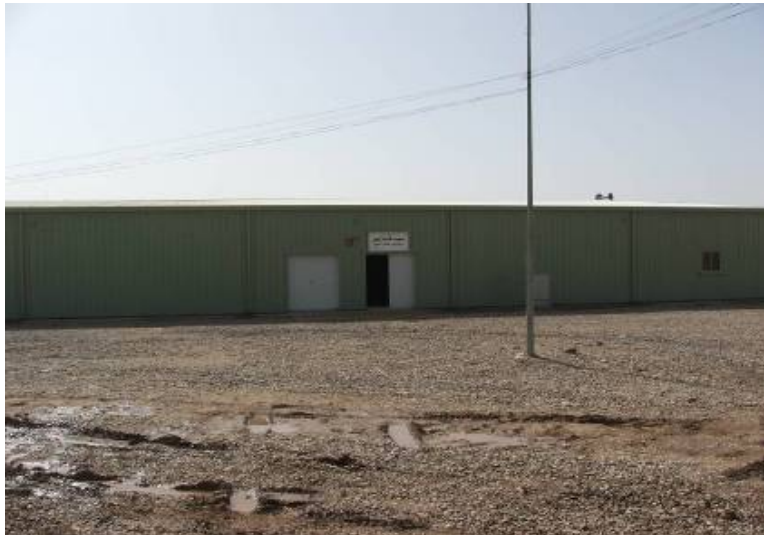
At the time of the assessment, the mosque design and construction were complete and the mosque was in-use (Site Photo 26). The SORS required the mosque comply with local customs. In keeping with local Iraqi tradition of not entering the mosque with dirty feet, the contractor provided a separate restroom next to the mosque, which allowed the Iraqi Army soldiers the opportunity to wash their feet prior to entering the mosque (Site Photo 27). It appears the mosque did meet the specifications of the design.

Site Photo 26. Front view of mosque

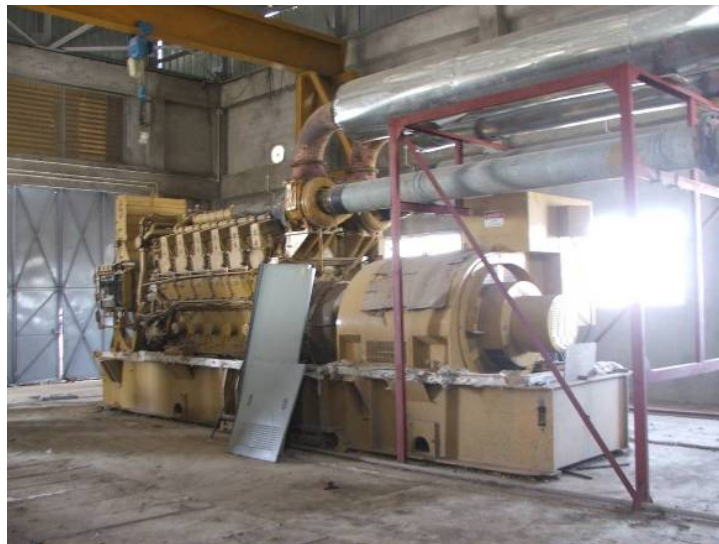
Work was pending on the installation and commissioning of the second bank of generators for the primary power distribution system. The two remaining primary power generators were government furnished equipment that was surplus from another site outside of Iraq. Each of the diesel generators was rated to produce 2.5 MW of electricity. The generators had been installed on a new concrete pad with a new generator building constructed around them. The contractor was in the process of connecting and commissioning the generators. Synchronization and load sharing of the power generation system was required to complete the contract. Site Photo 30 shows one of the generators inside the new generator building. We observed the installation of supporting equipment for the power generation system, such as the fuel supply and the cooling system (Site Photo 31), which appeared to meet the contract requirements.

Site Photo 30. 2.5 MW Electrical generator provided as government furnished equipment

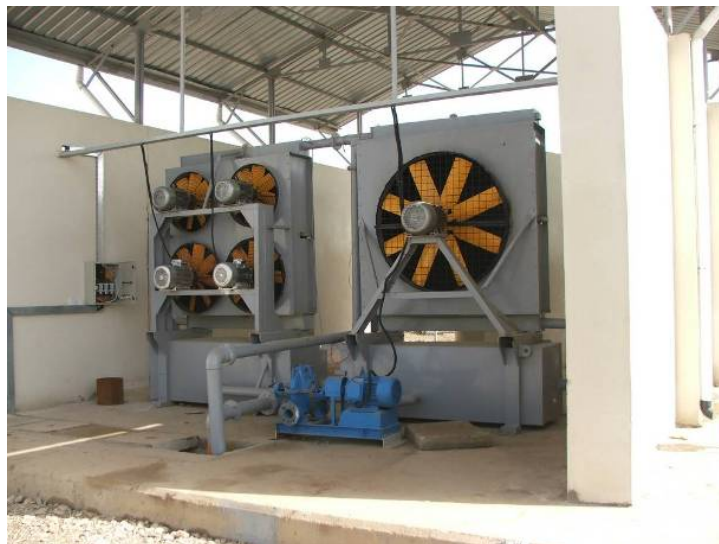
Site Photo 31. Generator building cooling system

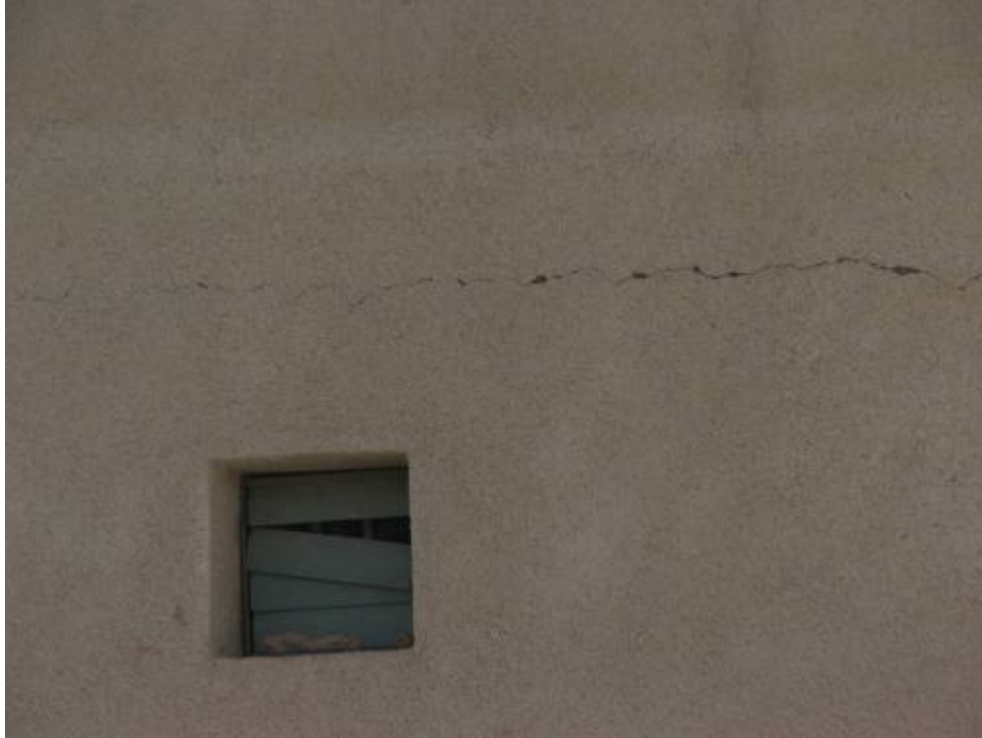
We observed warranty items, such as cracks in the exterior stucco walls (Site Photo 32), which need repair.

Site Photo 32. Crack in exterior stucco wall
