BASRAH INTERNATIONAL AIRPORT –
AIR SIDE POWER SUPPLY TO
NAVAIDS AND VISAIDS
BASRAH, IRAQ

PROJECT NUMBER SIGIR-PA-06-050

JUNE 30, 2006

SUBJECT: Basrah International Airport – Air Side Power Supply to NAVAIDS and
VISAIDS, Basrah, Iraq (Report Number SIGIR-PA-06-050)

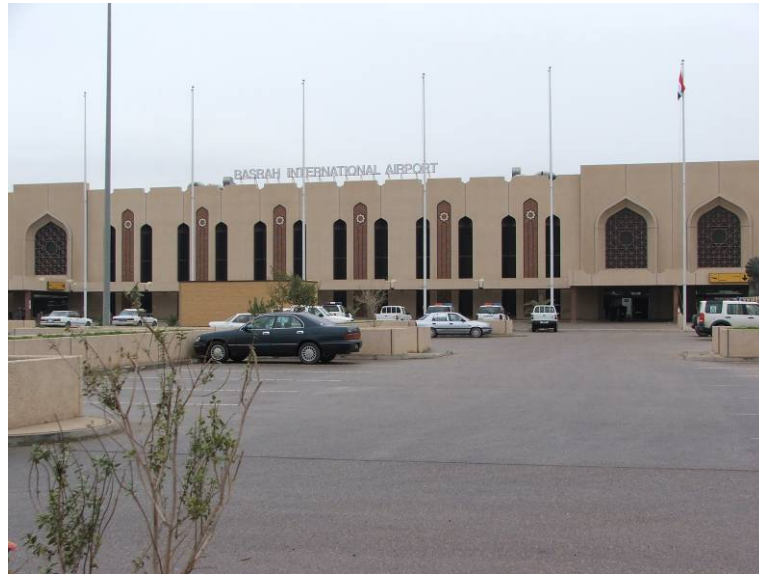
The BIA was an existing airport located outside of the city of Basrah in southern Iraq. Site Photo 1 shows the exterior of the terminal building at BIA. The airport is one of three major airports in Iraq. The airport electrical distribution systems were not operational because the systems were not properly maintained throughout the previous regime, and the electrical systems were damaged, looted, and cannibalized.

Site Photo 1: Exterior view of the terminal building

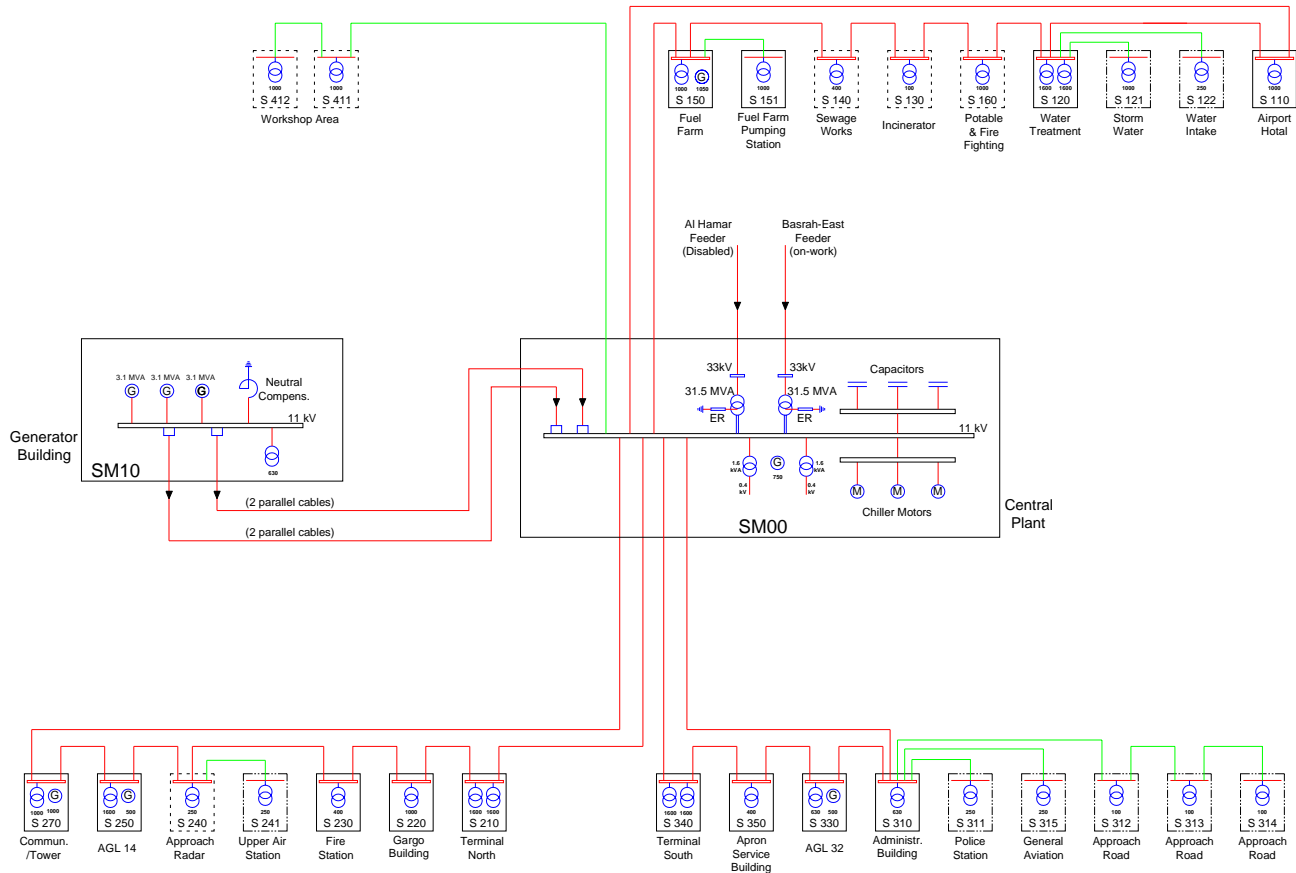
Based on information from the contract files, the BIA electrical system is serviced through two 33 kV (transmission voltage) feeder lines and three on-site generators. The feeder lines transmit power to switchgears and step-down transformers, which convert the electricity from 33 kV to 11 kV. The on-site generators were designed to produce 11kV electricity. The 11 kV electricity, referred to as medium voltage (MV), is distributed through three distribution circuits and are referred to as MV-1, MV-2, and MV-3. The distribution circuits transmit the 11kV electricity to secondary transformers, located at individual facilities within the airport. The secondary transformers convert the voltage from 11kV to 0.4 kV for usage. Figure 1 shows the schematic of the electrical distribution system at the BIA.

Figure 1: Schematic of electrical distribution system at the Basrah International Airport

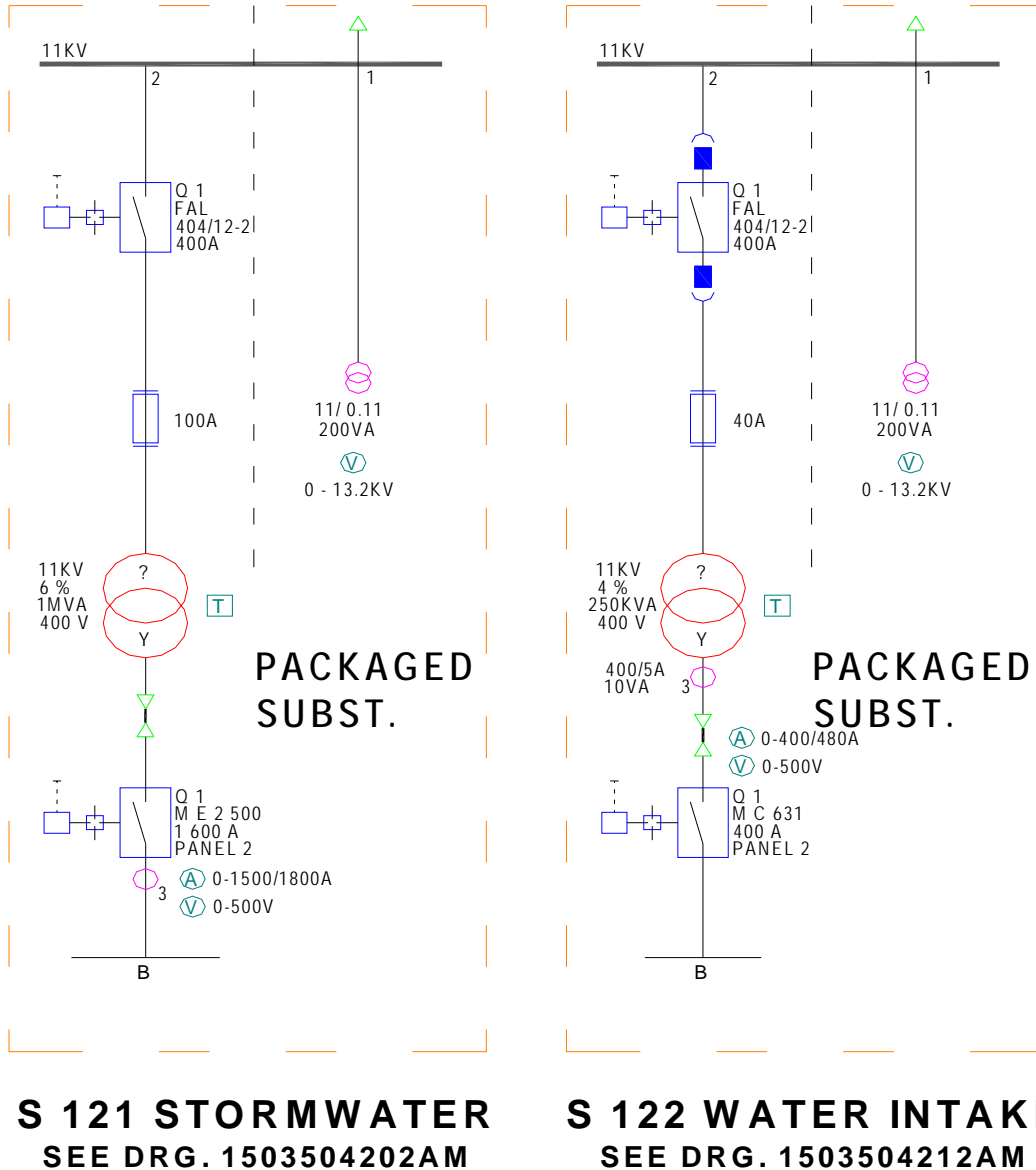
The electrical schematic diagram included the complete BIA MV system with the three MV rings and individual substations. Specific details for the quantity and type of components were included within the schematic. Figure 2 shows an example of a portion of the schematic, which included electrical system details for two of the substations.

Figure 2: Excerpt from PDR schematic showing details of the electrical distribution system at the Basrah International Airport

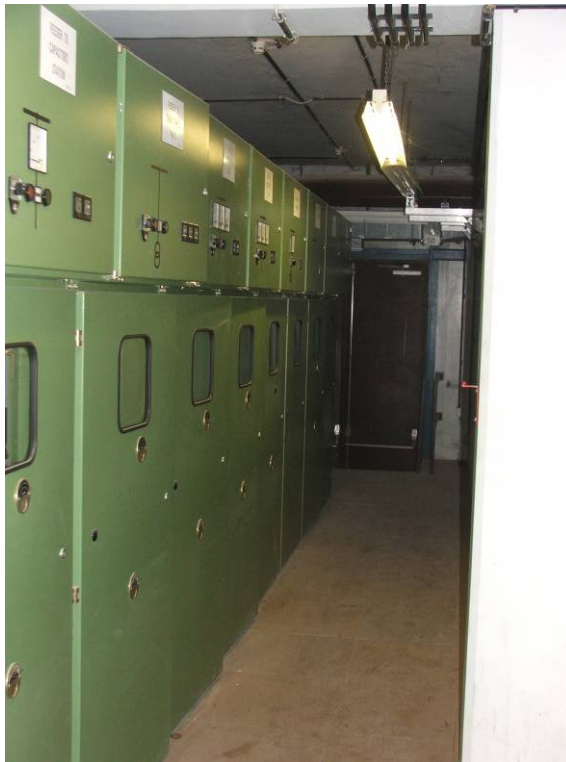
The main plant facility is located across a large parking area from the BIA passenger terminal. The plant facility houses the airport chillers and boilers, as well as the 33 kV to 11 kV switchgears and transformers. The main plant building appeared to be in good condition, and the 33 kV to 11 kV switchgear and transformers were in-place. The 33 kV switchgear and transformers were designed to feed the three MV distribution rings to supply power to the secondary transformers for ultimate usage. At the time of the assessment, the 33 kV switchgear and transformer appeared to be complete with no obvious missing components. The final PDR ROM recommended repair, maintenance, and upgrade of the systems. Site Photo 2 shows the external cabinets of the 33 kV to 11 kV switchgears.

Site Photo 2: Exterior view of 33 kV to 11 kV switchgear cabinets

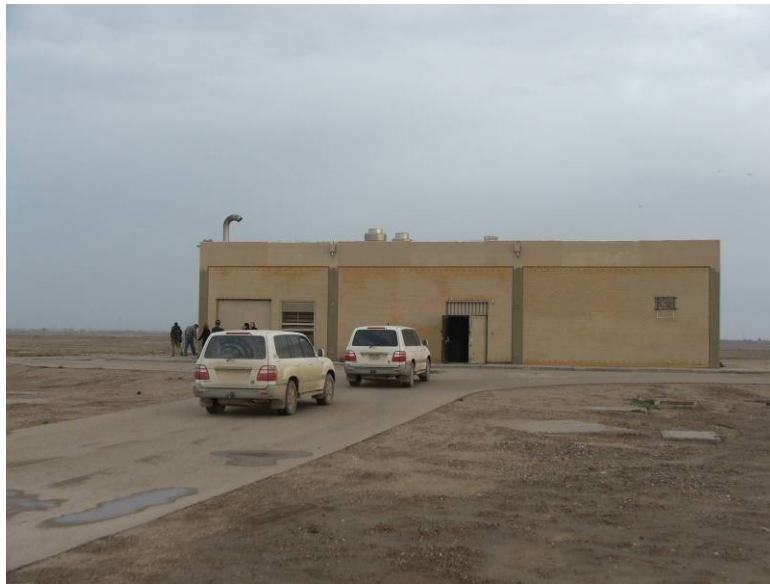
At the time of the assessment, the building appeared to be in good condition, although the electrical equipment appeared to be incomplete and was not operational. The recessed runway lighting receptacles were in-place, although the lights themselves were missing. The interim PDR recommended replacement of all equipment at S-330 and completing minor repairs to the existing building. The recommendations of the PDR were consistent with the observations during the site assessment visit.

Site Photo 3: Exterior view of S-330 substation

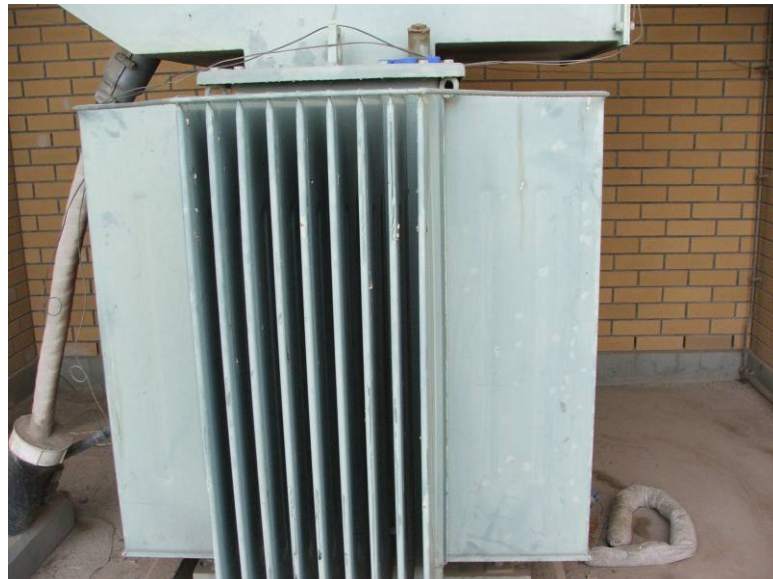
Site Photo 4: Transformer located at S-330

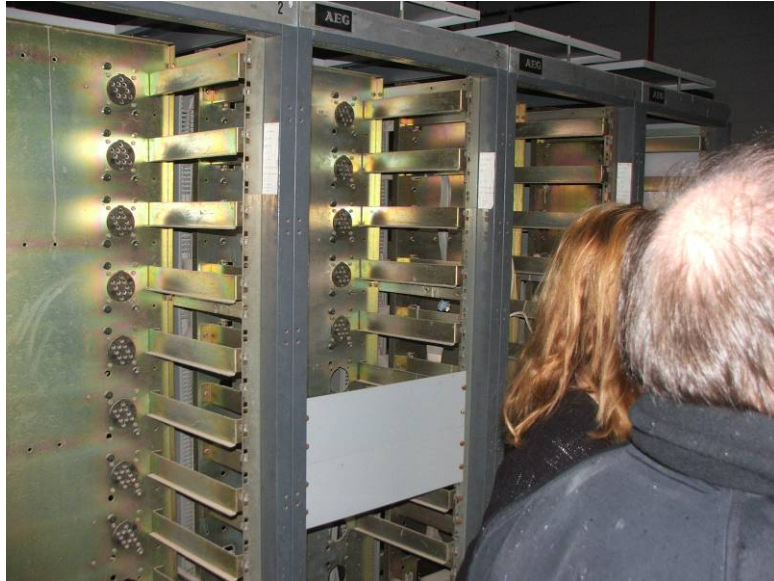
Site Photo 5: Missing electronic equipment at S-330

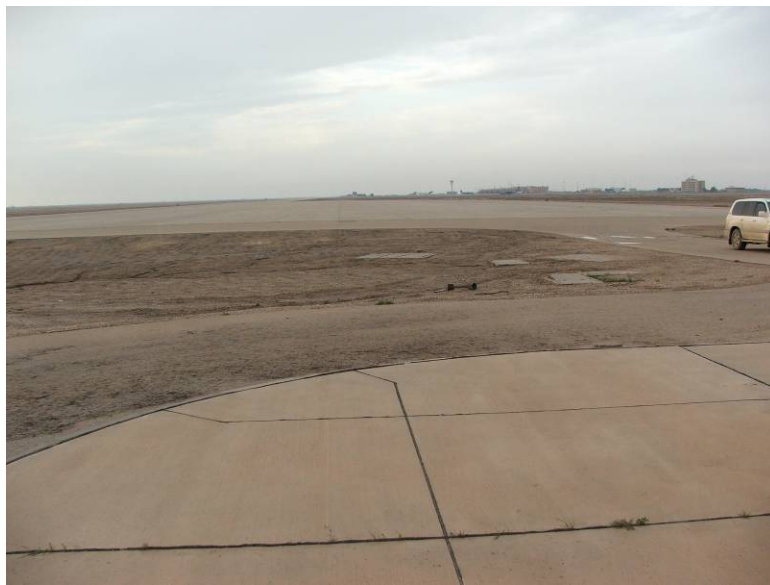
Site Photo 6: Runway system at Basrah International Airport

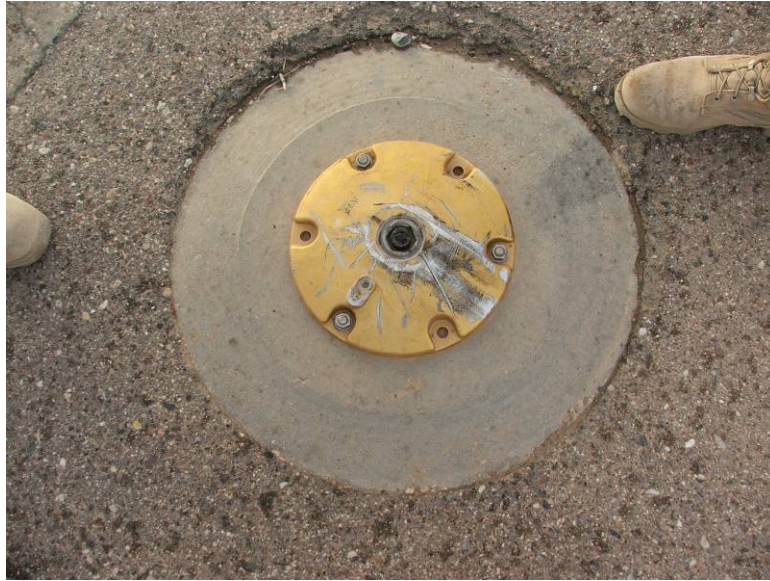
Site Photo 7: Runway light (VISAID)
