AL KAZIM WATER SUPPLY  
NASSRIYA, IRAQ

**SIGIR PA-08-125**  
**JULY 23, 2008**

SUBJECT: Report on Construction of the Al Kazim Water Supply, Nassriya, Iraq (Report  
Number SIGIR PA-08-125)

## Al Kazim Water Supply, Nassriya, Iraq

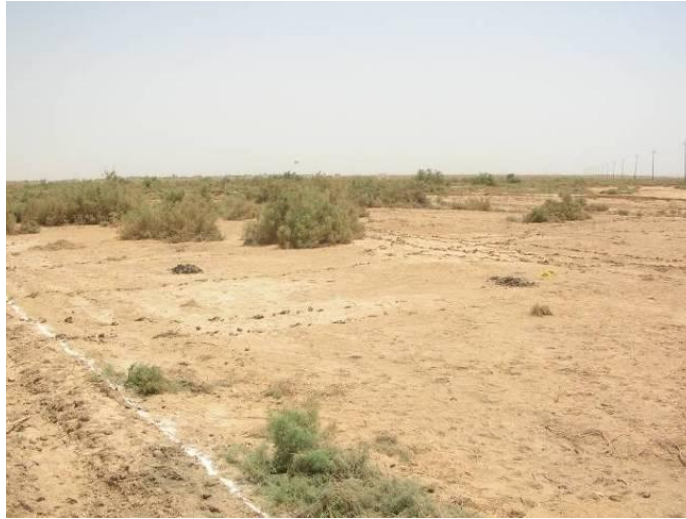
The land in general is low-lying at approximately 1-2 meters above sea level and can be well irrigated through a system of pump engines, locks, and channels (Site Photos 1 and 2).

**Site Photo 1. Location of the compact unit site (Courtesy of the USACE)**

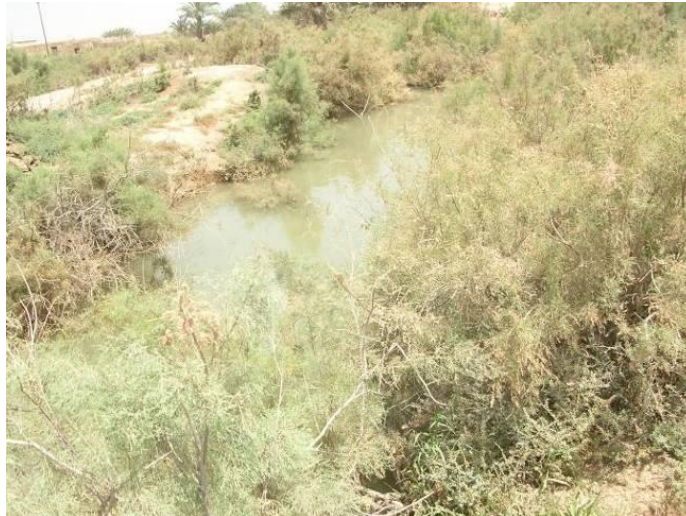
**Site Photo 2. Compact unit site's water resource (Courtesy of the USACE)**

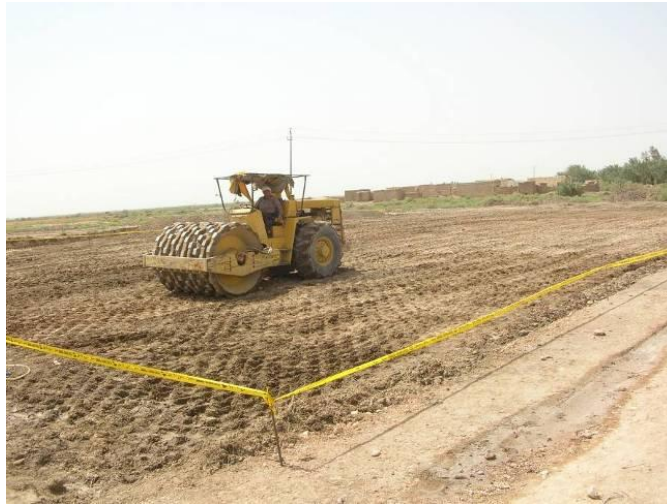
Prior to construction, the contractor excavated and leveled the site. Site Photo 3 shows the contractor's compaction of the first layer of backfill, and Site Photo 4 shows the contractor testing the compaction of the first layer of backfill.

**Site Photo 3. Compaction of first layer of backfill (Courtesy of the USACE)**

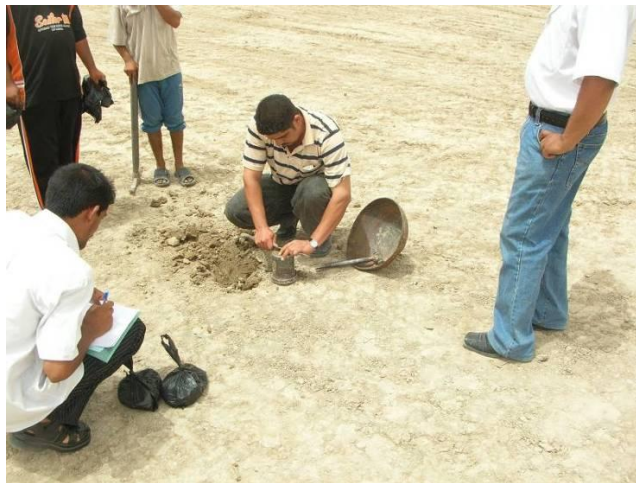
**Site Photo 4. Compaction test of first layer of backfill (Courtesy of the USACE)**

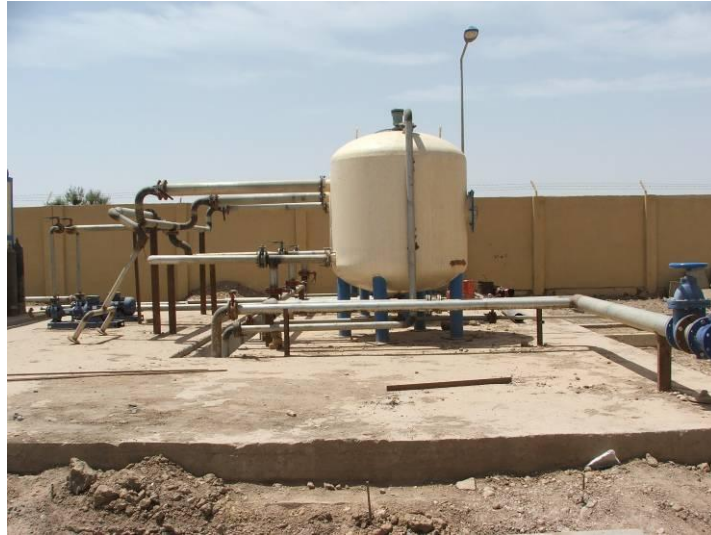
The contractor constructed a new reinforced concrete pad for the 50-m<sup>3</sup>/hr compact unit water treatment plant (Site Photo 5). The structural concrete SIGIR observed did not have any noticeable cracking, segregation, or honeycombing areas.

**Site Photo 5. Reinforced concrete pad for 50-m<sup>3</sup>/hr compact unit water treatment plant**

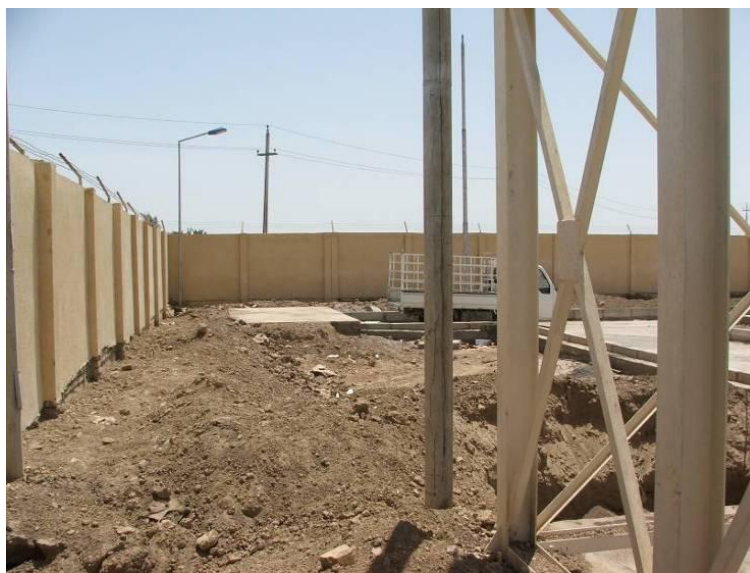
SIGIR observed significant work underway in the Al Kazim Water Supply construction area. For example, for the security of the plant and its operators, the description of work required exterior site fencing consisting of brick and topped with three strands of barbed wire. At the time of our second site visit, SIGIR observed that the exterior site fencing was nearly completed, including the three strands of barbed wire and perimeter lighting (Site Photo 6).

**Site Photo 6. Site fencing with barbed wire and perimeter lighting**

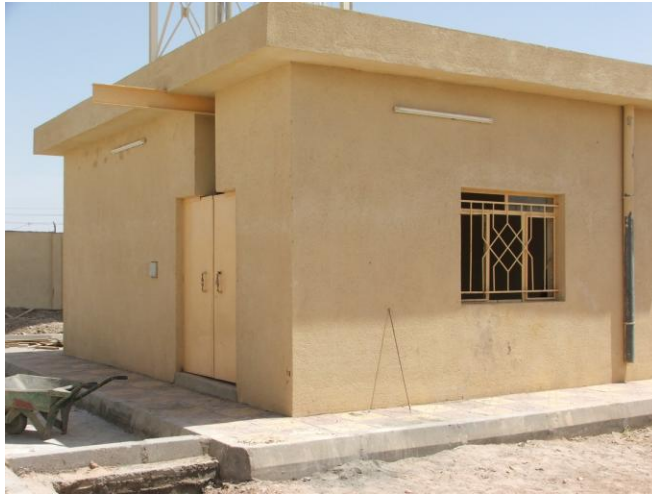
The contract included the construction of a chemical building (Site Photo 7), a water compact unit (Site Photo 8), an operator building (Site Photo 9), and a generator and fuel tank concrete foundation (Site Photo 10).

**Site Photo 7. Chemical building**

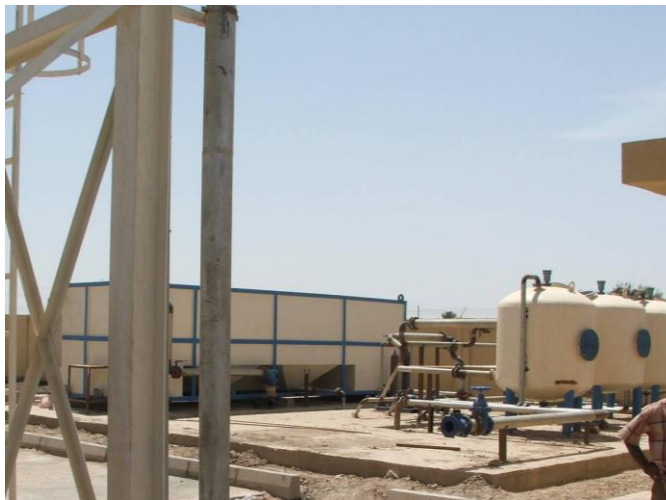
**Site Photo 8. Water compact unit**

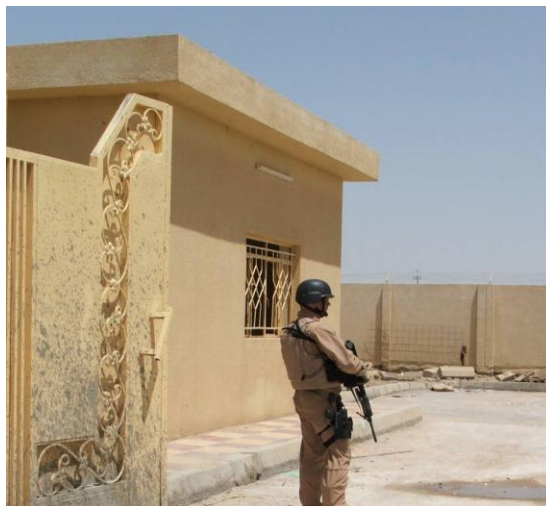
**Site Photo 9. Operator building**

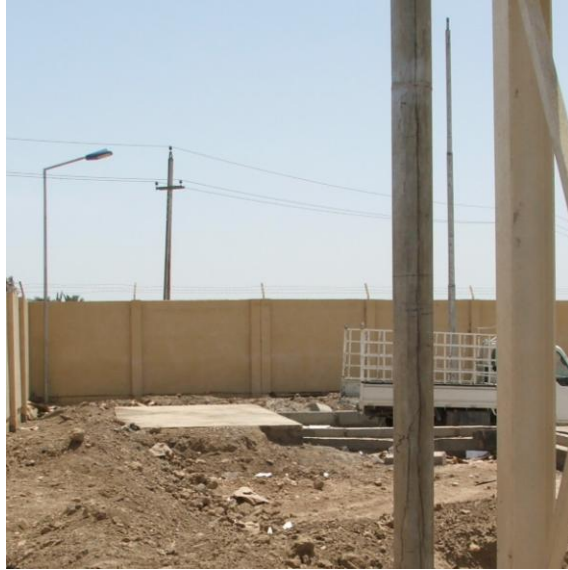
**Site Photo 10. Generator and fuel tank concrete foundation**

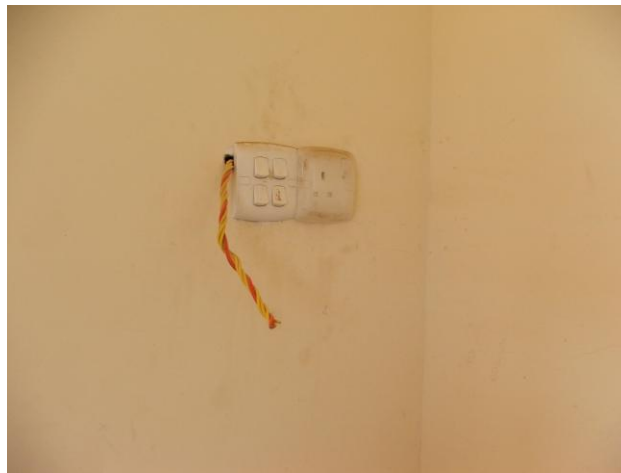
At the time of our second site visit, the contractor had not completed the chemical building, operator building, and water compact unit. For example, electrical work was still required in both the chemical and operator buildings (Site Photo 11). In addition, the contractor had not installed the crane for the chemical building (Site Photo 12). Further, the water compact unit sunshade and the generator and fuel tank sunshade were not constructed.

**Site Photo 11. Electrical work left unfinished**

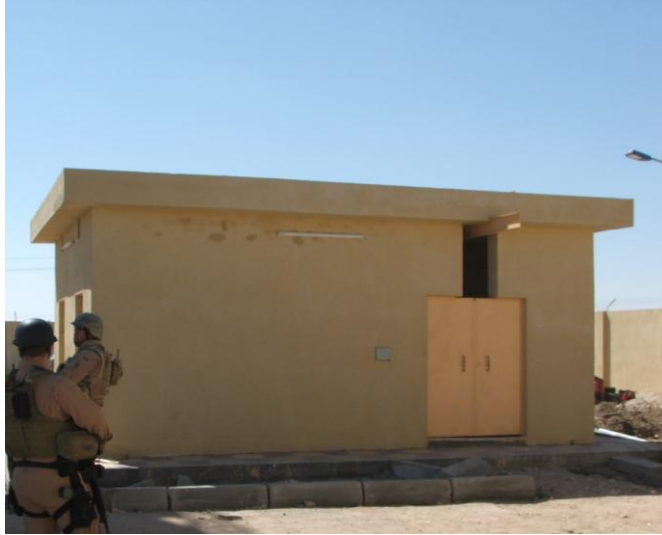
**Site Photo 12. Chemical building's crane in progress**

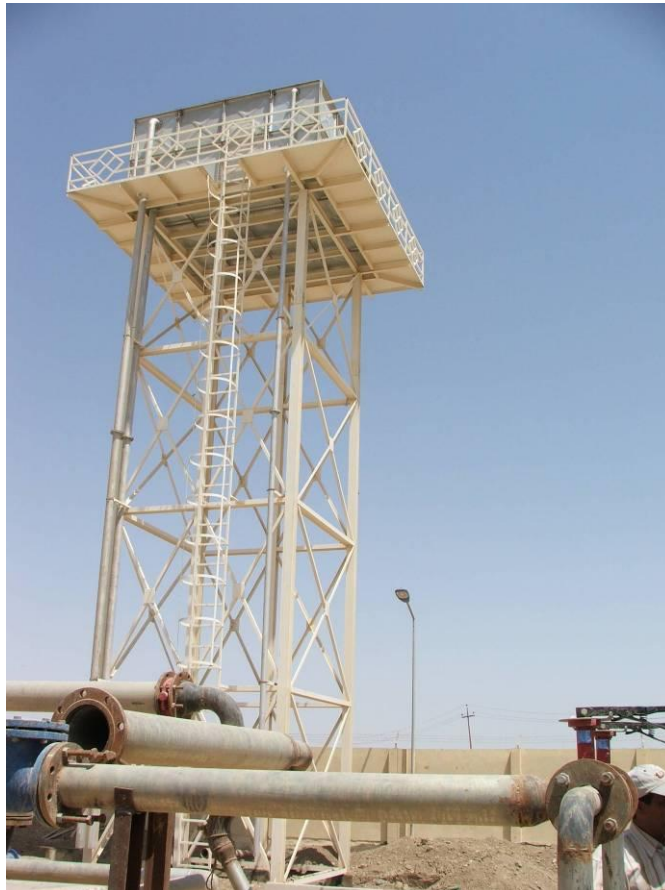
The contractor did finish construction of a new elevated storage reservoir (Site Photo 13).

**Site Photo 13. Elevated storage tank**

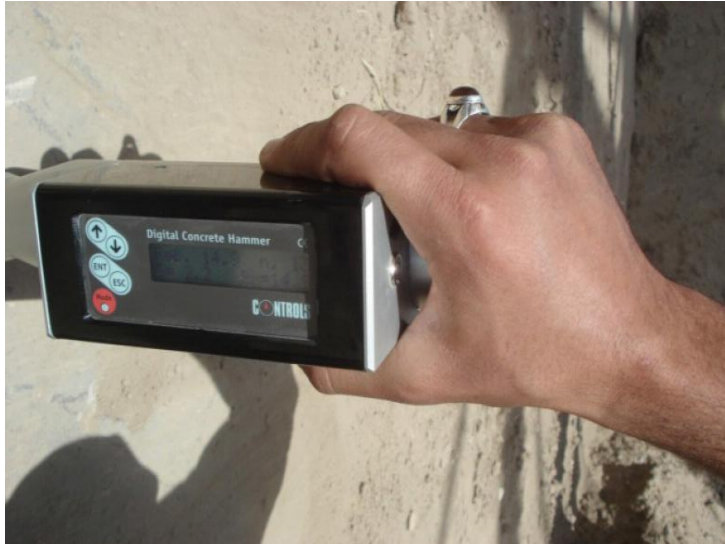
During the site visit, the GRS representative stated that the elevated storage tank's concrete foundation had not passed the Hammer (Site Photo 14) and Ultrasonic (Site Photo 15) tests. The elevated storage tank's concrete foundation would not support

**Site Photo 14. Hammer test for elevated storage tank (Courtesy of the USACE)**

the full load of the elevated storage tank when filled completely with water. The contractor provided the GRS a corrective action proposal plan for the concrete foundation. The corrective action plan for the elevated storage tank states that if the concrete foundation fails the core test and the second ultrasonic test, then the steel structure will be taken down, and a new concrete foundation will be constructed. In a follow-up email, the GRS stated that the concrete foundation failed the core test. The contractor would remove the elevated storage tank, and the contractor would use the old foundation as a blind, and the new foundation will be poured on top.

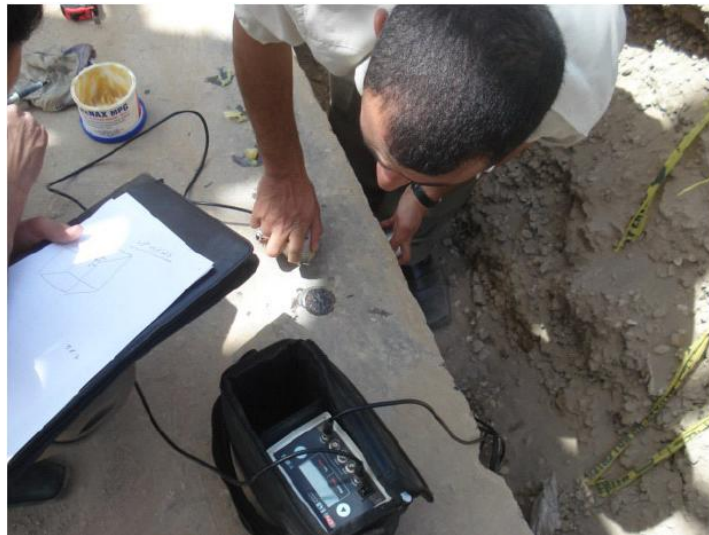
**Site Photo 15. Ultrasonic test for elevated storage tank (Courtesy of the USACE)**

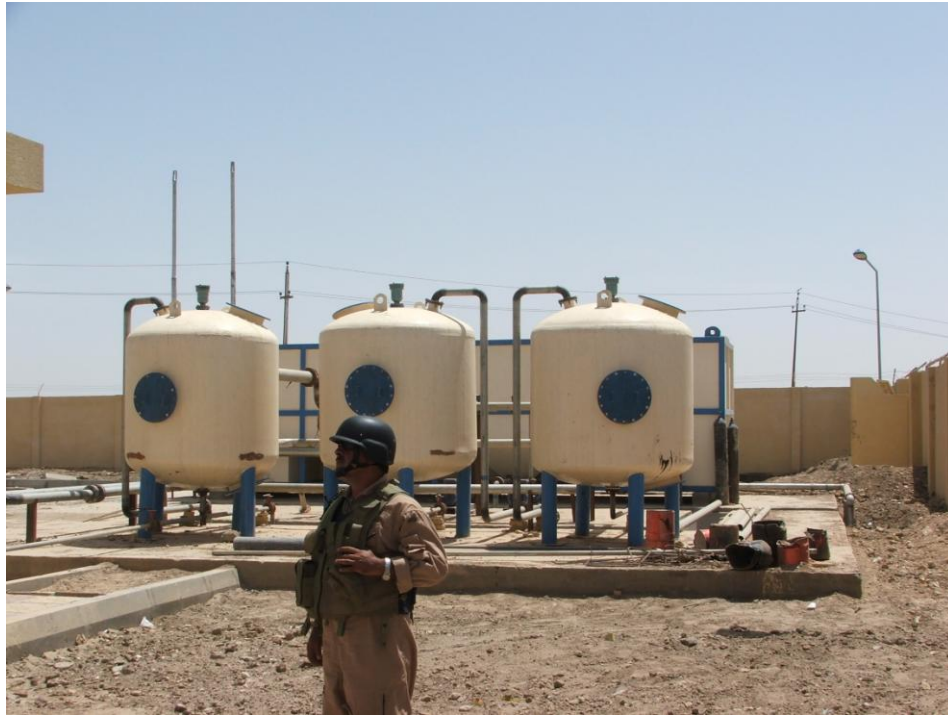
Since the Al Kazim Water Supply project was reported as 55% complete at the time of SIGIR's second site visit, there was significant interior and exterior work remaining on the water compact unit. The other required pending work included civil and site works, an internal road network and perimeter security roads, potable water treatment and distribution systems, a power generation system, sunshades (Site

Photo 16), wastewater collection and treatment systems, electrical systems, and all finishing work.

**Site Photo 16. Water compact unit without sunshade.**
