**FALLUJA WASTE WATER
TREATMENT SYSTEM
FALLUJA, IRAQ**

**SIGIR PA-08-144
SIGIR PA-08-145
SIGIR PA-08-146
SIGIR PA-08-147
SIGIR PA-08-148**

Falluja Waste Water Treatment System

Reports: PA-08-144 to 08-148

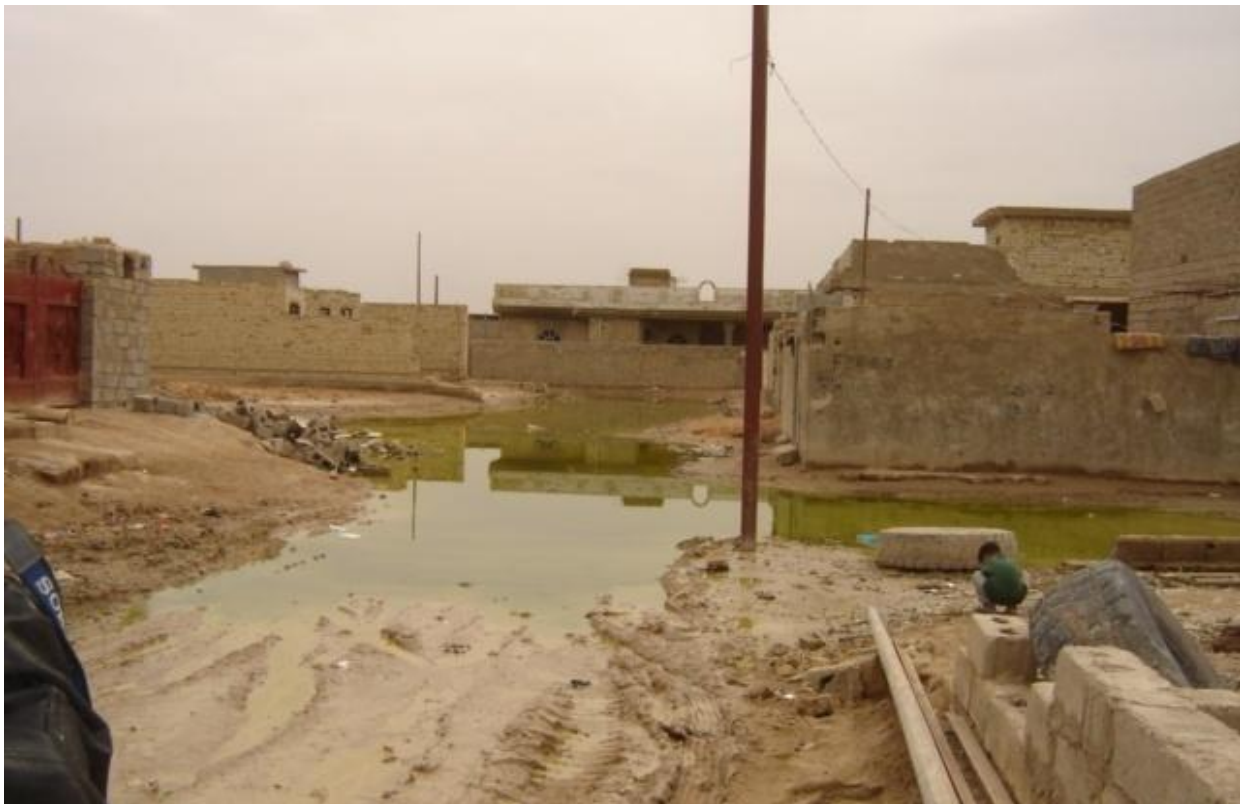
River contaminates the river water that is used by the public for several purposes, including a source of potable drinking water. In addition, sewer water runs down through the center of the city streets (Site Photo 1). Since children often play in the streets and sewer water, serious health issues, particularly among the young, exist.

Site Photo 1. Sewage flowing throughout Falluja city streets

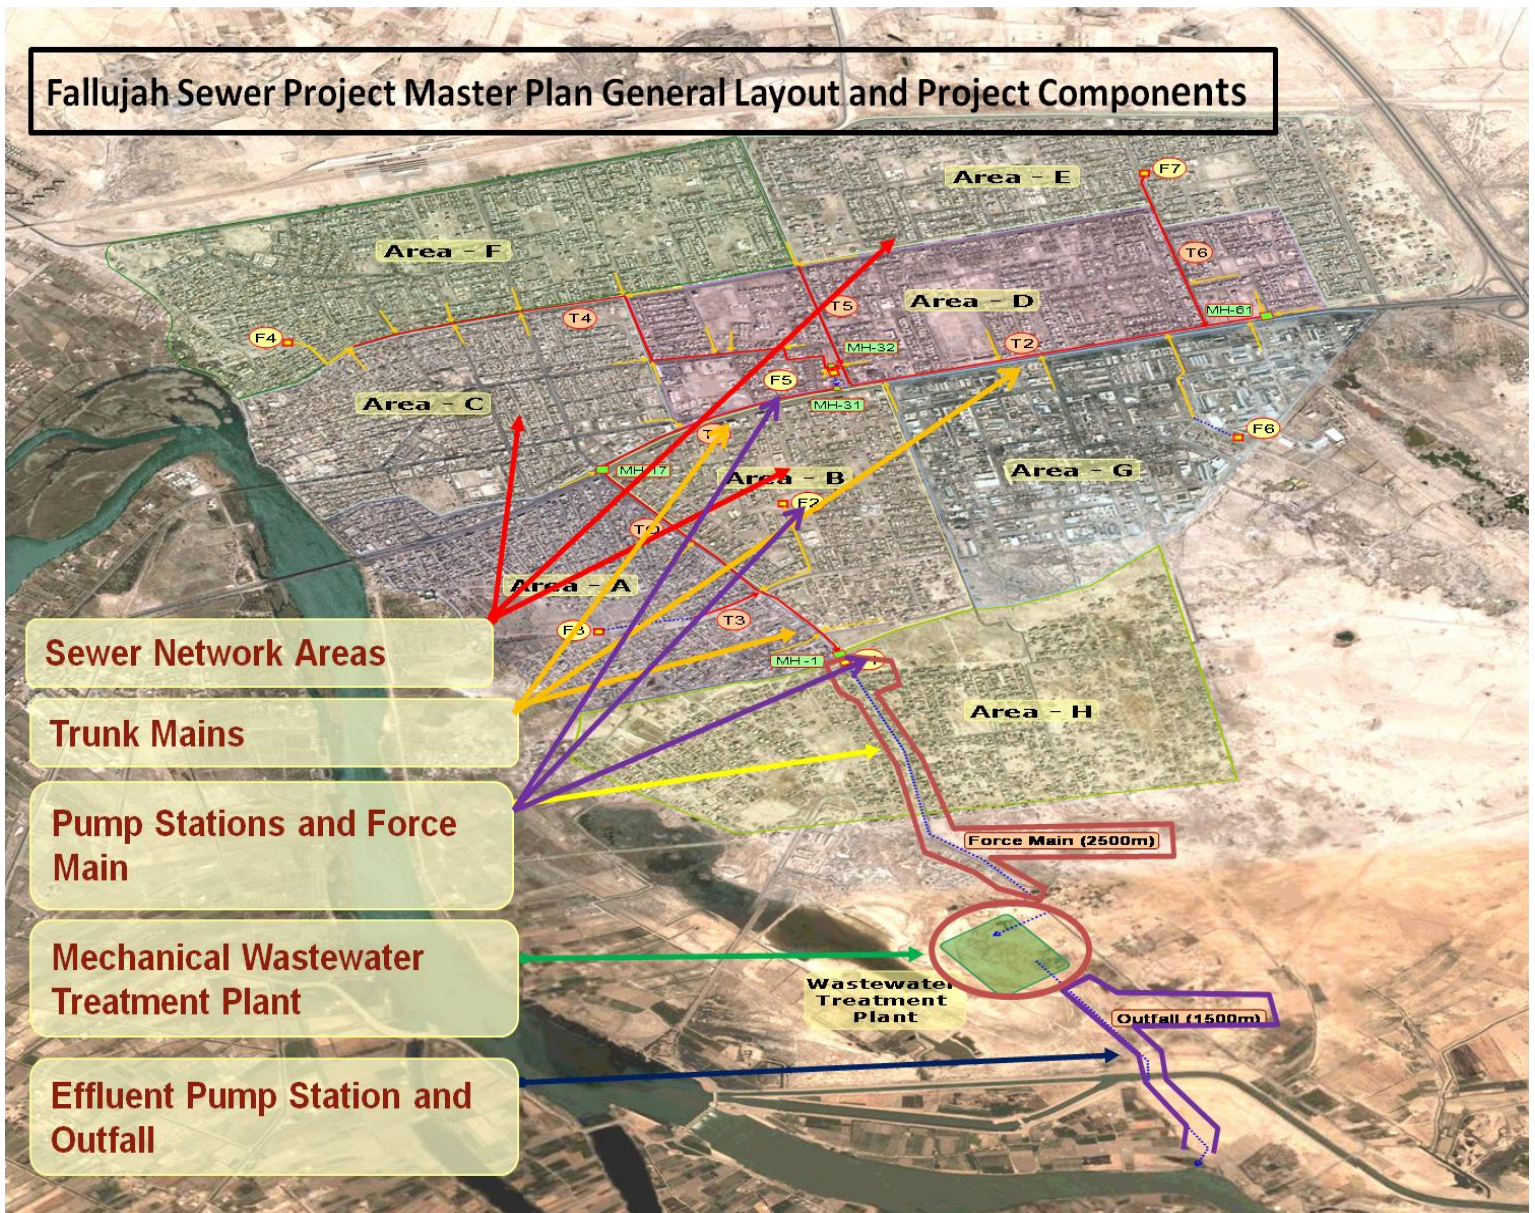
Figure 1 is an illustration of the original design for the entire Falluja Waste Water Treatment System.

Figure 1. Original design for the entire Falluja Waste Water Treatment System (Courtesy of the ITAO)

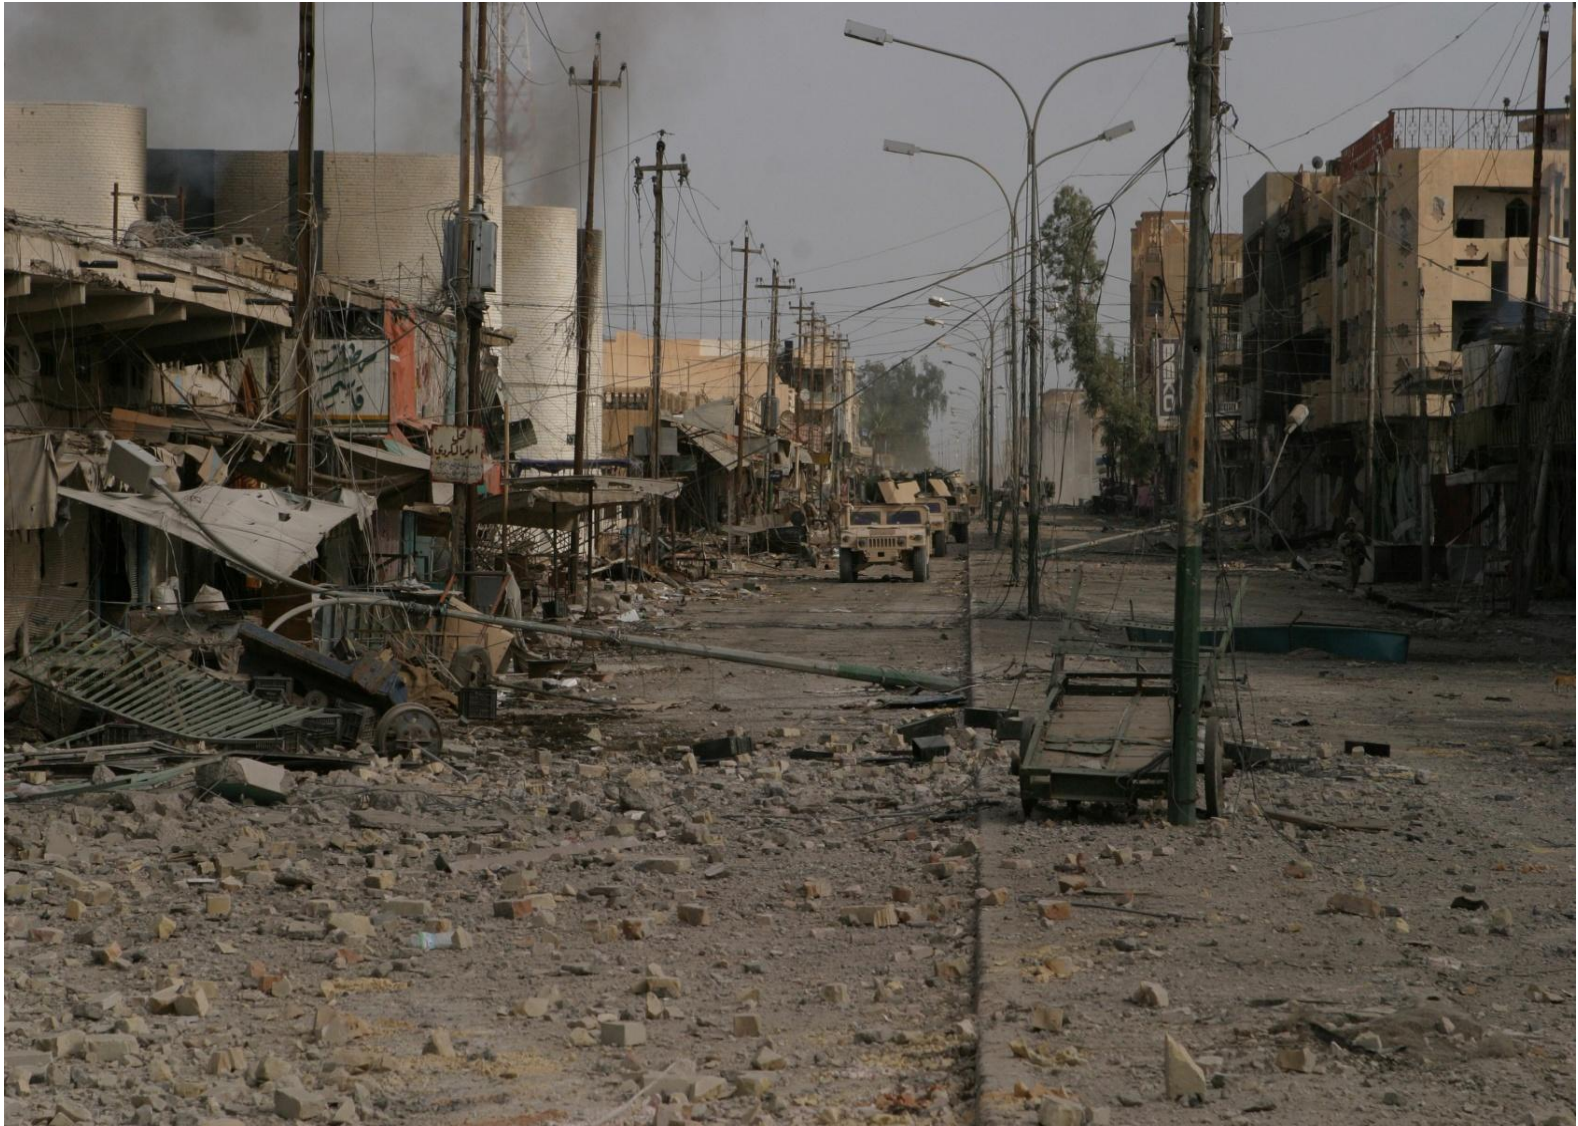
Further, even after the completion of Operation Phantom Fury in mid-November 2004, the city was in ruins due to months of airstrikes and clashes between CF and insurgents (Site Photo 2). Any new construction required the removal of debris from buildings and homes, which added additional time to the completion of the project. In addition, in order for the contractor to accurately design the wastewater distribution network system (i.e. collection systems), site surveys were needed to identify the house connections required. However, this again would require the contractor to enter each neighborhood, which was receiving airstrikes and armed clashes on a daily basis. According to Gulf Region Division (GRD) documentation, the contractor attempting to conduct geo-technical and survey work was hampered by confrontations with squatters and a member of the survey party received a gunshot wound.

**Site Photo 2. Condition of the city streets in Falluja in November 2004
(Photo Courtesy of USACE)**

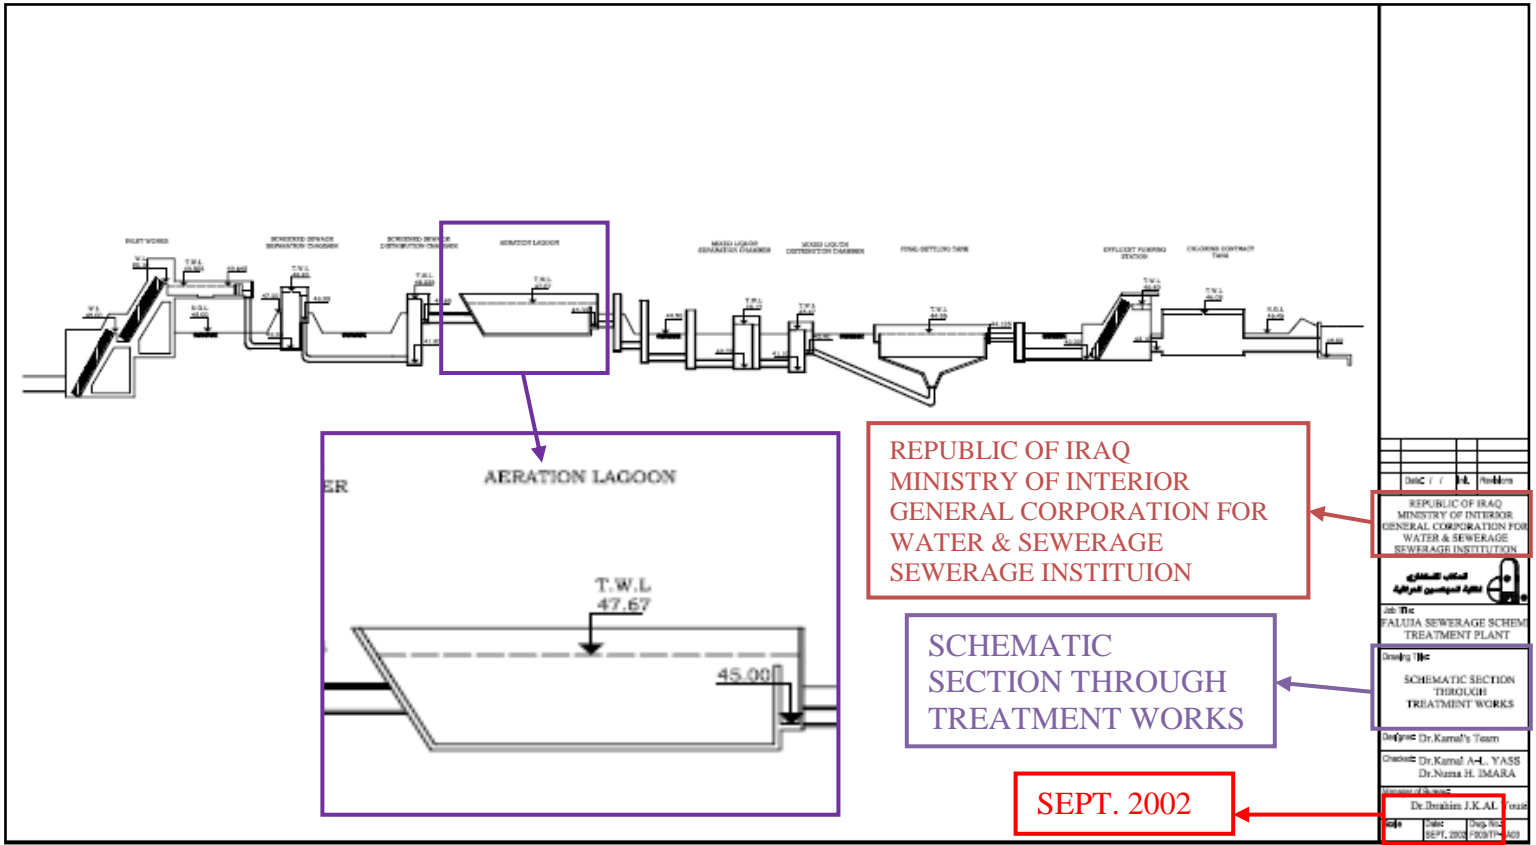
Figure 2. Ghadak’s original schematic layout of the WWTP, which was designed to use a lagoon system (Figure courtesy of the USACE)

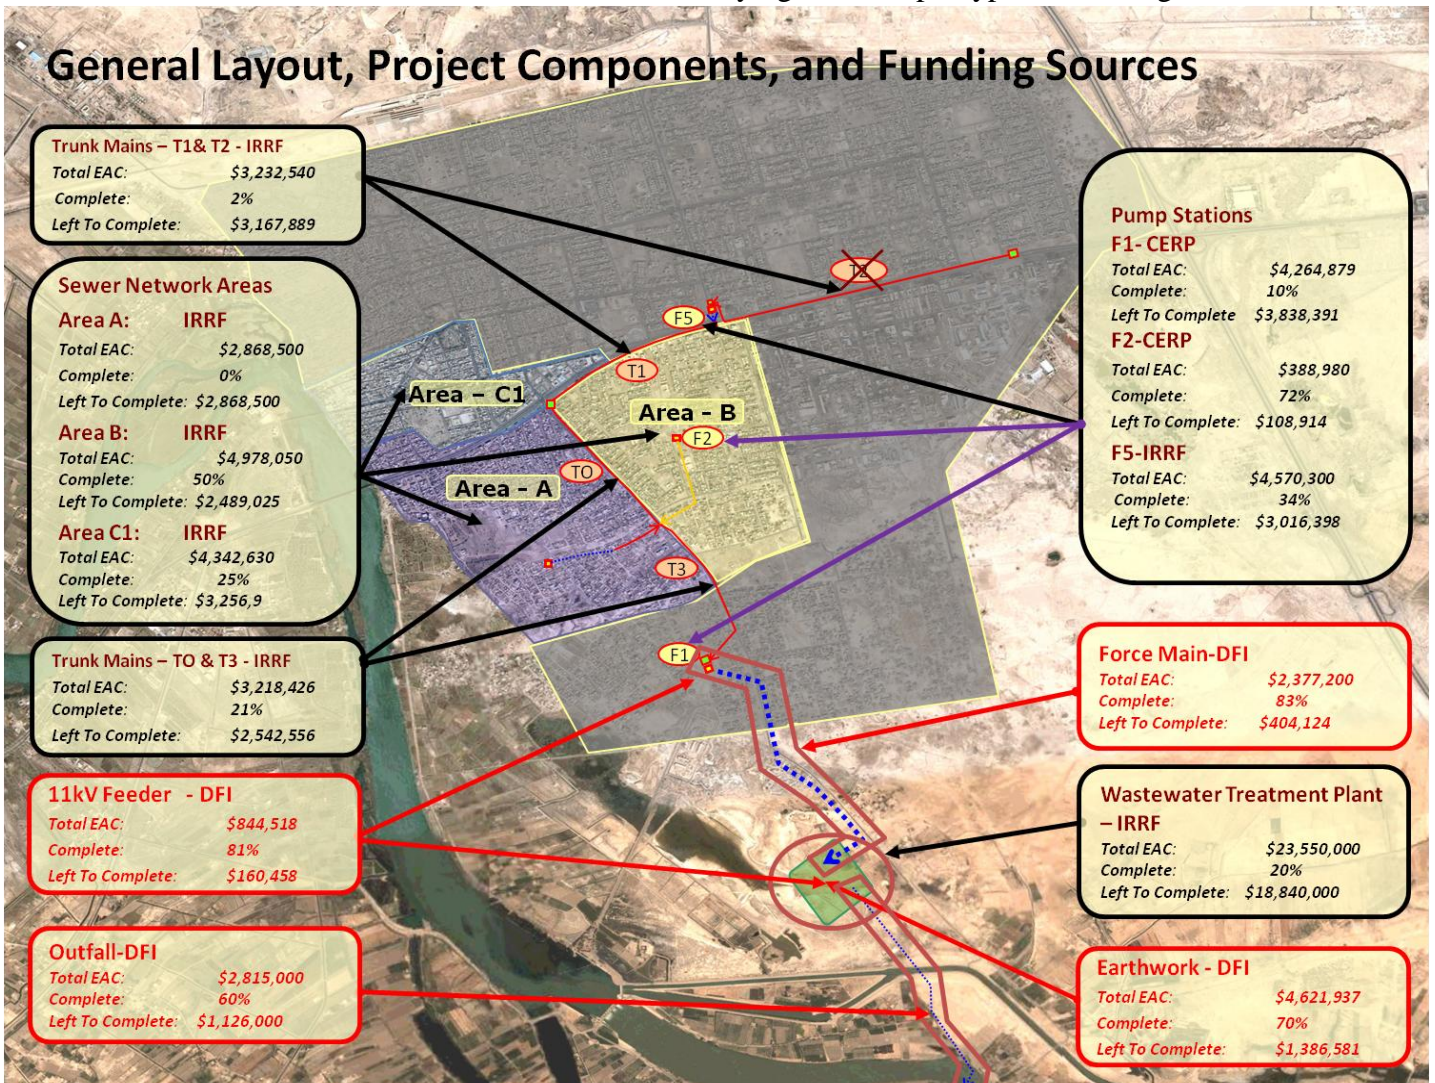
Figure 3 illustrates the complexity of this project in terms of interdependence between only the construction contracts; while also identifying the multiple types of funding sources.

Figure 3. General project layout and funding sources system

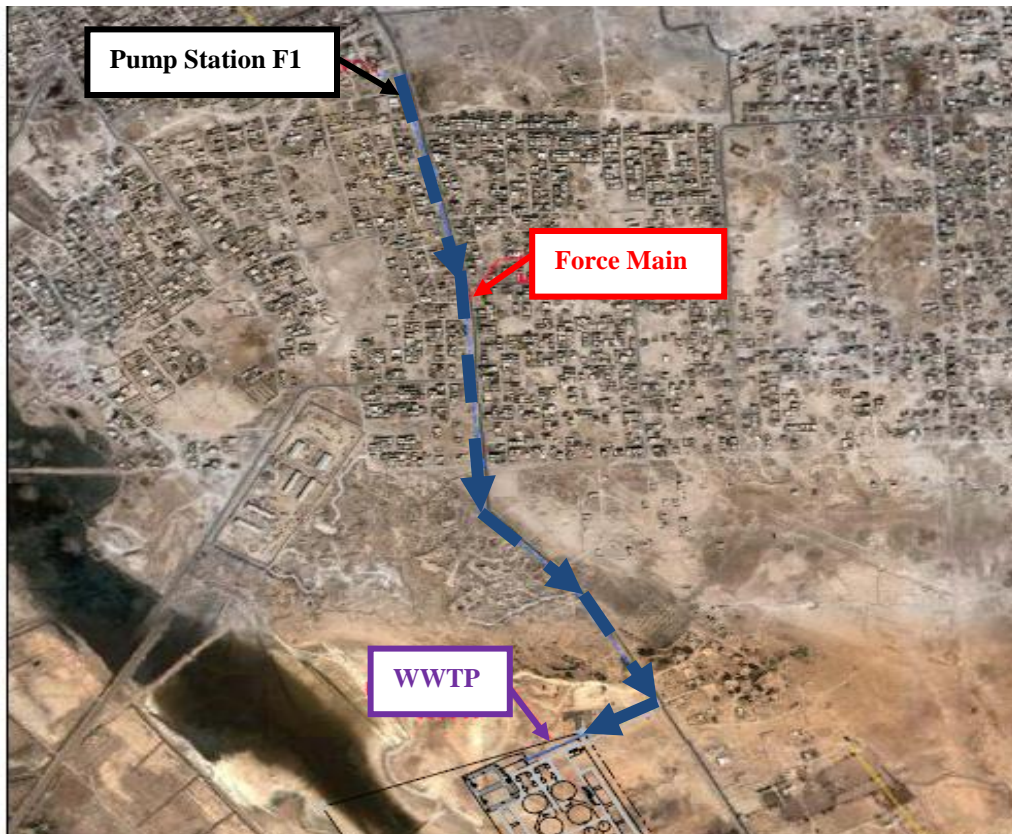
**Figure 4. Location of Force Main (between the Pump Station F1 and WWTP)
(Figure courtesy of the USACE)**

According to Camp Falluja Resident Office documentation, this project was constructed without delay and has been fully flow tested and hydrostatically tested. In addition, the contractor submitted his close-out package, including as-built drawings, test results, hydro-test results, equipment listings, and spare parts. The Camp Falluja Resident Office has identified this contractor as “one of the best we have experienced here in Fallujah to date.”

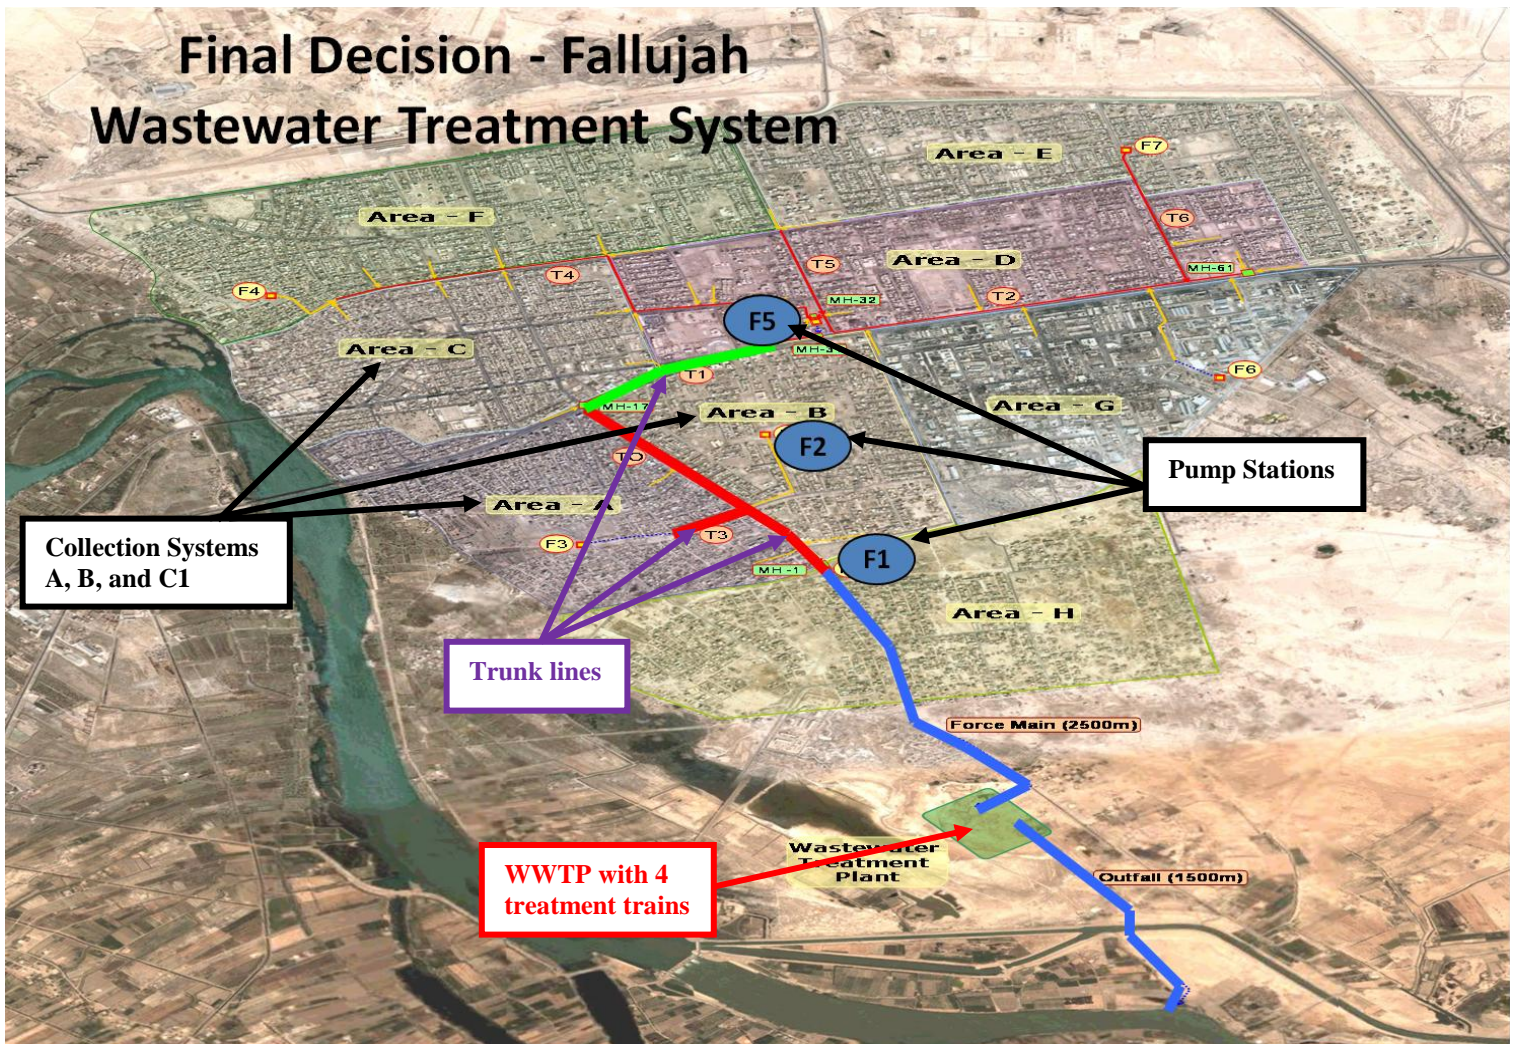
“the U.S. Government has decided to terminate the outstanding DFI contracts for this project and complete the remaining work using U.S. Government funds...Therefore, the scope of the final project will include:

1. Treatment plant with four treatment trains
2. Outfall
3. Force main and T0, T1, and T3 trunklines
4. Power connections to treatment plant and pump stations
5. F1, F2, and F5 pump stations
6. Collection systems in Areas A, B, and C1”

Figure 5. Final decision on construction work to be completed

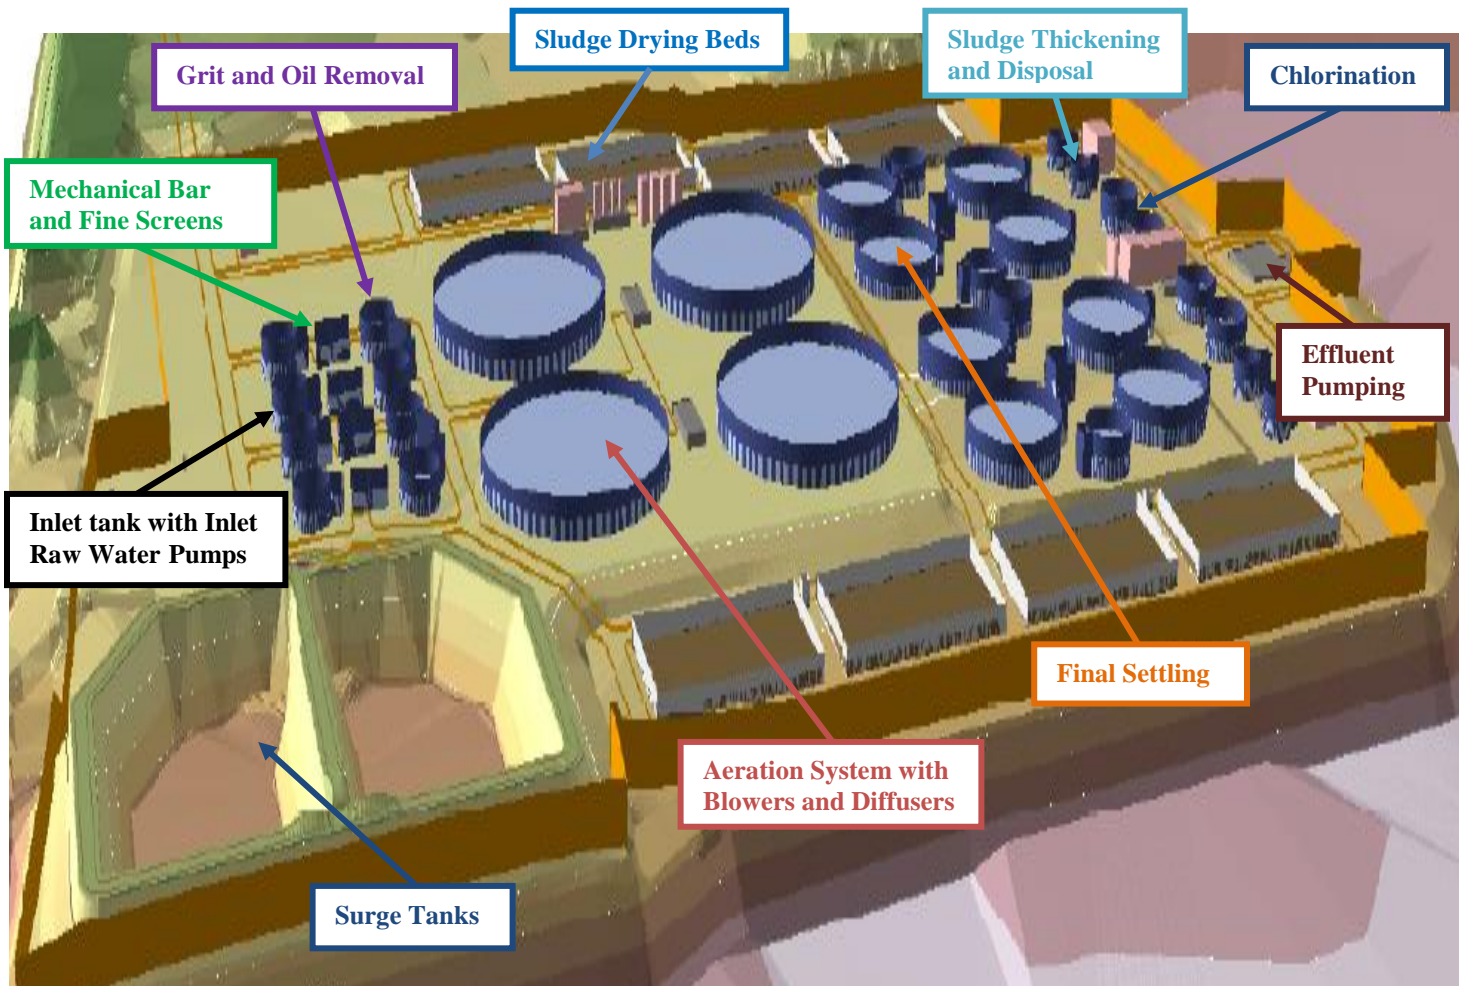
- inlet tank with inlet raw water pumps
- manual bar screen and mechanical fine screen
- grit and oil removal
- aeration system with blowers and diffusers
- final settling
- chlorination
- effluent pumping
- sludge thickening and disposal

The design later included surge storage basin capacity to the layout, along with a bypass system, to accommodate anticipated influent wastewater flows that exceed the combined ability of the packaged treatment system. Sludge will be thickened and placed on the sludge drying beds, after which it will need to be removed and properly disposed. The treated wastewater will then be discharged directly into the Euphrates River. Figure 6 provides an illustration of the WWTP and its components/processes.

Figure 6. General site arrangement of the WWTP

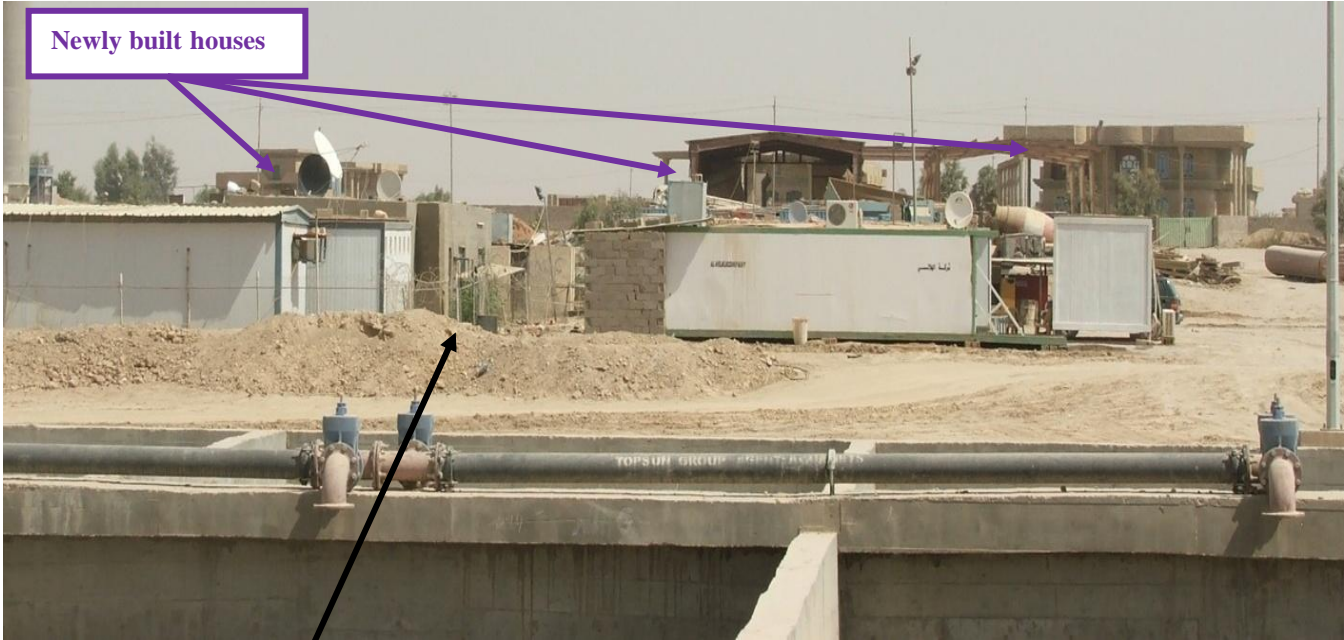
One of the primary reasons the MMPW rejected the use of the original design of a lagoon system was that it would lead to the “arising of stinking odor.” However, the MMPW’s design for the WWTP using the activate sludge units did not provide for odor control. Specifically, there are no odor control facilities furnished with this plant. According to Camp Falluja Resident Office representatives, the surge tank, inlet tank, and inlet works will generate undesirable odors. In addition, the area near the WWTP is fast developing into a residential area (Site Photo 6 and Figure 7), and it is anticipated that there will be complaints from the residents about the odor. Also, these residents may become angry because they are not part of the collection system. Consequently, these residents will see and smell the WWTP, yet will not benefit at all from it. Further, the residents near pump stations F1 and F5 may experience a “big stink” once the plant goes into operation. During the design review process, the lack of odor control facilities was identified; however, the potential solutions to the odor problem at the WWTP and pump stations are expensive, ranging from at least \$1 million to \$8 million. Due to project funding constraints, this was not remedied.

Site Photo 6. View of new houses near the WWTP sludge drying beds, where a significant odor will occur (photo taken from sludge drying beds)

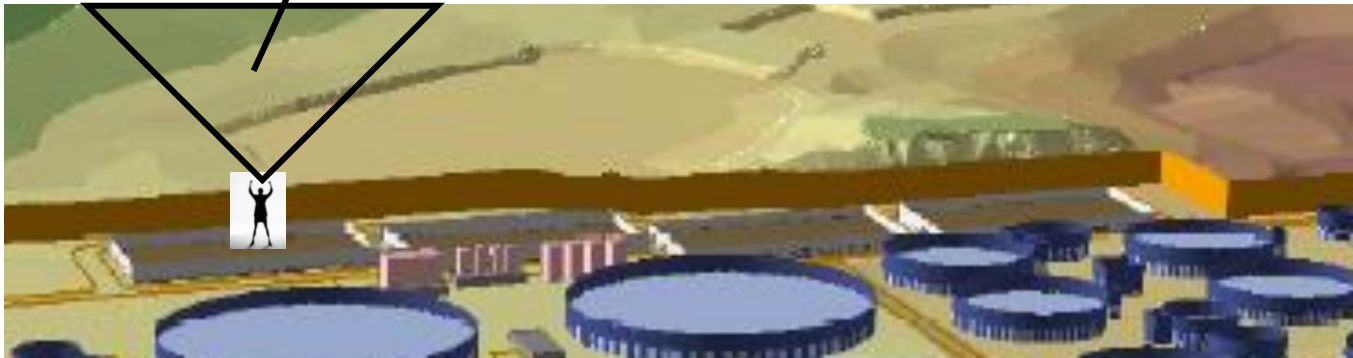
Figure 7. Portion of the WWTP (sludge drying bed area)

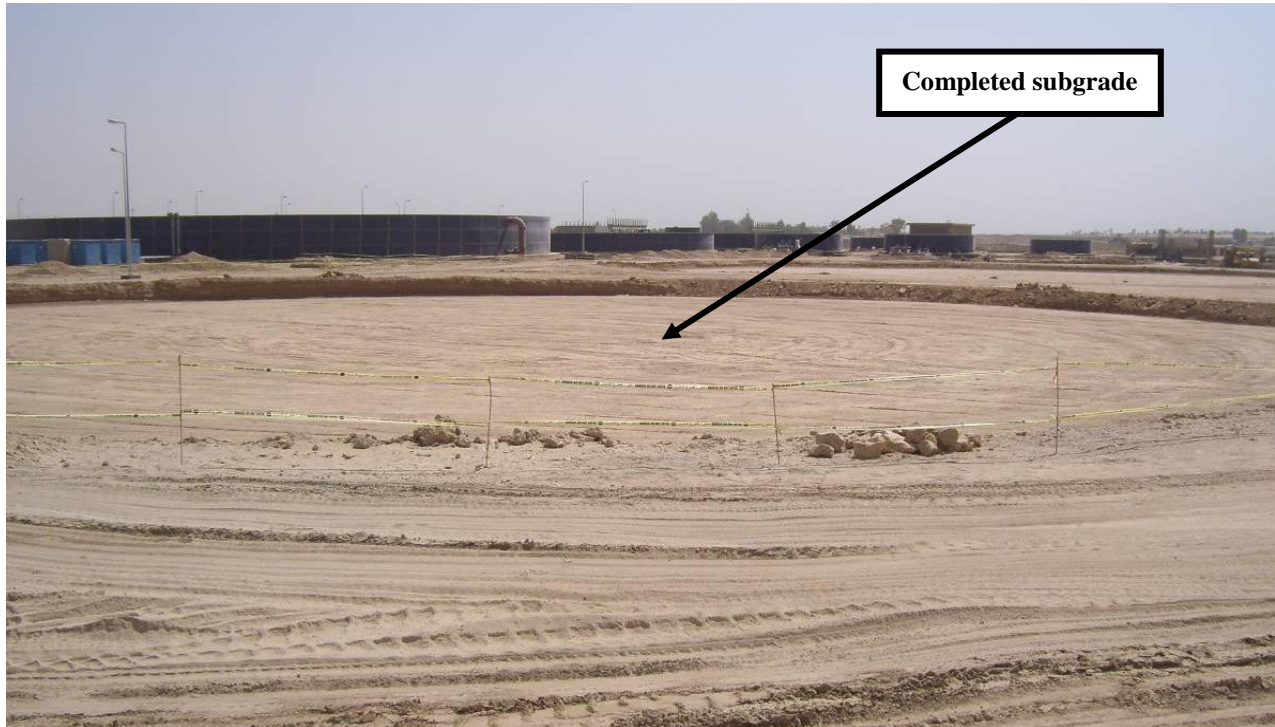
At the time of our site visits, the contractor had completed approximately 70% of the contract. The WWTP appeared to be filled to a consistent elevation of several meters above the adjacent dry lake bed, which should make the facility safe from potential flooding. The earth fill was consistent and appeared to be well compacted. According to Camp Falluja Resident Office representatives, the contractor used a "sheepsfoot" type roller to compact the fill. While the rough grading was complete, the finish grading activities had not yet begun. Site Photo 7 provides an example of the contractor's work, specifically the aeration tank subgrade.

Site Photo 7. Aeration tank subgrade

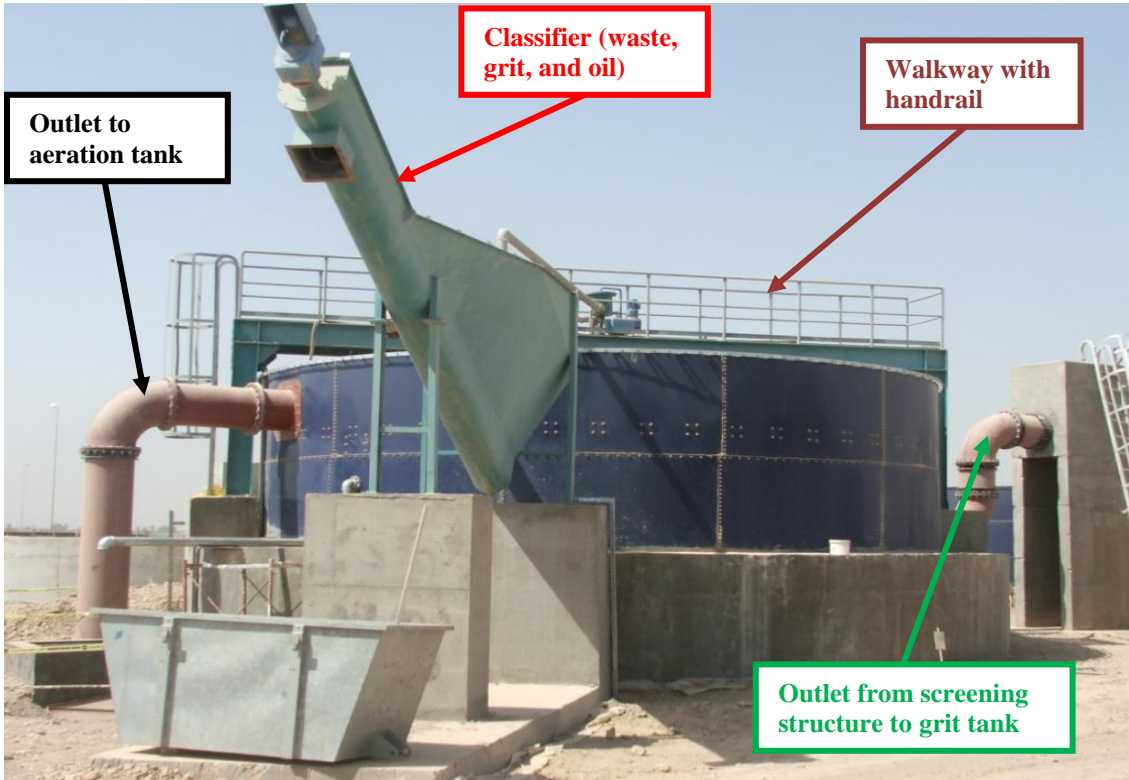
The grit and oil removal steel tanks and concrete foundations appeared to be adequately constructed (Site Photo 9). Camp Falluja Resident Office representative stated that the water stops at the connection between the steel tanks and the concrete foundations had leaked in several areas of the plant. This required the removal of some of the concrete so that the water stop could be repaired. The repairs appeared to be an epoxy-cement and are solid, which should result in satisfactory performance. We observed the top of the several tanks' foundations showing signs of this repair (Site Photo 10).

Site Photo 9. Oil and grit tank and classifier

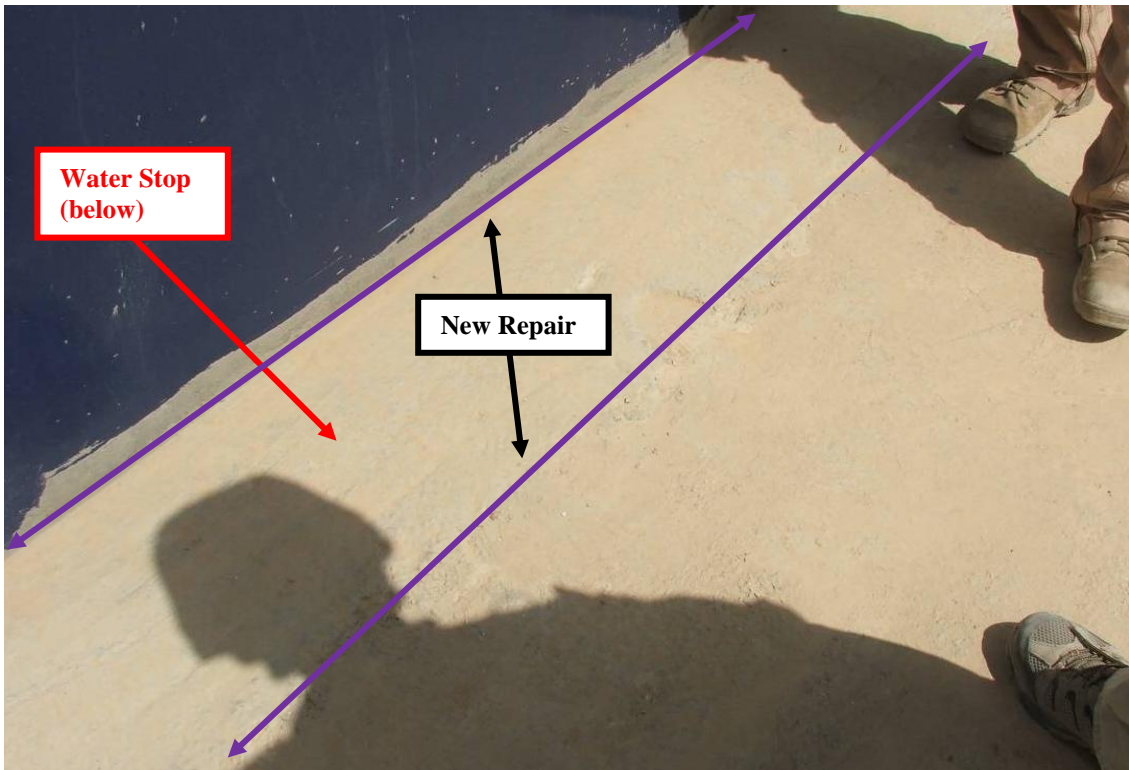
Site Photo 10. Example of concrete repair

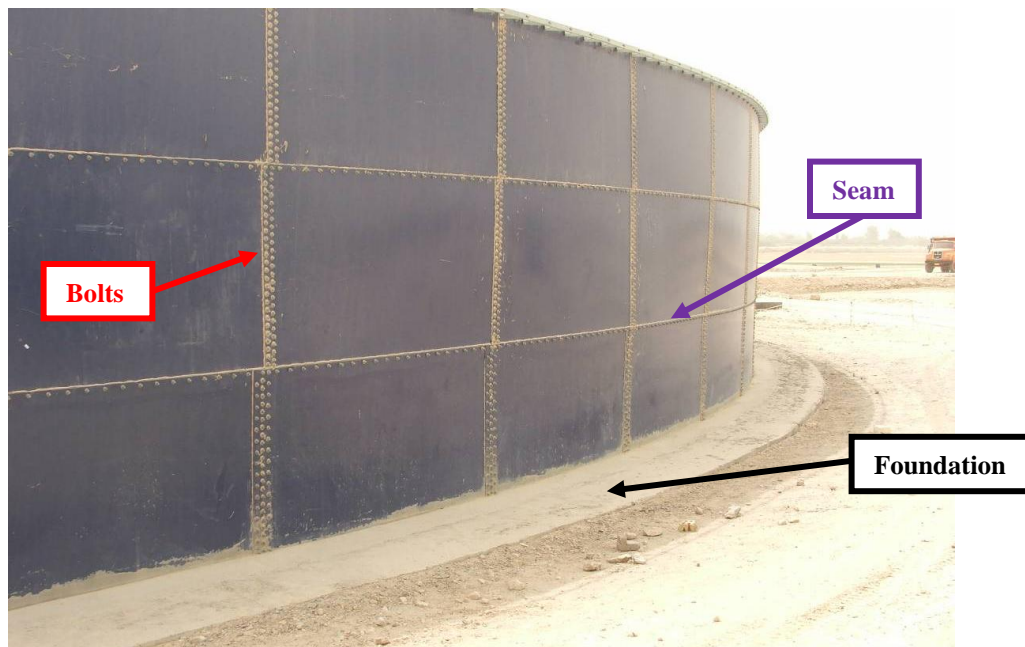
At the time of the site visits, two of the large steel aeration tanks had been installed (Site Photo 11). The tanks are constructed in sections and are bolted together on site. Each bolt and tank seam appeared to have sufficient amounts of sealant, and according to a Camp Falluja Resident Office representative, the hydraulic testing of the tanks has been completed. The Camp Falluja Resident Office representative stated some of the PVC diffusers in the tanks have been exposed to sunlight and will need to be replaced before commissioning. Some PVC materials degrade when exposed to sunlight, but once operational, the materials will be under the surface of the water and will not be exposed to sunlight except for during maintenance periods. The subgrade for two more aeration tanks was compacted and was ready to start constructing the foundations.

Site Photo 11. Aeration tank

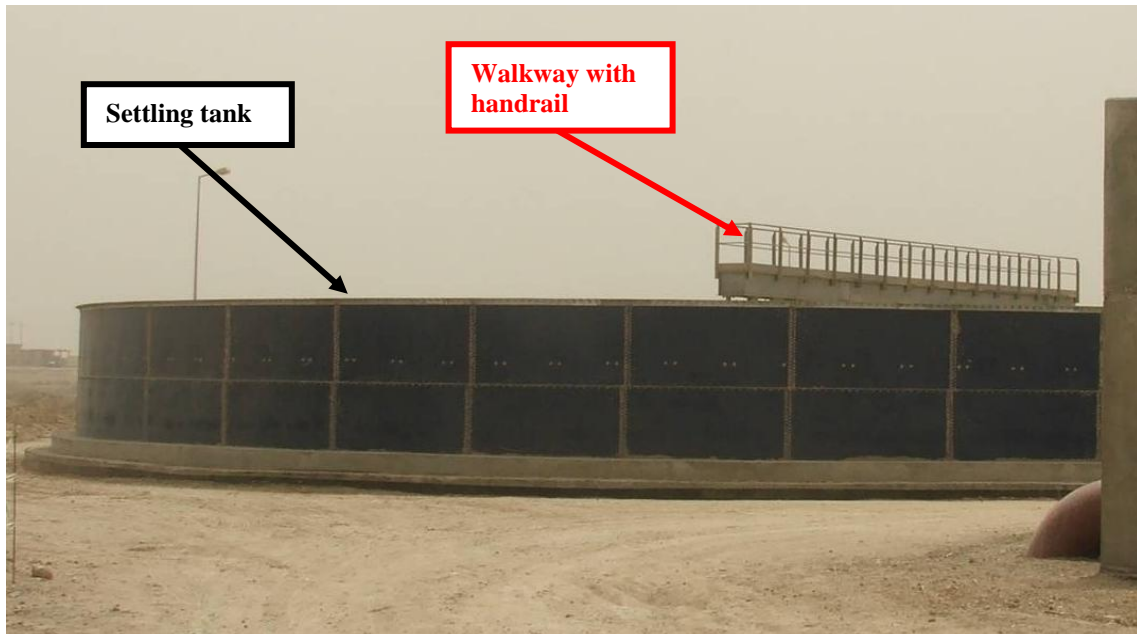
We inspected the final settling tanks for two of the treatment trains (Site Photo 12). The steel tanks, concrete foundations and mechanical equipment appeared to be installed in accordance with the design drawings. Camp Falluja Resident Office representative stated the underground piping and underground electrical wiring has been installed; however, the electrical wiring has not been completed in the Electrical Building.

Site Photo 12. Settling tank and concrete foundation

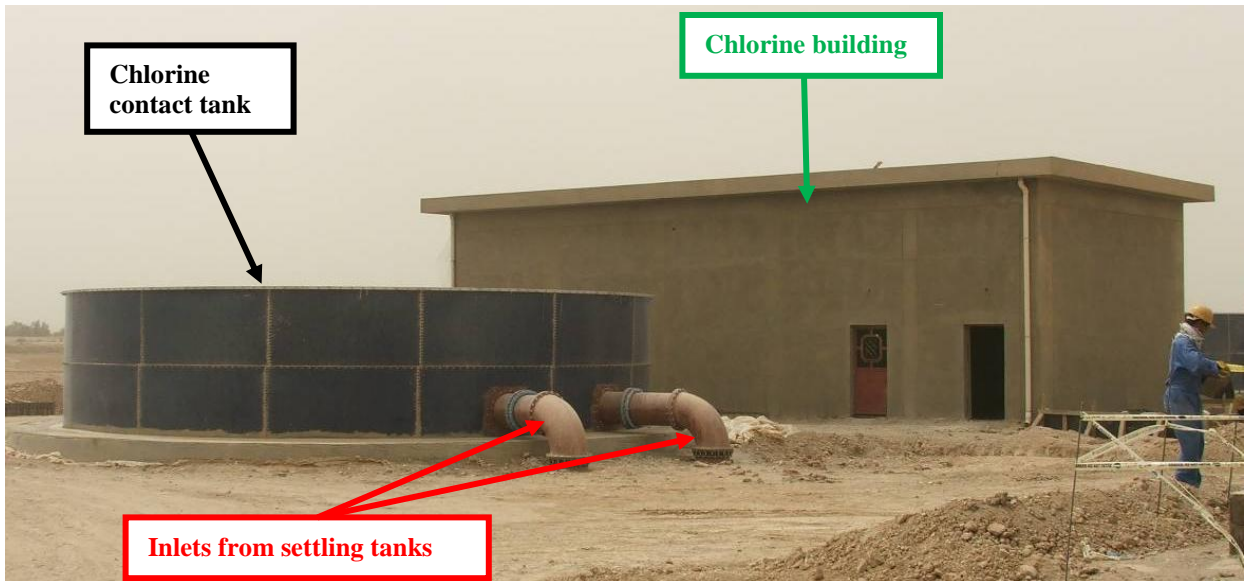
At the time of the site visits, the chlorine contact steel tanks and concrete foundations had been installed for the first two trains (Site Photo 13). The tanks and foundations appeared to be adequately constructed and in accordance with design drawings. The Chemical Building was not complete and no equipment was installed.

Site Photo 13. Chlorine contact tank and chlorine building

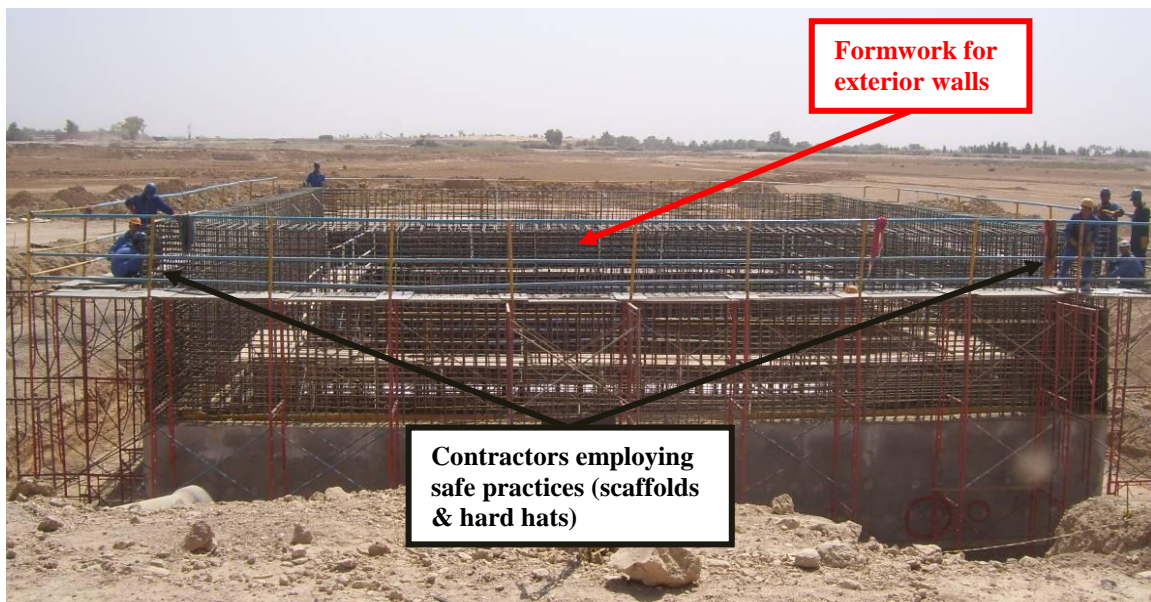
At the time of the site visits, the effluent pump station was partially constructed (Site Photo 14). The reinforced concrete walls were being formed to pour in the near future. The pump installation, piping connections, and backfill around the pump station still need to be completed.

Site Photo 14. Effluent pump station construction

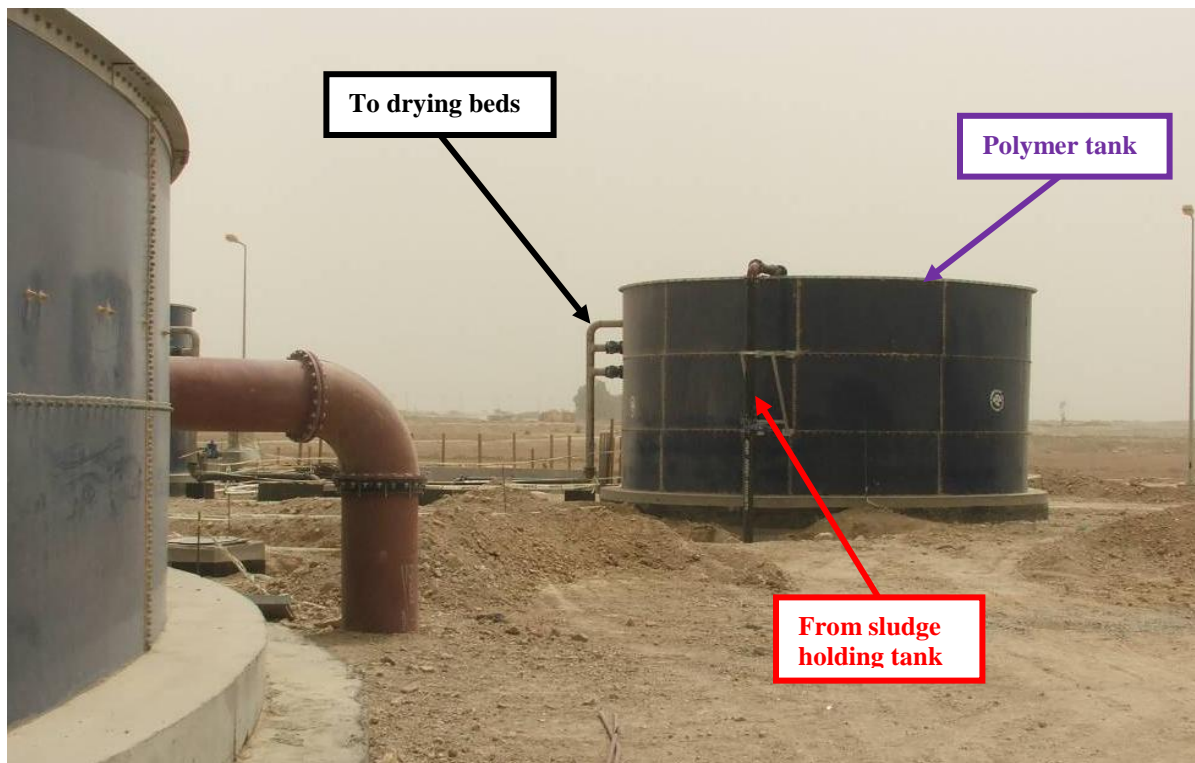
During our site visits, we observed two installed polymer mixing tanks¹⁴, which appeared to be constructed in accordance with design drawings (Site Photo 15). Camp Falluja Resident Office representative stated that initial commissioning will not use the polymer mixing tanks to its full potential because the gravity belt thickener is not being purchased with this contract; rather the interim process will be to inject the polymer into the sludge and send it to the sludge drying beds. The Camp Falluja Resident Office representative was concerned with using the polymer mixing tanks without having a gravity thickener to process the sludge. The primary concern is that the sludge polymer mixture would become too solid and the pumps would not be able to move the mixture to the drying beds. Pumping solid materials could result the clogging of the pipes and reduce the life of the pumps.

Site Photo 15. Polymer mixing tank

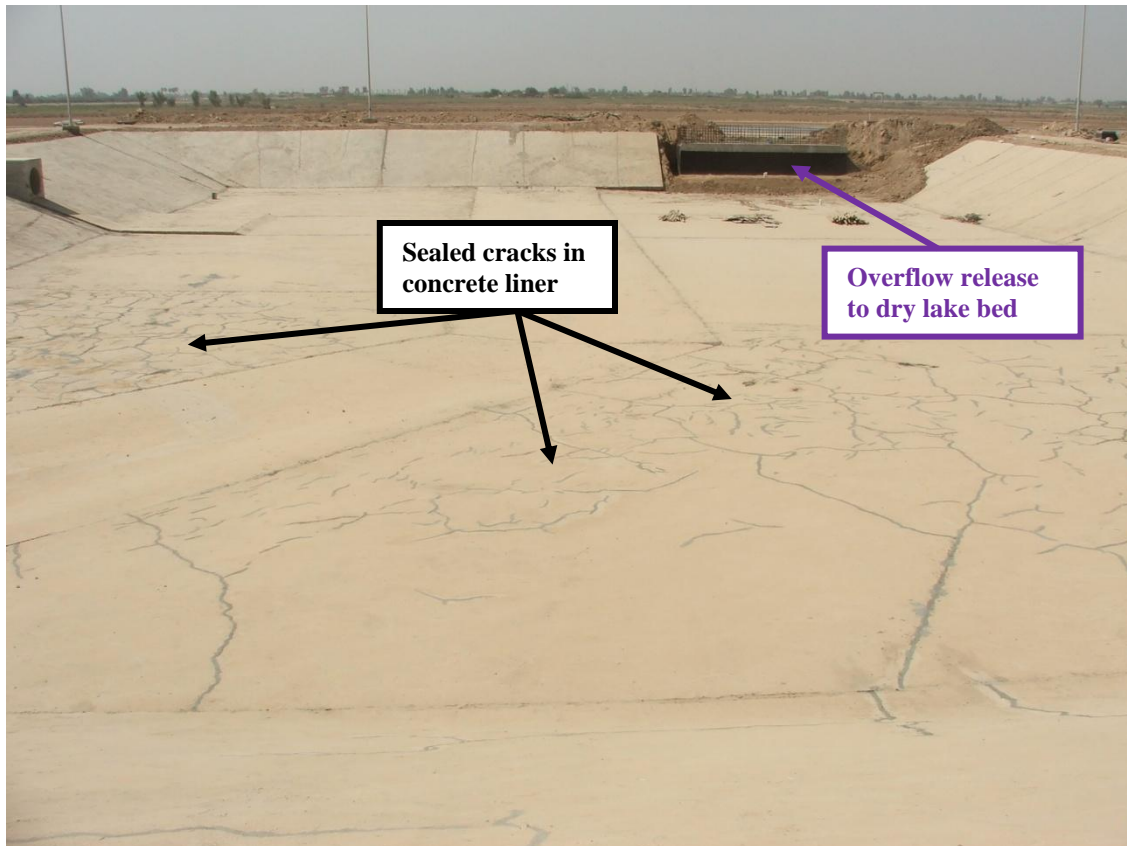
We observed the two constructed surge basins (Site Photo 16). The configuration of the surge basins appeared to match that of the construction specifications. An emergency overflow structure was constructed in the first basin and an equalization pipe was installed in between the two basins. The basins were constructed of earth fill material and were lined with concrete. According to the Camp Falluja Resident Office representative, the contractor requested to use concrete for the liner instead of the specification requirement of a cement/earth mixture. We noticed several cracks in the liner; however, the cracks appeared to be adequately sealed.

Site Photo 16. Surge basin
