**FALLUJA WASTE WATER
TREATMENT SYSTEM
FALLUJA, IRAQ**

**SIGIR PA-08-144
SIGIR PA-08-145
SIGIR PA-08-146
SIGIR PA-08-147
SIGIR PA-08-148**

Falluja Waste Water Treatment System

Reports: PA-08-144 to 08-148

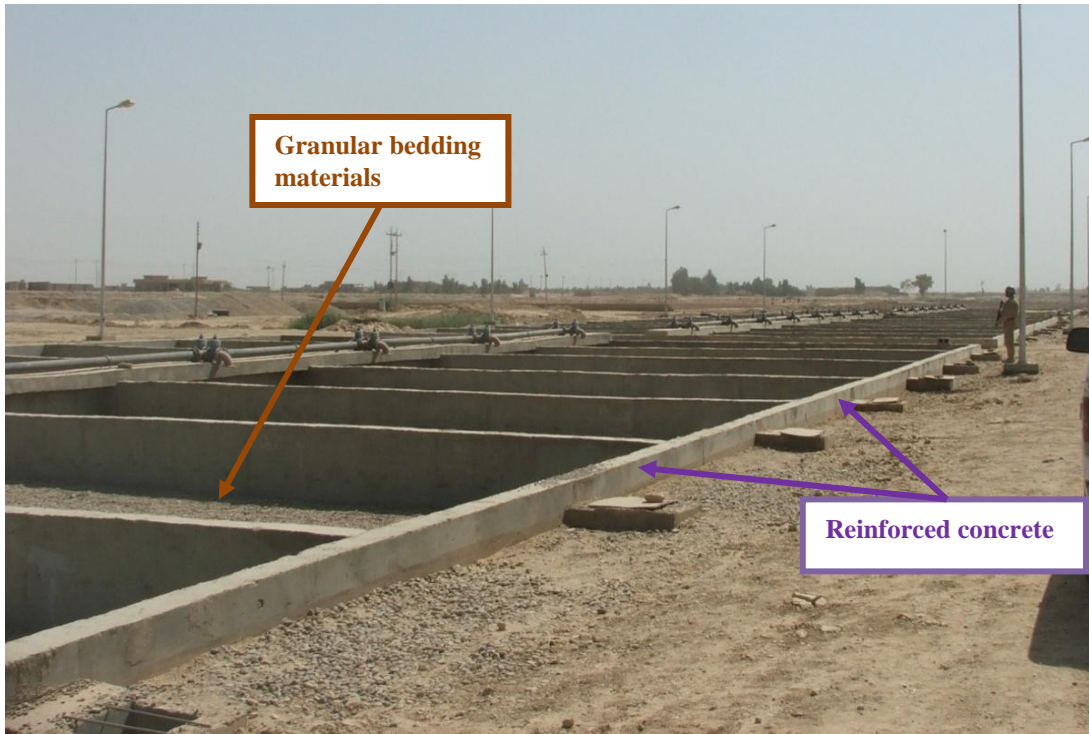
We observed the sludge drying beds (Site Photo 17), which were constructed of reinforced concrete with granular bedding materials installed to filter the sludge/water mixture. The sludge drying beds appeared to be constructed in accordance with design specifications. The water flows through the granular media and is pumped back to the inlet tank. The sludge is trapped on the media and when sufficiently dried is removed and disposed of off-site.

Site Photo 17. Sludge drying beds

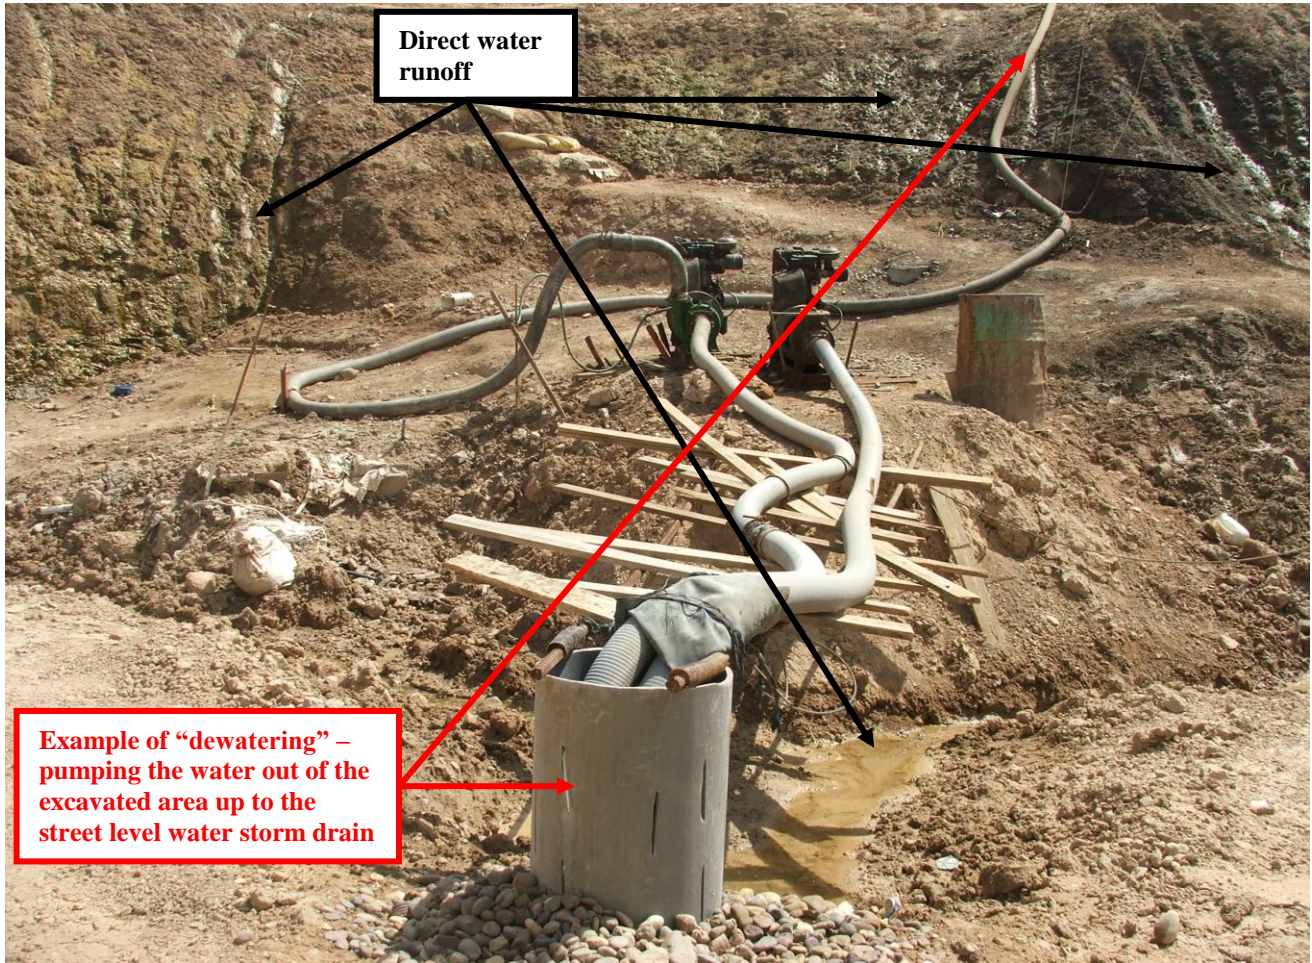
Site Photo 18. Water runoff and dewatering system

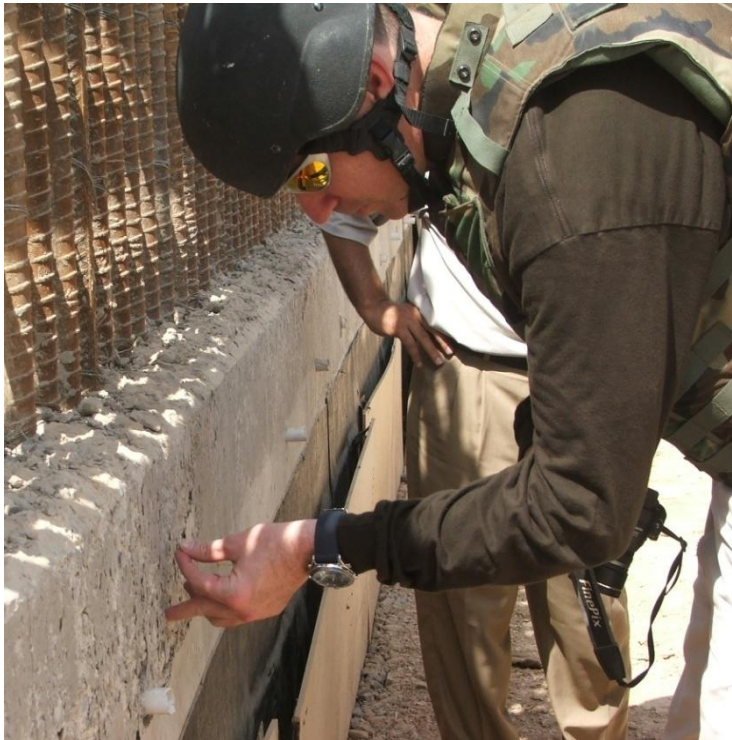
Site Photo 20. SIGIR Inspector checking concrete work

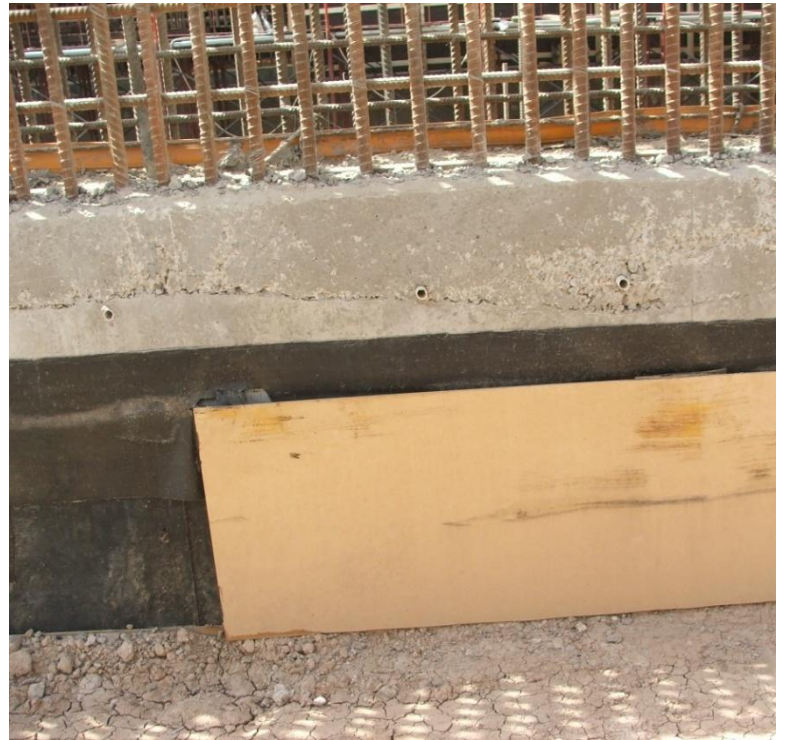
The Falluja Waste Water Treatment System project results will not be consistent with either the original or revised project objectives. During the site visit, SIGIR confirmed that the original designs for all three collection systems were technically inadequate, and the concrete at Pump Station F1 was improperly poured.

Site Photo 21. Inadequate concrete area (behind cover)

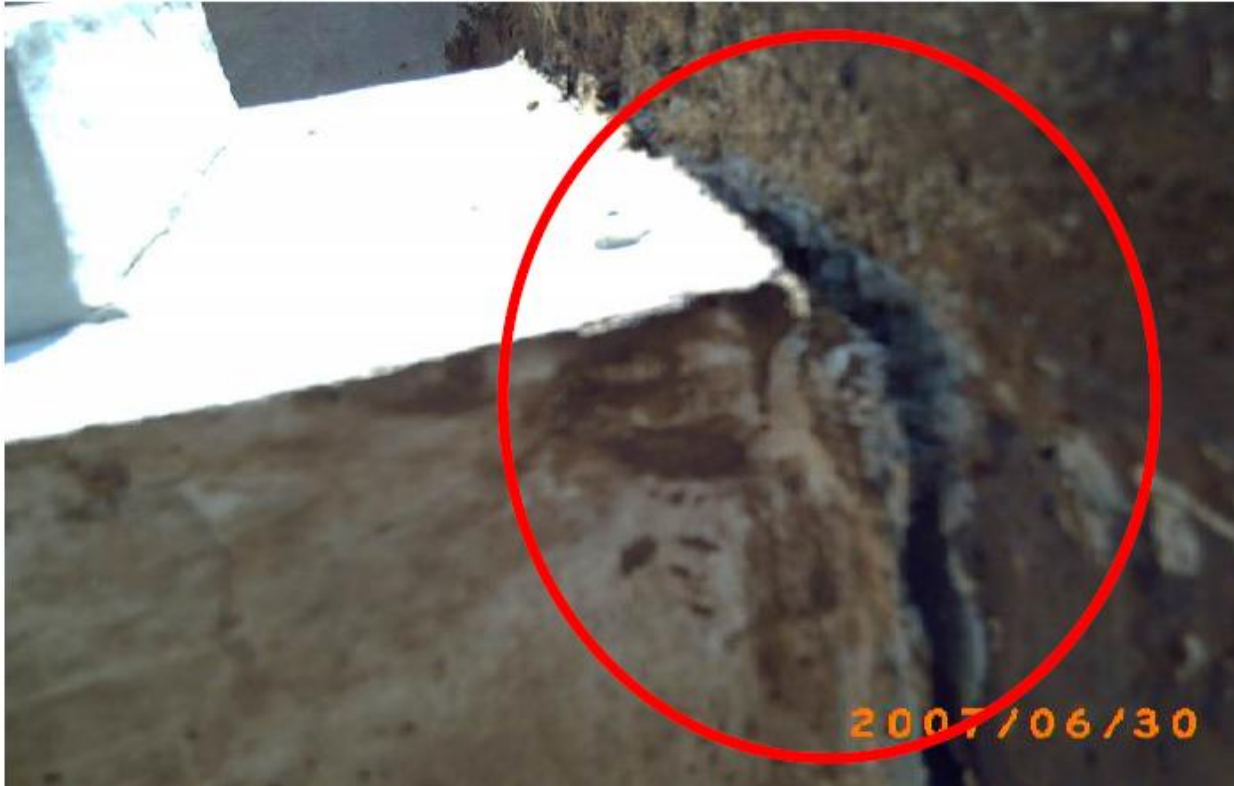
**Site Photo 22. Deficiency identified in daily QA report by field engineers
(Courtesy of the USACE)**
