**U.S. Department of the Interior  
Minerals Management Service  
Gulf of Mexico OCS Region**

Safety Alert No. 225  
January 14, 2005

### **Fatality on Rig Caused by Snagged Barricade**

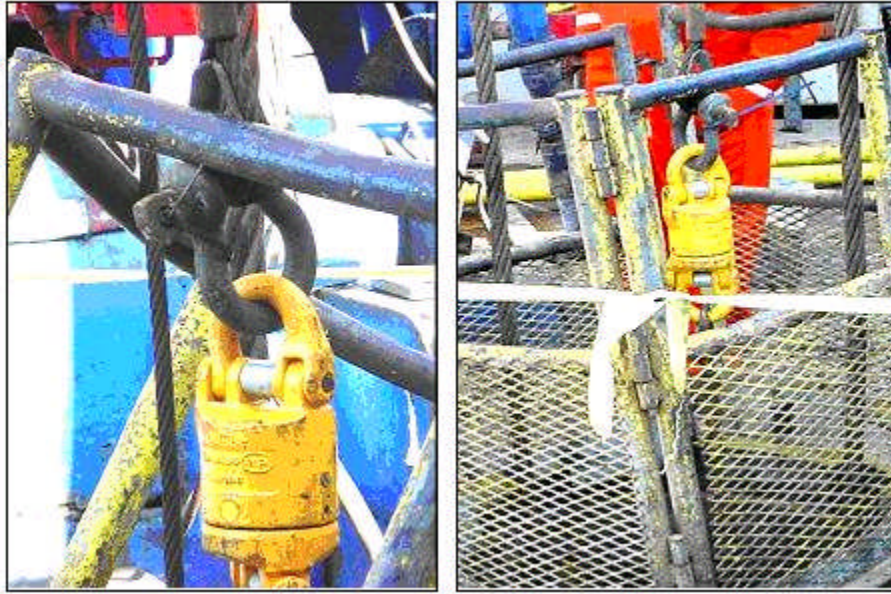
During drilling operations to re-connect the diverter, a welding crew was lifted from the texas deck using an air hoist, with the hoist assembly run through the rotary. The hoist assembly included an un-shimmed 7/8-inch shackle installed pin-side up. As the hoist assembly passed through the rotary, the shackle pin snagged a barricade placed around the rotary, lifting it 45 feet into the air.

**Shackle snagging on Barricade**

- Offshore crews should carefully inspect all lifting assemblies prior to use.
- Crews should follow guidelines for use of lifting components, including shimming all pad eyes to the proper tolerances recommended by manufacturers.
- Rigs should hold a detailed JSA meeting discussing any simultaneous operations being conducted when man-riding activities are planned.
