Subject: Tornado at Vancouver, Washington, April 5, 1972

VANCOUVER, WASHINGTON TORNADO

April 5, 1972

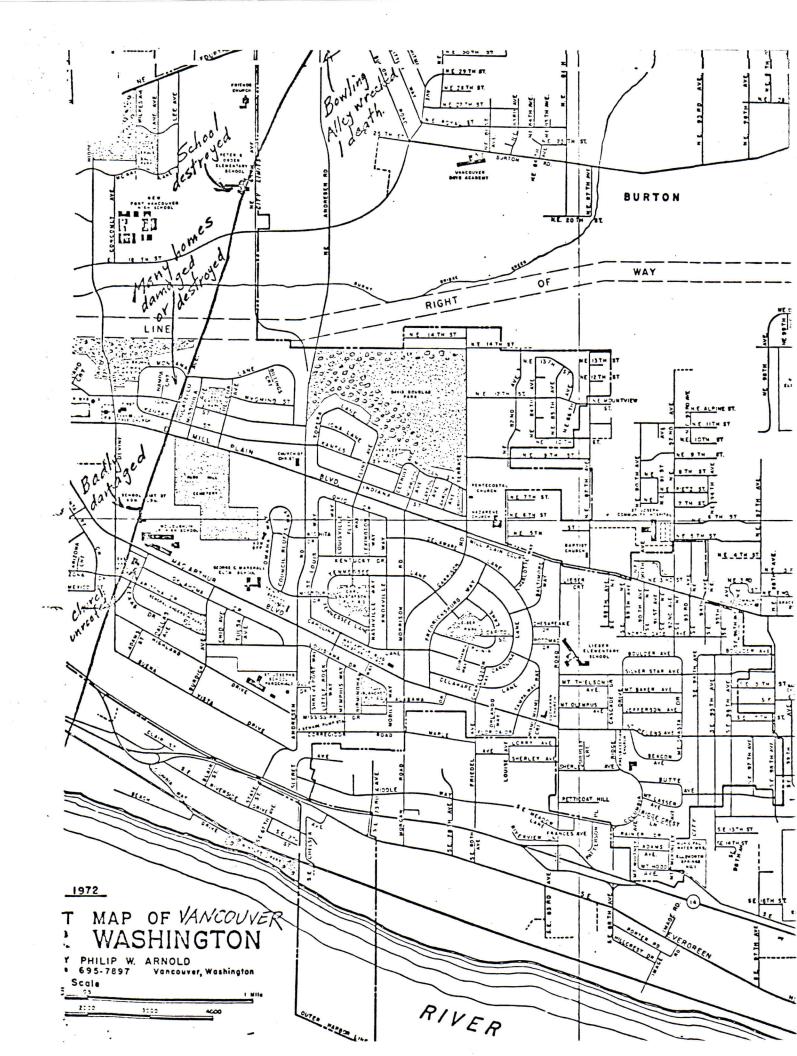
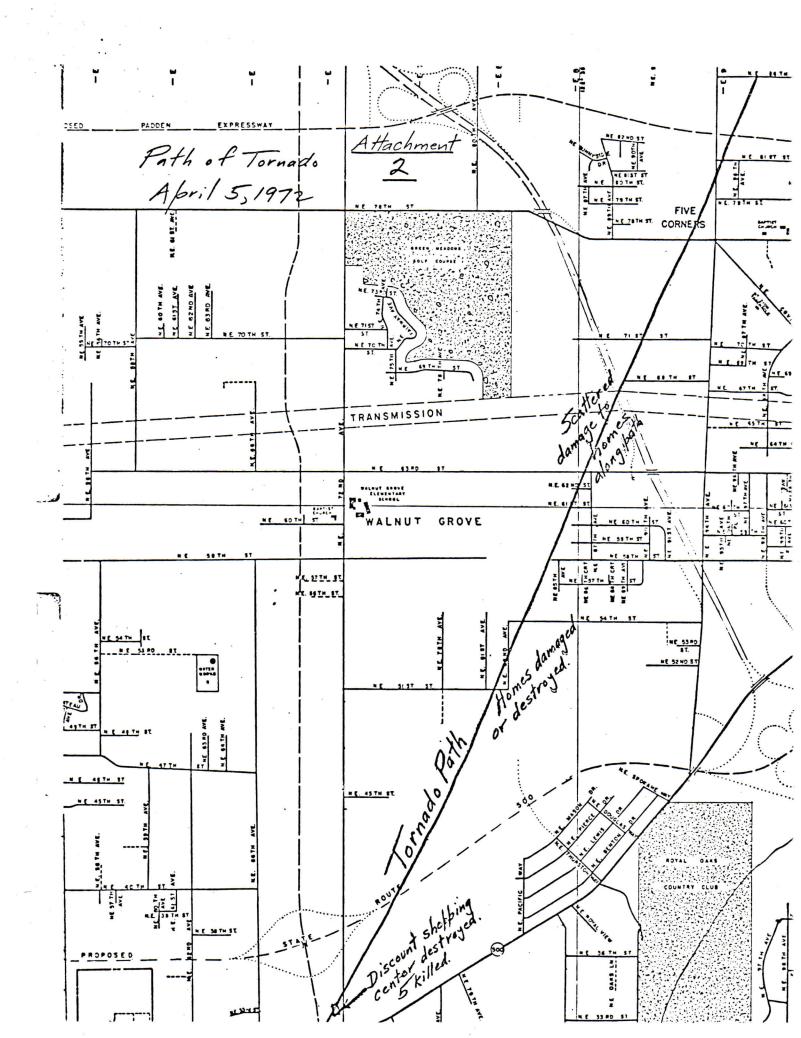
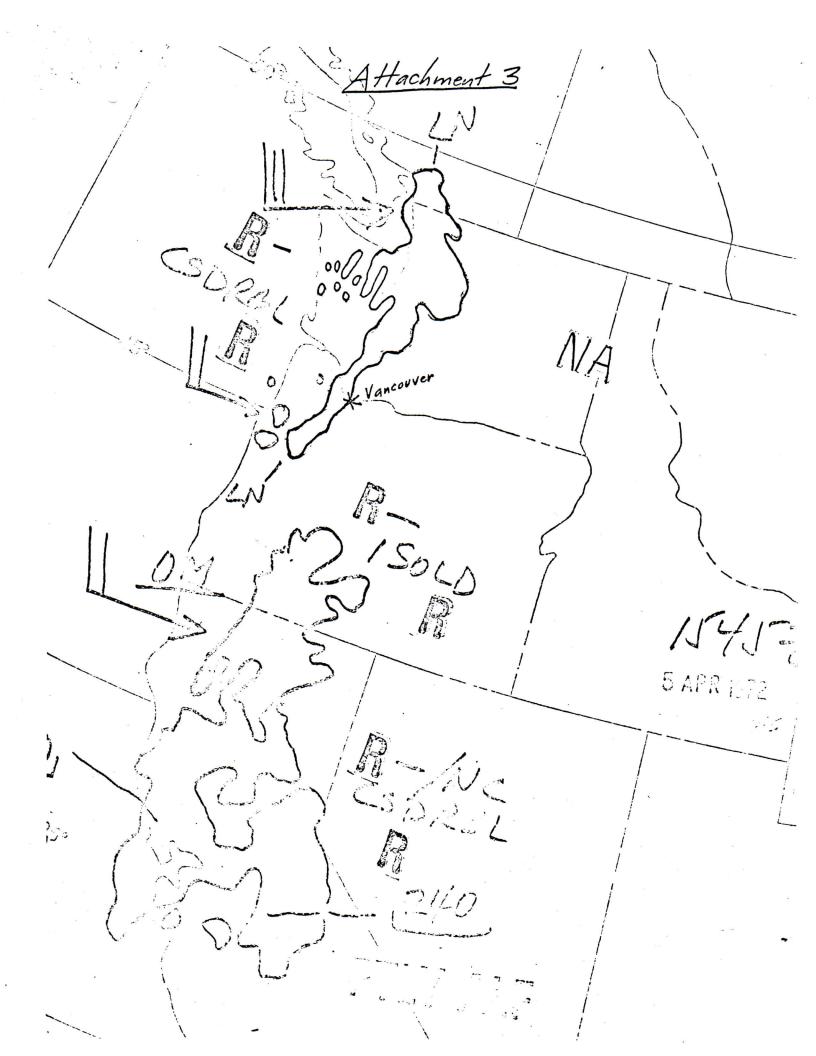
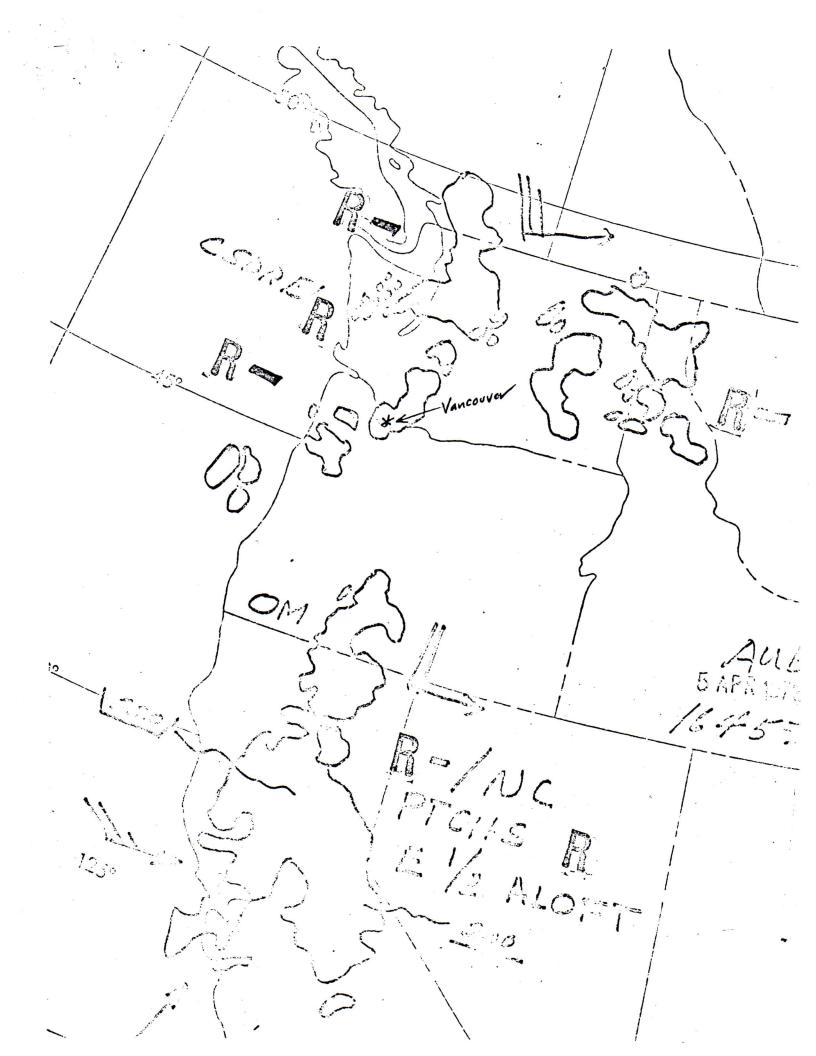
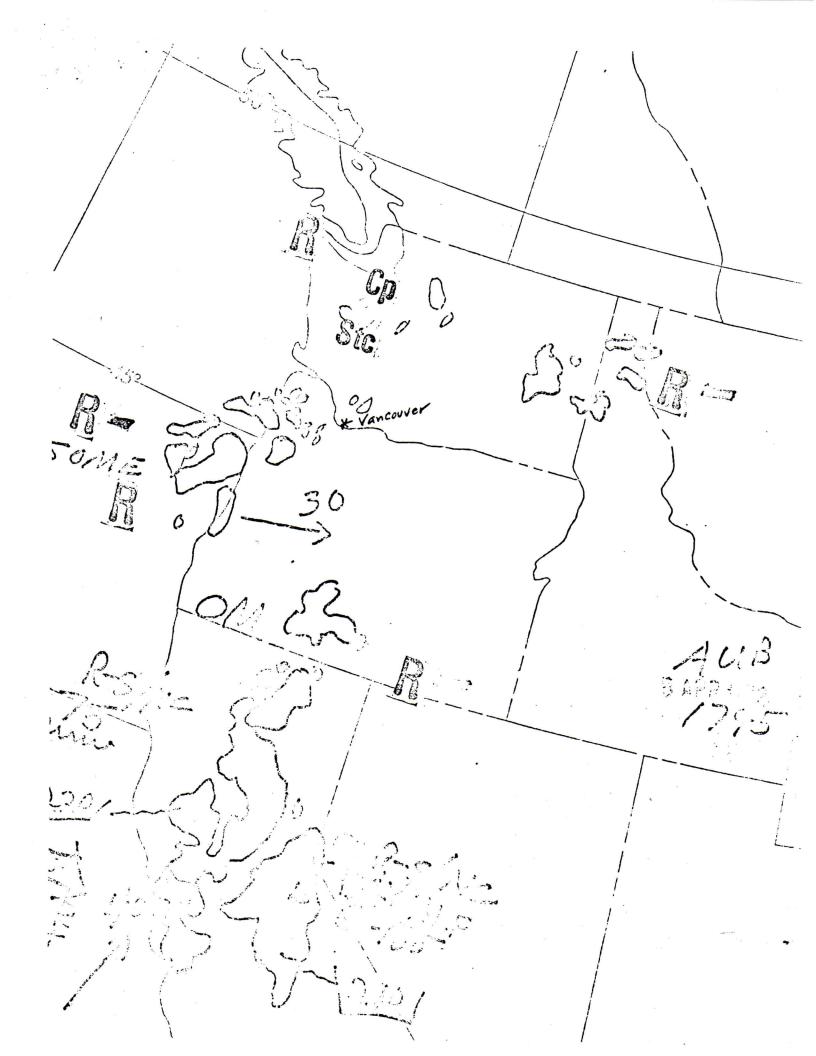
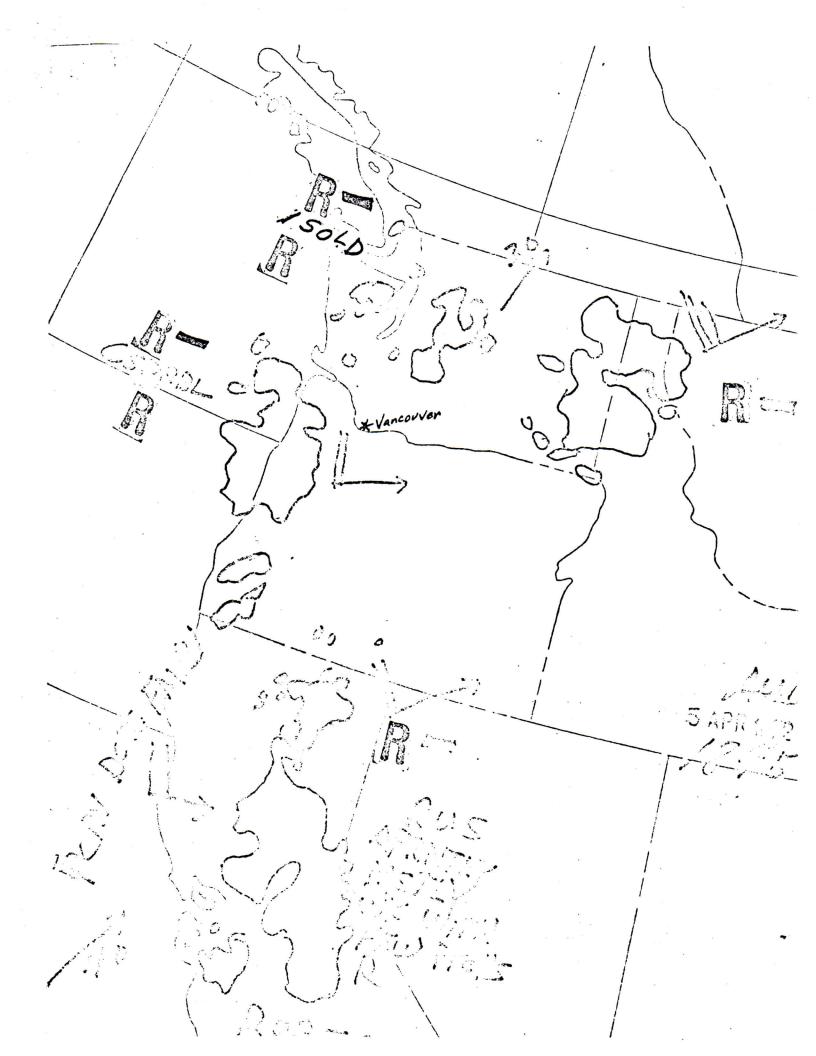
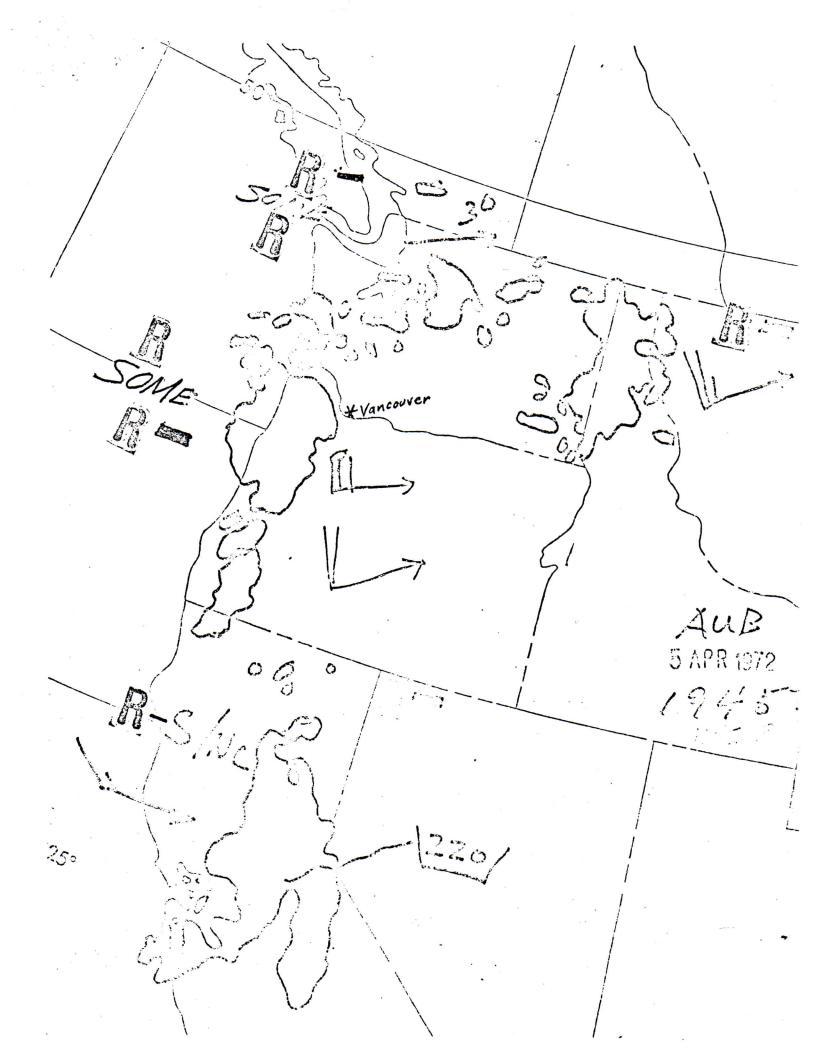
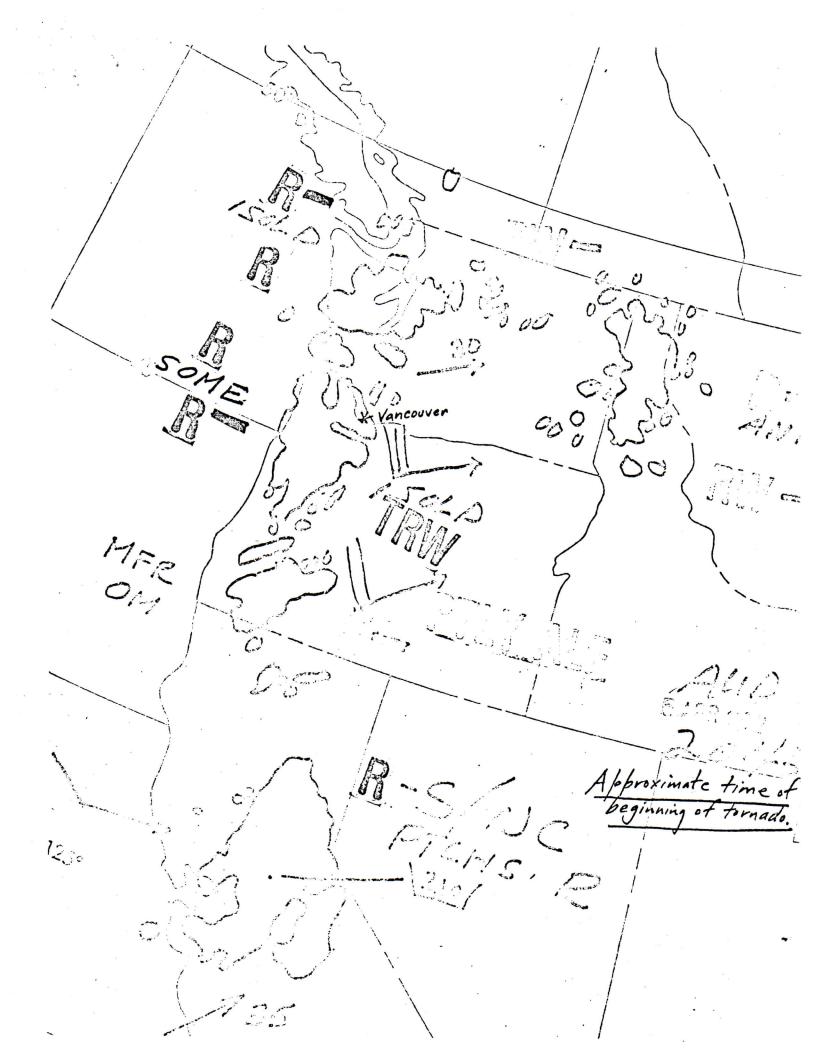
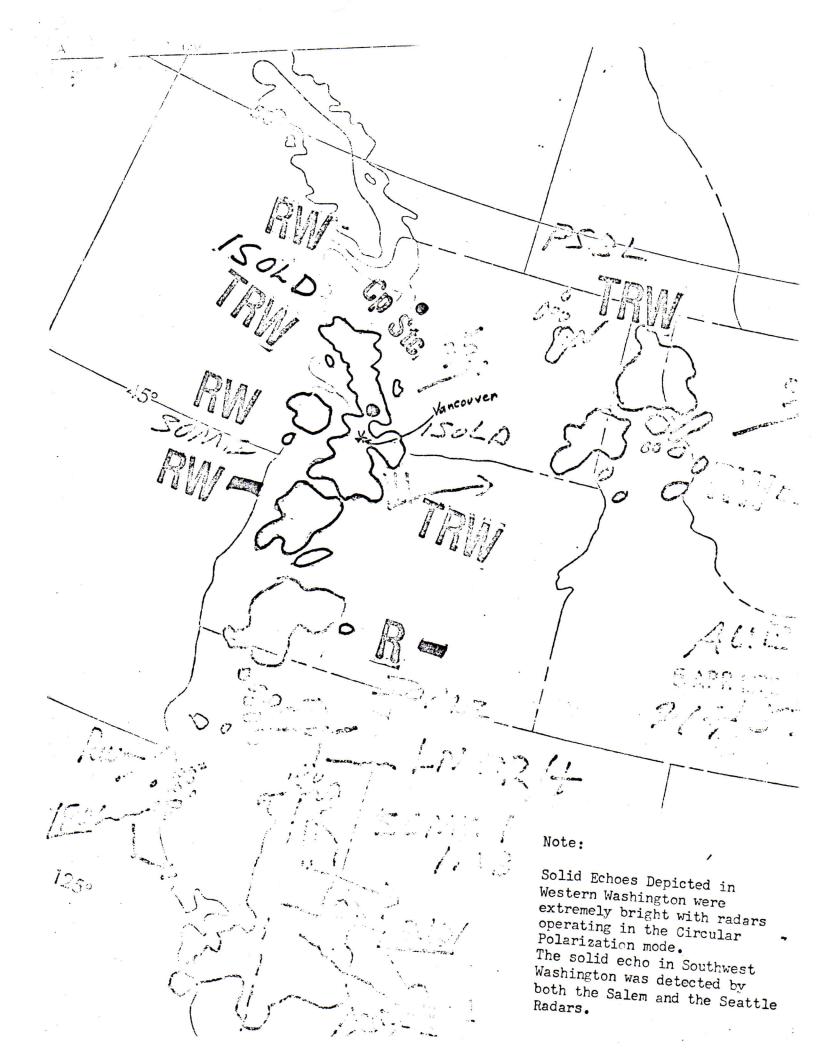
Attachment 1 is a number of newspaper photos of the destruction. We have other newspaper pictures, as well as about 30 $3\frac{1}{4}$ x $3\frac{1}{4}$ color photos taken both from helicopter and from the ground.

A number of witnesses reported the impression that buildings seemed to explode. Examination of the wreckage of the school shows some strong evidence in this regard. The end wall of the gymnasium which faced south toward the approaching storm fell with most of its bricks on the outside (to the south), and a section of west-facing wall was pushed westward. The east wall of the gym fell inward, and remained leaning against bleachers, which suggests a very strong east wind at this point.

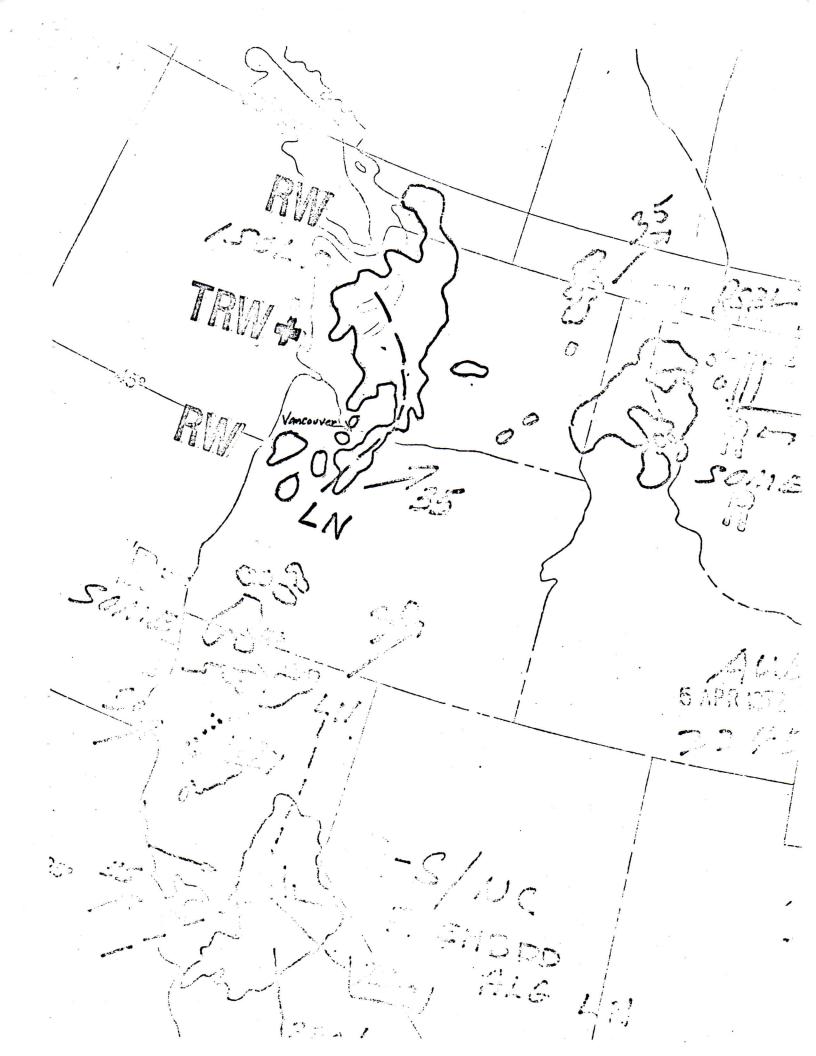
Attachment 2 is a map showing the tornado path and main destruction areas.

On Wednesday, April 5, 1972, at about 1:00 p.m. Pacific Standard Time, a squall line moving eastward through the Portland-Vancouver area spawned a tornado. It began its touchdown at the Columbia River at about 33rd Avenue and Marine Drive in Portland, where it destroyed some dock installations. Crossing the river (and the Washington-Oregon state line), it sent up a cloud of spray, and some reported seeing a waterspout. Then, as it moved up the north bank of the river and north-northeastward through Vancouver in the next 10 minutes, it left an incredible scene of destruction. Its path crossed some residential areas, where it destroyed or badly damaged about 50 homes. However, the greatest destruction occurred in a length of about 2 city blocks, where it completely destroyed the Peter S. Ogden Elementary School, then moved a block to wreck a bowling alley, then a half block to destroy a large discount store. Also badly wrecked were a lumber store, a service station and a number of other businesses in this shopping area. From here it began to skip as it moved NNE through rural areas interspersed with residential developments, where it deroofed a couple dozen homes and buildings, and completely destroyed a few. Hundreds of trees were also blown down and a few were left standing but denuded of branches. In general, the path width was 50 to 100 yards and in a few places there was evidence of multiple paths. Total length of destruction extended about 9 miles from the river, but with large skips toward the end. It has been categorized 322 on the Fujita-Pearson (FPP) scale.

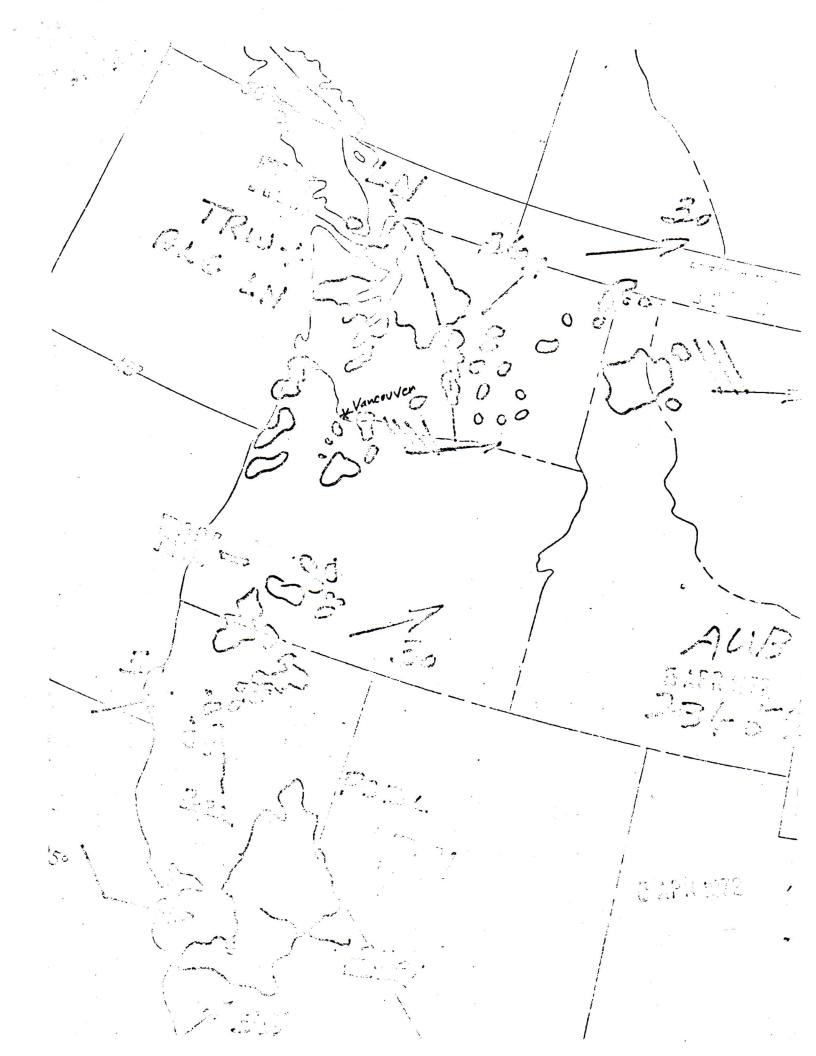
Attachment 3 is taken from the radar overlays, and shows the radar echoes associated with the squall line.

Radar offers the best hope, but radar identification of tornado echoes is very subjective. The routine observational program at an ARTC Center requires that the observer be away from the consoles for 20-30 minutes at a time. Reports by citizens indicate that this tornado was probably in existence less than 10 minutes. There were no signature echoes observed on the radar. However, the rarity of tornadoes in that area would hardly prompt the radar observer to make the kind of detailed analysis necessary to identify signs of a tornado echo.
