NTSB National Transportation Safety Board

Office of Highway Safety

**Motorcoach Override
of Elevated Exit Ramp
Interstate Highway 75
Atlanta, Georgia
March 2, 2007**

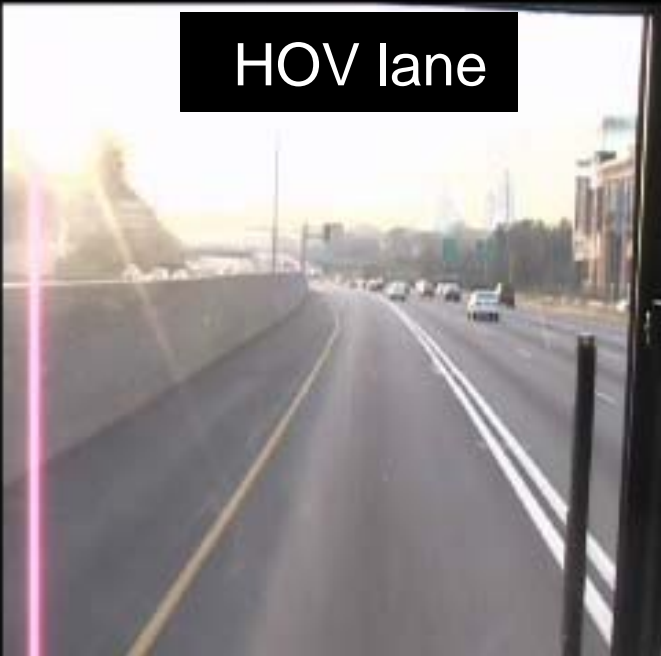
HOV lane

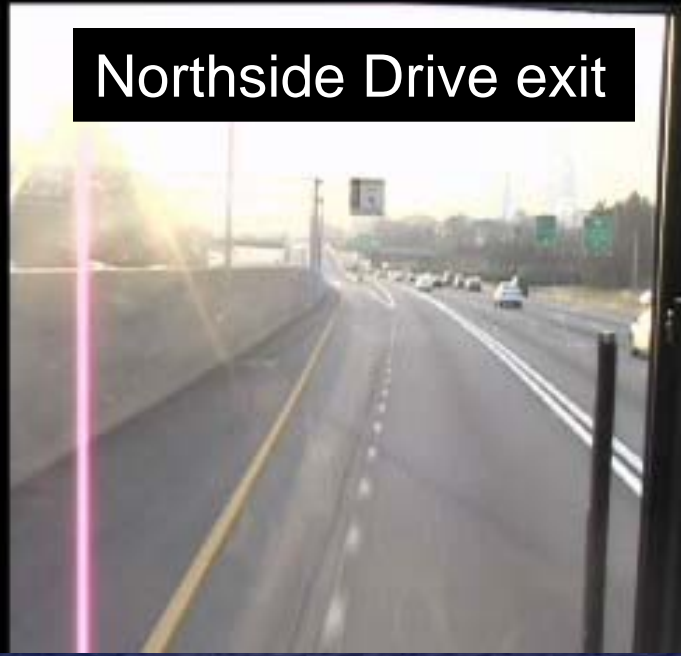
Northside Drive exit

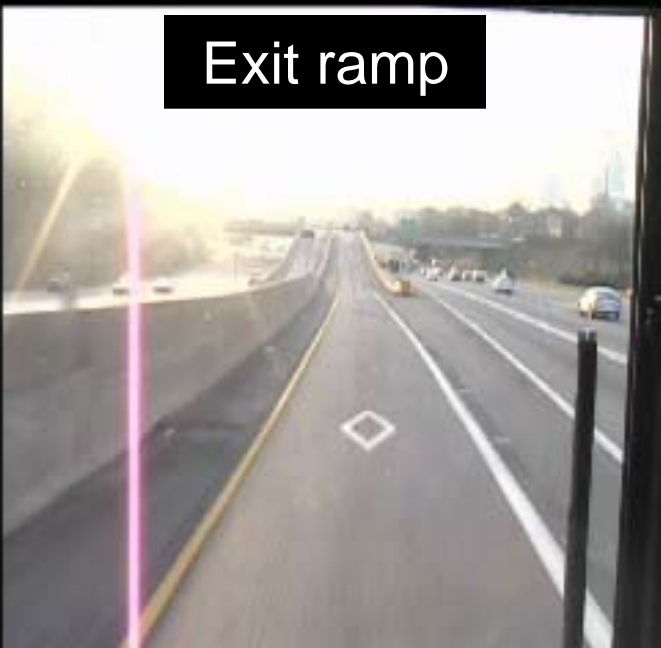
Exit ramp

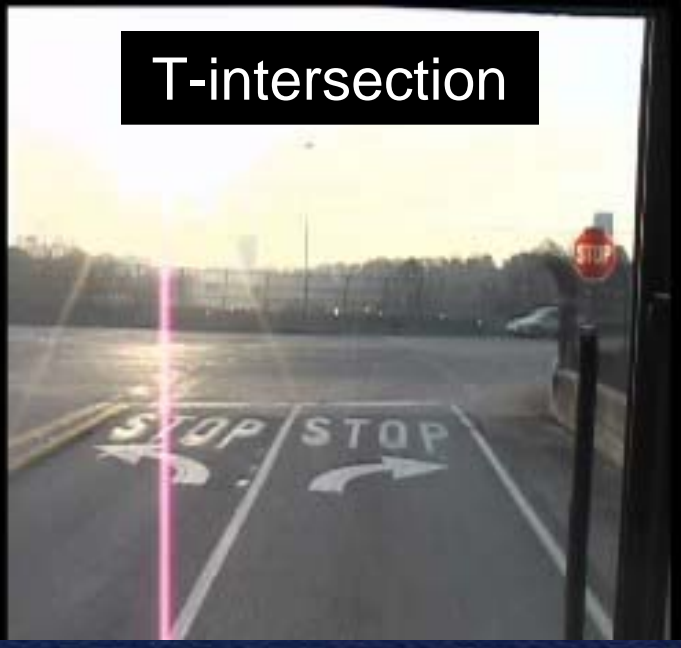
T-intersection

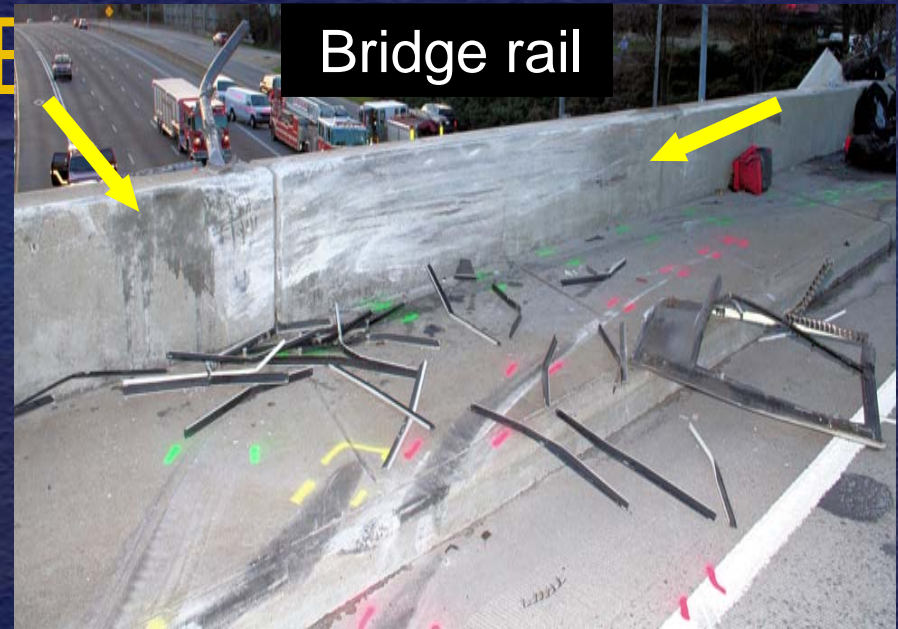
Bridge rail

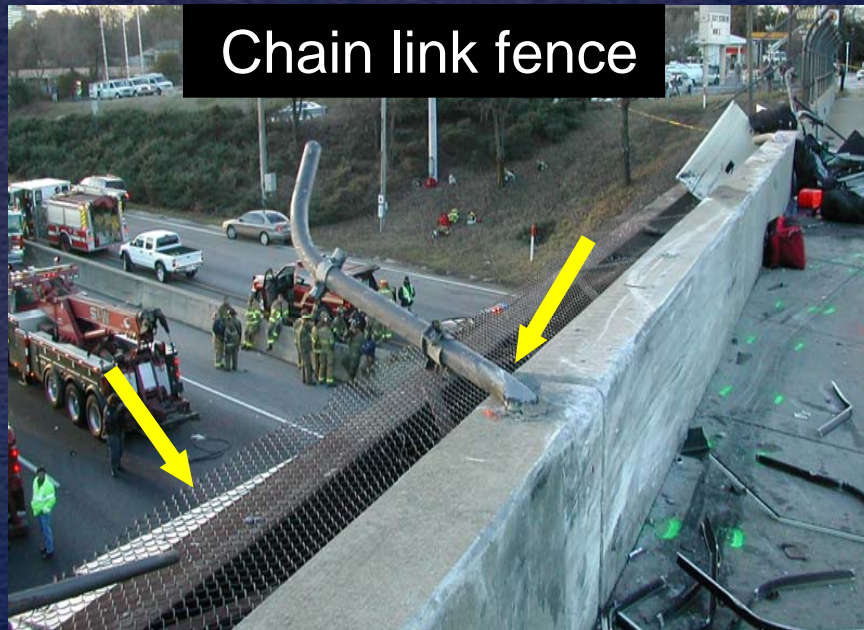
Chain link fence
