FEDERAL EMERGENCY MANAGEMENT AGENCY

Above the Flood: ELEVATING YOUR FLOODPRONE HOUSE

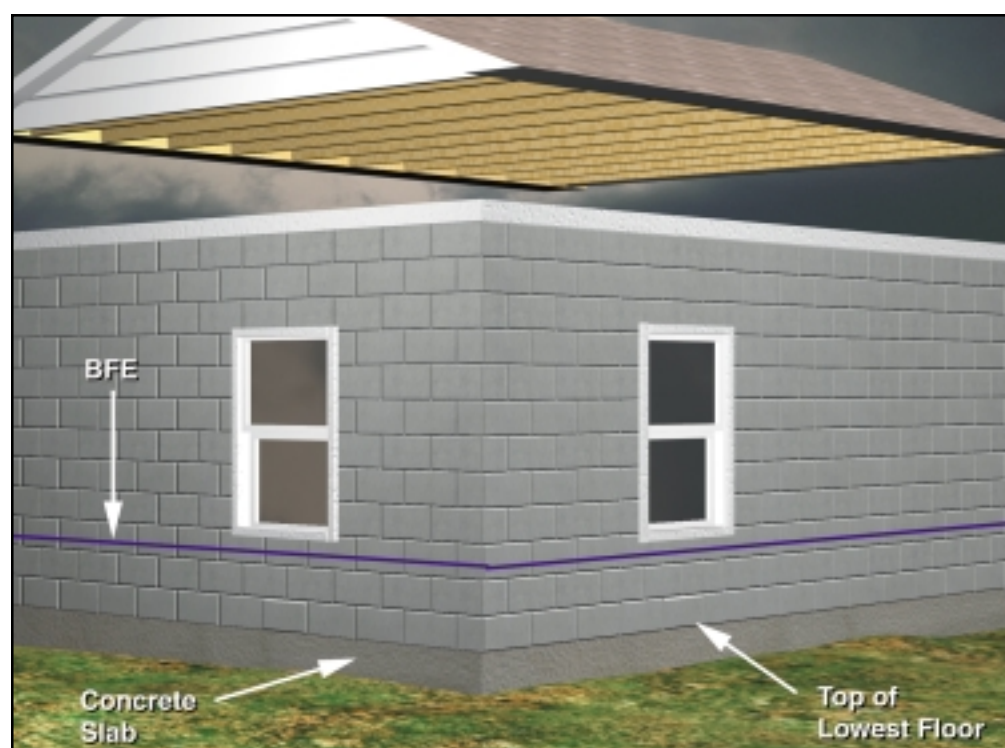
Figure 10
The first step in Technique 1 is removing the roof.

Technique 1 is appropriate for houses with concrete or masonry walls, but not for houses with other types of walls, such as those framed with wood studs, which would be more vulnerable to flood damage. This technique is usually appropriate when the depth of the base flood at the house is no more than 4 or 5 feet above grade. The elevation process begins with the temporary removal of the roof and roof framing, in a single piece if possible (Figure 10). This is commonly done with a crane. The roof is then stored on site so that it can be reinstalled later. The next step is to remove the windows and doors.

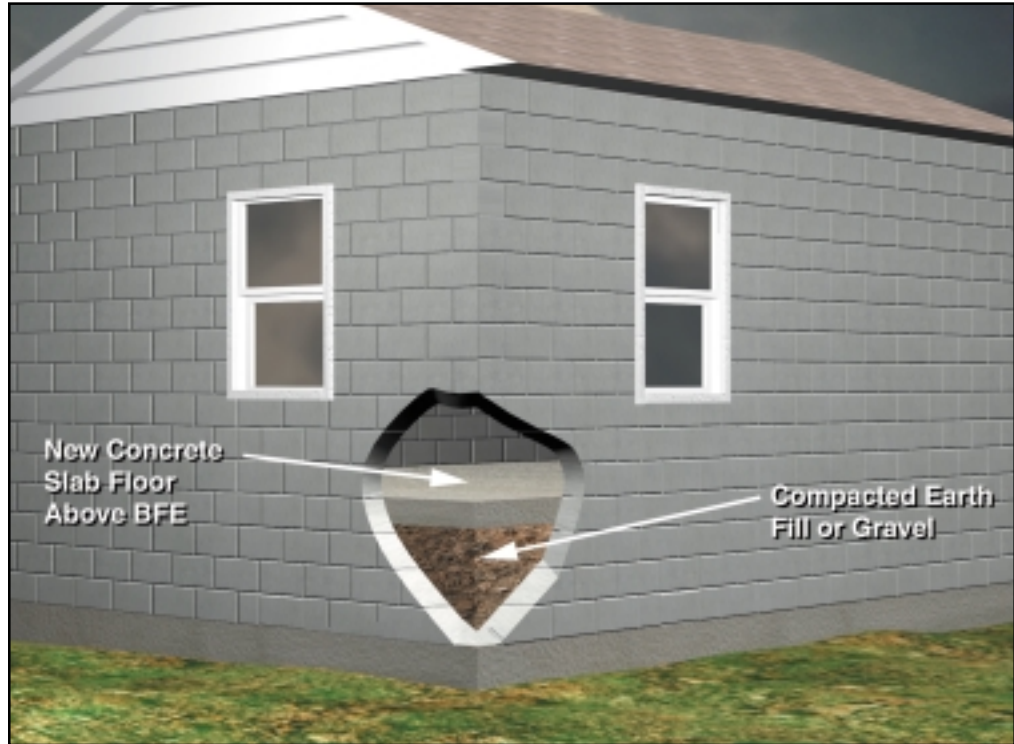
Figure 14
An alternative to building an elevated wood-frame floor is installing a new, elevated concrete slab floor on fill placed over the old slab.
