HIGHWAY SAFETY RECOMMENDATION LETTER
SAFETY RECOMMENDATIONS H-10-17 AND -18

RECOMMENDATIONS CONCERNING NONDESTRUCTIVE EVALUATION OF CONCRETE BRIDGE RAILINGS
FOLLOWING AN ACCIDENT ON THE WILLIAM PRESTON LANE, JR., MEMORIAL BRIDGE (CHESAPEAKE
BAY BRIDGE) NEAR ANNAPOLIS, MARYLAND, AUGUST 10, 2008

Date: November 23, 2010

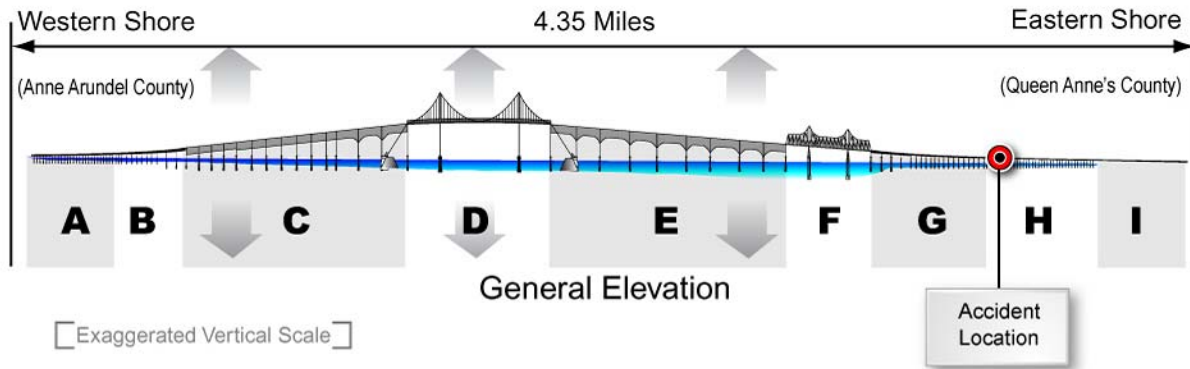
LEGEND		
A	1,841	Feet of Beam Spans
B	1,319	Feet of Girder Spans
C	4,296	Feet of Deck Truss Spans
D	2,923	Feet of Suspension Spans
E	4,665	Feet of Deck Cantilever Truss Spans
F	1,719	Feet of Through Cantilever Truss Spans
G	2,231	Feet of Girder Spans
H	2,272	Feet of Beam Spans
I	1,756	Feet of Filled Causeway

Figure 1. Diagram of eastbound span of Chesapeake Bay Bridge showing the different types of superstructures.

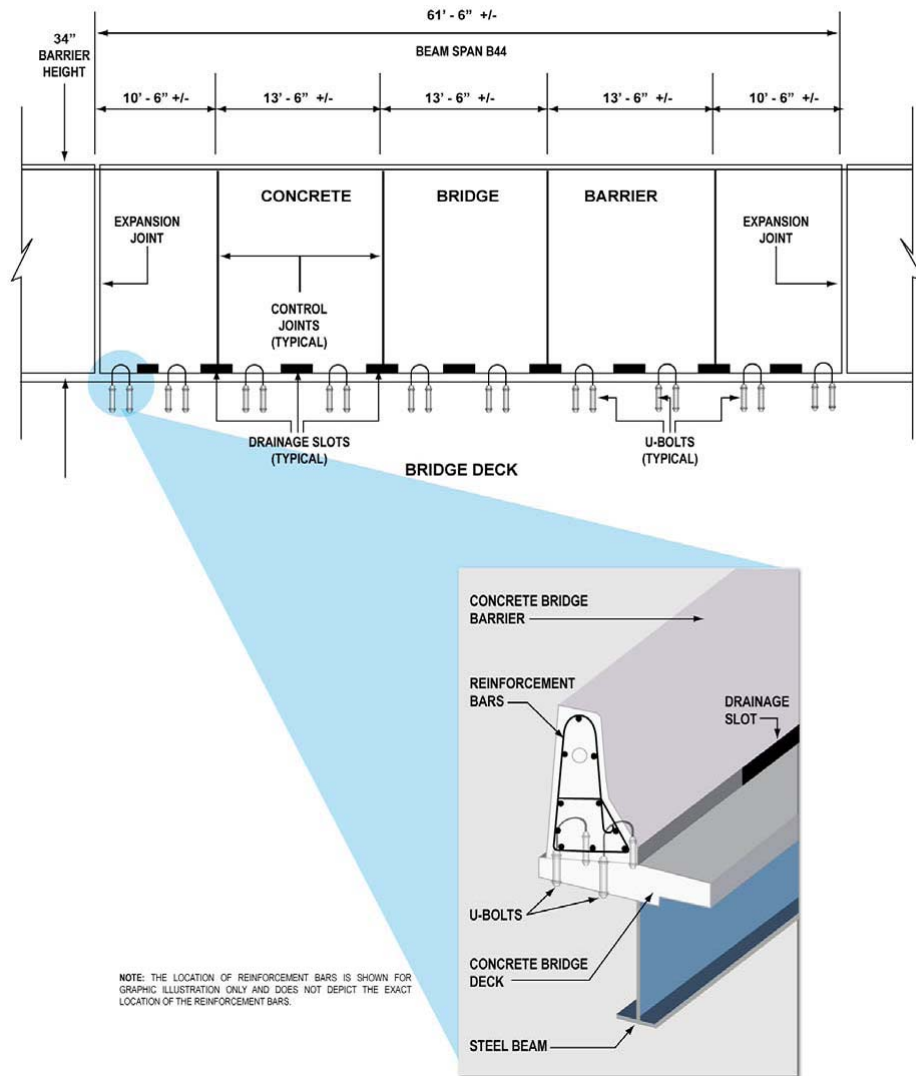
In 1951, as part of the original construction, the concrete barrier was attached to the bridge deck using a U-bolt anchorage system. Each section contained five segments and each segment was anchored to the deck at four locations using two U-bolts, threaded and attached with nuts and washers above and below the deck. The U-bolts were aligned perpendicularly across the barrier with one bolt closer to the traffic side of the barrier and the other near the bay side. The U-bolts were oriented “upside-down,” such that the bolt attached around the reinforcement bars inside the base of the barrier and the ends of the “U” extended down through the bridge deck and were bolted to the underside of the deck. (See figure 2.) A U-bolt anchorage system was used on all portions of the bridge barrier except the suspension span, which had a steel barrier bolted directly to the steel floor beams, independent of the bridge deck. The use of a U-bolt anchorage system would be considered “nonstandard” today; however, it conformed to the bridge railing designs contained in the 1944 American Association of State Highway Officials (AASHO) *Standard Specifications for Highway Bridges*.⁶

Figure 2. Bridge deck concrete barrier attachment detail.

The 1986 engineering drawings called for replacing the existing U-bolts installed between the barriers and the bridge deck in 1973 with 7/8-inch (0.875-inch) epoxy-coated bolts conforming to American Society for Testing and Materials (ASTM) A449-00. However, because the existing U-bolts (installed in 1973) were grouted into the deck, their removal and replacement proved too damaging to the bridge deck. Most of the existing 1973 U-bolt attachments were reused in 1986 to attach the new concrete barriers, which were cast in place using a “slip form” method.⁸

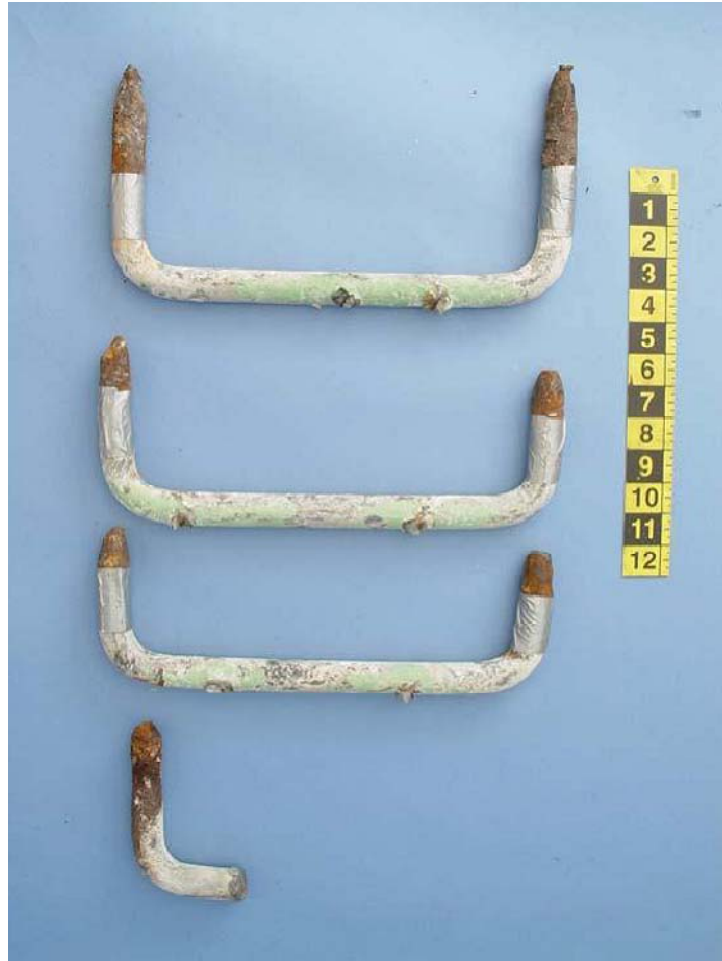
The NTSB materials laboratory examined the displaced barriers and retained eight concrete core samples, four U-bolts, and eight threaded U-bolt ends cut from the lower side of the deck for testing. Figure 3 shows U-bolts with threaded ends. The diameters of the U-bolts near the upper middle sections where there was no corrosion measured 0.994–1.002 inches. The lower ends of the U-bolts were reduced in diameter, and the smallest cross-sectional diameter was measured near the fractured ends. All of the bolts had reduced cross-sectional area due to corrosion; minimum diameter measurements were 0.648, 0.530, 0.415, 0.509, 0.378, and 0.305 inch. In one instance, the bolt diameter had corroded to the extent that it had decreased to a point. The fracture surfaces were covered in red, black, and orange oxides and exhibited reverse bending fatigue and environmental exposure. (See figure 3.)

Figure 3. Photograph of U-bolts after removal from barrier.

Diameters were measured in the eight samples cut from the U-bolt threaded ends extending from the lower side of the deck. Samples from the traffic side of the barrier had diameters of 0.99–1.00 inch; samples from the bay side had diameters of 0.87–0.89 inch. The NTSB found that the attachment U-bolts for the barrier dislodged by the accident showed reduced cross-sectional area due to corrosion. The NTSB concludes that, based on the degree of corrosion, the attachment U-bolts for the barriers in the accident location were substantially degraded at the time of the accident.

The MdTA noted that deicing materials (mainly salt) are applied to the bridge deck after the start of frozen precipitation. Corrosion of the U-bolts was most likely the result of exposure to environmental conditions, such as salt, moisture, and oxygen. The vertical grade of the bridge drains to the beam span sections, and the small joint between the bottom of the barrier and the surface of the bridge deck, allowed salt and water to infiltrate the joint. This phenomenon occurred for approximately 35 years, from the time the U-bolts were originally installed in 1973.
