**PROTECTED MARINE SPECIES WATCH PROGRAM
MIAMI HARBOR DEEPENING PROJECT**

**FINAL REPORT
US ARMY CORPS OF ENGINEERS CONTRACT
W912EP-05-C-0012**

December 2005

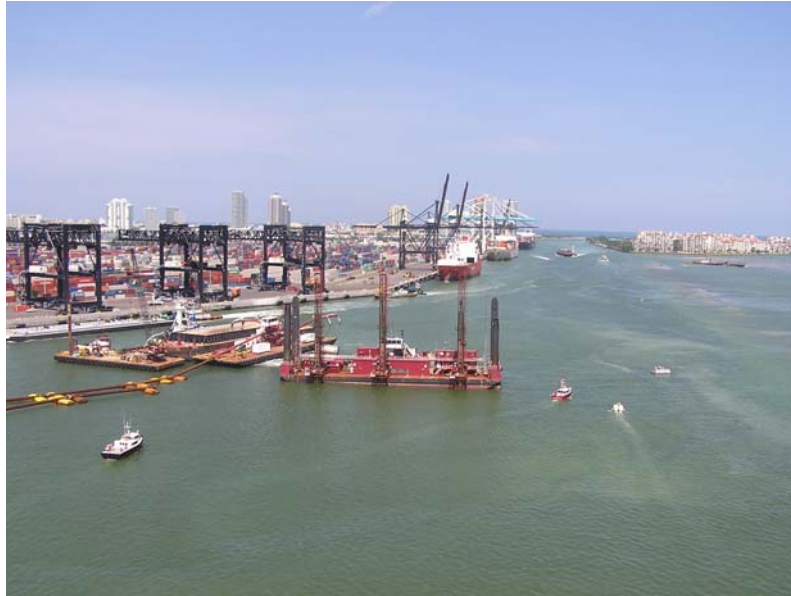
Figure 2. Drill Barge Apache set up in Miami Harbor.

A blast plan was developed between the ACOE and the blasting/dredging contractor to maximize the efficiency of the rock removal while minimizing the impacts to the surrounding environment and species. Through agency coordination, the blast plan that was accepted utilized confined blasting techniques, where a borehole containing explosives is capped with an inert material thus decreasing the strength of the pressure wave generated upon detonation. All blasting was done from the Great Lakes Dredge and Dock Company's Drill Barge, *Apache* (Figure 2).

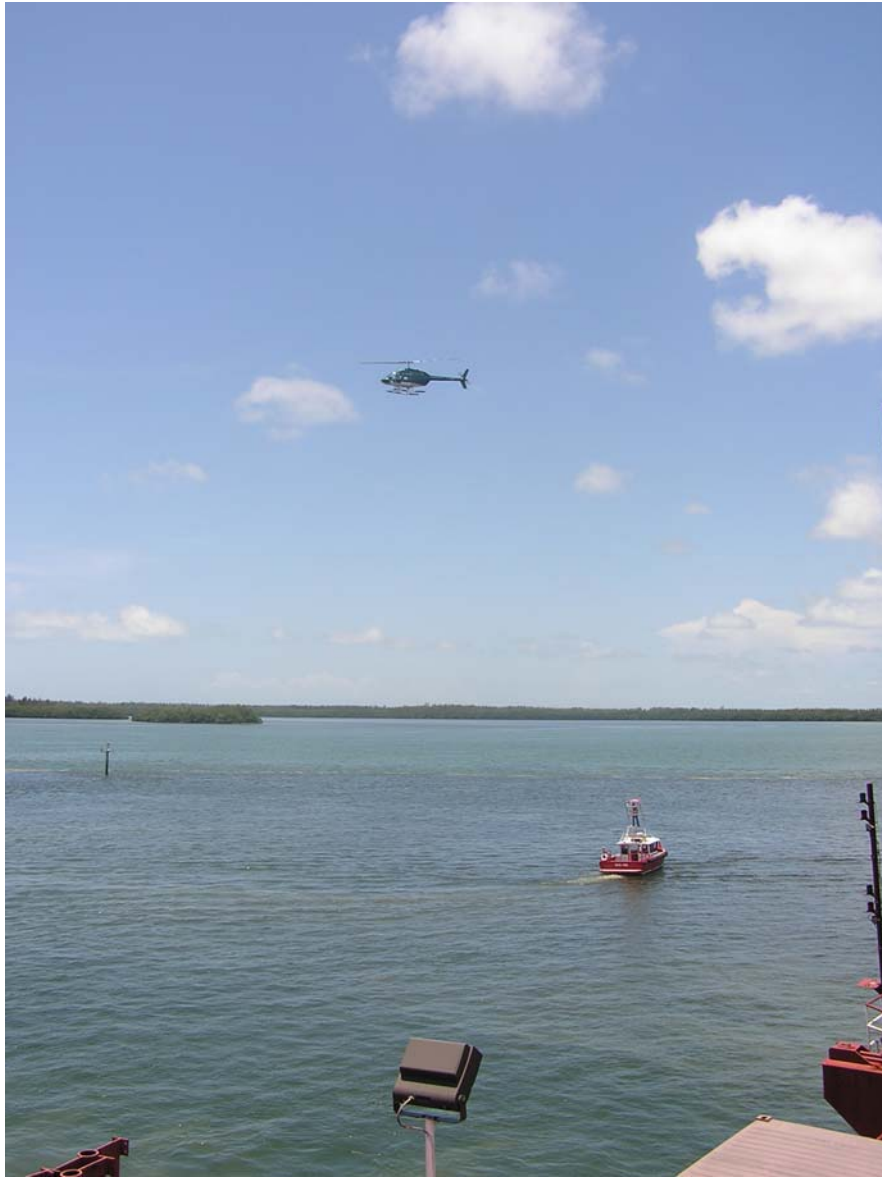
Figure 7. View of observer on drill barge looking south at one boat observer and the aerial observer

The drill barge observers were in place on the catwalk of the control tower approximately 30 ft above the water (Figure 7). One observer faced the blast array while the other faced away from the blast. This site is a critical site for observers as it not only gives an excellent view of the most critical impact zone, it also serves as back up communications between the aerial observer and the blaster in charge.
