CRC TEST PILE PROJECT

Marine Mammal Monitoring Report

May 2011

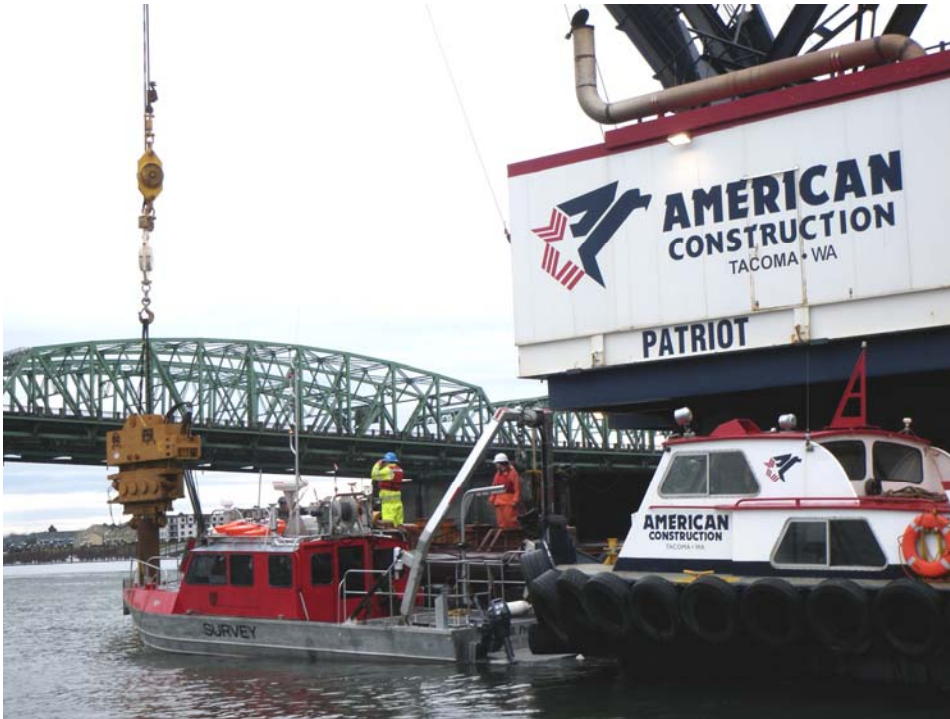
Photograph 2. Monitor (shown in yellow) on the work barge scans for marine mammals during vibratory pile activities.
