## **Protected Species Mitigation and Monitoring Report**

**Plate boundaries around the Chukchi borderland: An integrated geophysics cruise to test models for the formation of the Canada Basin.**

**Coakley Marine Geophysical Survey  
in the Arctic Ocean**

**R/V Marcus G. Langseth**

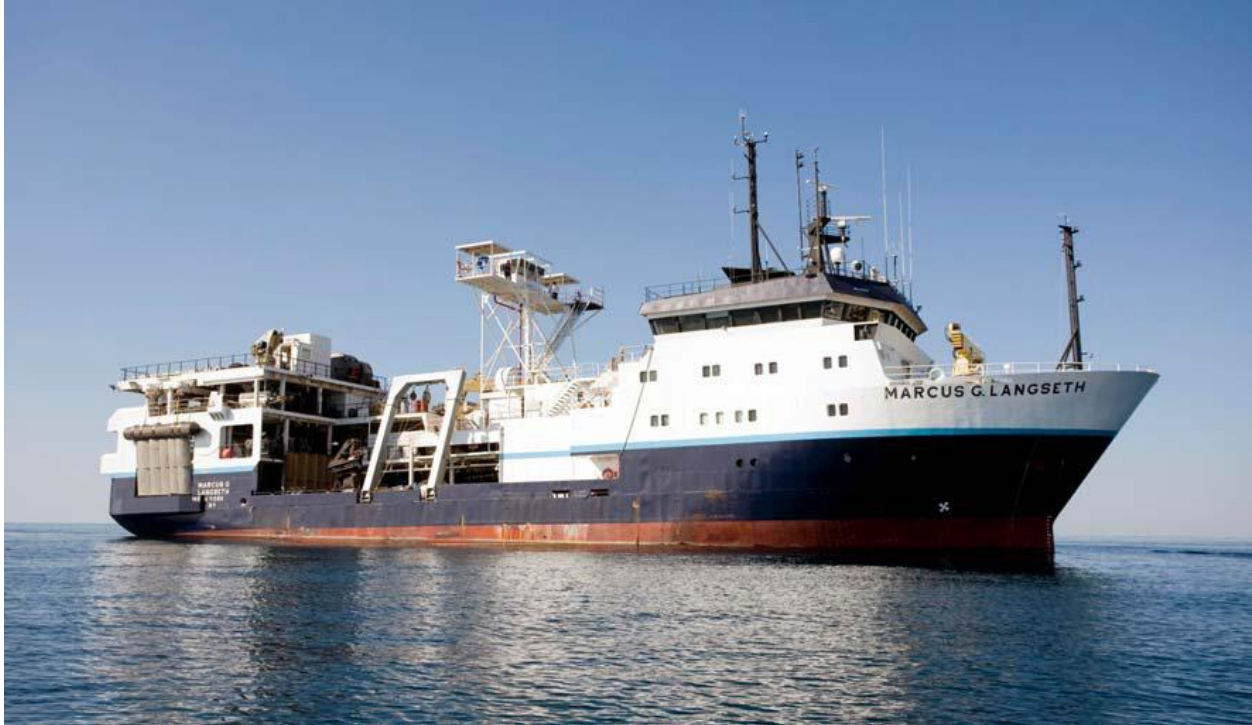
**Figure 2. The R/V Marcus G. Langseth showing location of bridge (12.8m asl) and MMO tower (18.9m asl), where observations were conducted.**

Due to the temperature being at or below freezing and frequent snow during the majority of survey most of the observations were held from the bridge (12.8m asl), however when the weather was warmer observations were held from the PSO tower (18.9m asl). The PSO tower was equipped with Fujinon 7x50 binoculars and well as two mounted 25x150 Big-eye binoculars. Inside the tent located in the middle of the platform was a laptop, for data collection, as well as a telephone for communication with the PAM station, bridge, or main lab. Also inside the tent was a monitor that displayed current information about the vessel's position, speed, and heading, along with water depth, wind speed and direction, and source activity. For the duration that observations were held from the bridge the laptop, binoculars, field guides, etc. were moved into the bridge. Night Quest NQ2200 Night Vision Viewers were also available to be used to conduct night time observations for nighttime ramp ups of the acoustic source, but were not used during this survey.

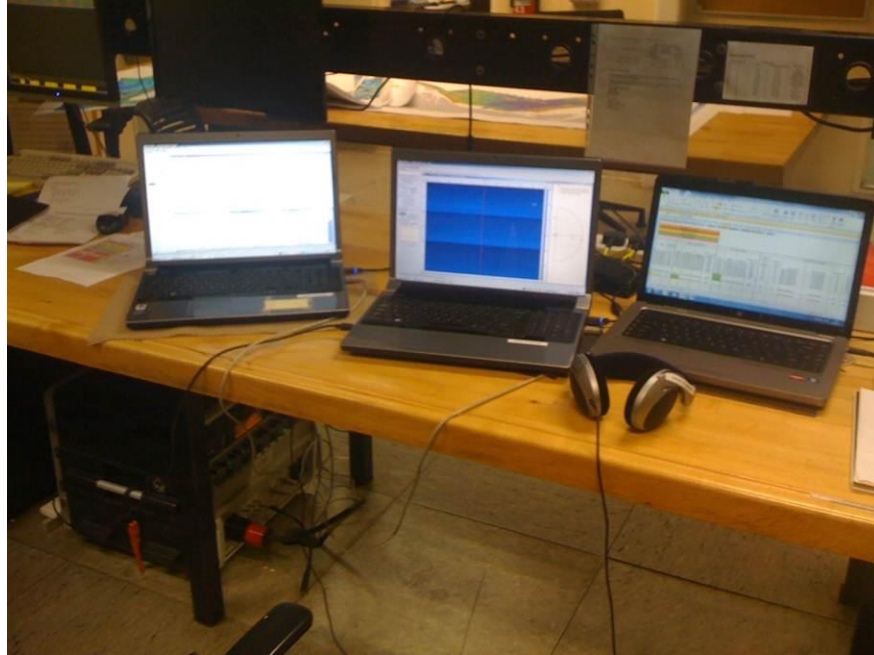
**Figure D.18: PAM Laptops and data processing unit setup**

The two laptops and data processing unit are set up in the main lab with a GPS cable feed (INGGA string) directly from the ship's navigation system to the low frequency laptop (Figure D.2). The data processing unit connects to the 250m hydrophone cable through a 100m deck cable that is run from the main lab out to the gun deck. Both the deck cable in use and the spare are run from the main lab out to the gun deck just in case one failed because the cable had to be run through the bulk head which can only be done while in port. The 250m hydrophone cable is wound on a section of a deckhead winch on the port side of the gun deck (Figure D.3). From the winch the hydrophone cable is fed astern and pulled further port by a line secured by a yale grip to the port sponson. (Figure D.4). An 8m rope drogue was secured to the end of the hydrophone cable with zip ties with a 9kg shackle secured to the end of the rope drogue with a knot and tape (Figure D.5). Second four lengths of chain weighing approximately 2.5kg each were secured on the cable with tape, 3m, 45m, 96, and 132m up from the depth gauge (Figure D.6). The hydrophone is deployed approximately 150m from the stern and 50m before the center of string. Being that the hydrophone cable is free and independent of the guns the cable is always retrieved before port gun strings are moved.

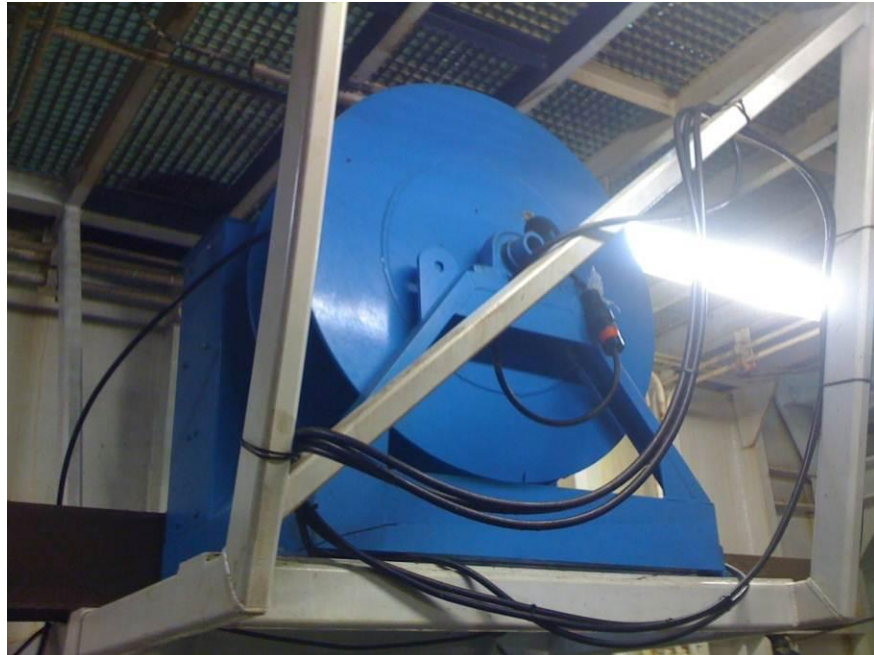
**Figure D.19: Hydrophone cable on winch**

The vessel had a winch installed on the port stern deckhead of the gun deck for deployment of the PAM hydrophone cable. Two deck cables, the main cable and a spare, were installed along the gun deck deckhead running from the winch to the science lab.

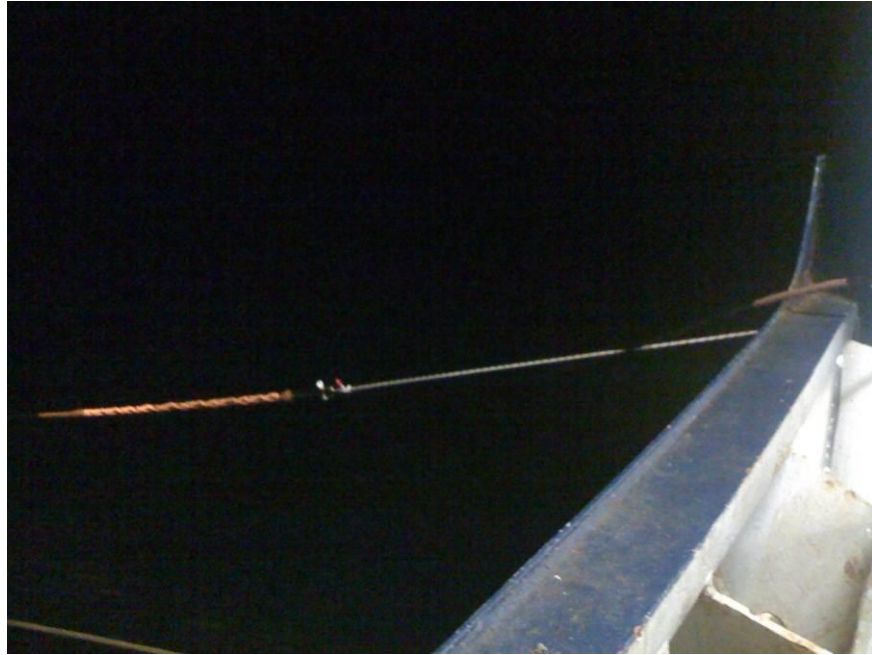
**Figure D.20: Hydrophone cable secured by a yale grip to the port sponson**

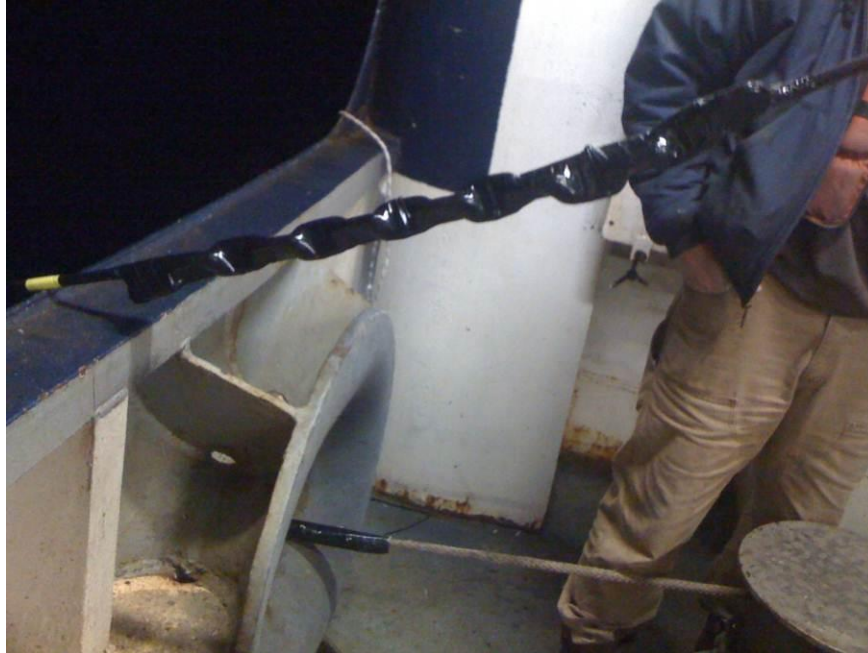
**Figure D.22: One of the four lengths of chain used to weigh down the cable.**
