## Glen Elder Dam Spillway Structure Concrete Repairs

The concrete spillway structure at Glen Elder Dam, near Glen Elder, Kansas is scheduled to receive maintenance repairs starting in the summer of 2009 and extending through the summer of 2010.

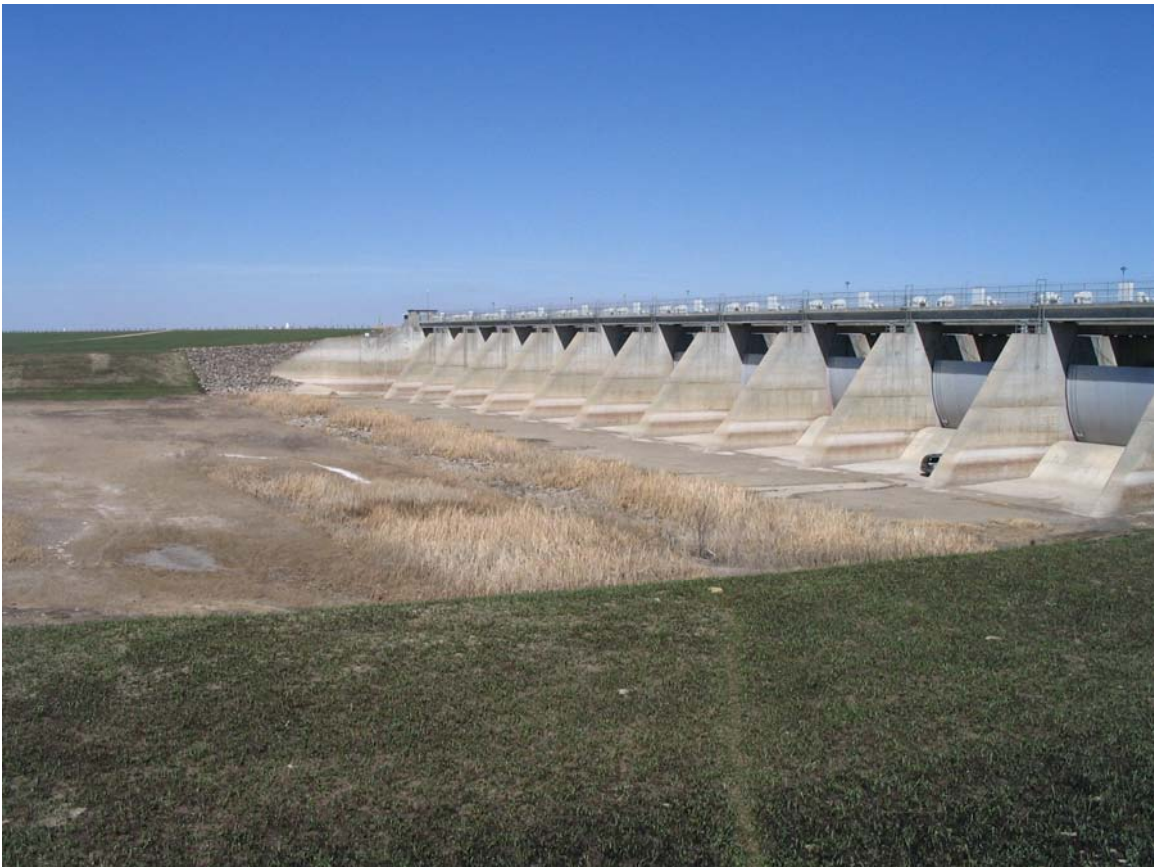
The spillway at Glen Elder Dam is a concrete structure containing twelve regulating gates used to control flood water. The concrete used to construct the Glen Elder Dam spillway in the 1960s is particularly susceptible to deterioration from cycles of freezing/thawing. A portion of the concrete on the upstream side of the spillway structure has experienced significant deterioration and requires repairs to maintain the spillway's structural sliding stability. The repairs will include: 1) selectively removing the deteriorated concrete using ultra-high pressure water jetting, 2) placing new concrete to the original lines and grades, and 3) covering the repairs with soil to provide additional protection from further deterioration.
