- **Task 120 – Preliminary Site Assessment
Site 2– Stratford Army Engine Plant Property
Map 50.05 Block 4 Lot 2
Main Street, Stratford
August 13, 2009**

**TASK 120 - PRELIMINARY SITE ASSESSMENT
SITE 1 - CITY OF BRIDGEPORT PROPERTY
MAP 50.04, BLOCK 3, LOTS 1 and 2
MAIN STREET, STRATFORD, CONNECTICUT**

**FINAL DESIGN AND PERMITTING
FOR THE RE-ALIGNMENT OF MAIN STREET (CT ROUTE 113)**

**URS Project No.: 38397085.00003
August 13, 2009**

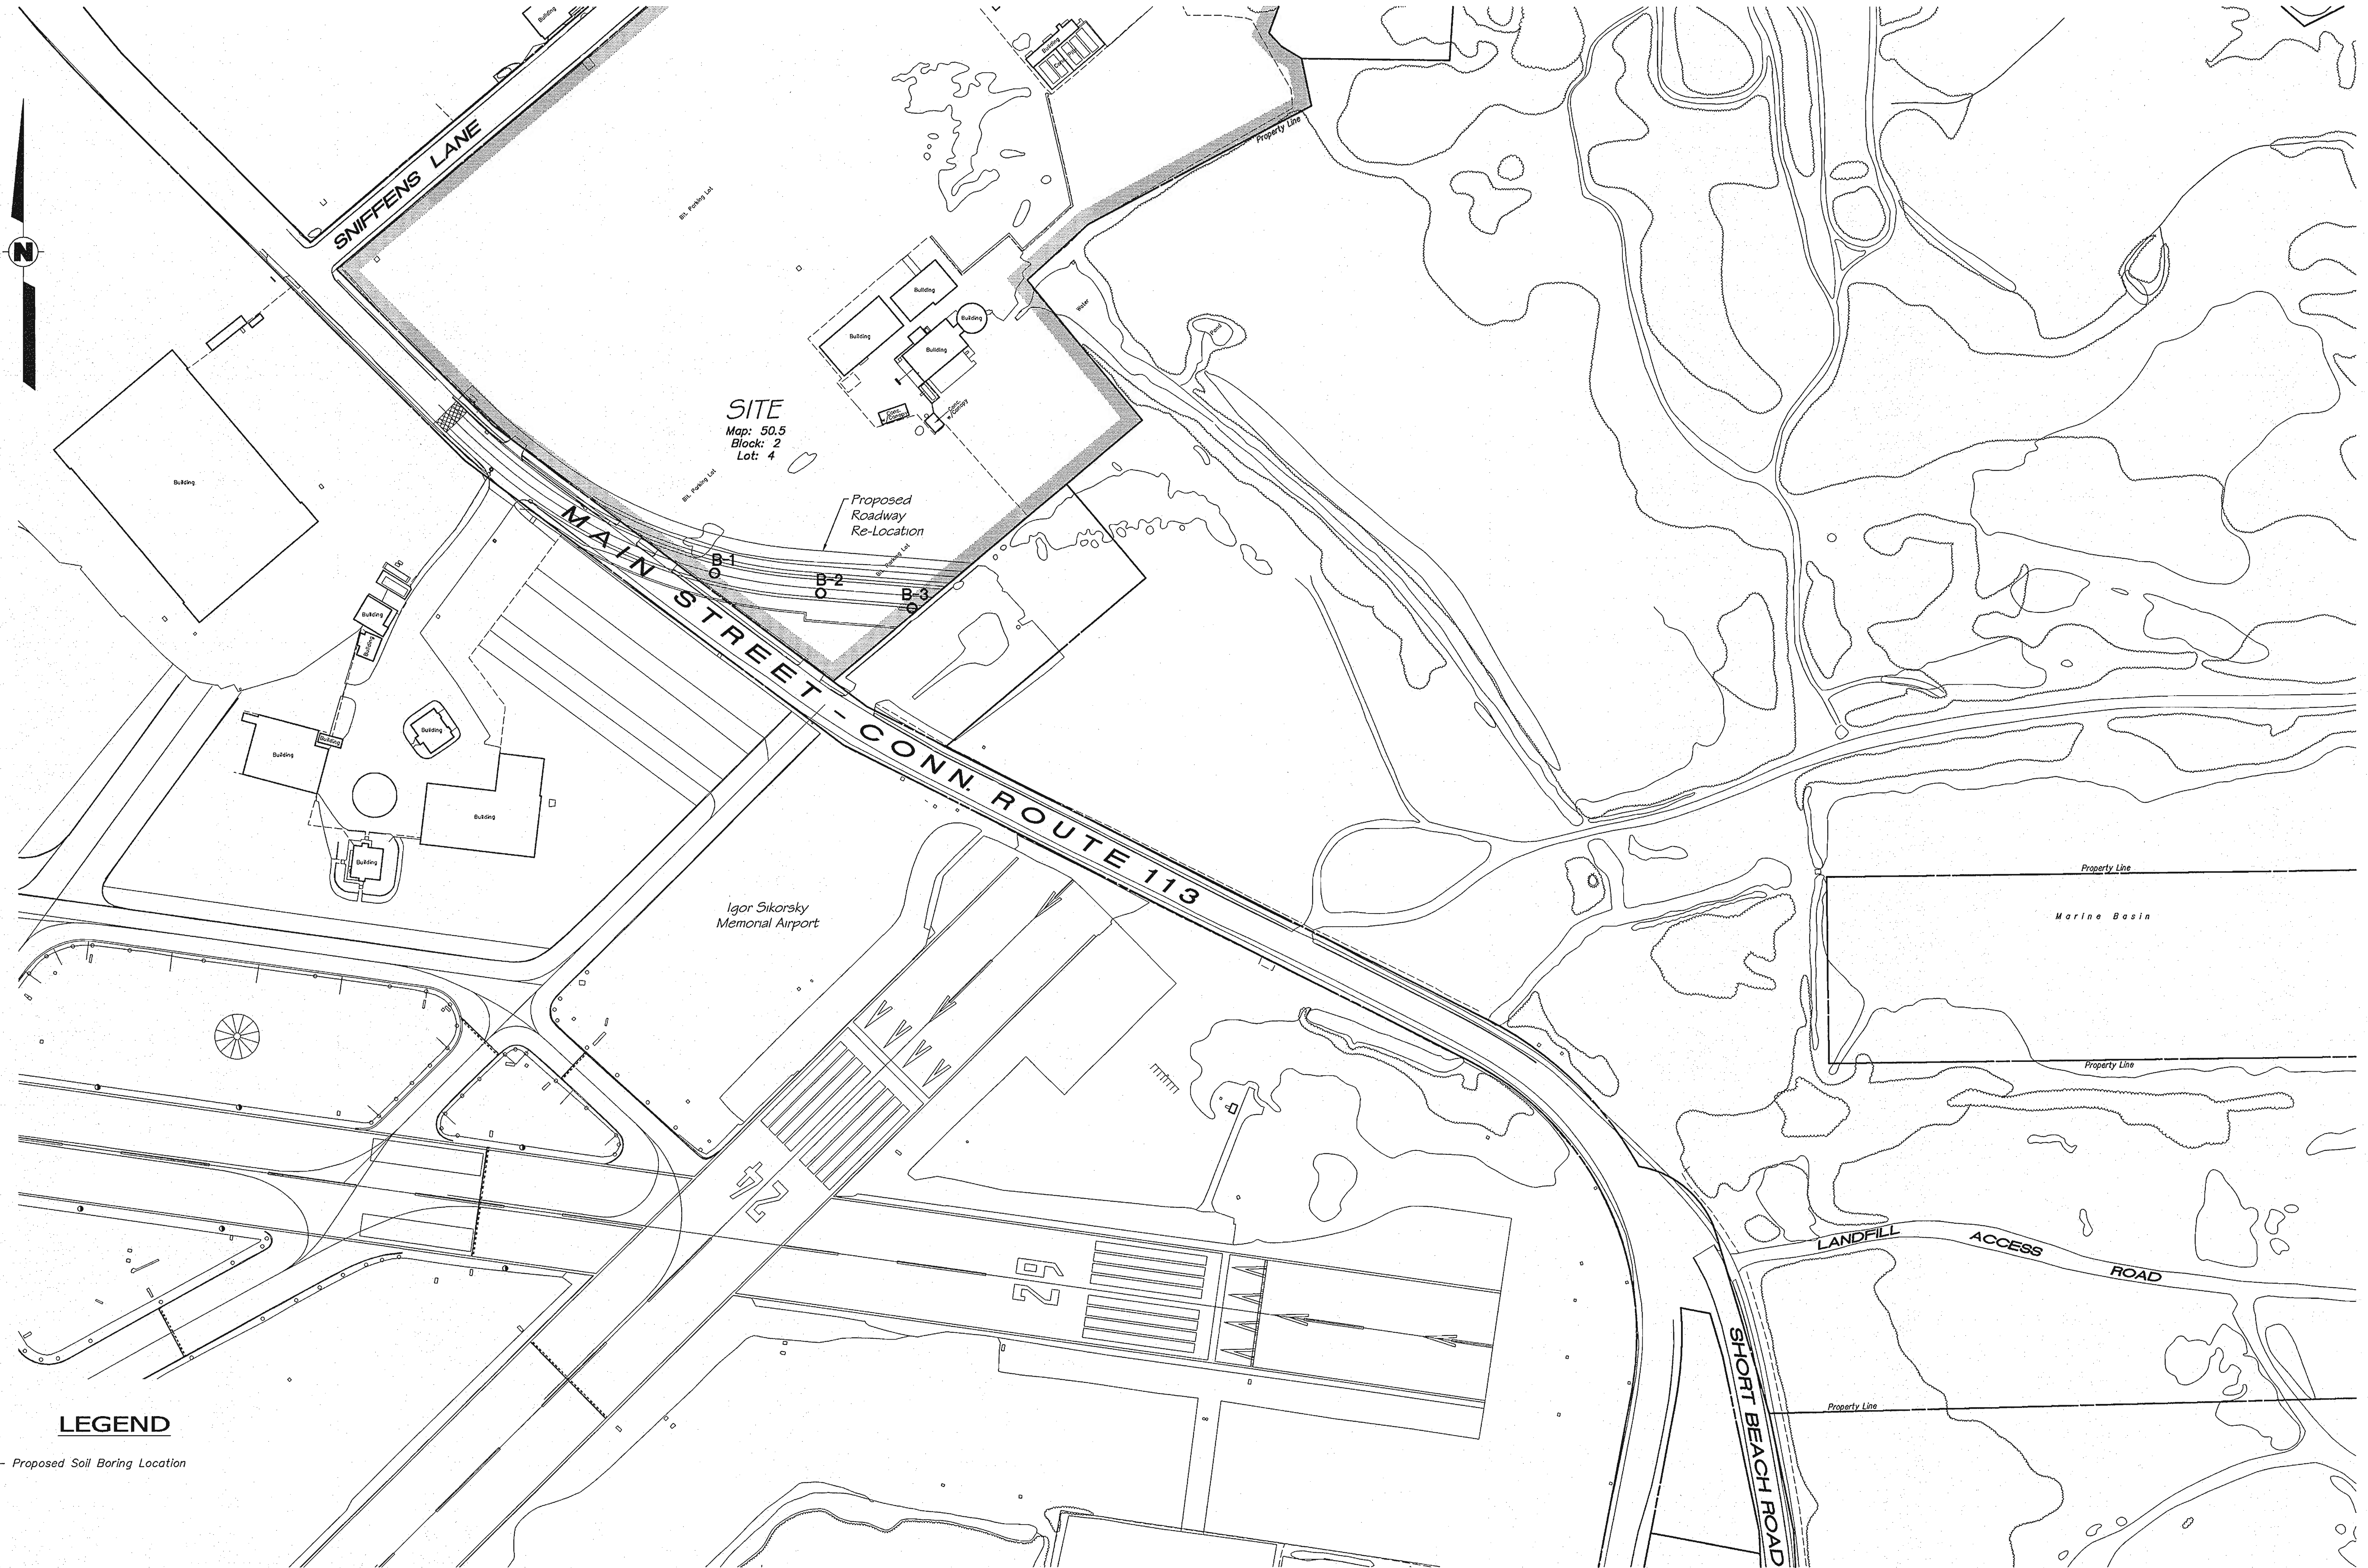
URS recommends collection and analysis of soil samples from within the limits of the project area, planned soil excavation areas and/or areas proposed to be disturbed by the proposed roadway construction activities to more completely evaluate soil conditions. If groundwater is anticipated to be encountered during the proposed roadway construction activities, URS recommends evaluation of impacts to groundwater in the project area portion of the Site. URS recommends completing at least three (3) soil borings for this project-specific investigation. Proposed soil boring locations are identified on **Figure 3**.
