CHAPTER 8

An Environmental Study of USS *Arizona* Bunker C Fuel Oil

Amanda M. Graham

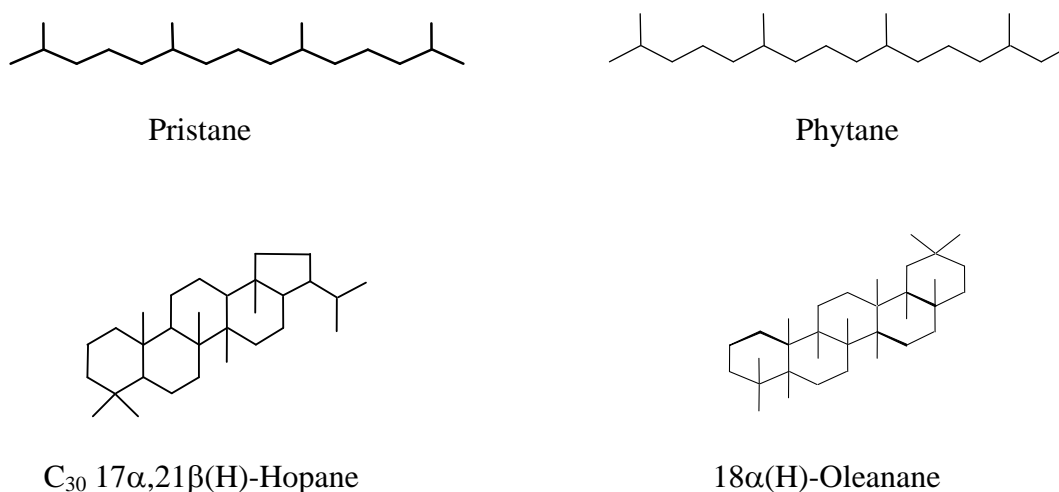
Figure 8.1. Selected biomarker chemical structures.

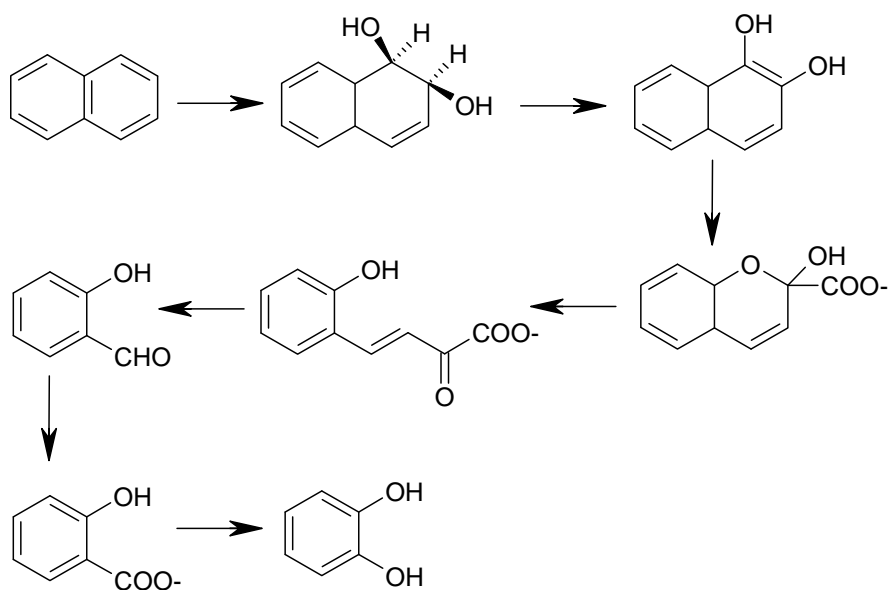
Figure 8.3. Representative pathway for microbial utilization of naphthalene (Adapted from Neilson 1994).

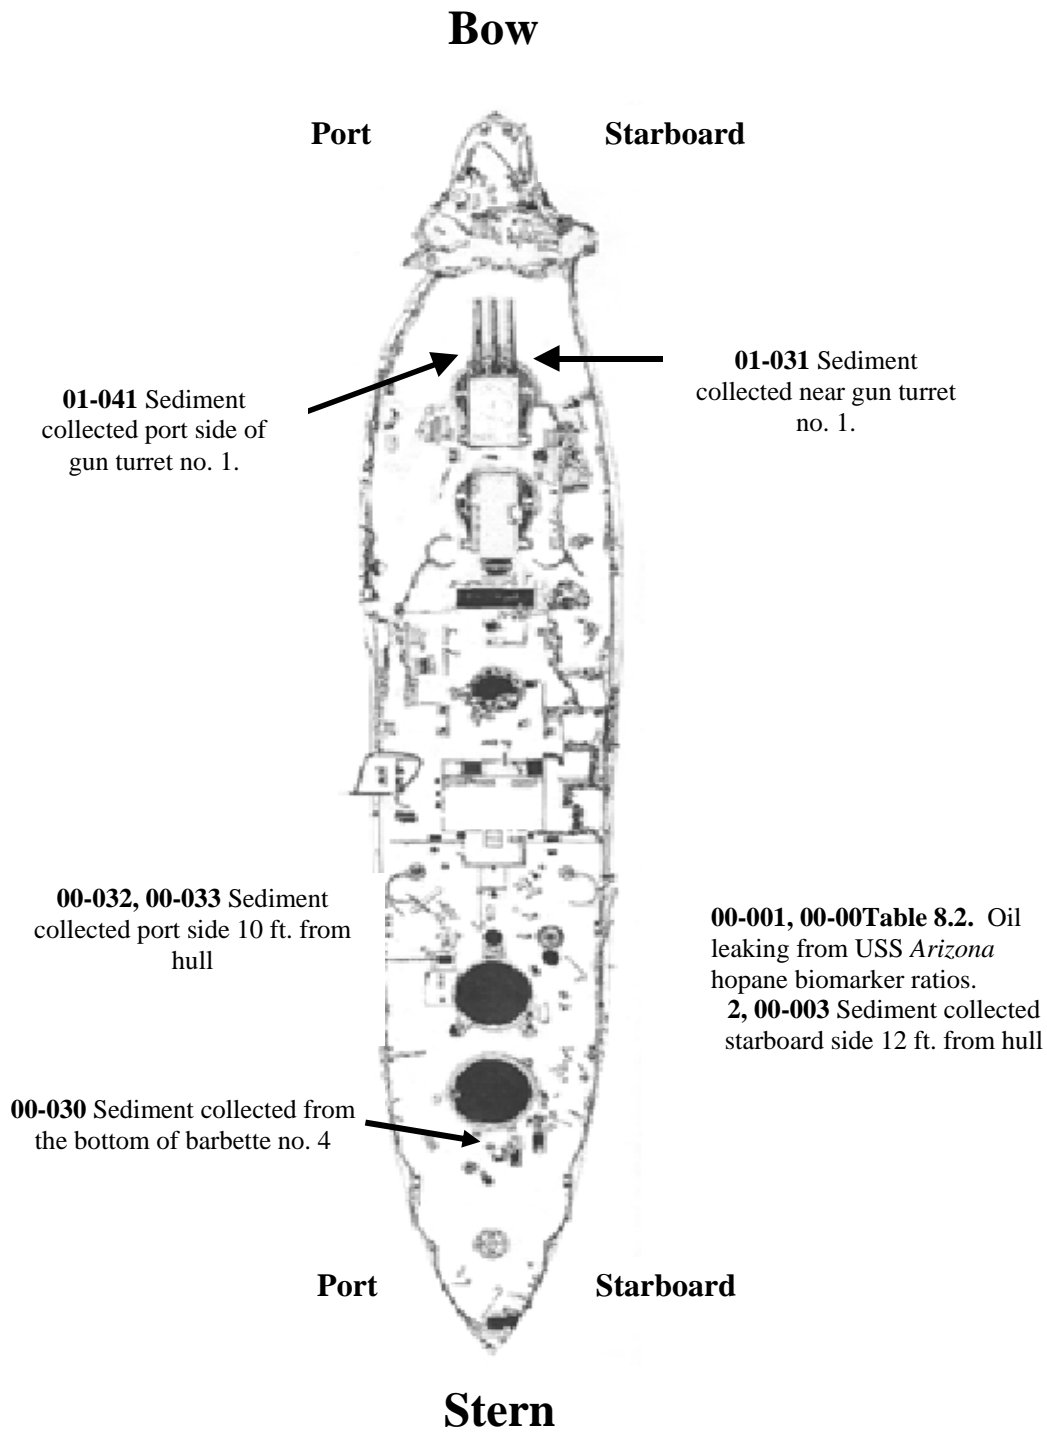
Figure 8.5. USS Arizona sediment sample locations.

Sediment and oil samples were collected from USS *Arizona* located in Pearl Harbor, HI, during 2000 and 2001 by underwater archaeologists from the National Park Service's Submerged Resources Center (Figures 8.4 and 8.5). Sediment samples were collected underwater by divers using 500 ml glass Erlenmeyer flasks. Sediment-filled flasks were brought to the surface, flushed with N₂, capped with black rubber stoppers, and sealed with electrical tape. Flasks were immediately placed in a cooler on ice. Samples of oil leaking from various USS *Arizona* locations (designated A and B) were collected using PVC pipes equipped with 50 ml conical polypropylene tubes attached to the end of the pipe. Conical tubes were brought to the surface, flushed with N₂, capped, and sealed with electrical tape. Samples were shipped on ice from Pearl Harbor to the laboratory in South Carolina and stored at 4°C.

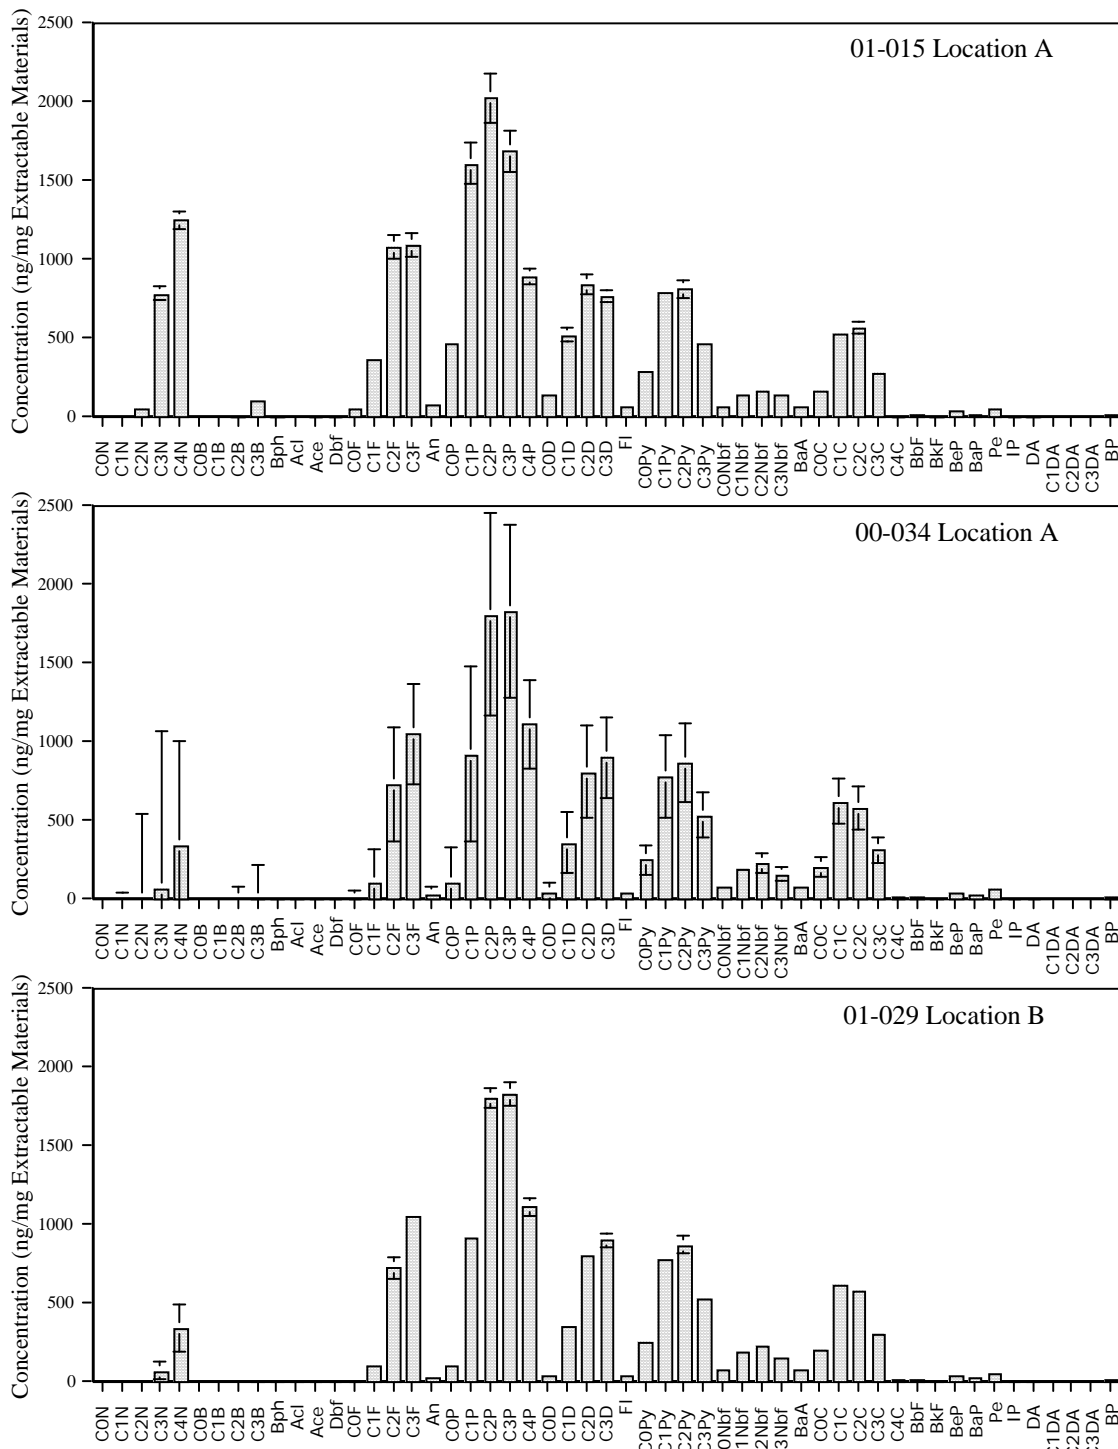
Figure 8.9 Individual PAH analysis for oil leaking from USS *Arizona*. Oil leaking from 00-034 and 01-029 shows a depletion of lower molecular weight PAHs in comparison to oil leaking from 01-015. Abbreviations are defined in Table 8.1 and locations of leaking oil are defined in Figure 8.4.

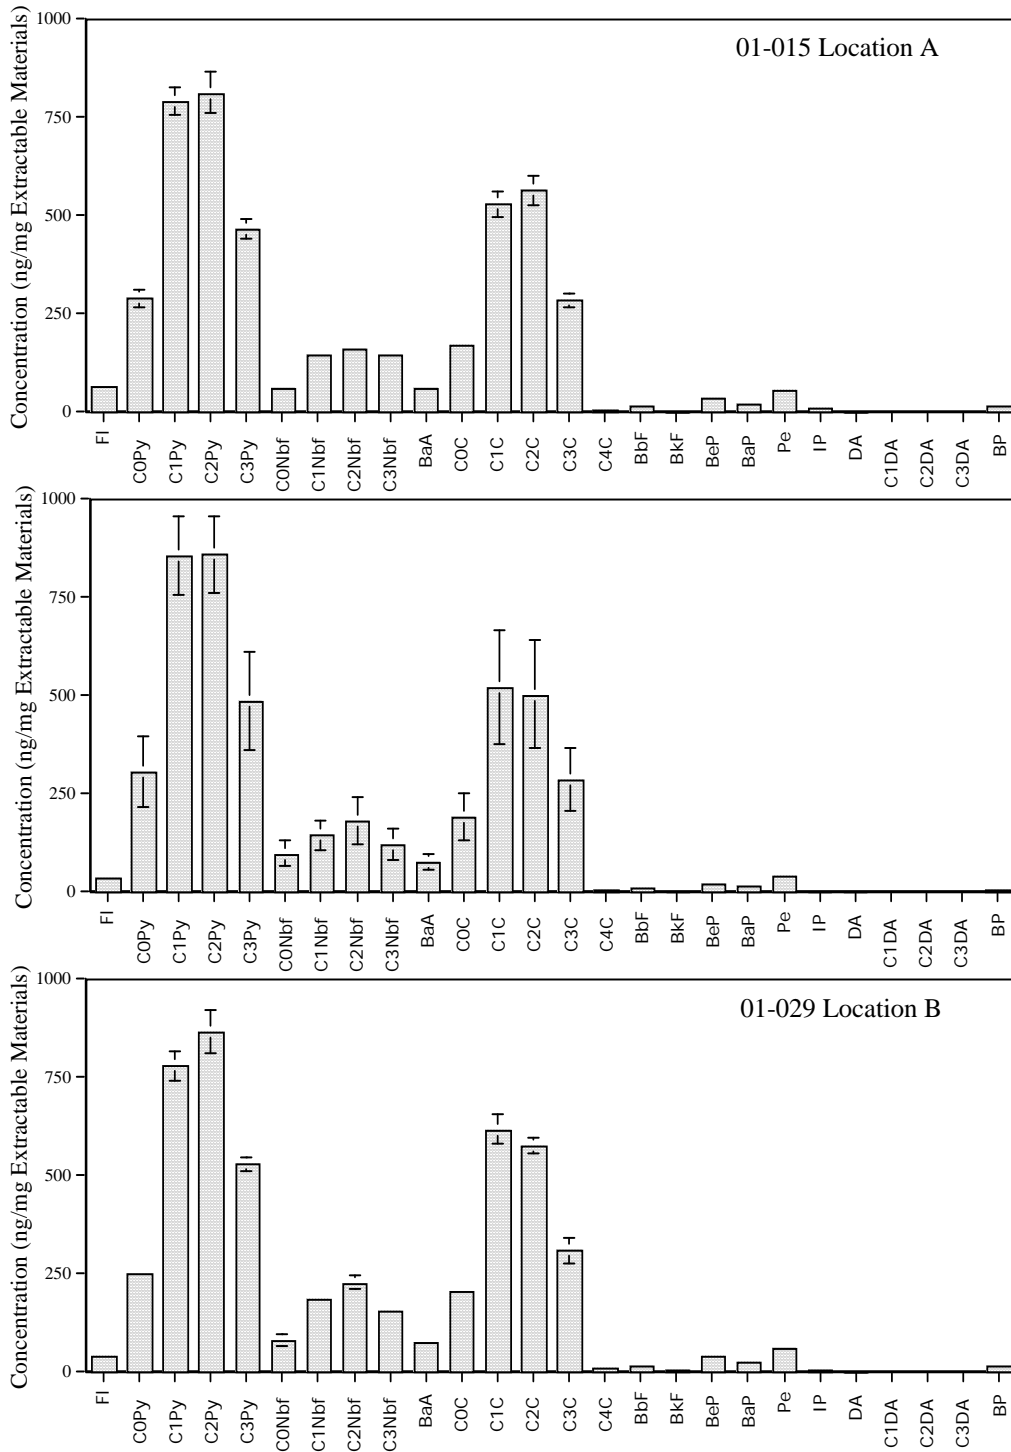
Figure 8.10. Individual PAH analysis of high molecular weight PAHs for oil leaking from USS Arizona. Abbreviations are defined in Table 8.1 and locations of leaking oil are defined on Figure 8.4.

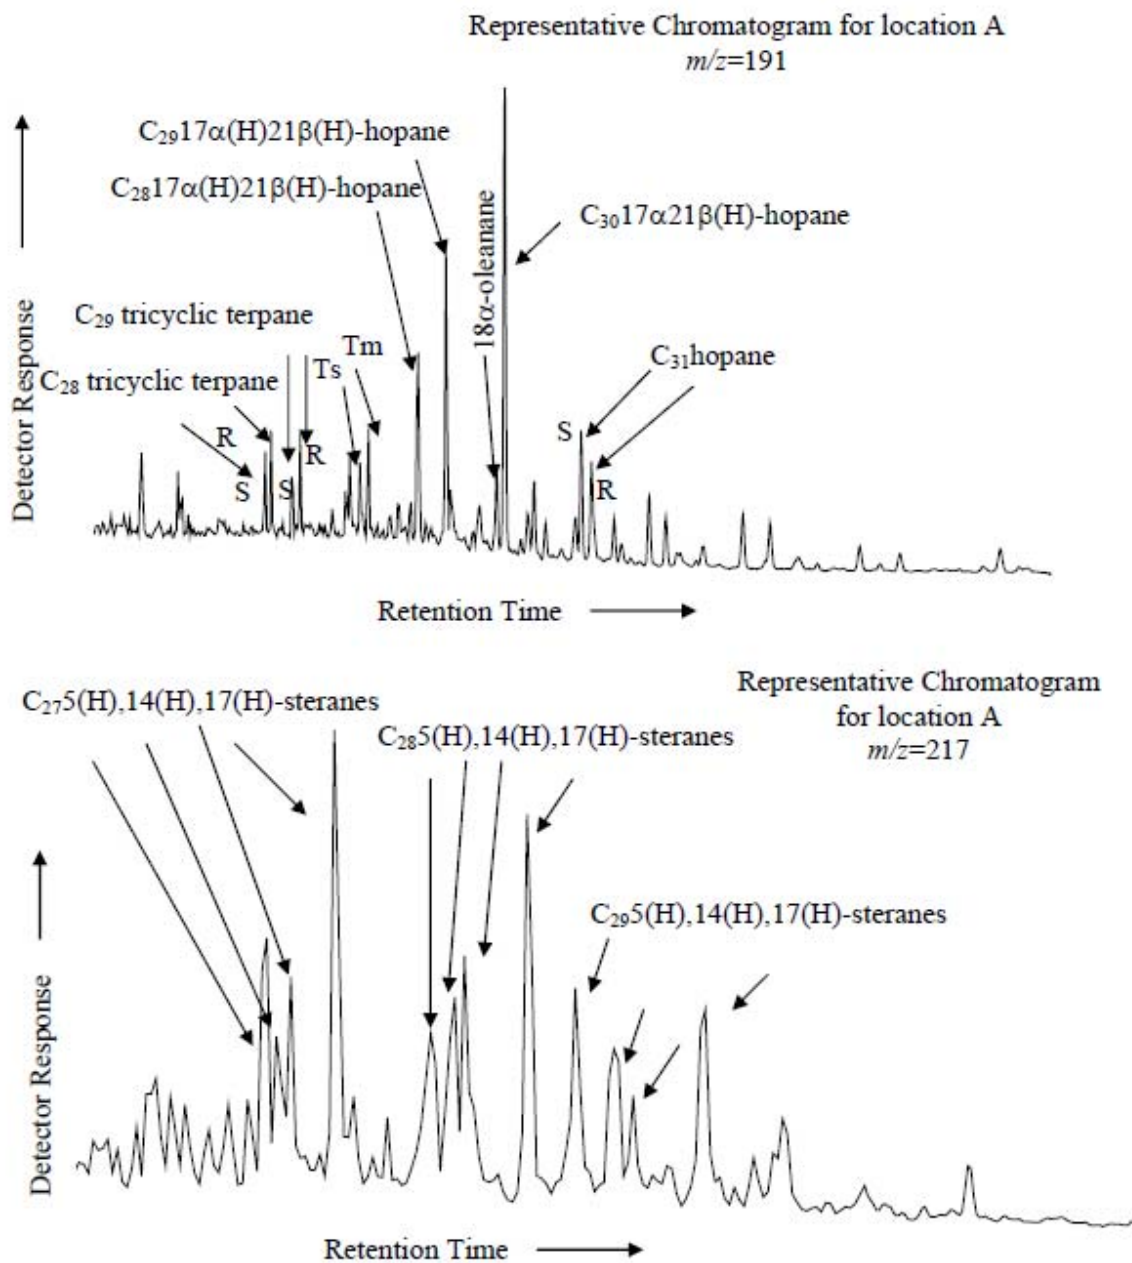
Figure 8.11. Representative mass chromatograms for 01-015 and 00-034 oil leaking from location A of USS Arizona for $m/z=191$ (hopanes) and $m/z=217$ (steranes).

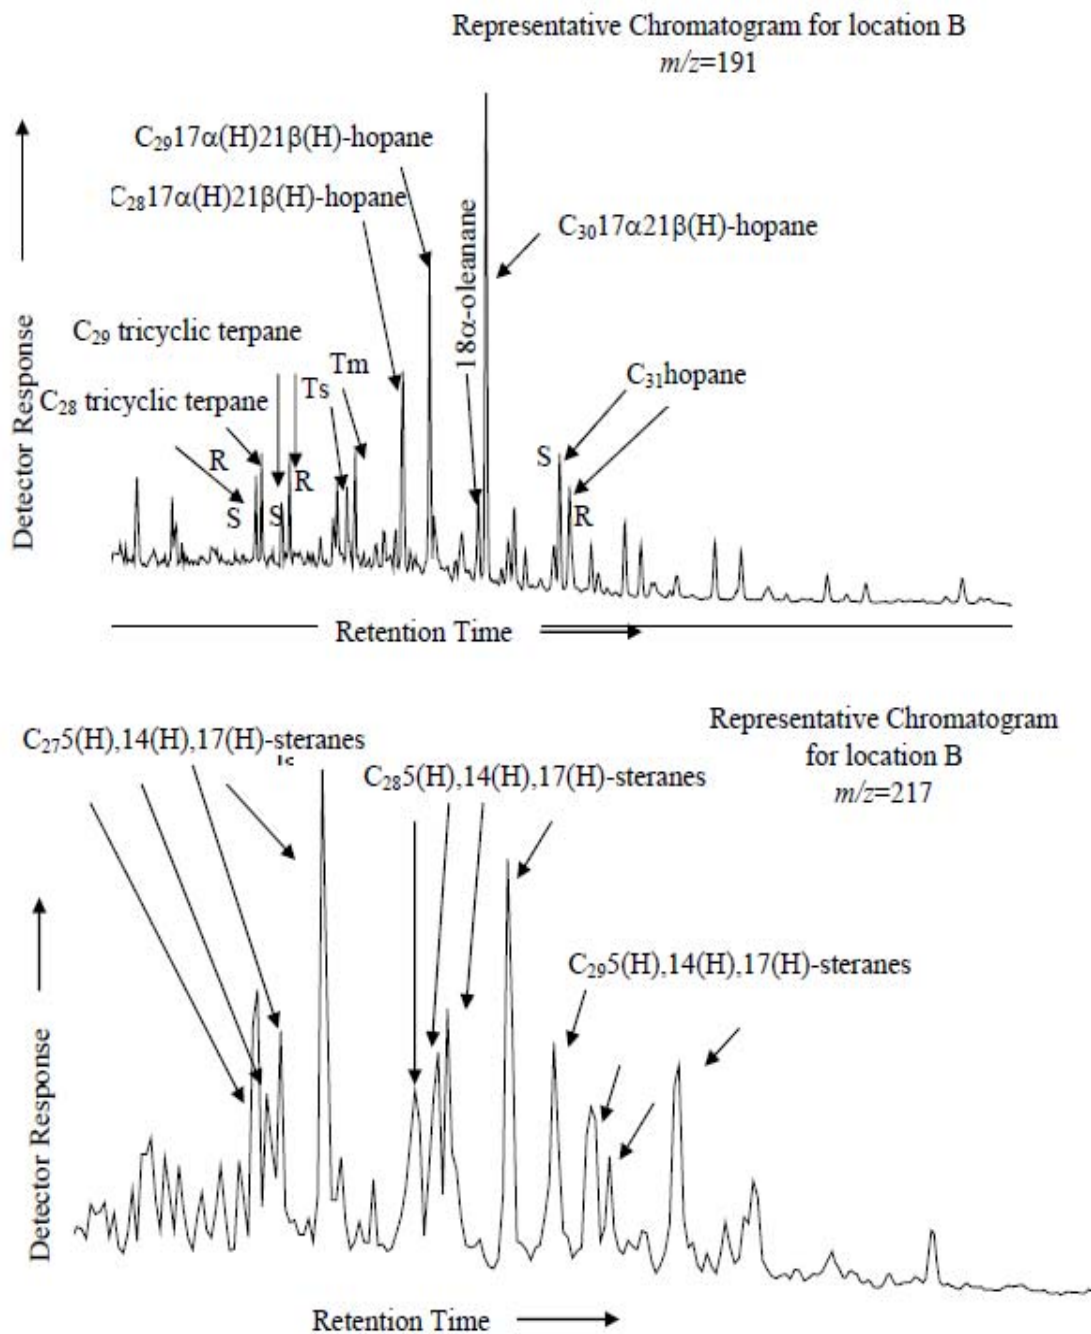
Figure 8.12. Biomarkers mass chromatograms for 01-029 oil leaking from location B of USS Arizona for $m/z=191$ (hopanes) and $m/z=217$ (steranes).

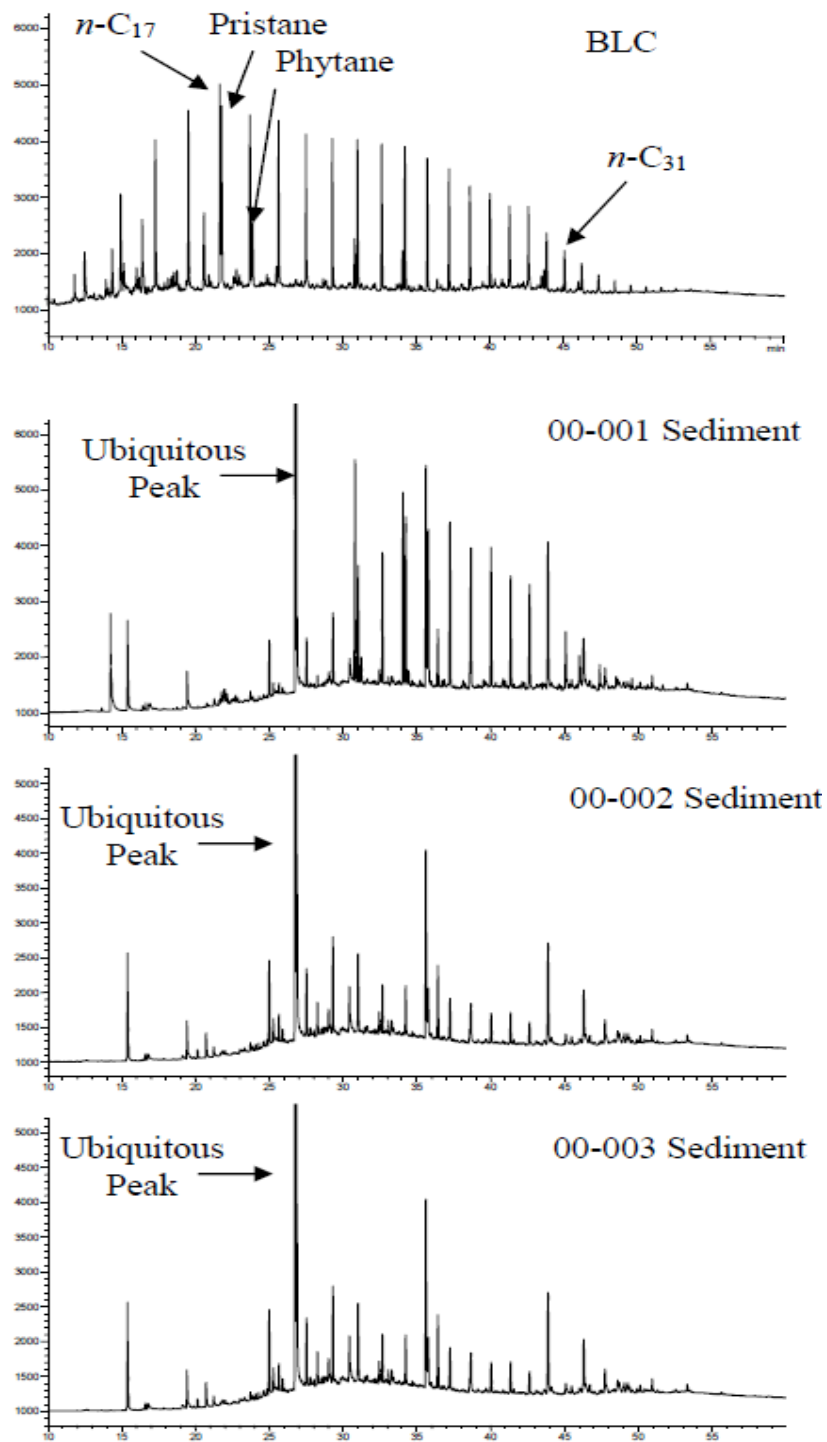
Figure 8.14. Gas chromatograms of solvent-extractable materials removed from sediments collected 12 ft. from the stern starboard hull. A GC trace for BLC (top trace) was conducted to compare retention times. Extracts contained n -alkanes and a ubiquitous peak found in all sediments. In the above chromatograms, the y-axis is detector response and x-axis is the retention time in minutes. The chromatograms have been scaled to a lower detector response than the highest peak to observe smaller peaks in the trace. The y-axis is not the same scale for each chromatogram.

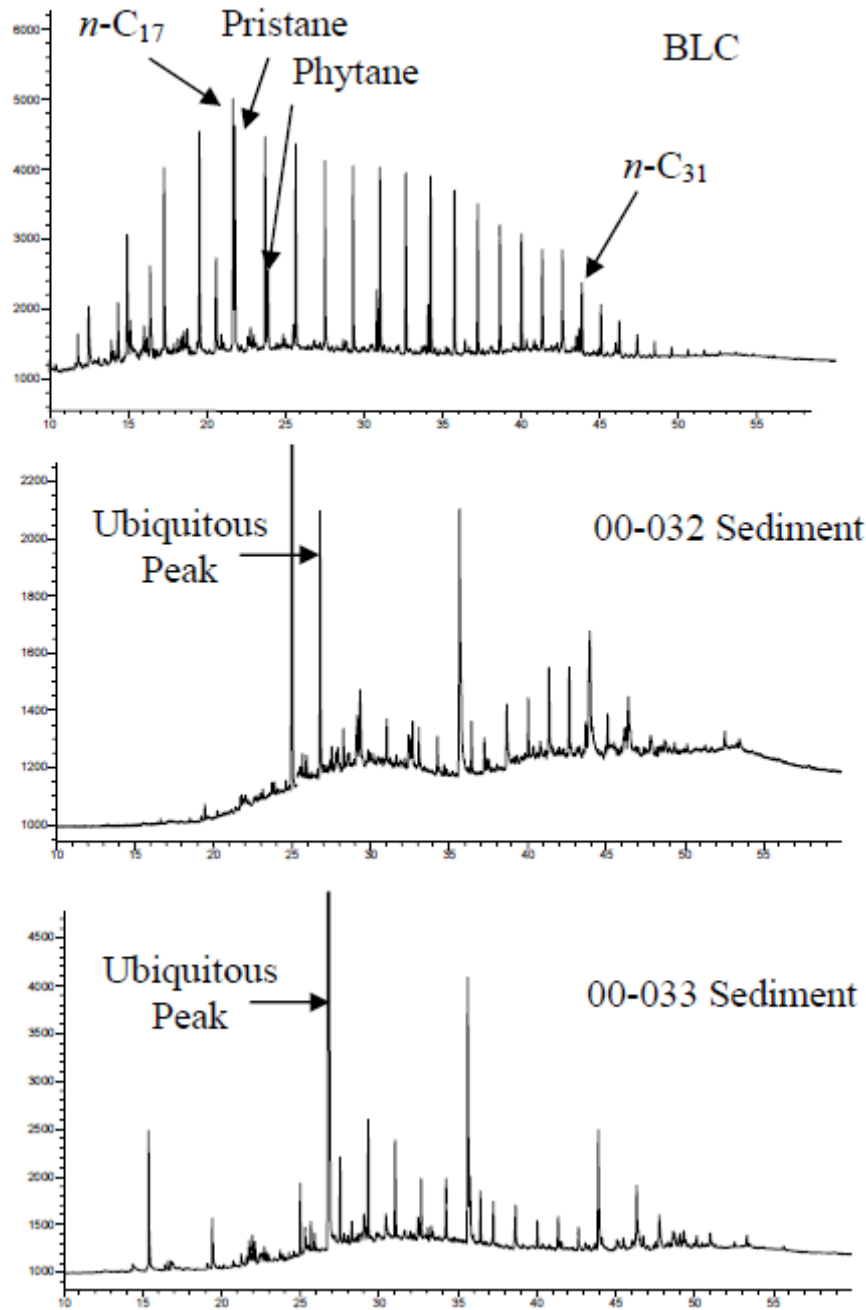
Figure 8.15. Gas chromatograms of solvent-extractable materials removed from sediments collected 12 ft. from the port starboard hull. A GC trace for BLC (top trace) was conducted to compare retention times. Extracts contained n -alkanes and a ubiquitous peak found in all sediments. In the above chromatograms, the y-axis is detector response and x-axis is the retention time in minutes. The chromatograms have been scaled to a lower detector response than the highest peak to observe smaller peaks in the trace. The y-axis is not the same scale for each chromatogram.

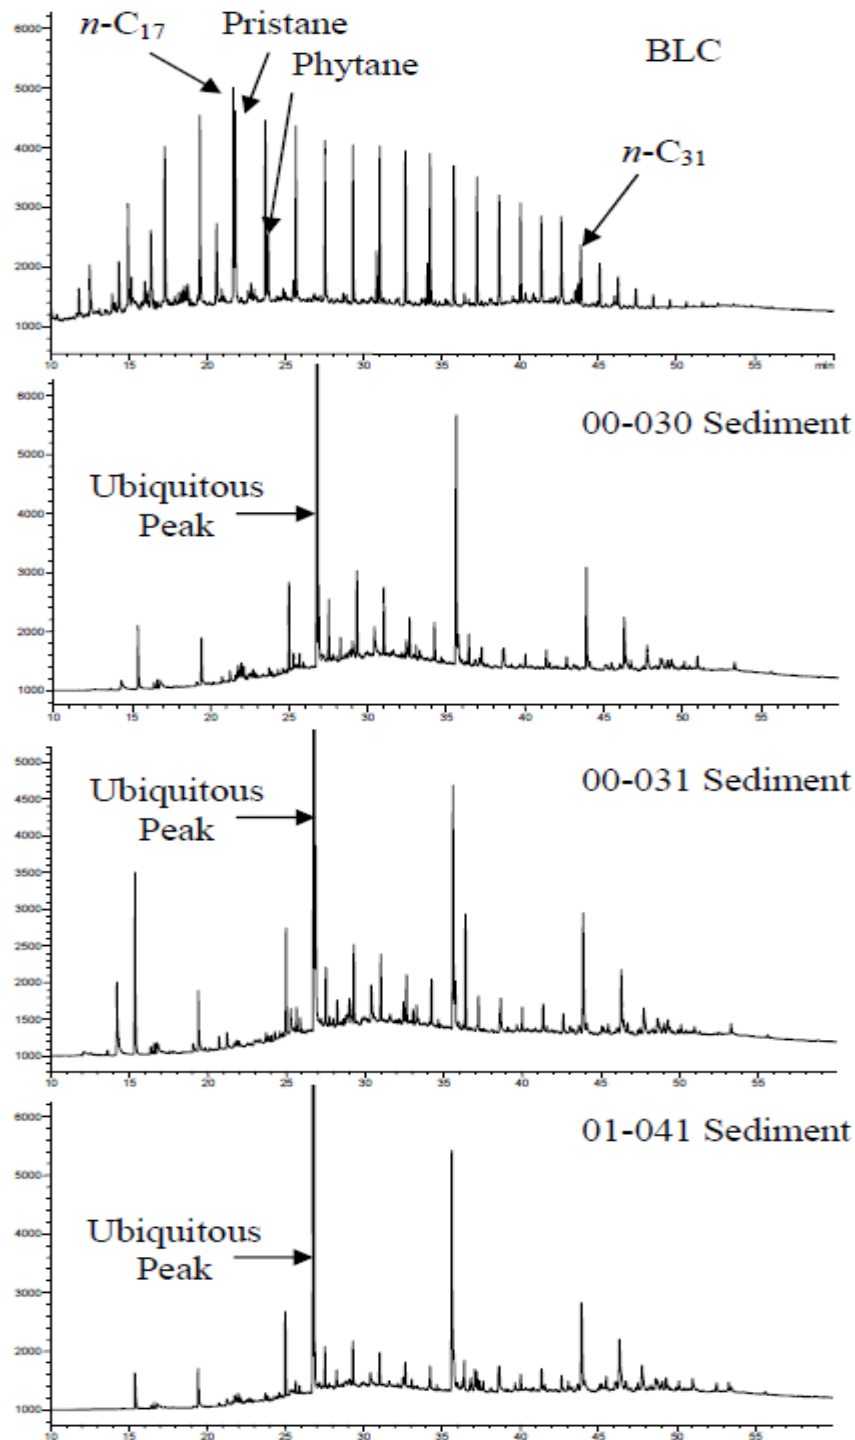
Figure 8.16. Gas chromatograms of solvent-extractable materials removed from sediments collected on top of the ship. A GC trace for BLC (top trace) was conducted to compare retention times. Extracts contained n -alkanes and a ubiquitous peak found in all sediments. In the above chromatograms, the y-axis is detector response and x-axis is the retention time in minutes. The chromatograms have been scaled to a lower detector response than the highest peak to observe smaller peaks in the trace. The y-axis is not the same scale for each chromatogram.

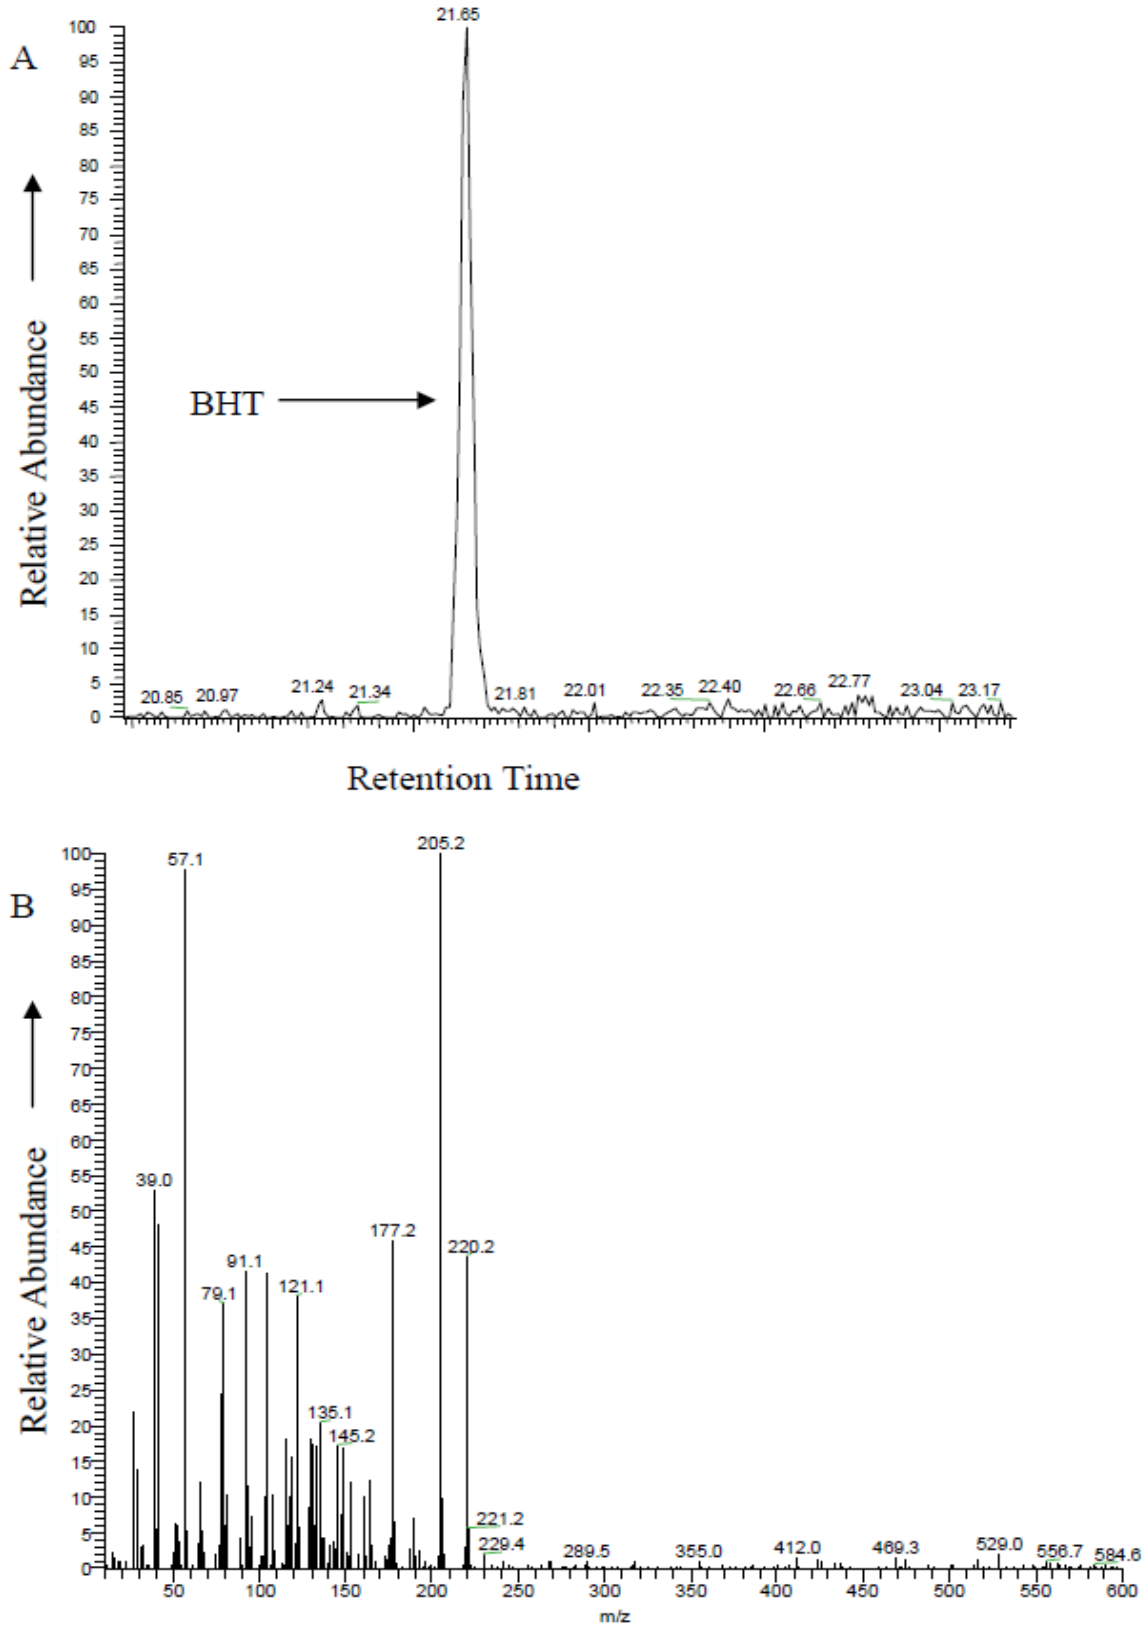
Figure 8.19. Total ion chromatogram trace of BHT found in oil sample 00-034 leaking from USS Arizona (A). The mass spectra monitored at $m/z=205$ was identified as BHT (B).

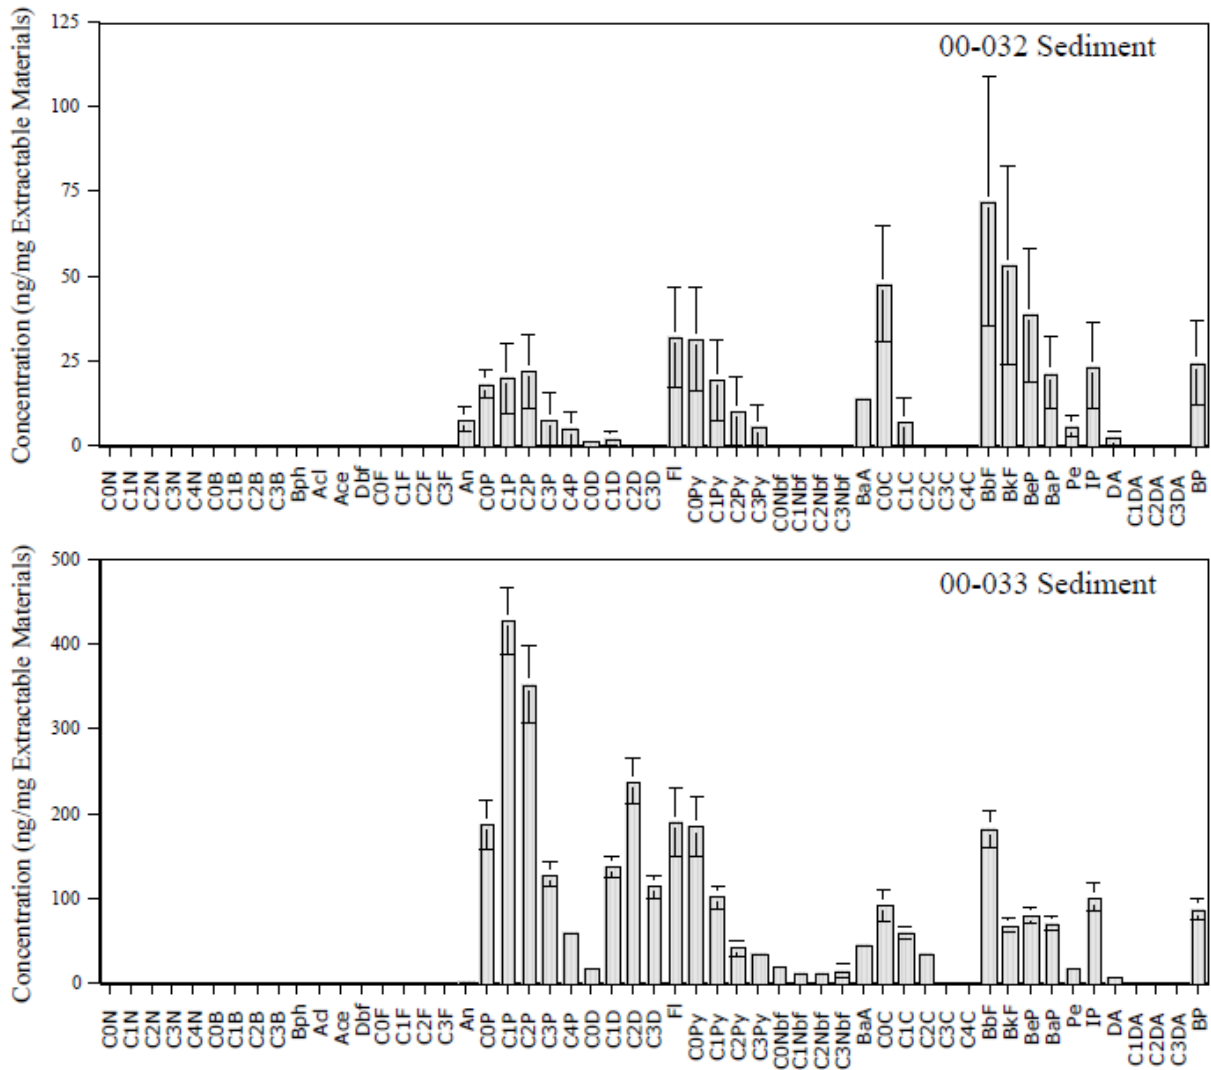
Figure 8.21. Individual PAH analysis for solvent-extractable materials from sediments collected 10 ft. off the port side of USS *Arizona*. There are no detectable amounts of low molecular weight PAHs (i.e., naphthalene), but high molecular weight PAHs (i.e., pyrene) were detected. Concentration for the y-axis is not the same scale for each histogram. Abbreviations are defined in Table 8.1 and locations of sediments are defined in Figure 8.5.

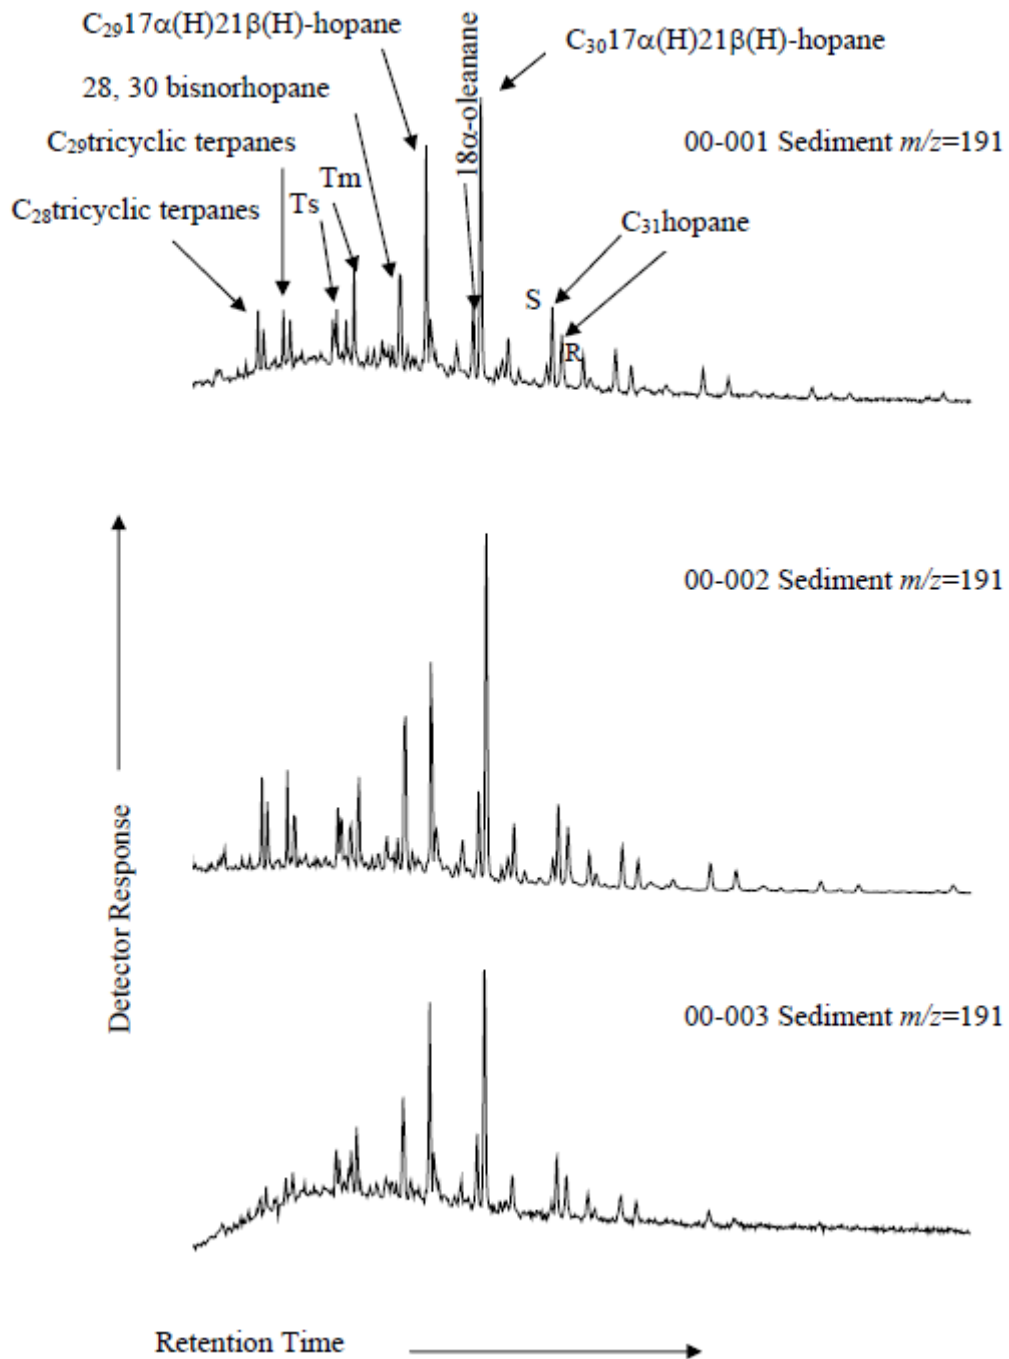
Figure 8.23. GC-MS chromatograms ($m/z=191$) of solvent-extractable material from sediments collected from the stern section, starboard side, 12 ft. from hull. Chromatograms are representative of triplicate samples.

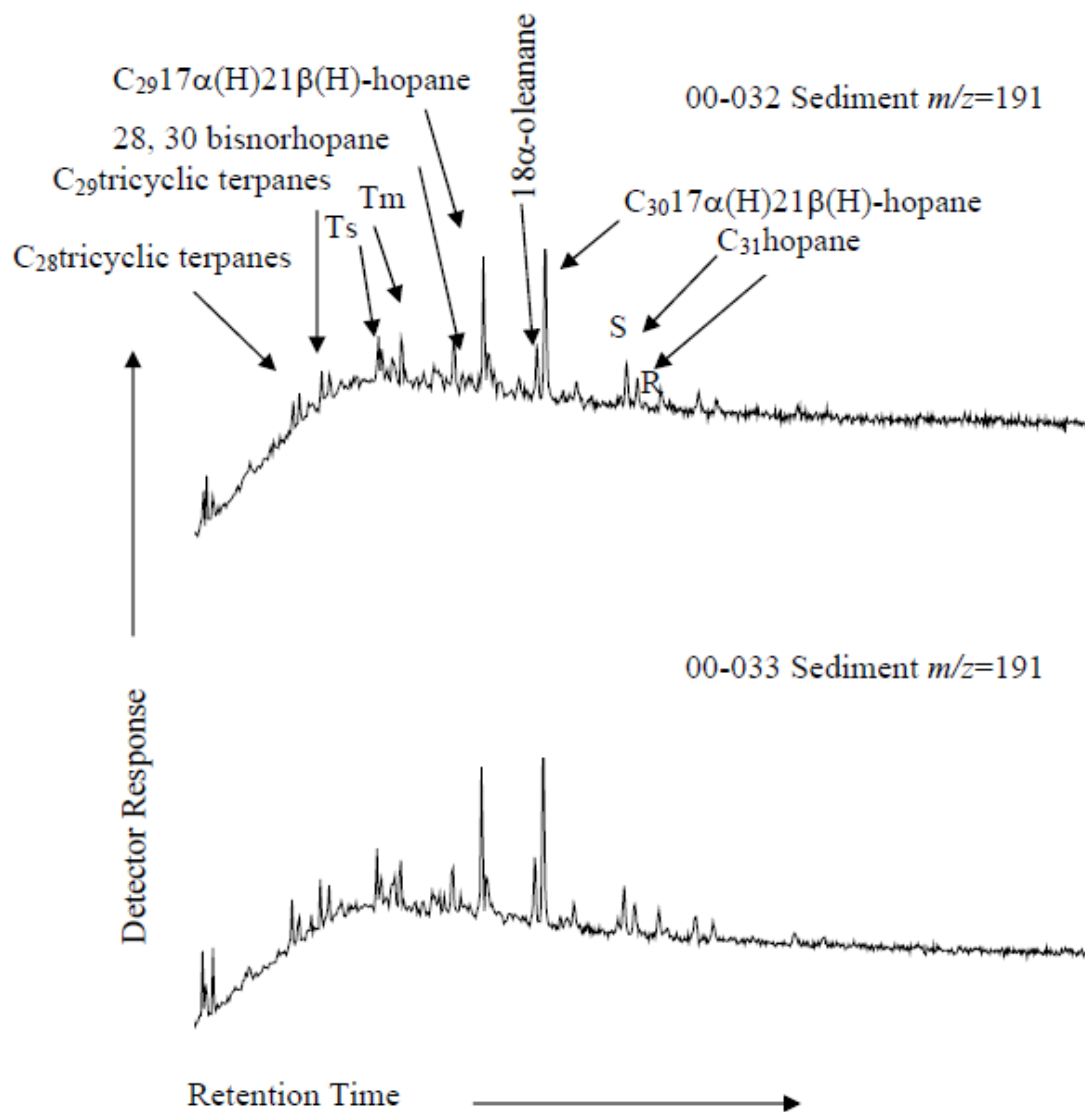
Figure 8.24. GC-MS chromatograms ($m/z=191$) of solvent-extractable material from sediments collected from the stern section, port side, 10 ft. from hull. Chromatograms are representative of triplicate samples.

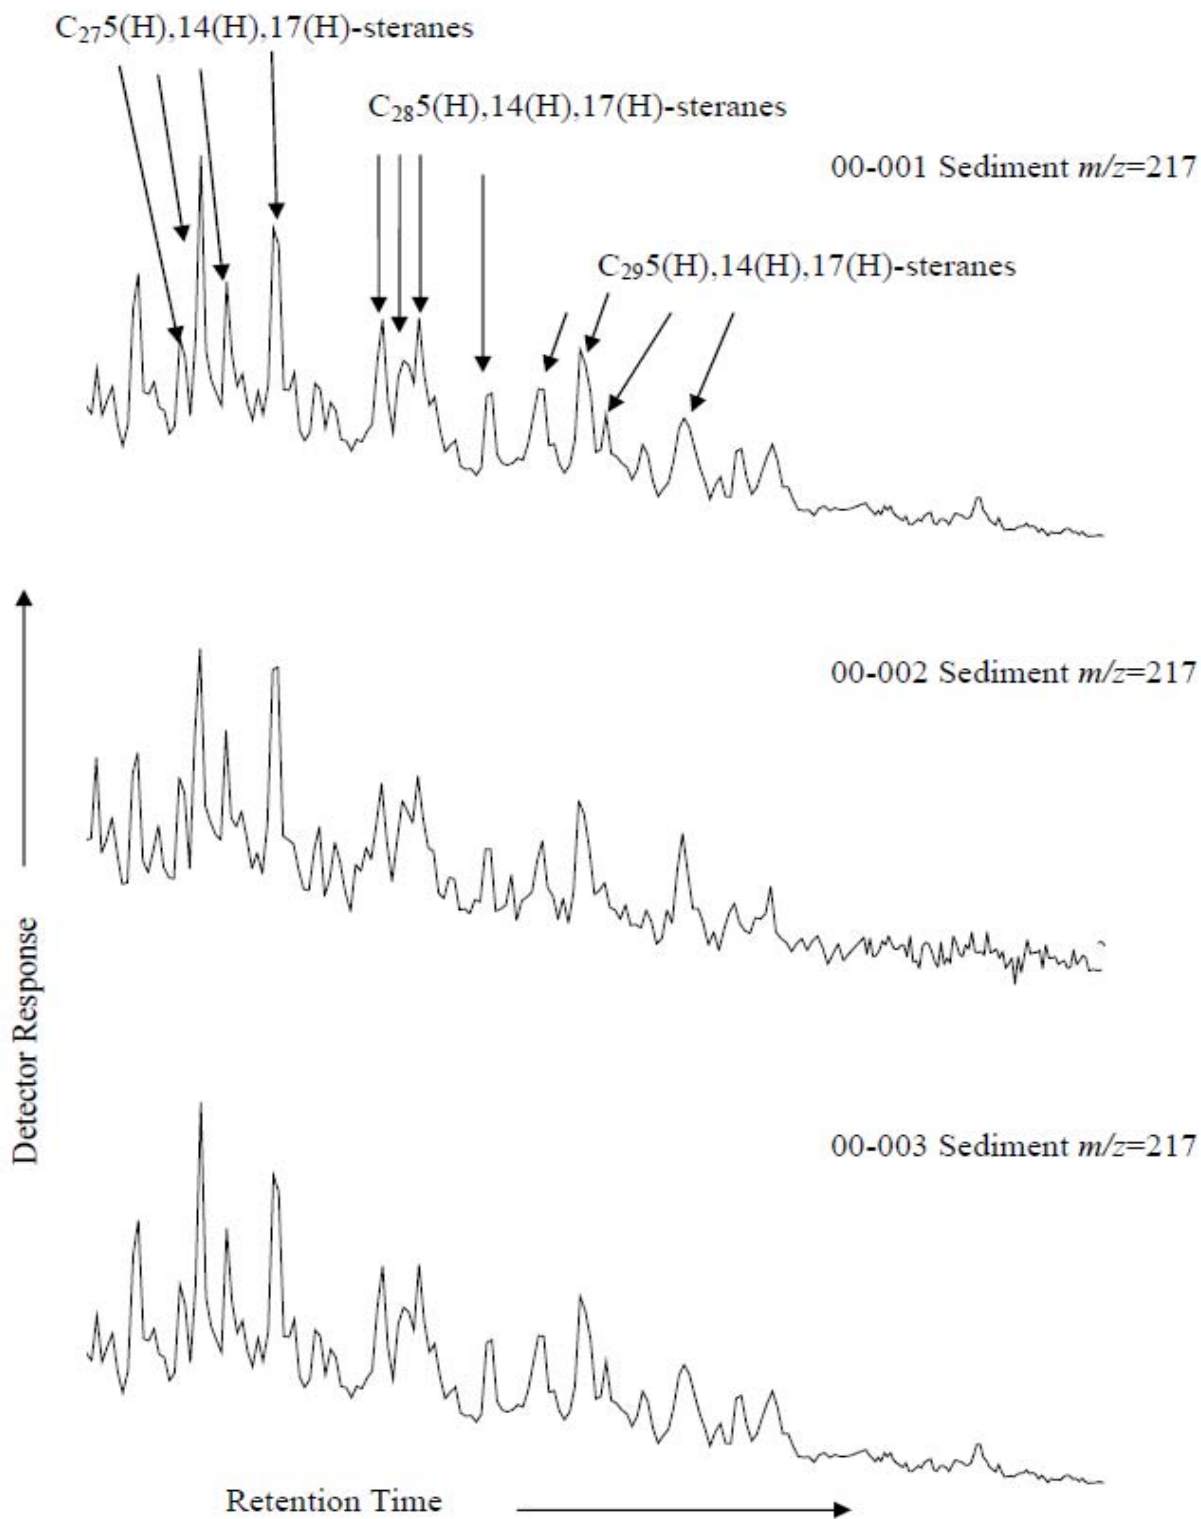
Figure 8.26. GC-MS chromatograms ($m/z=217$) of solvent-extractable material from sediments collected from the stern section, starboard side, 12 ft. from hull. Chromatograms are representative of triplicate samples.

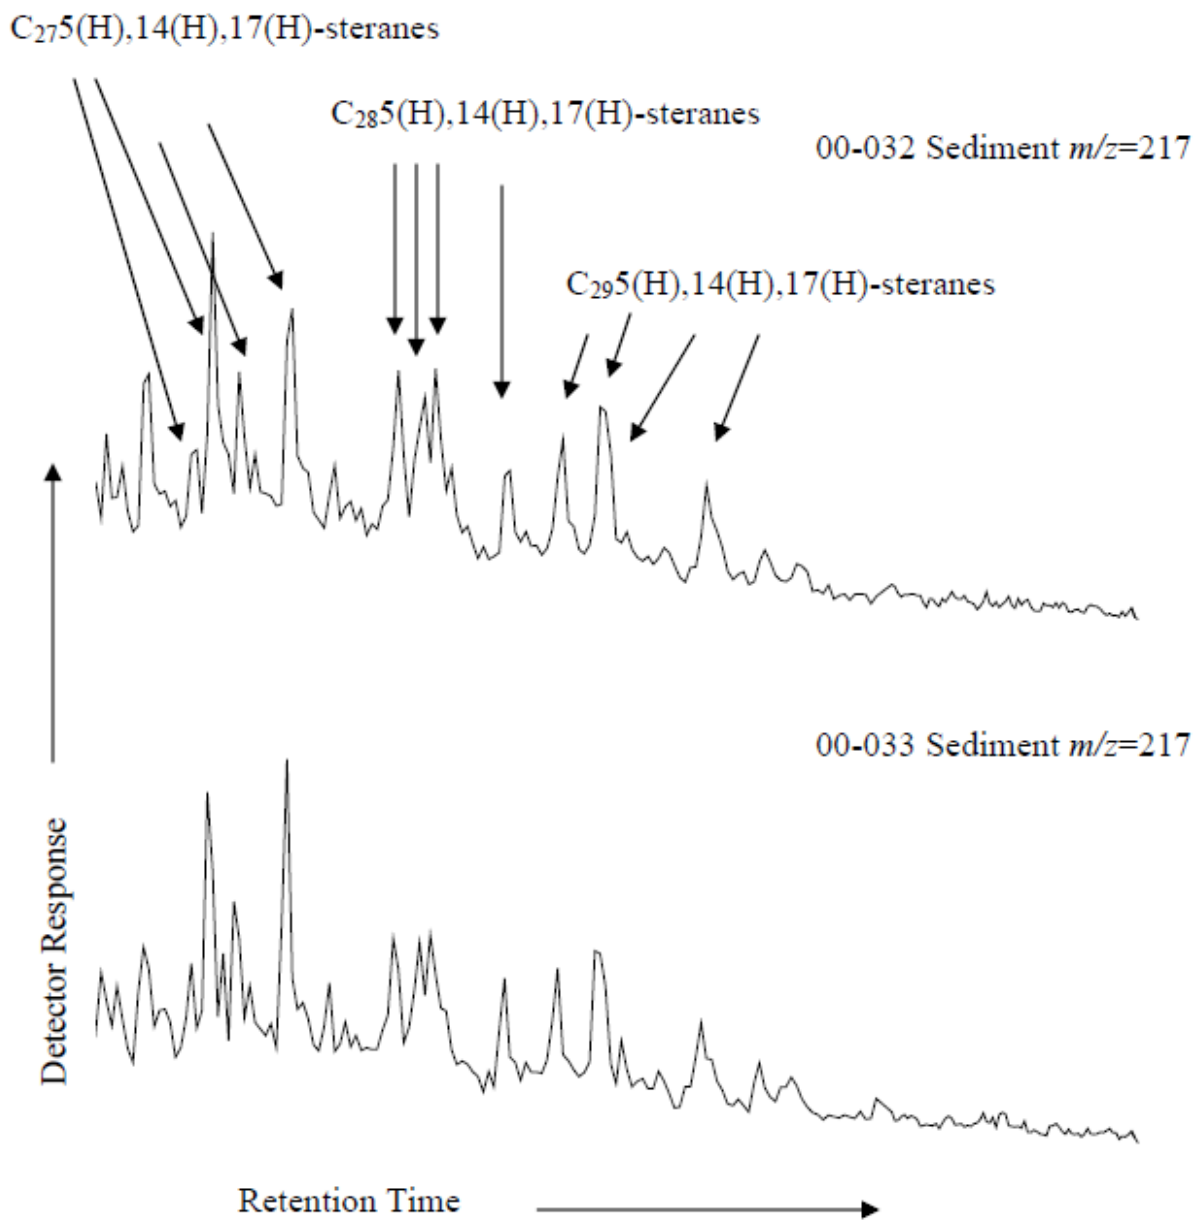
Figure 8.27. GC-MS chromatograms ($m/z=217$) of solvent-extractable material from sediments collected from the stern section, port side, 10 ft. from hull. Chromatograms are representative of triplicate samples.
