CHAPTER 8

An Environmental Study of USS *Arizona* Bunker C Fuel Oil

Amanda M. Graham

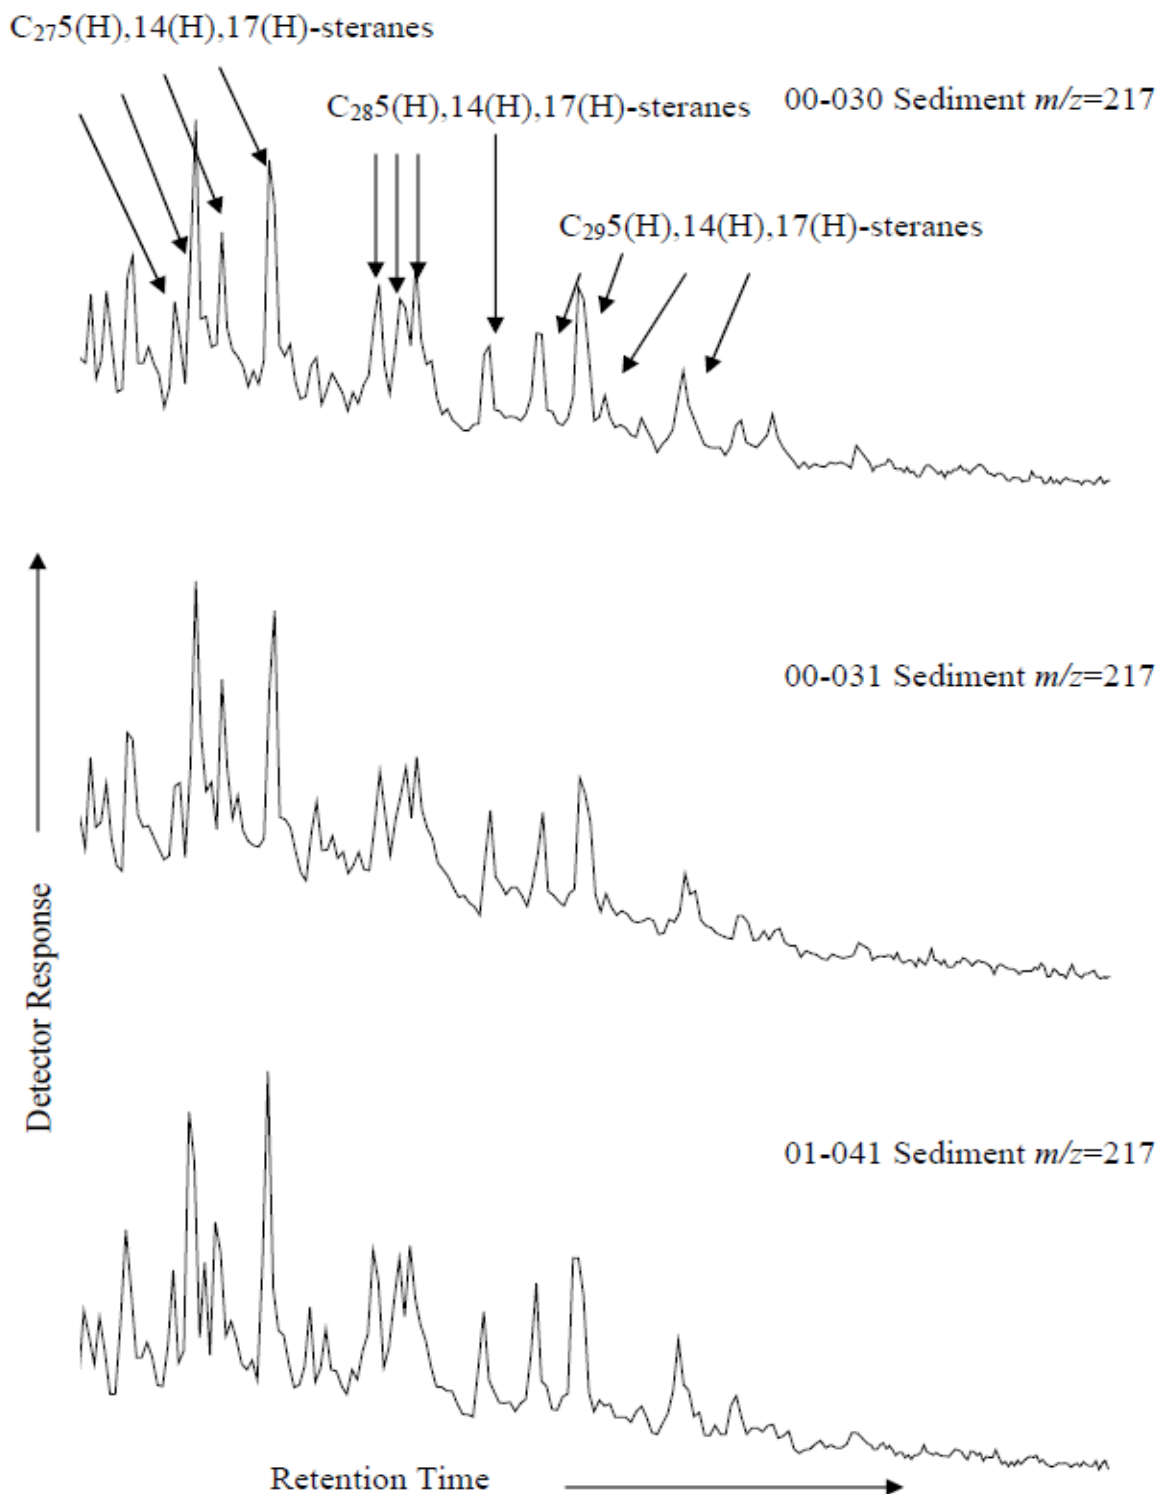
Figure 8.28. GC-MS chromatograms ($m/z=217$) of solvent-extractable material from sediments collected on top of the ship. Chromatograms are representative of triplicate samples.

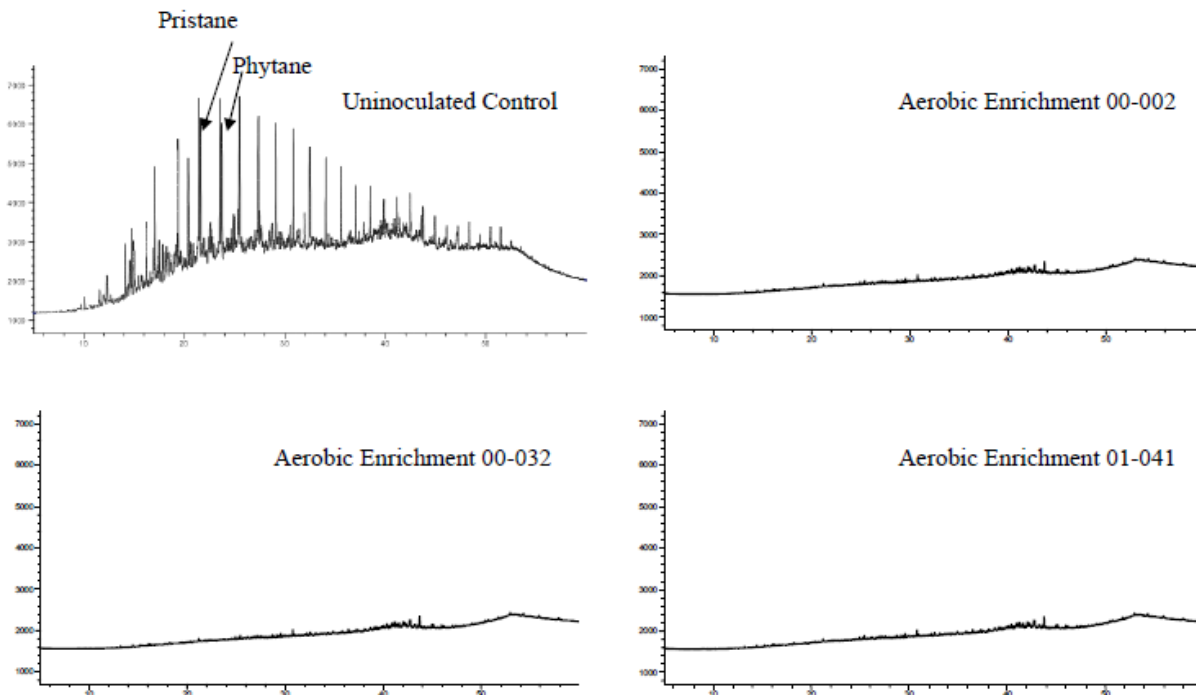
Figure 8.29. Gas chromatographic traces of oil extracted from USS *Arizona* aerobic enrichment cultures. The uninoculated control after 30 days still contains *n*-alkanes and branched alkanes. In comparison, following 30 days of microbial growth with Bunker C fuel oil as the only carbon source, loss of *n*-alkanes and the branched alkanes, pristane, and phytane, were observed. The y-axis is the detector response and x-axis is the retention time in minutes.

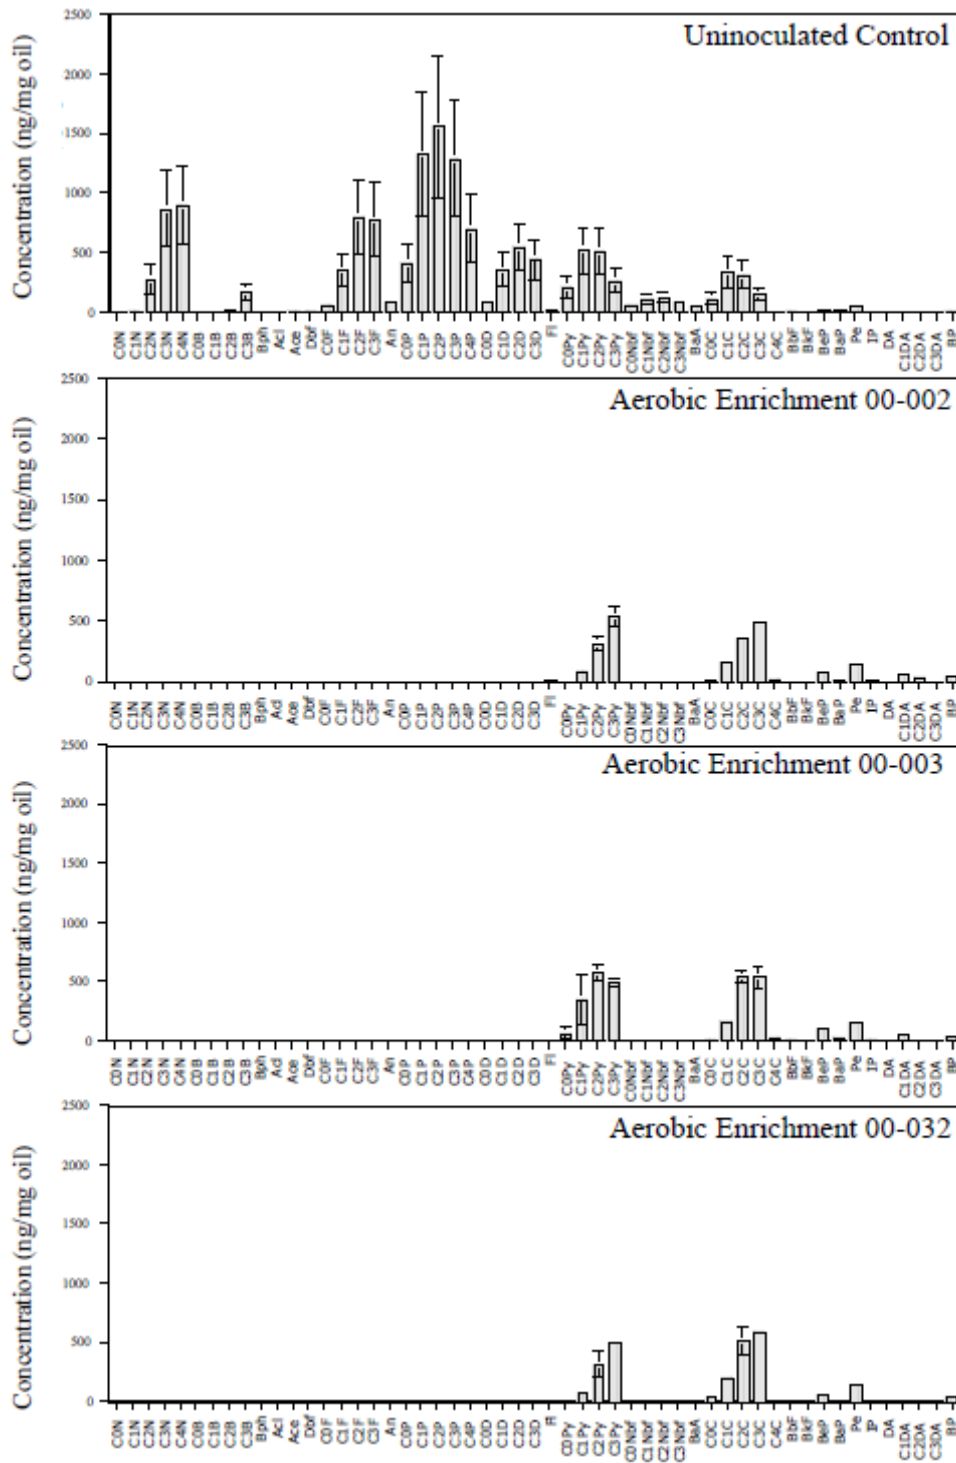
Figure 8.30. Individual PAH analysis for oil extracted from USS *Arizona* aerobic enrichments initiated from sediments surrounding the ship following 30 days growth indicates a substantial loss of PAHs in comparison to the uninoculated control. Abbreviations for PAH compounds are defined in Table 8.1 and locations for sediments used for aerobic enrichment inoculum are defined in Figure 8.5.

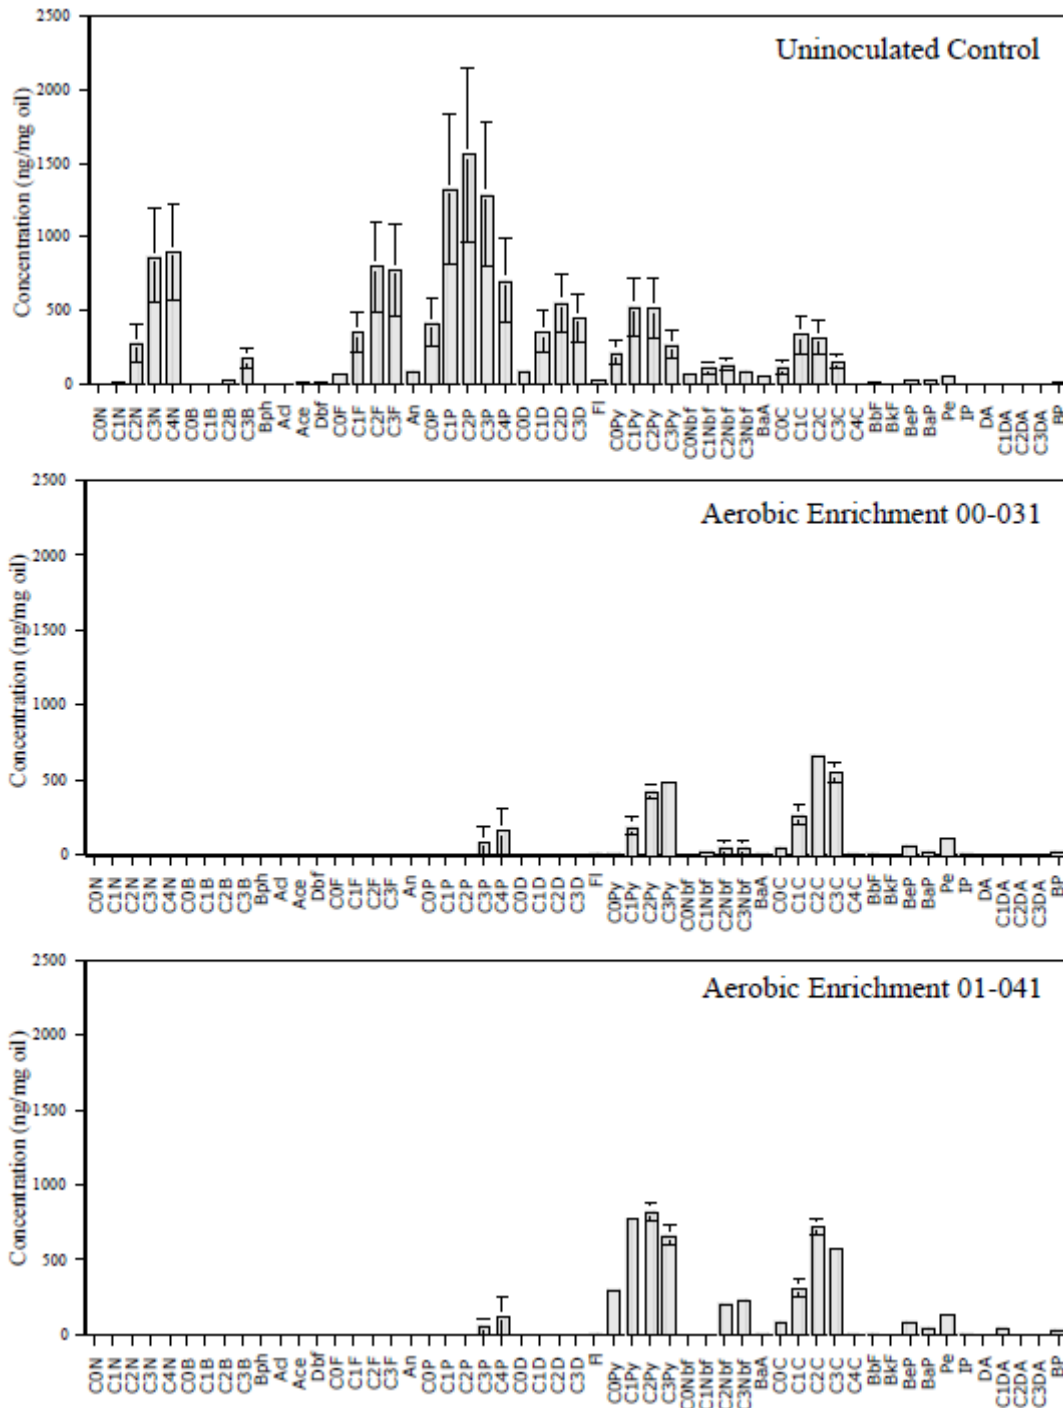
Figure 8.31. Individual PAH analysis for oil extracted from USS Arizona aerobic enrichments initiated from sediments on top of the ship following 30 days incubation indicates a substantial loss of PAHs in comparison to the uninoculated control. Abbreviations for PAH compounds are defined in Table 8.1 and locations for sediments used for aerobic enrichment inoculum are defined in Figure 8.5.

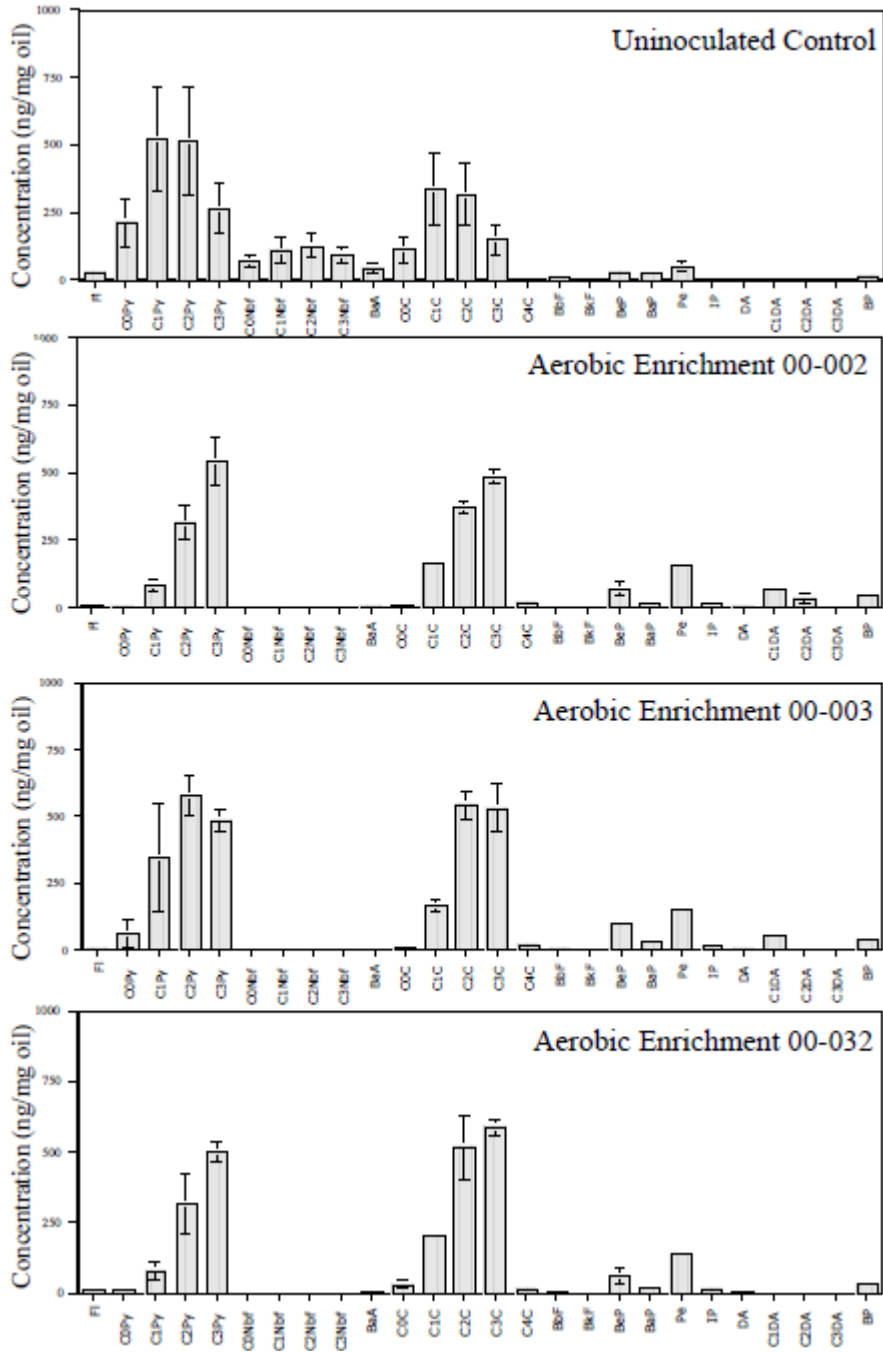
Figure 8.32. Individual PAH analysis of high molecular weight PAHs for oil extracted from USS Arizona aerobic enrichments initiated from sediments surrounding the ship following 30 days growth. Abbreviations for PAH compounds are defined in Table 8.1 and locations for sediments used for aerobic enrichment inoculum are defined in Figure 8.5.

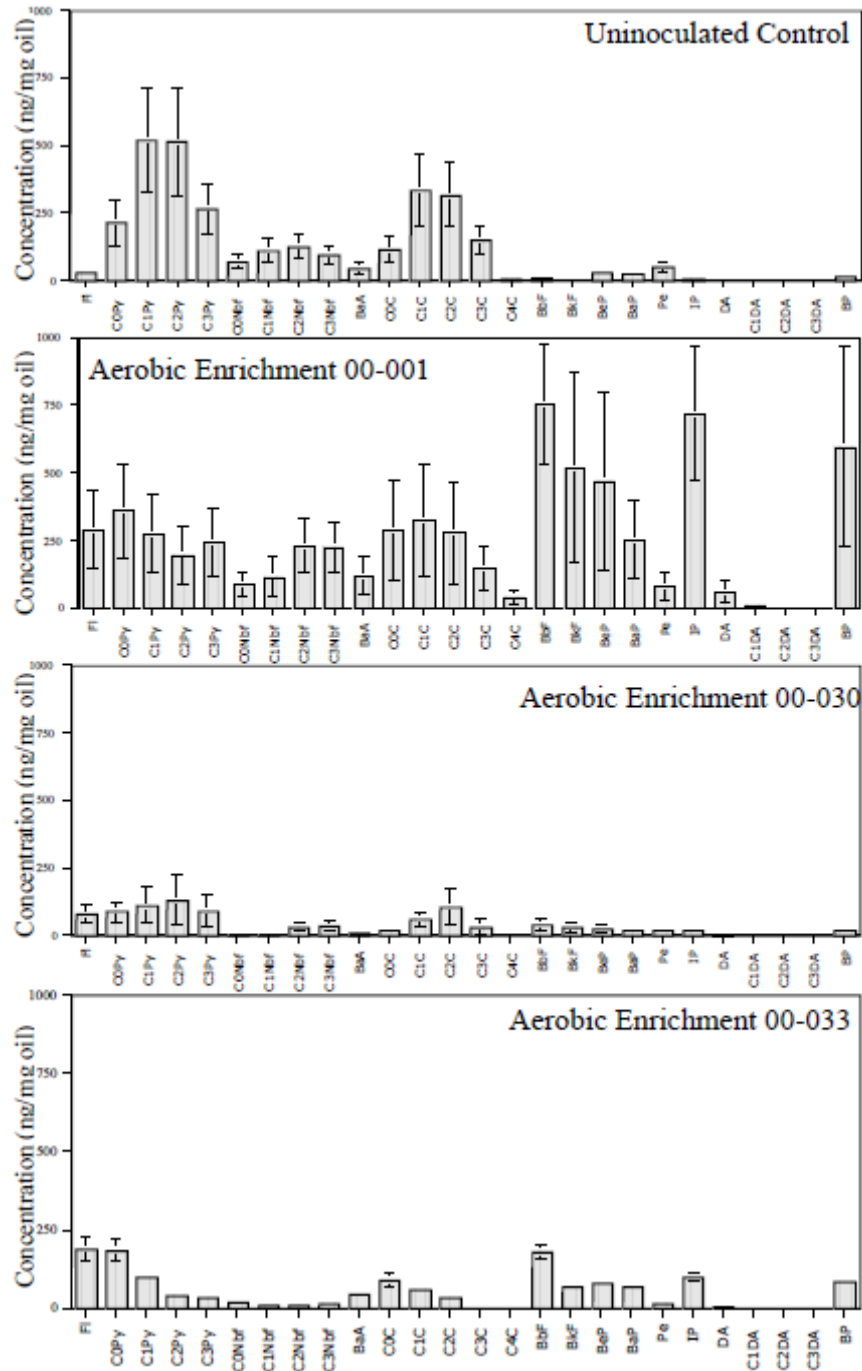
Figure 8.35. Individual PAH analysis of high molecular weight PAHs for oil extracted from USS *Arizona* aerobic enrichments following 30 days incubation. These enrichments had one of the three triplicates that did not show oil degradation. Abbreviations for PAH compounds are defined in Table 8.1 and locations for sediments used for aerobic enrichment inoculum are defined in Figure 8.5.

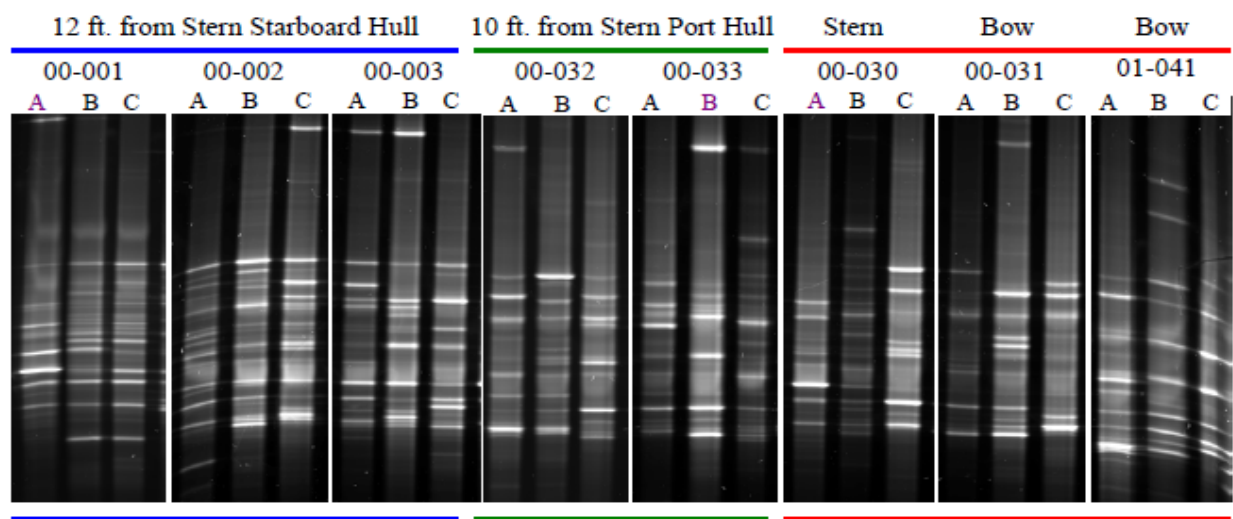
Figure 8.36. DGGE analysis of USS *Arizona* aerobic enrichment cultures. Triplicate cultures are designated by A, B and C. The blue bar denotes enrichment cultures that were inoculated with sediments collected from the stern section, starboard side, 12 ft. from the hull. The green bar denotes enrichment cultures that were inoculated with sediments collected from the stern section, port side, 10 ft. from the hull. The red bar denotes enrichment cultures that were inoculated with sediments collected from the top of the ship, and title above indicates the section they were collected from (bow or stern). The purple letters denotes enrichments that not did show degradation (00-001 A, 00-033 B and 00-030 A).

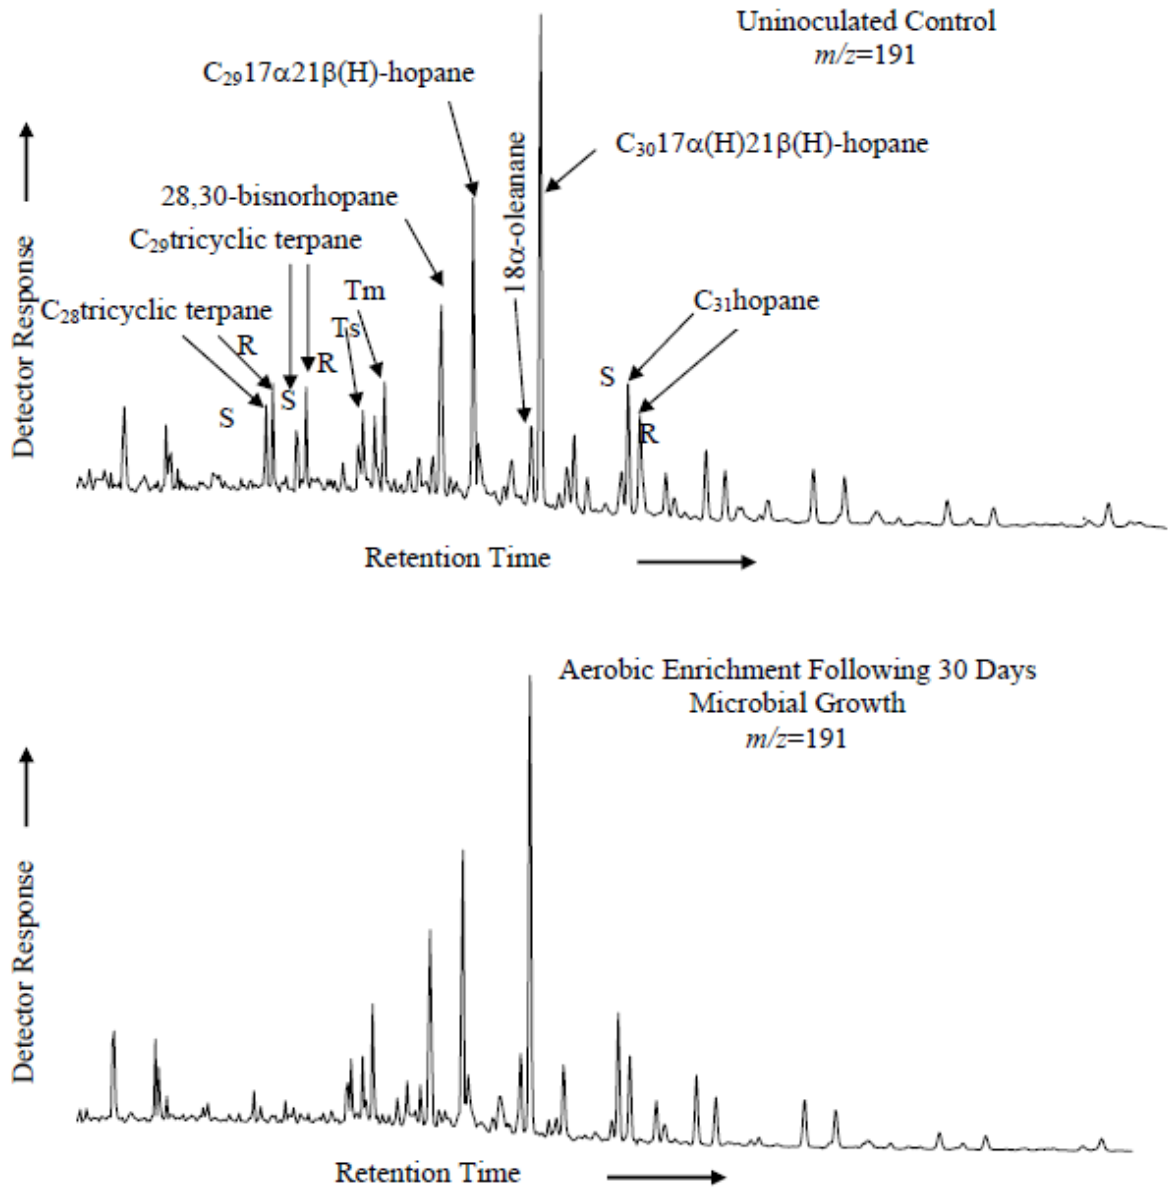
Figure 8.37. GC-MS chromatograms ($m/z=191$) of hopanes extracted from USS *Arizona* aerobic enrichments and uninoculated controls following 30 days of microbial incubation. Chromatograms are representative of triplicate samples.

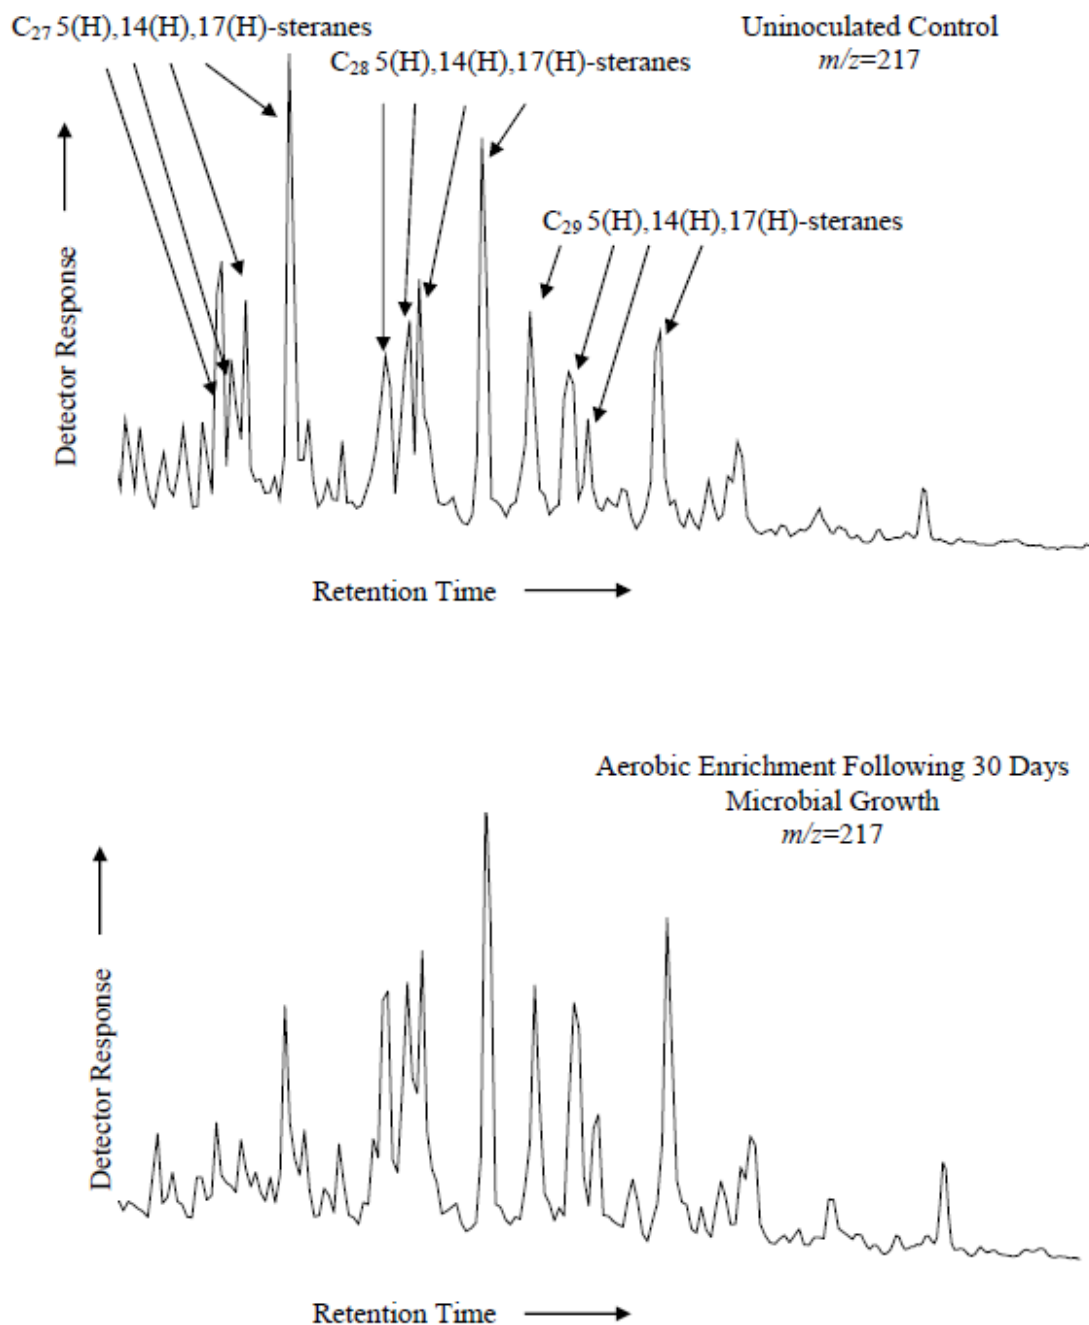
Figure 8.38. GC-MS chromatograms ($m/z=217$) of steranes extracted from USS *Arizona* aerobic enrichments and uninoculated controls following 30 days of microbial incubation. Chromatograms are representative of triplicate samples.

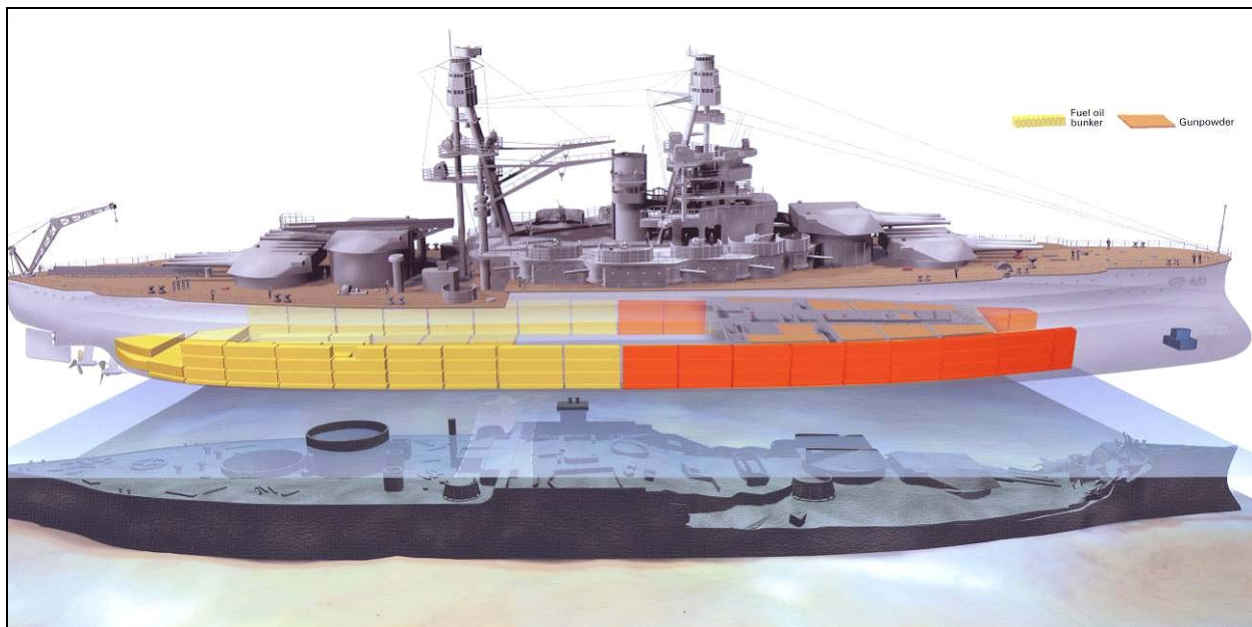
Figure 9.1. Graphic of oil bunker locations relative to hull damage. The yellow bunkers in the aft section (left) are presumed intact. This graphic depicts 50% of the hull remaining, rather than the more accurate 40% (Graphic by National Geographic Society).

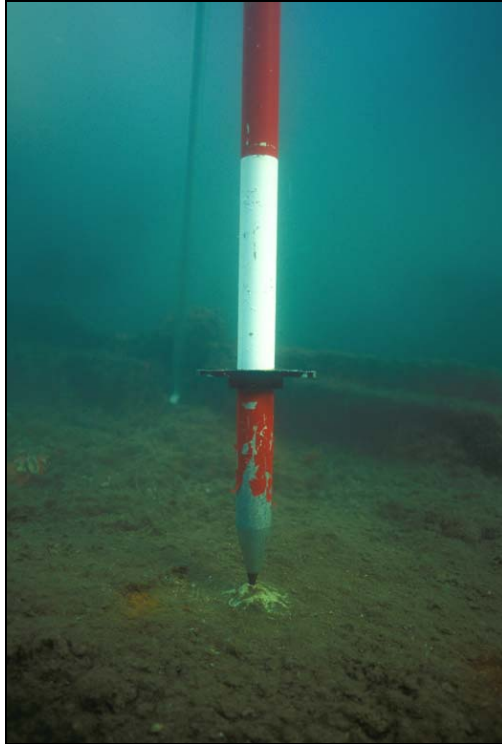
Figure 9.4. Surveying GPS monitoring points on *Arizona*, here using original velocity tool-set, stainless steel bolt surrounded by epoxy (NPS Photo by Brett Seymour).

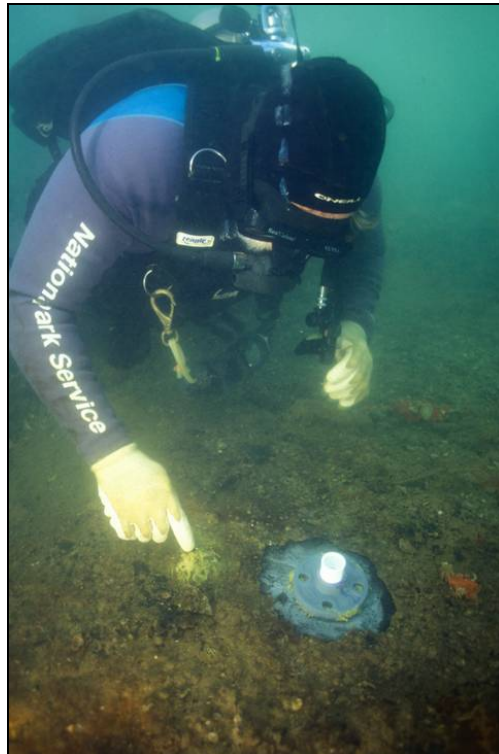
Figure 9.5. Comparison of the original, left, and current GPS monitoring points. Note: 2001 epoxy covered by pioneering organisms (NPS Photo by Brett Seymour).

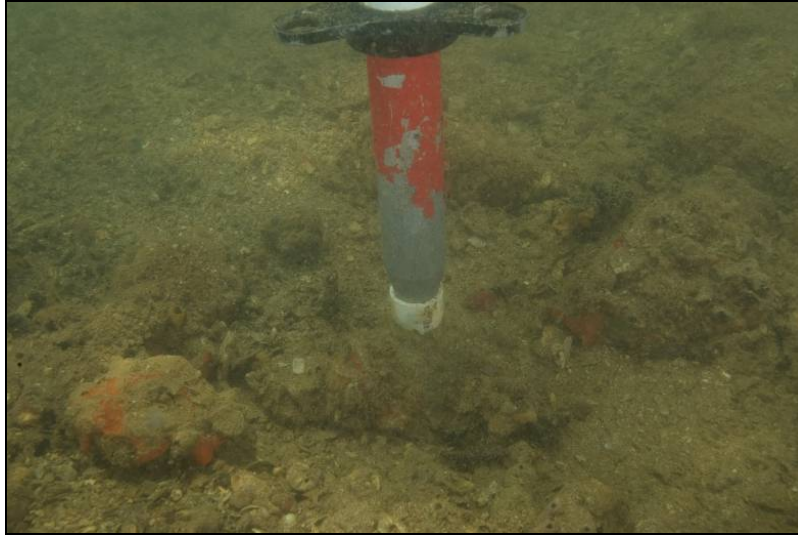
Figure 9.6. Surveying GPS monitoring points on *Arizona*, here using replacement PVC epoxyed to metal. This accommodates the point and facilitates set up. Note epoxy has been covered with pioneering organisms (NPS Photo by Brett Seymour).

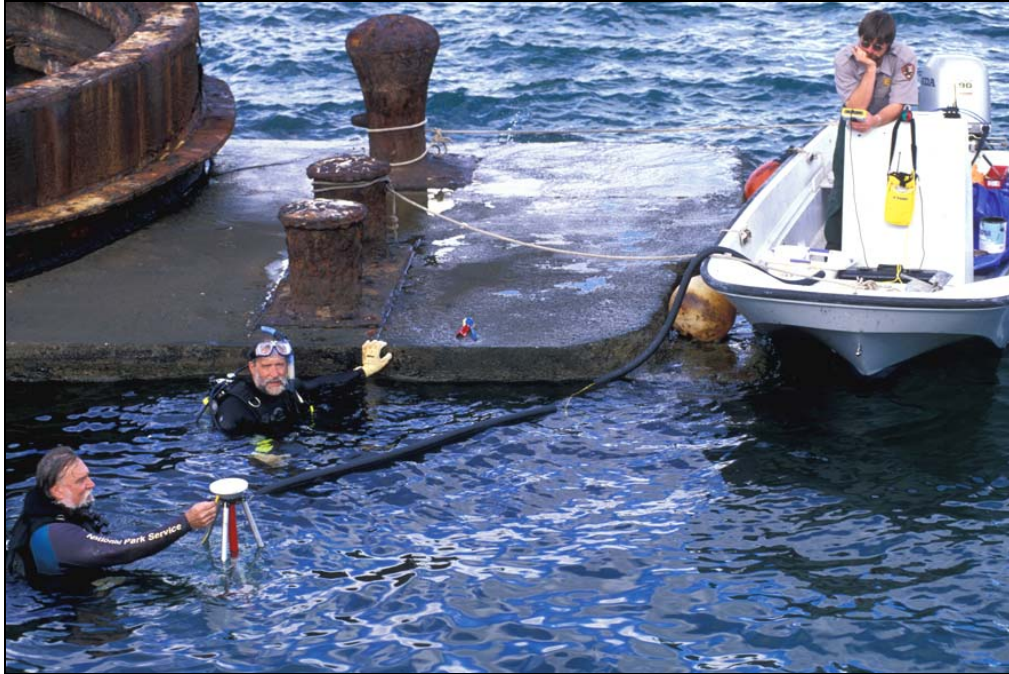
Figure 9.9. GPS surveying “Superpoint #2,” forward of barbette no. 3 (NPS Photo by Brett Seymour).

During the 2001 field season when the initial occupation of the monitoring points took place, the NPS partnered with the U.S. Army’s 29th Engineer Battalion Survey Platoon, who provided state-of-the-art, Trimble Navigation, Ltd. (Sunnyvale, CA) 4700 SSE survey grade, dual-frequency GPS receivers, and a survey team. At that time, NPS owned no survey grade GPS receivers. The occupation time of each point for the 4700 receivers is two minutes. Several points were positioned several times to verify accuracy and reproducibility. Results are presented in Table 9.1.

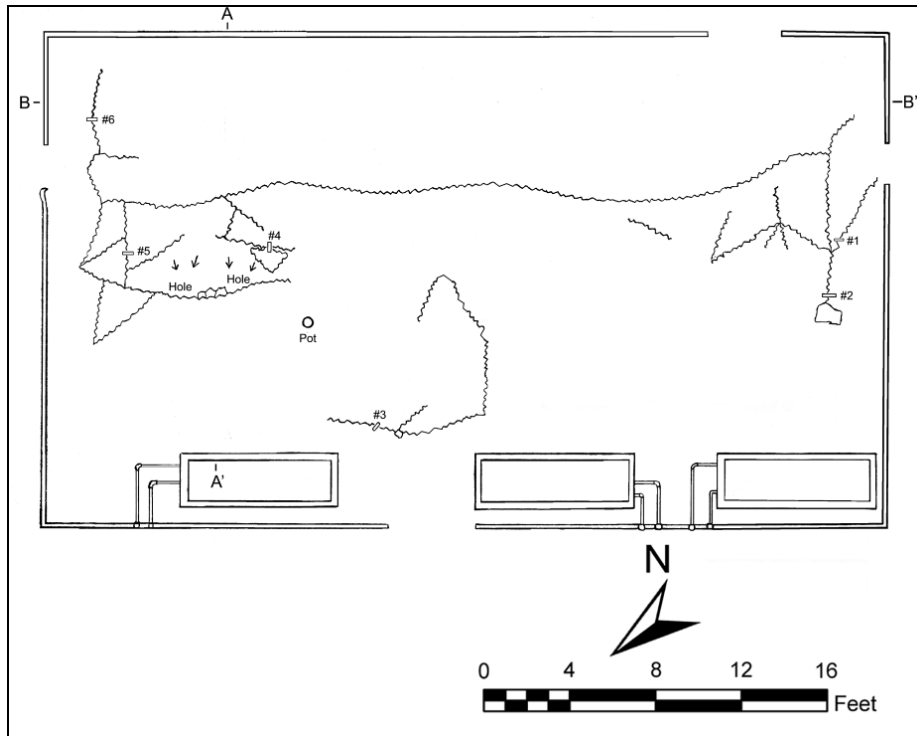
Figure 9.12. Plan view of *Arizona* galley area showing cracks and collapsed areas. *Arizona*'s bow is to the bottom of the drawing, port side to the right. Crack monitors are identified by numbers (Drawing by NPS-SRC).

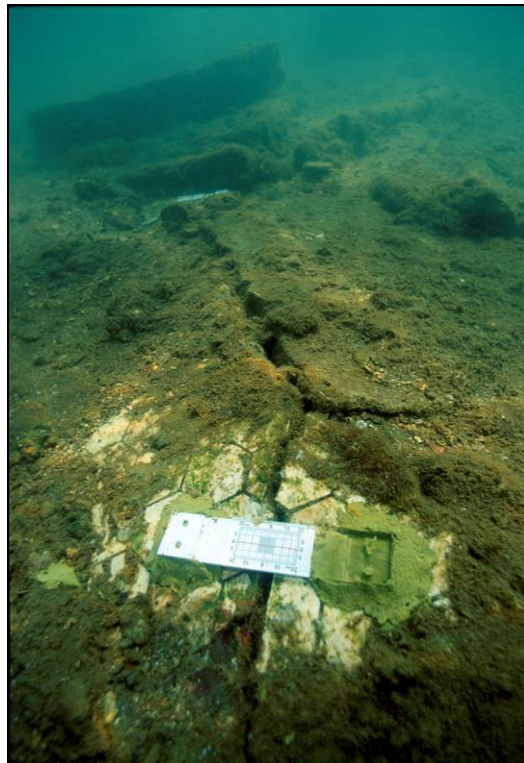
Figure 9.13. Crack monitor in *Arizona* galley-area (NPS Photo by Brett Seymour).

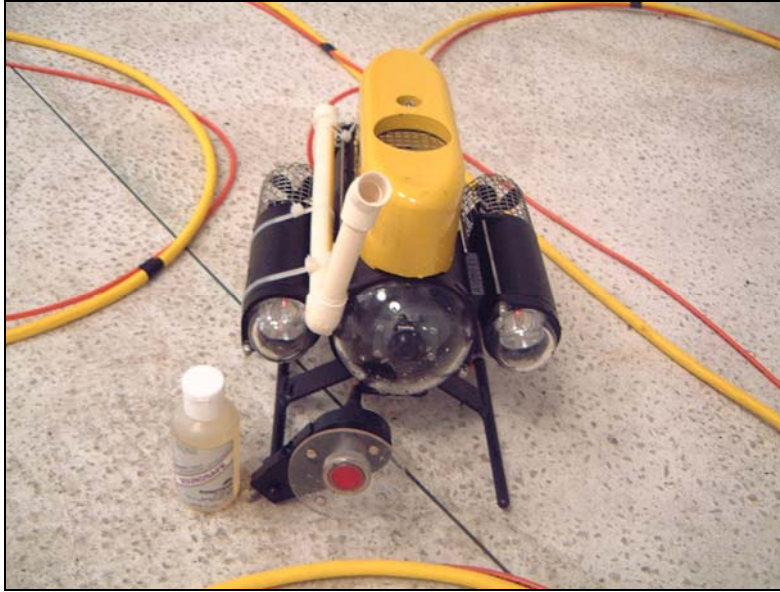
Figure 9.17. VideoRay ROV rigged for interior oil collection (NPS Photo by Brett Seymour).

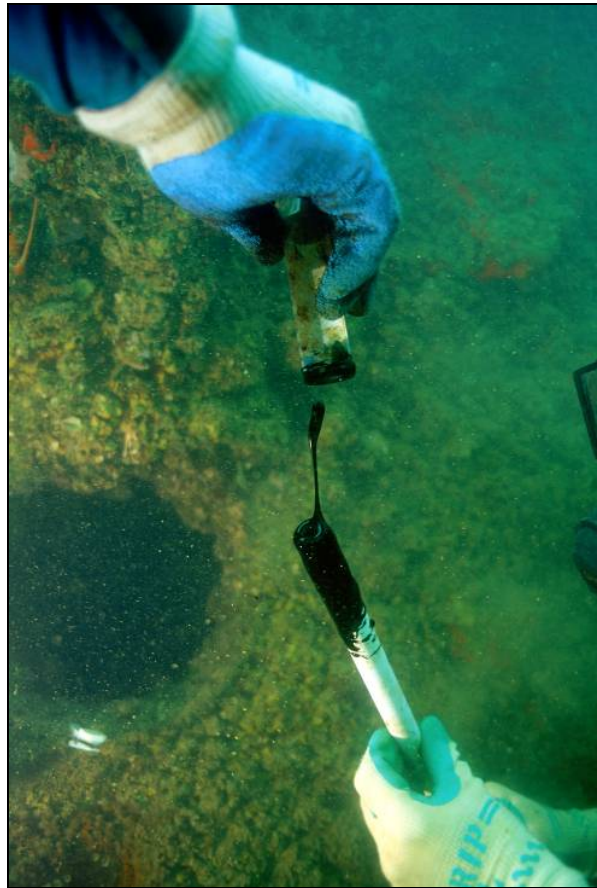
Figure 9.18. Internal oil measurement and oil sample collected by reaching PVC pipe in porthole and pushing vertically to the overhead. Overhead oil depth is indicated by oil on pipe (NPS Photo by Brett Seymour).

Internal oil observations and samples were collected with the VideoRay ROV (Figure 9.17), although most internal oil samples were collected from cabin overheads by reaching through an open second deck port hole on *Arizona*'s starboard side with a PVC pipe. No oil was observed in the port overhead spaces, likely due to the ship's 2–3° port list, which funnels the buoyant oil to the higher, starboard side. Oil has collected in most observable, starboard-side second deck cabin overheads, and the depth of oil in each cabin overhead was measured to give an idea of where internal oil releases are concentrated. A PVC pipe was pushed vertically up to the cabin overhead to obtain a depth (thickness) measurement of the oil layer, and samples were collected when the pipe was extracted (Figure 9.18). The results of oil depth measurements in overhead compartments on the second deck (Figure 9.19) indicate that oil concentrations increase moving forward from the stern, with the highest concentrations between frames 88–98. This is consistent with increased oil release observations in the upper deck, midships area (forward of frame 92). However, it also reinforces the observation that oil release in the midships and galley area is primarily “degraded” oil coming from secondary oil concentrations in second and main deck cabin overheads, not “undegraded” oil coming from primary oil containment spaces. The main deck (aft of frame 92) above oil-containing cabin overheads is apparently sound; there is no oil leakage above these second deck spaces. The closest oil leaks to this area are two open hatches on the main deck that continually release oil drops (see Figure 9.19). The oil coming from the aft-most hatch is different than the oil in cabin overheads, in that

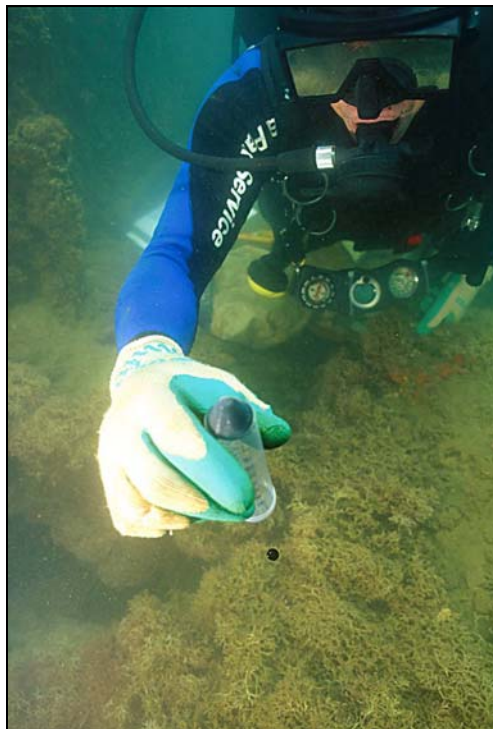
Figure 9.20. USS *Arizona* open water oil sampling (NPS Photo by Brett Seymour).

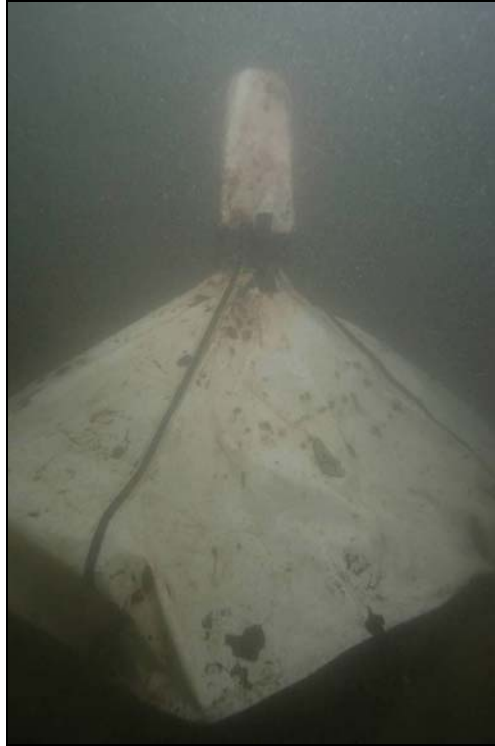
Figure 9.21. Oil catchment tent deployed on *Arizona* (NPS Photo by Brett Seymour).

Open water column samples for analysis are collected by simply catching a drop of oil as it rises to the surface (Figure 9.20). For measuring release rates in the current USS *Arizona* Preservation Project, we used a custom-designed, purpose-built catchment tent that funnels oil droplets into hole in the top fitted for a 32-oz. collection jar (Figure 9.21 and 9.22). The first tent was constructed in 1998 by USIA Corporation (St. Helens, Oregon), followed by a revised version in 2002. The tent is set up above an oil release point and left in place for a specific time period, after which the volume of oil collected is measured, and an average 24-hour release rate calculated. Systematic oil release monitoring began in 1998, focused on the two starboard hatches that had been identified in the 1980s, and continued in 2003, 2004, and 2006, with each including more oil release locations.

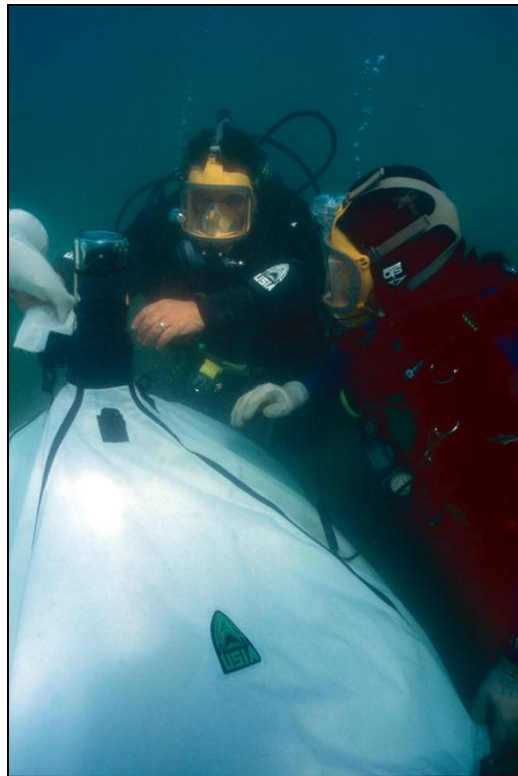
Figure 9.22. Oil catchment tent deployment on *Arizona* (NPS Photo by Brett Seymour).

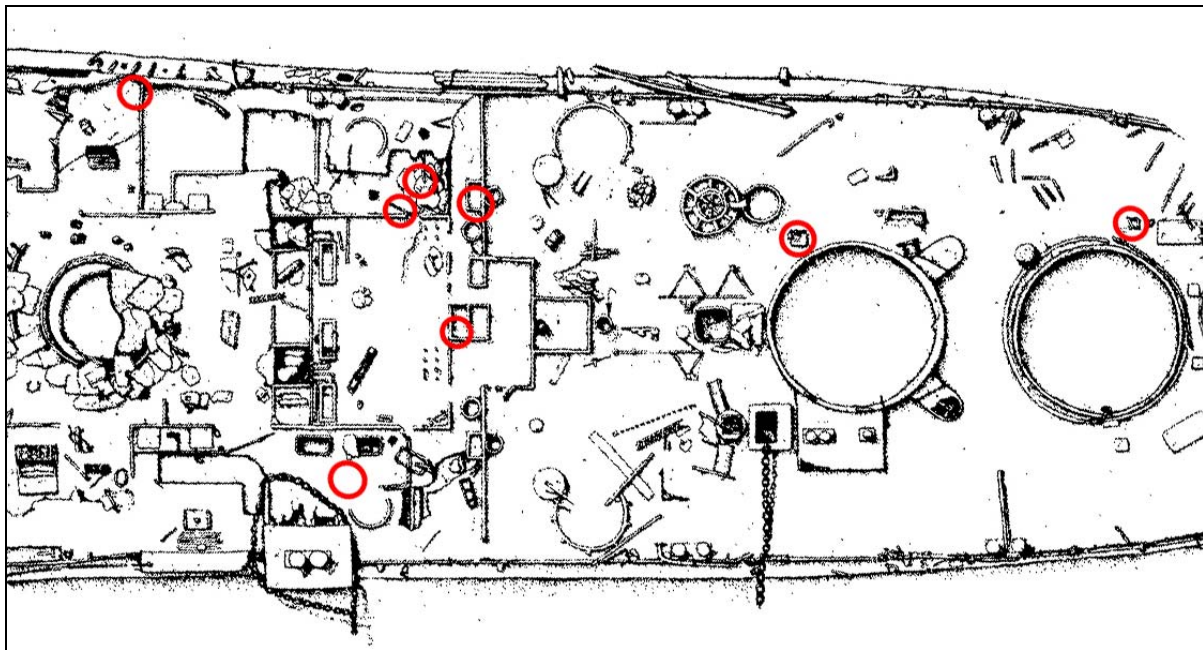
Figure 9.23. Oil release points measured on *Arizona's* hull, June 2006 (bow is to left) (Graphic by NPS-SRC).

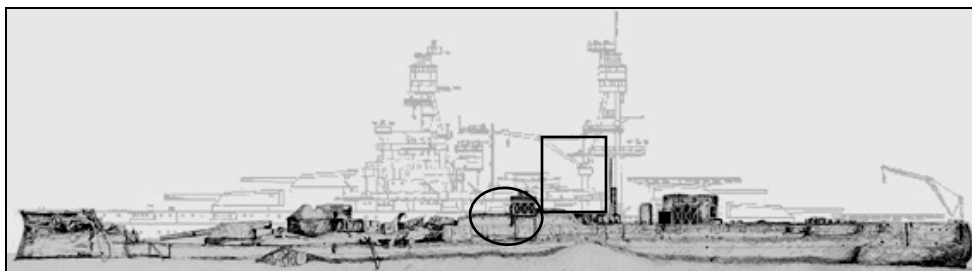
Figure 9.24. USS *Arizona* wreck overlay on intact vessel plans. Oval indicates galley area oil release area and rectangle is Memorial location (Graphic by NPS-SRC).

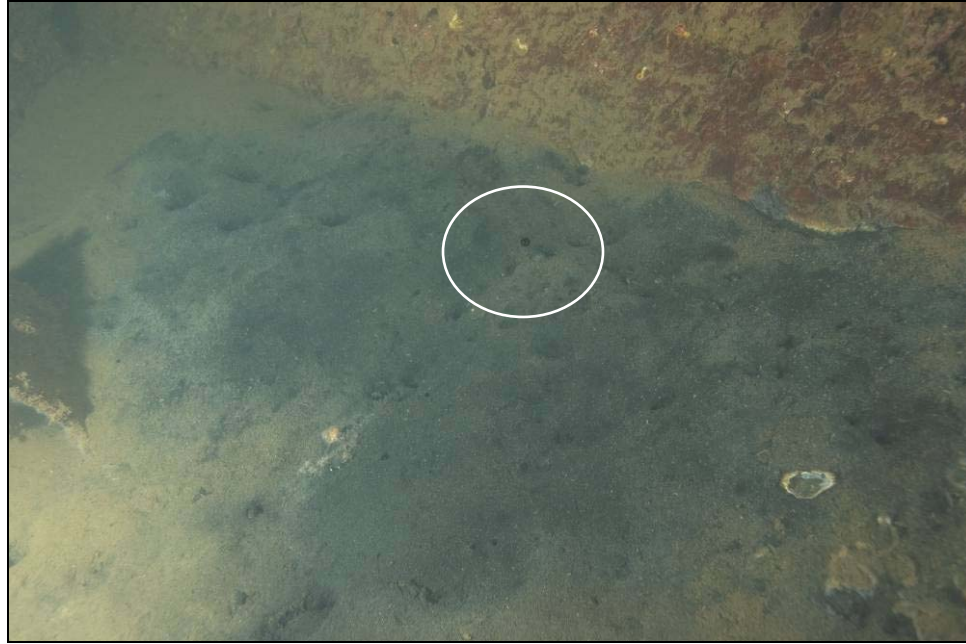
Figure 9.25. Sediments in crew’s galley area forward of Memorial. Dark areas are oil saturated sediments. White oval circles a drop of released oil moving toward the surface (NPS Photo by Brett Seymour).

The oil escaping from the hull in the galley area comes through the sediments, which appear to be fully saturated with oil in several locations. Oil release has increased in this area based on comparisons with the 1980s fieldwork. Additional oil leaking from lower decks floats to the area beneath these sediments, and dislodges trapped oil that rises to the surface (Figure 9.25). It is a reasonable question to ask “where does the oil leaking through the galley area sediments likely originate?” A partial answer is revealed by an examination of the ship's blueprints on this area, specifically focusing on ship's plans in the area between frames 70–90. The crew's galley was on the upper deck. Directly beneath this area, below the third deck were engine, boiler, distribution and pump spaces (Figures 9.26–9.32). Oil bunkers are on the first platform and below. There is no record of damage to these spaces, only the main and third decks are mentioned as being accessed by divers during the salvage work, but it is very likely there is damage to the engine and boiler spaces in this area. Oil could be coming from associated piping, machinery, cracked or damaged bunkers, and trapped in overhead spaces. Episodic releases may be caused by further collapse of lower decks, much like that observed on the upper deck area. More likely, the oil in the galley area is resulting from original battle damage, and weakened decks collapsing and releasing trapped oil that rises up from engine, boiler and pump spaces, than from deteriorating oil bunkers. The rising oil is directed by collapsed decks to cracked areas surrounding the upper deck galley that contain sediment, where the oil saturates the sediment and is released.

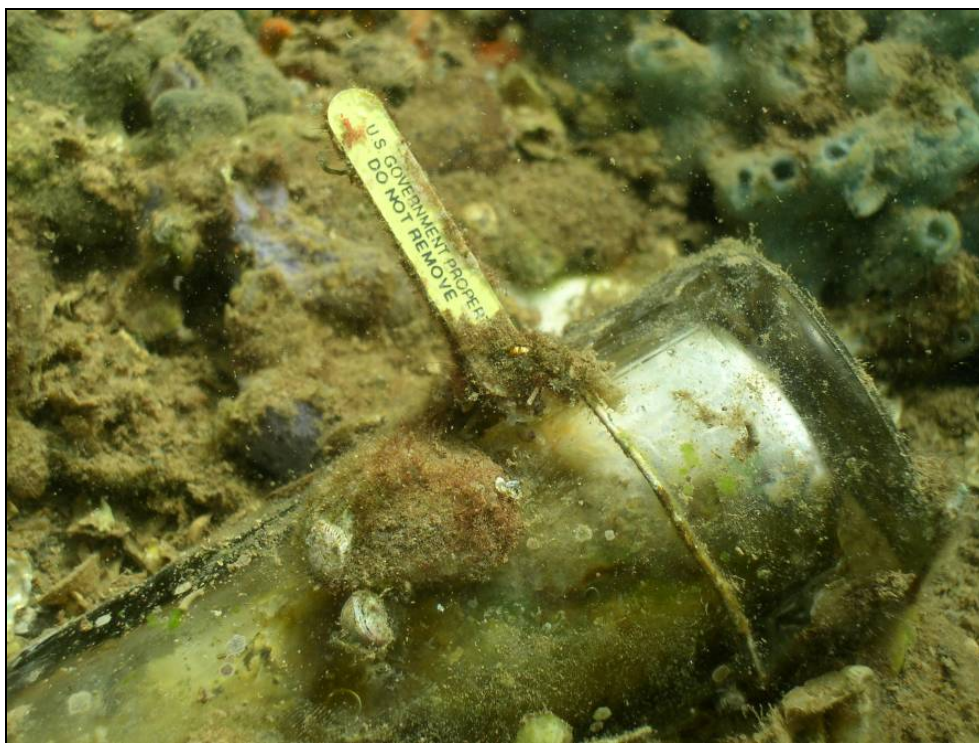
Figure 9.33. USS *Arizona* artifact with monitoring tag affixed (NPS photo by Brett Seymour).
