CHAPTER 8

An Environmental Study of USS *Arizona* Bunker C Fuel Oil

Amanda M. Graham

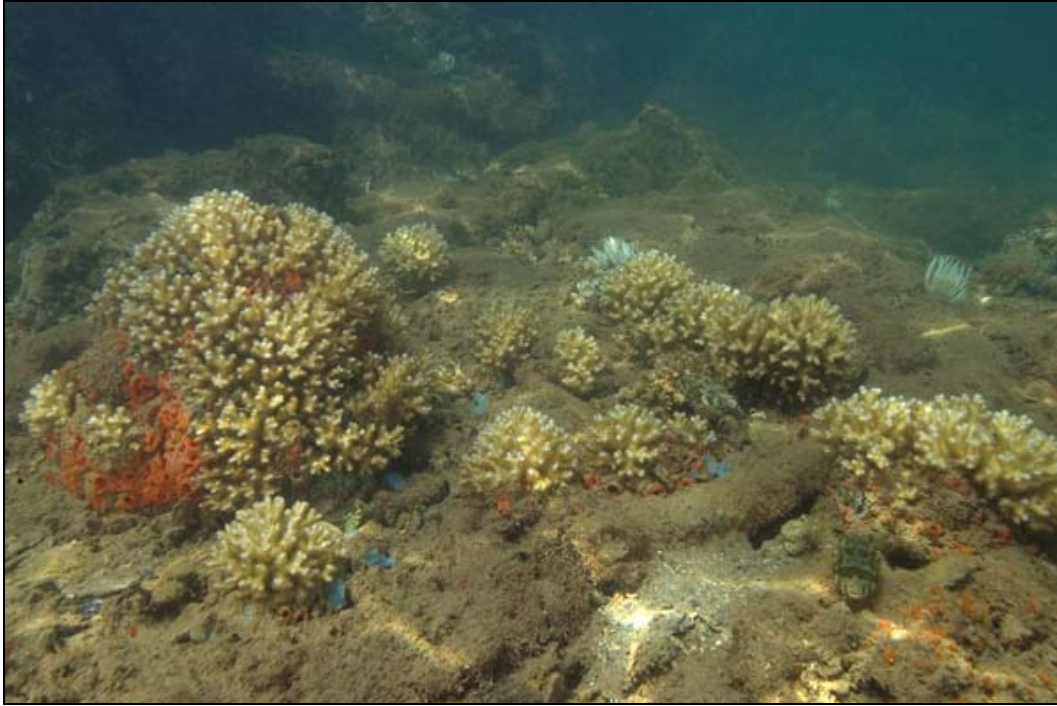
Figure 9.34. Live coral on *Arizona*'s deck (2006), which requires good water quality to grow. There was no hard coral observed in 1986 (NPS Photo by Brett Seymour).

Submerged Resources Center personnel have been conducting research on USS *Arizona* since 1983. During the course of this research, scientists and archeologists working on *Arizona* have noted a general improvement in overall environmental conditions. This improvement manifests in increased visibility and increased coral growth, and fauna presence and diversity on the hull (Figure 9.34). In 1986, researchers conducted a biological inventory of growth attached to the hull and deck. There were about 25 common taxa of organisms living on the hull and about 25 species of fish observed. Most of the encrusting organisms were filter feeding organisms such as vermetid mollusks, oysters, bryozoans, tube worms, sponges, tunicates and algae. Resurveys were conducted in 1987 and 1988, and monitoring station photographs were taken and analyzed (Henderson 1989). The monitoring program could not be sustained and was discontinued afterwards. In addition, lack of funding prevented a repeat inventory for quantitative inventory comparison as a part of the current research project, which is needed. However, presence of seahorses (identified by USS *Arizona* Memorial personnel as *Hippocampus kuda*, or yellow seahorse, Figure 9.35), first observed in 2005, indicates improving water quality in Pearl Harbor. Qualitative comparisons can also be made through photographic evidence taken of features during the 1980s documentation project and more recent photographs of the same objects (Figures 9.36–9.39). This 20-year observation period of biological indicators on USS *Arizona* show that both the environment in and around *Arizona* is relatively benign, and the general conditions of Pearl Harbor have markedly improved in the last two decades.

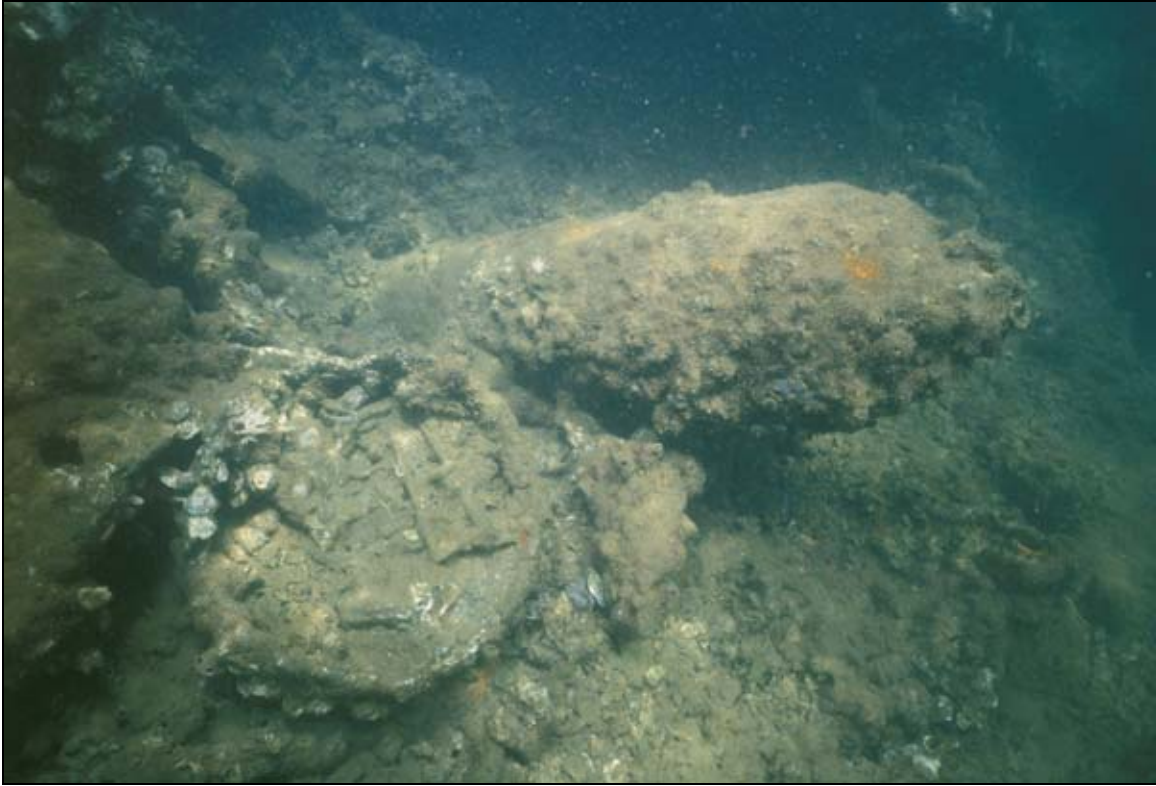
Figure 9.36. Gas cylinder *Arizona*'s deck in 1983 (NPS photo by Larry E. Murphy).

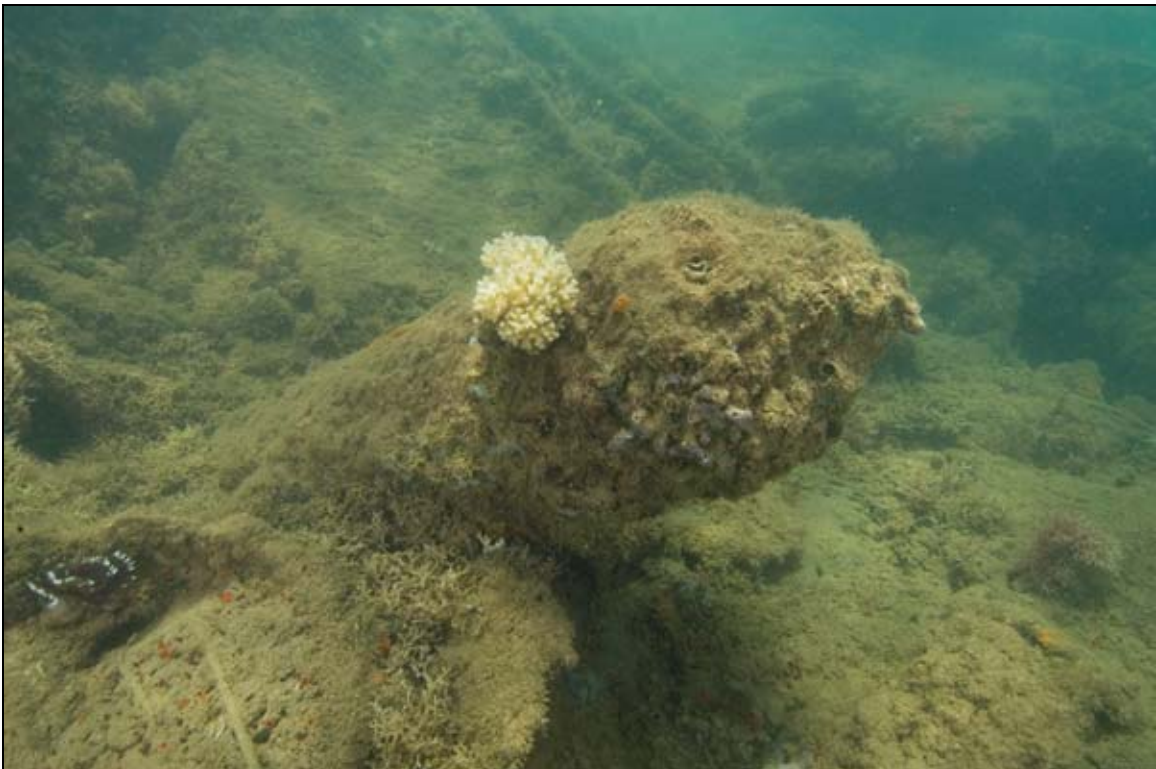
Figure 9.37. Gas cylinder *Arizona*'s deck in 2005, with hard coral (NPS photo by Brett Seymour).

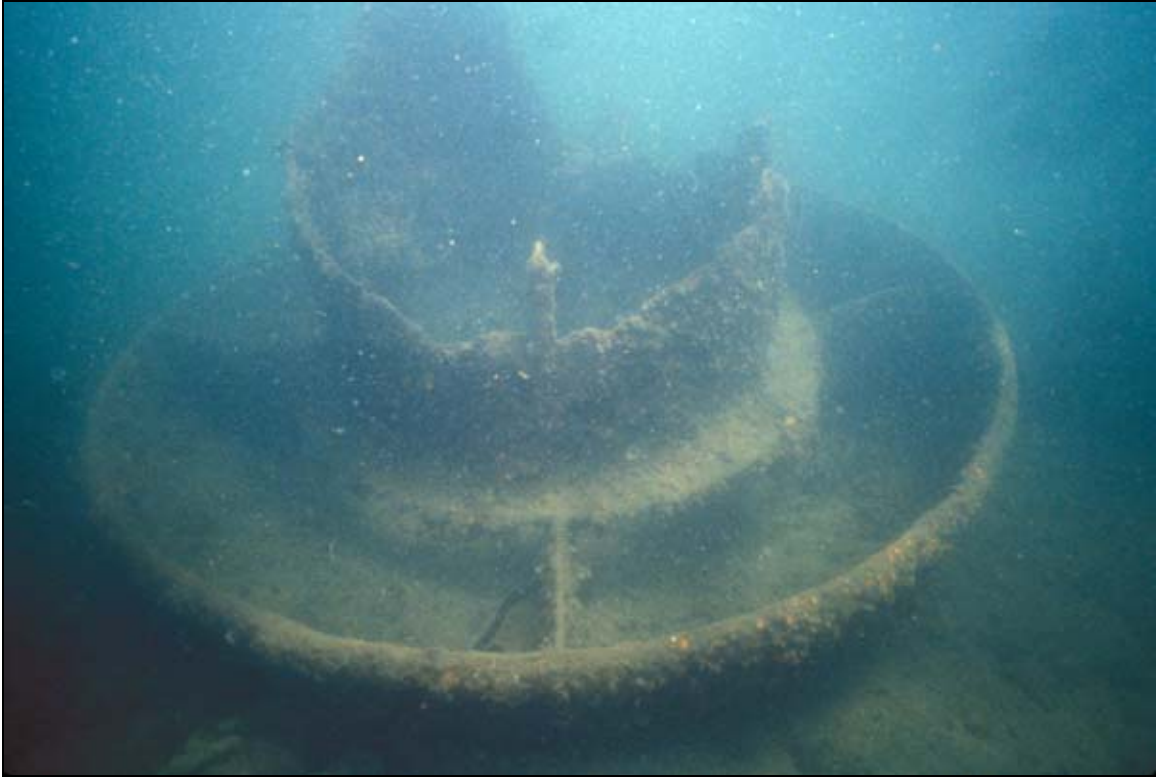
Figure 9.38. Inverted ventilator, on *Arizona*'s aft deck in 1983 (NPS photo by Larry E. Murphy).

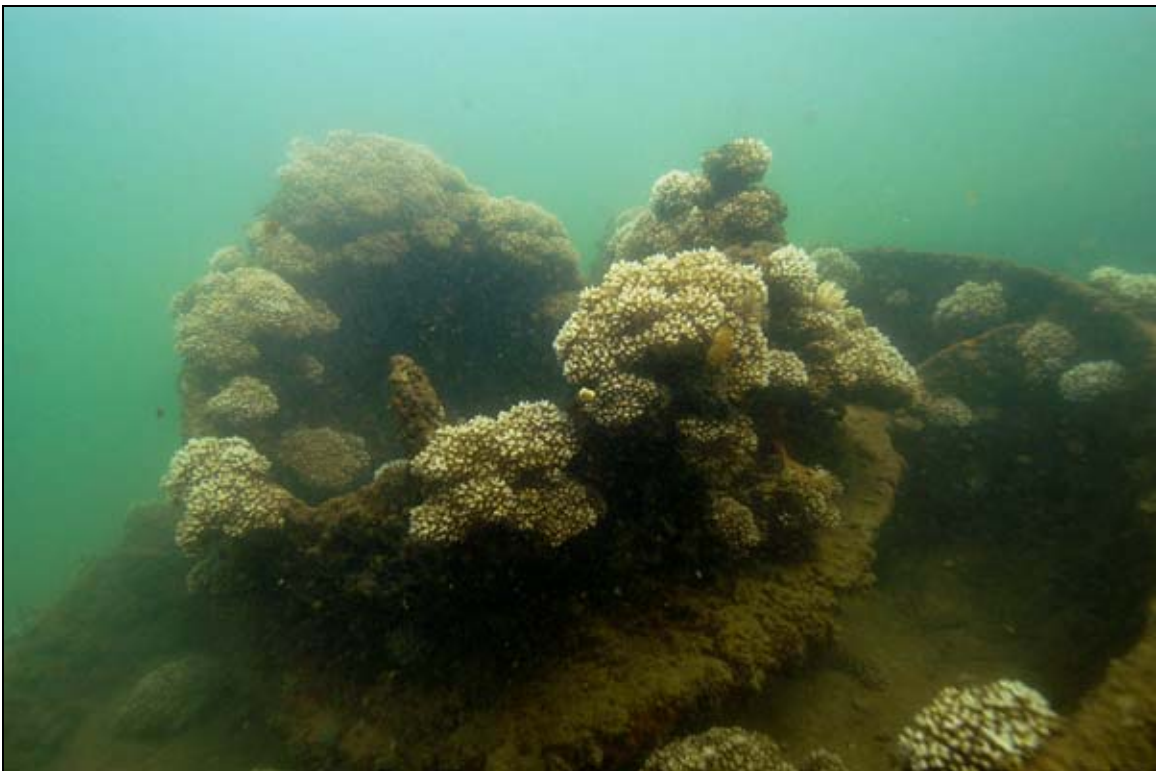
Figure 9.39. Inverted ventilator, on *Arizona*'s aft deck in 2005 (NPS photo by Brett Seymour).

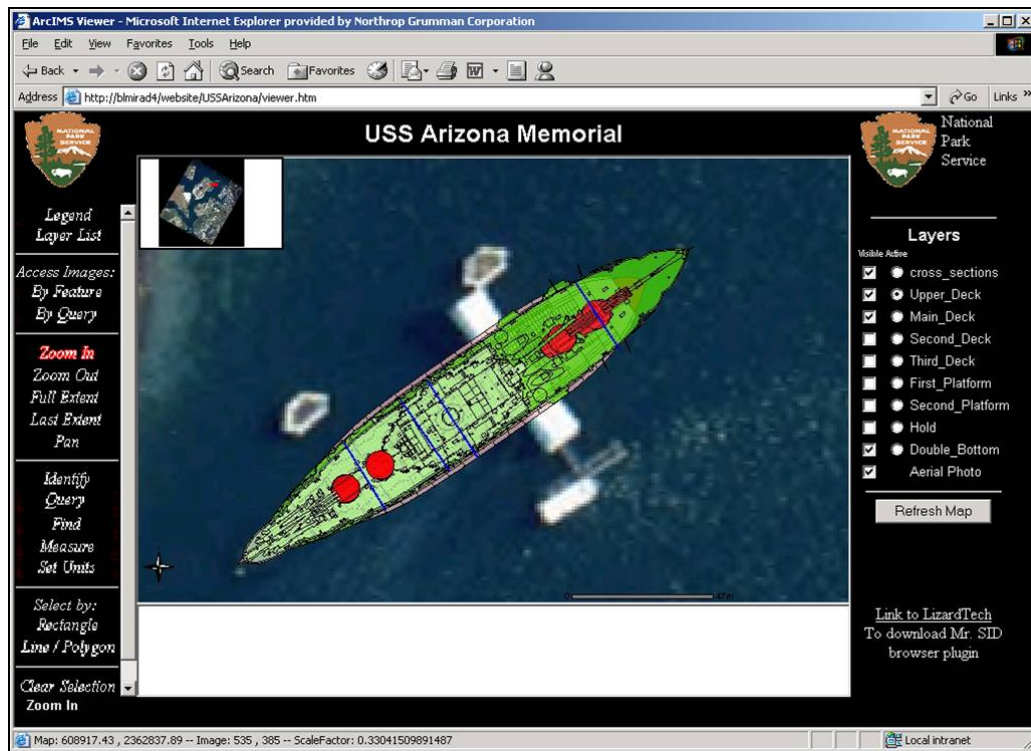
Figure 9.40. Georectified blueprints of USS *Arizona* (Image from USAR GIS Project).

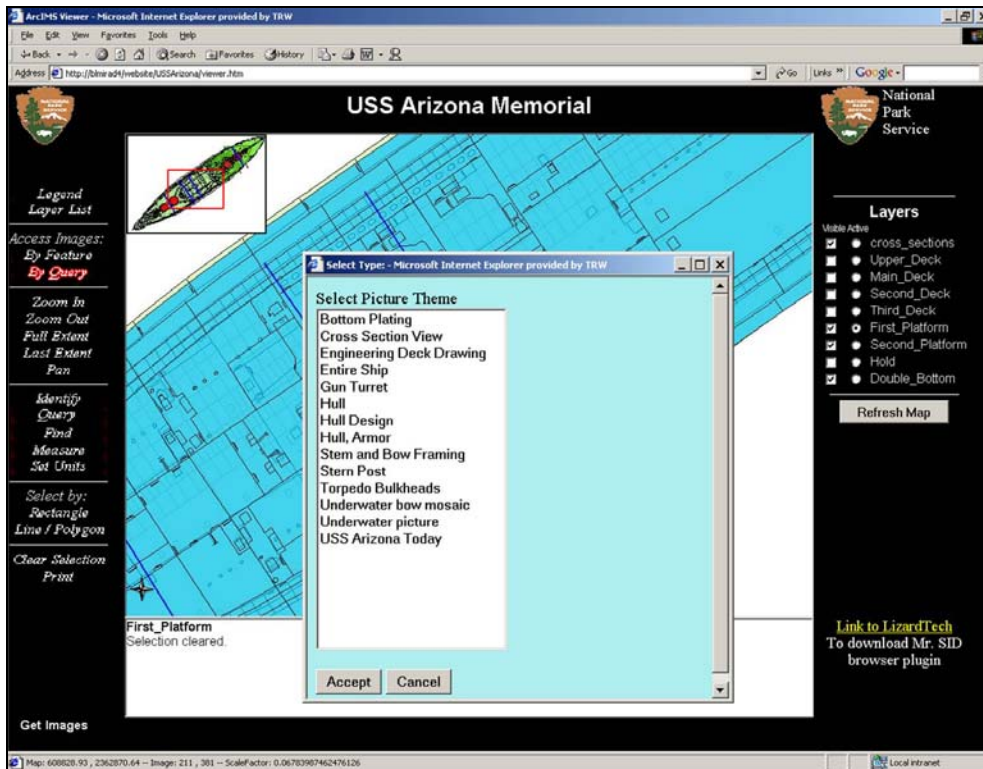
Figure 9.44. Example of accessing images and geodatabase by query (Image from USAR GIS Project).

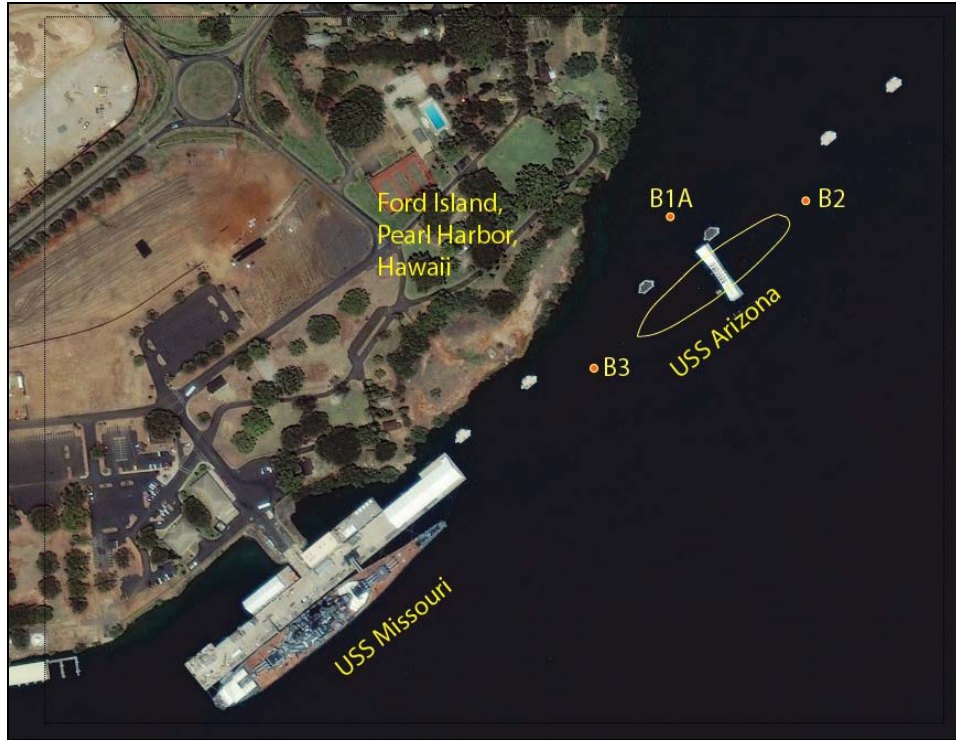
Figure 10.1. Boreholes B1a, B2 and B3 located around the hull of USS Arizona, west of Ford Island.

The three boreholes are located as follows: B1A is located midship between the USS *Arizona* and Ford Island (E608813, N2362945) in 8.5 m of water at the time of drilling; B2 is located directly northeast of the vessel (E608943, N23662957) in 11.9 m of water at the time of drilling; B3 is located directly southwest of the vessel (E608749, N23662811) in 11.3 m of water at the time of drilling (Figure 10.1). The boreholes B1A, B2, and B3 have sub-bottom drill depths of 15.2, 21.3, and 15.2 m. USS *Arizona* is currently resting on the floor of Pearl Harbor, submerged and tilting away from Ford Island. Immediately following the attack, on December 7, 1941, portions of the deck and railing were sub-aerially exposed, along with the superstructure and guns removed during salvage operations (Figure 10.2). The superstructure and guns were removed in 1942. Photos taken in the winter and spring of 1942 clearly show much of the vessel

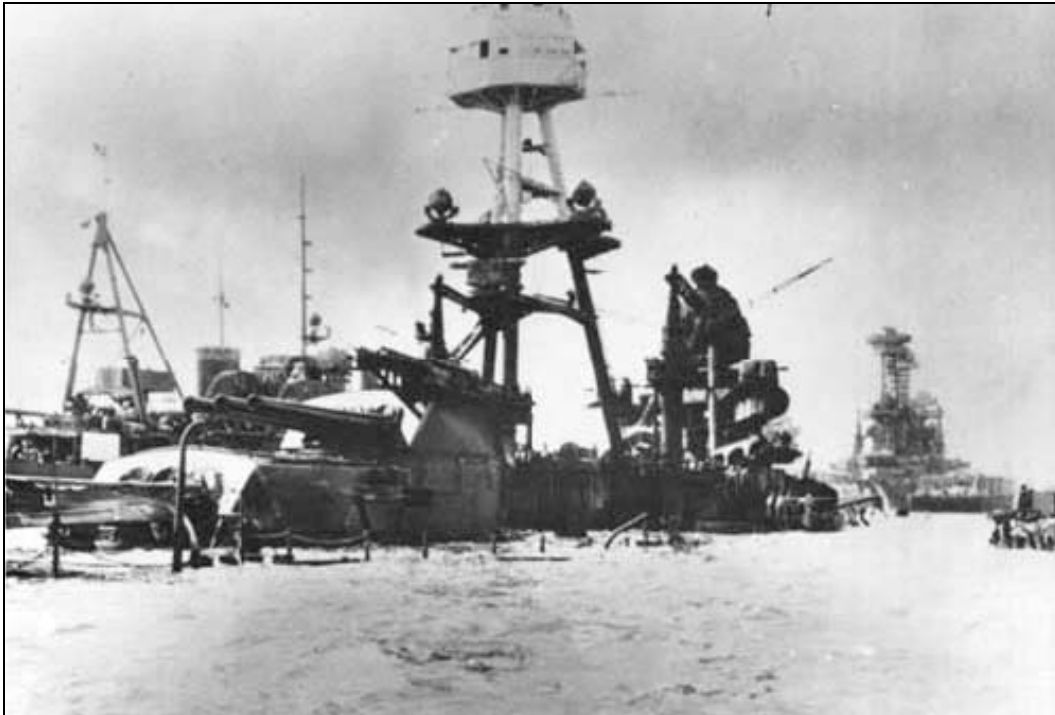
Figure 10.3. Gunnery deck and deck railings visible above the harbor water in 1942 (USS Arizona Memorial Photo Archive).

deck at, or above, water level (Figures 10.3–10.5). Today, 63 years later, the deck of the vessel is submerged in up to approximately 2 m of water.

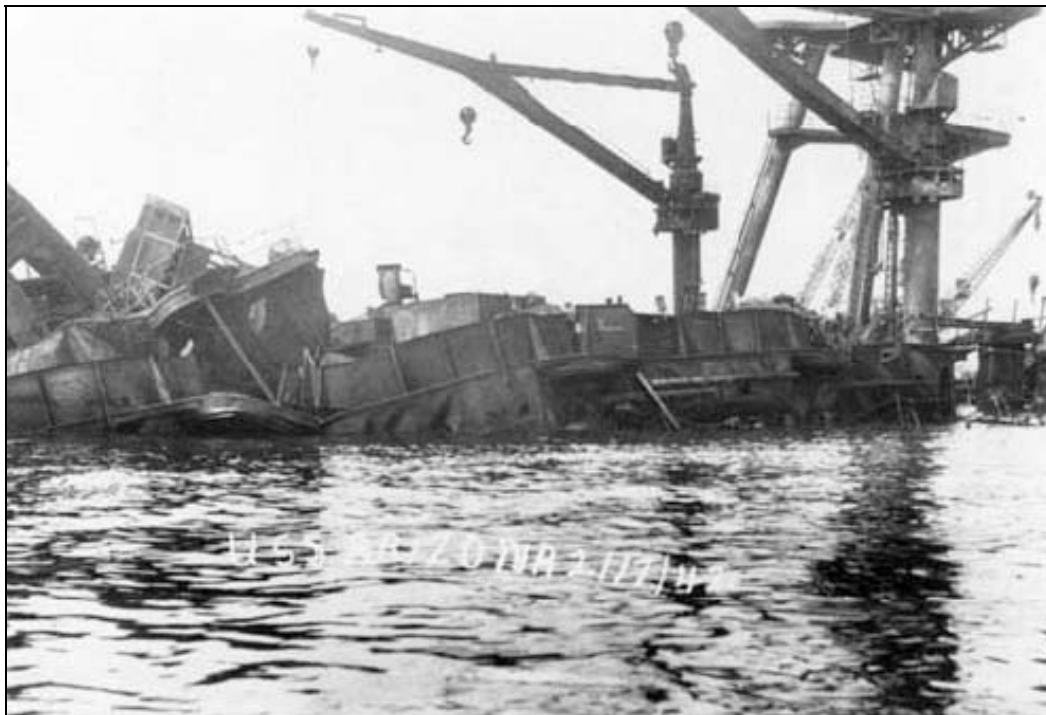
Figure 10.4. A photograph of USS Arizona's damaged exposed deck (USS Arizona Memorial Photo Archive).

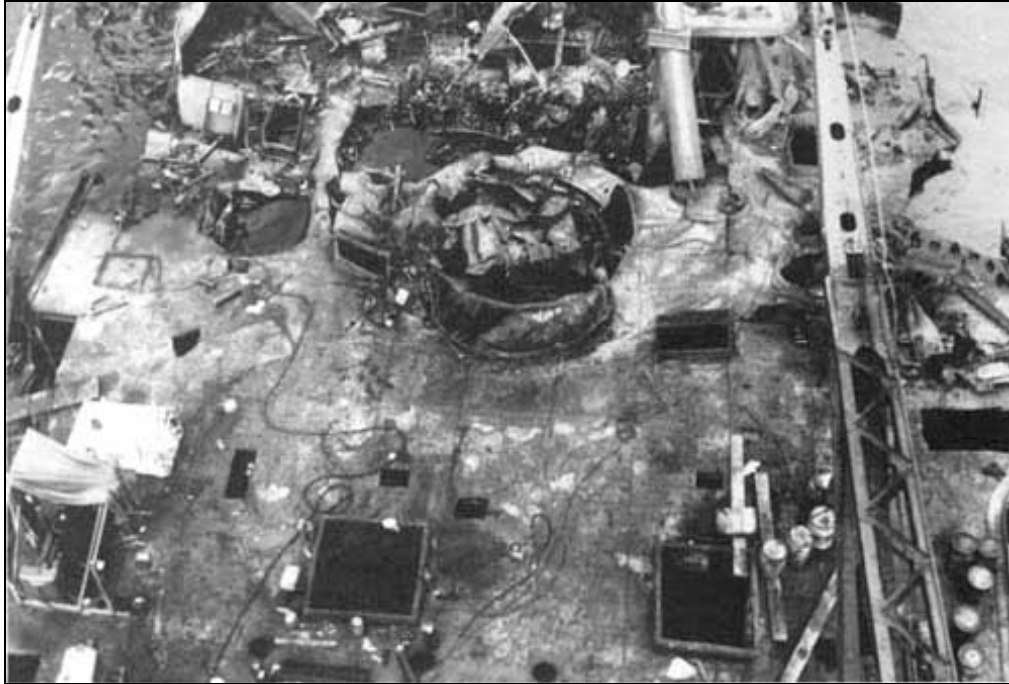
Figure 10.5. Salvage crews in 1942 were able to work on the deck above water and cut entry-ways into the vessel for recovery operations (USS Arizona Memorial Photo Archive).

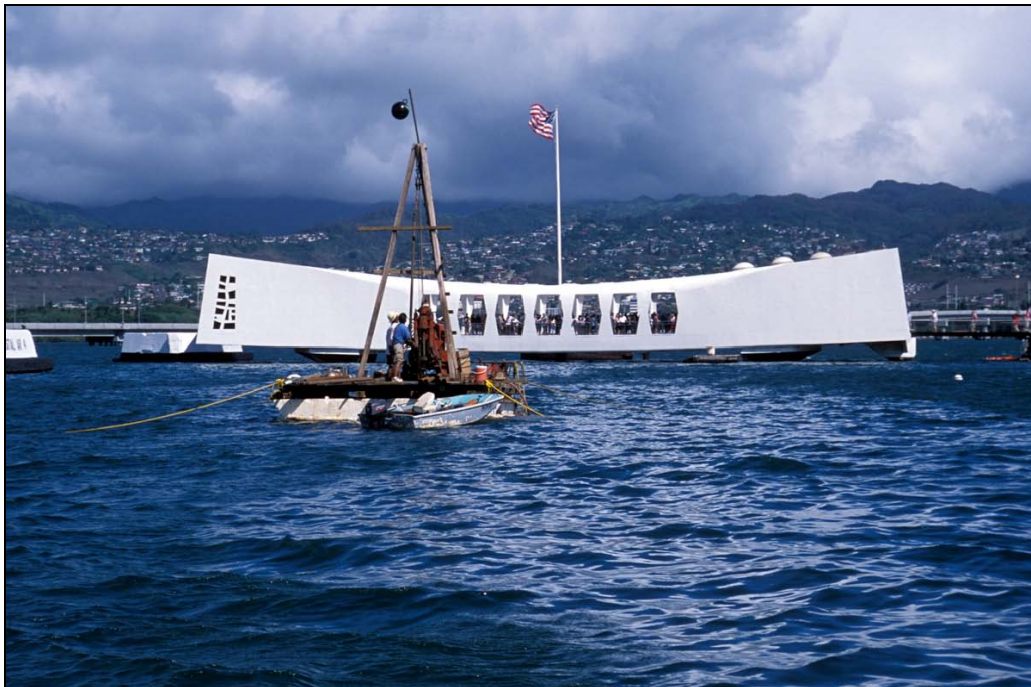
Figure 10.6. A small anchored barge was used to advance the borehole. The deck and railings of USS *Arizona* are completely submerged in 2003, with the vessel tilting several degrees to the southeast (USGS Photo).

Field sampling operations, taken from a small drill barge, were focused on collecting soil samples with several coring devices. In general, the drillers sampled sediment with either 100 mm Shelby tubes or 75 mm steel pipe (Figure 10.6). The Shelby tubes are enameled, non-reactive, sample tubes designed for acquiring sediment with saline pore water. The recovered samples are encased in whole-round steel liner tube and capped by the drillers, and then were transported to an onshore laboratory near the drill site.

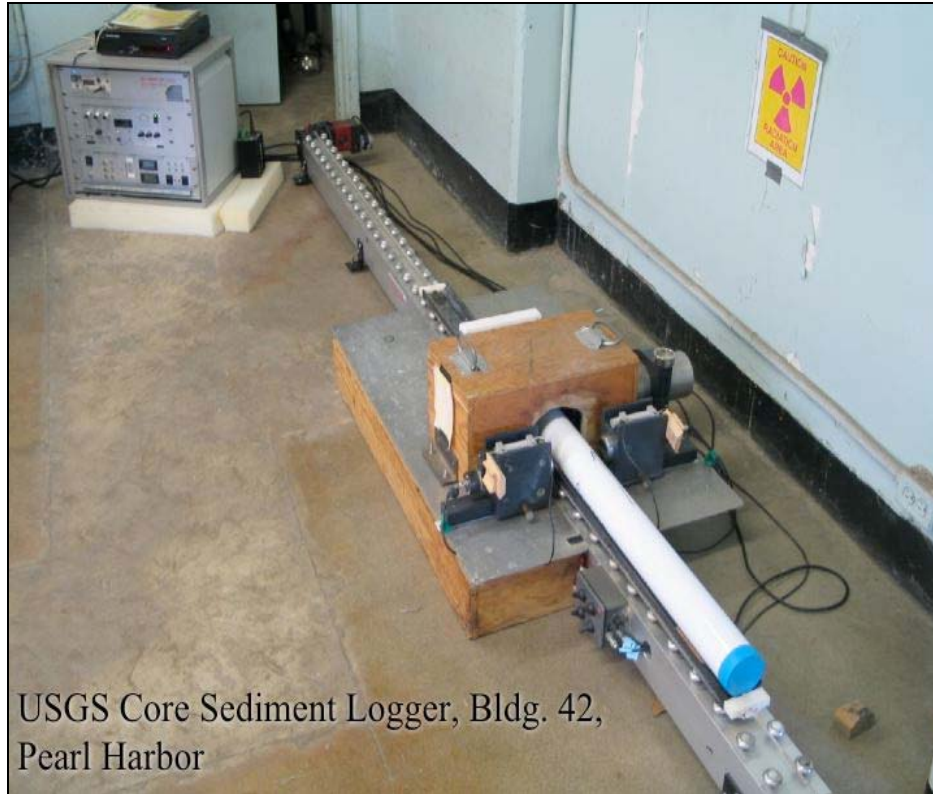
Figure 10.10. USGS core sediment logger set up in Navy Building 42 during the drilling operations. An enameled steel Shelby tube is being scanned (USGS Photo).

At the lab in Building 42, on Ford Island, samples in Shelby tubes were logged for their geotechnical properties on the USGS multi-sensor whole core sediment-logging device, built in Great Britain by Geotek, Ltd. Sealed cylindrical sediment cores were placed horizontally upon a transport sled and moved by a computer-controlled stepper motor through a frame supporting three sensors (Figure 10.10). In a sequence, the logging device measures core diameter and attenuation of gamma rays from a ^{137}Cs source to compute soil wet bulk density. Measurements of density were typically taken at 1cm increments, often within the first hour after the cores are sampled. The transport sled is capable of carrying individual core sections up to 1.5 m in length. Because the core liner is steel, we are able to only characterize the bulk density of the sediment, but not the magnetic susceptibility of p-wave velocity.

The USGS developed an Apple HyperTalk™ driven software program called HYPERSCAN to automate the logger system and support a number of user and system tailored scanning options (Kayen and Phi, 1997). The program includes a suite of subroutines for system

calibration and permits the sensors to be activated or disabled. For example, at Pearl Harbor the cores retained sediment within metal core liner (e.g. Shelby tube samples) that not allow for measurement of magnetic properties: in this case we disabled the magnetic susceptibility sensor to increase the efficiency of the system. Computer automation also allows the technician to maintain some physical distance from the Cesium (^{137}Cs) gamma-ray source. During automated scanning, an un-split sediment core is driven down a track system in user-prescribed increments and the Macintosh computer interrogates sensors. As data enter the computer, the bulk density, and p-wave velocity and magnetic susceptibility if they were logged, are calculated, logged into a matrix data file, and presented in real-time on a 3-plot graphics display window.
