**The Penobscot Expedition Archaeological Project:
Field Investigations 2000 and 2001**

FINAL REPORT

**Prepared by:
Naval Historical Center
Underwater Archaeology Branch
805 Kidder Breese St., SE
Washington Navy Yard, D.C. 20374-5060**

Fall 2003

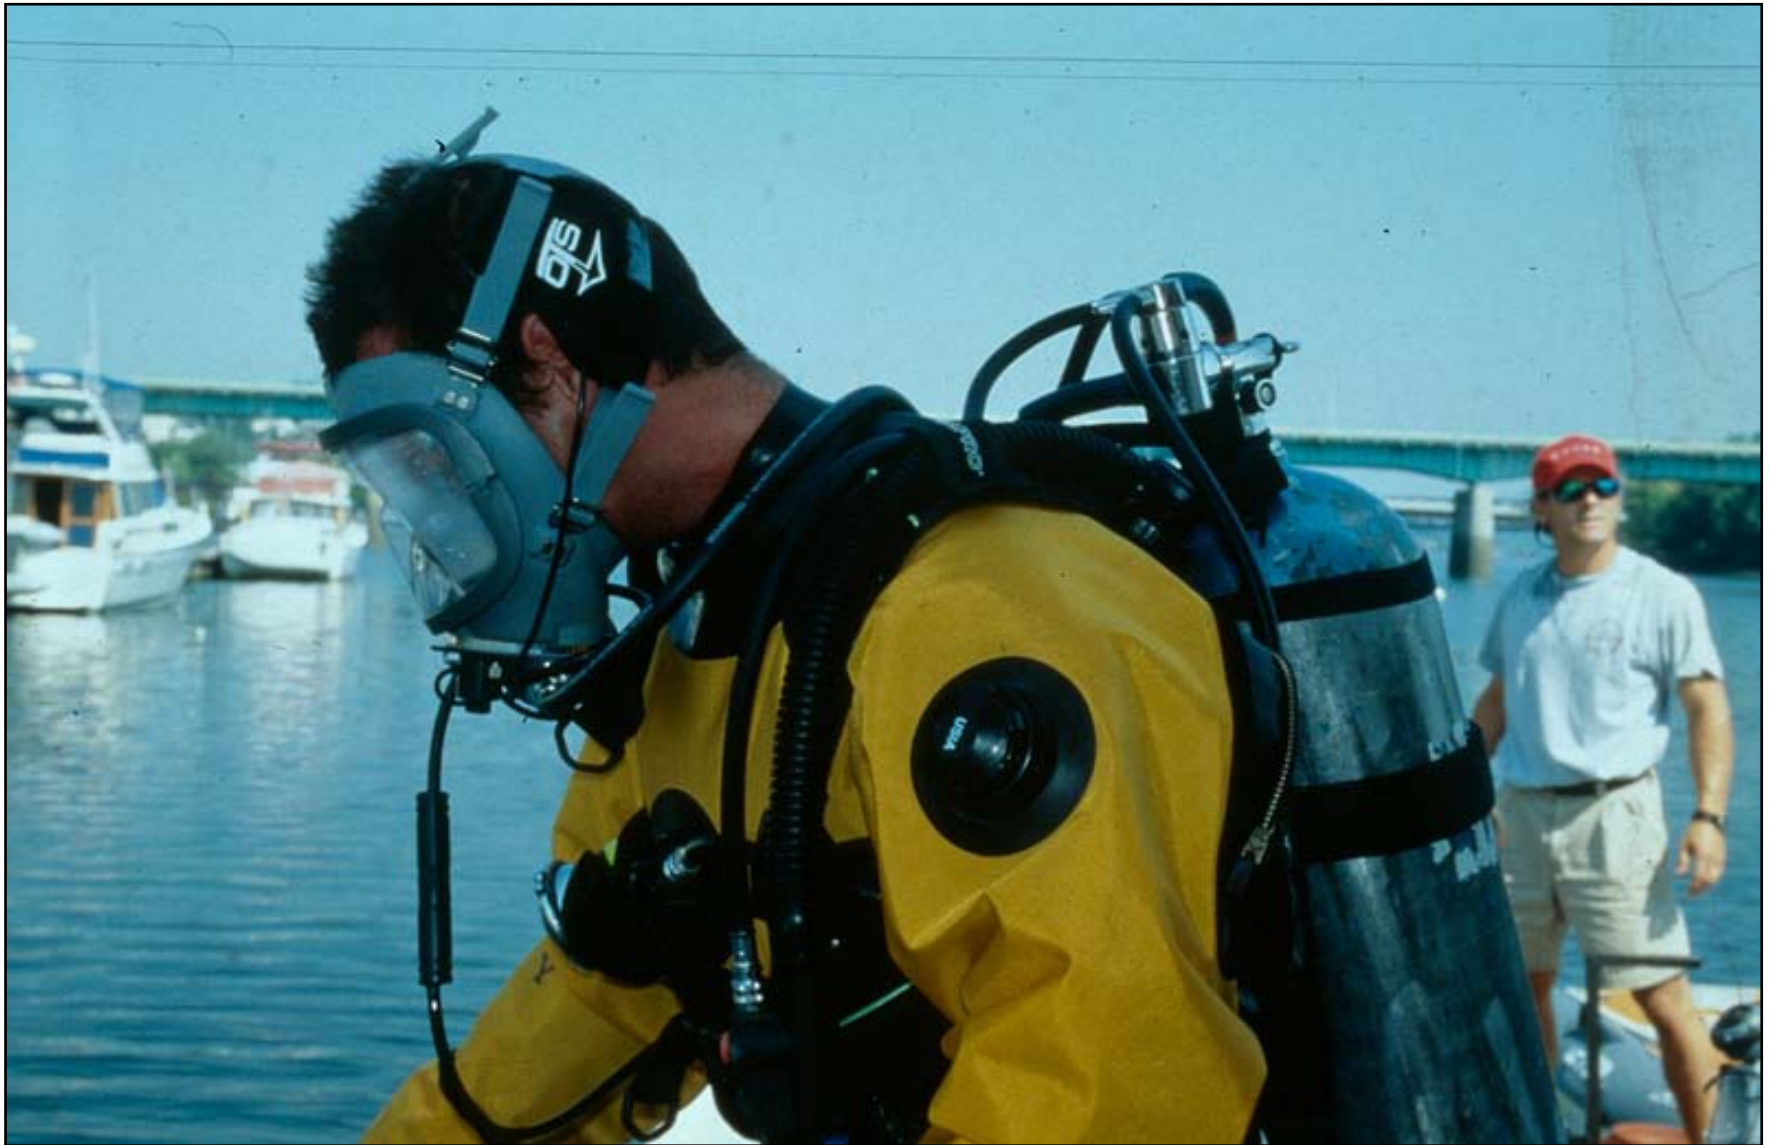
Figure 5. NHC underwater archaeologist preparing to dive on the Shoreline Site. Note the MKII AGA full-face mask and OTS SSB-2010 wireless communications system. Photograph by Barbara Voulgaris.

Although low visibility and moderate to high current was encountered in the Penobscot River during the duration of both projects, the overall dive environment was considered safe enough for NHC staff to operate on Self-Contained Underwater Breathing Apparatus (SCUBA). However, due to a variety of potentially hazardous underwater conditions encountered during both field investigations (i.e. deep water, significant tidal fluctuations, and low light) all divers wore MKII AGA full-face masks with underwater lights and an OTS SSB-2010 wireless communications system (Figure 5). Additionally, divers were required to wear a safety harness attached to a 200-foot nylon safety tether during periods of moderate (approximately one knot) current. Safety protocol stipulated that all diving operations were to cease entirely when the river current exceeded two knots. At all times during dive operations on both field campaigns, a suited stand-by SCUBA diver was prepared to enter the water and render assistance in the event of an emergency. NHC field crew not employed at underwater tasks worked topside and fulfilled a variety of roles, including those of dive supervisor, time and record keeper, communications operator, photographer, and deckhand.

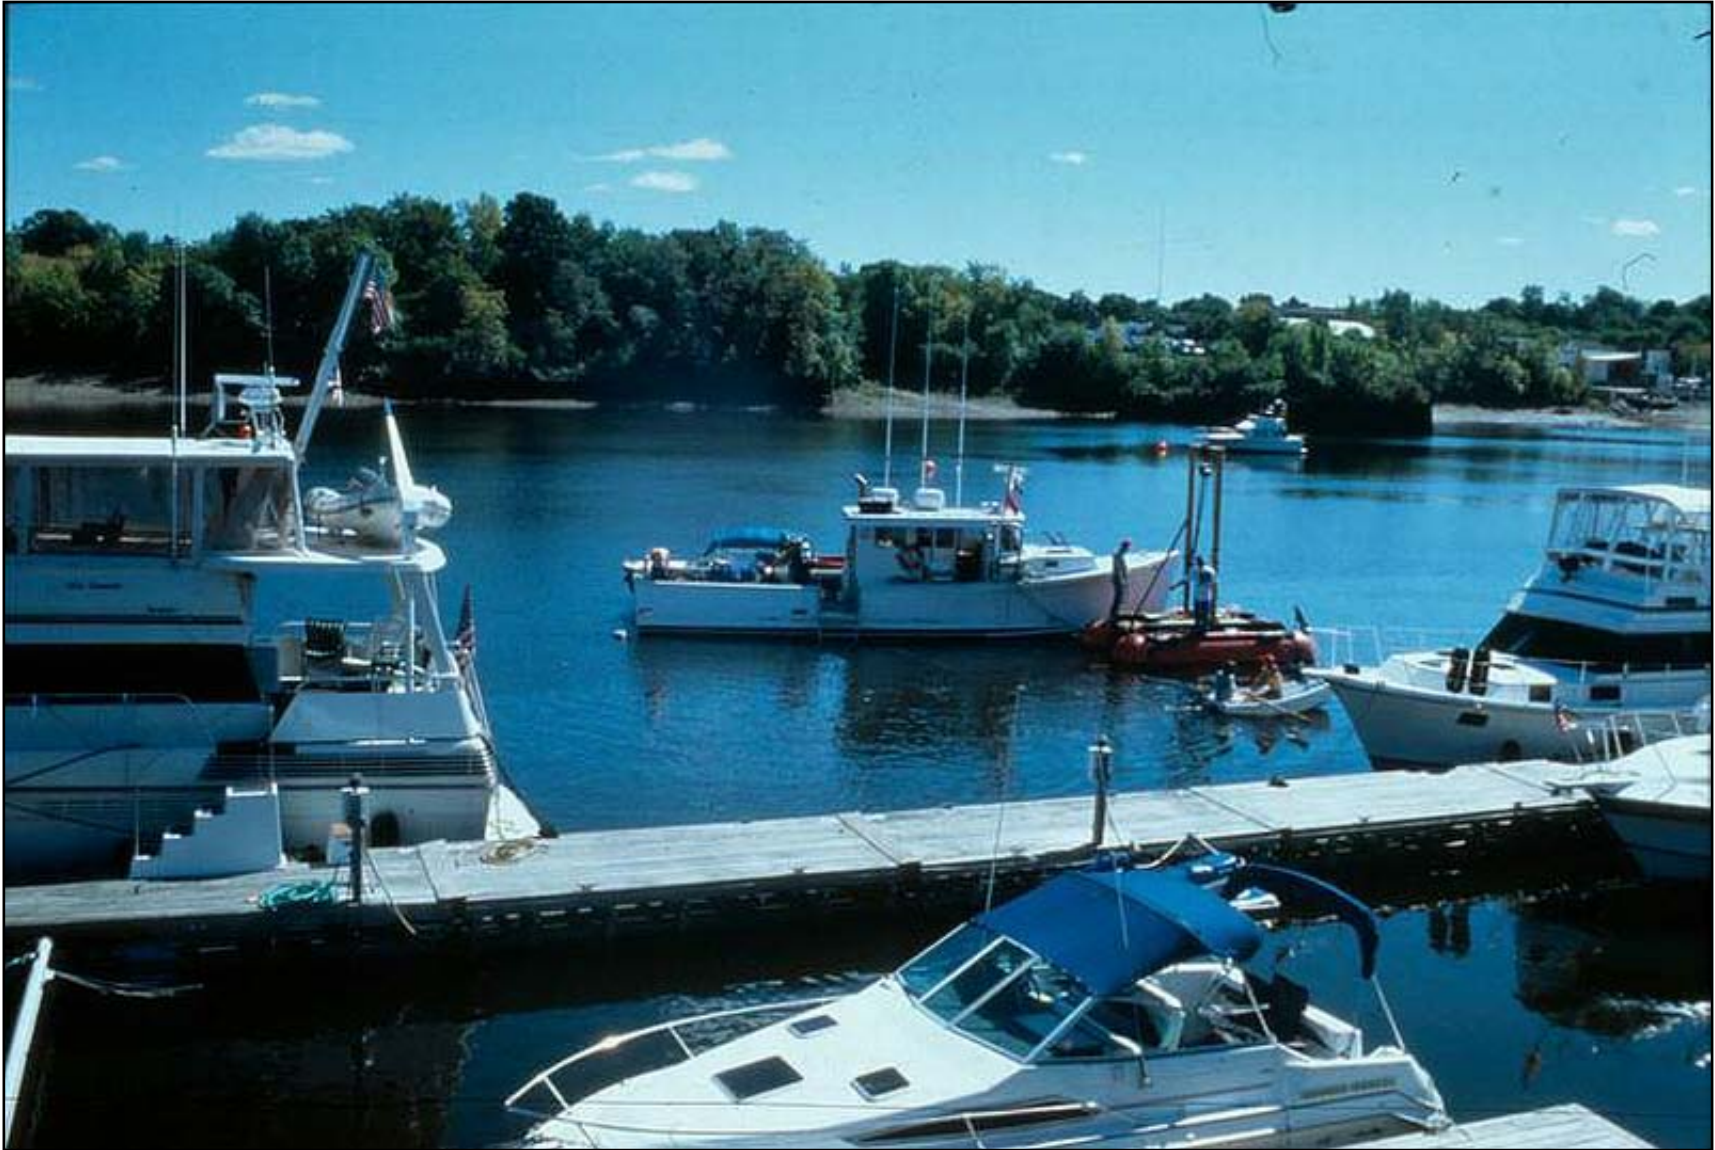
Figure 6. The Darling Marine Center's *R/V Ira C.* (center of photograph) moored over the Shoreline Site in September 2001. Photograph by David Whall.

UA operated from two vessels during the 2000 and 2001 field investigations. The primary dive platform was the *R/V Ira C.*, a 42-foot custom-built Maine lobster boat owned and operated by the University of Maine's Darling Marine Center (Figure 6). In addition to its role as a dive platform, *Ira C.* served a limited capacity as a remote-sensing craft. An 18-foot shallow-draft motorboat owned by Mr. Brent Phinney was employed as the project's primary remote-sensing platform, but was also frequently used as a support vessel to transport divers, equipment, and

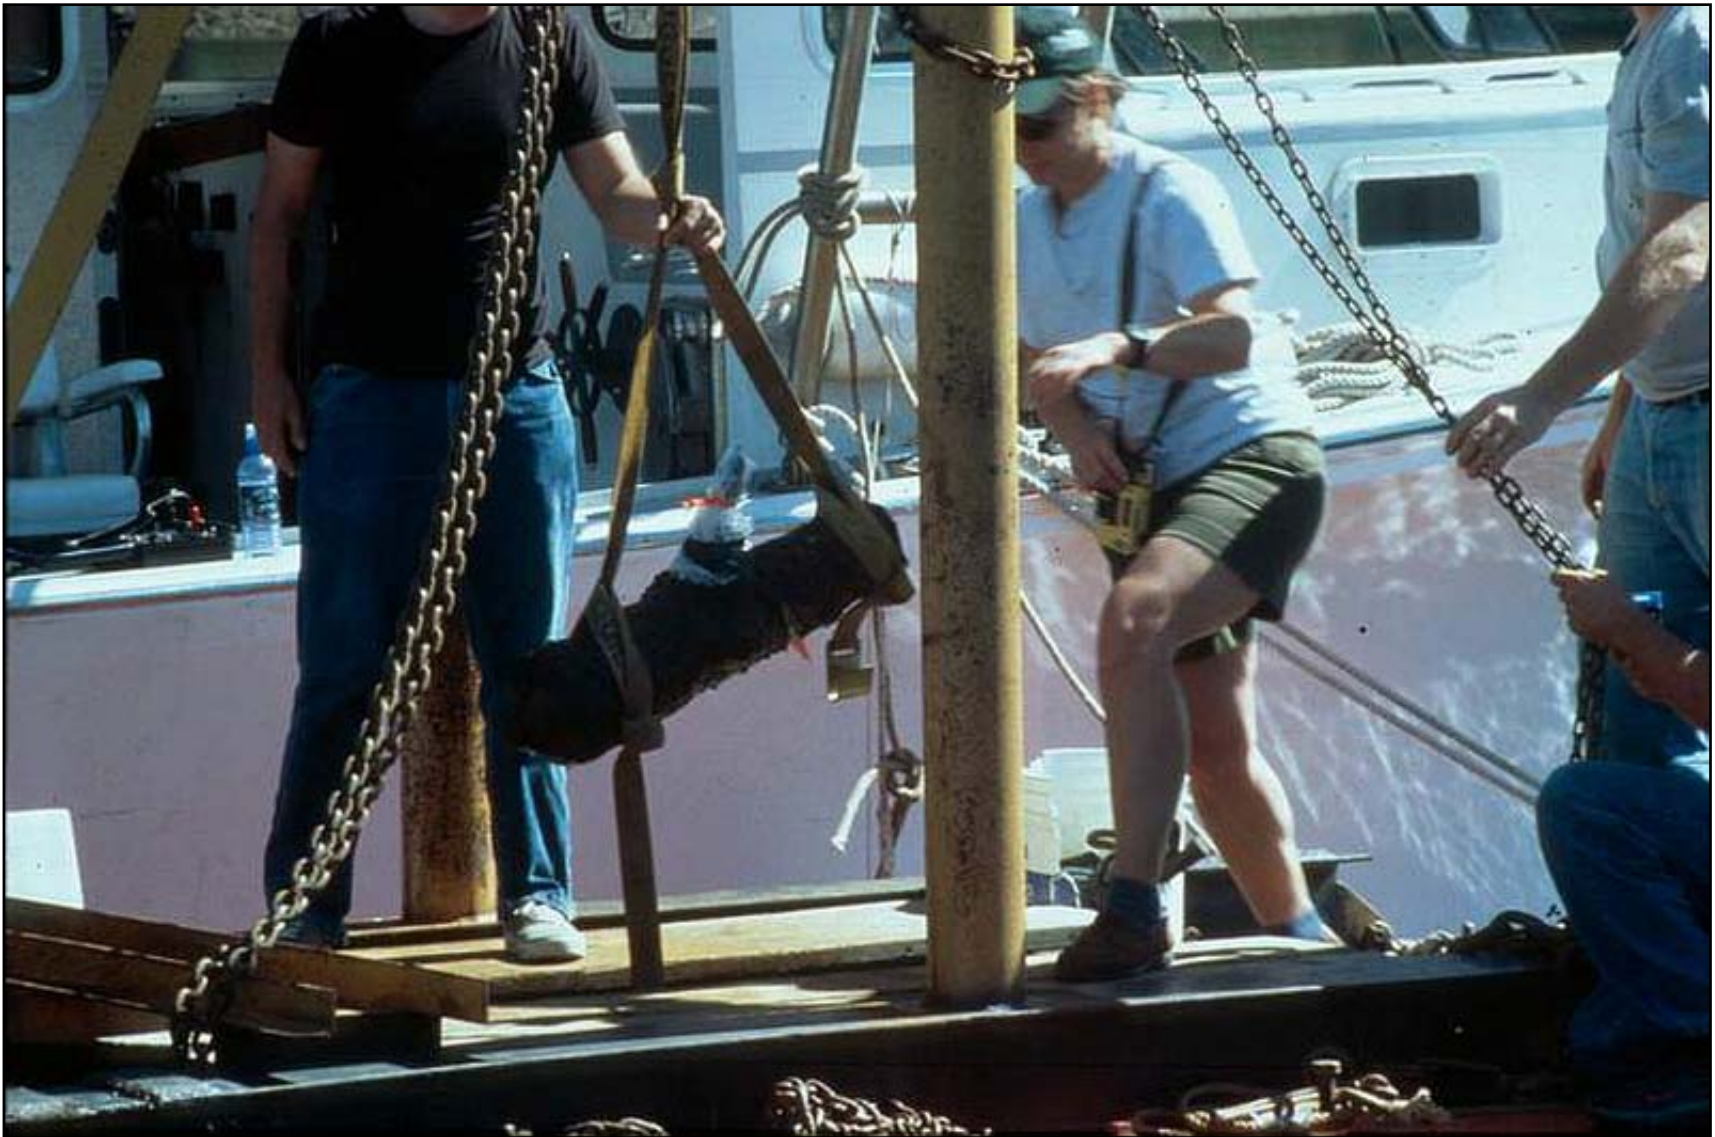
Figure 7. The cast iron swivel gun (PB2-022) being recovered from the Shoreline Site. Photograph by Barbara Voulgaris.

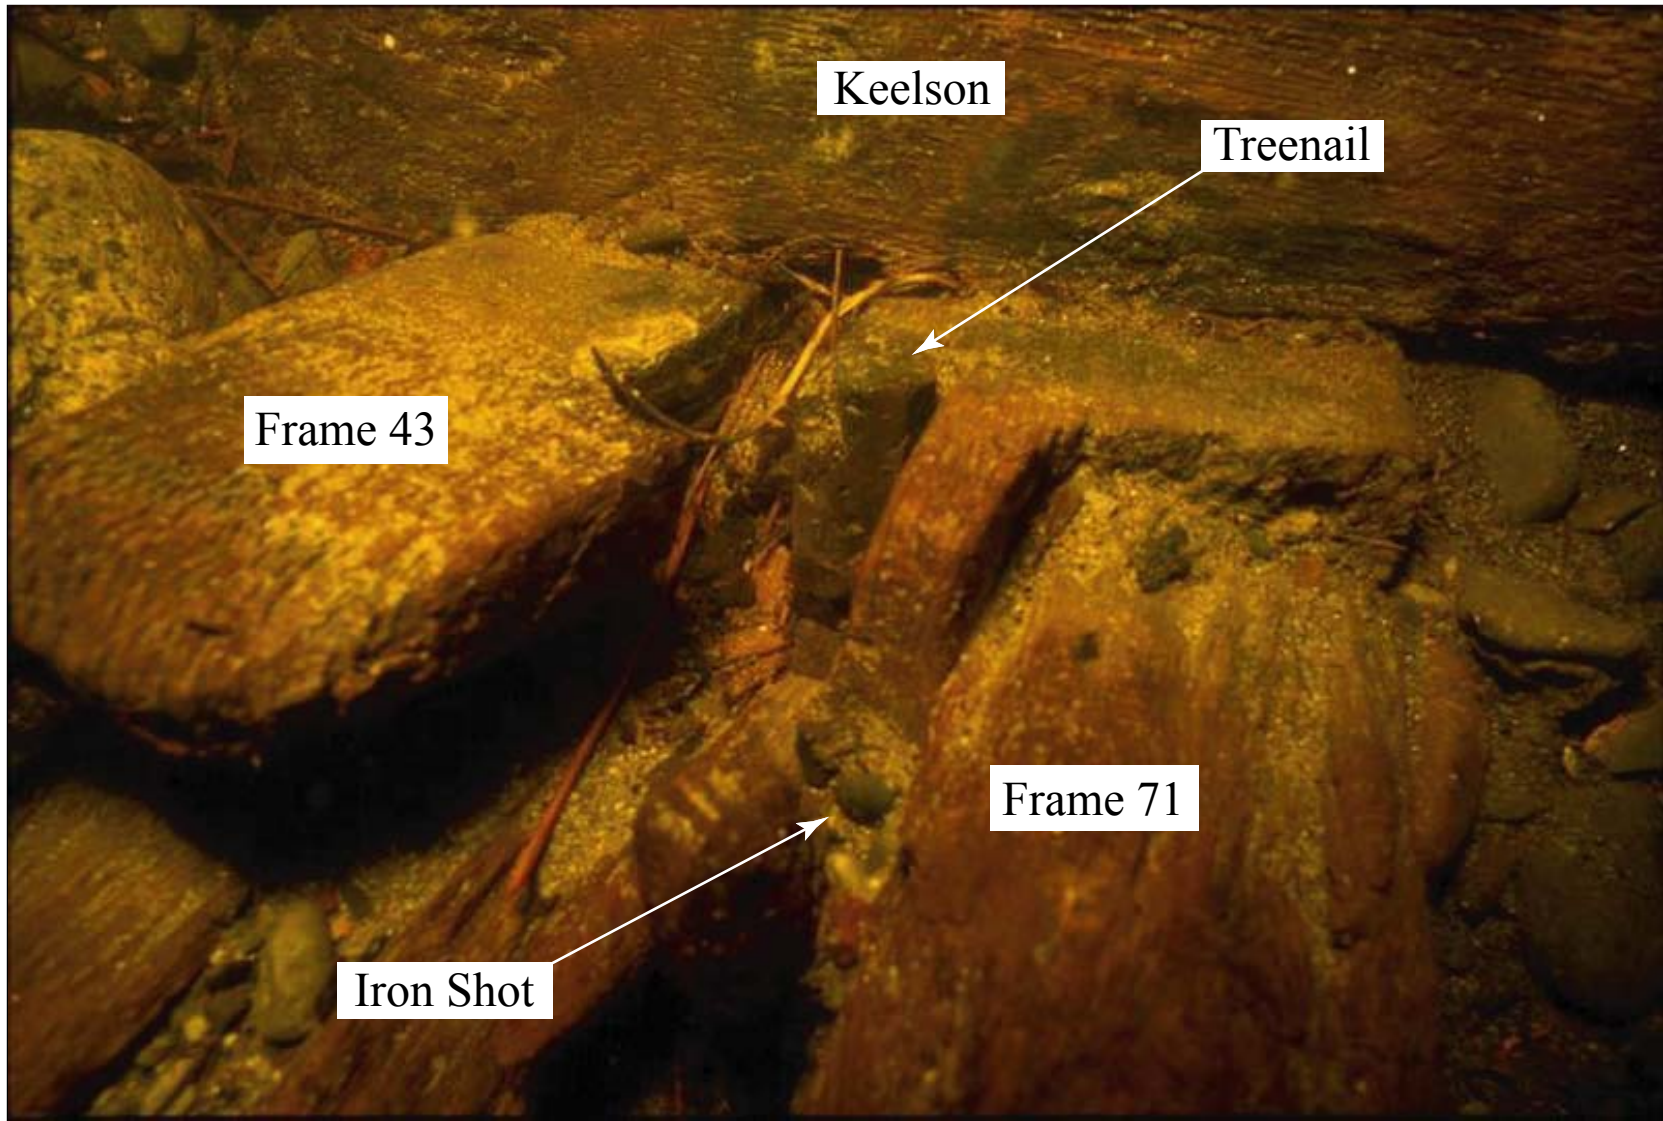
Figure 9. Close-up of starboard frames in Grid T-1, showing point of hull fracture near the wreck's centerline. Note eight-sided wooden treenail and small iron shot associated with Frame 71. Photograph by David Whall.

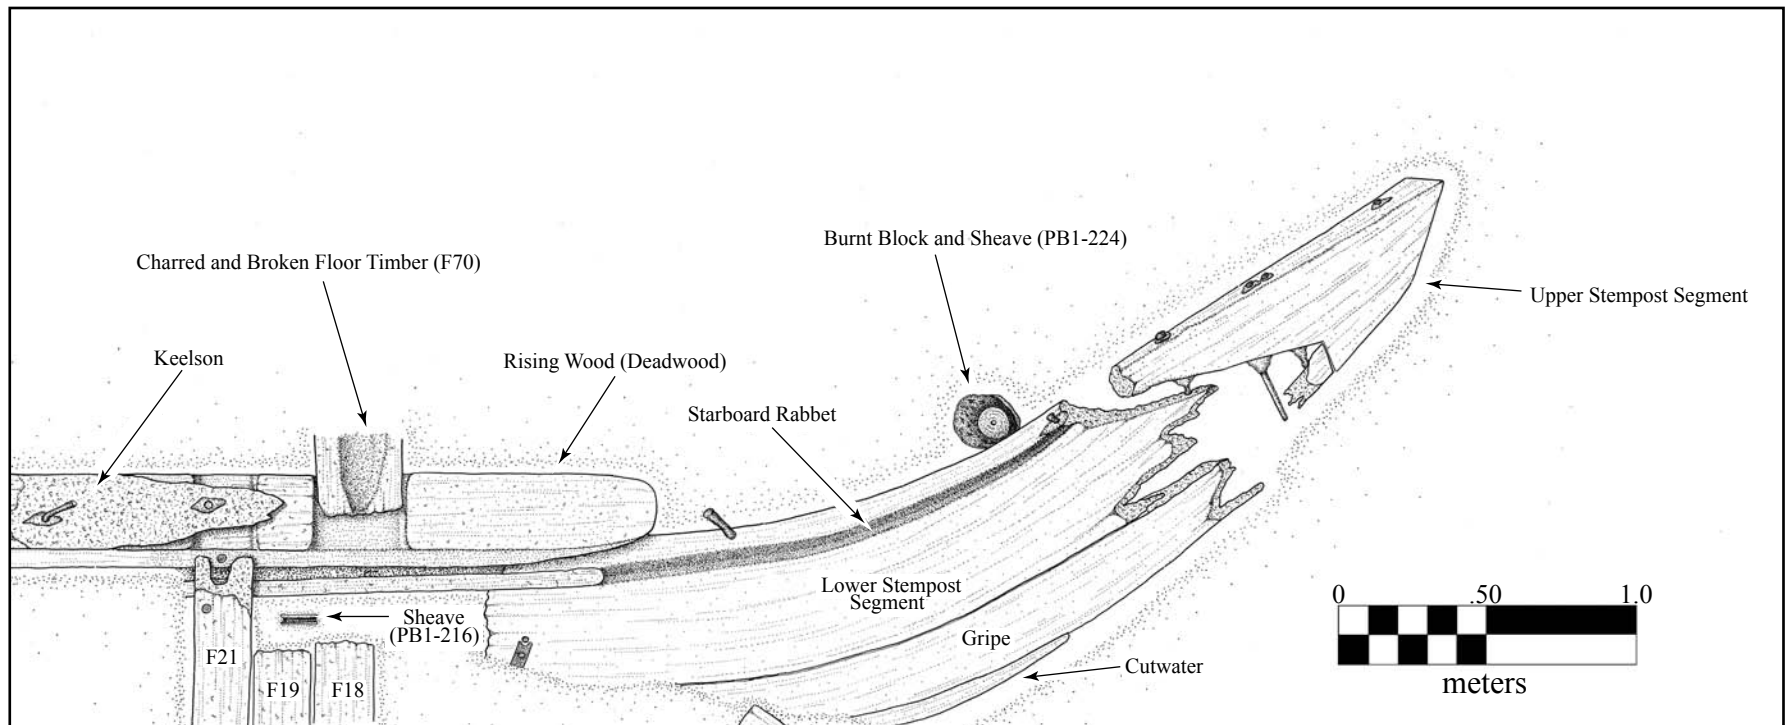
Figure 10. Plan view of Phinney Site stem assembly *in situ*.
Illustration by James W. Hunter, III.

The Phinney Site's stem is an assemblage of timbers that serves as the point of attachment for the two forward sides of the vessel. The remains of the stem were found disarticulated from the rest of the hull, lying on its port side slightly forward and to starboard of the vessel's keelson and bow rising wood (Figure 10). The size and fragmentary condition of the stem assembly precluded any examination of its buried port side; however, a number of detailed measurements were obtained for the side that was exposed. At least three separate elements of the stem are preserved: these include the lowermost portions of the stempost, gripe, and cutwater. In profile, the Phinney Site's stem assembly bears a strong resemblance to that of *Betsey*, a British-built collier brig used as a Royal Navy transport and scuttled during the siege of Yorktown in 1781 (Morris 1991: 97). Similar architectural attributes are also evident in the bow of *Eagle*, a 20-gun American brig built during the final year of the War of 1812 (Steffy 1994: 178-183).

Reconstructed to its approximate original position, the stem would have butted against the chamfered forward edge of the bow rising wood and risen sharply away from the bottom of the vessel (Figure 11). However, the manner in which it was joined to the keel remains unclear. Presumably, if the vessel were built according to mid-eighteenth century standards of British (or British influenced) ship construction, its stem assembly would have been fayed to the forward

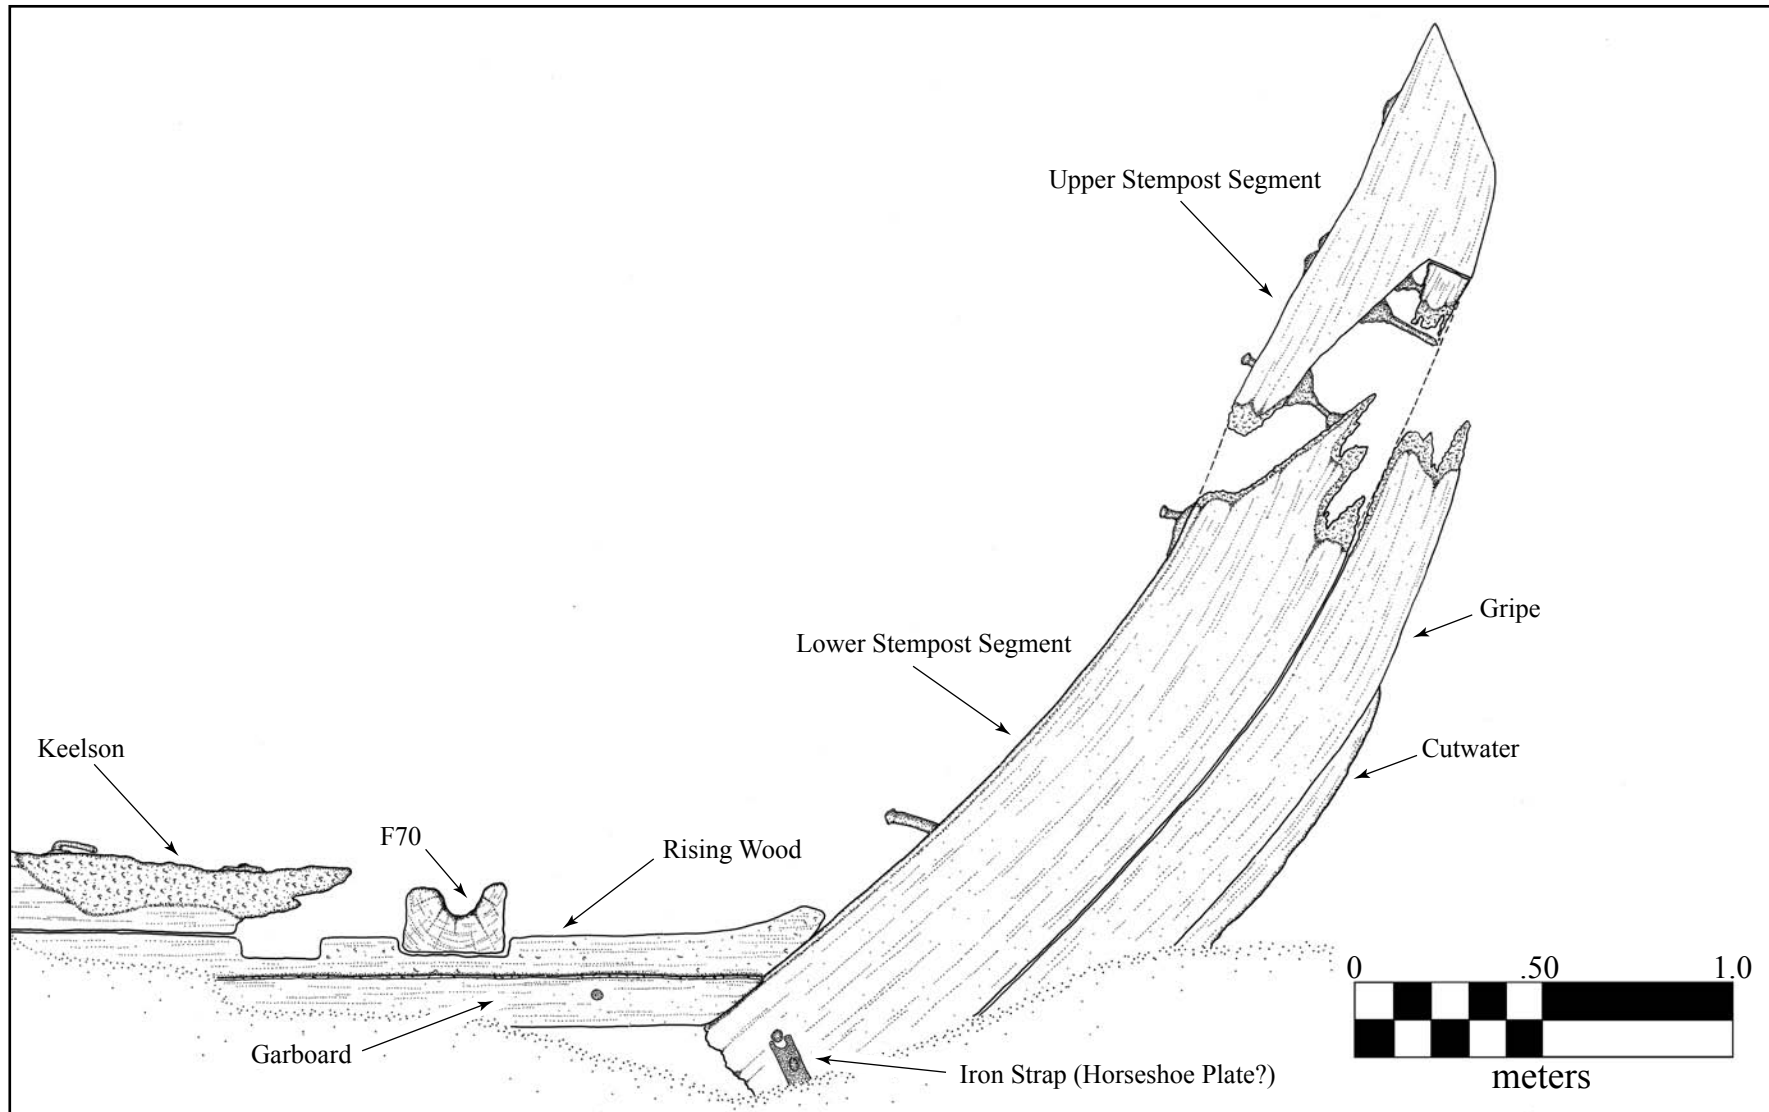
Figure 11. Reconstruction of Phinney Site stem assembly, profile view. Illustration by James W. Hunter, III.

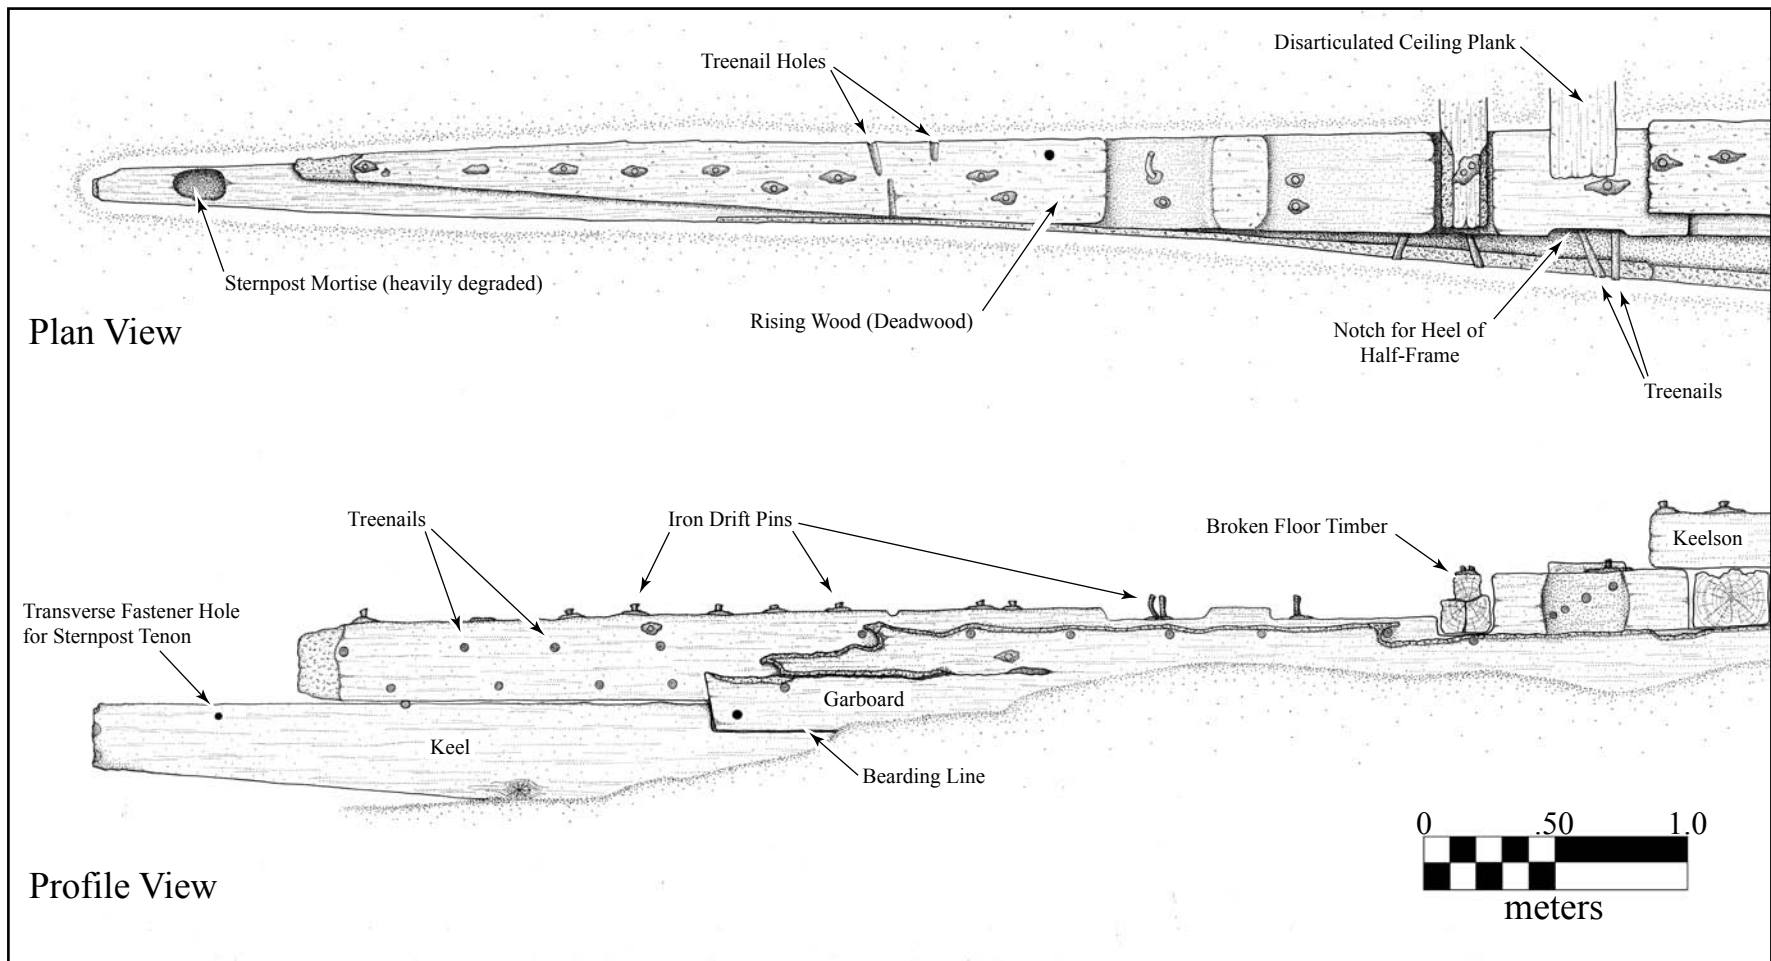
Figure 12. Plan and profile views of Phinney Site stern assembly *in situ*. Illustrations by James W. Hunter, III.

A series of nine iron drift pins begins 32 centimeters abaft the last stern deadwood notch and continues aft for the remainder of the timber. All nine drift pins measure 2 centimeters in diameter and are spaced between 25 and 30 centimeters apart along the approximate centerline of the deadwood. The purpose of these fasteners remains unclear; however, their arrangement and frequency suggests that they may have been used to fasten additional deadwood or a stern knee to the rising wood. Conversely, they may have bolted a series of gradually narrowing and rising floors or half-floors to the vessel's centerline. Eight 3-centimeter diameter treenails are arranged transversely across the rising wood in two rows, slightly abaft the hood end of the vessel's

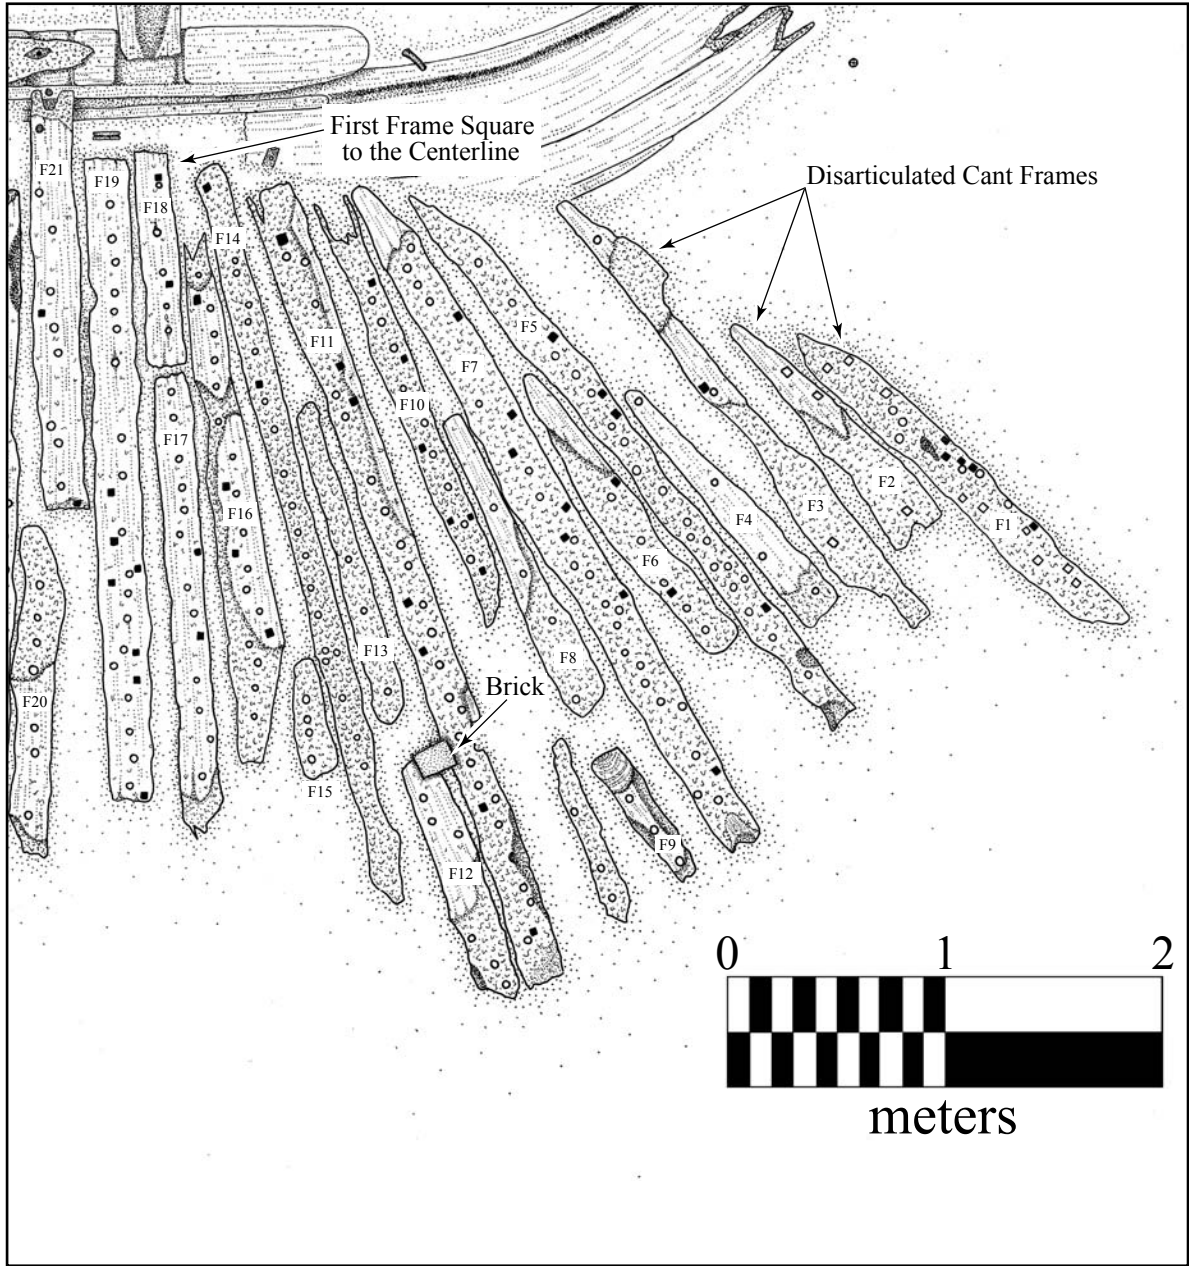
Figure 13. Phinney Site cant frame assembly *in situ*, showing cant frames, filler frames and first frame square to the centerline. Illustration by James W. Hunter, III.

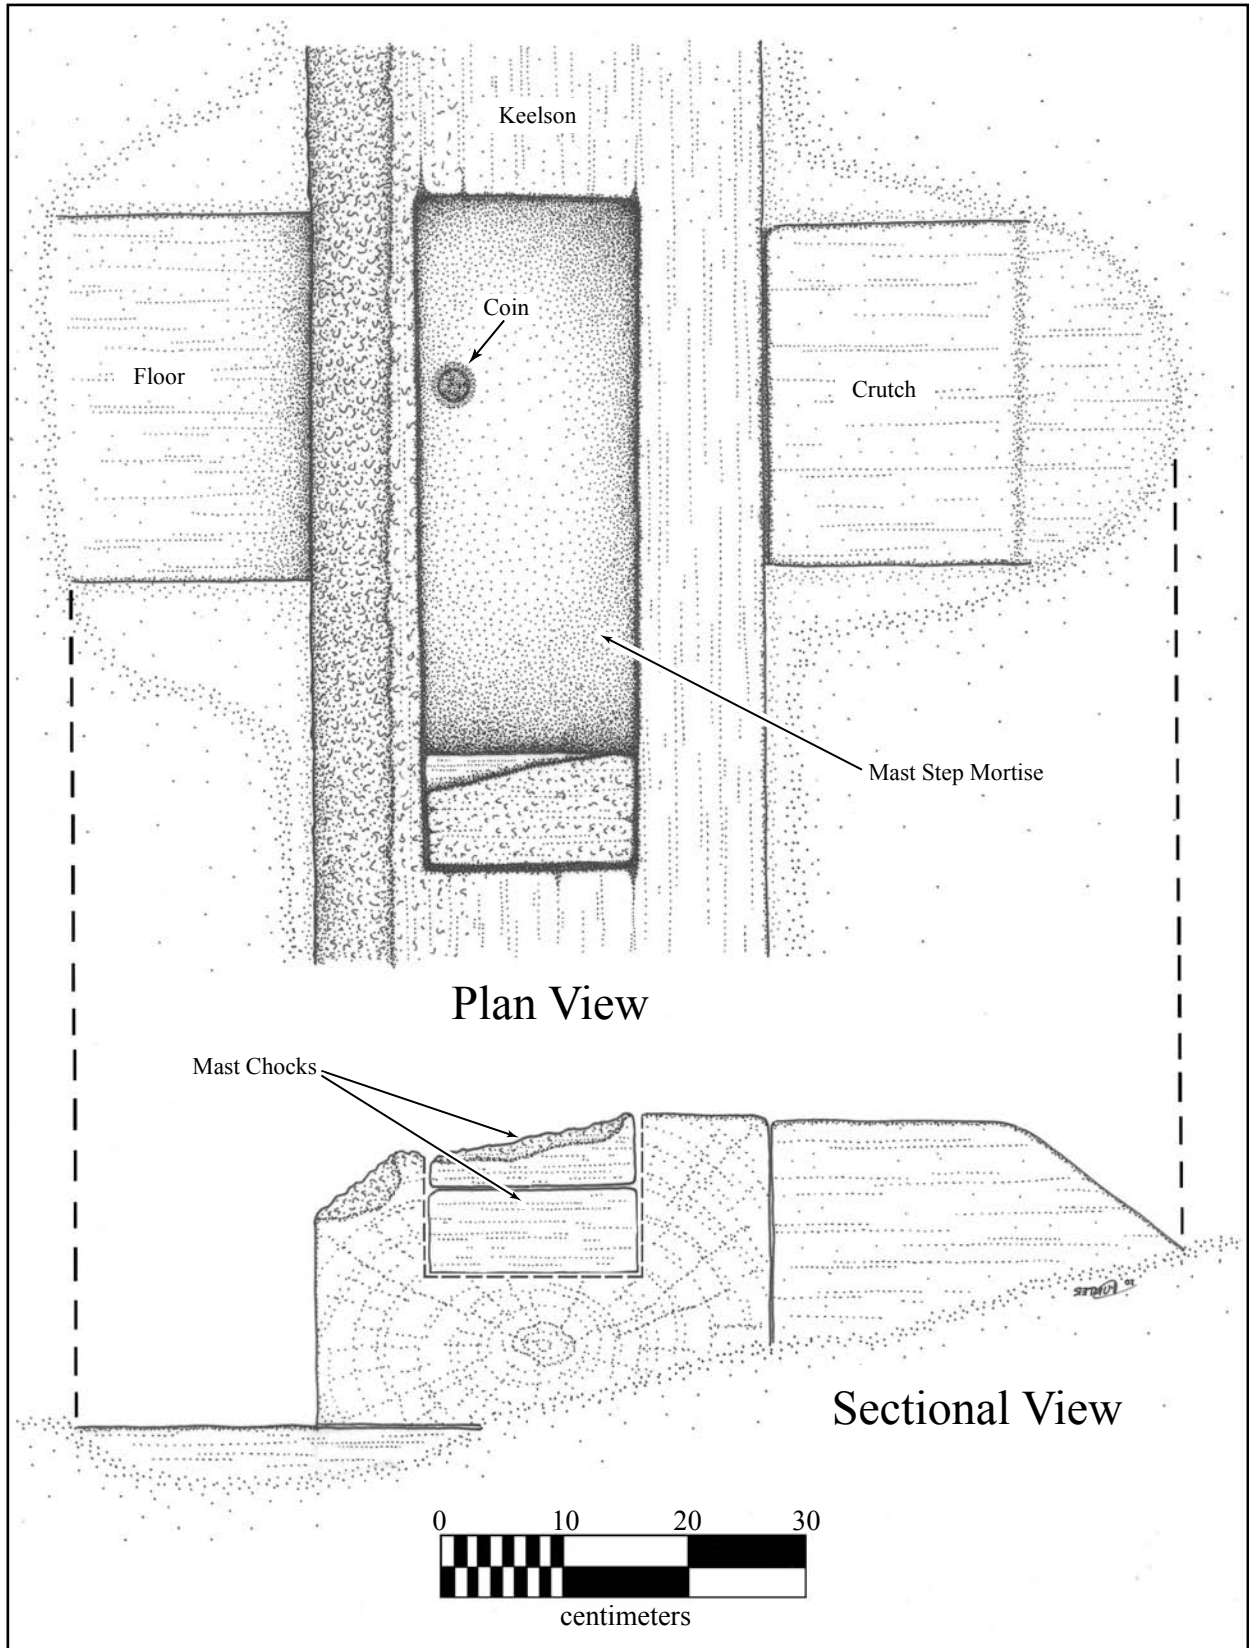
Figure 14. Plan and sectional views, Phinney Site mainmast step. Illustrations by James W. Hunter, III.

Located approximately 12.2 meters abaft the foremost preserved extremity of the keel is the vessel's mainmast step. The mast step assembly is positioned aft of amidships and would have seated the tenoned heel of the mainmast. It consists of a simple mortise cut directly into the keelson, two mast chocks, and what appears to be an angled buttress or crutch (Figure 14). Similar mast step assemblies were discovered during the excavations of *Defence*, *Betsey*, the

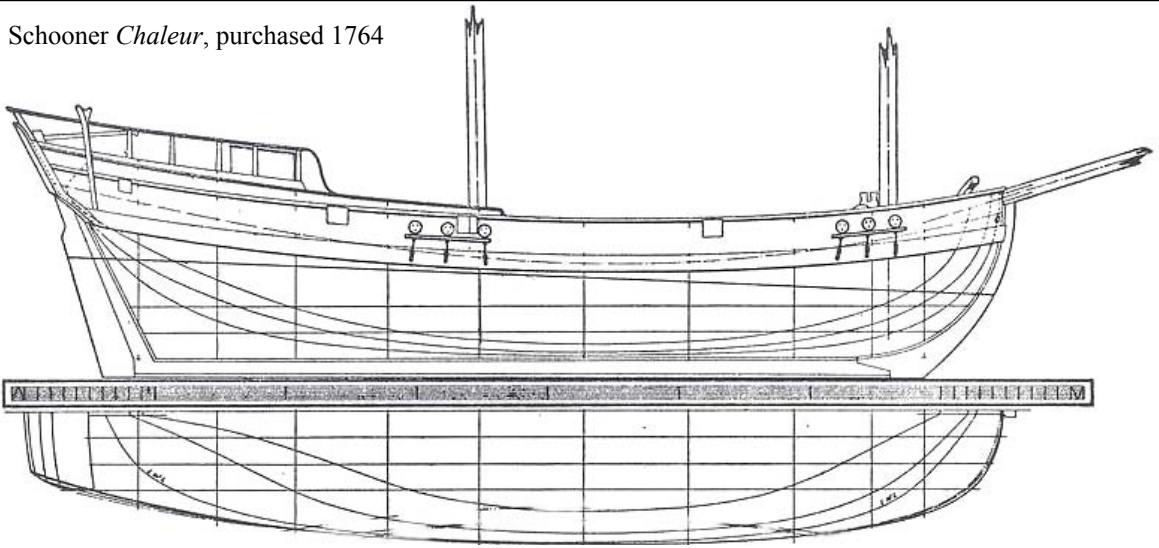
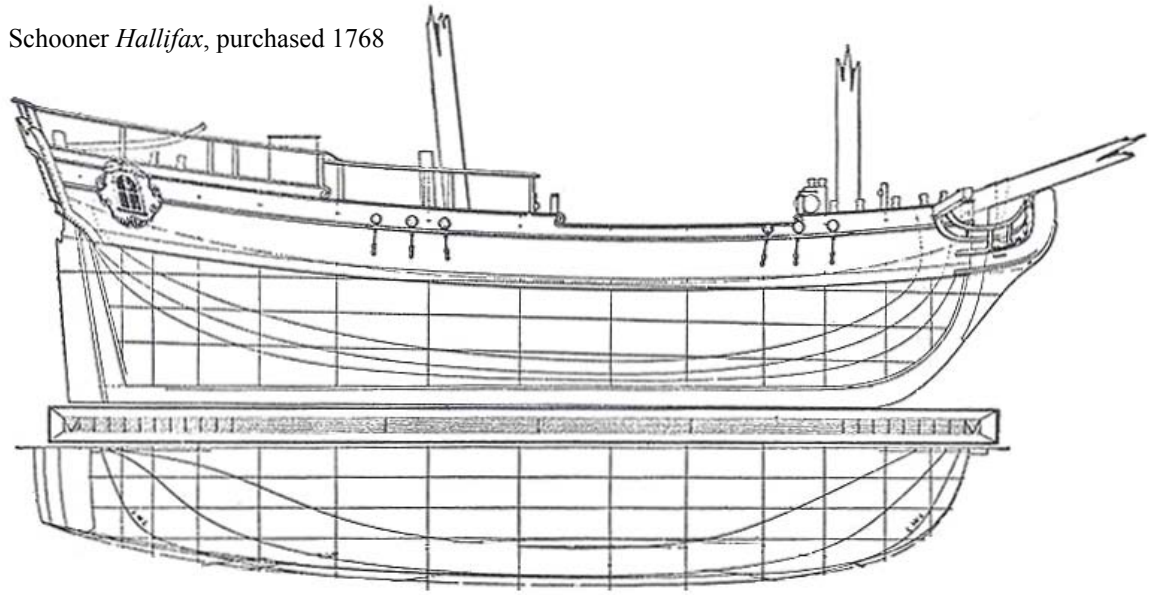
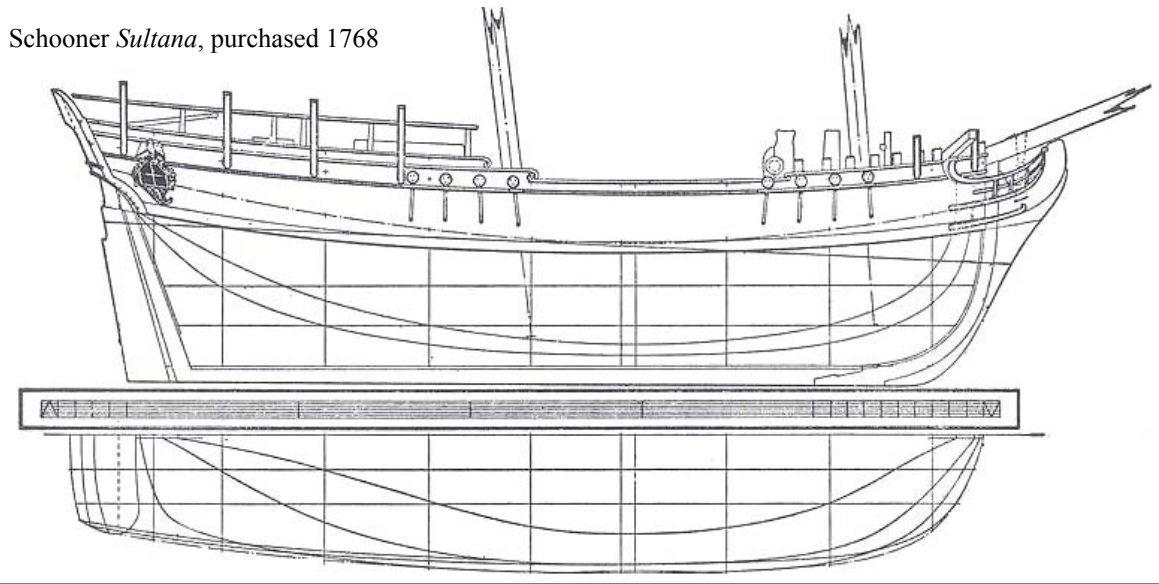
Schooner *Chaleur*, purchased 1764

Schooner *Hallifax*, purchased 1768

Schooner *Sultana*, purchased 1768

Figure 15. Three examples of American-built, twin-masted vessels purchased by the British Royal Navy in the years immediately prior to the American Revolution. Illustrations adapted from Howard I. Chapelle, *The History of American Sailing Ships*, Bonanza Books, New York (1935), pp. 35, 39, 42.

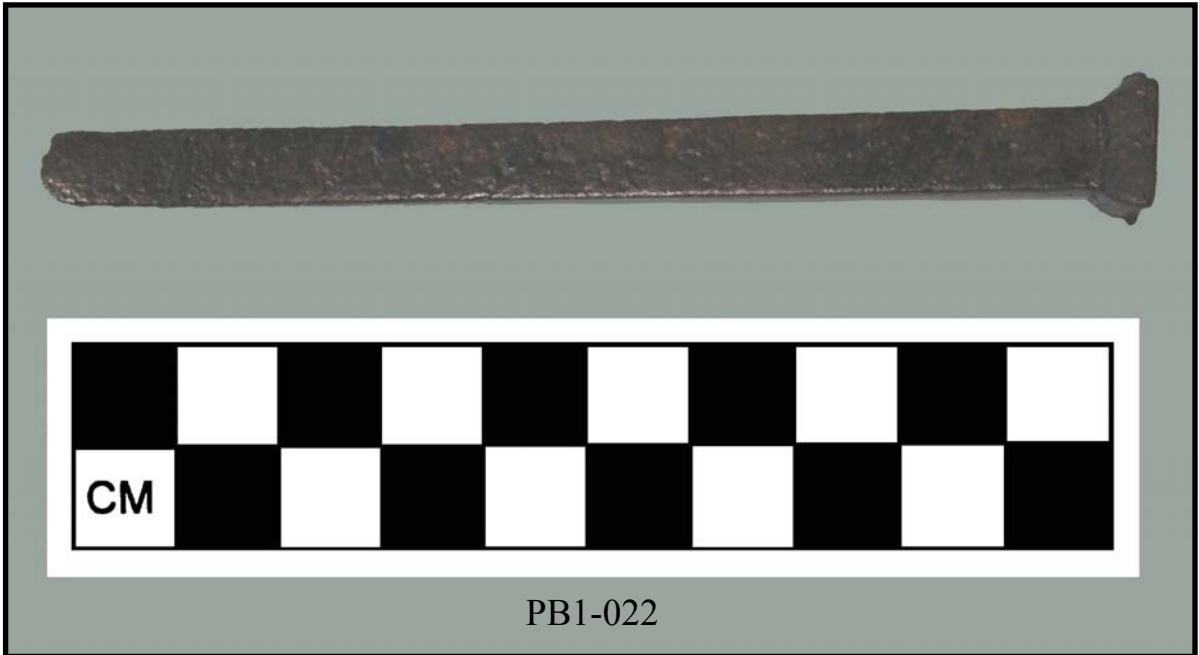
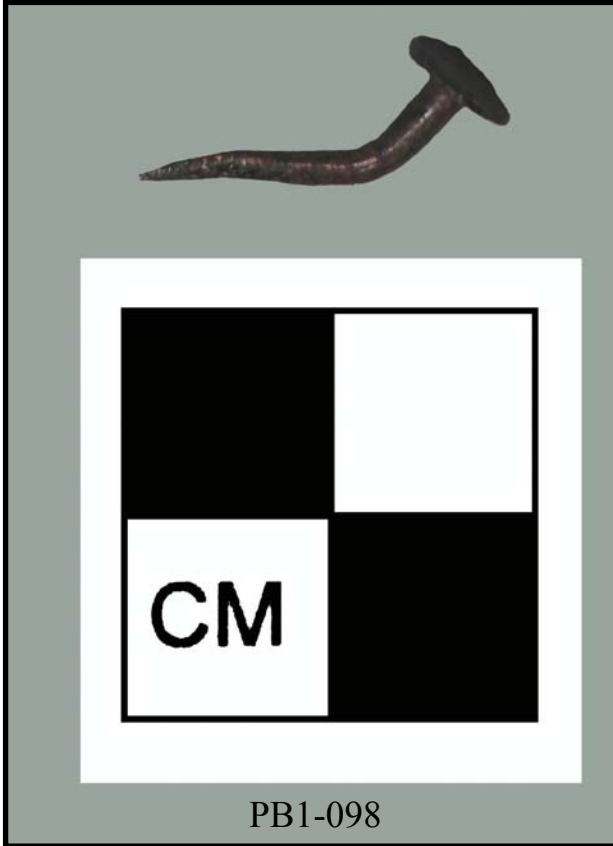
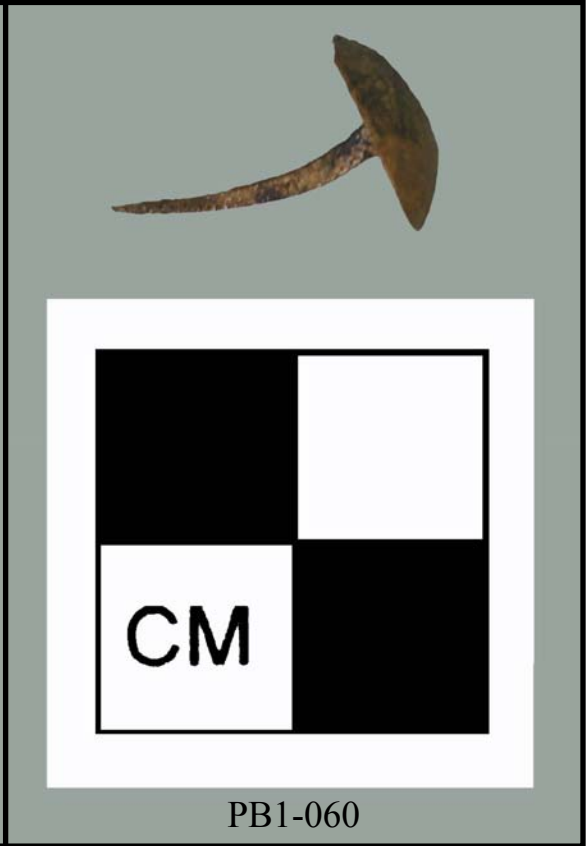
Figure 16. Copper fasteners recovered from the Phinney Site: *top*; spike, *left*; utility tack, *right*; dome-headed furniture tack. Photographs by James W. Hunter, III.

Although copper-alloy spikes were not used in colonial shipbuilding with as much frequency as those produced from iron, the presence of one on the wreck is not surprising. During the
