**The Penobscot Expedition Archaeological Project:
Field Investigations 2000 and 2001**

FINAL REPORT

**Prepared by:
Naval Historical Center
Underwater Archaeology Branch
805 Kidder Breese St., SE
Washington Navy Yard, D.C. 20374-5060**

Fall 2003

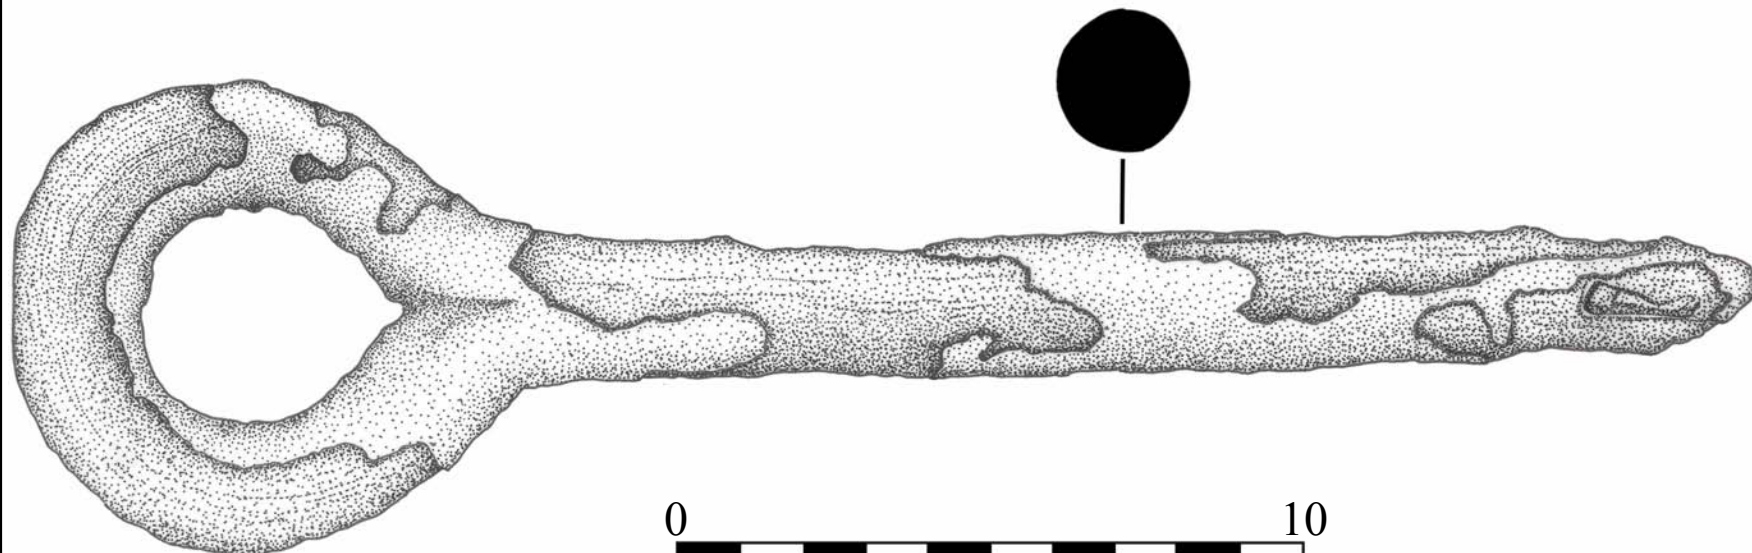
Figure 17. Wrought-iron eyebolt (PB1-081) recovered from Grid T-1. Illustration by James W. Hunter, III.

A concreted wrought iron eyebolt (PB1-081) was recovered from Grid T-1 during the 2000 field investigations (Figure 17). Eyebolts—essentially bolts with a circular opening at one end—were driven into a vessel's hull at various locations and served as securing points for lines and various tackle hooks (Dodds and Moore 1984: 48; Pearson and Hoffman 1995: 136-137 and Steffy 1994: 271). Eyebolts were also frequently used in conjunction with iron carriage rings and installed on shipboard gun carriages to help maneuver or secure them on a vessel's deck. An excellent example of the aforementioned was recovered from the Continental gondola *Philadelphia* in 1935 (Bratten 2002: 117). The eyebolt recovered from the Phinney Site is round in cross-section, has a maximum preserved length of 28.2 centimeters, a shaft diameter of 2.4 centimeters, and an eye that measures 7.7 centimeters across. Its provenience, located among a large cluster of shot in Grid T-1, suggests that it may have been used in association with a gun carriage or gun station tackle. Conversely, it may have been installed in the upper works of the vessel and deposited in the hull during its destruction.

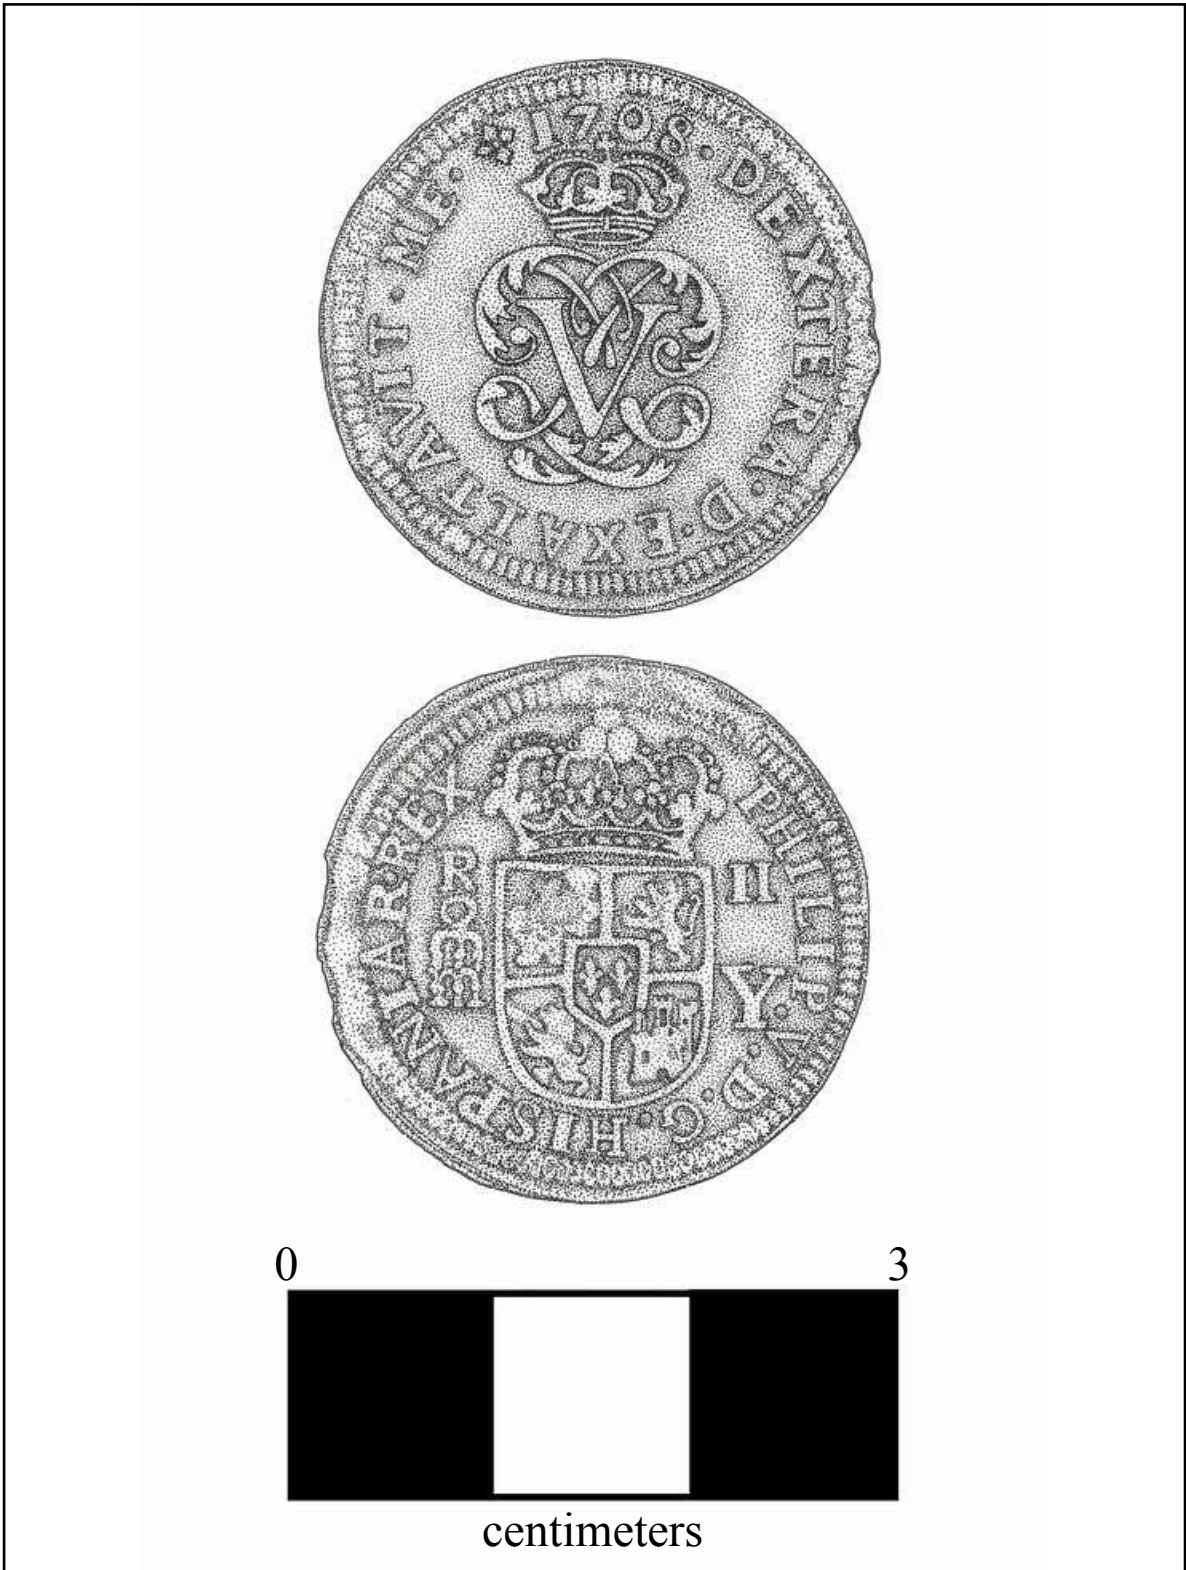
Figure 18. Spanish 2-Reale coin recovered from the Phinney Site's mainmast step: *top*; obverse side, *bottom*; reverse side. Illustration by James W. Hunter, III.

A concreted silver coin (PB1-150) was recovered from the base of the Phinney Site's mainmast step during the 2000 field investigations (Figure 18). According to Richard Doty (personal communication) it is a 2-*Reale* piece produced at the Royal Mint Mill in Segovia, Spain during the reign of Philip V (1700-1724). It has a maximum diameter of 2.8 centimeters, maximum thickness of 2 millimeters, and weighs 4.5 grams. The coin is ornately decorated and exhibits a variety of numismatic markings. Along the periphery of the obverse (front) face is a legend showing the year the coin was produced and the phrase **DEXTERA*D*EXALTAVIT*ME**

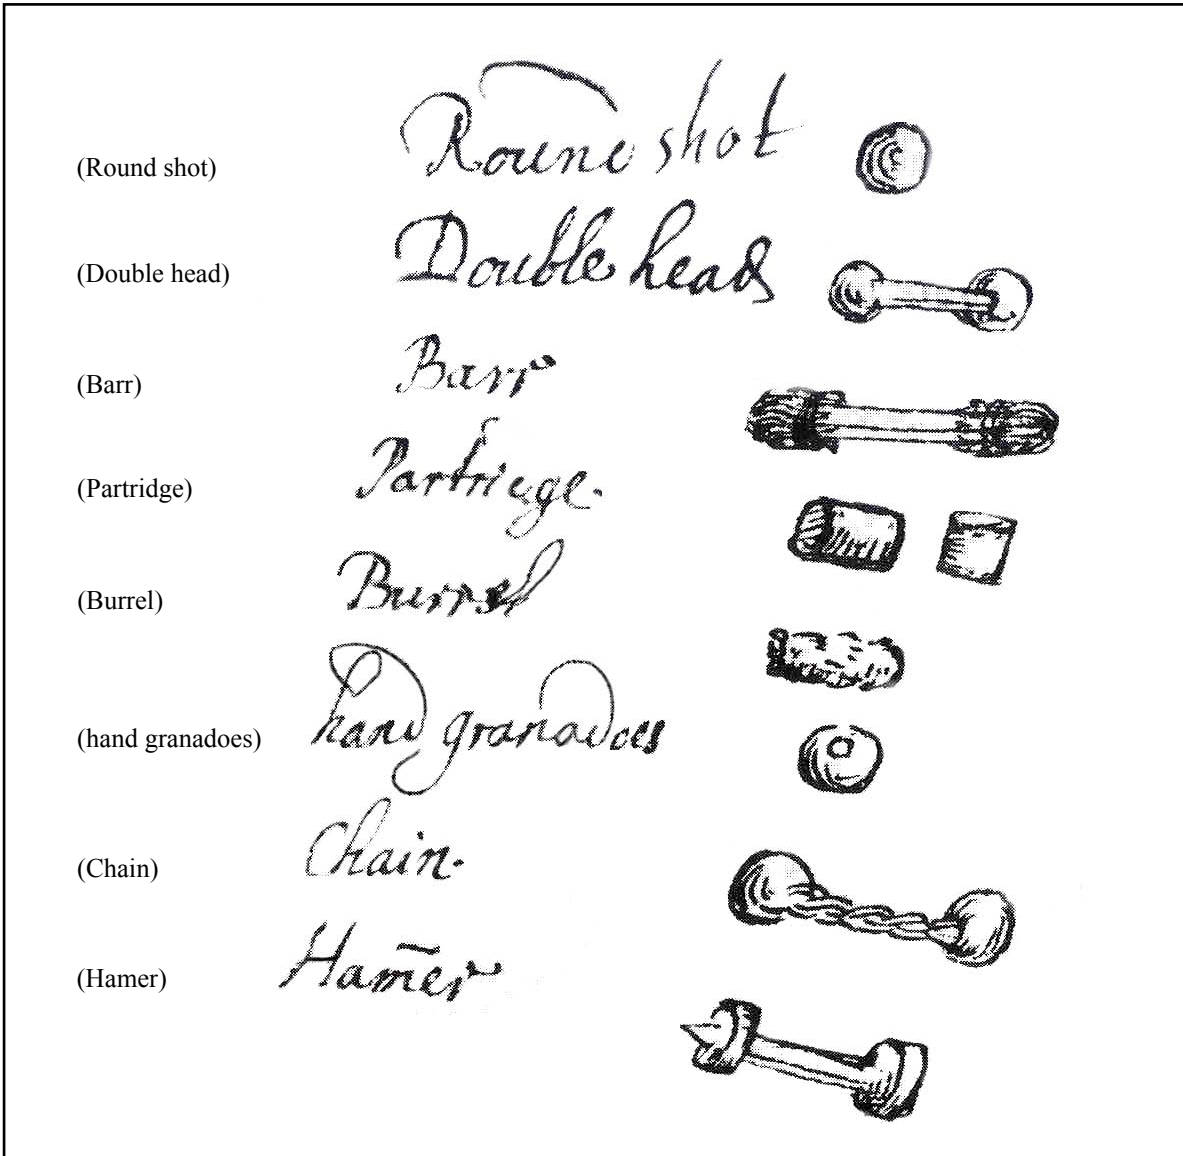
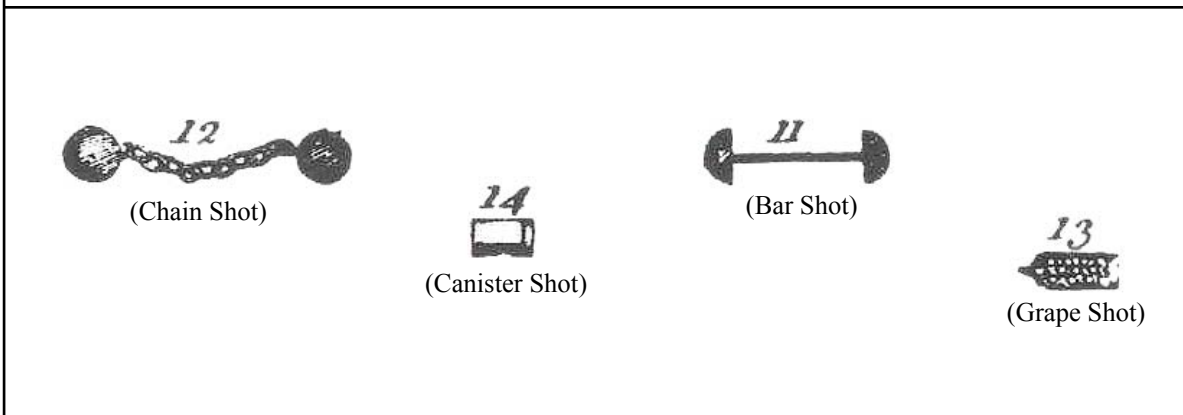
Figure 19. Contemporary illustrations from late-seventeenth century (top) and mid-eighteenth century (bottom) naval treatises, showing the types of shot used aboard armed vessels. Illustrations adapted from Brian Lavery, *The Arming and Fitting of English Ships of War, 1600-1815*, Naval Institute Press, Annapolis, Maryland (1987), p. 137.

ownership placed upon British ordnance and government stores that resembles a crude arrowhead. The smallest examples (2.5 to 3.5 centimeters in diameter) best correspond to sizes specified in British artillery treatises for rounds of grape, case, or canister shot (Cloves 1898: 11; Mountaine 1781: 72; Petersen 1965: 83-83; Peterson 1969: 42 and Wilkinson-Latham 1973: 28-32). Grape shot consists of a group of iron balls packed around a central stool (a small wooden disc with a vertical wooden peg at its center) and held in place with a canvas cover and lashings. By contrast, canister and case shot incorporate the use of a sheet metal cylinder filled with numerous small lead or iron shot (Figure 19). Grape, canister, and case ammunition were intended to break apart and scatter when fired, clearing enemy vessels of sails, rigging, and personnel. In addition to the aforementioned, the smaller varieties of shot may also have been used as single projectiles for a small caliber swivel gun (Carauna 1997: 222-228; Ford and Switzer 1982: 54-55; Lavery 1987: 136-137; Peterson 1969: 27 and Wilkinson-Latham 1973: 29-32).

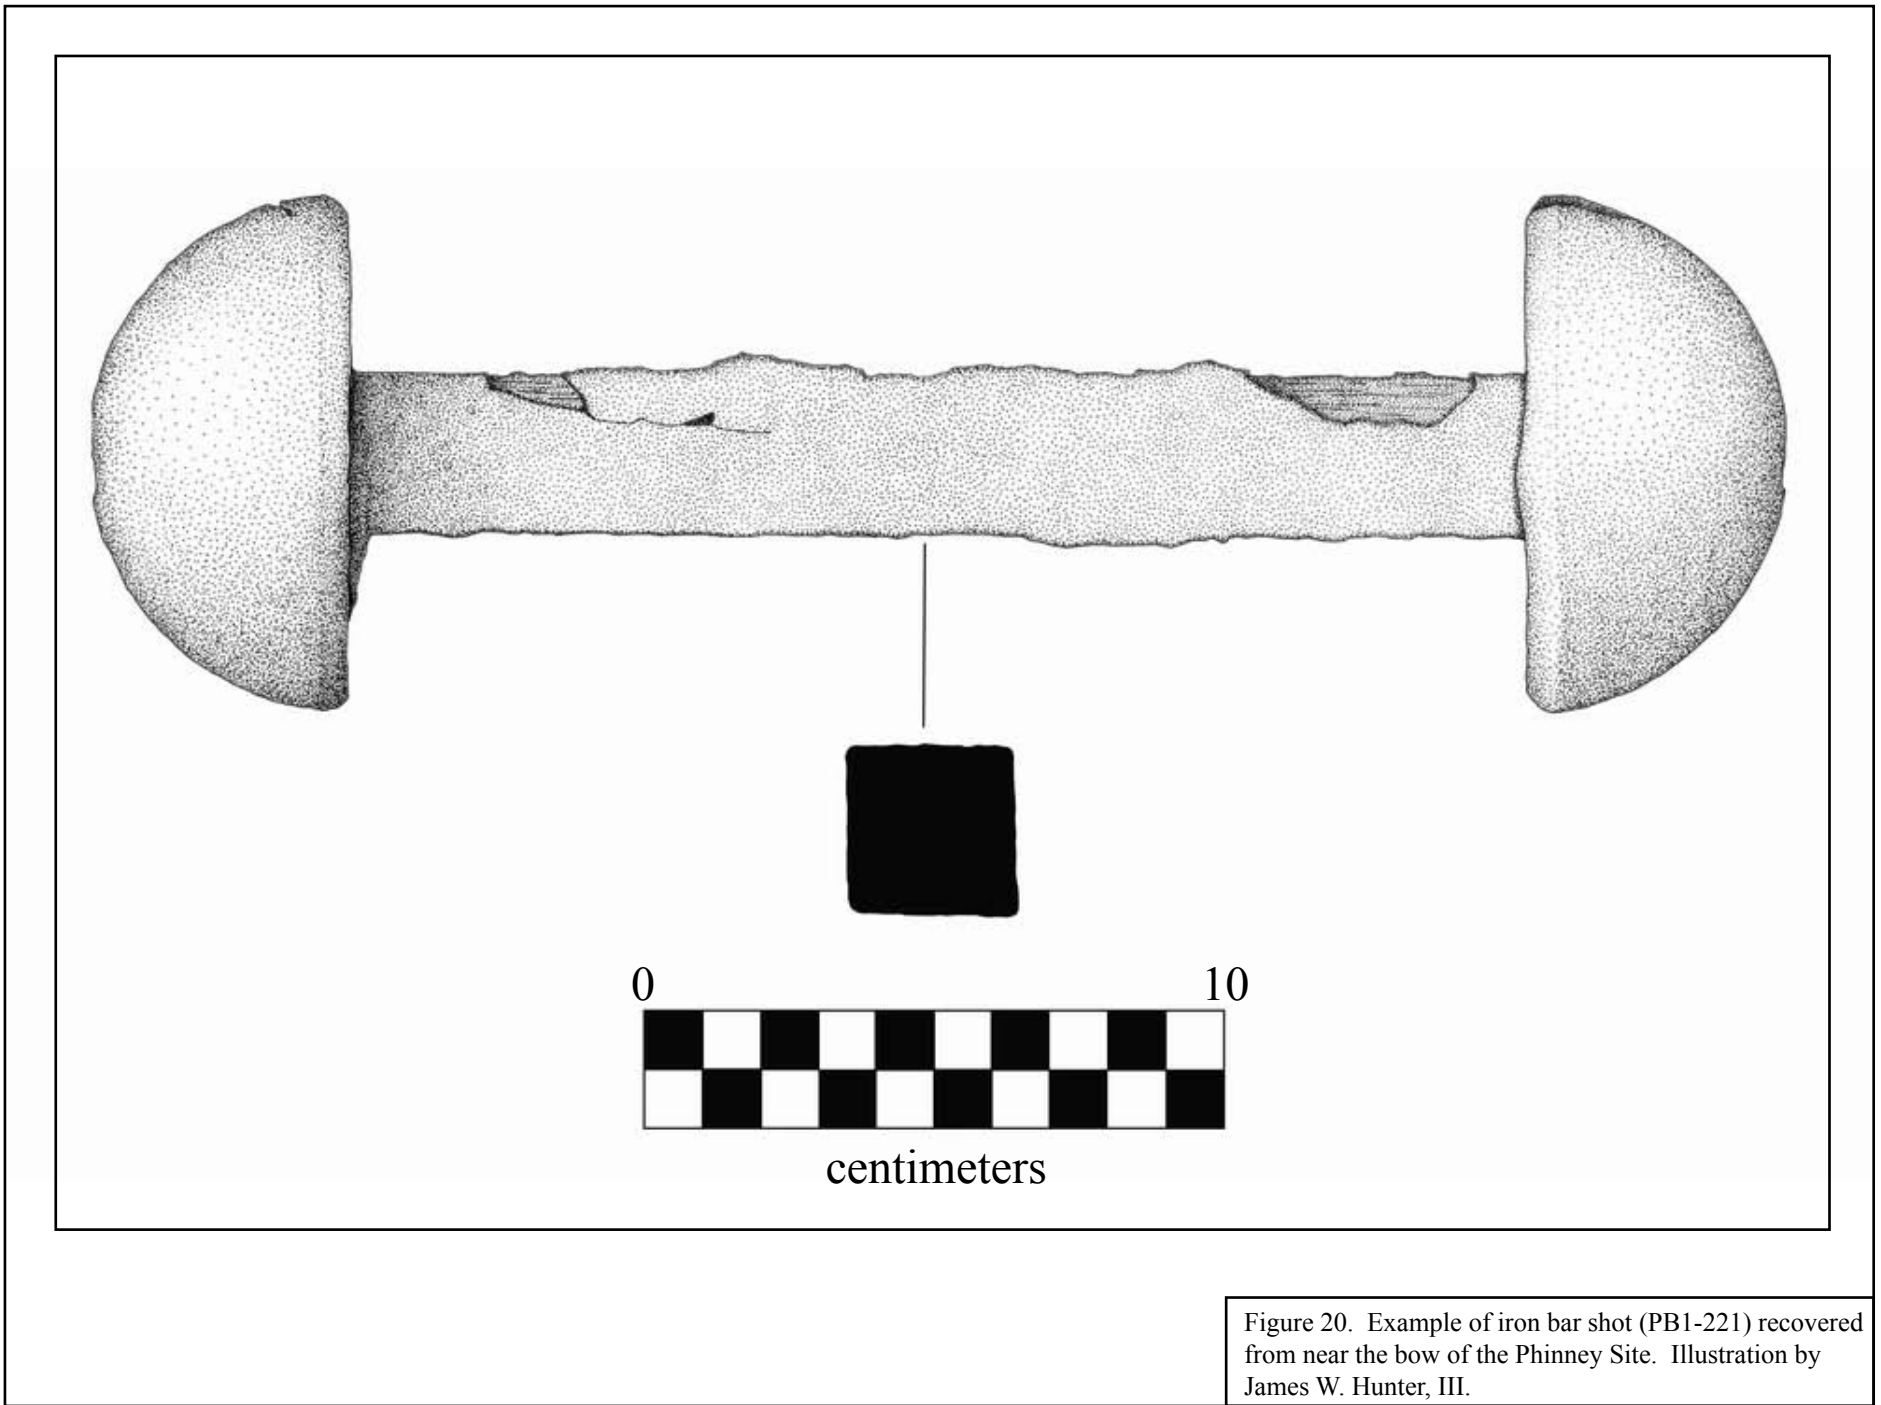
Figure 20. Example of iron bar shot (PB1-221) recovered from near the bow of the Phinney Site. Illustration by James W. Hunter, III.

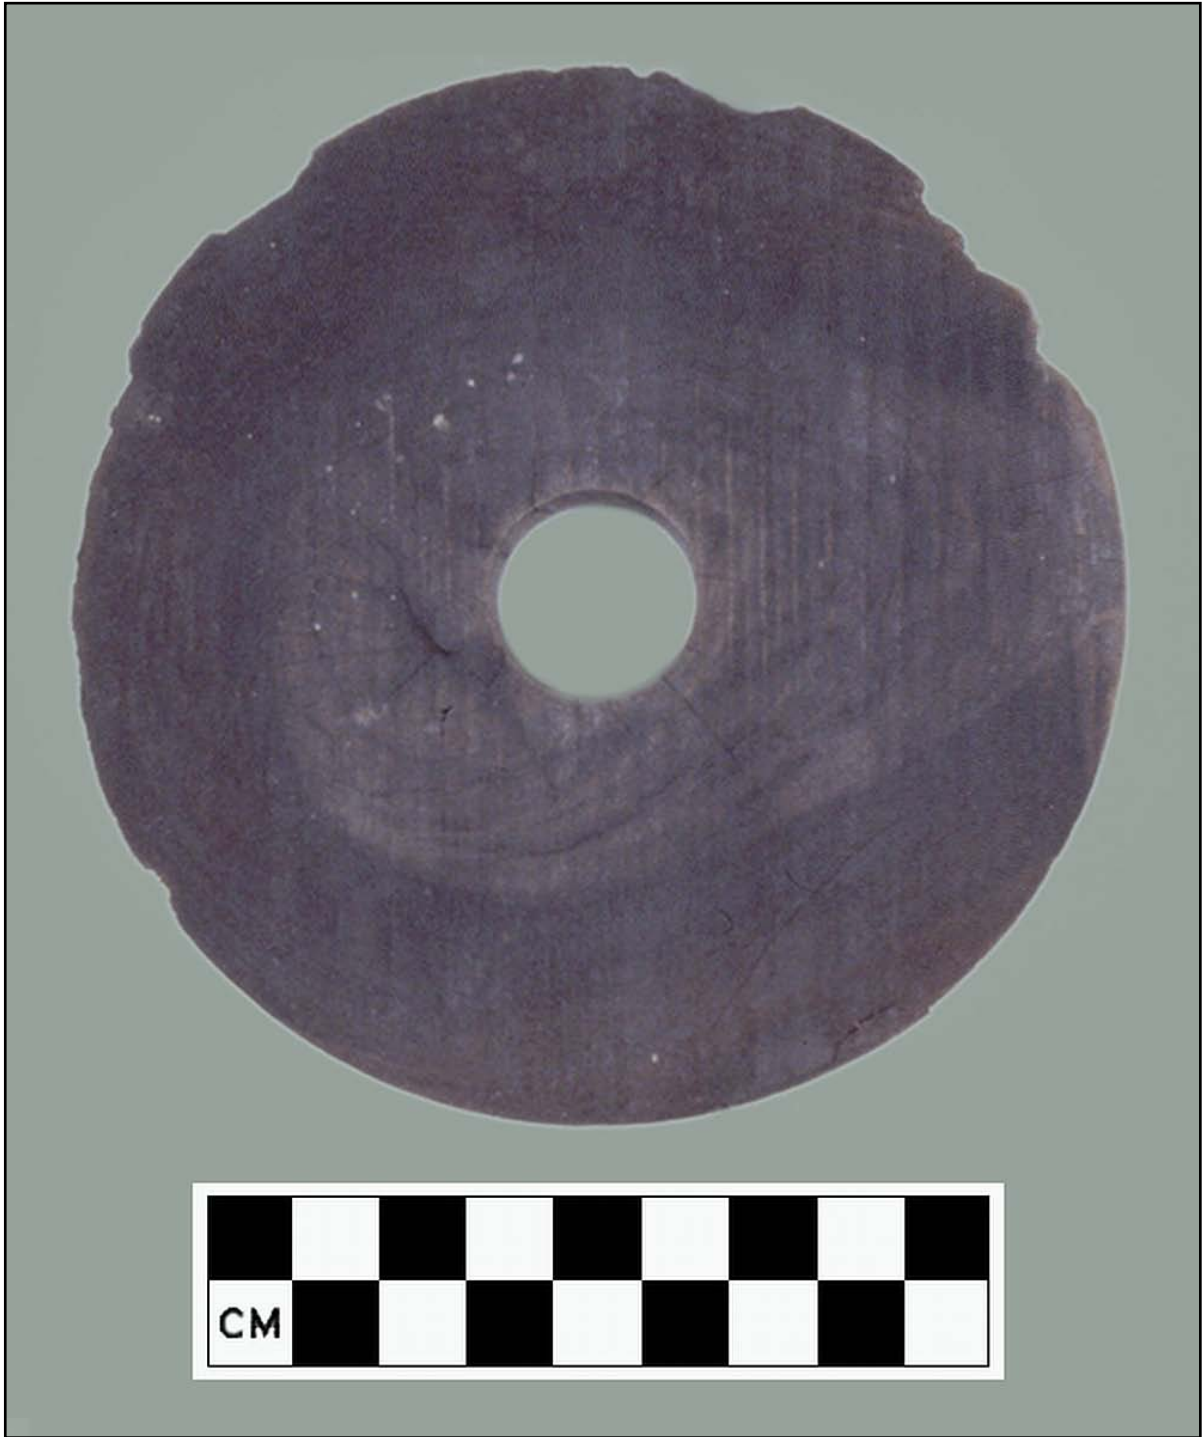
Figure 21. Wooden rigging sheave (PB1-216) recovered from the bow section of the Phinney Site. Photograph by James W. Hunter, III.

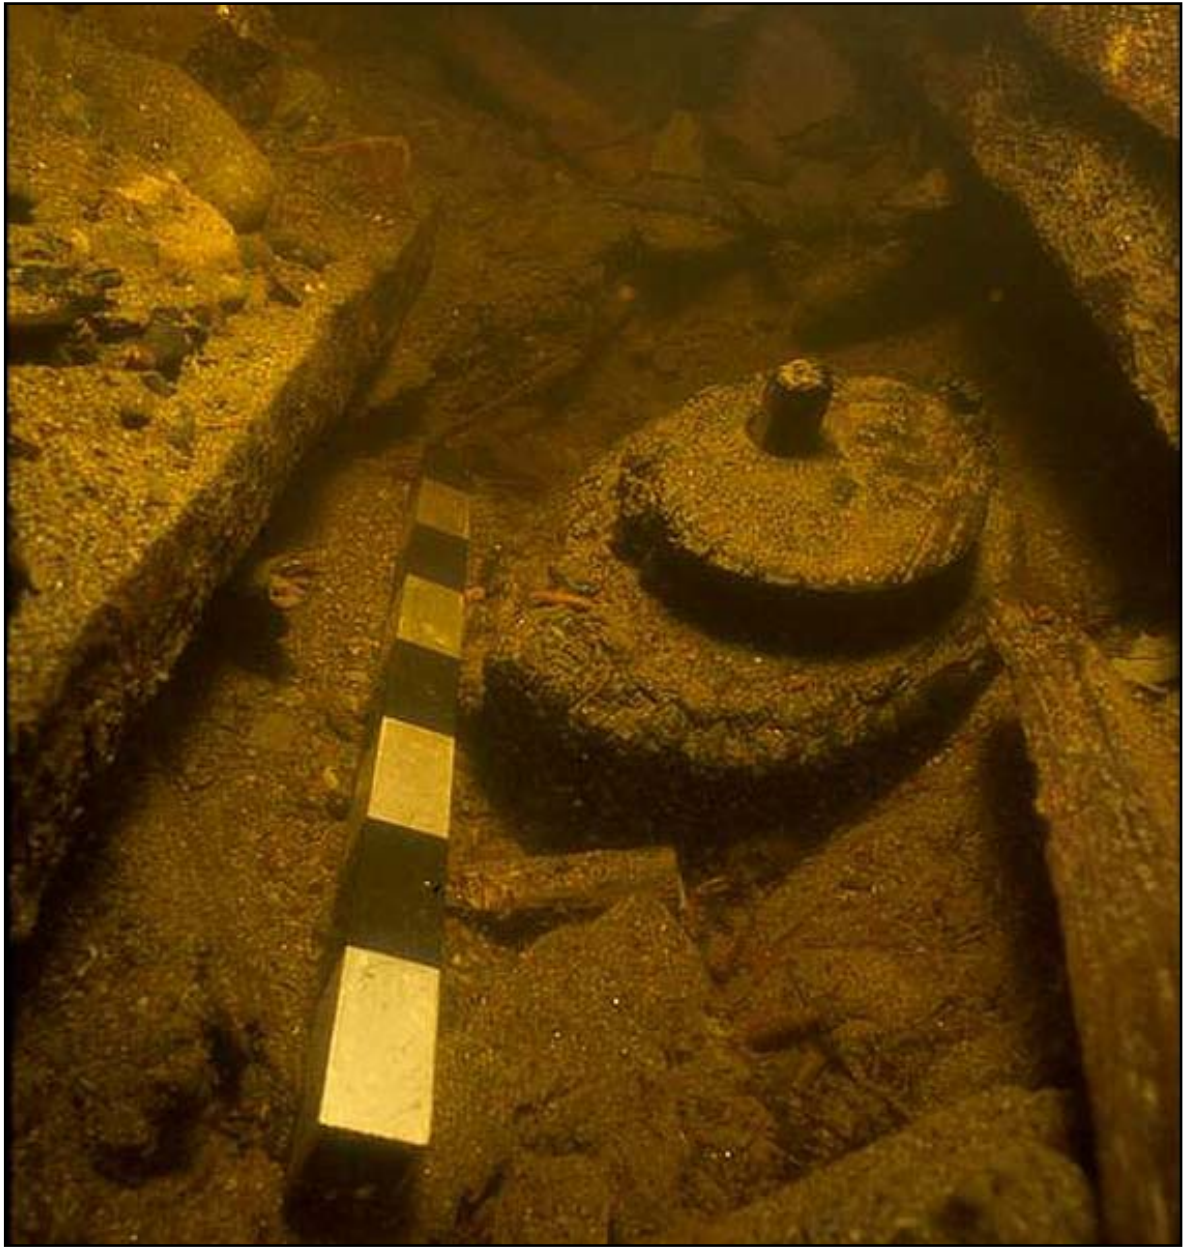
Figure 22. Burned double block (PB1-224) *in situ*. Photograph by David Whall.

NHC archaeologists discovered the remains of the double block (PB1-224) a short distance from the sheave. It was found partially buried under the collapsed stem assembly, immediately adjacent to the scarp between the preserved upper and lower segments of the stempost (Figure 22). Although heavily degraded on one side—approximately half of the shell is missing and a significant portion of one sheave is badly charred—the block retains enough of its original

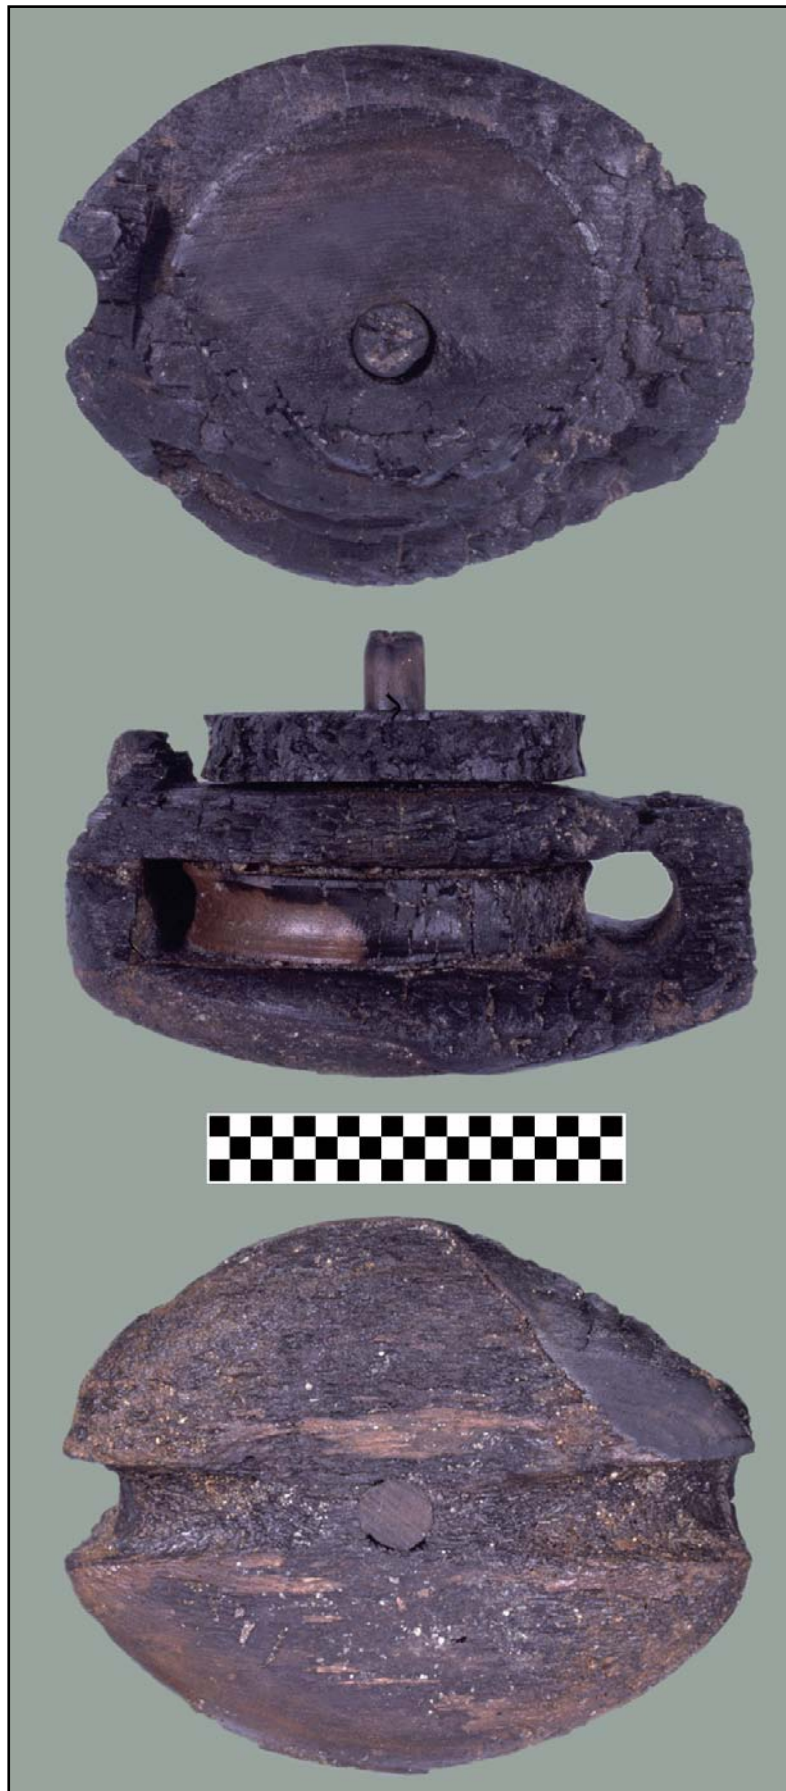
Figure 23. Three views of a charred, partial wooden double block (PB1-224) recovered from the bow section of the Phinney Site. Photographs by Claire Peachey.

Ten-inch double blocks identical to that recovered from the Phinney Site are present in the artifact assemblages of both *Philadelphia* and *Defence* sites and are believed to have been used aboard those vessels to work the largest running rigging components (Bratten 2002: 128, 188; Ford and Switzer 1982: 34-36 and Switzer 1998: 192). Because it was located at the forward extremity of the wreck, the example recovered from the Phinney Site may have been part of the running rigging associated with the vessel's foremast. Conversely, it could have been stowed in the bosun's locker or another forward compartment as a spare. Many of the double blocks recovered from *Defence* were found nested deep within the forepeak, while all of the blocks discovered on *Philadelphia* were stowed in the gondola's forward cockpit (Bratten 2002: 173 and Switzer 1998: 192). Spare rigging blocks have also been recovered from the extreme forward

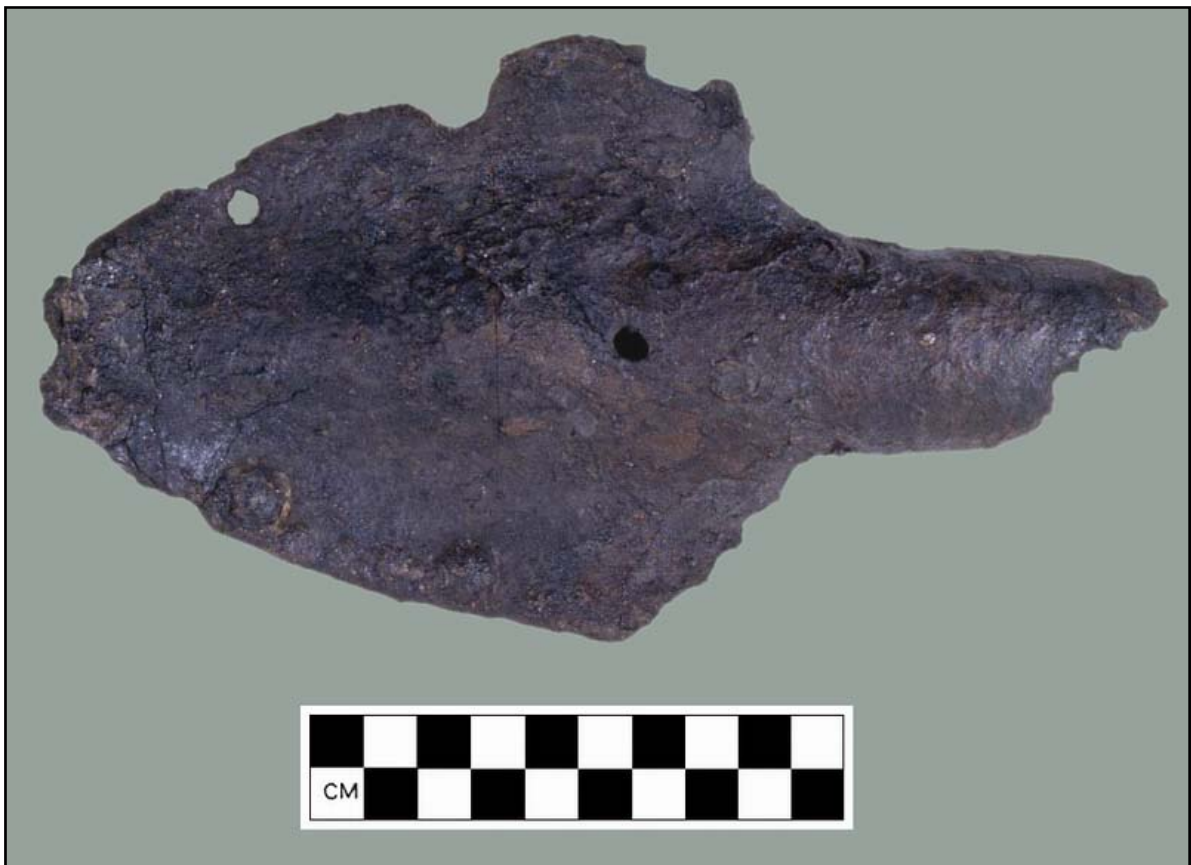
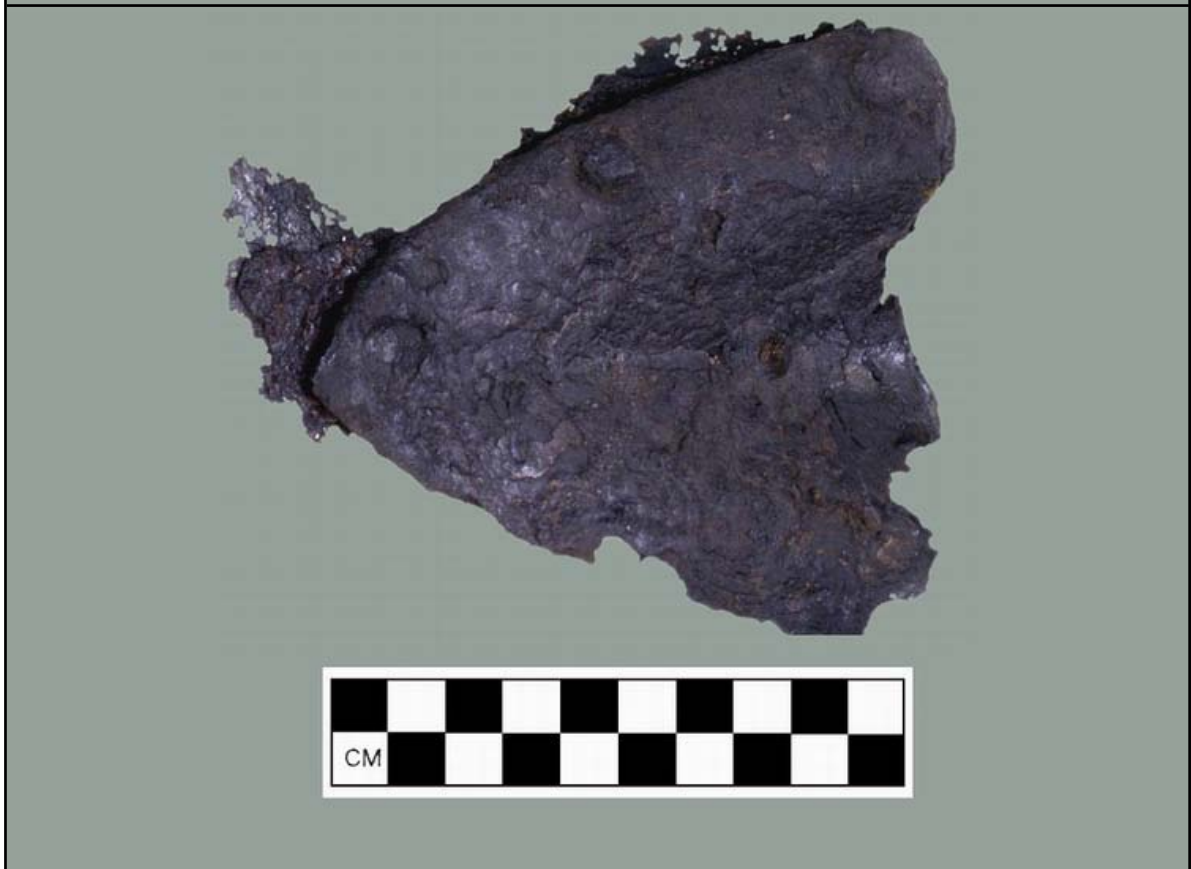
Figure 24. Shovel or spade components recovered from the Phinney Site: *top*; PB1-227, *bottom*; PB1-042. Photographs by Melanie Pereira.

Two wrought-iron spade or shovel components were discovered at opposite ends of the wreck's centerline. Both artifacts appear to be the remnants of iron 'leaves' used to connect the wooden handle and iron blade components to one another (Figure 24). The largest example (PB1-227) was found partially exposed in riverbed sediment on the vessel's port side, immediately adjacent to Grid T-1. It consists of a semi-cylindrical shaft that widens to form a flat, spade-shaped head with a slightly concave central recess. The head is perforated by four circular fastener holes (two of which still retain 5-millimeter diameter iron rivets) and the partial remains of two others. Artifact PB1-227 has a preserved overall length and width of 20.5 centimeters and 10.9 centimeters, respectively. Its preserved maximum thickness is 2 millimeters.

Two of the more basic tools employed by both American and British forces during the American Revolution were spades and shovels. Although similar in appearance, both implements were uniquely constructed to perform distinctly different functions (Tully 2000). Spades were characterized by a relatively flat blade and used primarily to cut sod, which was used to line various earthworks (Muller 1968: 49). Spades were also used to make fire pits and to trench around tents. By contrast, shovels exhibited slightly concave blades and served as the primary hand tool for excavating camp kitchens, graves, and trenches. They were also employed to fill gabions—defensive earthworks comprised of baskets or cages filled with rocks and sediment—during the construction of field fortifications (Tully 2000). Noël Hume (1969: 275) states that an iron “shank divided into two concave leaves” characterizes most eighteenth century spades and shovels. The two-part shank was placed around a wooden shovel handle and held in place with iron nails or rivets (Noël Hume 1969: 275).

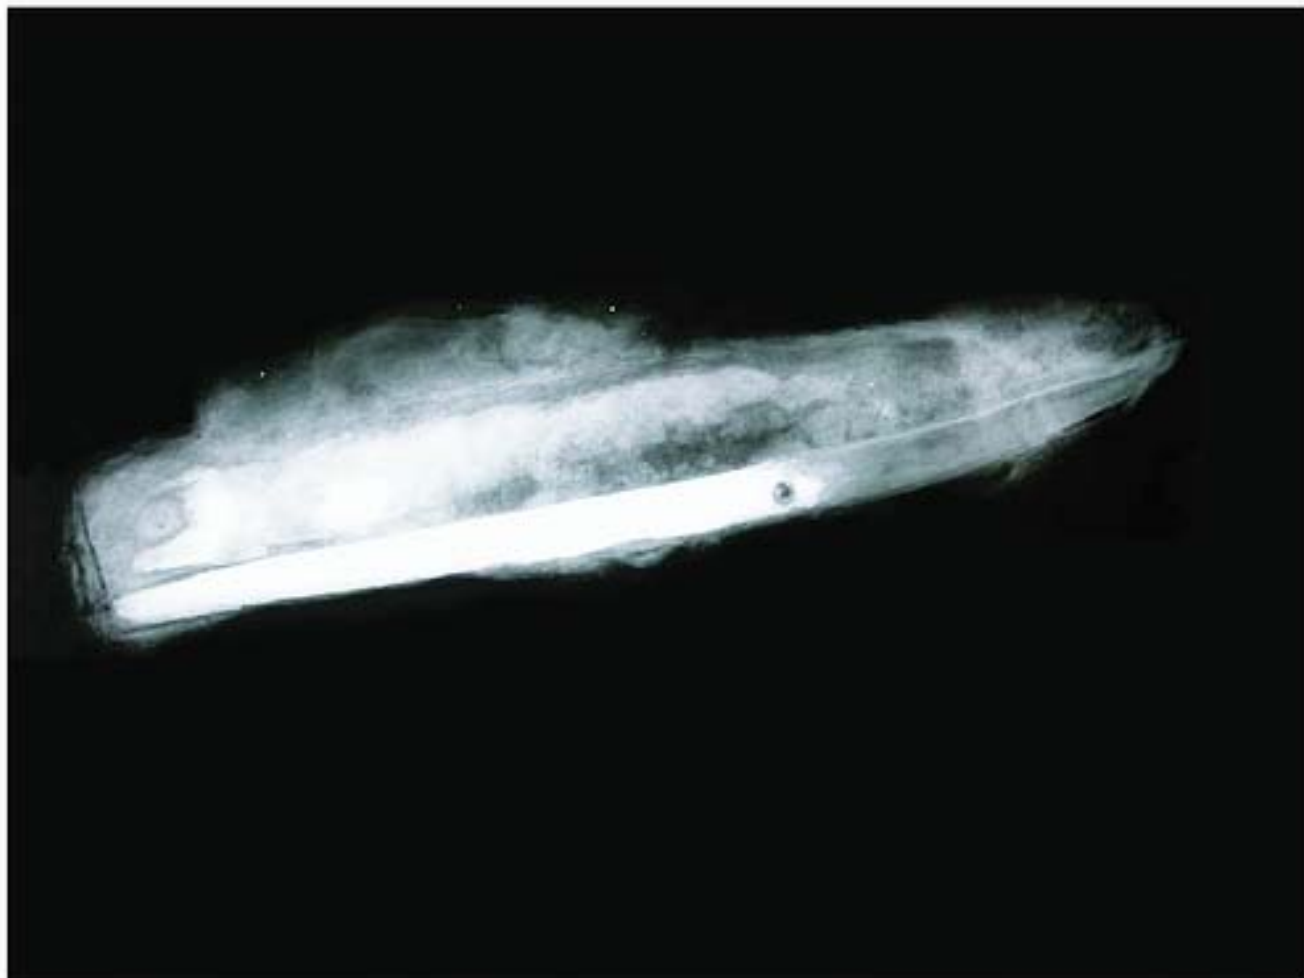
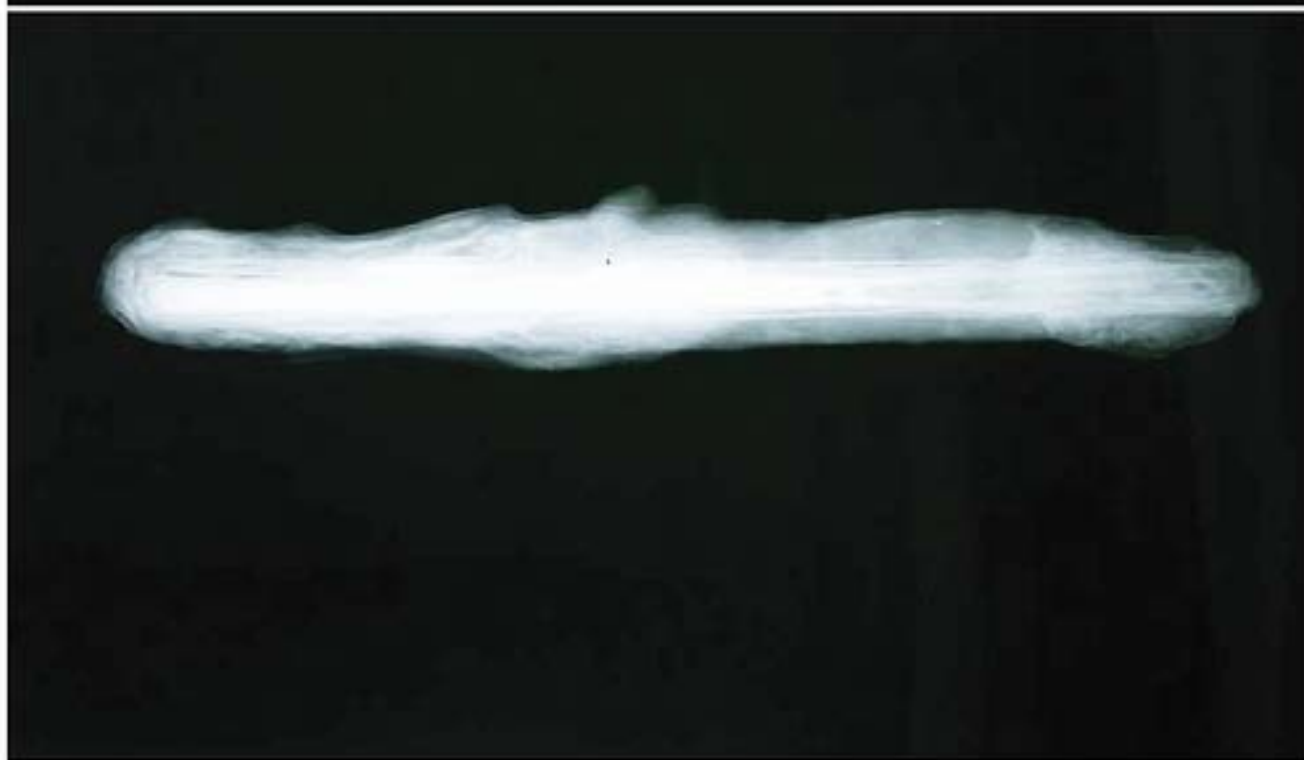
Figure 25. Radiographic images of the folding knife recovered from the Phinney Site: *top*, side view, *bottom*, top view. Photographs by Claire Peachey.

A small iron concretion (PB1-148) recovered from Grid T-1 was initially identified as a fastener. However, radiographs revealed that the concretion contains a well-preserved folding

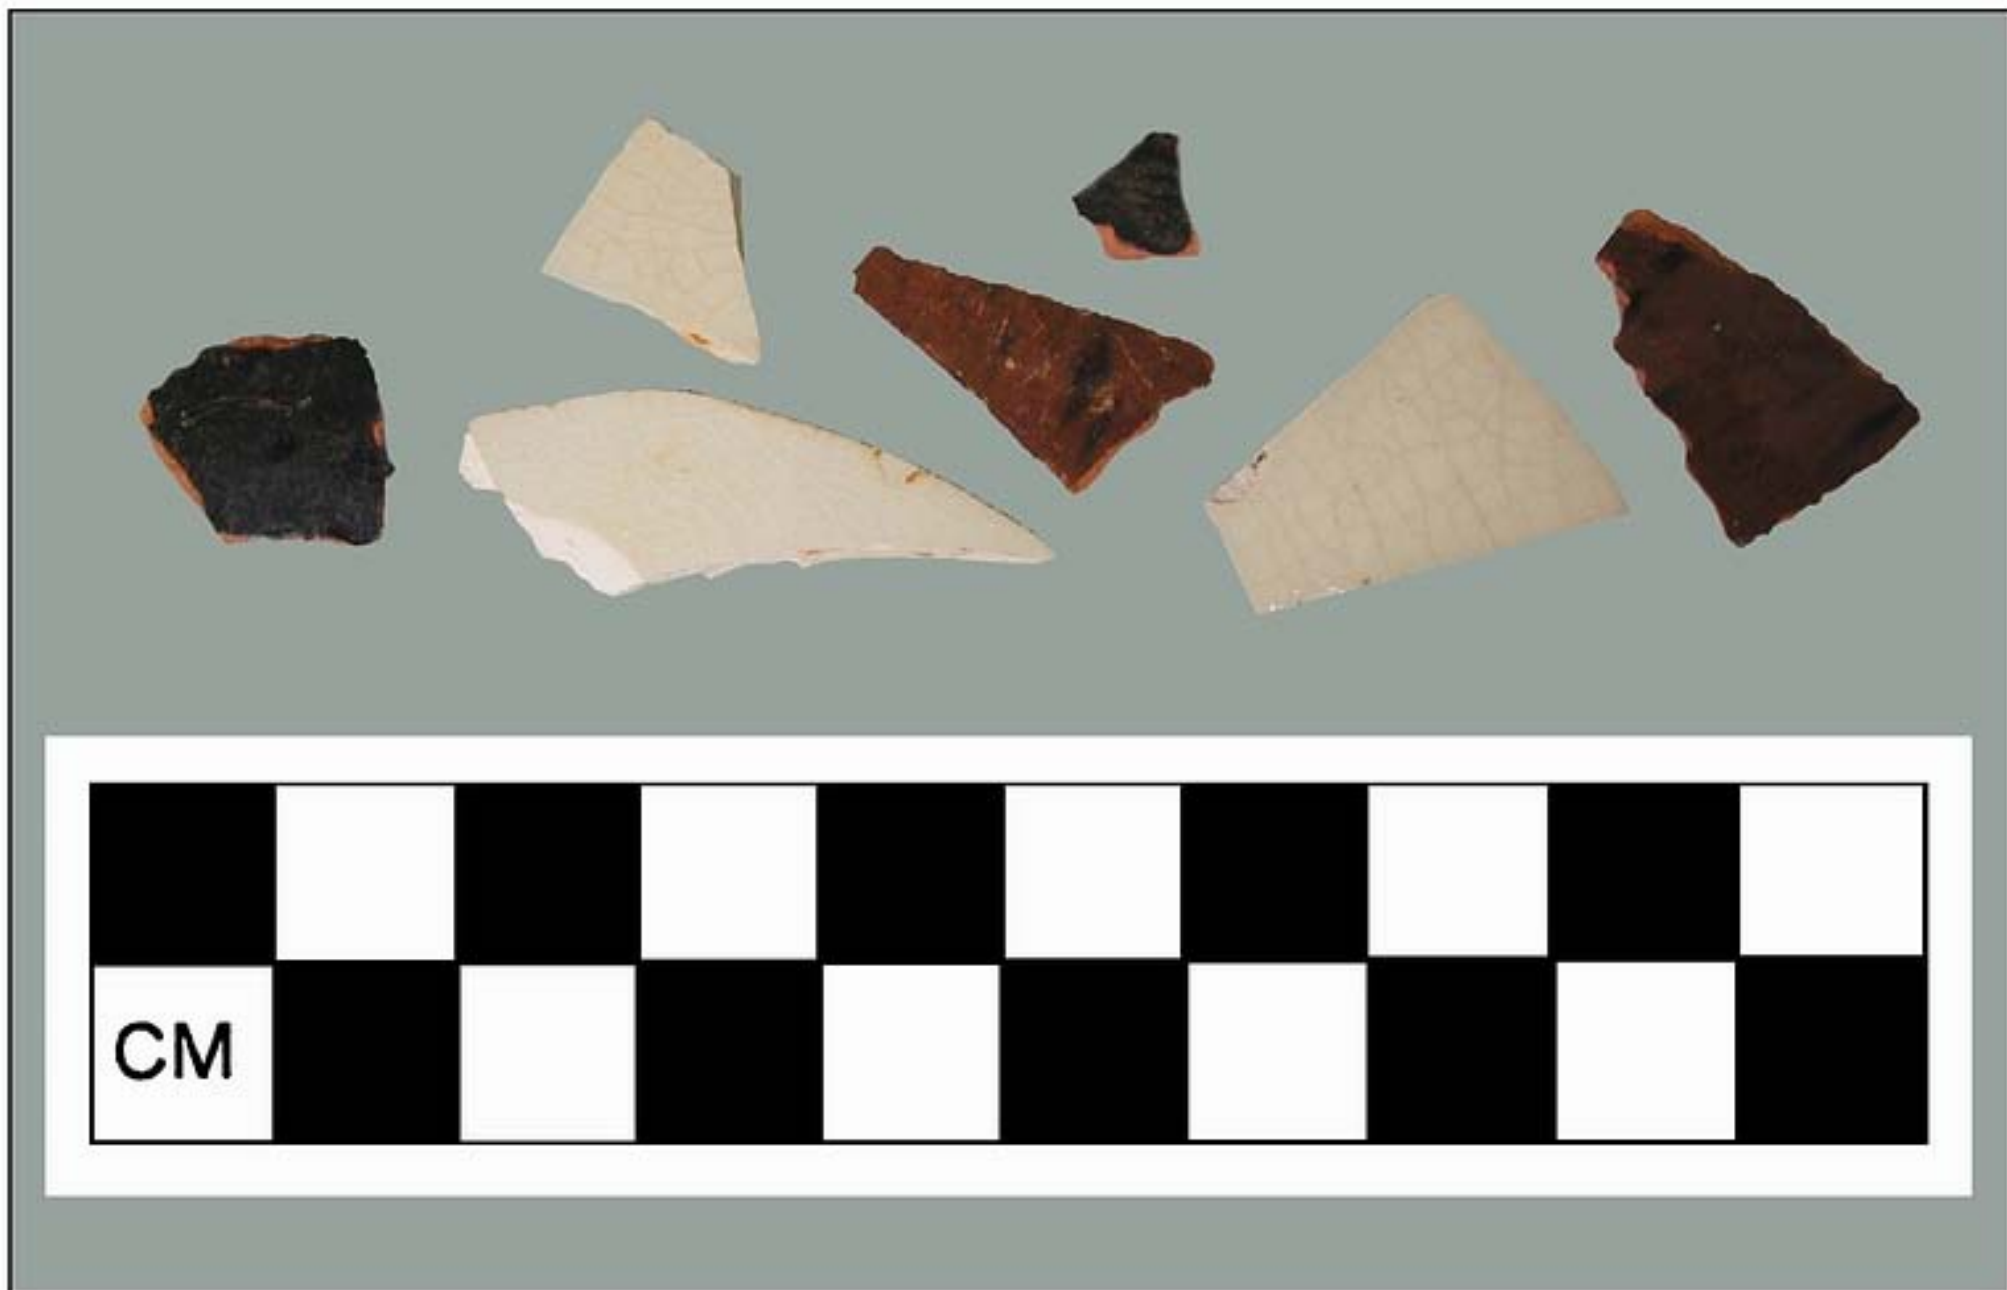
Figure 26. Creamware and redware ceramic sherds recovered from Grid T-1 in sediment just above the Phinney Site's starboard garboard. Photograph by James W. Hunter, III.

Three fragments of creamware (PB1-131-B, PB1-131-D and PB1-131-E) were recovered during excavation of Grid T-1. All were found mixed with American redware sherds in a lens of sediment immediately above the interior surface of the vessel's starboard garboard (Figure 26). Each sherd is approximately 2 millimeters thick and exhibits a refined, cream-colored earthenware paste that is uniformly covered with a clear glaze on both its interior and exterior surfaces. None of the recovered examples are decorated; however, a fine network of discolored cracks (crazing) has developed in the glaze of each during its long immersion in the Penobscot River. The size, thickness, and appearance of the sherds suggest that they originated from relatively small, delicate items such as teacups or saucers. Since all three are physically and proportionally similar, the possibility also exists that they came from the same ceramic vessel.
