**The Penobscot Expedition Archaeological Project:
Field Investigations 2000 and 2001**

FINAL REPORT

**Prepared by:
Naval Historical Center
Underwater Archaeology Branch
805 Kidder Breese St., SE
Washington Navy Yard, D.C. 20374-5060**

Fall 2003

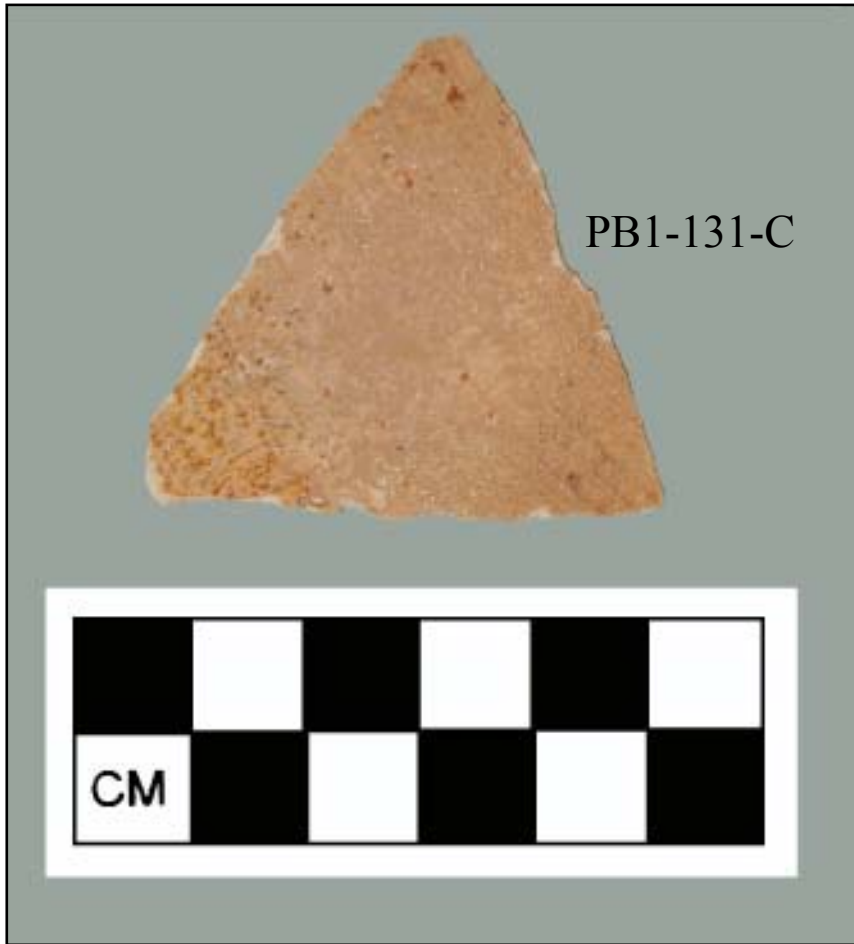
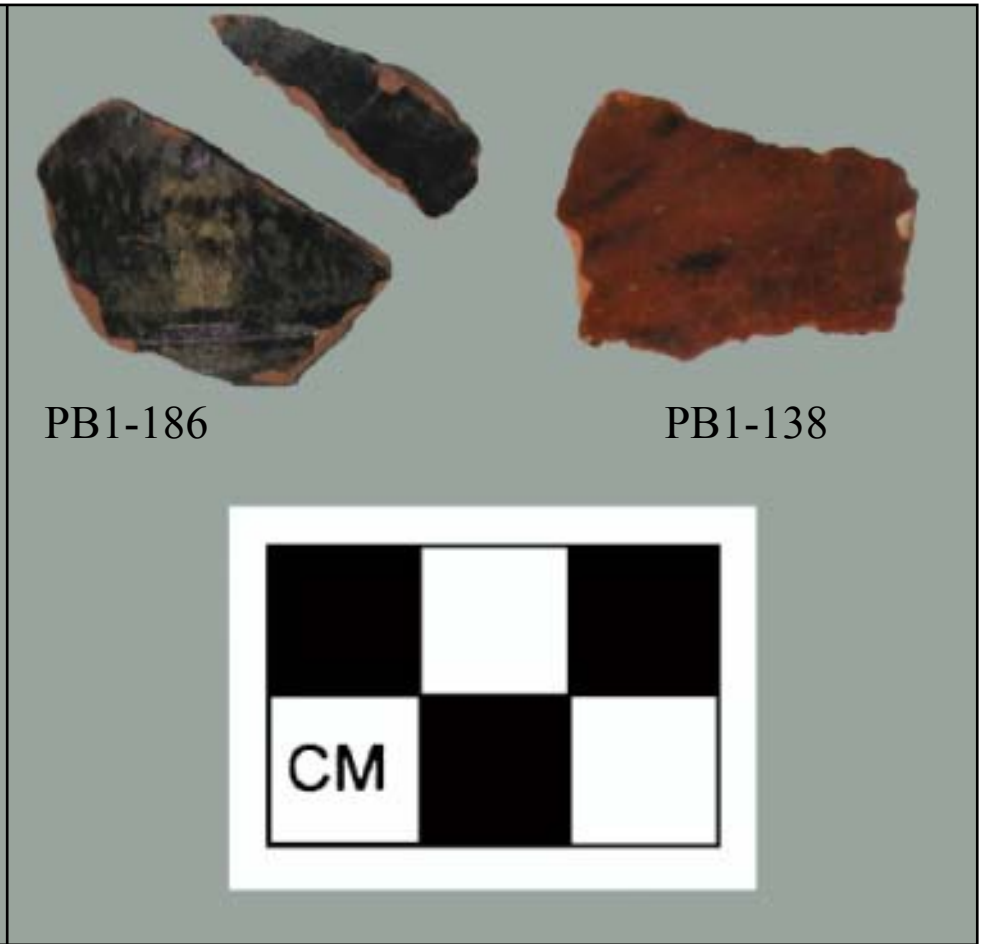
Figure 27. Other Revolutionary War-era ceramic sherds excavated from Grid T-1: *left*; Fulham stoneware, *right*; variations of American redware with red and black glaze. Photographs by James W. Hunter, III.

A single triangular-shaped fragment of what appears to be Fulham stoneware (PB1-131-C) was discovered lying atop the vessel’s garboard strake in close proximity to the aforementioned examples of redware and creamware (Figure 27). It is comprised of a dense, granular light gray stoneware body with numerous dark inclusions. The sherd’s exterior is salt-glazed and exhibits a gray to buff color over much of its surface. A darker brown mottled slip characteristic of English brown stoneware is evident at one corner. Prominent rill (throwing) marks are present along the interior surface of the sherd, indicating that the vessel from which it originated was manufactured on a potter’s wheel. Smaller, barely perceptible rill marks are also evident on portions of the exterior not covered by brown slip.

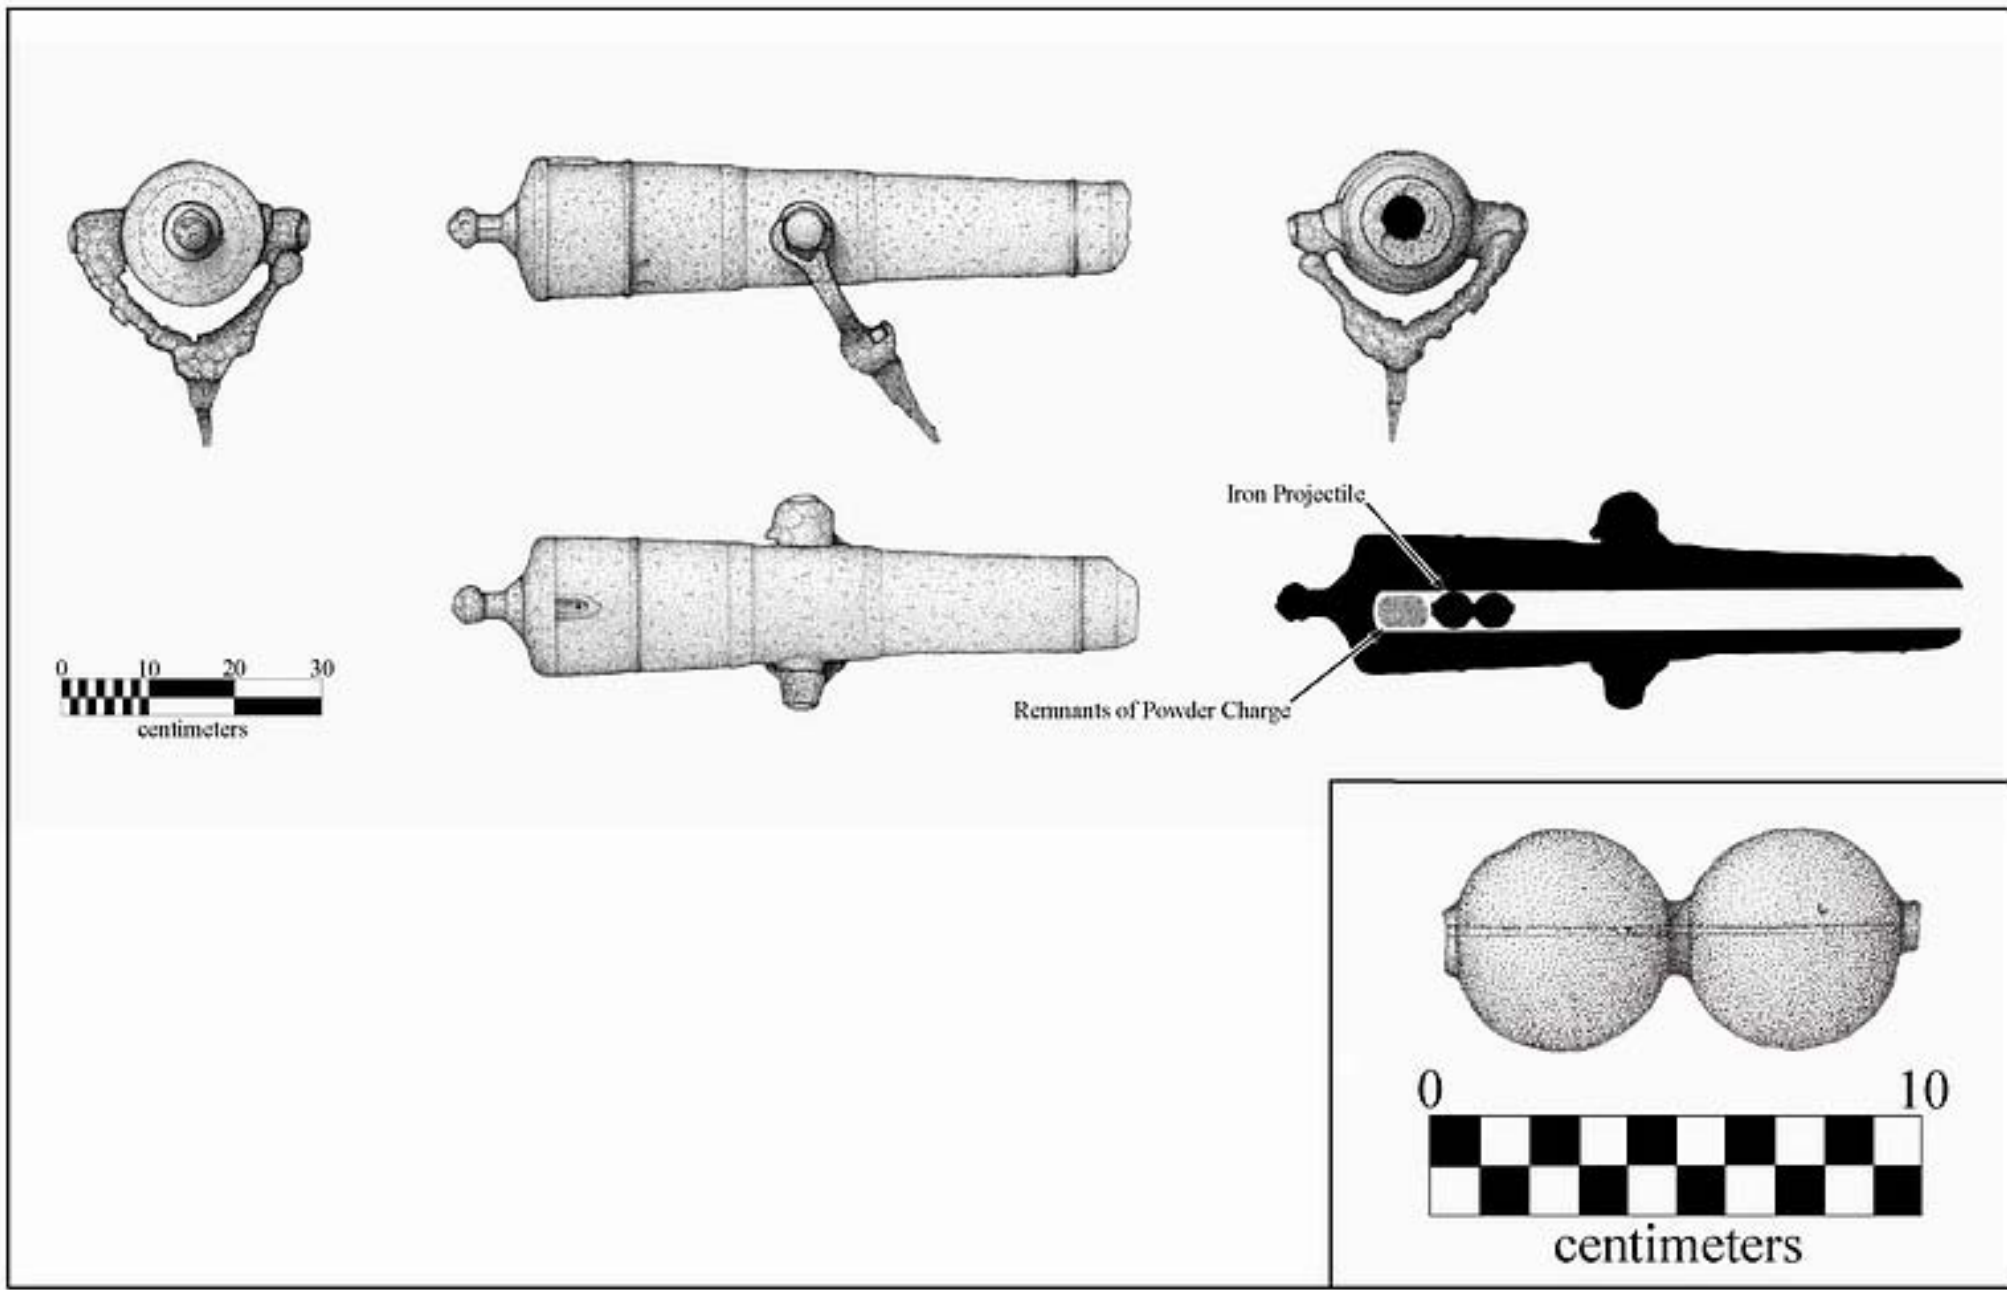
Figure 31. Cast iron swivel gun recovered from the Shoreline Site: *inset*; unusual "double-shot" iron projectile recovered from the interior bore of the swivel gun. Illustrations by James W. Hunter, III.

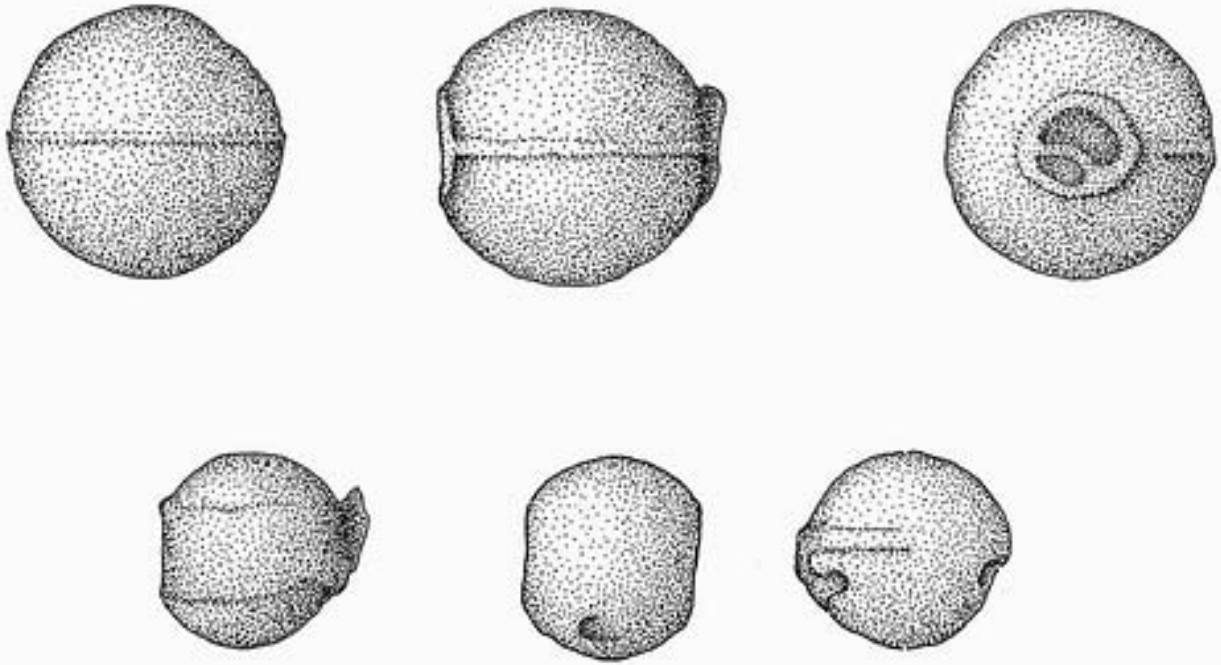
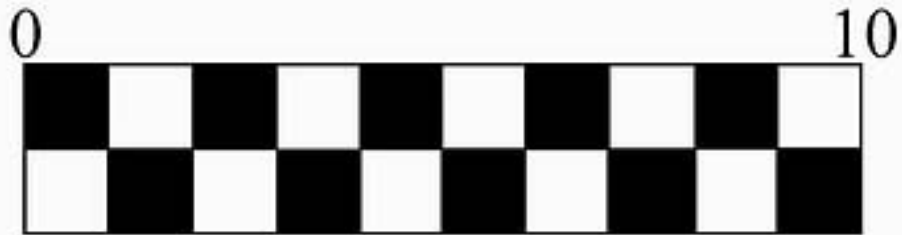
Figure 32. Examples of grape and canister shot recovered from the Shoreline Site. Illustration by James W. Hunter, III.

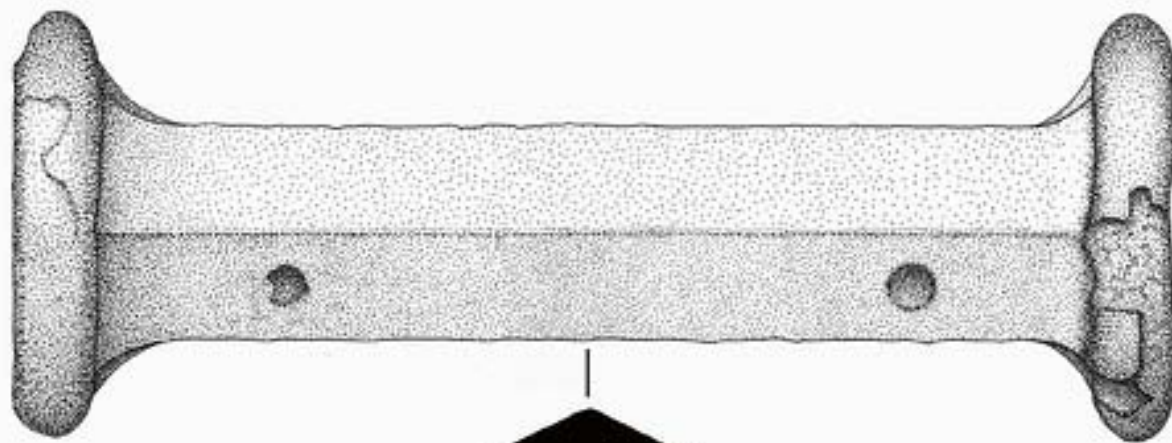
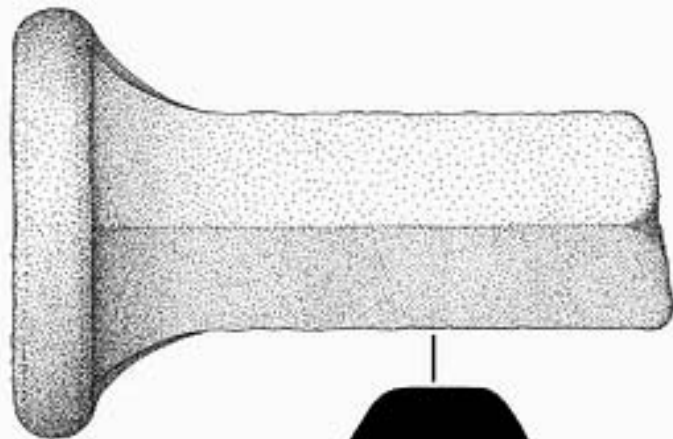
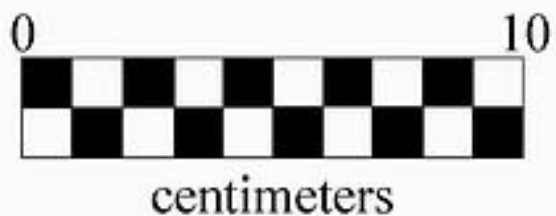
Figure 33. Examples of unique iron cannon projectiles recovered from the Shoreline Site: *top*; bar shot, *bottom*; half-bar shot. Illustrations by James W. Hunter, III.

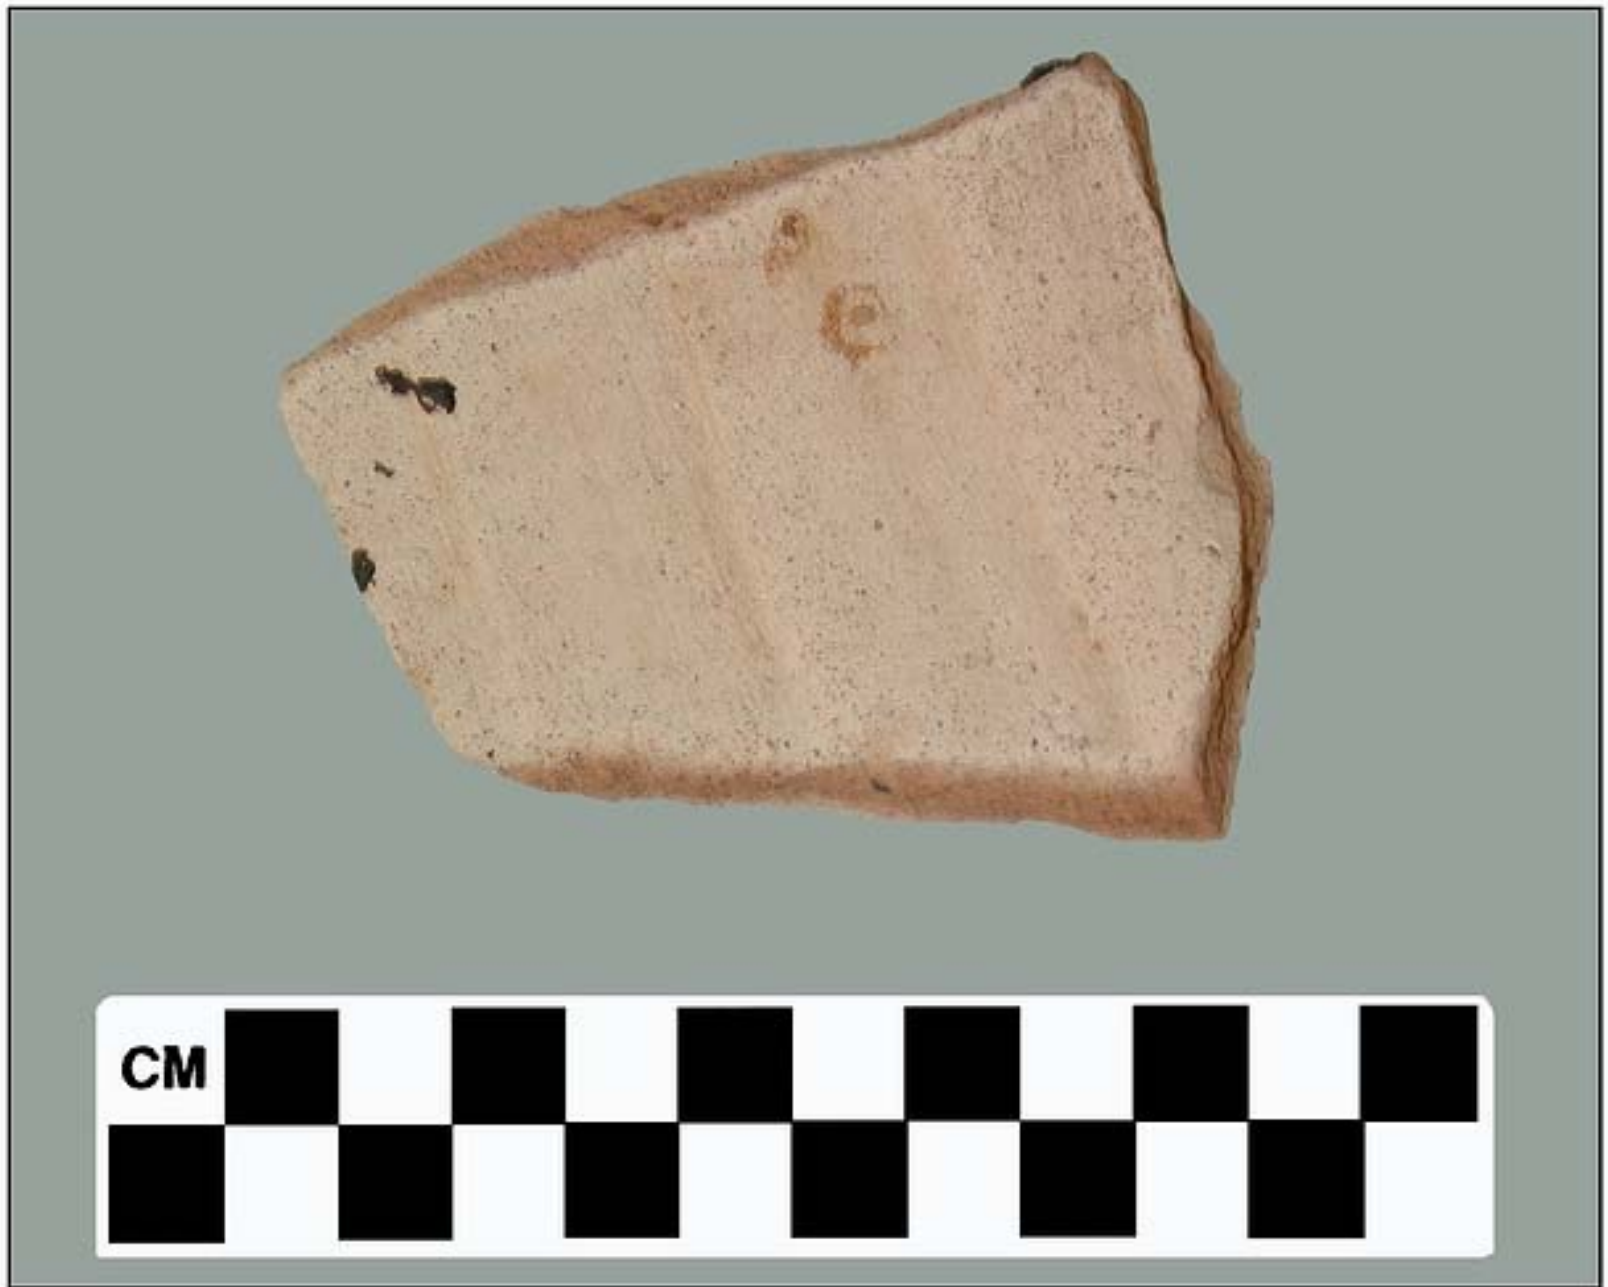
Perhaps the oldest ceramic object recovered from the Shoreline Site is a small body sherd of coarse earthenware (PB2-025), likely from a Spanish olive jar (Figure 34). The sherd is tan on its interior and exterior surfaces, and exhibits a tan to buff colored porous paste with small sand inclusions. It appears to have originated from an incompletely fired vessel, exhibits rill marks on both its interior and exterior surfaces, and measures 8.2 x 6.7 centimeters with a thickness of 1.3

Figure 34. Olive jar body sherd (PB2-025) recovered from the Shoreline Site. Photograph by James W. Hunter, III.

centimeters. The olive jar fragment was located approximately ten meters north of Baseline One at the 47-meter mark. It was buried beneath 8-10 centimeters of gravel and coarse sand, and was located during hand fanning of bottom sediments around a concreted iron bar (PB2-024).

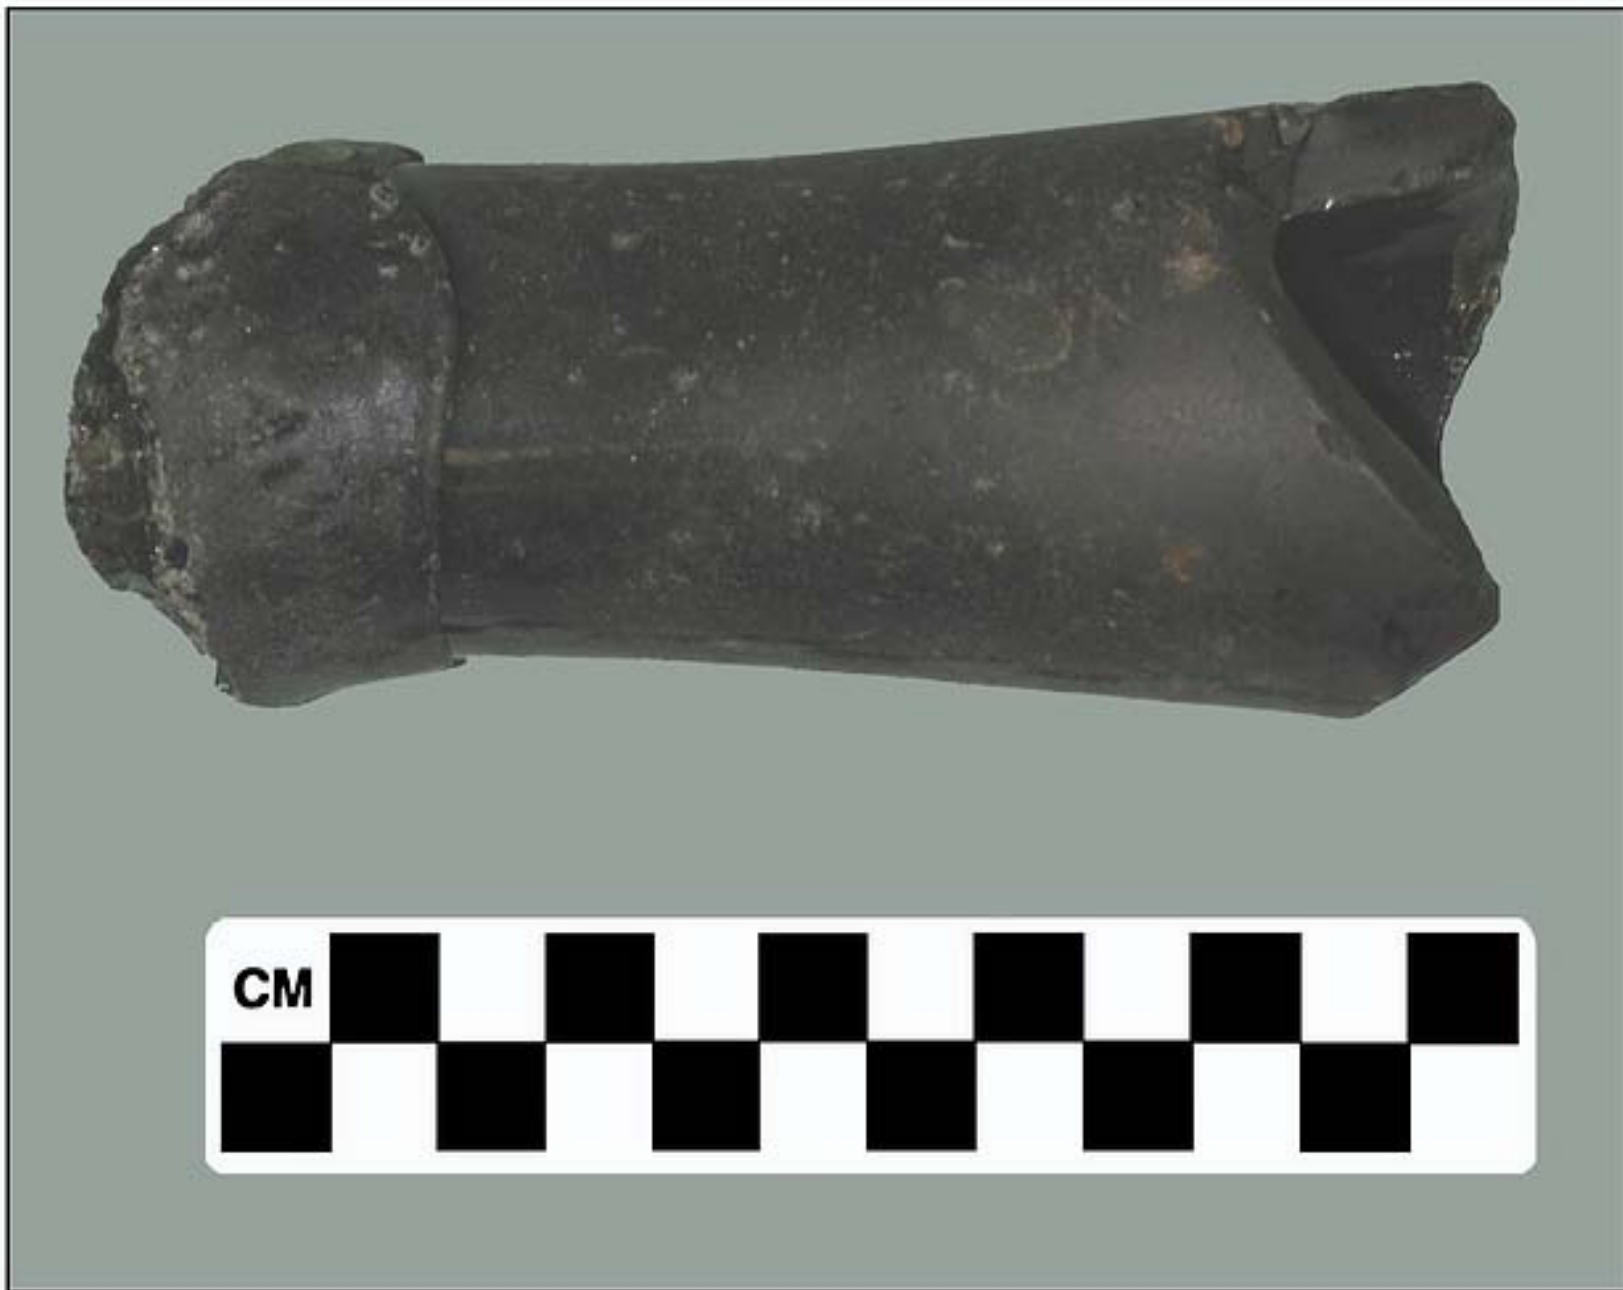
The colonial-era artifact (PB2-016) is a large olive-green glass bottleneck with an applied string lip (Figure 35). Its early origin is indicated by a number of identifying characteristics, including the color, large number of small air bubbles in the glass, and the artifact’s crudely applied rim. Although too large to have originated from a standard spirit or wine bottle, it is about the right size for a carboy or demijohn.

Figure 35. Colonial-era glass 'carboy' bottle neck (PB2-016) recovered from the Shoreline Site. Photograph by James W. Hunter, III.

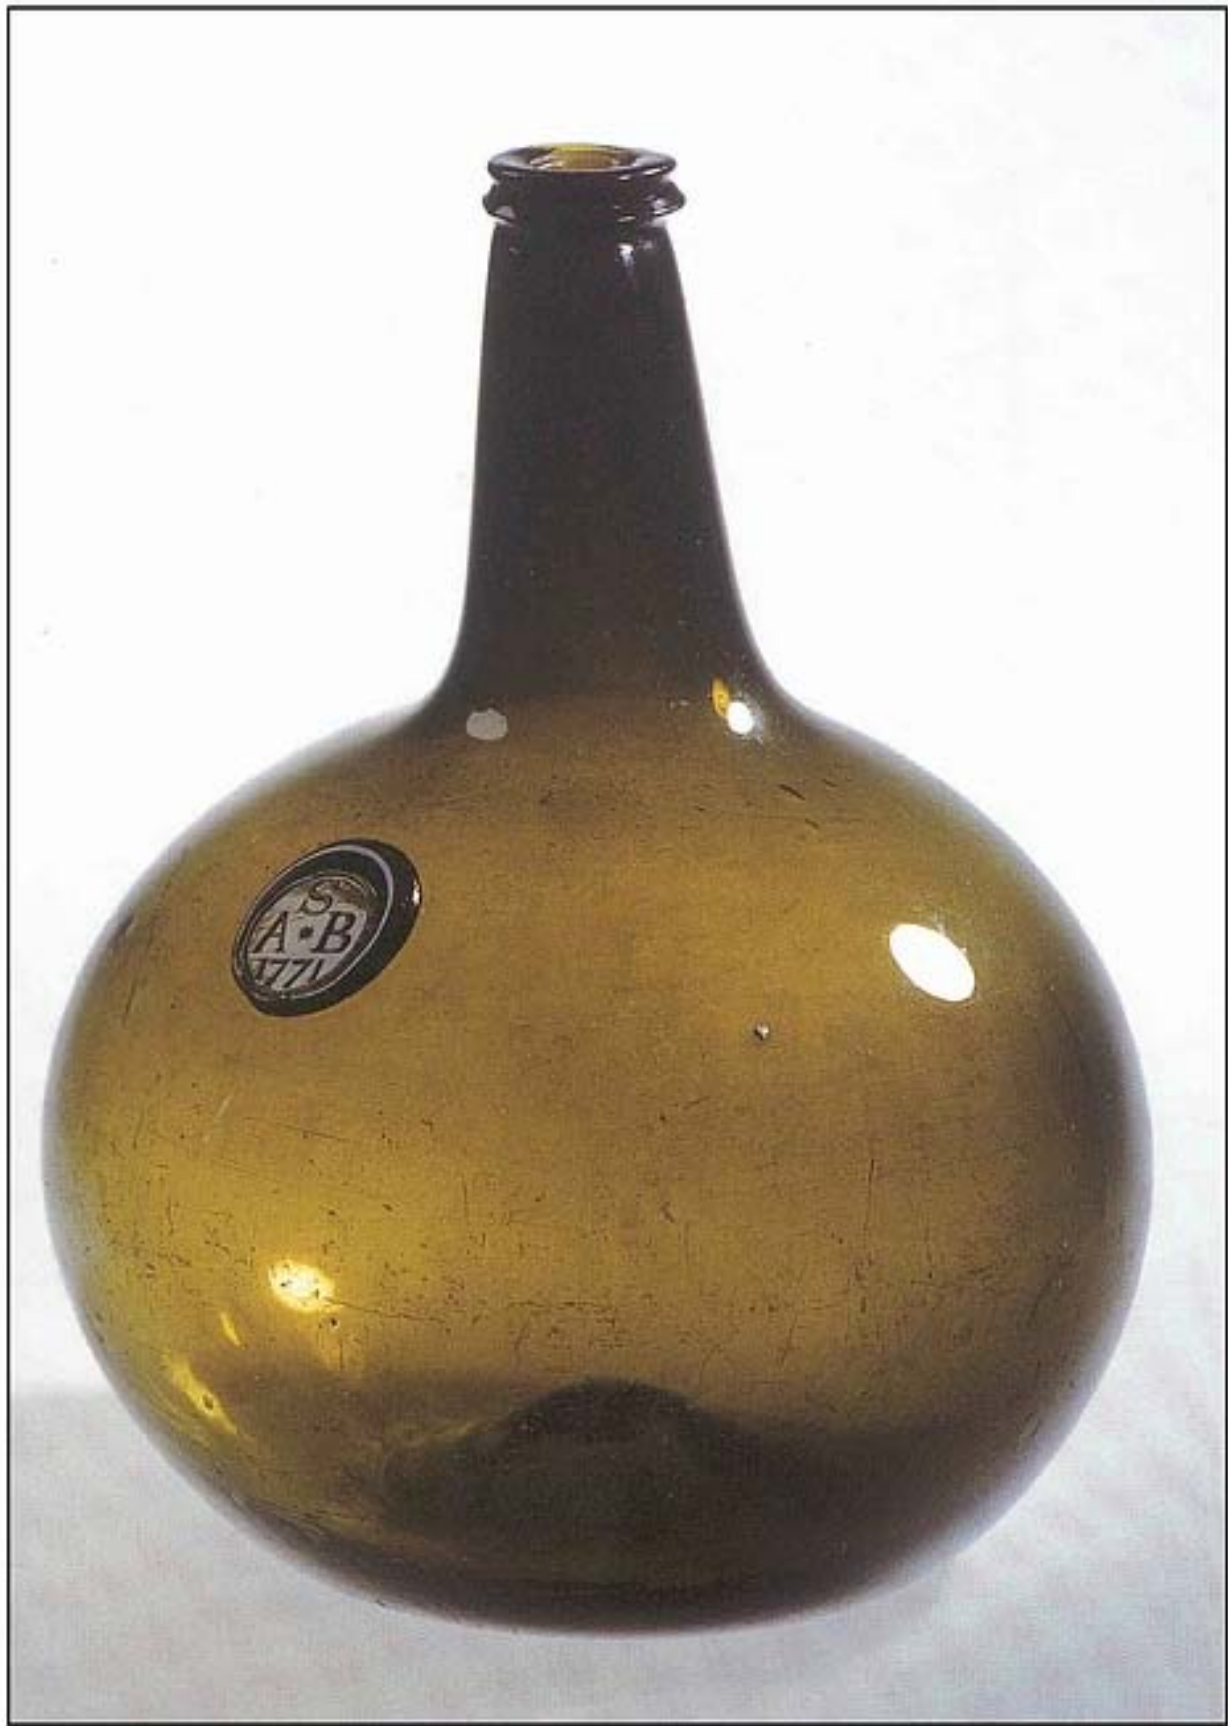
The terms “carboy” and “demijohn” were first used by mid-eighteenth century manufacturers and merchants to describe large bottles that were typically hand-blown, covered with wicker casings, and used to ship and store bulk quantities of liquids (Figure 36). Prior to 1800, differentiation between demijohns and carboys apparently did not exist, and the names were used interchangeably to describe similar glass vessels. While most examples were imported from England, a sizable number of large bottles were produced in American glasshouses, including those in New York, Pennsylvania, and Connecticut. Imported bottles ranged in size from 4 to 20 gallons, while their American counterparts rarely exceeded 5 gallons. Although a wide assortment of sizes was available, the gallon was the largest glass bottle in regular production during the Revolutionary War era (McKearin and Wilson 1978: 255-256).

Figure 36. Example of a large English "carboy," dated 1771. Bottle height is 30 centimeters; maximum diameter is 24 centimeters. Photograph adapted from Willy Van den Bossche, *Antique Glass Bottles: Their History and Evolution (1500-1850)*, Antique Collector's Club, Woodbridge, England (2001), p. 96.

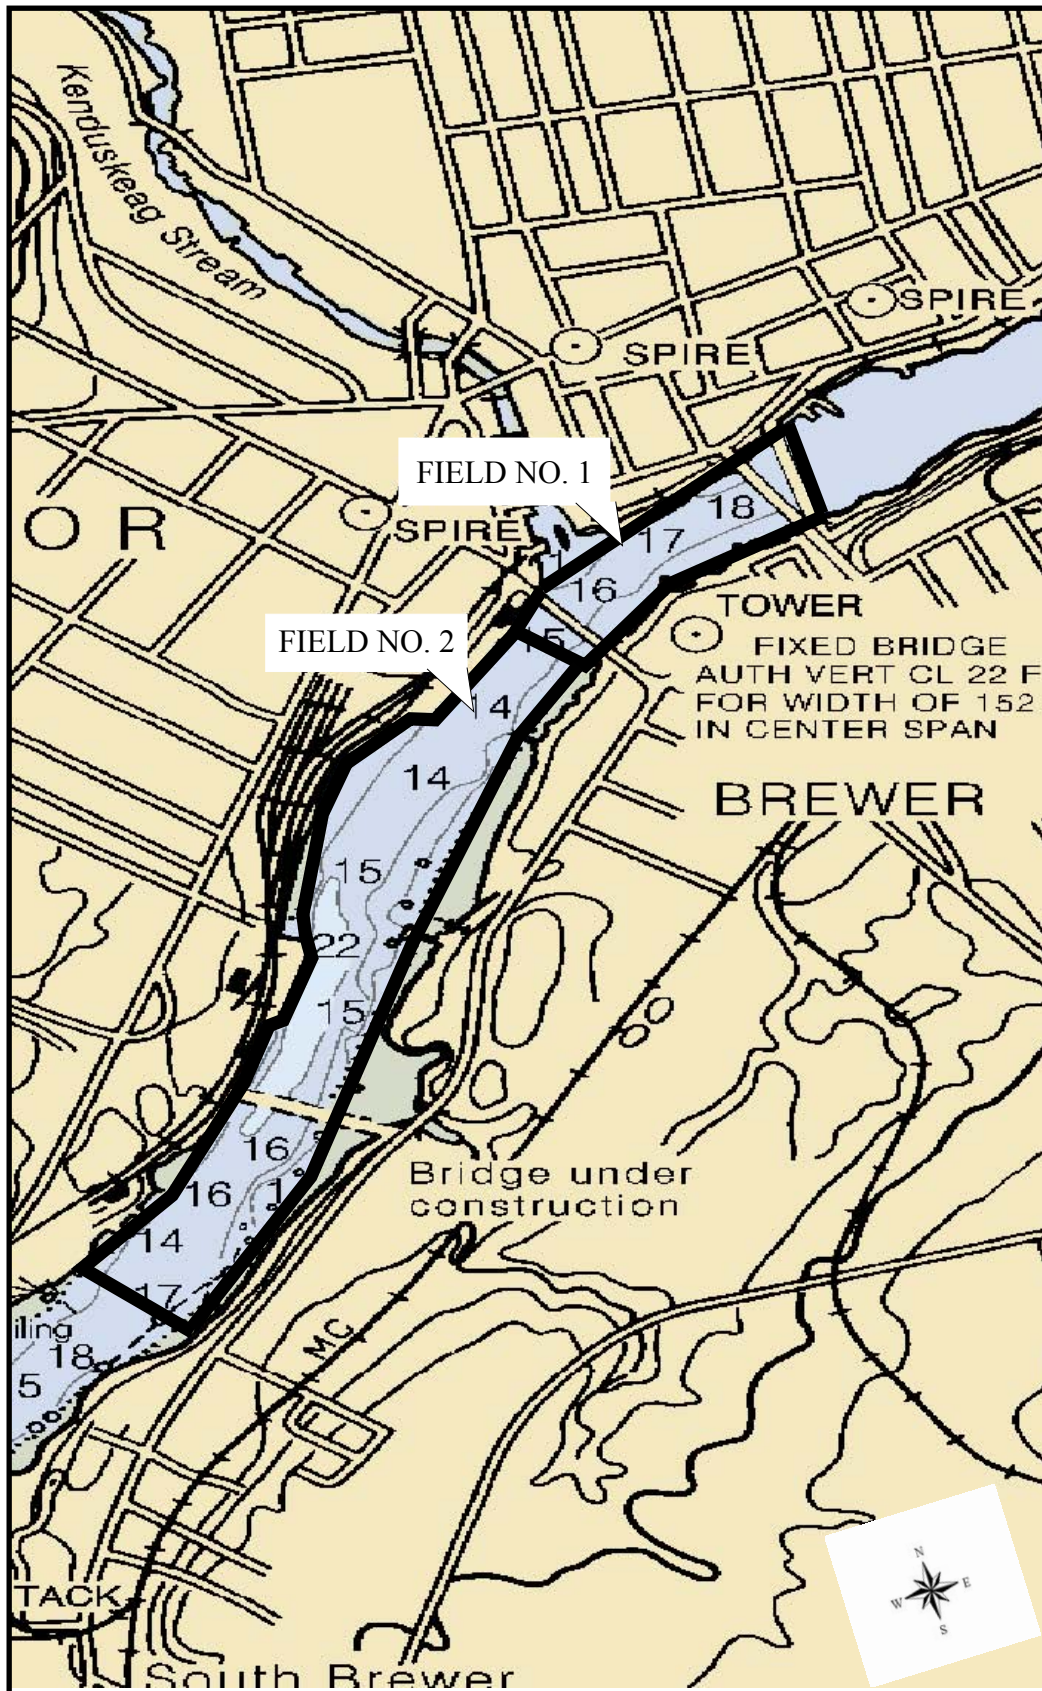
FIGURE 1
 PROJECT AREA MAP
 PENOBSCOT RIVER
 PENOBSCOT COUNTY, MAINE

The Penobscot River project area (Figure 1) covered two contiguous survey grids, called fields, totaling approximately 47.3 ha. The two contiguous fields are rectangular in format with the survey lines running parallel to the river's shoreline. The survey design defined each of the two fields as indicated in Table 1. To provide overlapping coverage across the entire field, a maximum 10-meter (m) interval separated the survey lines.

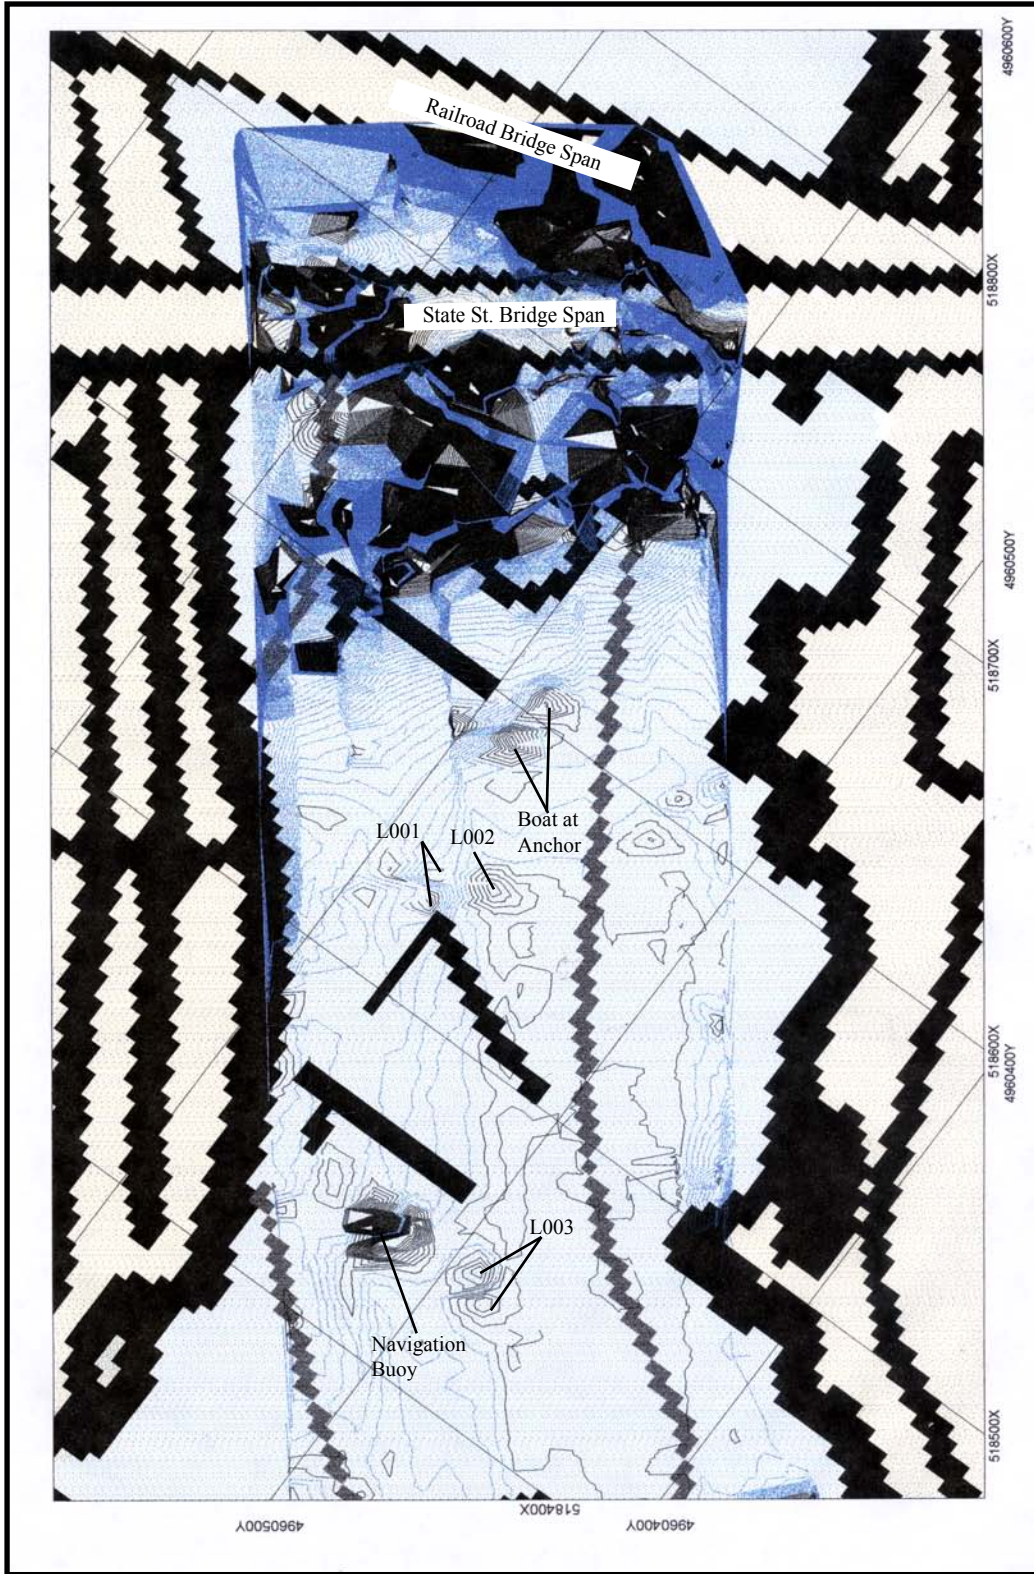
In Field No. 1 a series of high-amplitude anomalies correlated to the charted bridge spans along the rail line and at State and Wilson streets. Several other identified sources include: two barges; one motor vessel; cribbing; a navigation buoy; and pier. Unidentified sources account for five anomaly clusters of various size, complexity and amplitude, and herein designated localities L001-L005 (Figures 2 and 3).

Locality L001 is mid-channel, oriented perpendicular to the shoreline, and consists of two anomalies that ranged in maximum variation of 161 nT. The moderate-amplitude and simplistic dipolar structure associated with these two anomalies is not indicative of a complex wreck signature. The mid-channel location is a strong indicator that the potential source is modern, such as pipe or scrap metal. In addition, the relatively narrow and sharp vertical profile is a strong indicator that the potential source is extant off the bottom.

Locality L002 is mid-channel, about 20-m southeast of L001. The anomaly is a moderate-amplitude (+115 nT) monopole, relatively proportional in profile and overall simplistic in structure. Its signature is not indicative of a complex wreck signature and is a strong indicator of an uncomplicated magnetic source. Its mid-channel location is a strong indicator that the potential source is modern.

□ FIGURE 2
 □ PENOBSCOT RIVER SURVEY
 □ PENOBSCOT COUNTY, MAINE
 □ FIELD NO. 1
 NHC Field Season 2000

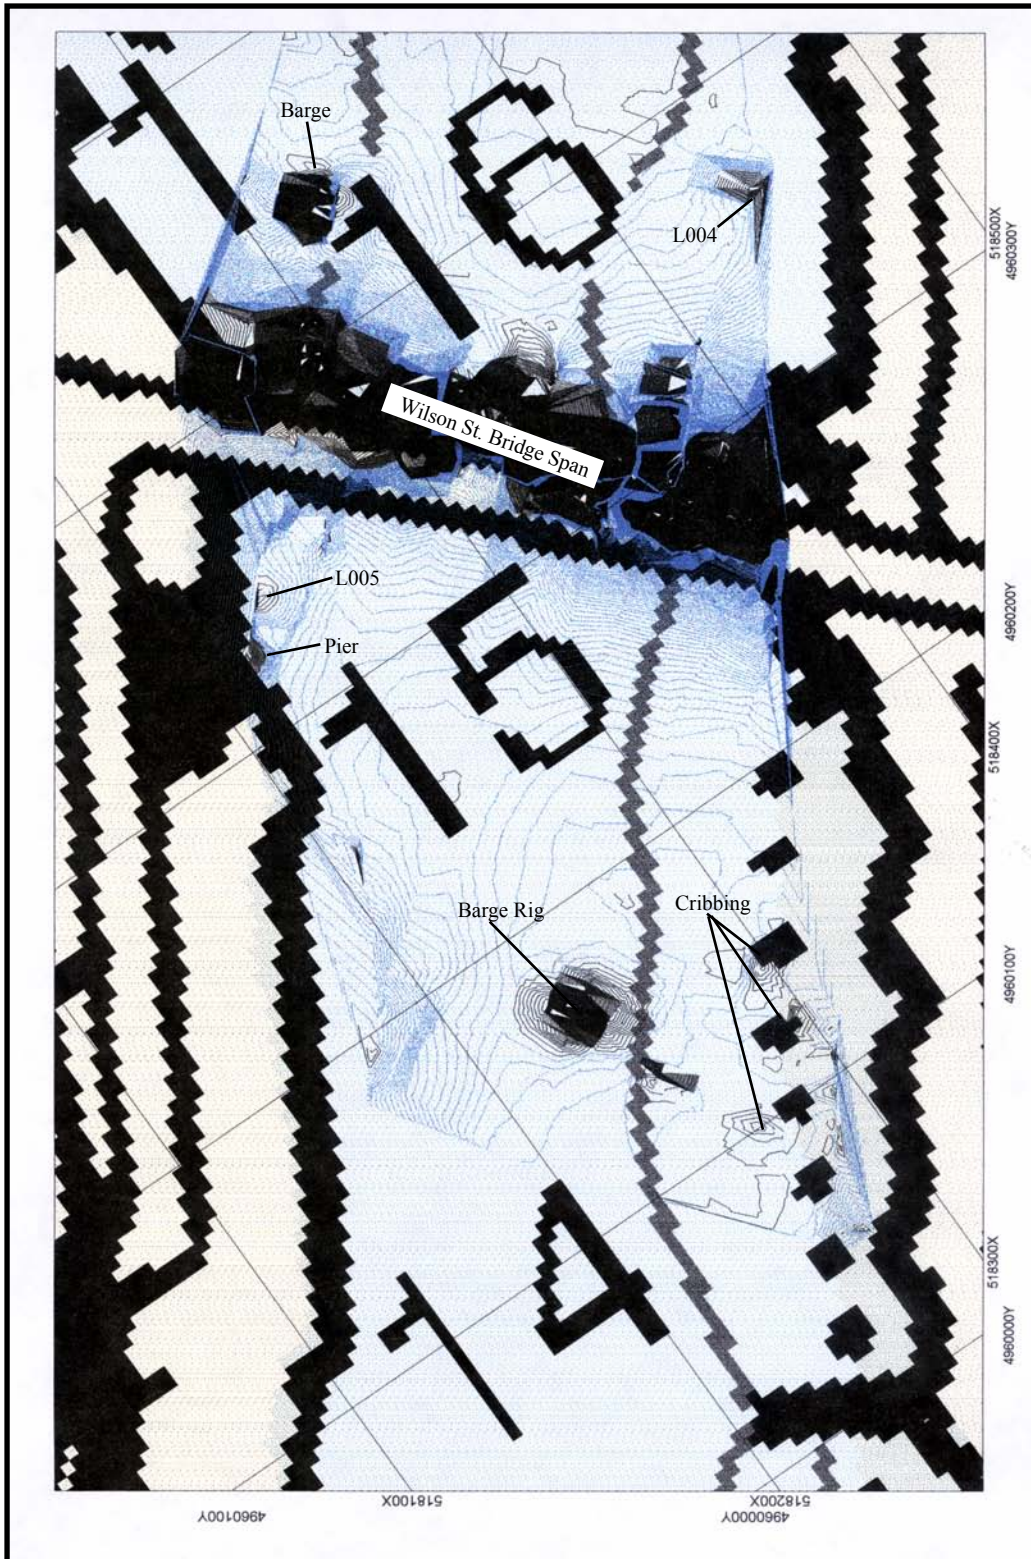
FIGURE 3
 PENOBSCOT RIVER SURVEY
 PENOBSCOT COUNTY, MAINE
 FIELD NO. 1 CON'T □
 NHC Field Season 2000

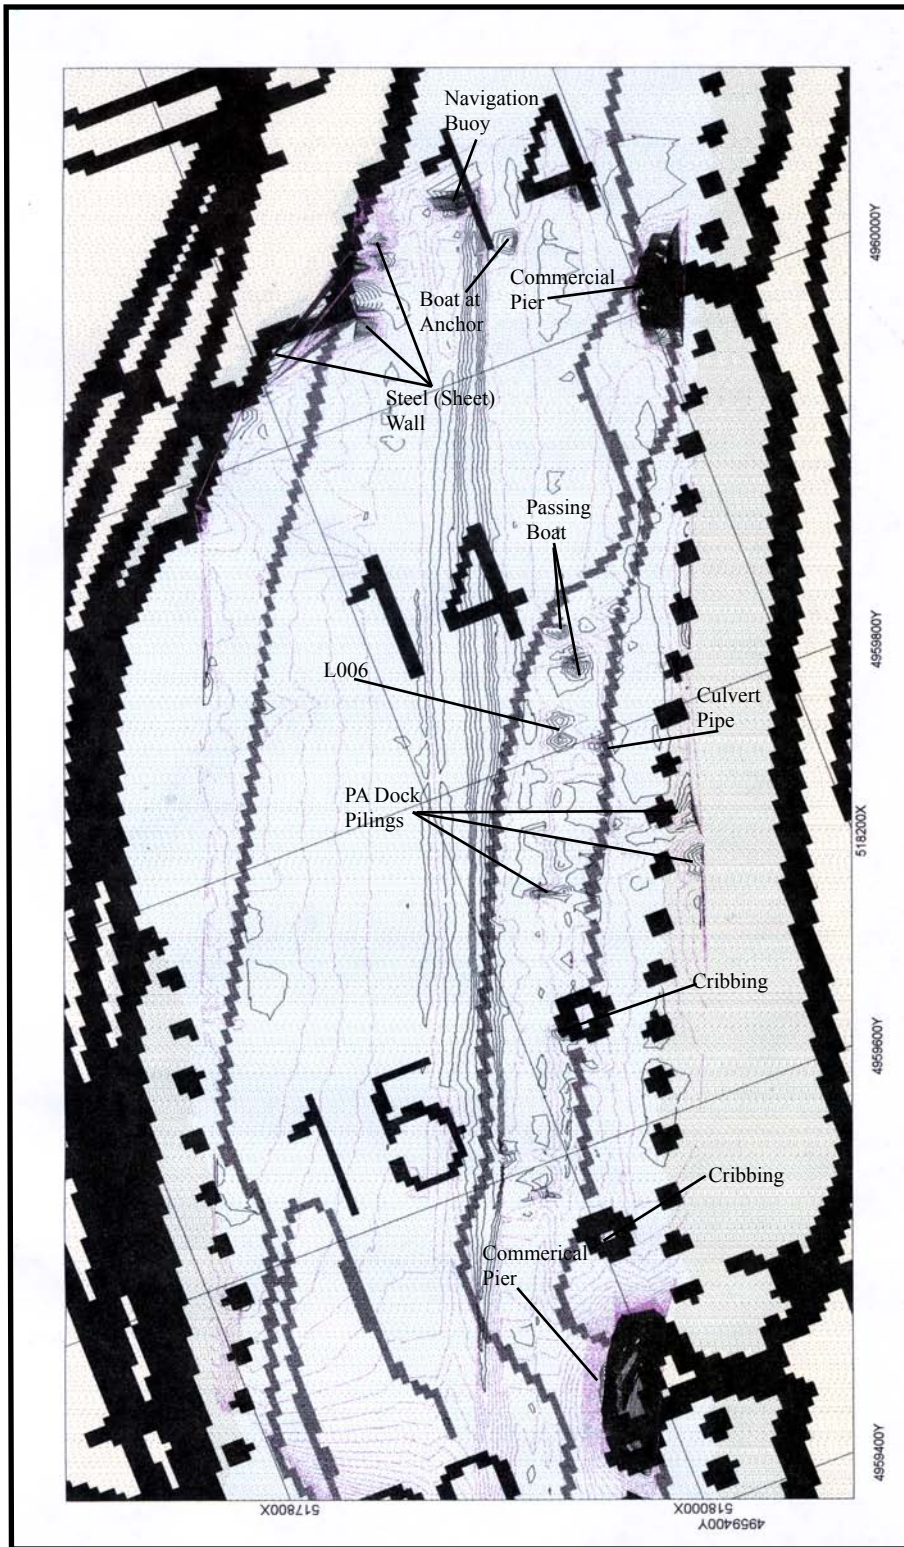
In Field No. 2 a series of high-amplitude anomalies correlated to the charted bridge span along I-395. Other identified sources include: a steel sheet erosion barrier; two motor vessels (one at anchor); cribbing; culvert pipe; navigation buoy; commercial facilities (e.g., docks and piers), train wheels (i.e., scrape metal), steel I-beam, and, a power line crossing. Unidentified sources account for four anomaly clusters of various size, complexity, and amplitude, and are herein designated localities L006-L009 (Figures 4, 5 and 6).

Locality L006 is on the Brewer side of the river, about 25-m inshore of the channel and well within the shoulder. It consists of two anomalies that ranged in maximum variation of 64.6 nT. The low-amplitude and simplistic dipolar structure associated with these two anomalies is not indicative of a complex wreck signature. The relatively narrow and unbalanced profile indicates that the sensor passed close to one end of a potentially small magnetic source (i.e., a section of culvert pipe).

Locality L007 is on the Brewer side of the river, about 156 m upriver from the charted bridge span along I-395. It consists of two anomalies that ranged in maximum variation of 33.5 nT. The anomalies appeared along only one run line, about 13-m inshore of the channel and well within the shoulder small. The low-amplitude and simplistic dipolar structure associated with these two anomalies is not indicative of a complex wreck signature. The short wavelength (about 8 m) and

FIGURE 4
 PENOBSCOT RIVER SURVEY
 PENOBSCOT COUNTY, MAINE
 FIELD NO. 2
 NHC Field Season 2000

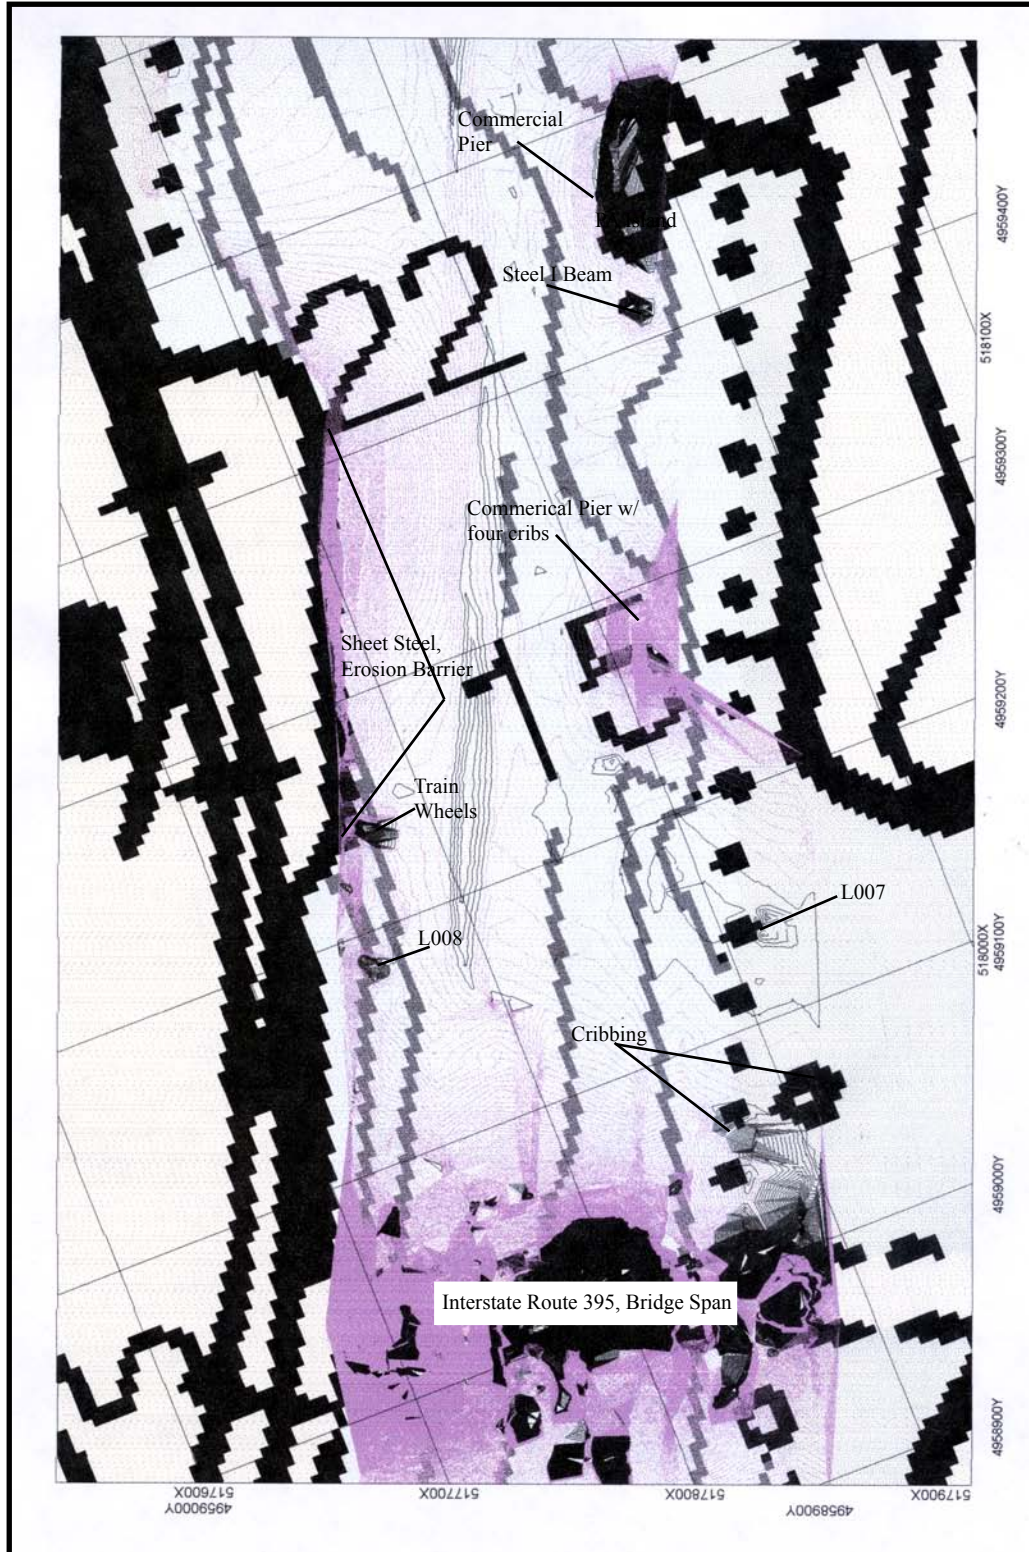
FIGURE 5
 PENOBSCOT RIVER SURVEY
 PENOBSCOT COUNTY, MAINE
 FIELD NO. 2 CON'T...
 NHC Field Season 2000
