**The Penobscot Expedition Archaeological Project:
Field Investigations 2000 and 2001**

FINAL REPORT

**Prepared by:
Naval Historical Center
Underwater Archaeology Branch
805 Kidder Breese St., SE
Washington Navy Yard, D.C. 20374-5060**

Fall 2003

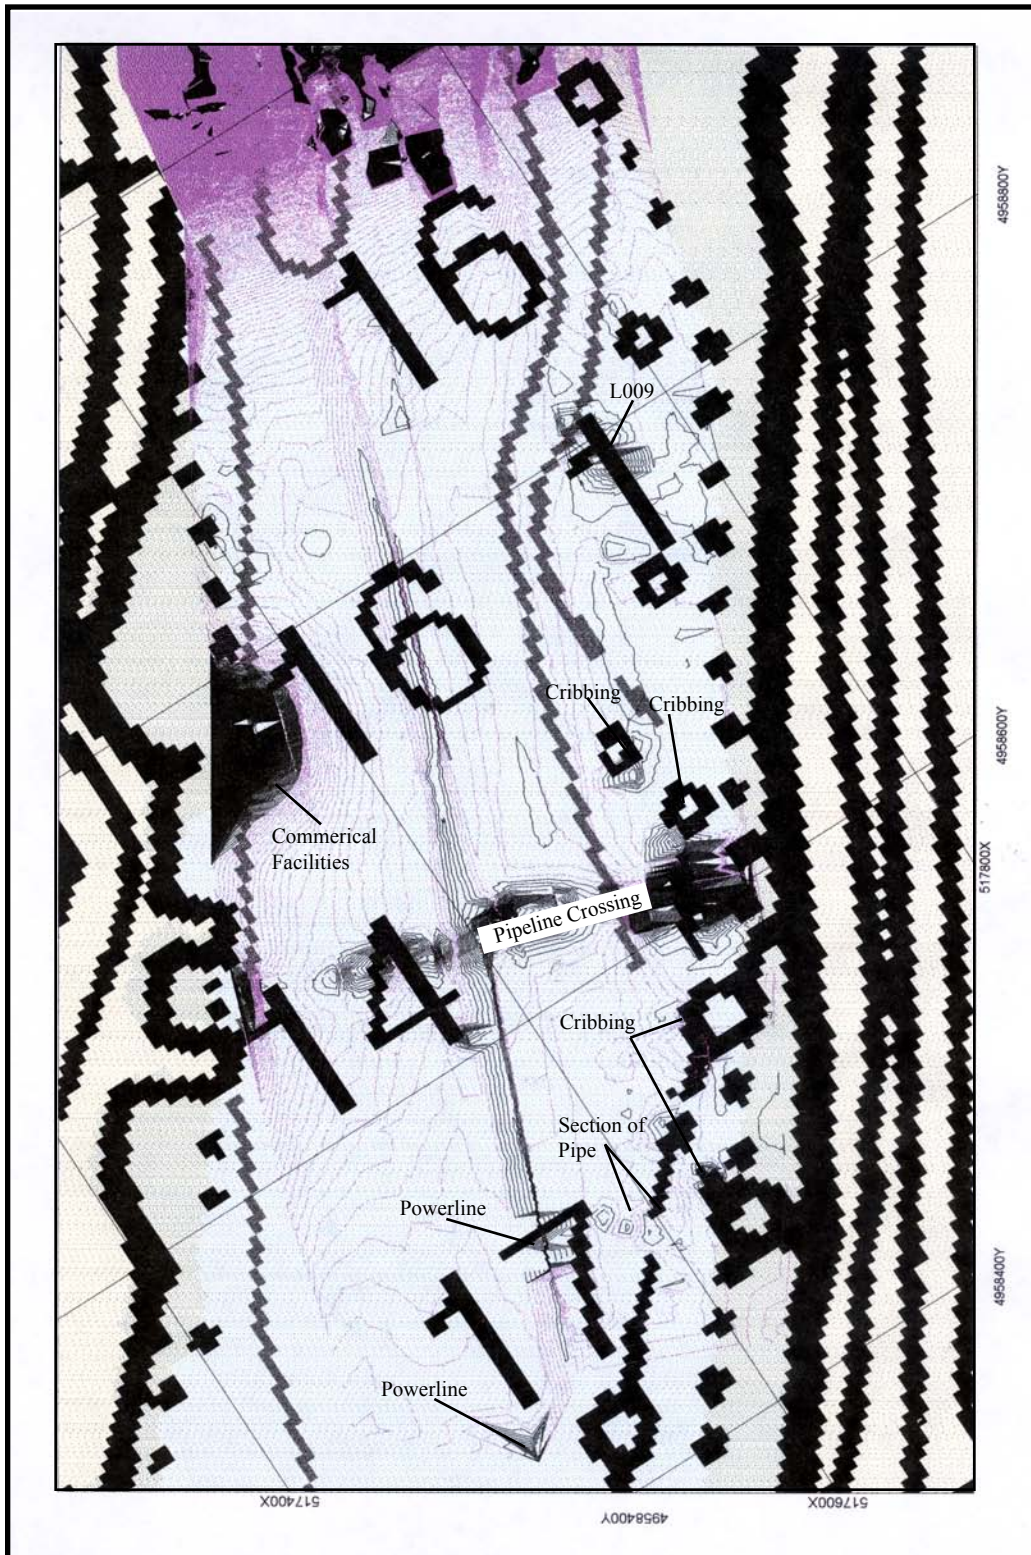
FIGURE 6
 PENOBSCOT RIVER SURVEY
 PENOBSCOT COUNTY, MAINE
 FIELD NO. 2 CON'T...
 NHC Field Season 2000

In Field No. 2 a series of high-amplitude anomalies correlated to the charted bridge span along I-395. Other identified sources include: a steel sheet erosion barrier; two motor vessels (one at anchor); cribbing; culvert pipe; navigation buoy; commercial facilities (e.g., docks and piers), train wheels (i.e., scrape metal), steel I-beam, and, a power line crossing. Unidentified sources account for four anomaly clusters of various size, complexity, and amplitude, and are herein designated localities L006-L009 (Figures 4, 5 and 6).

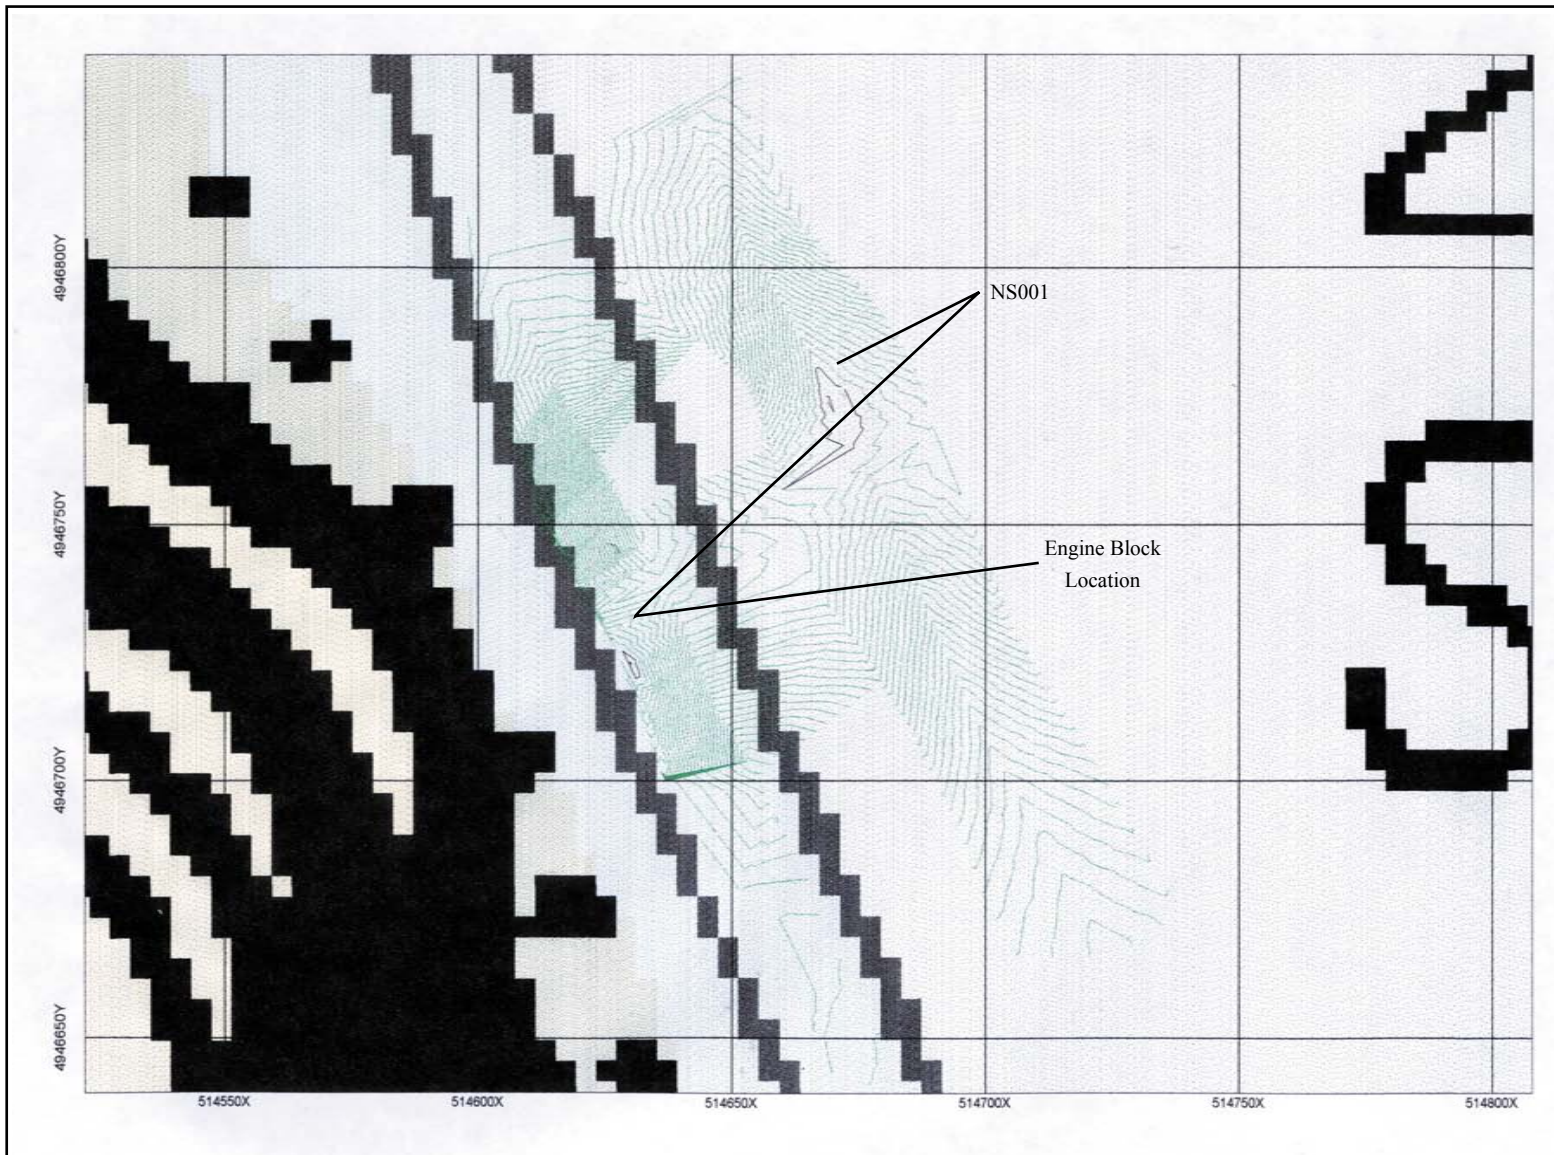
In the North Segment of Oak Point (Figure 1), an unidentified source (NS001) created a high-amplitude monopole (+450 nT). Although the long wavelength and simplistic monopole signature is characteristic of geological sources, the high amplitude indicated that the source represented a man-made object. It's thought that the broad wavelength signified an object superimposed on a broader regional gradient. The NHC conducted a brief ground truthing excursion on the target and identified a six-cylinder engine block as the primary anomaly source. In addition, limited exploration around the block revealed several eel traps, their magnetic signature masked by the engine block.

FIGURE 1
PENOBSCOT RIVER SURVEY
PENOBSCOT COUNTY, MAINE
OAK POINT, NORTH SEGMENT
 NHC Field Season 2001

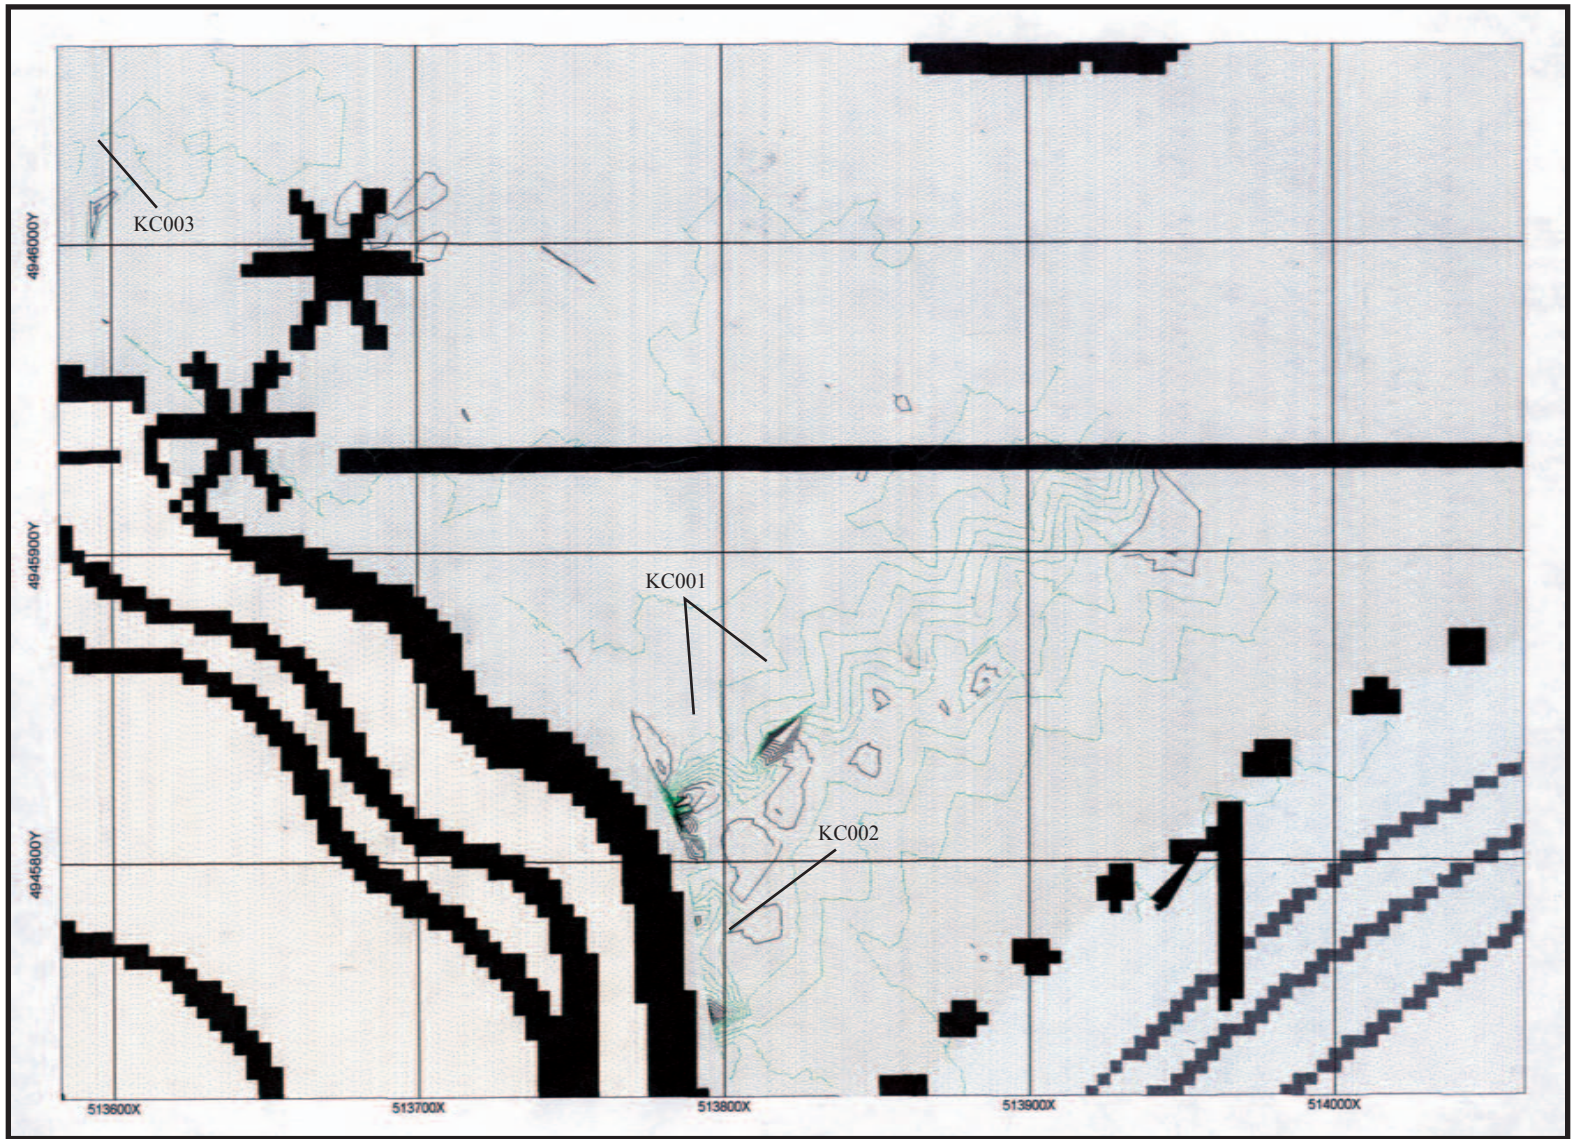
Locality KC001 (Figure 2) is an anomaly cluster that contained at least four nodes of various sizes, complexity, and amplitude that ranged 167 nT in maximum variation. Its location on the southwest shoreline, about 68-m north of KC002, may be a peripheral indication of a potential magnetic source that extends farther inshore. Also, the relatively short wavelength and narrow, steep profile of each node indicated that the source is most likely close to the surface, although the shallow water depth could be more of an influencing factor in the signature.

Locality KC002 (see Figure 2) extends from the outer edge of the southwest shoreline. The anomaly is a moderate-amplitude (-130 nT) monopole. Its overall simplistic shape is not indicative of a complex wreck signature. Its broad appearance could be due to the regional gradients, or, even more likely, indicate more distant sources that extend inshore.

Locality KC003 (see Figure 2) extends from the northwestern shoreline. The anomaly is a low-amplitude monopole (+30 nT) and displayed a very simplistic shape. Its overall structure is not indicative of a complex wreck signature. Its predominant permanent magnetization (steep and narrow in profile) is a strong indicator that the potential magnetic source is a single fabric unit.

FIGURE 2
PENOBSCOT RIVER SURVEY
PENOBSCOT COUNTY, MAINE
KEMPTON COVE
NHC Field Season 2001

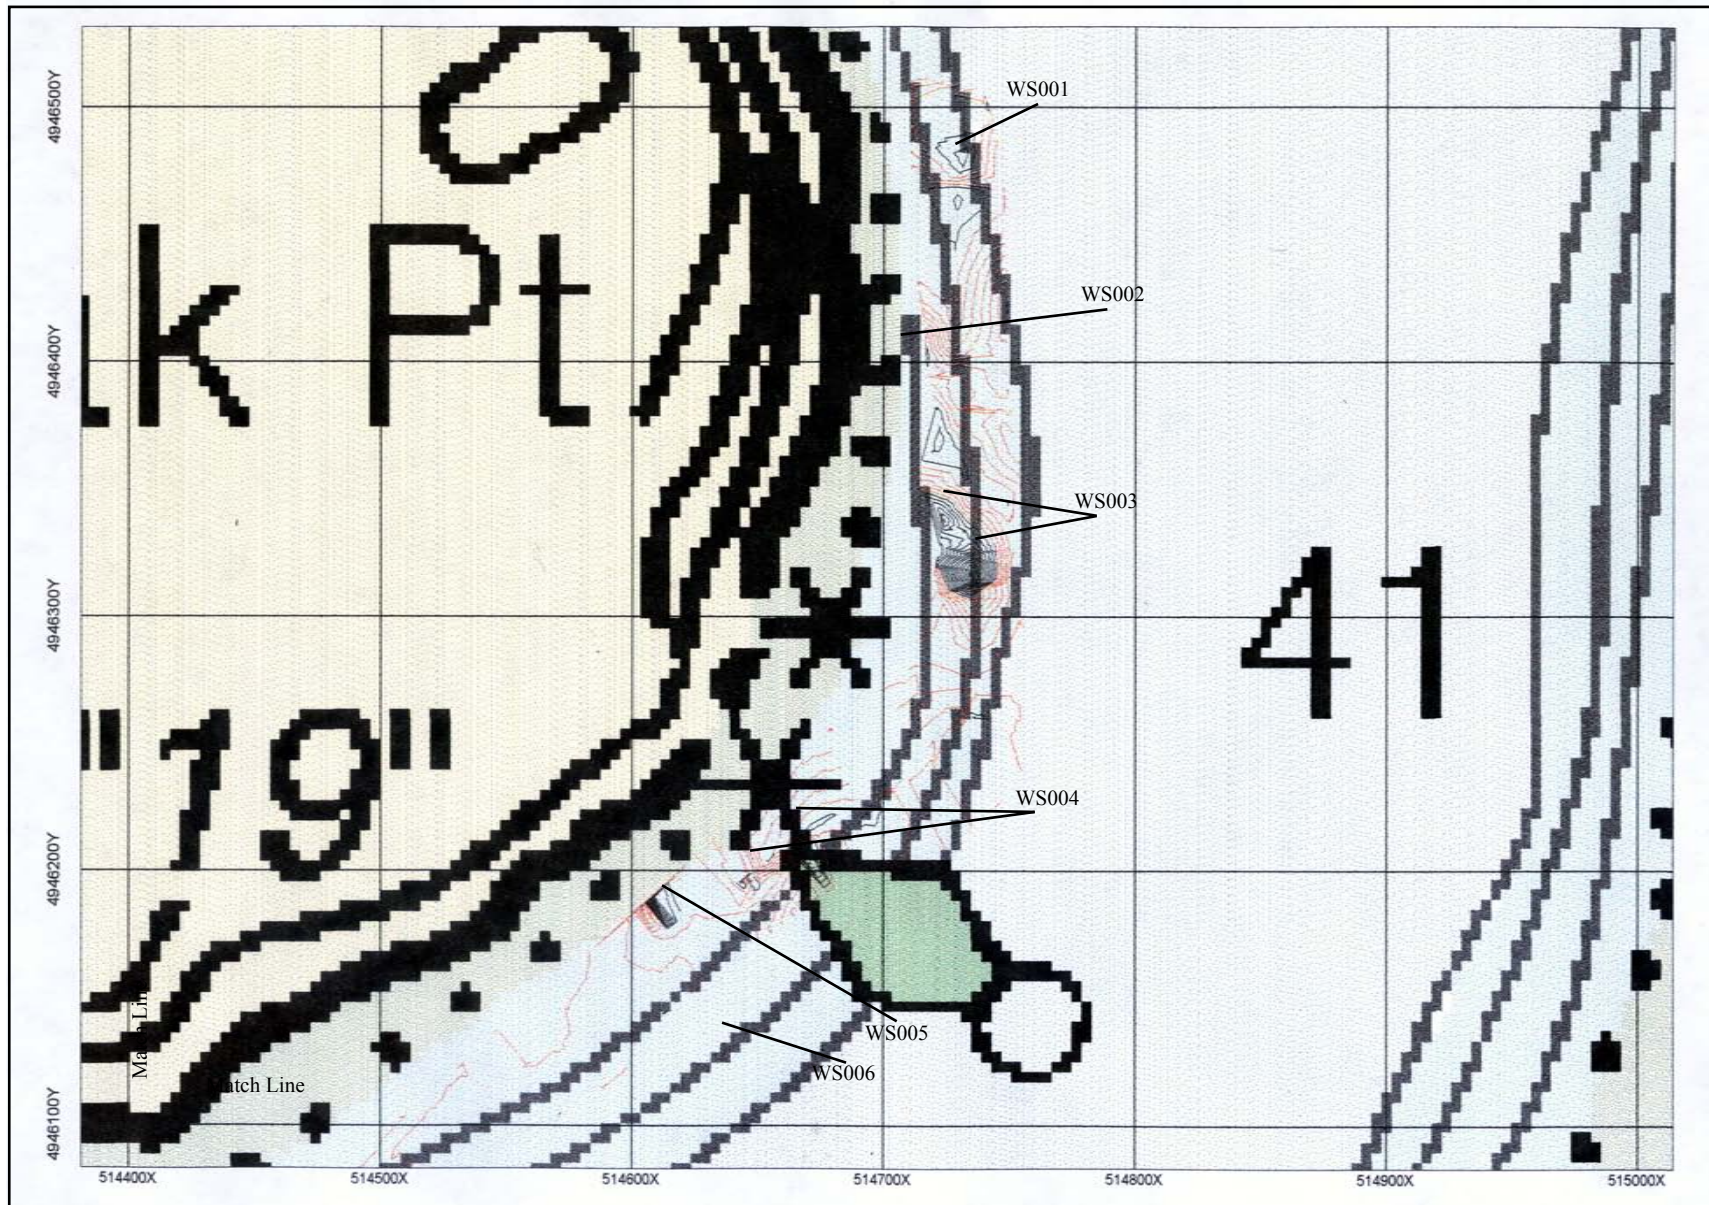
Locality WS001 (Figure 3) exhibited a moderate-amplitude (195 nT) dipole anomaly. The amplitude behavior (e.g., steep in the positive direction [+170 nT] and narrow in wavelength) indicated the sensor passed close to one pole or end of the object. In general, the moderate amplitude suggested a good measure of detectability (i.e., ferromagnetic mass); however, WS001 was too simplistic to produce a meaningful interpretation without an associated sonar target.

Locality WS003 (see Figure 3), a moderate-amplitude (183 nT maximum) dipole anomaly, exhibited two positive nodes (+109 and +183 nT). The amplitude behavior of each node (e.g., steep in the positive direction [+183 nT] and narrow in wavelength) was probably a function of the shallow water depth and sensor orientation. Overall, Locality WS003 appeared to represent

■ FIGURE 3
 ■ PENOBSCOT RIVER SURVEY
 ■ PENOBSCOT COUNTY, MAINE
 ■ OAK POINT, WEST SHORELINE
 NHC Field Season 2001

Locality WS004 (see Figure 3) marked two low-amplitude dipole anomalies on the channel shoulder. The more pronounced dipole (± 45 nT) anomaly coincided with a charted channel buoy (green can). In addition, a smaller dipole (-41 nT- $+19$ nT), just 20 m down river, is probably associated with the channel buoy and/or its mooring and chain. In addition to the low amplitude, the profile is steep and narrow, indicating a small, exposed source of a relatively simplistic structure.

Locality WS005 is a low-amplitude dipole anomaly that extended from the western shoreline into the shallows (see Figure 3). The amplitude behavior, steep in both the positive and negative direction and narrow in wavelength, was probably a function of the shallow water depth and sensor orientation. The observed anomaly may only represent the periphery of potential magnetic source; however, its overall simplistic shape is not indicative of a complex wreck signature.

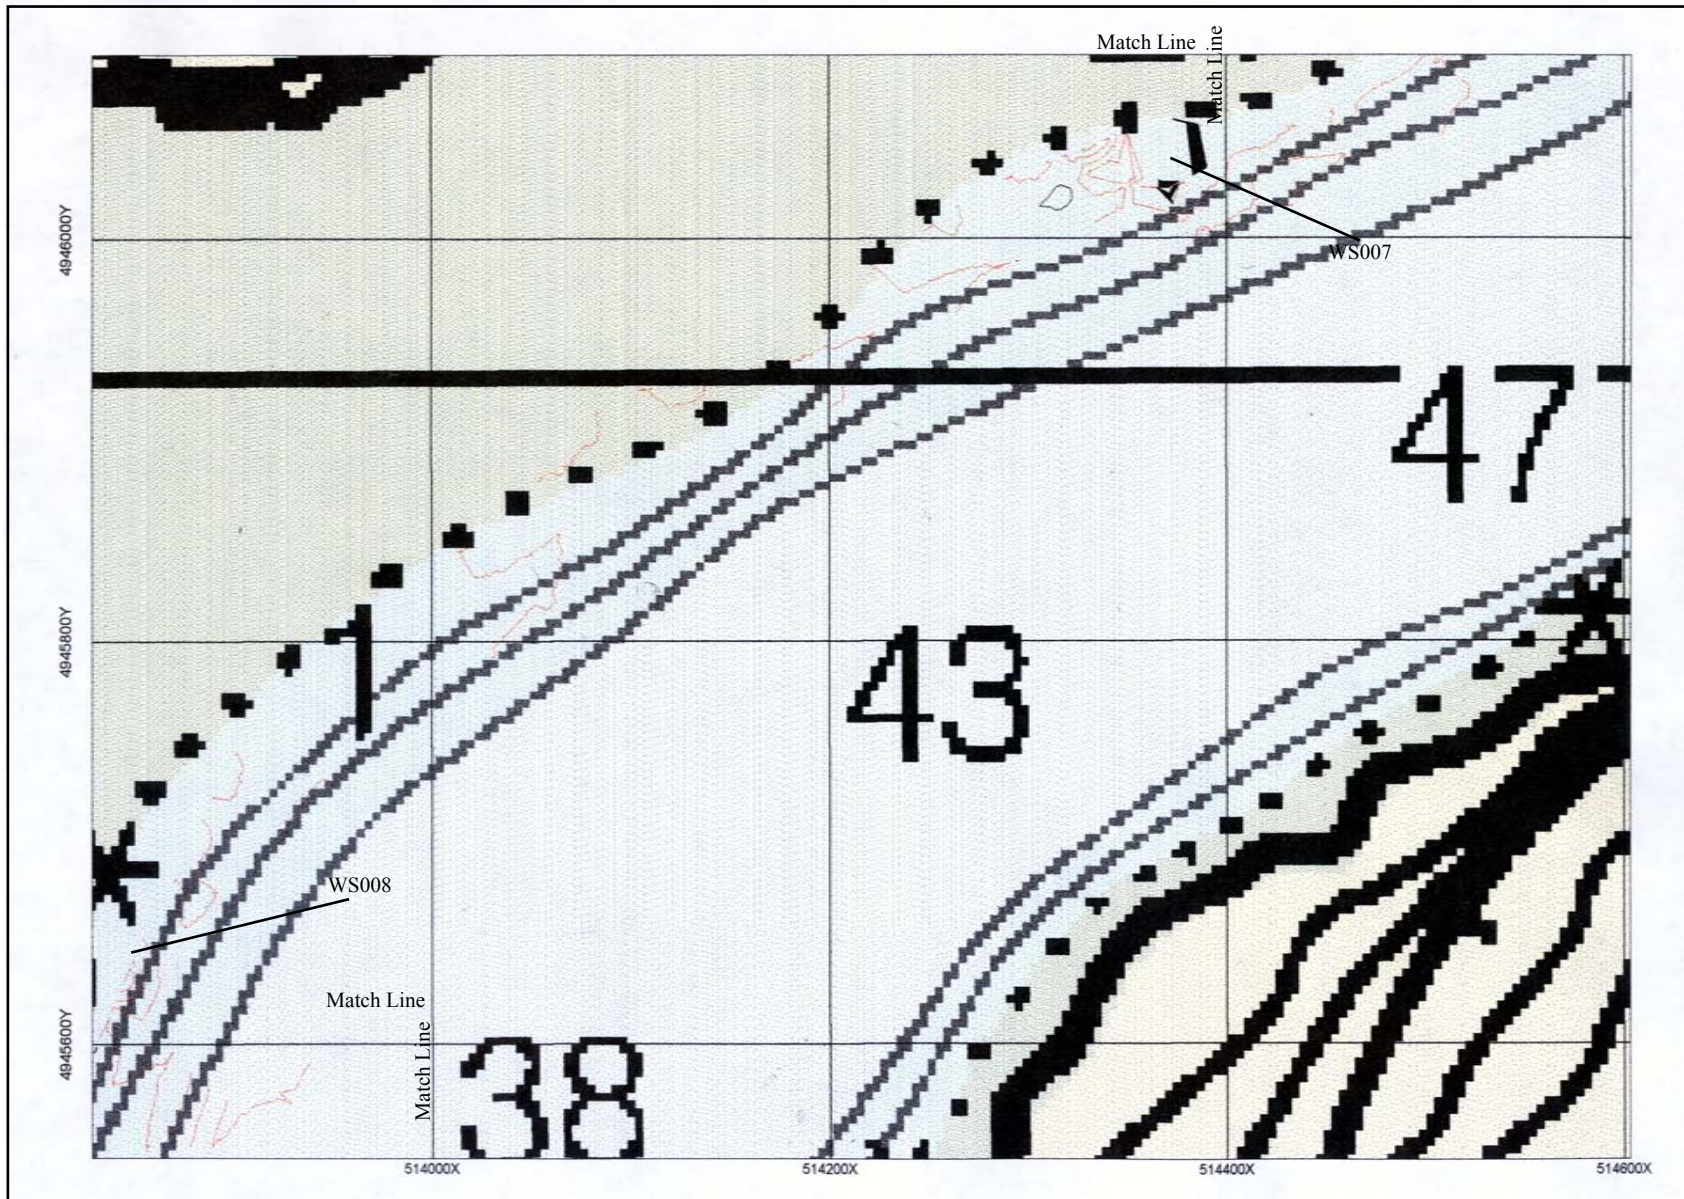
Locality WS008, a low-amplitude ($+35$ nT) monopole anomaly that likely represented the periphery of potential magnetic source extending into the river from inshore (see Figure 4). The weakness in amplitude detected may be the effect of a distant point of measurement. The simplistic shape is not indicative of a complex wreck signature and an isolated magnetic pole alone is not sufficient evidence to merit recommendation.

■ FIGURE 4
 ■ PENOBSCOT RIVER SURVEY
 ■ PENOBSCOT COUNTY, MAINE
 ■ OAK POINT, WEST SHORELINE
 NHC Field Season 2001

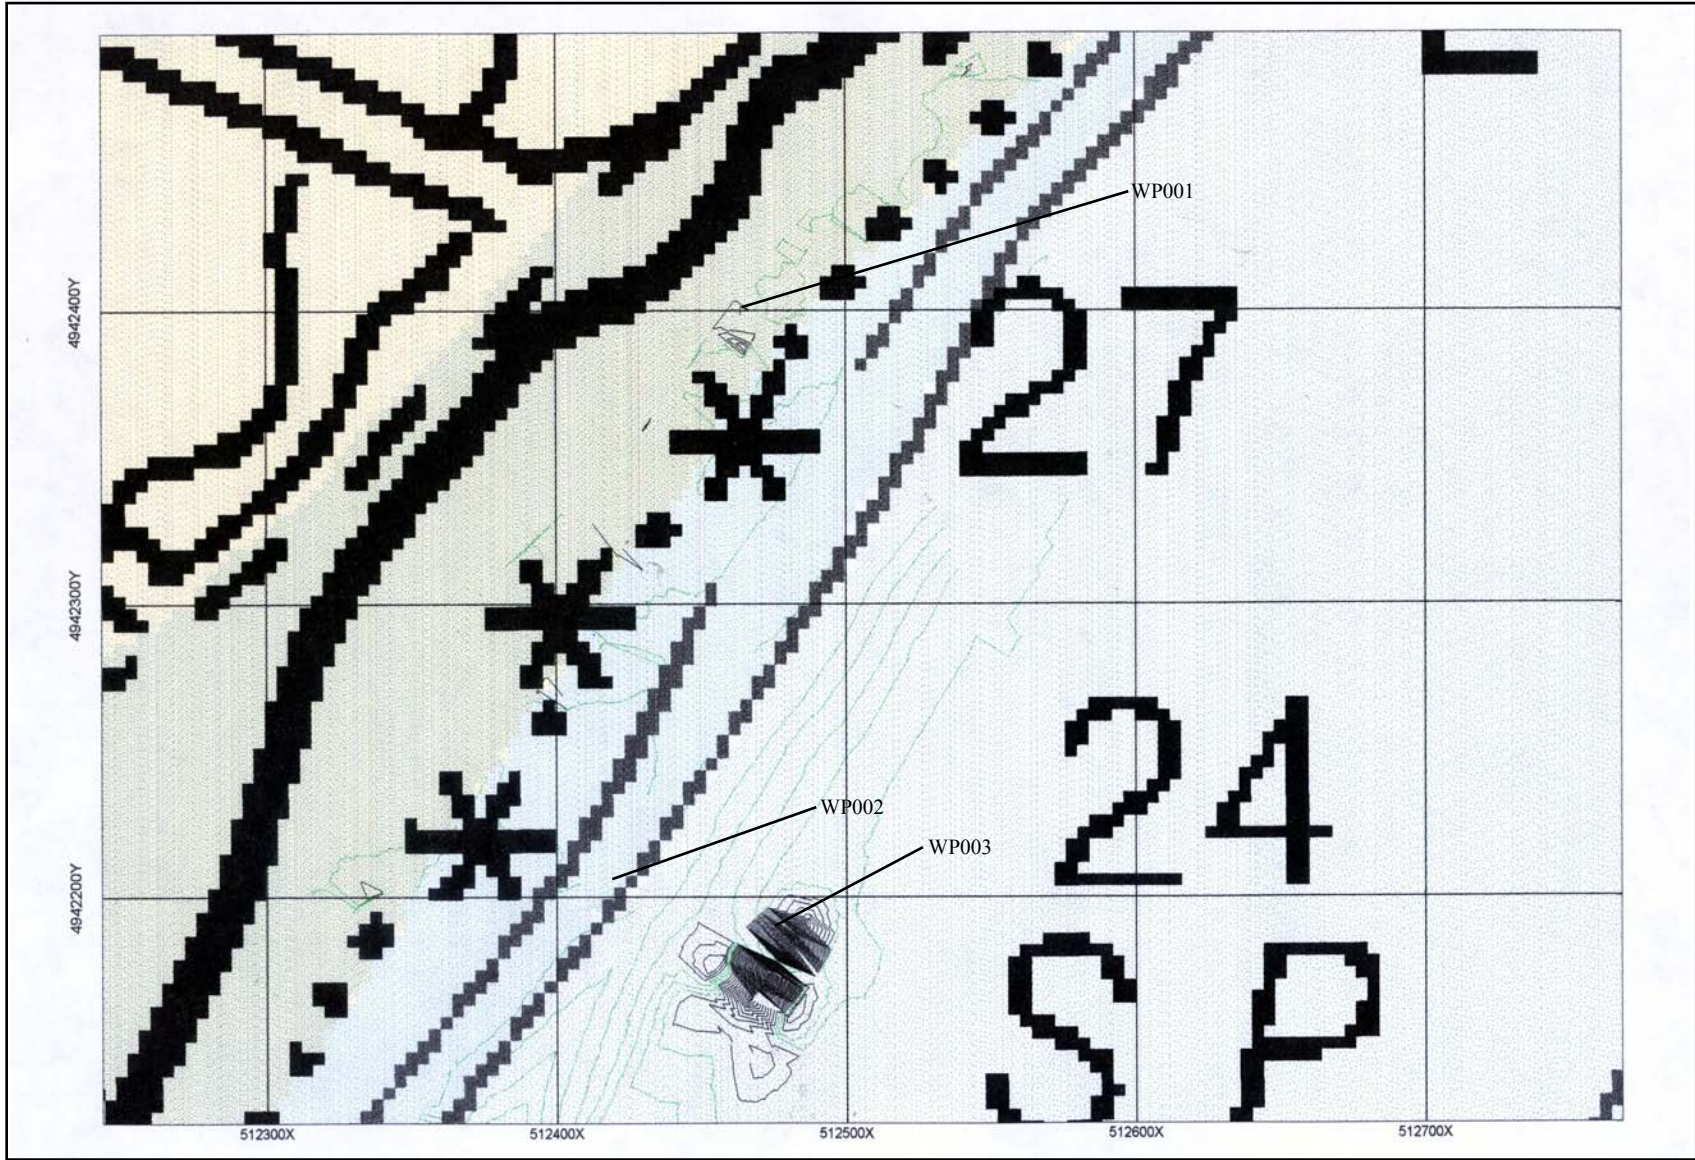
Locality WP003 indicated a high amplitude dipole that ranges 674.5 nT in maximum variation (see Figure 7). The amplitude behavior, steep in both the positive and negative direction and narrow in wavelength, was a function of the sensor orientation and nature of the source. Although the anomaly lacked an associated sonar target, the high magnetic contrast of the two nodes (+335/-339.5) may have masked proportionally smaller anomalies in the near field.

■ FIGURE 7
 ■ PENOBSCOT RIVER SURVEY
 ■ PENOBSCOT COUNTY, MAINE
 ■ WINTERPORT SHORELINE
 NHC Field Season 2001

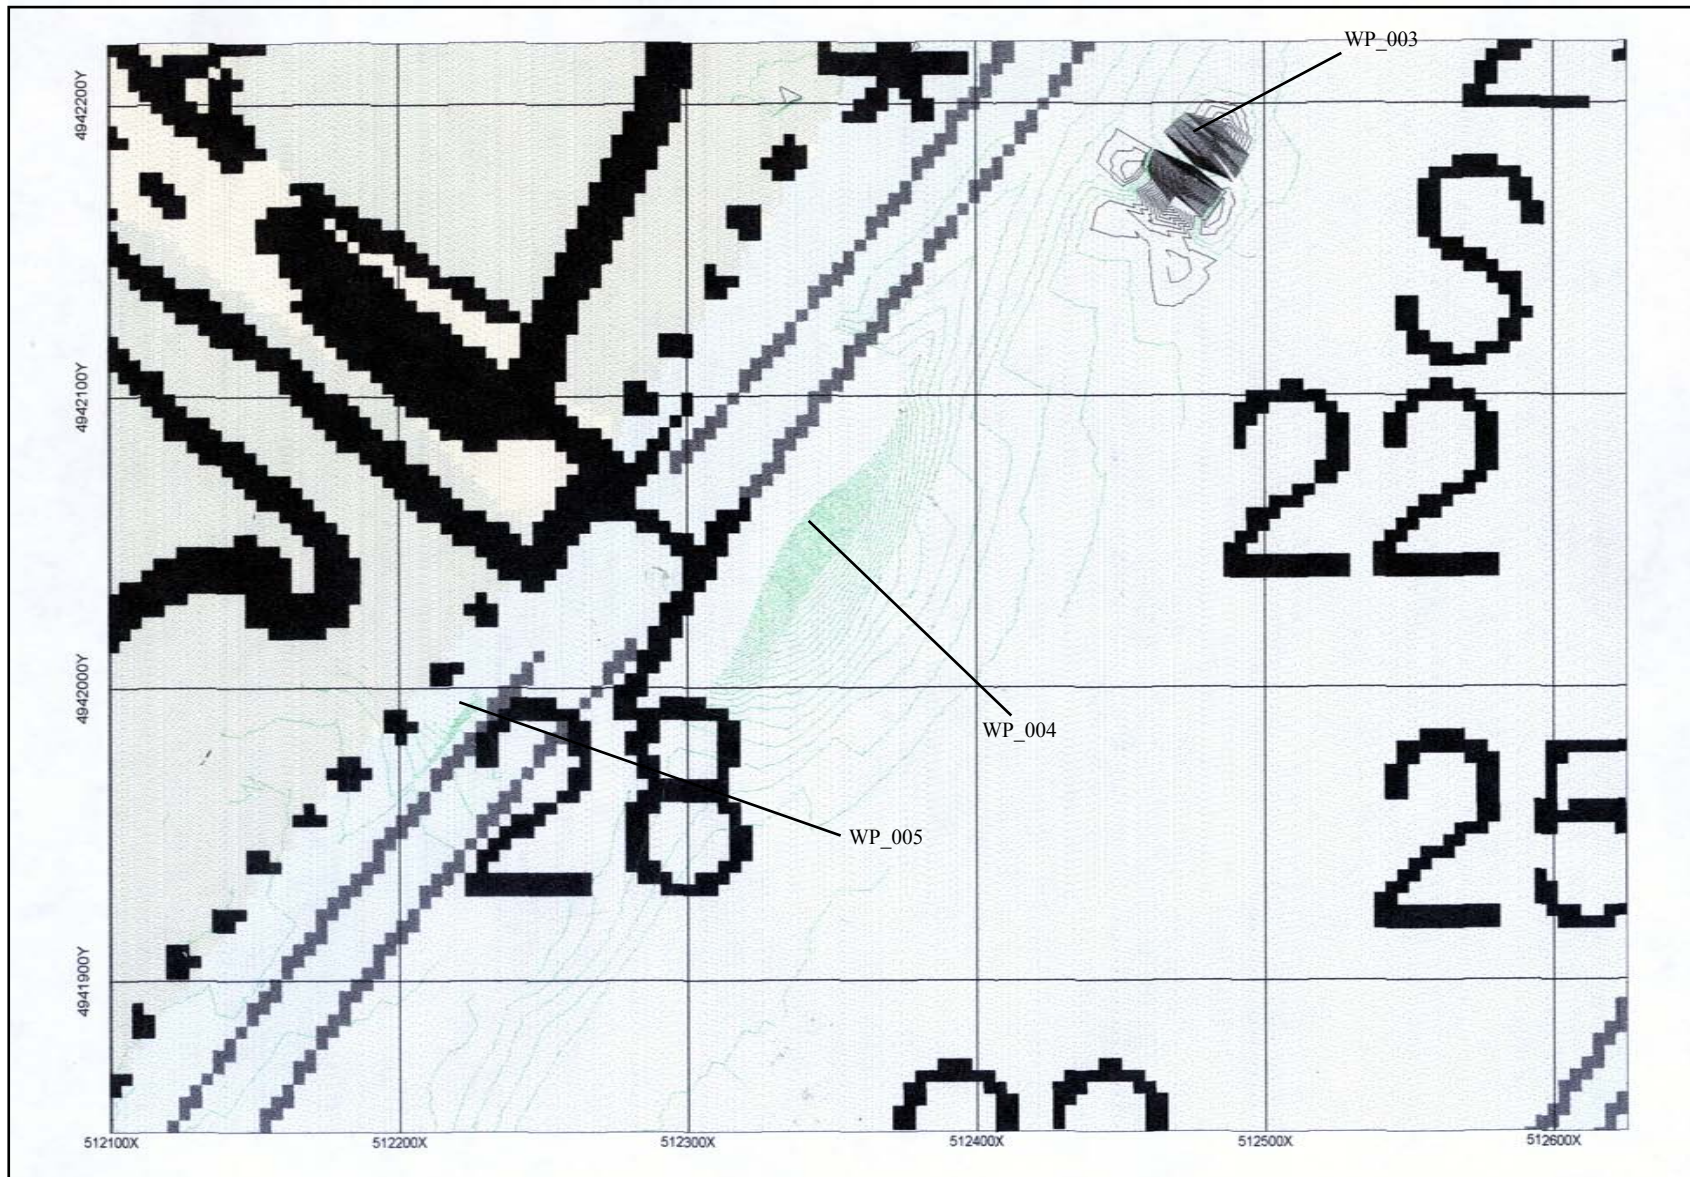
Locality WP004 (Figure 8), a high-amplitude (+585 nT) monopole anomaly, corresponded to the terminal pier at Winterport. The terminal pier consisted of a converted iron barge about 61 m long. Its high magnetic contrast influenced the recordings observed on six adjacent survey lines.

□ FIGURE 8
 PENOBSCOT RIVER SURVEY
 □ PENOBSCOT COUNTY, MAINE
 □ WINTERPORT SHORELINE
 NHC Field Season 2001

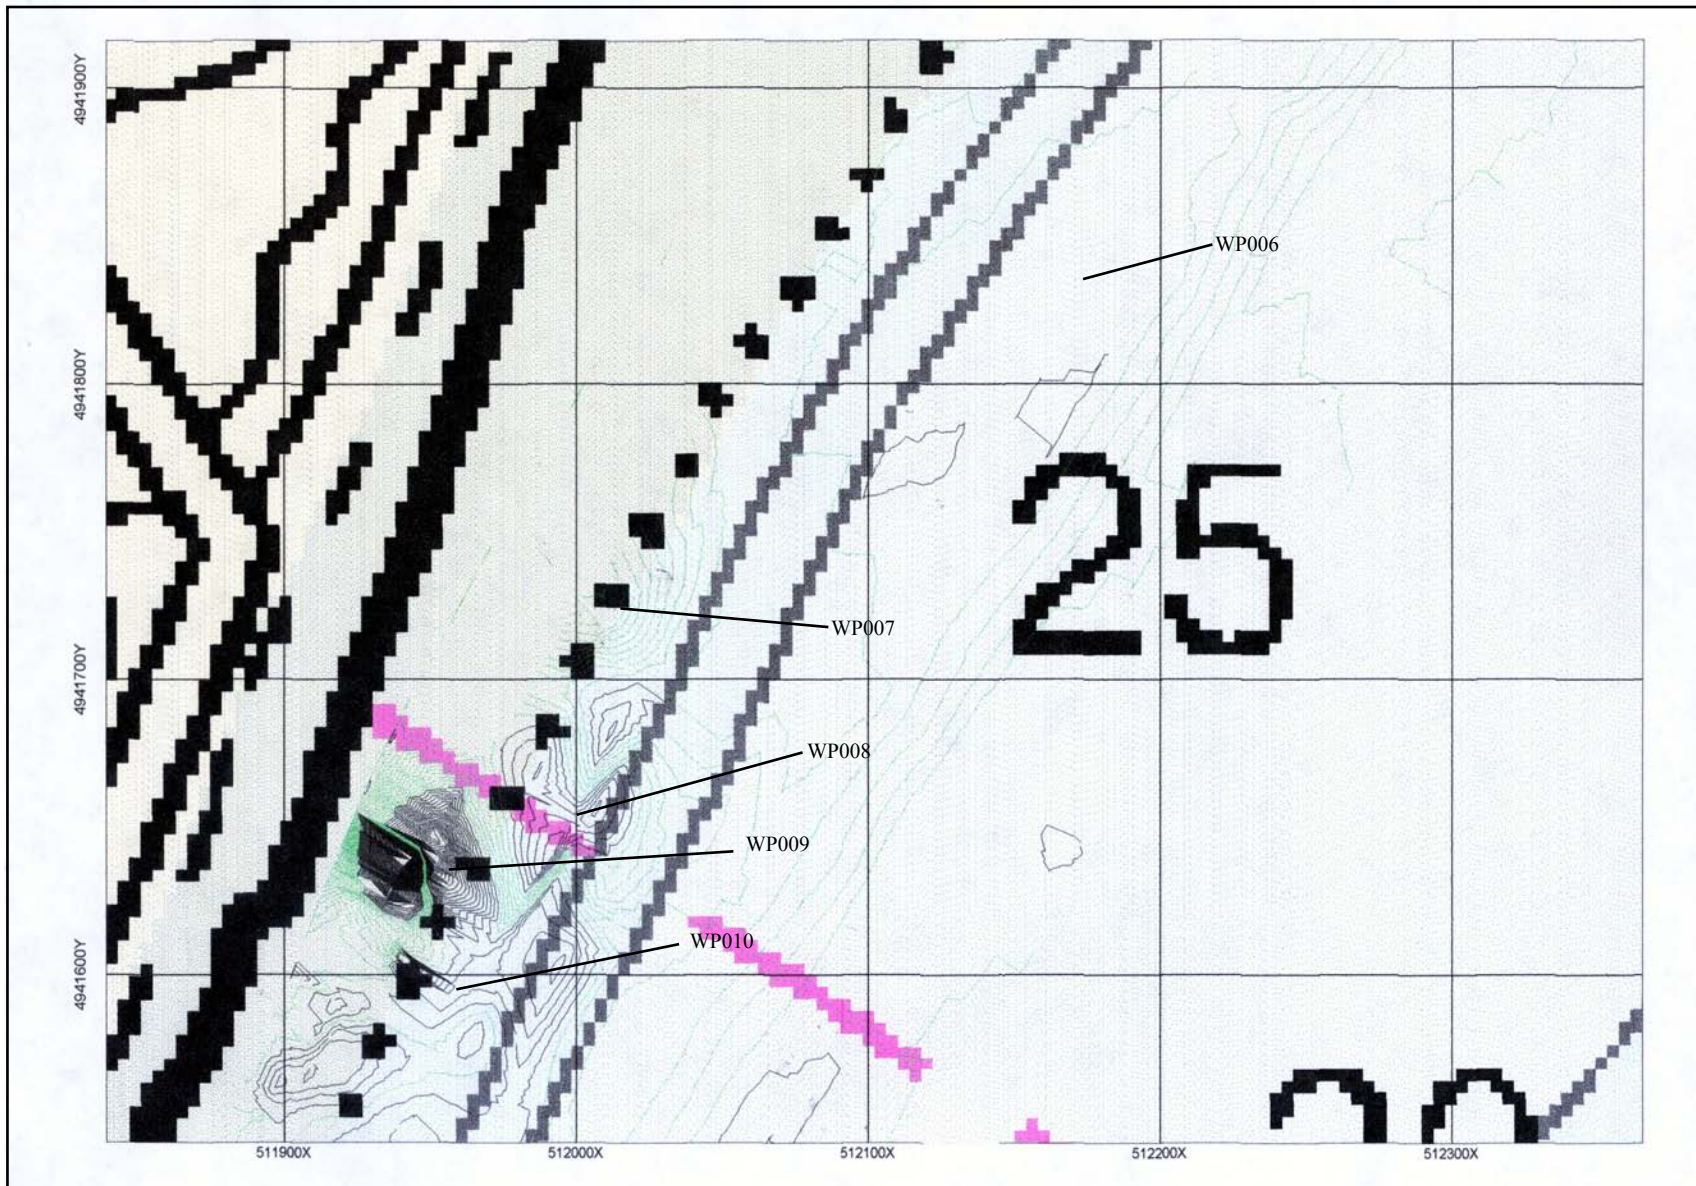
Locality WP009 corresponded to a high-amplitude (848 nT), unbalanced (+646/-202 nT), dipole anomaly (see Figure 9). The anomaly, discovered on line 31 in the charted Cable area and observed over three survey lines, demonstrated a high magnetic contrast and influence over the ambient background recording. The high magnetic contrast and proportionally narrow profile represented a function of the shallow water depth (about 2 m at flood tide), sensor orientation, and the source's ferromagnetic content. The lack of a compelling sonar target and the locale inside the cable crossing area leads to the interpretation that the potential source is likely a modern object.

Locality WP010 (Target 15_006) marked a moderate-amplitude (139 nT), unbalanced (+34/-105 nT), dipole anomaly and an associated sonar target (see Figure 9). The weak negative value and proportionally narrow profile represented a function of the sensor orientation passing close to

■ FIGURE 9
 PENOBSCOT RIVER SURVEY
 ■ PENOBSCOT COUNTY, MAINE
 ■ WINTERPORT SHORELINE
 NHC Field Season 2001

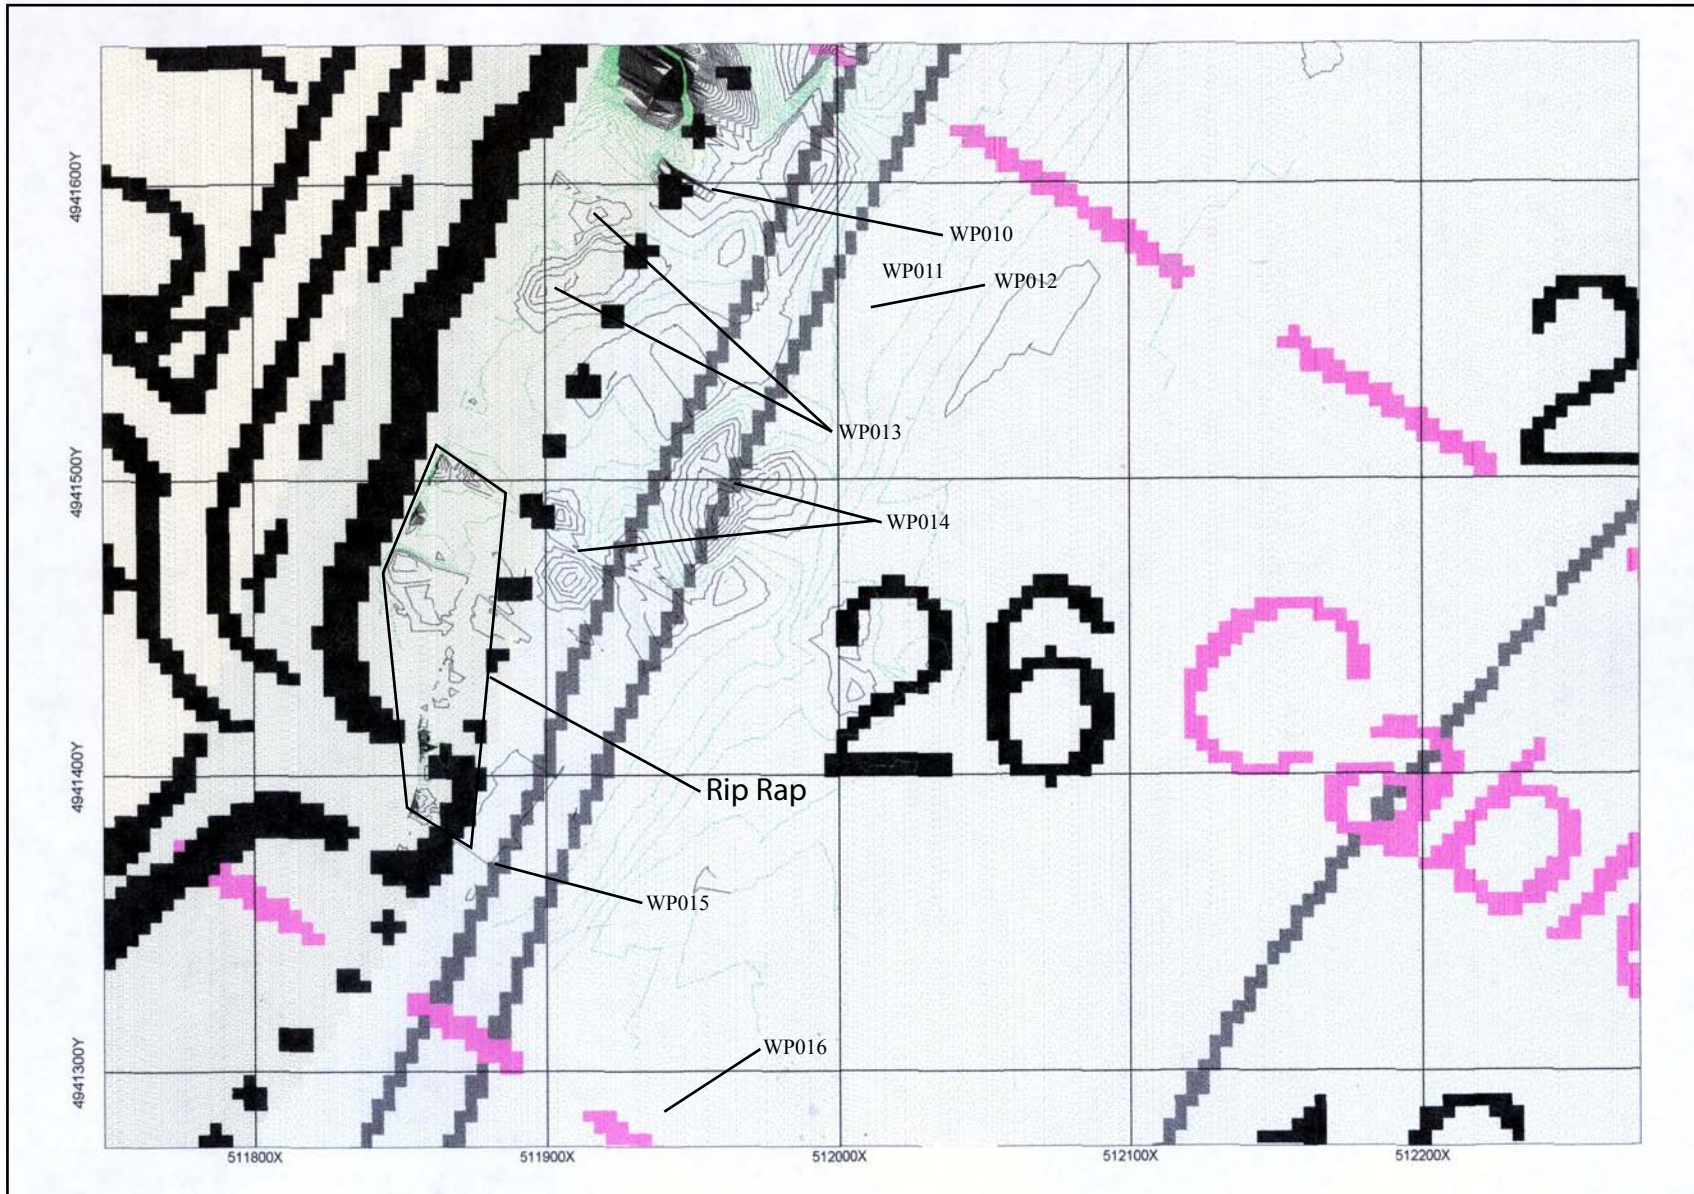
■ FIGURE 10
 ■ PENOBSCOT RIVER SURVEY
 ■ PENOBSCOT COUNTY, MAINE
 ■ WINTERPORT SHORELINE
 NHC Field Season 2001

Base Map: Maptec® 13309_1 "Penobscot River, ME"
 Coordinate Grid: UTM Zone 19, WGS 1984

Locality WP013 corresponded to an anomaly complex that contained five nodes of various size and amplitude that ranged 229 nT in maximum variation (Figure 10). Although a relatively simplistic signature, the low-to moderate contrast appeared on two adjacent lines. The unbalanced configuration and proportionally broad profile appeared indicative of a deeply buried source. Overall, its long wavelength and broad profile is not indicative of a complex wreck signature.

Locality WP014 represented a low-amplitude (110 nT), unbalanced, anomaly complex (see Figure 10). The complex contained six nodes varying in amplitude from -53 to +57 nT. Its influence appeared on five adjacent lines and exhibited the greatest magnetic contrast closest to shore. The relatively low amplitude and proportionally broad profile are indicative of a buried source. The lack of a compelling sonar target, the long wavelength (about 75 m), and, its locale inside the cable area, leads the interpretation to deduce that the potential source is likely discarded cable.
