# USS *Arizona* Memorial

*Legacy Resources Management Fund Project No. 03-170*  
*2003 Annual Report*

**Long-Term Management Strategies for the USS *Arizona*:  
A Submerged Cultural Resource in Pearl Harbor, Hawaii  
National Park Service  
Submerged Resources Center and USS *Arizona* Memorial  
Legacy Resources Management Fund Project No. 03-170  
2003 Annual Report**

Technical Report  
Number 15

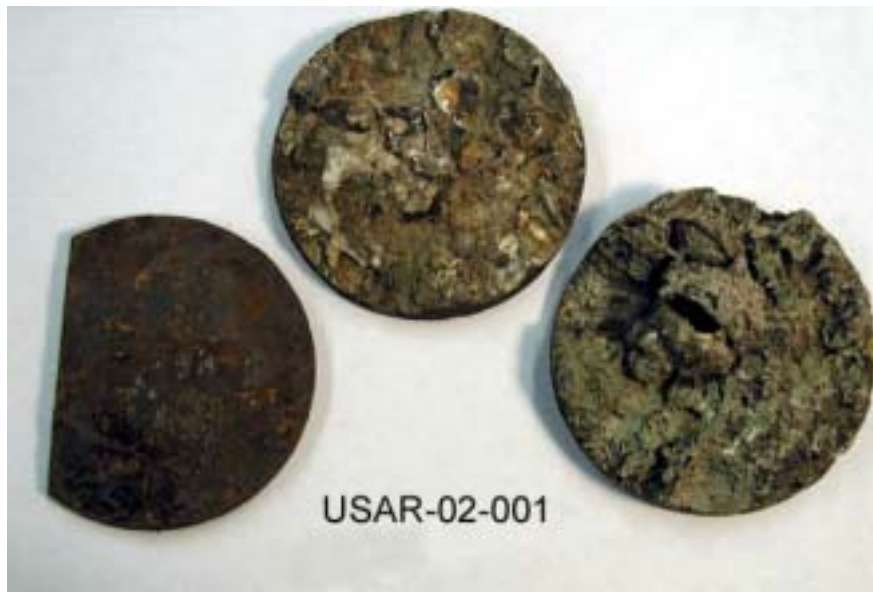
**Figure 2.** Hull “coupon” with interior and exterior concretion. Note the “chord” cut from the steel sample on left.

Coupons were initially sent to Rail Sciences, Inc. (RSI) Materials Engineering in Omaha, Nebraska, where Dr. Don Johnson and Dr. John Makinson made detailed thickness measurements around the circumference of each coupon under laboratory conditions. They removed a small "chord" from each sample for optical measurement of plate thickness and metallographic examination (Figure 2). This precise thickness measurement was compared to original hull thickness in each location, and a corrosion rate for that location determined.

Assuming a consistent corrosion rate since *Arizona*'s loss, the corrosion rates varied from 1.1 to 6.0 mils per year (1 mil = one thousandth of an inch). The fastest corrosion rates were obtained from the top of the hull near the surface where there is the highest level of dissolved oxygen and water movement. These hull corrosion rates can be compared to the laboratory-determined corrosion rate of unprotected mild steel, which is 4.5 mils per year. A combination of environmental variables and concretion formation are believed to account for the observed variation, a hypothesis under investigation.

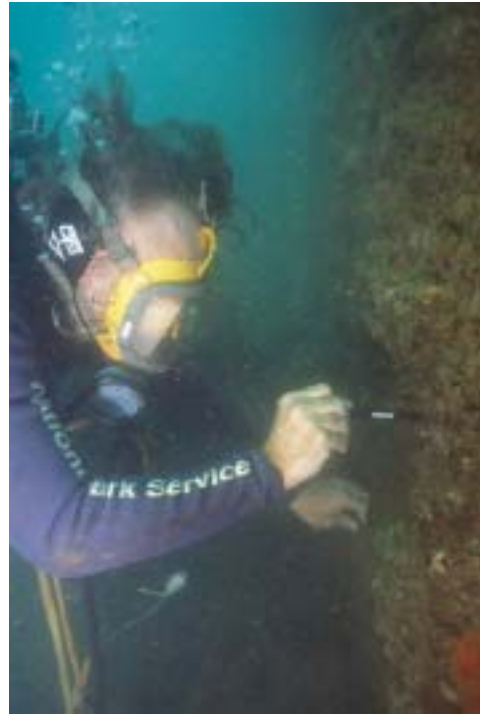
**Figure 3.** NPS archeologist taking corrosion potential readings at coupon location.

Immediately prior to removing hull coupons in August 2002, NPS archeologists measured corrosion potential ( $E_{\text{corr}}$ ) and pH in each coupon sample location. Using the same procedure as in past field operations, SRC archeologists drilled through the concretion in proximity to the sample area measuring pH and  $E_{\text{corr}}$  at various concretion-depths. Hole depths were controlled by several depth jigs to provide uniform data.  $E_{\text{corr}}$  and pH instruments were connected to the surface by cables; the topside recorder had voice communication with the diver (Figure 3). We have found this method to produce the most consistent, reproducible results for these measurements. Immediate review by topside researchers allows anomalies or errors to be discovered and measurements retaken to ensure accuracy.

The 2002 sample locations were revisited in November 2003 to once again collect  $E_{\text{corr}}$  and pH data. This replication allows researchers to gauge the impact to the ship of removing the hull coupons and surrounding encrustation. Data collected were comparable to 2002 data from the same locations, indicating no negative impact to the ship resulted from coupon removal, and that the epoxy sealing had succeeded in preventing formation of local areas of increased corrosion during the year since coupon collection.

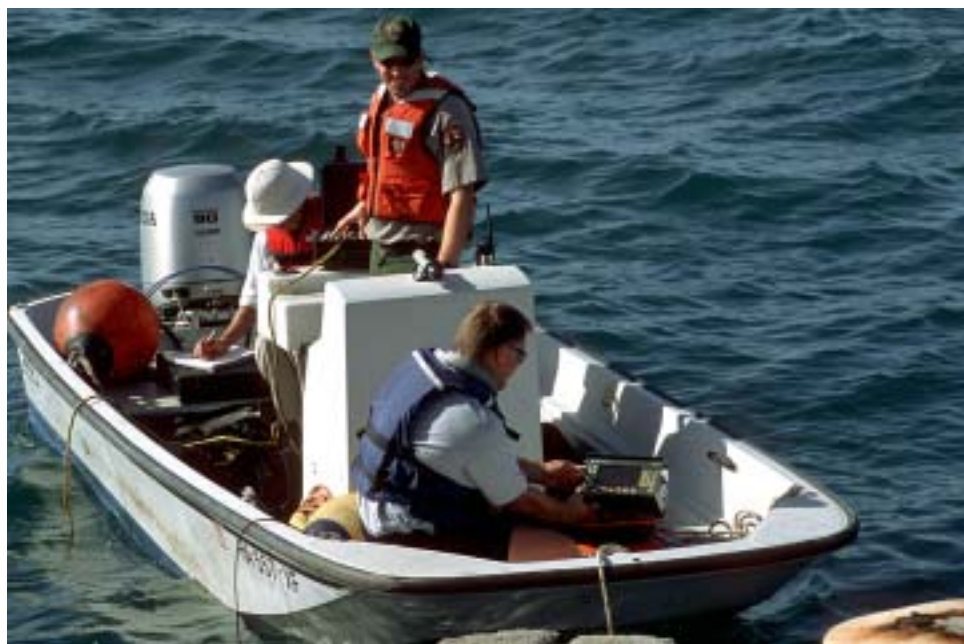
**Figure 4.** November 2003 topside ultrasonic thickness operations.

During UST operations, NPS researchers worked underwater to prepare the hull's surface and deploy the probe, while Dr. Johnson and Mr. Schraan worked topside with the instrument's user interface (Figures 4 and 5). Surface preparation on the ship involved removing the outer encrustation and using a pneumatic grinding wheel to flatten the surface.

We could not get reliable readings on the unprepared hull surface, which is mildly pitted from corrosion. Even on locations where we employed significant surface preparation, grinding the hull steel until it was shiny and smooth, the readings were not always consistent—sometimes they were accurate and other times not. For future operations in areas where the hull thickness is not already known, there would be too much doubt in the final results to be useable.

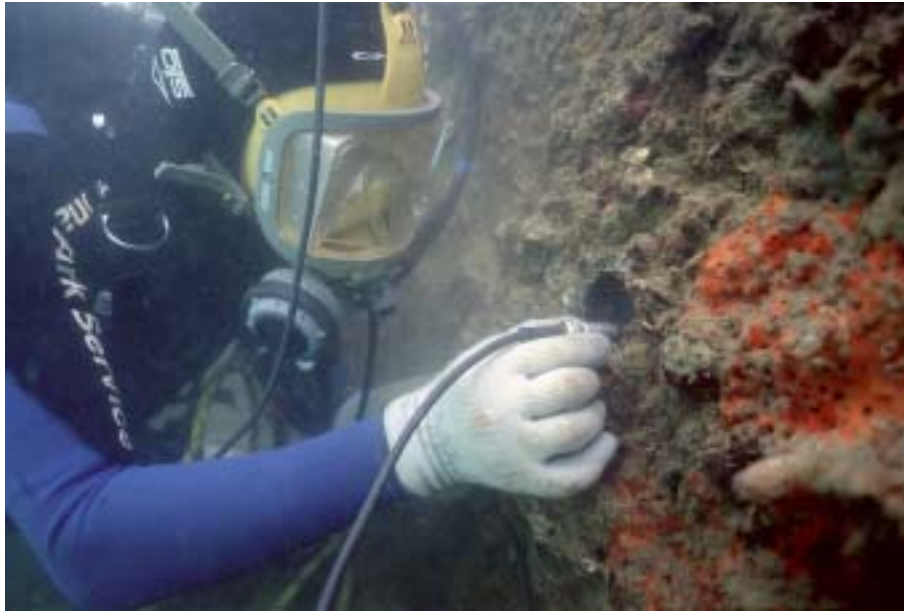
**Figure 5.** Deploying the ultrasonic thickness probe on *Arizona*'s hull.

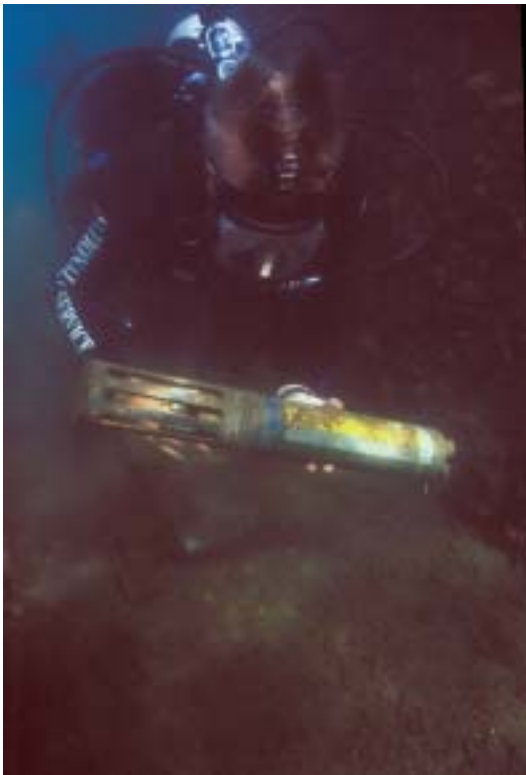
**Figure 7.** NPS researcher recovering YSI multi-parameter sonde.

The SonTek instrument was left in place approximately 25 m off *Arizona*'s port bow for a one-year period, from November 21, 2002 to November 20, 2003 (Figure 6). On November 20, 2003, NPS staff relocated the instrument to 25 m off *Arizona*'s starboard bow, where it will collect comparative data for another year. The YSI instrument was deployed on January 30, 2003 on *Arizona*'s main deck, amidships, just

aft of the Memorial (Figure 7). It has so far collected data for a one-year period, with the exception of four months during summer 2003 due to equipment malfunction. This instrument will be left in its current location at least through summer 2004 to make up for lost data. Data from both instruments will then be synthesized by USGS and NPS scientists to determine potential effect environmental variables have on *Arizona*'s corrosion rates.

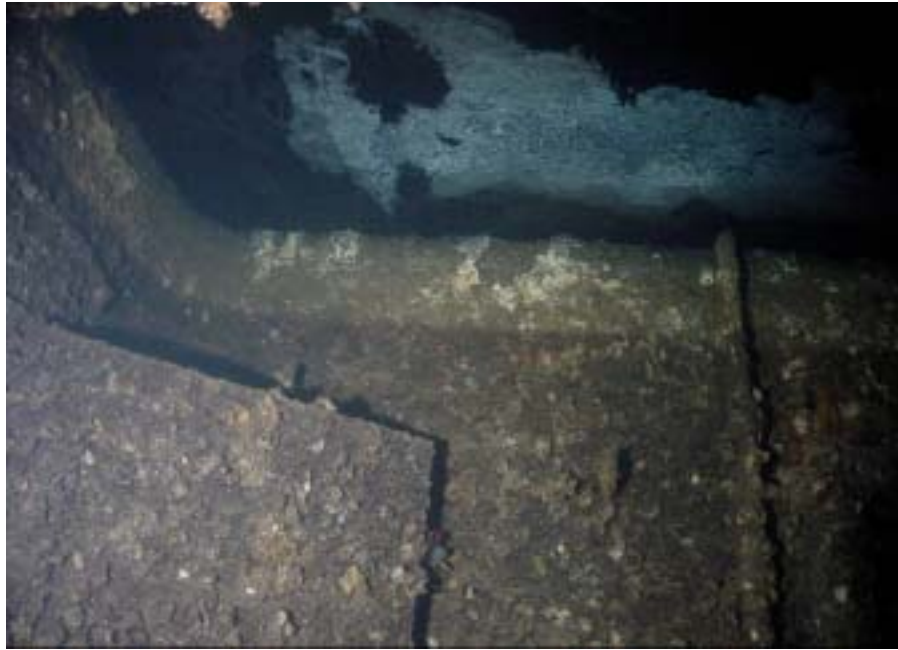
**Figure 10.** Microbial colonies on oil in cabin overhead sampled in November 2003.

In addition to laboratory analysis, NPS-SRC researchers collected additional oil samples and bacterial samples during November 2003 fieldwork for continuing analysis at MUSC (Figure 10). These samples are currently being cultured and their DNA extracted for identification.

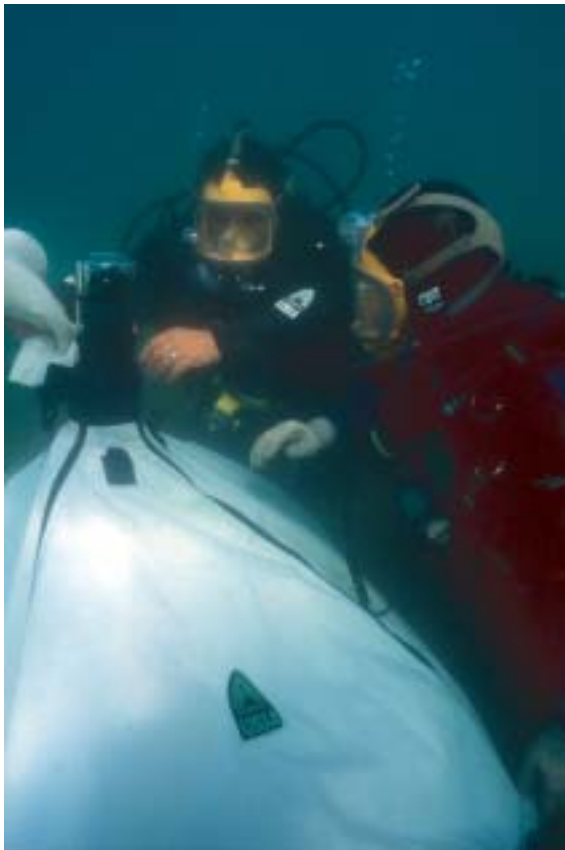
**Figure 11.** Oil catchment device deployed on hatch to starboard of Barbette No. 4.

escaping from the ship at several locations. This was done to quantify the leakage rate for long-term monitoring to see whether specific location oil leakage is stable or increasing. The device used for quantitative monitoring is a custom-designed oil catchment device (OCD) provided by USIA, a corporate partner. Based on qualitative observations, the primary escape point during the 1980s was a single hatch on the port side of Barbette No. 3. This point was measured in 1998 and a rate of 1.0–1.5 quarts per 24 hours was established. Since 2000, at least two additional leak points have been observed. In November 2003, NPS archeologists measured oil escaping from two primary leak points—one of which was the hatch on the starboard side of Barbette No. 3 that was measured in 1998 (Figure 11). The other was a hatch on the starboard side of Barbette No. 4. Slightly less than 1.0 quart was recorded in a 24 hour period from the hatch adjacent to Barbette No. 3, which means there has been no net increase in oil release at this point since first measured in 1998; in fact, somewhat less was recorded in 2003 than in 1998. The hatch to starboard of Barbette No. 4 had 1.3 quarts recorded during each of two 24-hour collection periods. These points will be monitored periodically, as will any new release points.

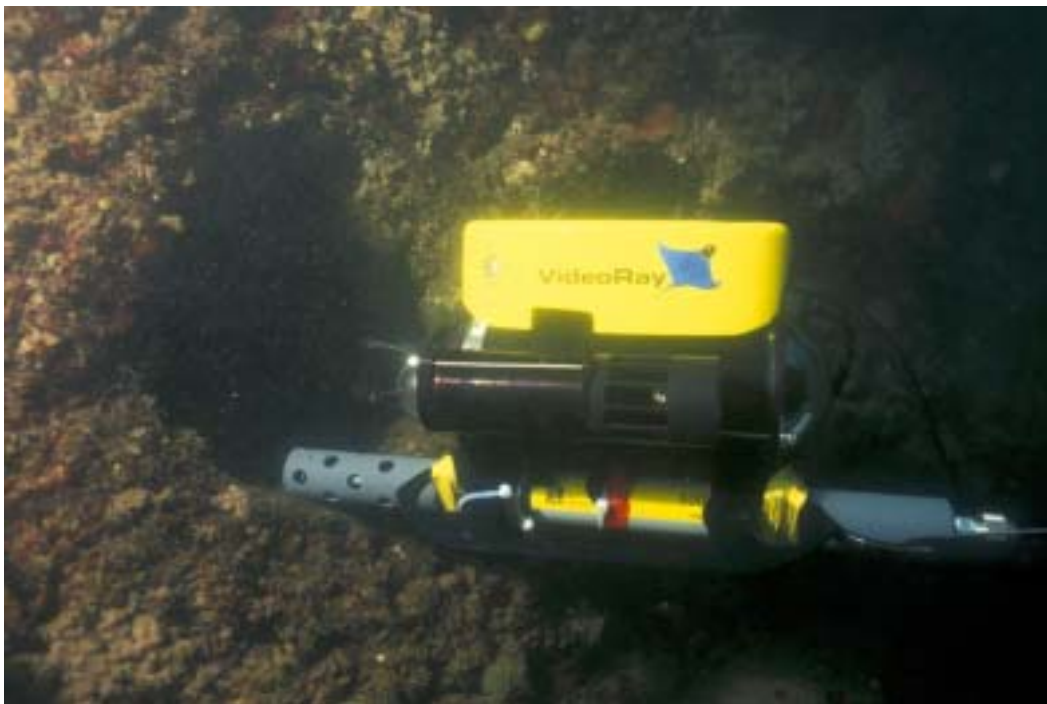
**Figure 12.** VideoRay ROV equipped with YSI sonde entering porthole on *Arizona*'s second deck.

potential and conductivity (Figure 12); and a GMC corrosion potential ( $E_{\text{corr}}$ ) probe to collect corrosion measurements necessary for characterizing interior corrosion processes. Investigations were focused on second deck cabins accessible via open portholes and inside Barquette No. 3. Baseline measurements were collected outside each open porthole, and then a separate file was collected inside each cabin at various locations along vertical profiles. All VideoRay operations were recorded, and video time code was used to collate ROV location to specific measurements from both the YSI and GMC instruments. The VideoRay did not have the ability to carry both instruments simultaneously, so we first completed the YSI survey then conducted the GMC recording of the same interior spaces.

same inside the ship, at least on the second deck level, as outside: pH was 8.0–8.1, temperature about 80–81° F, salinity approximately 33.5 parts per thousand (ppt). Dissolved oxygen (DO), however, dropped dramatically upon entering the ship. Outside, DO levels were about 86–88% saturation; typical levels inside were around 65–68%, and in some instances dropped considerably lower than this. One of the more interesting observations is that interior cabin water is stratified by a subtle thermocline of about 0.5°F—DO levels, however, change significantly across this thermocline, from nearly 70% saturation above to about 50% saturation below the thermocline. This indicates very little water movement within interior cabins, even with open portholes. Researchers are looking into what effect this has on overall interior corrosion rates and affect on microbial colonies.

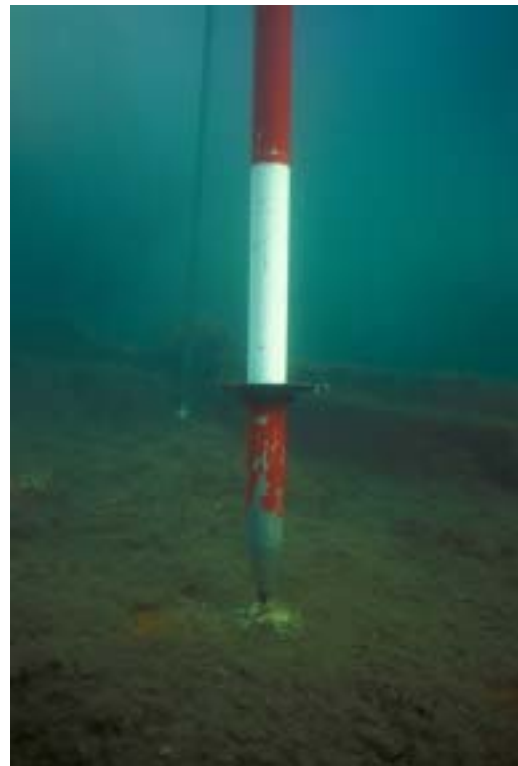
**Figure 13.** GPS tripod set on a 2001 monitoring point.

The first reoccupation of the GPS monitoring points was scheduled for November 2003. In the intervening two-year period, the NPS acquired the necessary instruments to complete the survey in-house. Mr. Tim Smith from the NPS-GPS Program and Mr. Mark Duffy from Assateague Island National Seashore provided instruments and expertise to complete the operation. The first problem encountered was that most of the stainless steel studs, which were encased in epoxy, had corroded away. The epoxy did not prevent electrolytic corrosion of

Although the accuracy of each point was mathematically calculated to about 0.5 cm, it became clear that a more conservative threshold of change should be applied to future monitoring relocations. Because of environmental conditions and differences in equipment and stadia variations, we determined a more realistic threshold was 10 cm. Errors of up to 10 cm could be caused by instrument error, set-up

error, or most likely, nearly imperceptible antenna movement caused by water movement. Consequently, any observed change that is less than 10 cm cannot be reliably attributed to actual movement of the ship; however, corroborative evidence would be sought for any level of change.

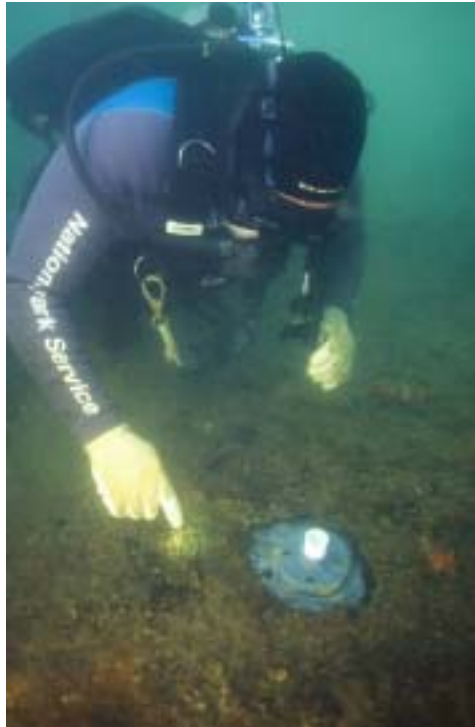
**Figure 14.** NPS archeologist installing new GPS monitoring point (right) adjacent to the old point (left).

the stainless steel imbedded in the mild steel of the deck plates. Each point was reoccupied as best as possible, but we made the decision that new points not subject to corrosion must be established (Figure 13 and Table 1). PVC was used, and each new point was established adjacent to the original point. Each of these new points was then surveyed and will become the permanent monitoring points (Figure 14).

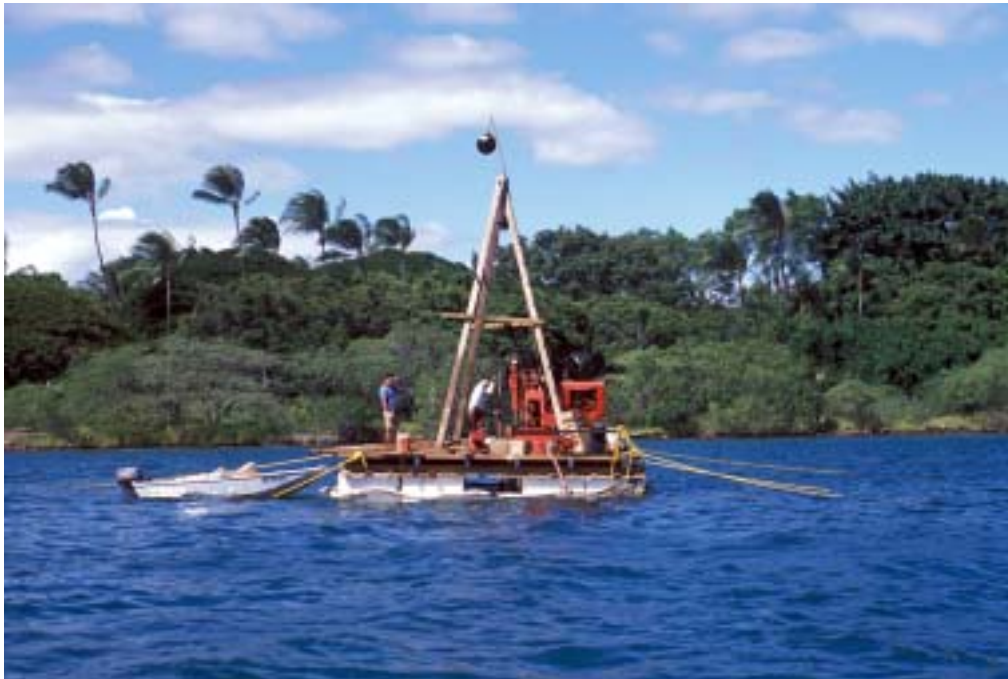
**Figure 15.** Geological coring operations, November 2003.

In November 2003, NPS-SRC collaborated with Dr. Rob Kayen and Mr. Brad Carkin from the USGS's Western Region Coastal and Marine Geology Program. The joint NPS/USGS team worked with an environmental contractor from Honolulu, Ernest K. Hirata & Associates, Inc. to collect geological cores from around *Arizona* (Figure 15). Because of field exigencies, primarily encountering very hard substrate in the first boring, only three of the four planned cores were collected. The three borings were drilled to depths ranging from 15.2 to 21.3 m below the harbor bottom. The borings were drilled using portable drilling equipment mounted on a temporary barge. Continuous sampling was performed from the harbor bottom down to the maximum depths drilled in all borings (Hirata 2003).
