Paper Number GT2004-54254

SCREENING AND EVALUATION OF MATERIALS FOR MICROTURBINE RECUPERATORS

Edgar Lara-Curzio, R. Trejo, K. L. More, P. A. Maziasz and B. A. Pint
Metals & Ceramics Division
Oak Ridge National Laboratory
Oak Ridge, TN 37831-6069

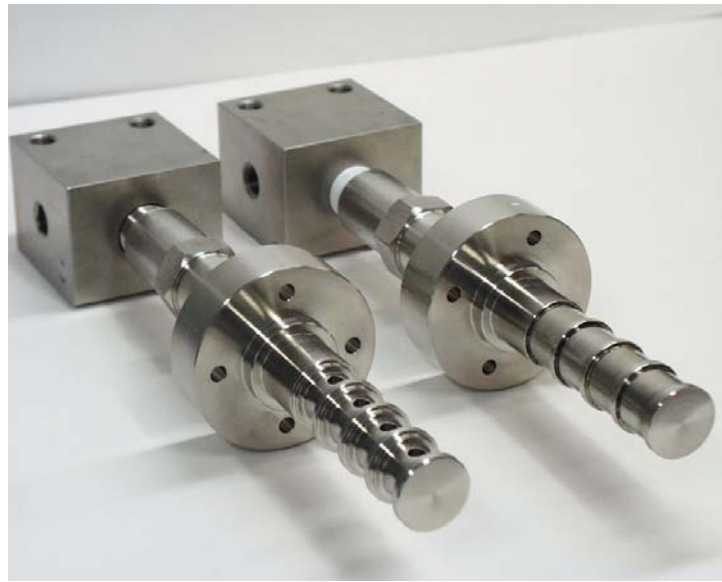
Figure 2. Sample holders with and without foils. The holes in the sample holder allow the placement of thermocouples and the flow of gas for mechanically stressing the foils through the internal pressurization of the sample holder.

The sample holders are cylindrical in shape and allow the placement of four test specimens. Figure 2 shows a photograph of sample holders with and without foil test specimens. The sample holders have orifices to allow the placement of thermocouples to monitor the temperature of each metallic foil specimen during the test. These orifices also allow the pressurization of the sample holder with a gas (e.g.- air), which in turns allows the mechanical stressing of the test foils. This is an important feature of this test facility because it allows the simultaneous investigation of the effects of temperature, stress and environment on the durability of candidate materials.

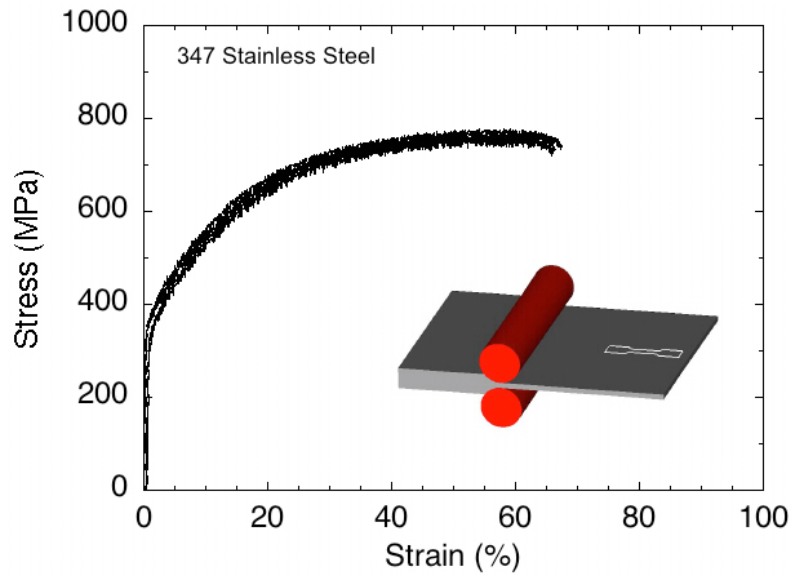
Figure 5. Stress-strain curves obtained from the tensile evaluation of miniature dog-bone shaped test specimens of 347 stainless steel 0.089-mm thick foils. Test specimens had been obtained by electric discharge machining with their axis parallel to the foil rolling direction.

Figure 5 presents a collection of tensile stress-strain curves obtained from the evaluation of miniature dog-bone specimens of as-received 347 stainless steel foils. As indicated by the inset in the graph, the test specimens were obtained with their axis parallel to the foil rolling direction. The evaluation of test specimens with their axis perpendicular to the rolling direction produced tensile strength and ductility values that were found to be significantly different, at the 95% confidence level, than those obtained from the evaluation of test specimens aligned parallel to the rolling direction. These results are summarized in Table II. The fracture surfaces of these test specimens revealed features that are typical of ductile failure and fracture planes were found to be aligned at 45° with respect to the loading direction, as illustrated in Figure 6. This orientation of the fracture plane is consistent with the large amount of deformation experienced by the test specimens and the alignment of the high-density planes parallel to the direction of maximum shear stress.

Figures 11 and 12 show a collection of stress-strain curves obtained from the tensile evaluation of miniature tensile specimens obtained from foils A and D, respectively. When comparing these results with those shown in Figure 5 for the as-processed 347 stainless steel foils, it can be observed that both the tensile strength and ductility of test specimens obtained from foil A have been significantly affected after the 500-hr test exposure. Although the ultimate tensile strength of test specimens obtained from foil D was not affected, it was found that the ductility had decreased. Loss of ductility in this material usually results from carbide precipitation between 400°C and 800°C. Table III summarizes the results from the

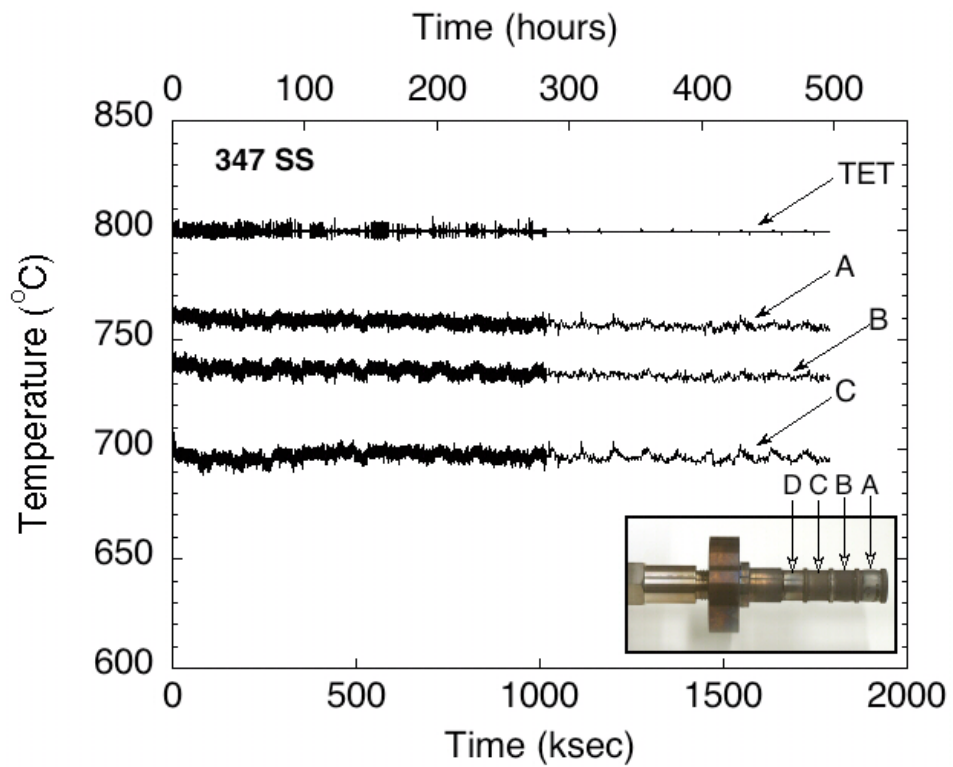
Figure 7. Temperature history for 500-hr test to evaluate the behavior of 0.089-mm thick foils of 347 stainless steel.

During the test the temperature of each test specimen, which was monitored using type-K thermocouples, was recorded and it is plotted in Figure 7 for the 500-hr test duration. These values of temperature are consistent with the temperature profile presented in Figure 4, which had been obtained by positioning a type-K thermocouple at 5 mm intervals along a sample holder during microturbine operation at TET=800°C.

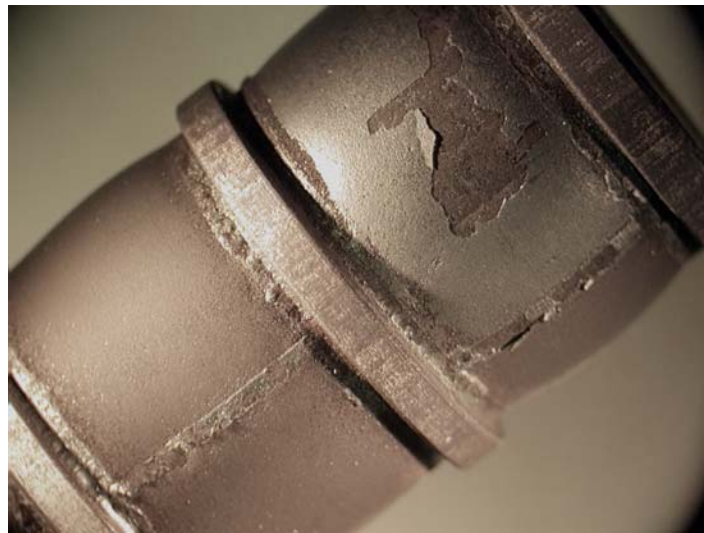
Figure 9. Optical micrograph of foils A and B (0.089-mm thick foils of 347 stainless steel), after 500-hr test at a TET of 800°C and tensile tangential stress of 50 MPa. Note the corrosion scale on the surface of the foils. The weld seam in foil B is evident.

At the end of the test, the pressure was released from the sample holder and the sample holder was allowed to cool down. After the sample holder was removed from the microturbine it was found to be heavily corroded as illustrated in Figures 8 and 9. The photograph in Figure 9 is a close-up of foil A, which had experienced the highest temperature during the test. The photograph in Figure 8 also shows that the foil in location A had ballooned as a result of creep deformation. It was also found that this foil had cracked in a direction parallel to the axis of symmetry of the sample holder.

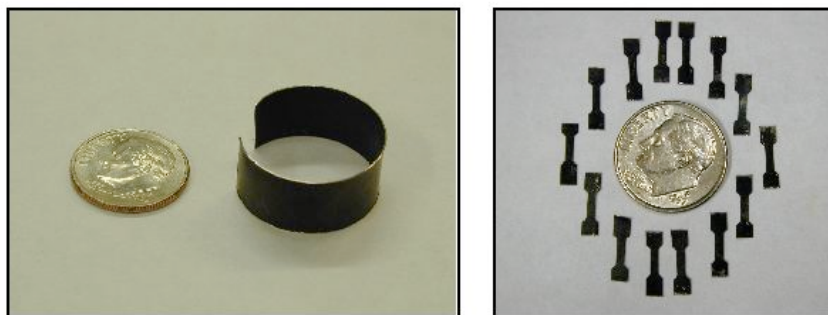
Figure 10. Foil after being removed from sample holder at end of 500-hr exposure test. Fourteen miniature tensile specimens were obtained from each foil.

The foils were removed from the sample holder, and miniature test specimens were obtained by electric discharge machining, as illustrated in Figure 10. A total of fourteen test specimens were obtained from each foil, except from foil A, where only six test specimens were obtained due to high degree of damage in the material.

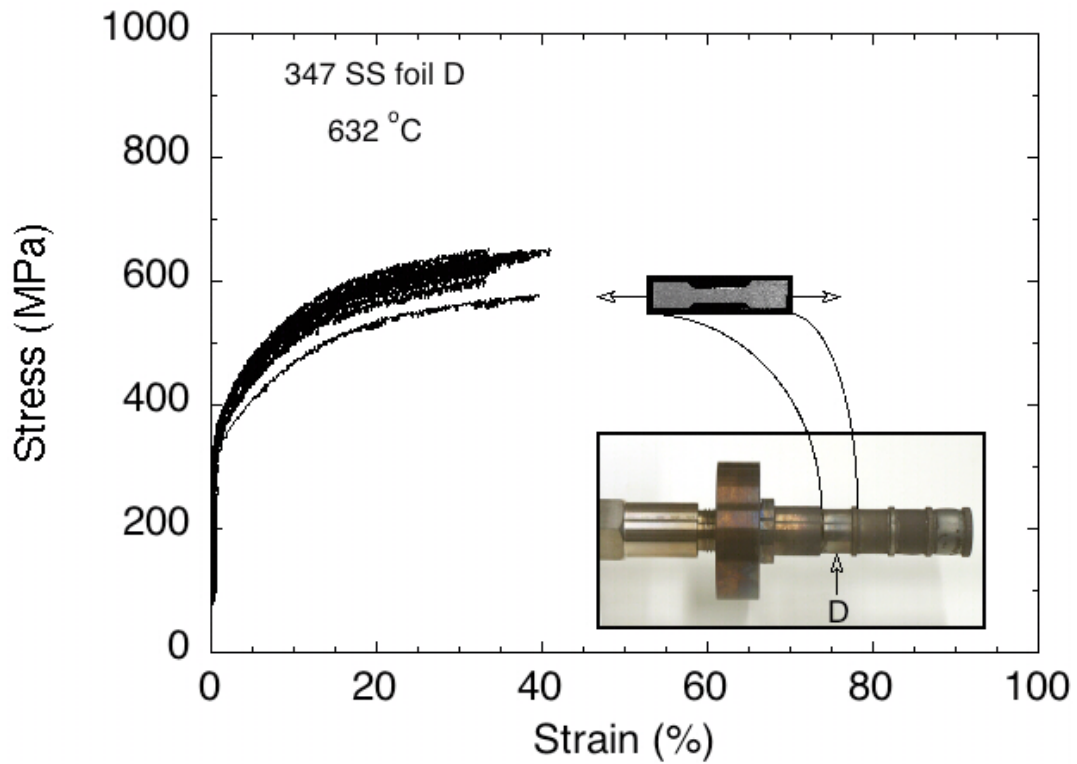
Figure 12. Stress-strain curves obtained from the tensile evaluation of miniature test specimens obtained from foil D (0.089-mm thick foil of 347 stainless steel) after 500-hr test.
