## Paper Number GT2005-68630

### EVALUATION AND CHARACTERIZATION OF IRON- AND NICKEL-BASED ALLOYS FOR MICROTURBINE RECUPERATORS

**Edgar Lara-Curzio, R. Trejo, K. L. More, P. J. Maziasz and B. A. Pint**  
Metals & Ceramics Division  
Oak Ridge National Laboratory  
Oak Ridge, TN 37831-6069

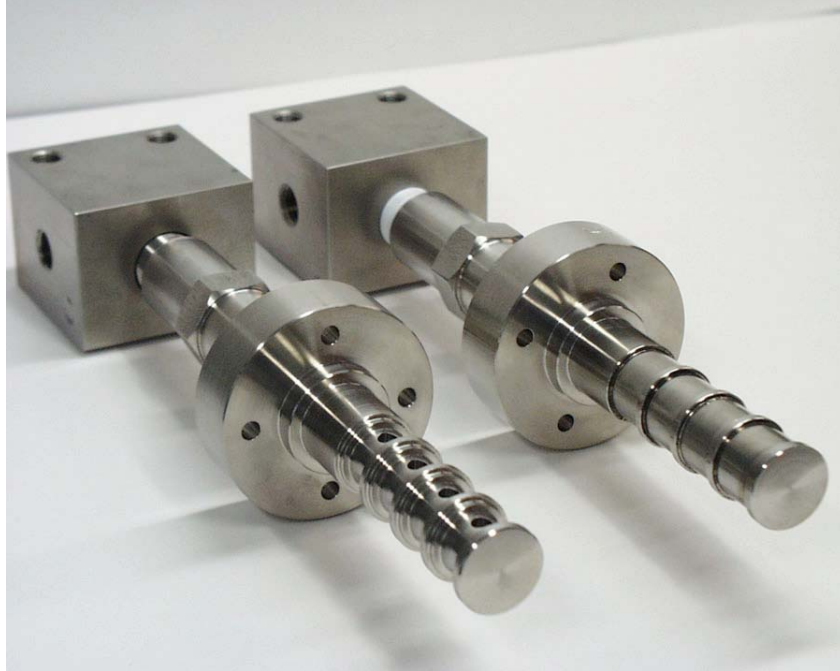
Figure 2. Sample holders for exposure of metallic foils in ORNL's microturbine recuperator testing facility. The orifices where thermocouples are placed and that are used to allow mechanical stressing of test specimens through pressurization is shown on the left. A sample holder with laser-welded metallic foils is shown on the right.

The sample holder onto which the foils under evaluation are laser-welded was 23.1 mm in diameter. Prior to welding the foils, type-K thermocouples were placed in each one of the four holes in the sample holder. Figure 2 shows photographs of sample holders with and without welded foil samples.

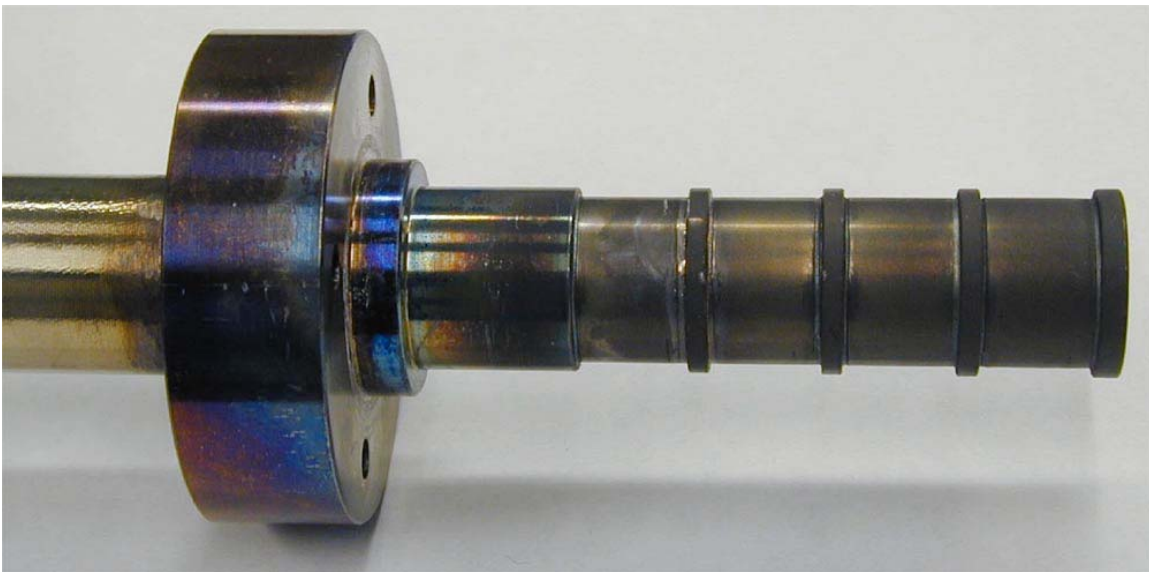
Figure 11. Sample holder with HR120® alloy foils after 500-hr exposure in ORNL's microturbine recuperator testing facility at TET=800°C.

Figure 11 shows the sample holder with HR-120® alloy foils at the end of the 500-hr exposure in ORNL's microturbine. Under regular lighting conditions the appearance of the foils in locations 2, 3 and 4 of the sample holder was "shiny" and brass-looking. The foil that had been exposed to the highest temperature had a dark, dull appearance.

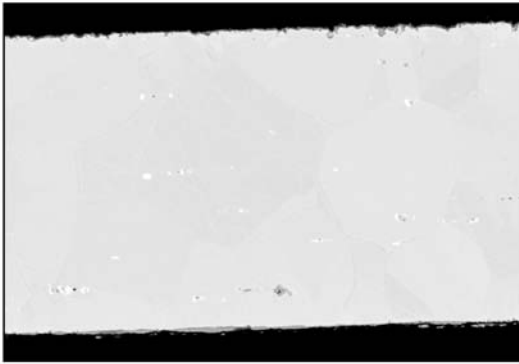
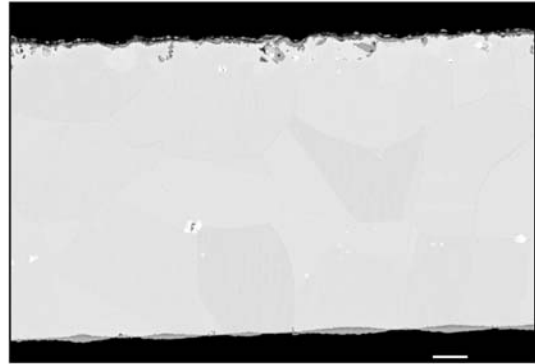
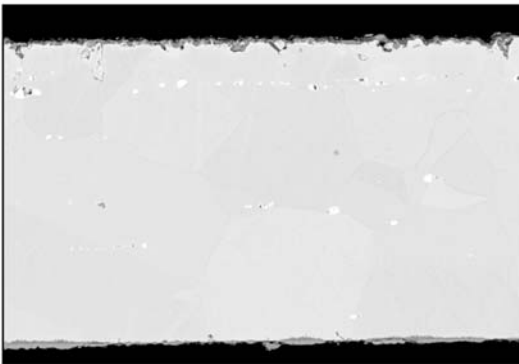
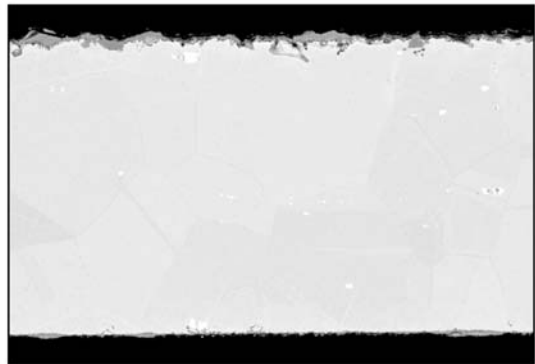
Figure 12. BSE images of cross-sections obtained from 89- $\mu\text{m}$  thick HR-120<sup>®</sup> alloy foils after 500-hr exposure at TET=800°C. The upper surface in the micrograph had been exposed to the microturbine exhaust gases.

Figure 12 presents BSE images of cross-sections obtained from HR-120® alloy foils after 500-hr microturbine exposure.

A thin multiphase oxide scale had formed and it was thicker on the surface exposed to the exhaust gases. An elemental compositional map (Figure 13) revealed that the grain boundaries closest to the surface and just below the surface exposed to the exhaust gases had been depleted of chromium and enriched in nickel. In the case of HR-120® alloy foils, the oxide scale possesses a multilayered structure consisting of mixed oxides of silicon, chromium and iron.

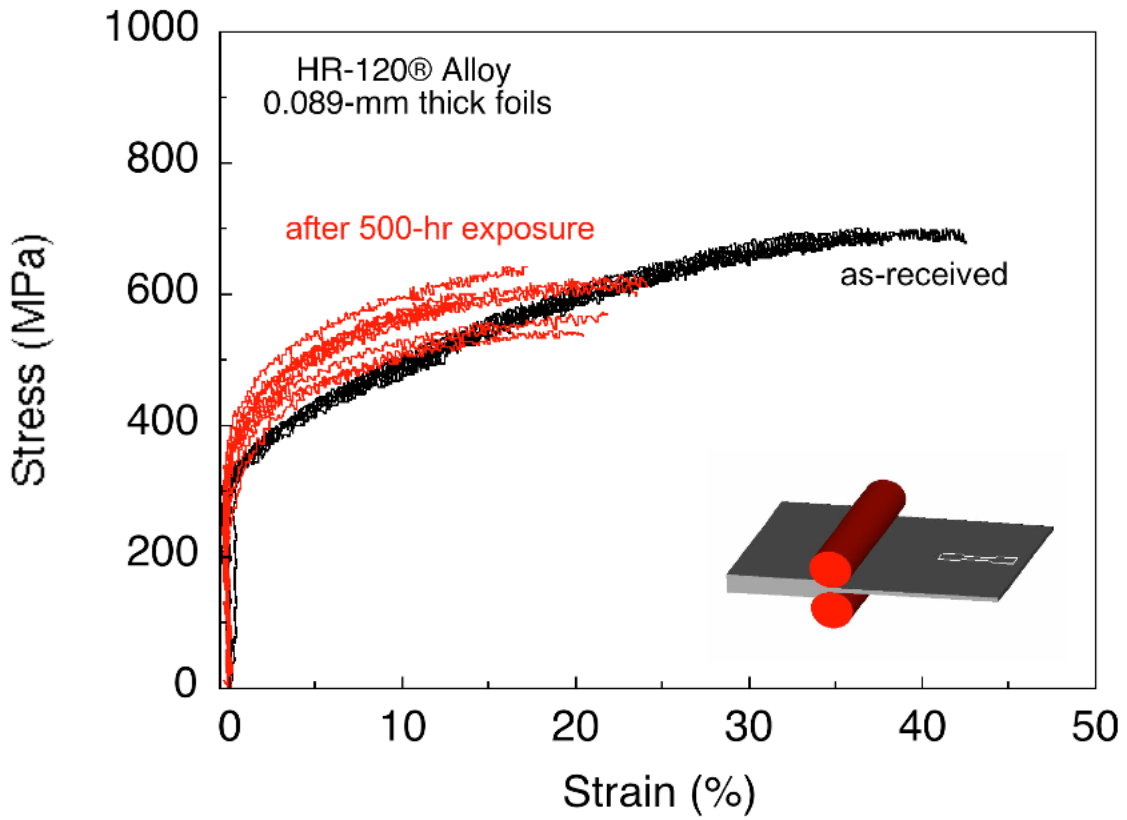
Figure 14. Tensile stress-strain results obtained from the evaluation of miniature tensile specimens of 89- $\mu\text{m}$  thick foils of HR-120® alloy before and after 500-hr exposure in ORNL's microturbine recuperator testing facility at 745°C.

Figure 14 presents the stress versus strain curves obtained from the tensile evaluation of the miniature test specimens of HR-120® alloy before and after 500-hr long exposure in ORNL's microturbine recuperator testing facility. It was found that the ultimate tensile strength and ductility of the HR-120® alloy decreased by 15% and 50%, respectively, after exposure at 745°C. At the lowest exposure temperature of 632°C the ultimate tensile strength and ductility decreased by 10% and 23%, respectively. Table VII summarizes the tensile results.
