# *Characterization of Erosion and Failure Processes of Spark Plugs After Field Service in Natural Gas Engines*

**H. T. Lin and M. P. Brady**  
Metals and Ceramics Division

**15th International Conference on Wear of Materials, San Diego, CA, April 24-28, 2005**

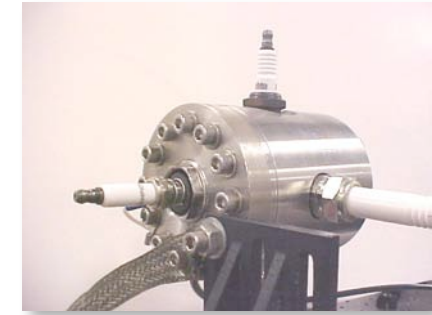
Test Chamber

- Ca from the engine lubricant oil
- No detection of Pt, W or Ir from electrode tips

**Detection of Ni in new spark plug suggests the erosion of Ni-based electrode due to sputtering process**

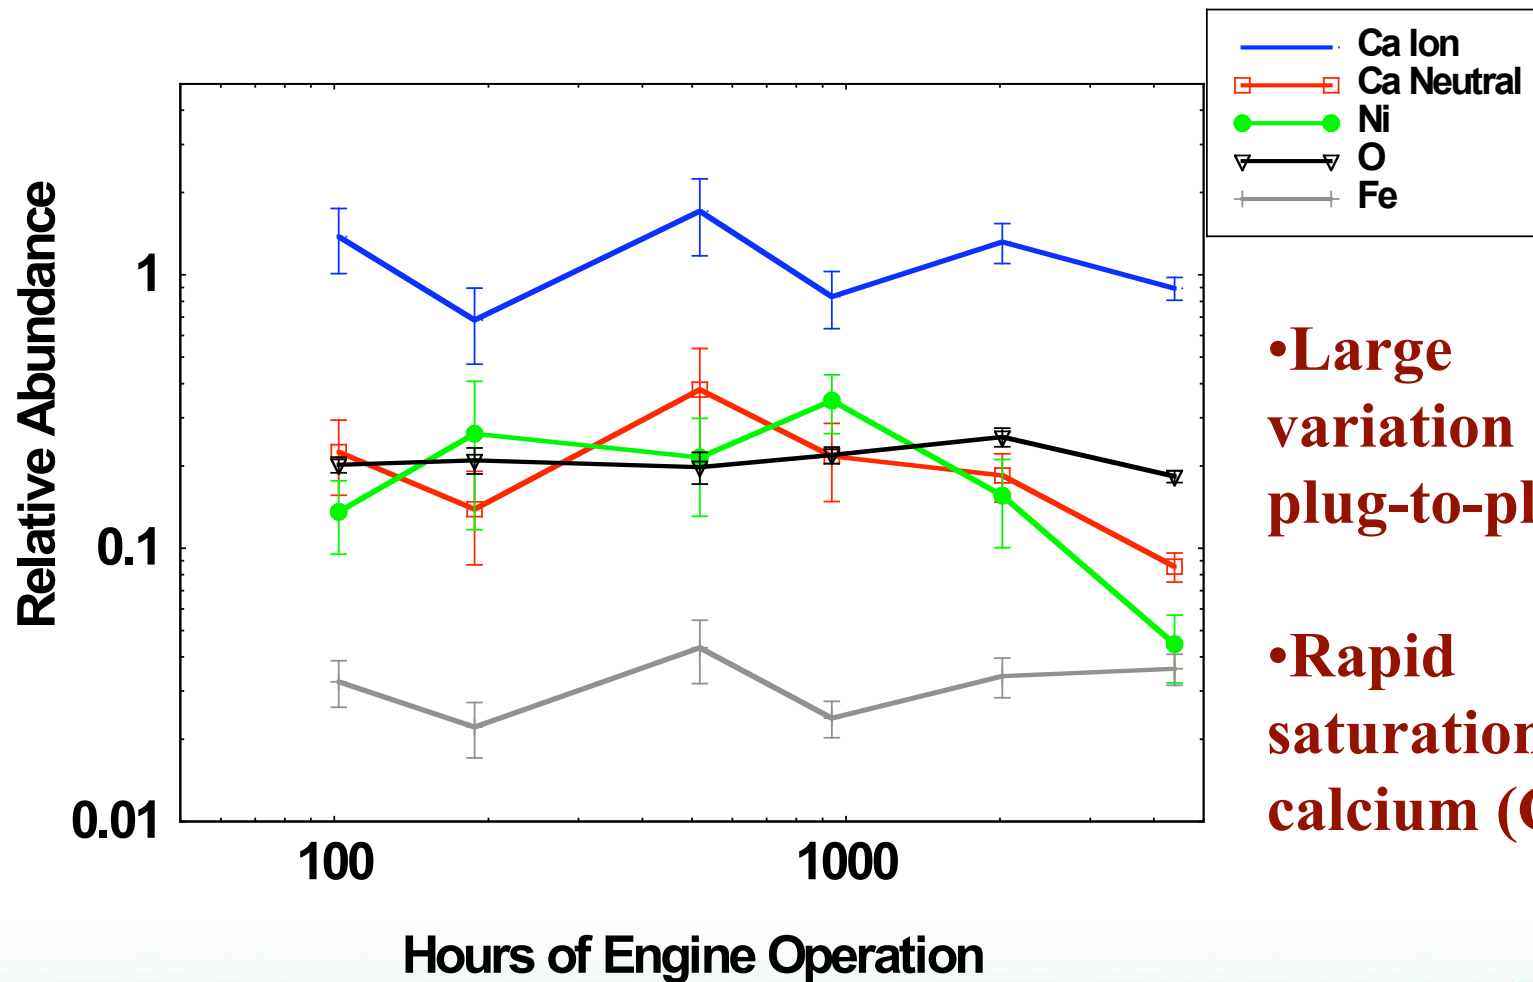
• Large variation plug-to-plug

• Rapid saturation of calcium (Ca)

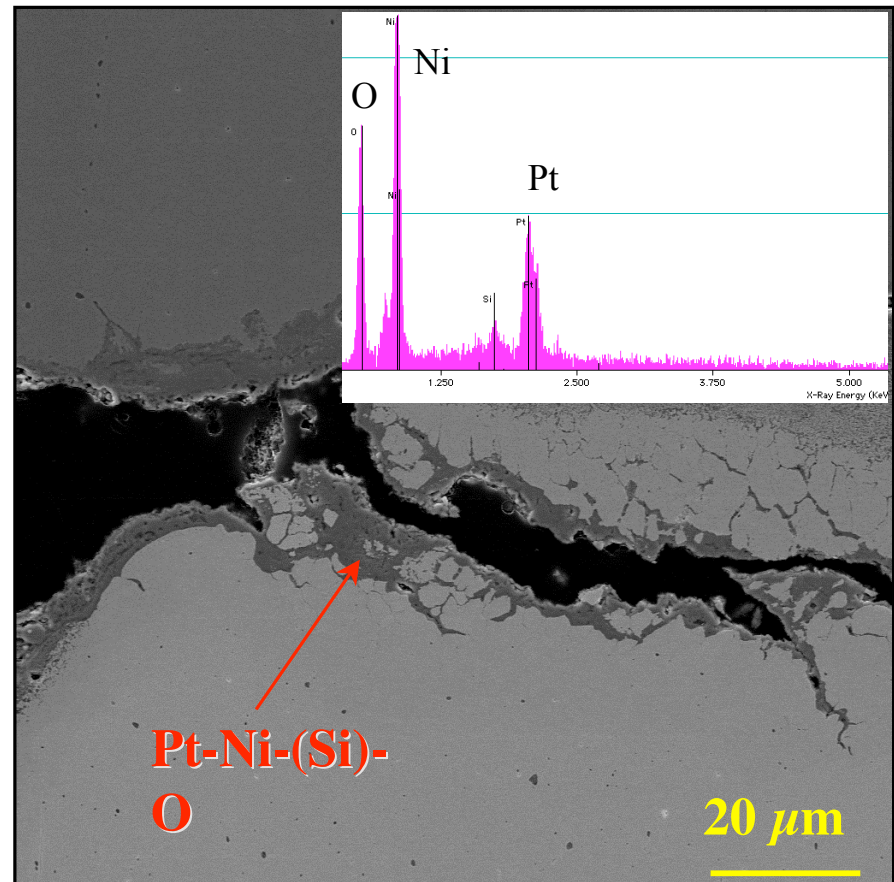
# Substantial Crack Generation and Growth Observed Between Pt-alloy and Ni-based Electrode After Field Service

An oxide-based (Pt-Ni-O) reaction zone, which is brittle in nature, formed between Pt and Ni-based electrode. Crack generation and growth and oxide-based interface could significantly degrade the ignitability/performance, and ultimate cause failure of spark plugs
