DRAFT ICEF2004-875

# Characterization of Erosion Mechanisms for Natural Gas Engine Spark Plugs

Engineering Science and Technology Division

Oak Ridge National Laboratory

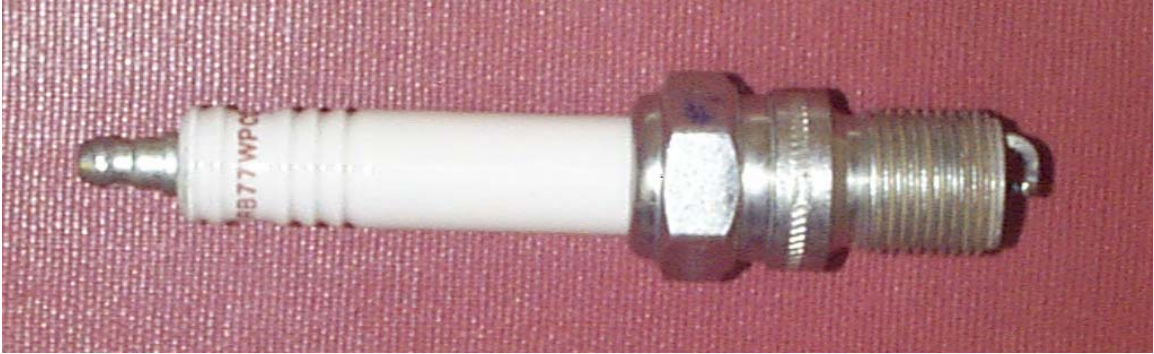
**Figure 3.** Photograph of new spark plug, Champion, part number RB77WPCC. These are J-type spark plugs with the tip of the center electrode being iridium (Ir) and the ground side an alloy of platinum-tungsten (Pt-W).

The spark plugs used in this study were acquired from Caterpillar Inc. (part number 194-8518) in sets of 16, that were Champion spark plugs manufactured by Federal Mogul, Inc. The plugs were used in several Caterpillar 770 eKWatt natural gas engines until sufficient wear required that they be replaced. Sets of these worn plugs were obtained for operating times of 2,020, 2,200, 4,386, 5,280 and 5,388 hours. Some of the spark plugs from these sets were found to have electrical breakdown in the dielectric and could not be used for spectroscopic studies but were still available for metallurgical examination. For comparison, a similar set of new spark plugs was obtained from Champion, part number RB77WPCC as shown in Fig 3. These are J-type spark plugs with the electrodes consisting of a nickel-base alloy (~ nominal 90-95 wt.% Ni in the plugs examined) with the tip of the center electrode being iridium (Ir) and the ground, platinum-tungsten (Pt-W) base alloy (W content in the nominal range of 5 wt.% in the plugs examined).

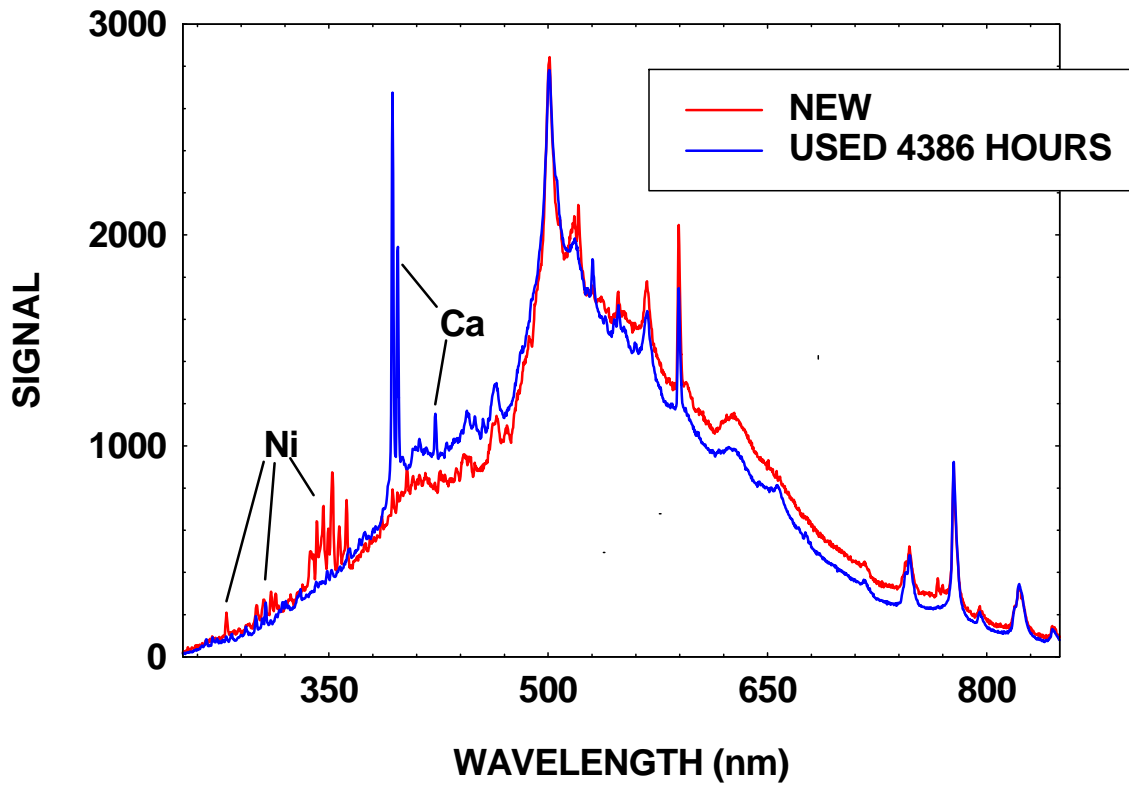
**Figure 4.** Plot of the spectrum from a new (red) and used (blue) spark plug. The used plug was removed after 4,386 hours of operation. The most striking difference between these curves is the presence of emission lines from nickel in the new plug and the calcium in the used plug.

The spectroscopic results are summarized in Fig. 4 where the emission spectra for both a new and used (4,386 hour) plug are compared. Sets of plugs with different hours of operation have also been examined and found to produce similar spectra to that shown with the blue curve in Fig. 4. Most of the spectral emissions for both new and used plugs come from air (nitrogen and oxygen lines). However, at the shorter wavelengths, several metal lines can be observed. With new spark plugs, emission lines from Ni are observed. For used spark plugs, the nickel lines become insignificant and calcium (Ca) lines appear. The more interesting result is the lack of lines from Ir, Pt and W. Such results would indicate that the Pt and Ir tips are producing the desired results in limiting electrode surface wear, although it is also conceivable that these elements are leaving as clusters of atoms and were not detected by the spectroscopic technique used.

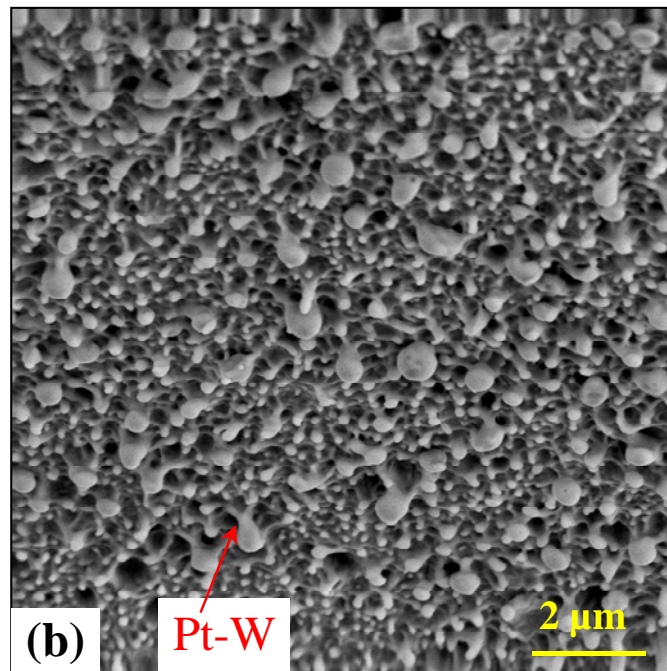
The observation of Ca in the used plug emission spectrum was confirmed by SEM analysis of the electrode side surfaces (Ni alloy) and Ir/Pt-W tips of the 4,383 h used plug (Figs. 5 and 6). Although this observation is for plugs with 4,386 hours of use, the investigation of plugs involving 2,020 hours is in progress and initial observations on surfaces revealed similar features. The side surfaces of the Ni alloy ground electrode (Fig. 5a) were covered with a glassy Pt-W base oxide phase, with a significant quantity of Ca. The center electrode showed comparable features, with a Ir-Ni base oxide, again containing significant quantities of Ca (Mn, Cr, and Si were also detected in some regions) (Fig. 5b). Examination of the Pt-W tip showed evidence of extensive cracking and local melting (Fig. 6a and 6b), but no evidence of oxide-containing phase(s) formation. The absence of oxide formation at the Pt-W tip surface suggests its loss during the sparking process and

that significant material loss during sparking may be occurring at the Pt-W ground electrode tip insert. At the Ir tip (Fig. 6c), cracking was also observed, although there were no signs of local melting and the surface was fully covered by the Ir-Ni-Ca oxide phase (Fig. 6d). The source of the Ca is speculated to be the engine lubricant, as Ca-containing compounds are an additive in low ash lubricants required for NG engines [1]. The formation of such Ca-containing oxide glass(s) may lead to enhanced wear as Ca is known as a glass former and can readily decrease the melting point of oxides.

**Figure 6.** SEM micrographs show the top surface morphology of Pt-W (a, b) and Ir (c, d) tip insert after field service. Note that (b) and (d) are the high magnification of (a) and (c), respectively. This plug had 4,386 hours of engine operation.

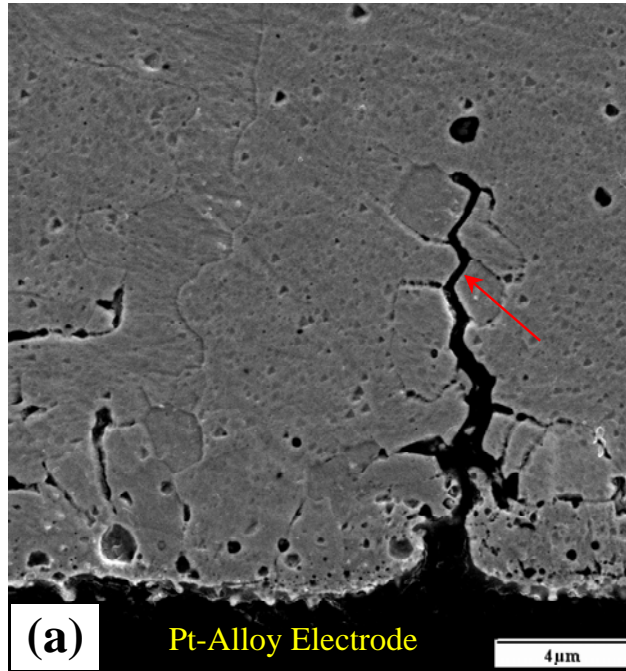
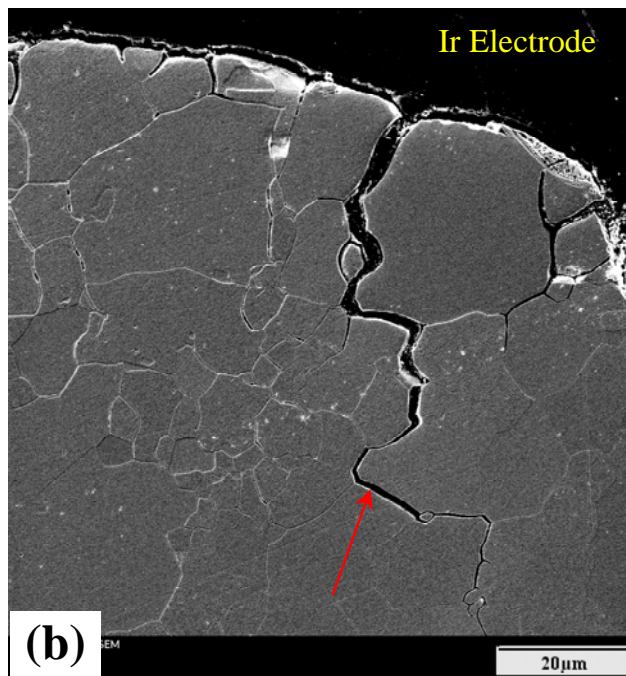
Figs. 8a and 8b show etched cross-sections of the outer surface of the Ir and Pt-W alloy tips. Intergranular cracking is evident in both Pt-W and Ir tip. In addition to the typical surface erosion processes/material loss phenomena resulting from sputtering, melting, ablation, particle erosion, and related effects during sparking [e.g. 2, 3], the generation, growth, and coalescence of intergranular cracks would also result in significant material loss and accelerated erosion during service. Characterization of shorter term NG tested partially worn spark plugs is planned in an attempt to determine the relative contribution of this intergranular cracking to the loss of electrode tip material.

The absence of significant Pt in the emission spectrum of the used plug is consistent with loss of Pt-W alloy by cracking rather than directly during sparking, however, again, the absence of these metals in the emission spectrum could be the result of clustering of atoms during sparking not registering with the spectroscopic techniques used. The cause of this cracking is not yet known, although Pt alloys have been reported to be susceptible to intergranular cracking when exposed to carbon at elevated temperatures [4].

**Figure 8.** SEM micrographs show extensive formation of intergranular cracks in both Pt-W (a) and Ir (b) tip insert after field service. This plug had 4,386 hours of engine operation.

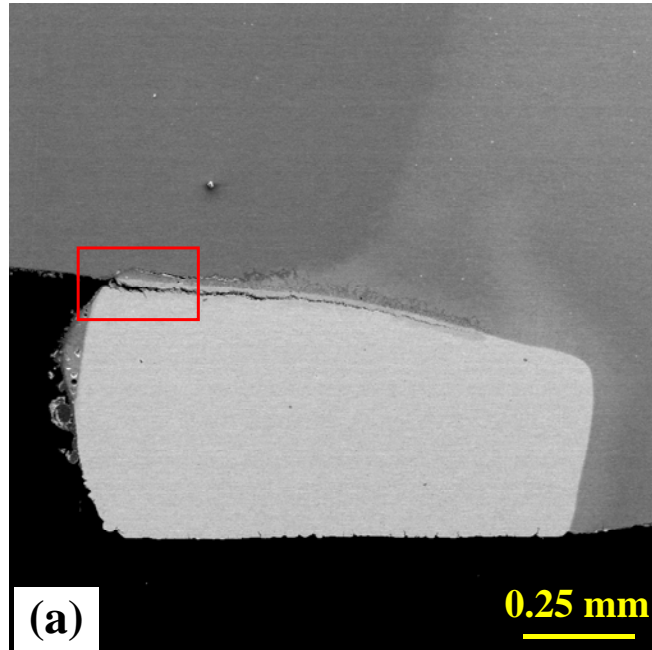
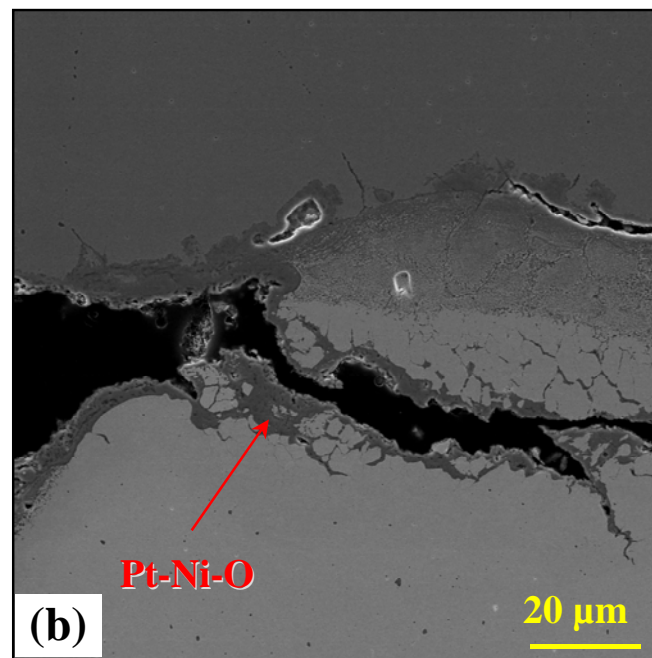
Figs. 9a and 9b show a higher magnification SEM image of the interface between the Ni alloy and the Pt-W alloy insert. An oxidized crack was found to extend along much of the interface, effectively nearly completely separating the Pt-W tip from the ground electrode. Such cracking has been observed in several end-of-life plugs, and may be the life-limiting final step in the wear process. Susceptibility at this location may be the result of interdiffusion or joining issues between the Pt-W tip and Ni alloy.

**Figure 9.** (a) SEM micrographs show extensive oxidation and crack formation at the interface between Ni alloy and Pt-W tip insert after field service and (b) a detailed view of the crack. This plug had 4,386 hours of engine operation.
