Characterization of Erosion and Failure Processes of Spark Plugs After Field Service in Natural Gas Engines

H. T. Lin and M. P. Brady
Metals and Ceramics Division

Oak Ridge National Laboratory
Oak Ridge, TN 37831

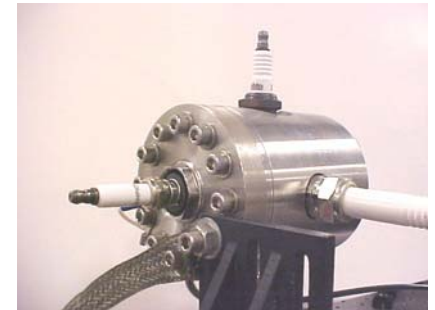
Optical Spectroscopic Analysis Detected Substantial Amount Calcium Present in Field Tested Spark Plugs

- Ca from the engine oil
- No detection of Pt or Ir from electrode tips

Detection of Ni in new spark plug suggests the erosion of Ni-based electrode due to sputtering process

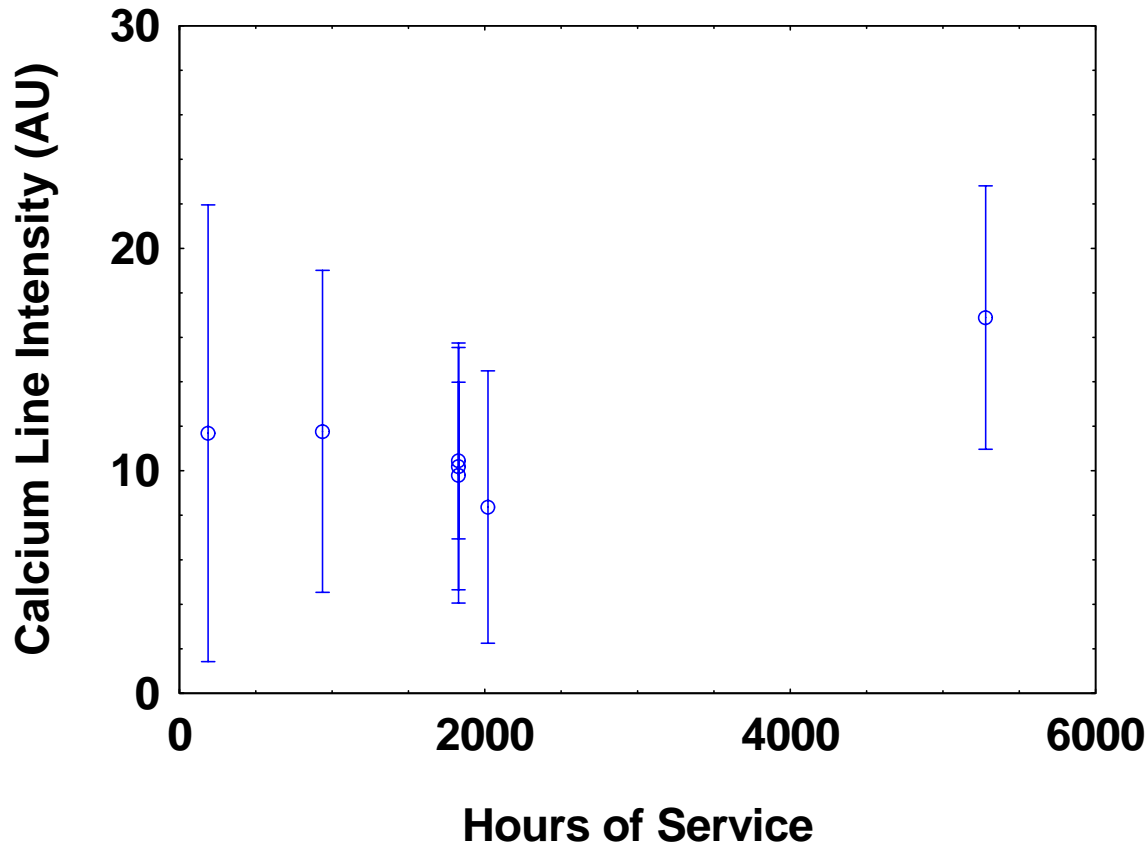
Variation of Calcium with Hours of Service

- Large variation plug-to-plug

- Rapid saturation of calcium

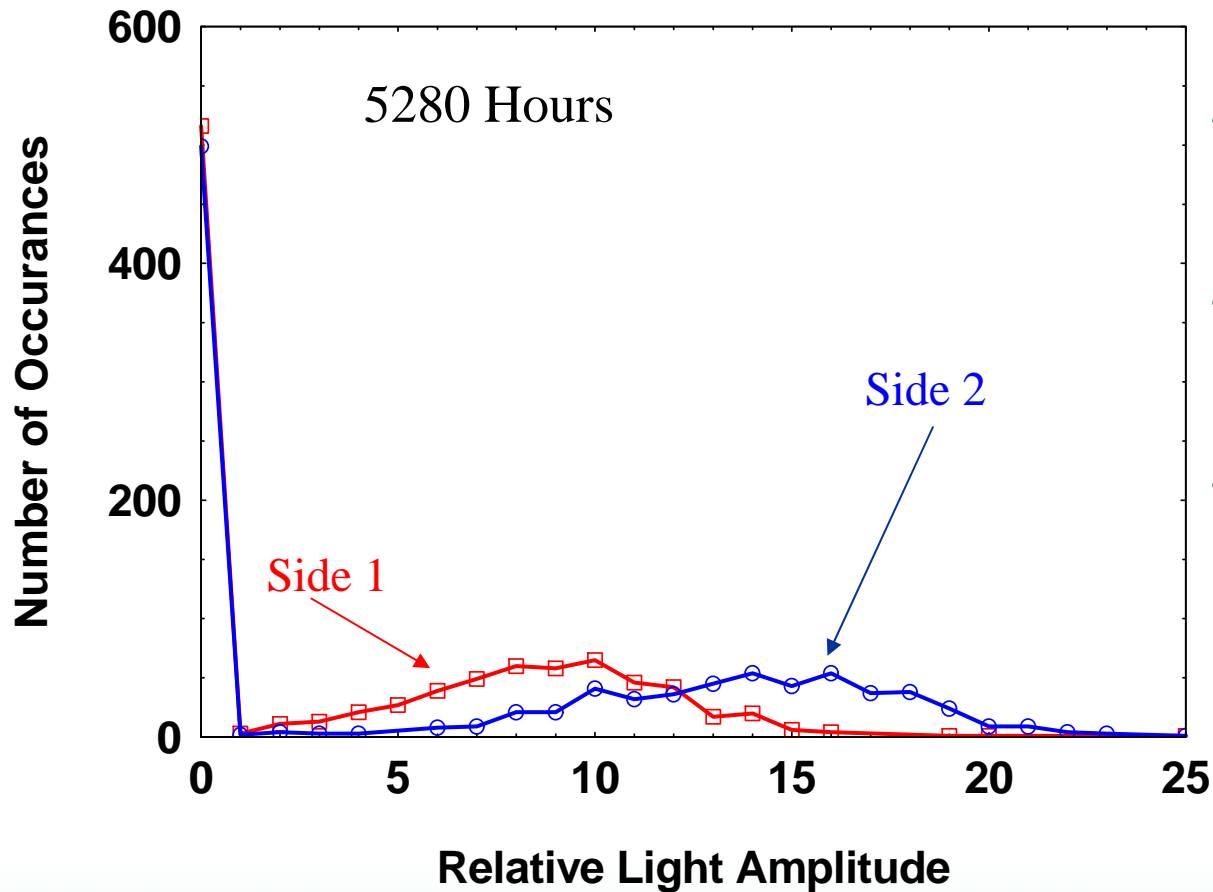
FOR 1000 CONSECUTIVE ARCS HALF PRODUCE NO SPECTROSCOPIC SIGNAL

- Light still present – misses collecting optics
- Two distinct spatial points of light from each side of plug tip
- Amplitude can be used to see where breakdown occurred

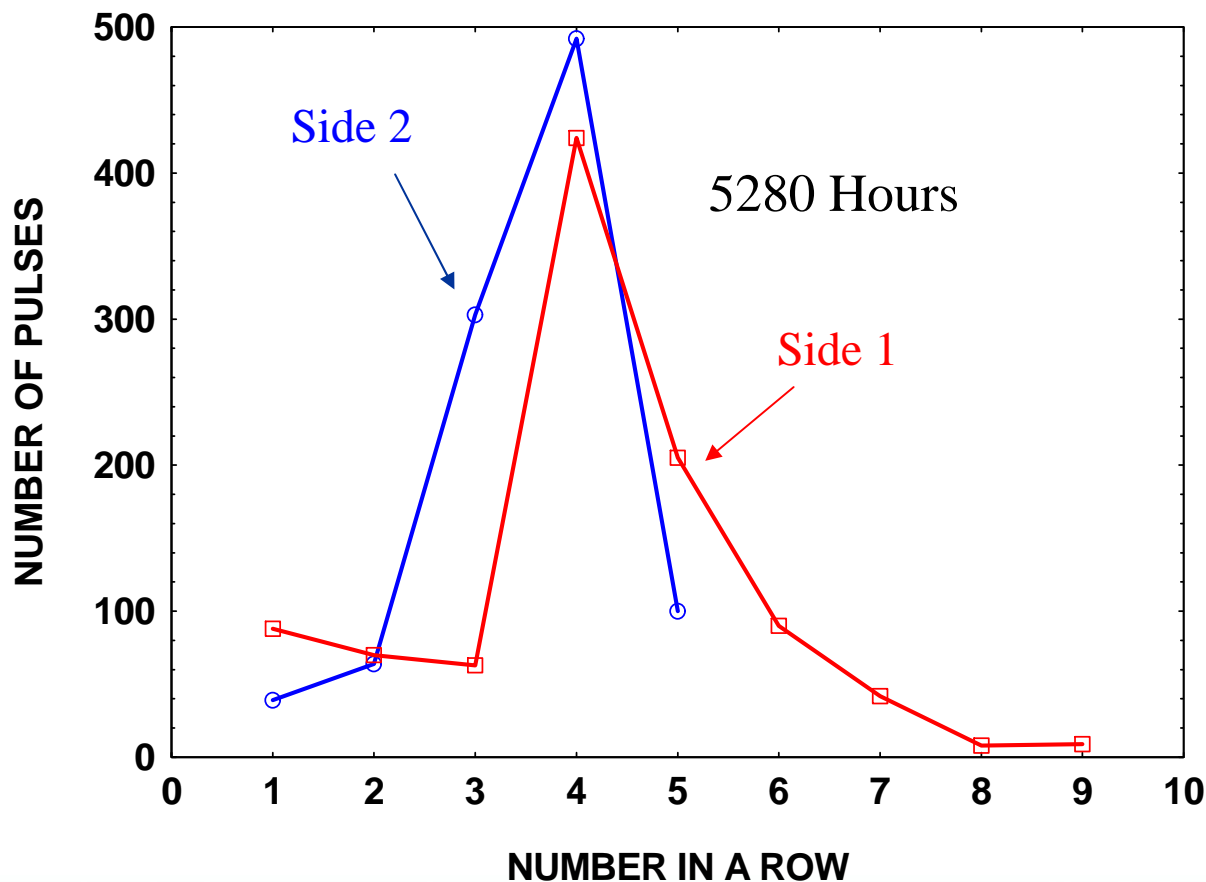
ARC LOCATION IS PREDICTIVE – AFTER 4 CONSECUTIVE BREAKDOWNS AT SAME LOCATION THE ARC MOVES TO THE OTHER SIDE

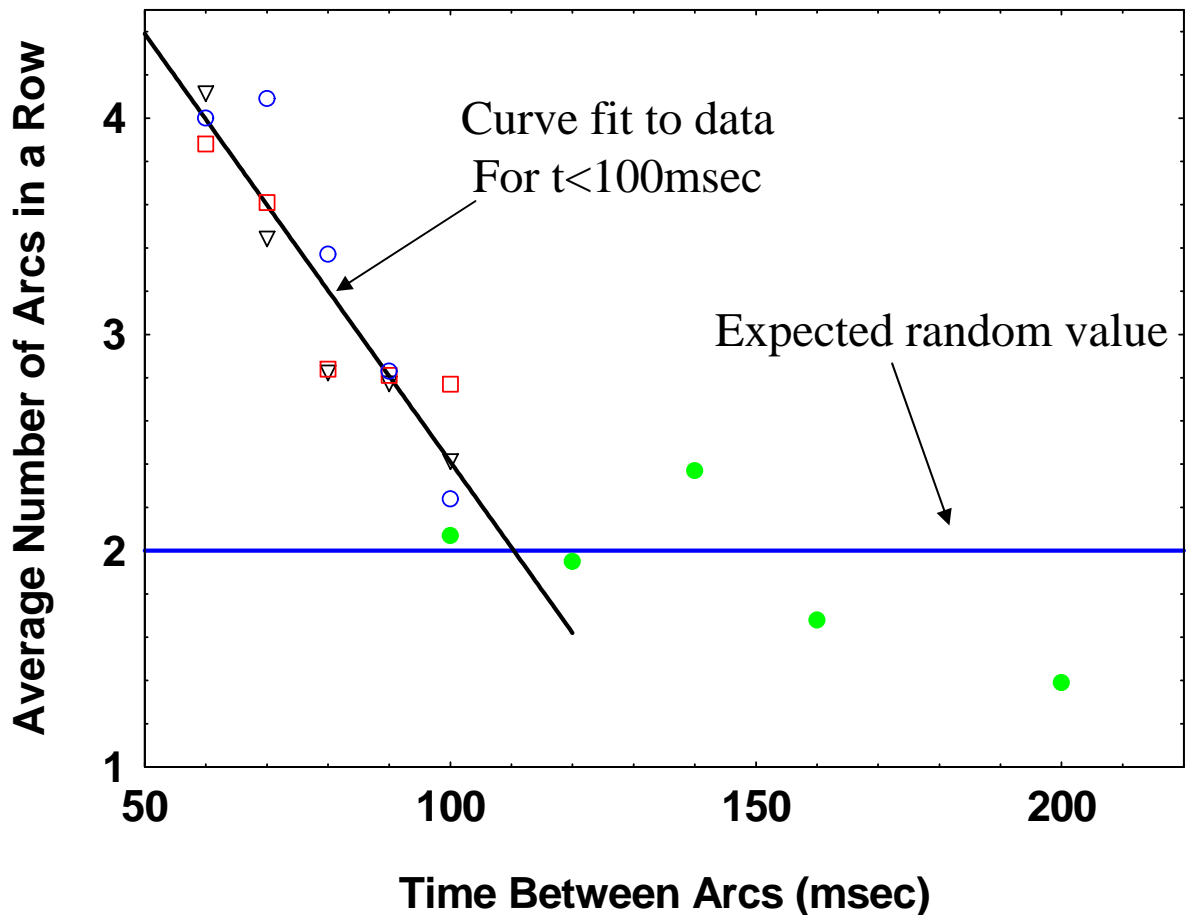
Spark Variation with Rate

- Some variation plug-to-plug
- Expect a value of 2 for random events
- Trend toward random arcs for longer times
- A longer time allows the plug tip to cool
