Protocol for Selecting ASR-Affected Structures for Lithium Treatment

Publication No. FHWA-HRT-06-071

This TechBrief describes a protocol for evaluating damaged concrete structures to determine whether they are suitable candidates for lithium treatment to address alkali-silica reactivity (ASR). A major part of the TechBrief's source document, *Protocol for Selecting Alkali-Silica Reaction (ASR)-Affected Structures for Lithium Treatment* (FHWA-HRT-04-113), deals with the approach/tools that can be used to determine whether ASR is the principal cause, or only a contributing factor to, the observed deterioration (diagnosis); determine the extent of deterioration due to ASR in the structure; and evaluate the potential for future expansion due to ASR (prognosis). A full version of the report is available through the Federal Highway Administration (FHWA).⁽¹⁾

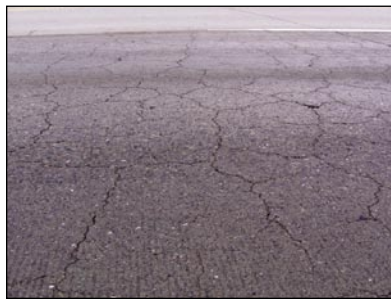
Figure 2. Map cracking in a section of pavement on Interstate 84 near Mountain Home, ID.

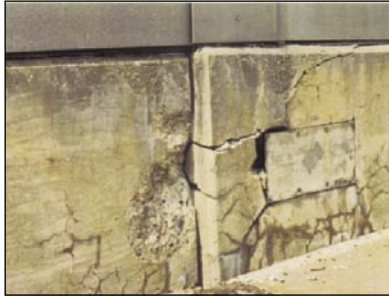
Figure 5. Misalignment of adjacent sections of a parapet wall on a highway bridge due to ASR-induced expansion.⁽²⁾

such as relative movements, misalignment, or separation of adjacent concrete members or structural units. (See figure 5.)

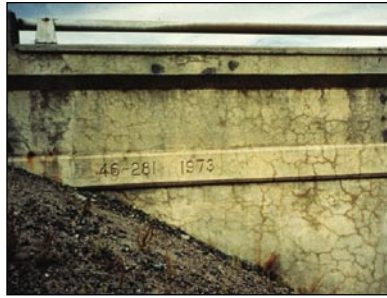
Figure 6. Surface discoloration in a bridge structure caused by ASR.

- *Surface discoloration.* Cracks caused by ASR often are bordered by a broad brown zone that appears to be permanently damp. (See figures 6 and 7.)
- *Surface deposits* (gel exudation versus efflorescence). Although surface gel exudation is a common and characteristic feature of ASR, the presence of surface deposits is not necessarily as indicative of ASR as of other mechanisms (such as frost action); however, a chemical analysis can help determine whether ASR gel is present in the deposit. Canadian Standards Association (CSA) A864 provides a classification system based on the occurrence of the above features obtained from the field survey of concrete structures.⁽³⁾ Additional information can be found in the FHWA document FHWA-HRT-04-113.⁽¹⁾

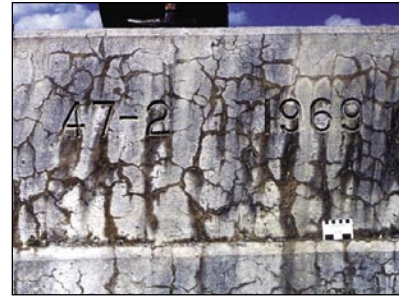
Figure 7. Concrete structure showing discoloration, or "gel staining," around cracks.

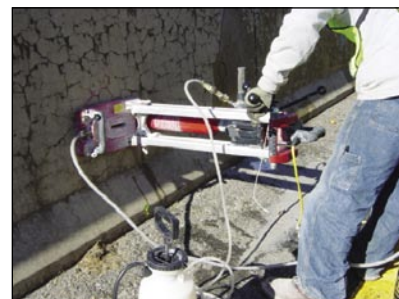
Figure 8. Core extraction from a concrete barrier along State Highway 2 near Leominster, MA.

Samples, typically 100 millimeters in diameter, are to be taken from the major components of the structure and/or those areas showing the most typical signs of deterioration. Samples also are needed from areas subjected to different exposure conditions and exhibiting different degrees of damage. (See figure 8.)

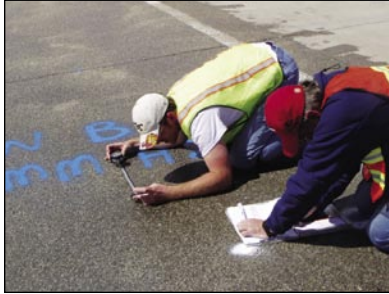
Figure 13. Expansion measurements being conducted after pavement was treated with lithium nitrate.

- **Expansion measurements.** The long-term change of length between reference points mounted on or embedded in the concrete surface can be measured. (See figure 13.)
- **Crack mapping.** Crack mapping is a useful visual tool for evaluating the progress of the expansion or deterioration. (See figure 14.)
- **Temperature and humidity measurements.** Humidity and temperature measurements at different depths within the concrete elements can be helpful when inter-
